Bridge Needs Study 2024

INSPECTION SUMMARY REPORT

Town of Parry Sound

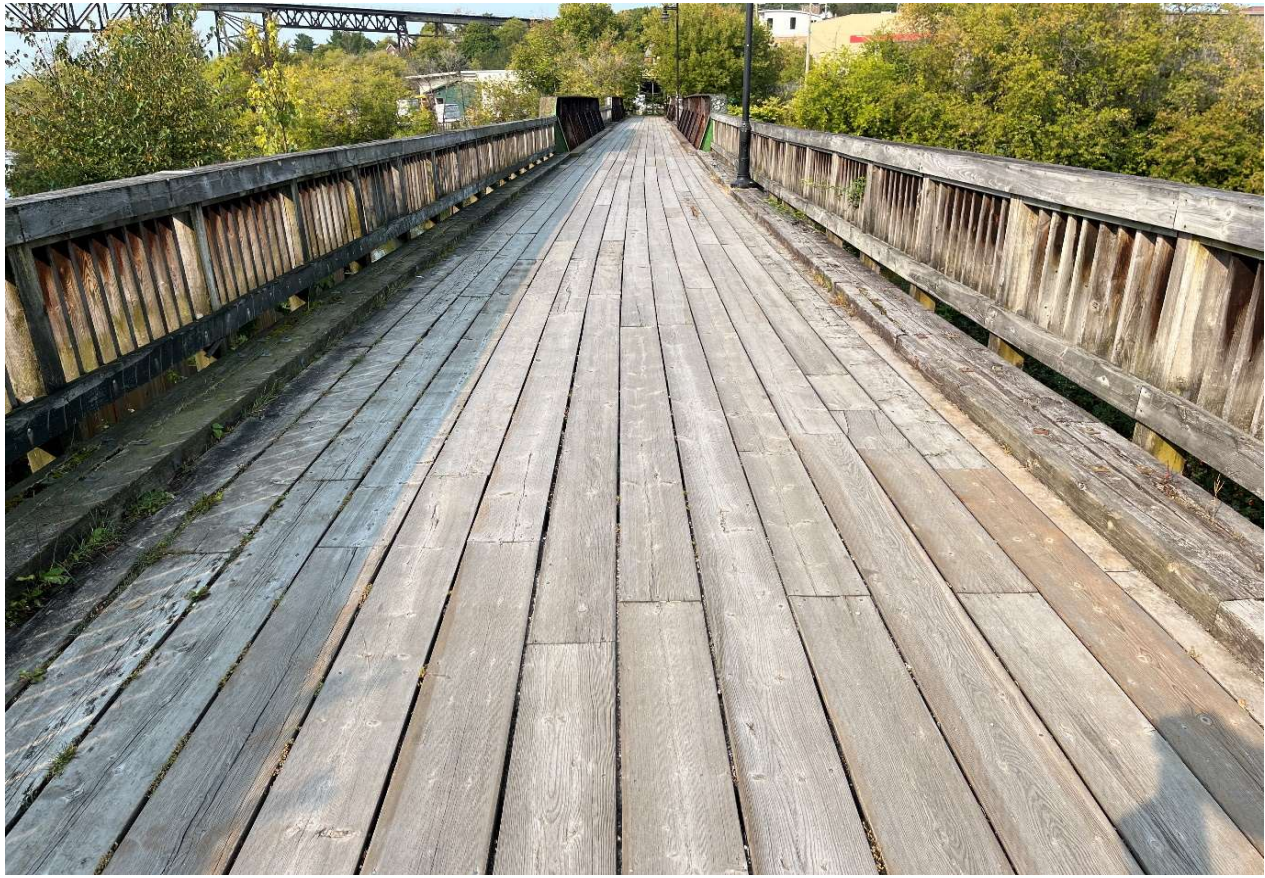
Description of Photo: Wearing surface, typ.

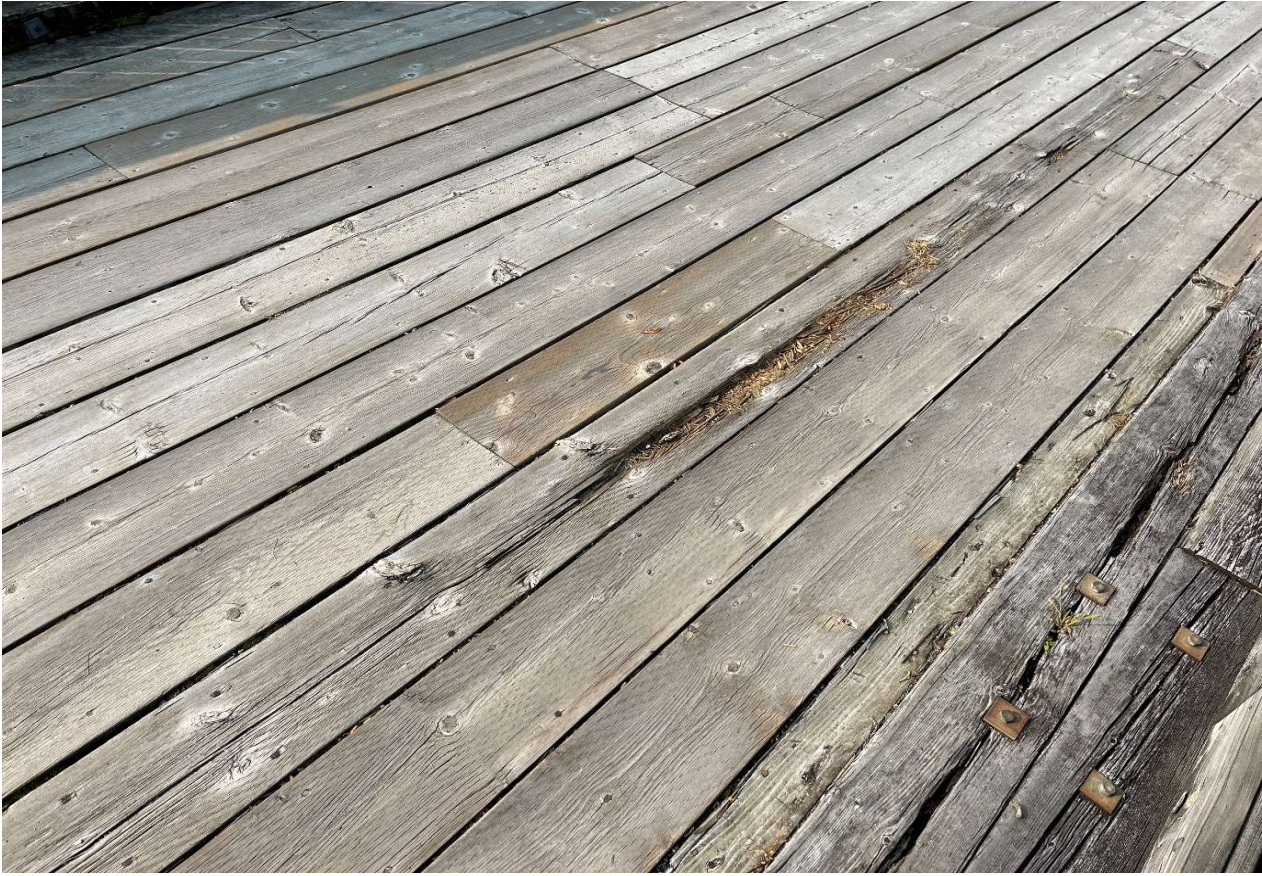
Description of Photo: Rotten board

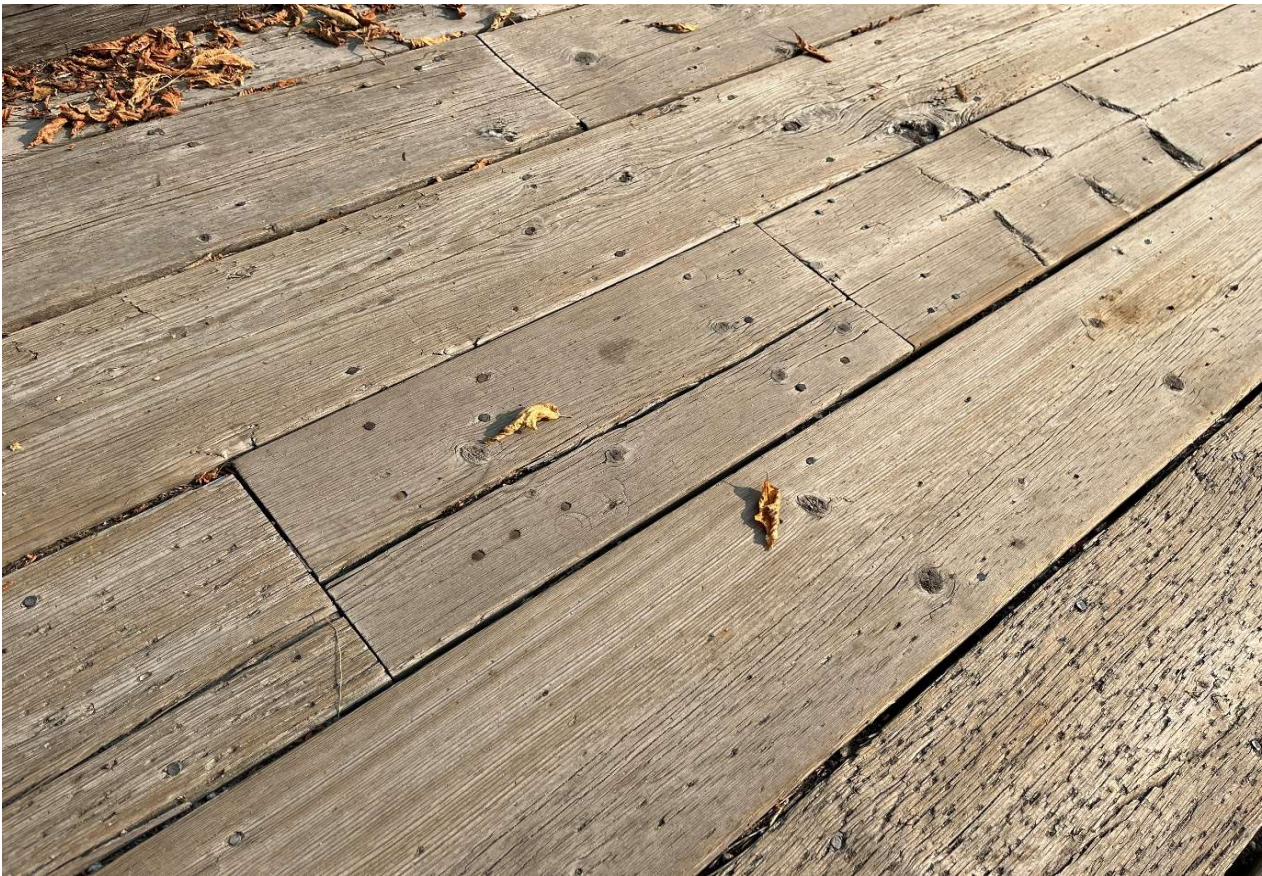
Description of Photo: Split board

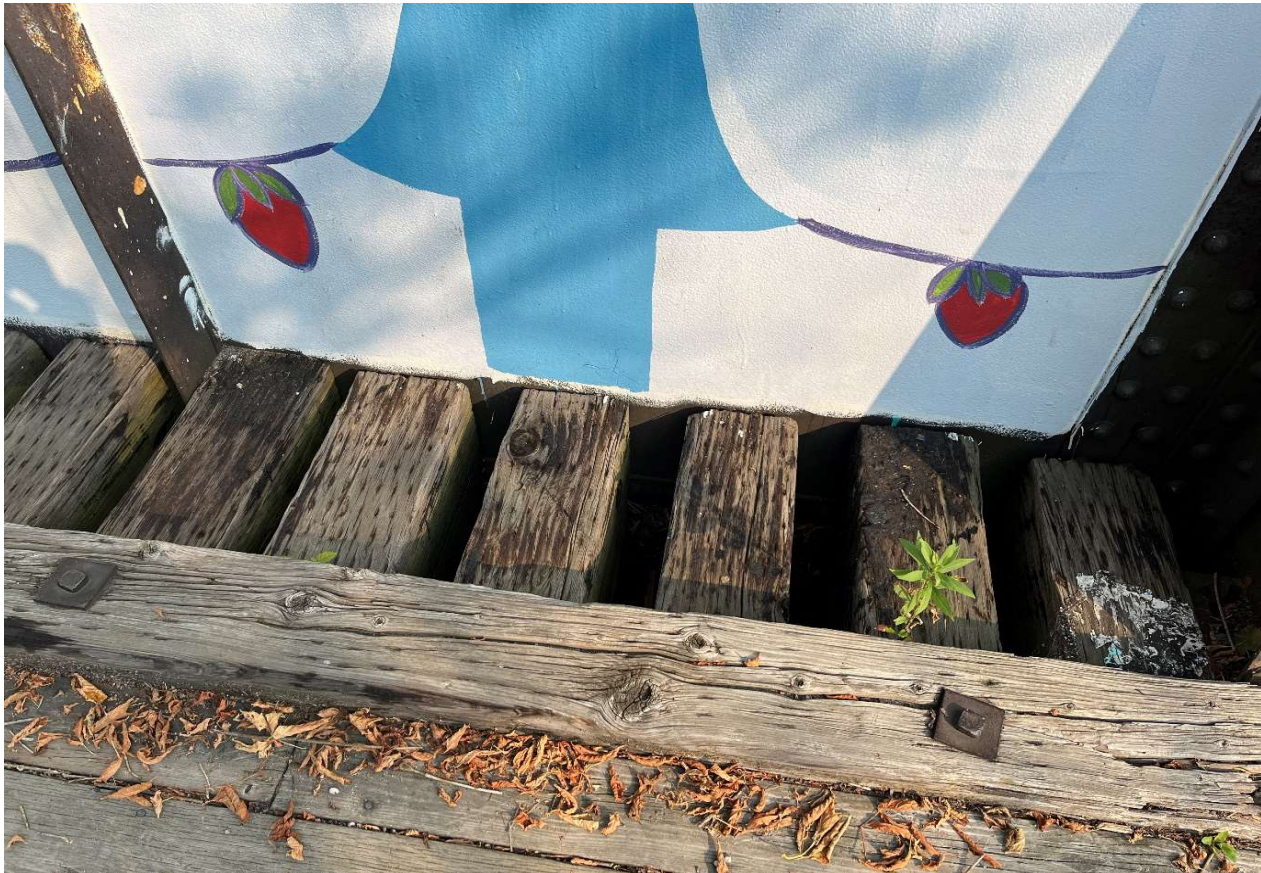
Description of Photo: Deck top

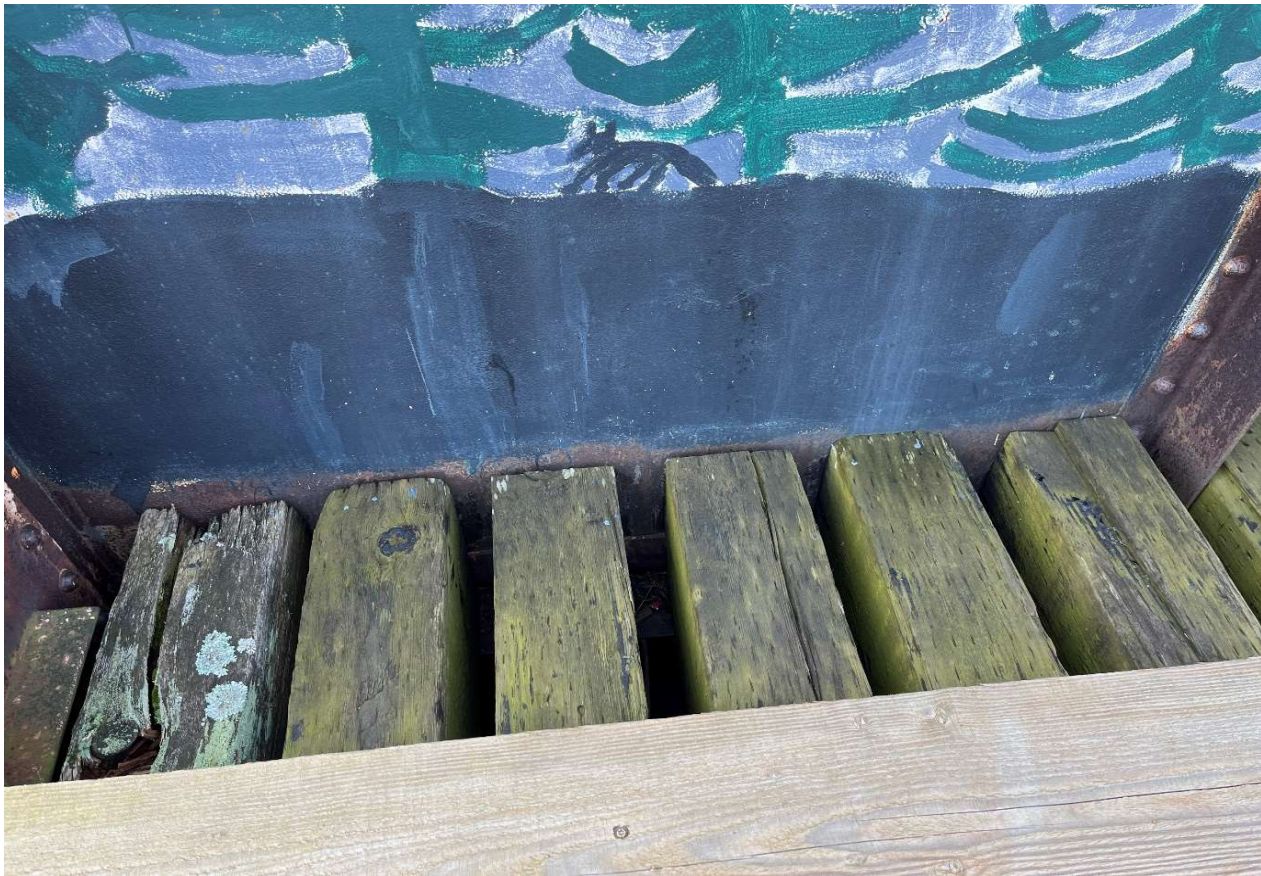
Description of Photo: Deck top

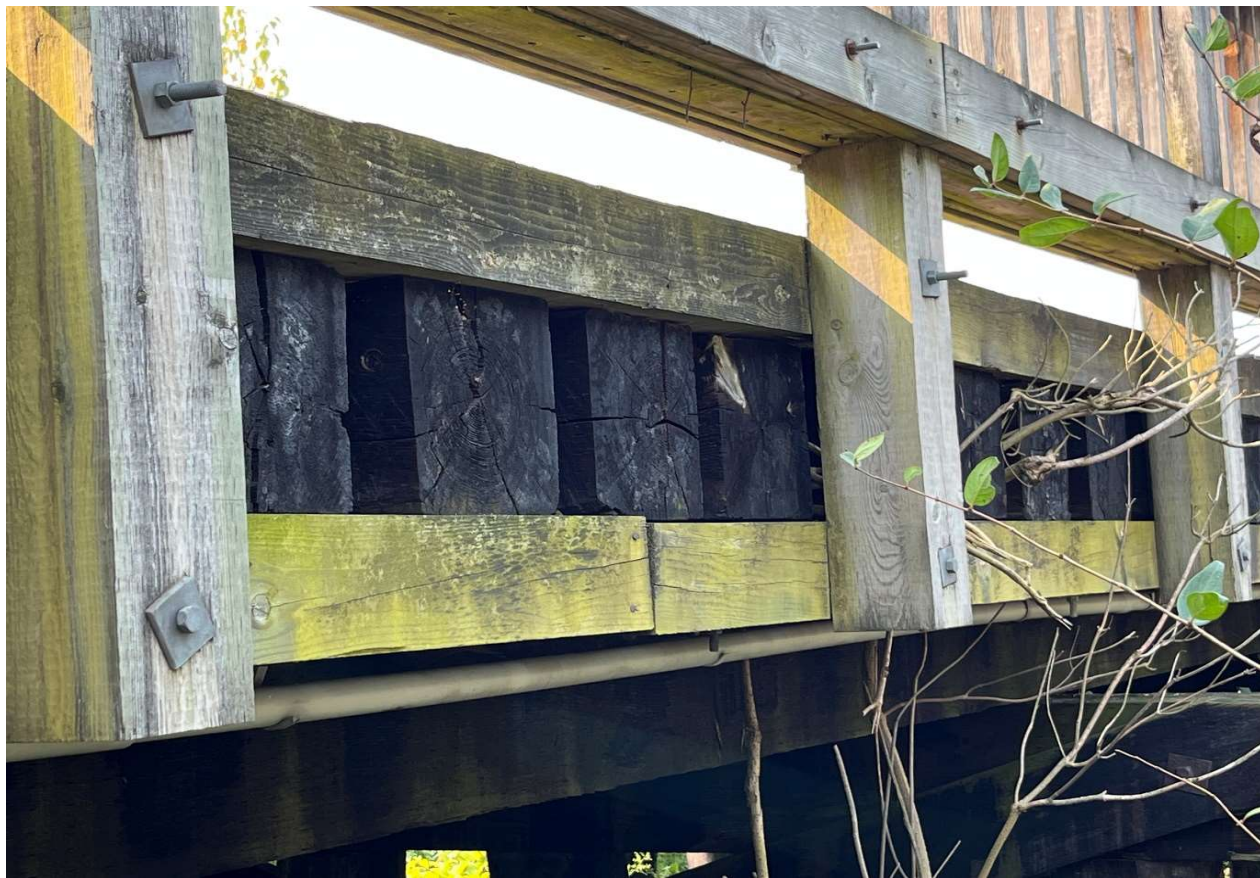
Description of Photo: Crossies

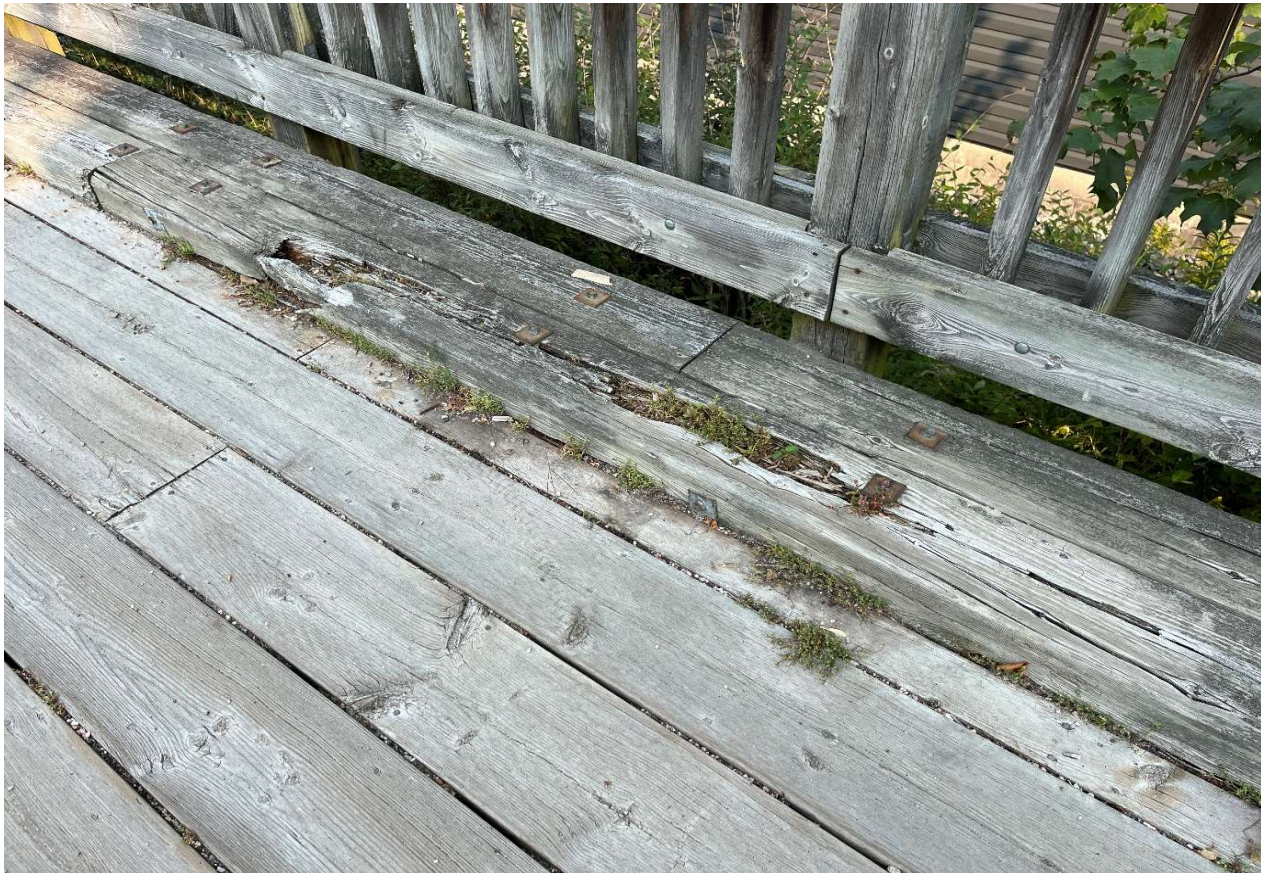
Description of Photo: Rotten curb

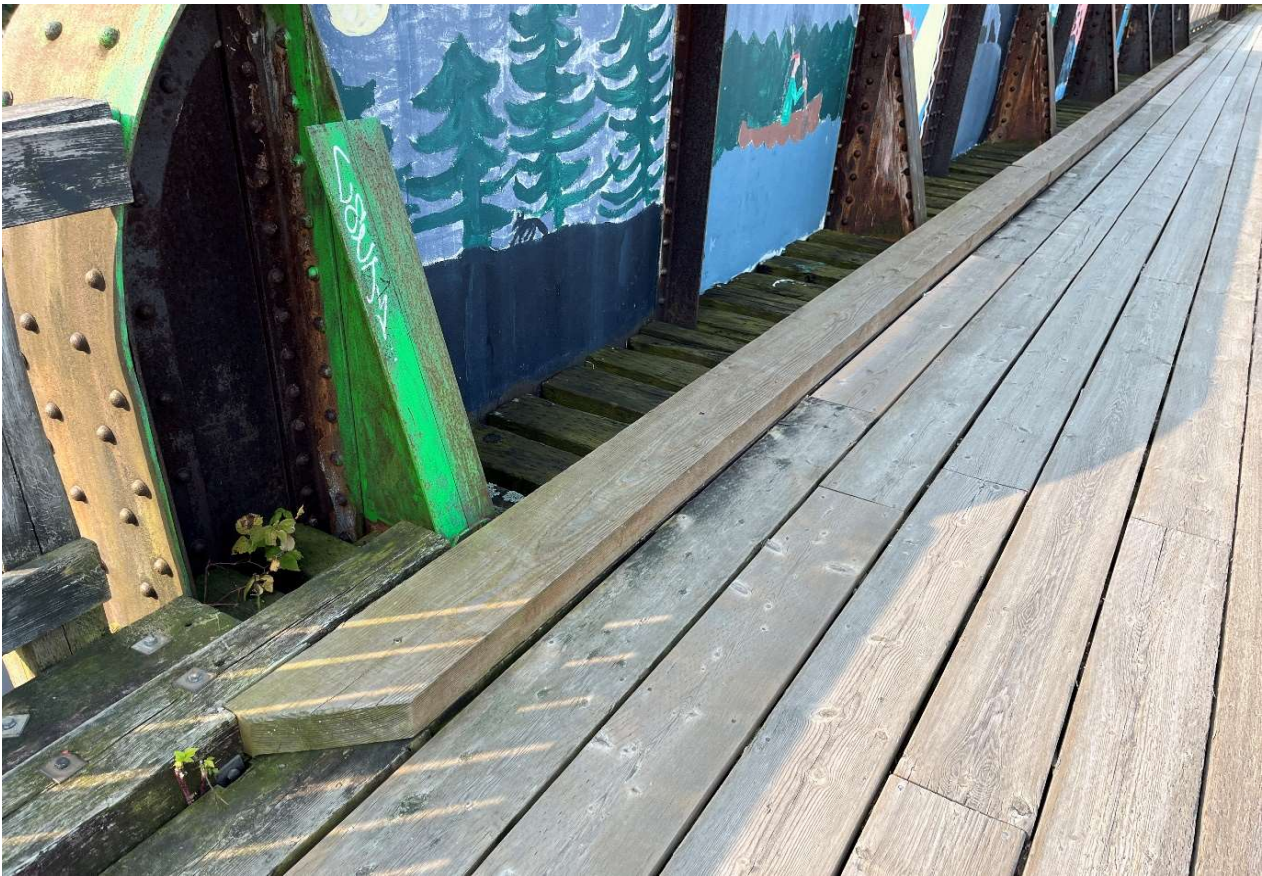
Description of Photo: Curb

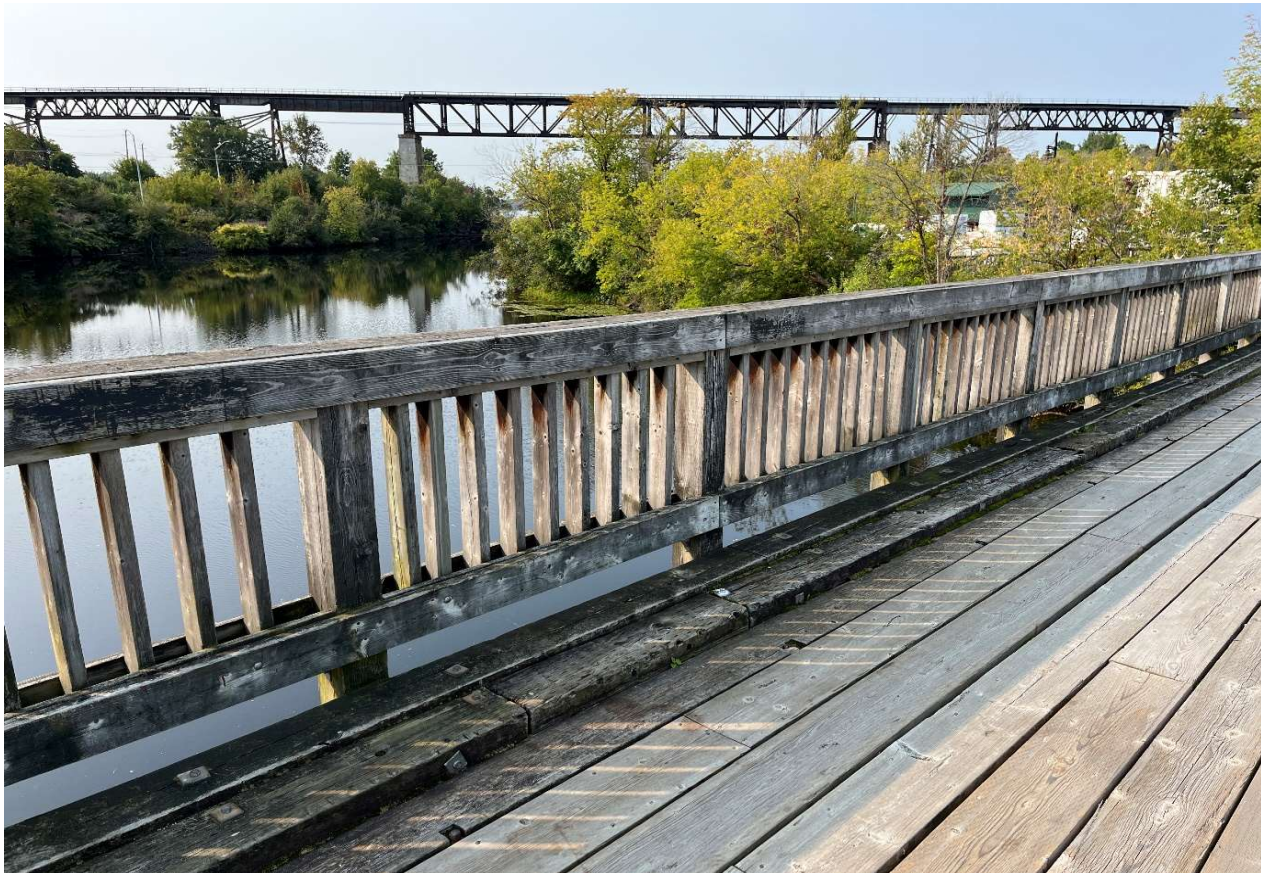
Description of Photo: Railing system

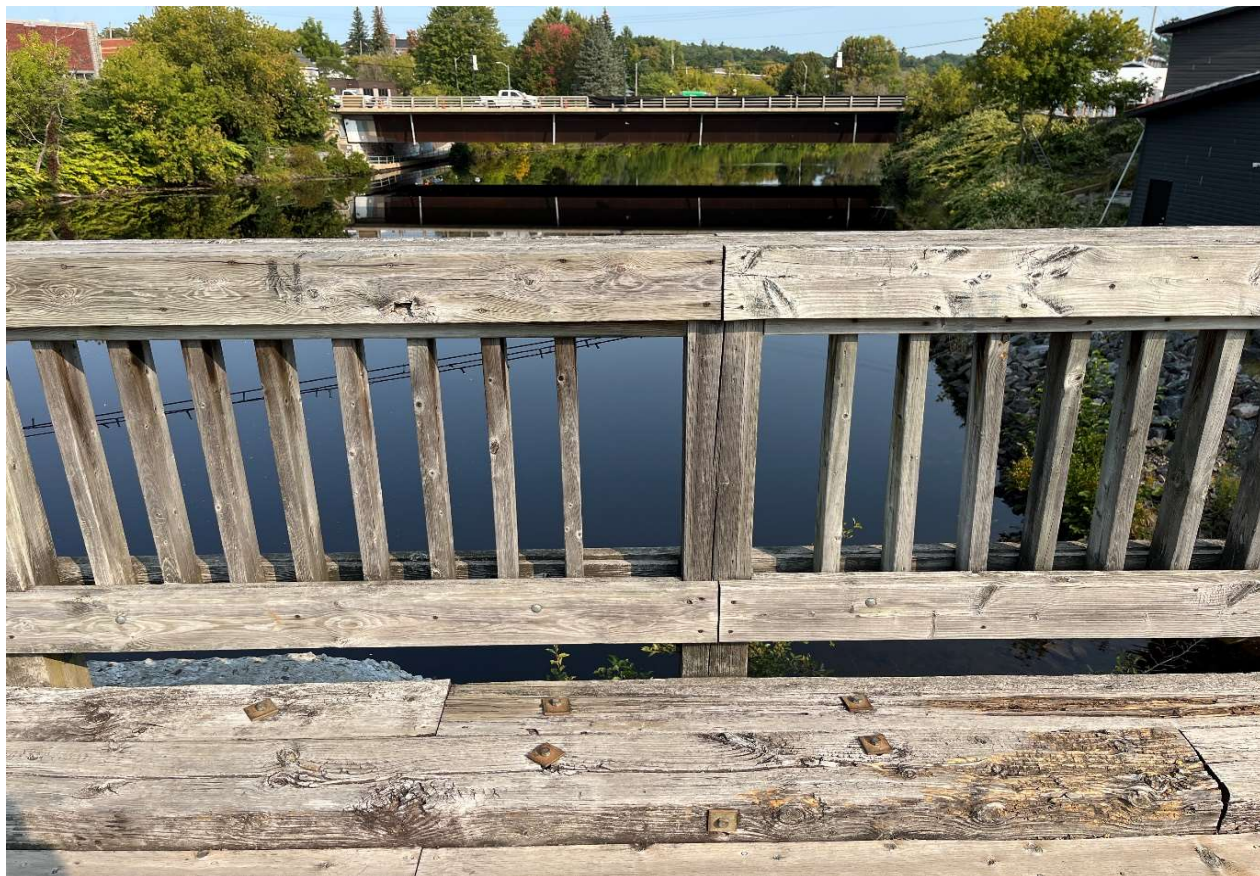
Description of Photo: Missing picket at north

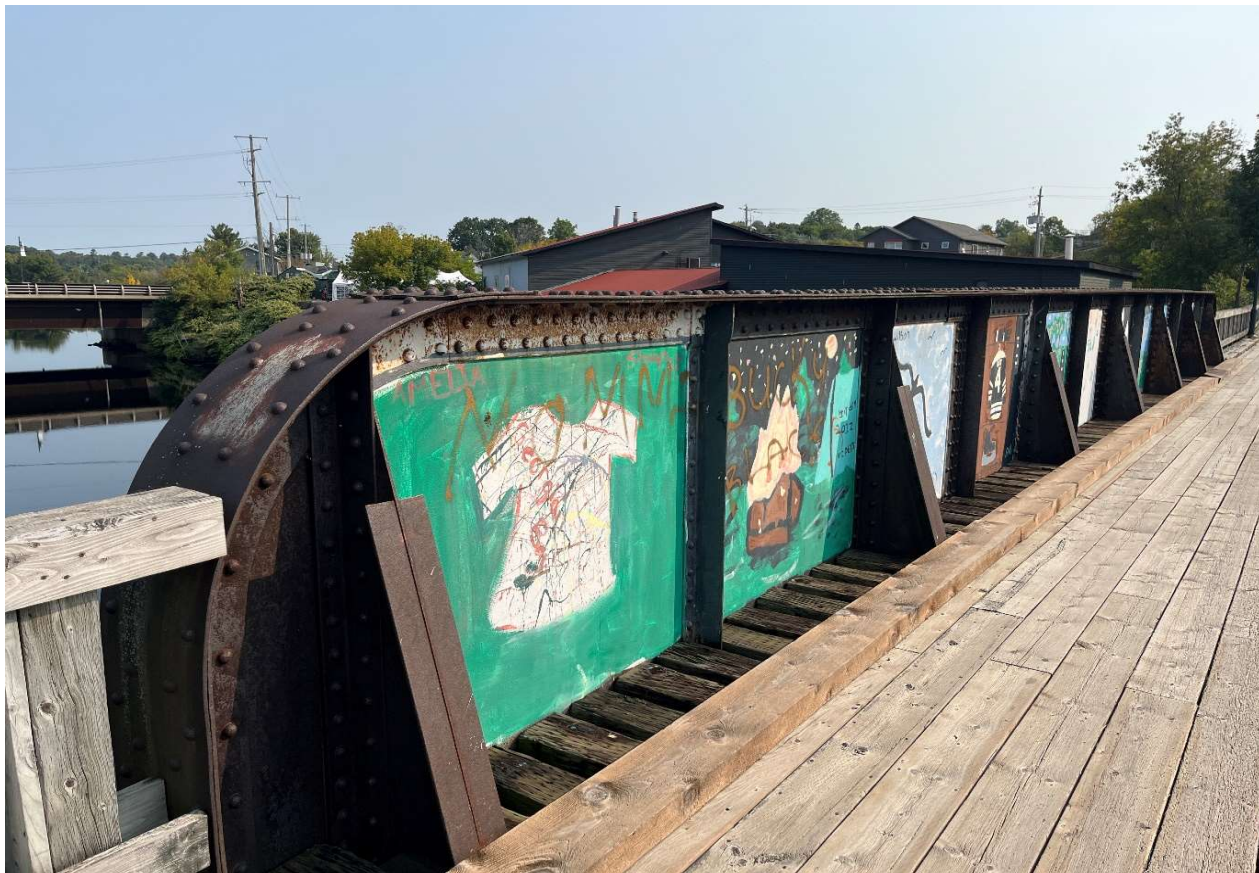
Description of Photo: Inside face of girder

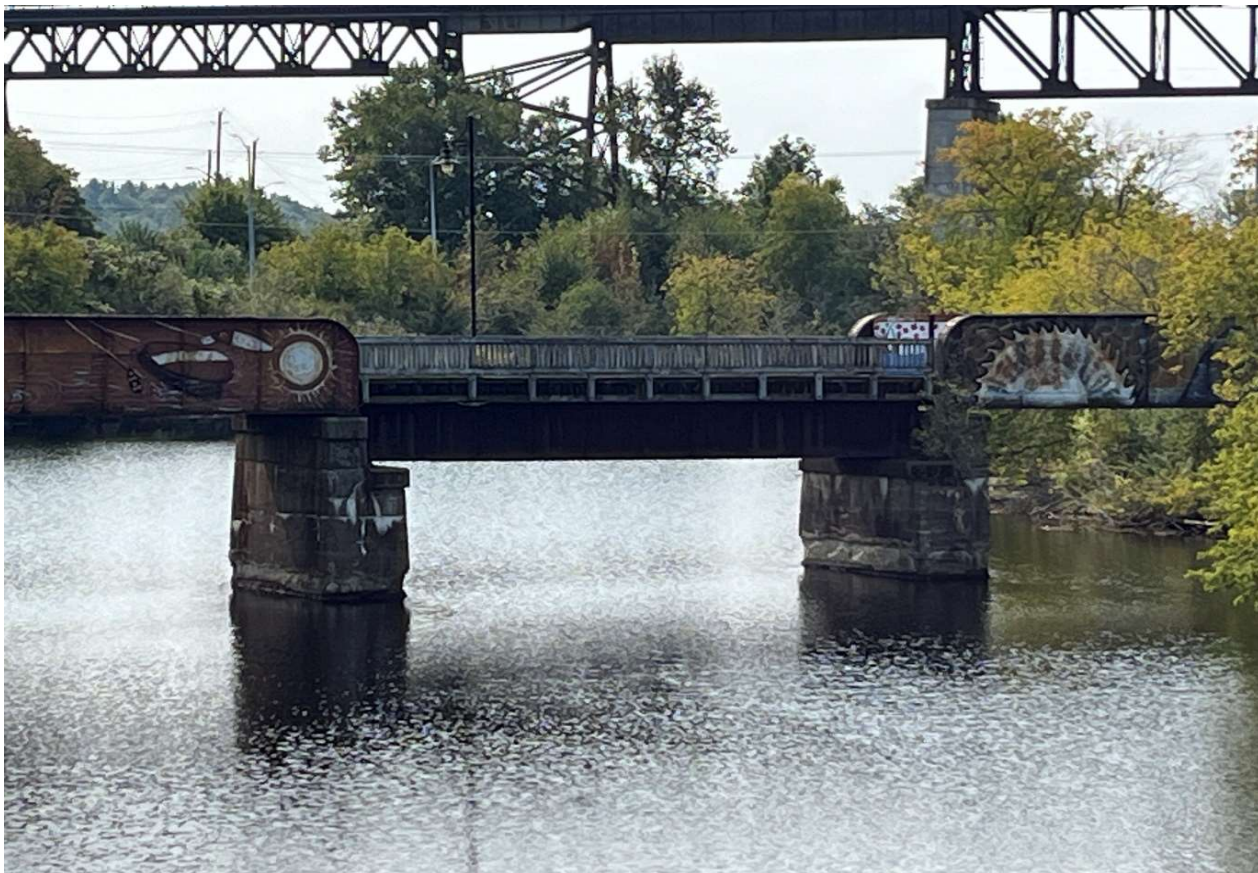
Description of Photo: Deck Plate girder span

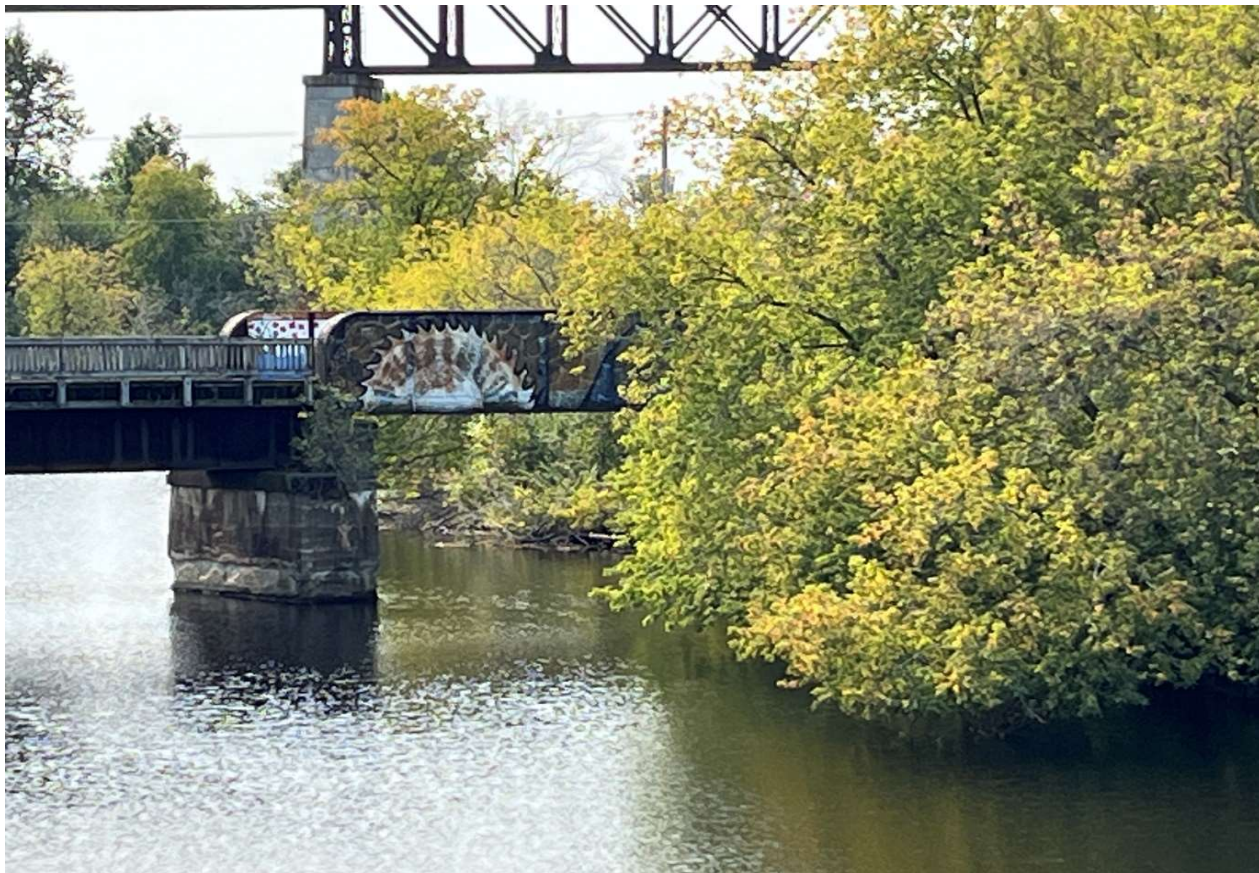
Description of Photo: West through plate girder span

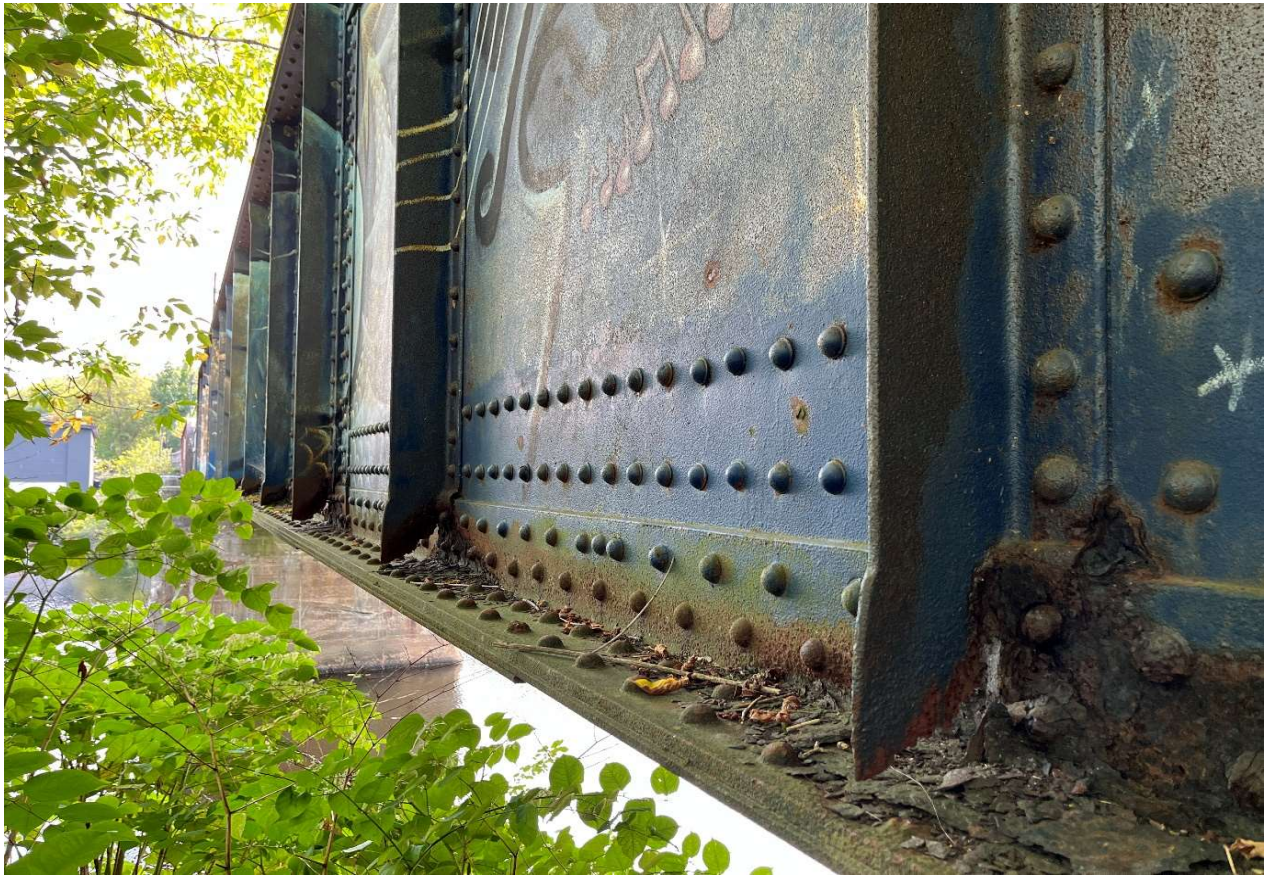
Description of Photo: Exterior face, Note corrosion at bottom of stiffeners

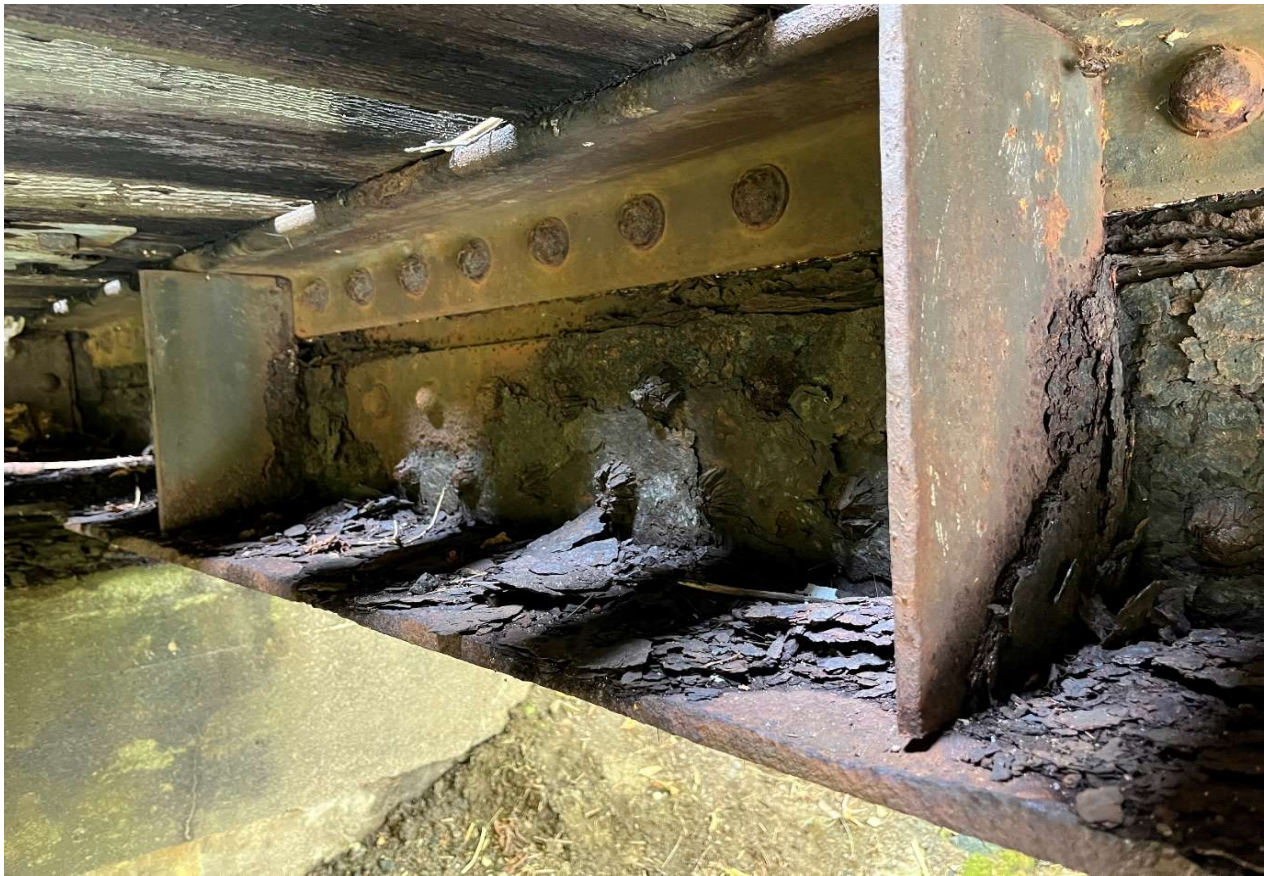
Description of Photo: Severe corrosion along bottom flange

The structure is in generally good to fair condition. A major rehabilitation should be planned within the 1-5 year timeframe, including repairs to Span 12 steel, concrete repairs for the abutment wall and three piers within waterway, and repair railing system.

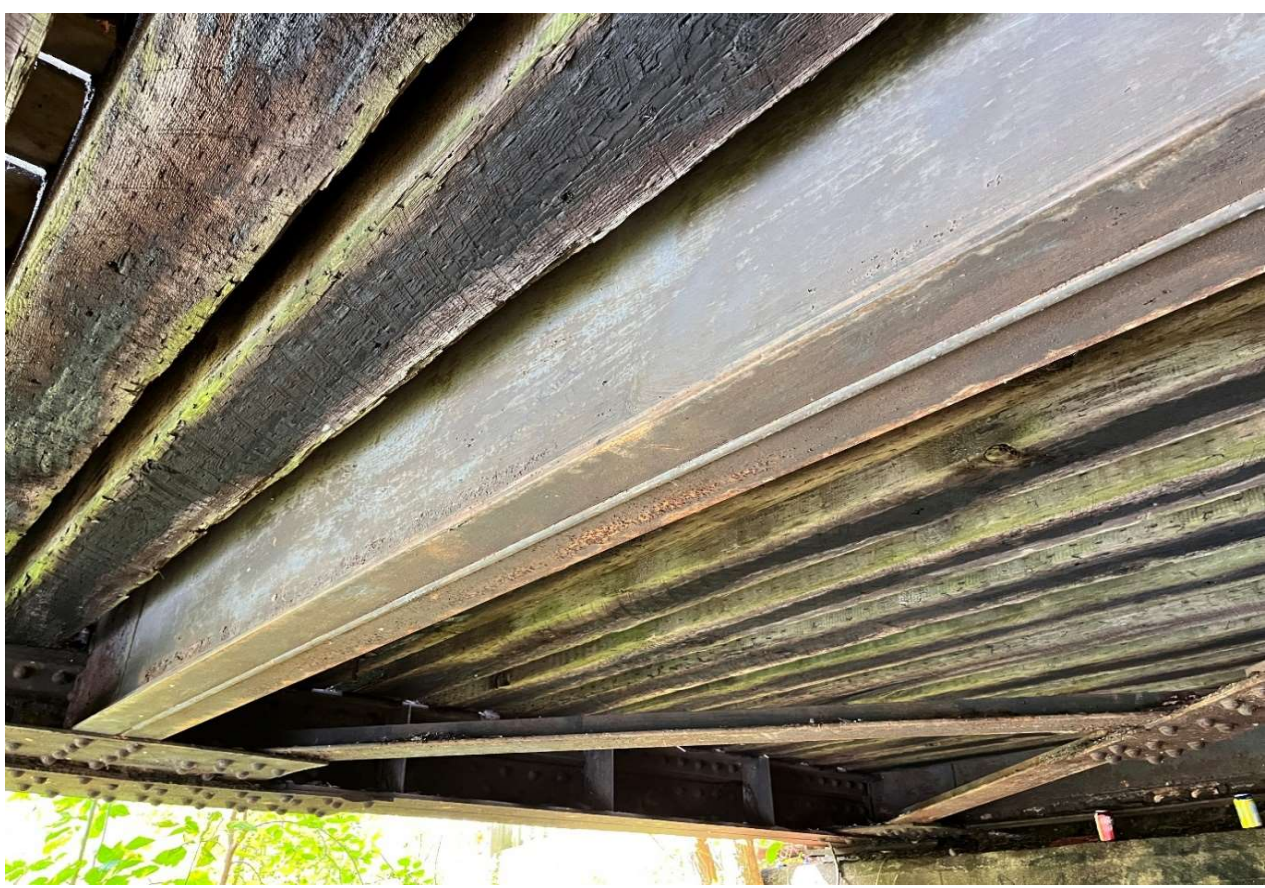
Description of Photo: Floor beams

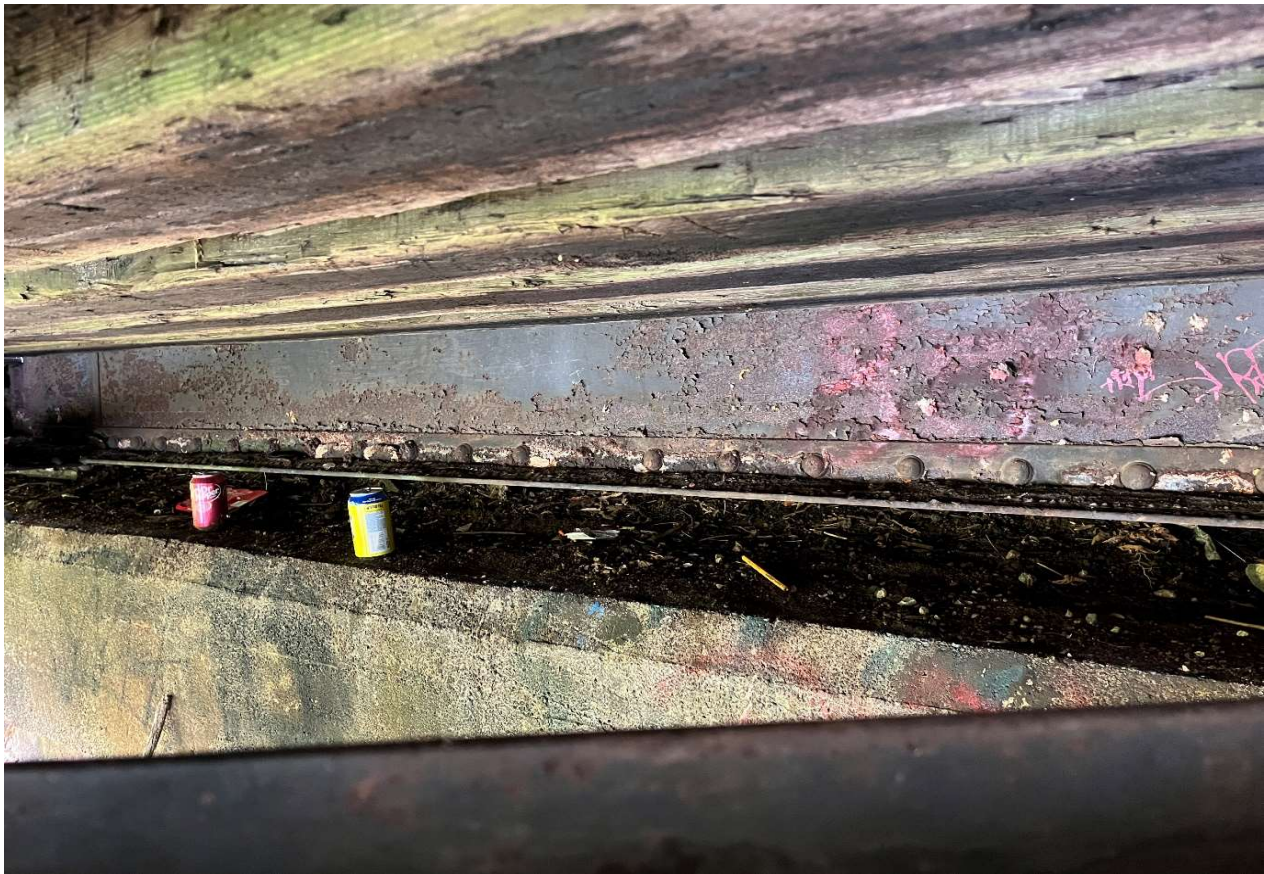
Description of Photo: Floor beams

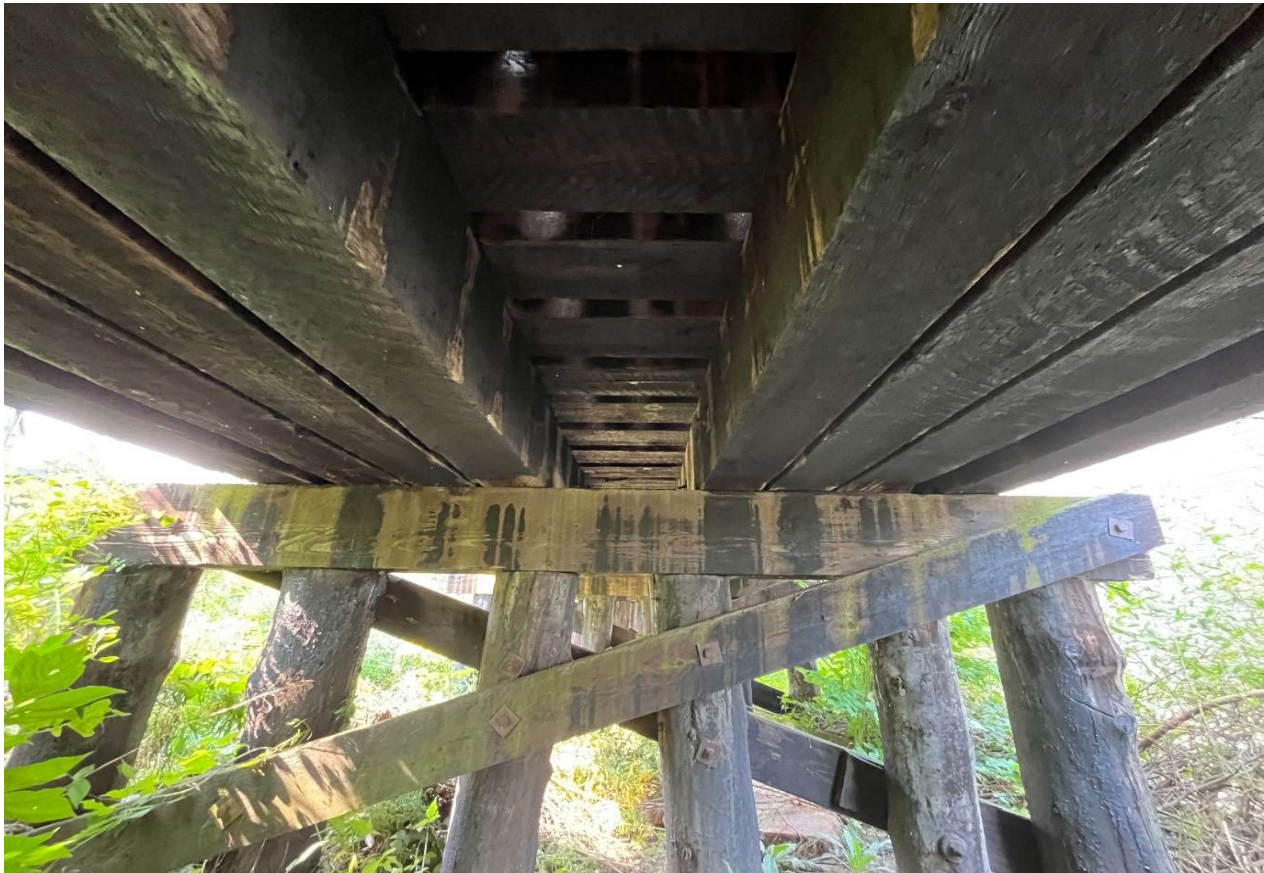
Description of Photo: Stringers

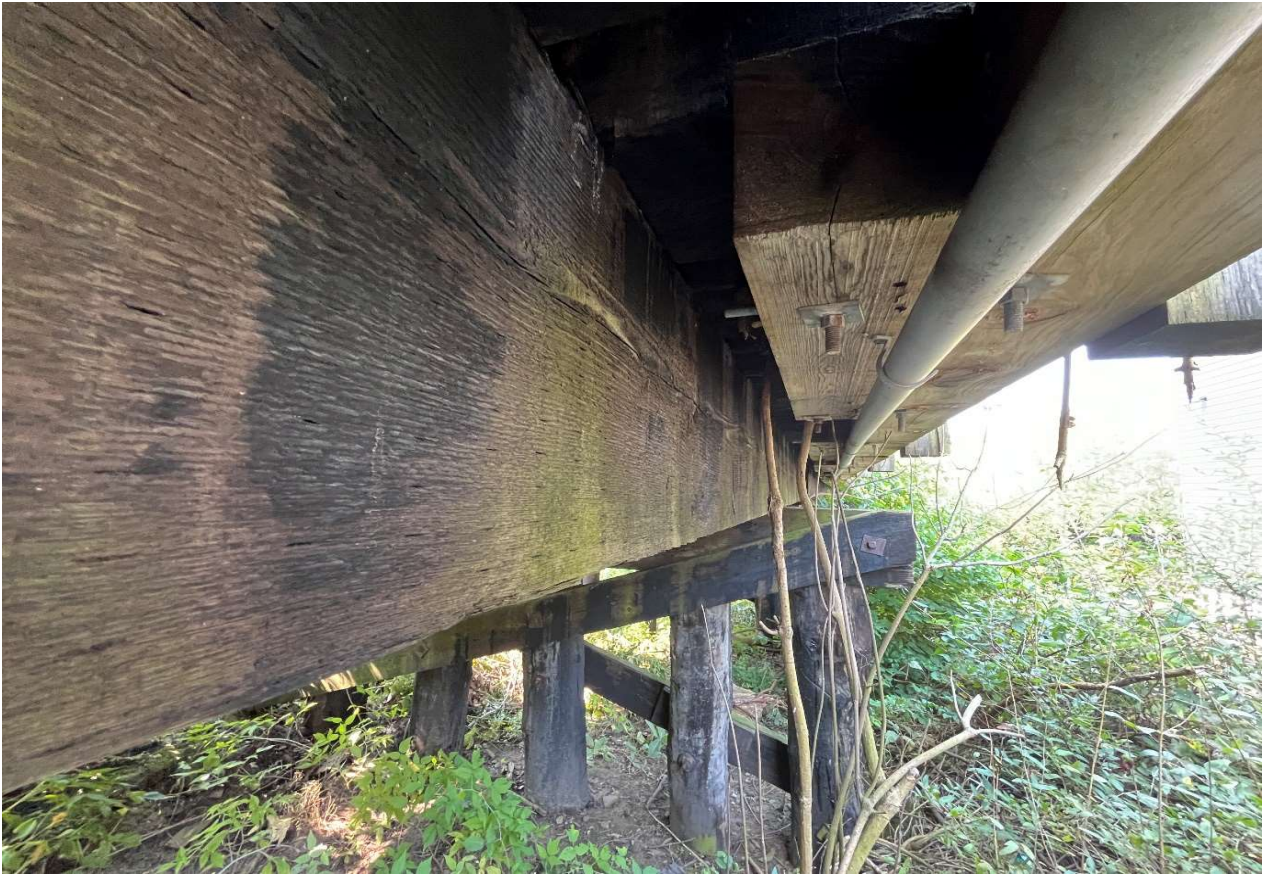
Description of Photo: Stringers

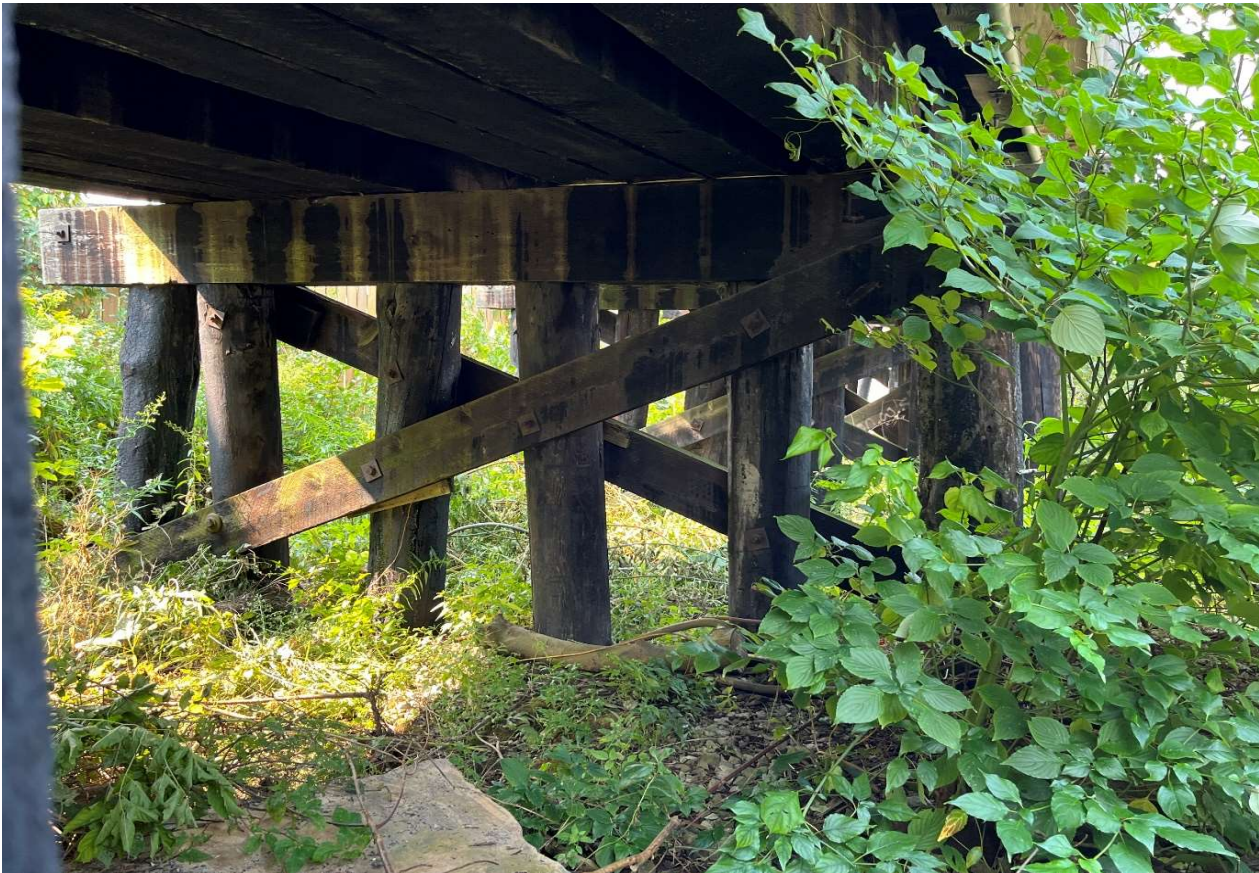
Description of Photo: Pier column bracings
