Bridge Needs Study 2024

INSPECTION SUMMARY REPORT

Town of Parry Sound

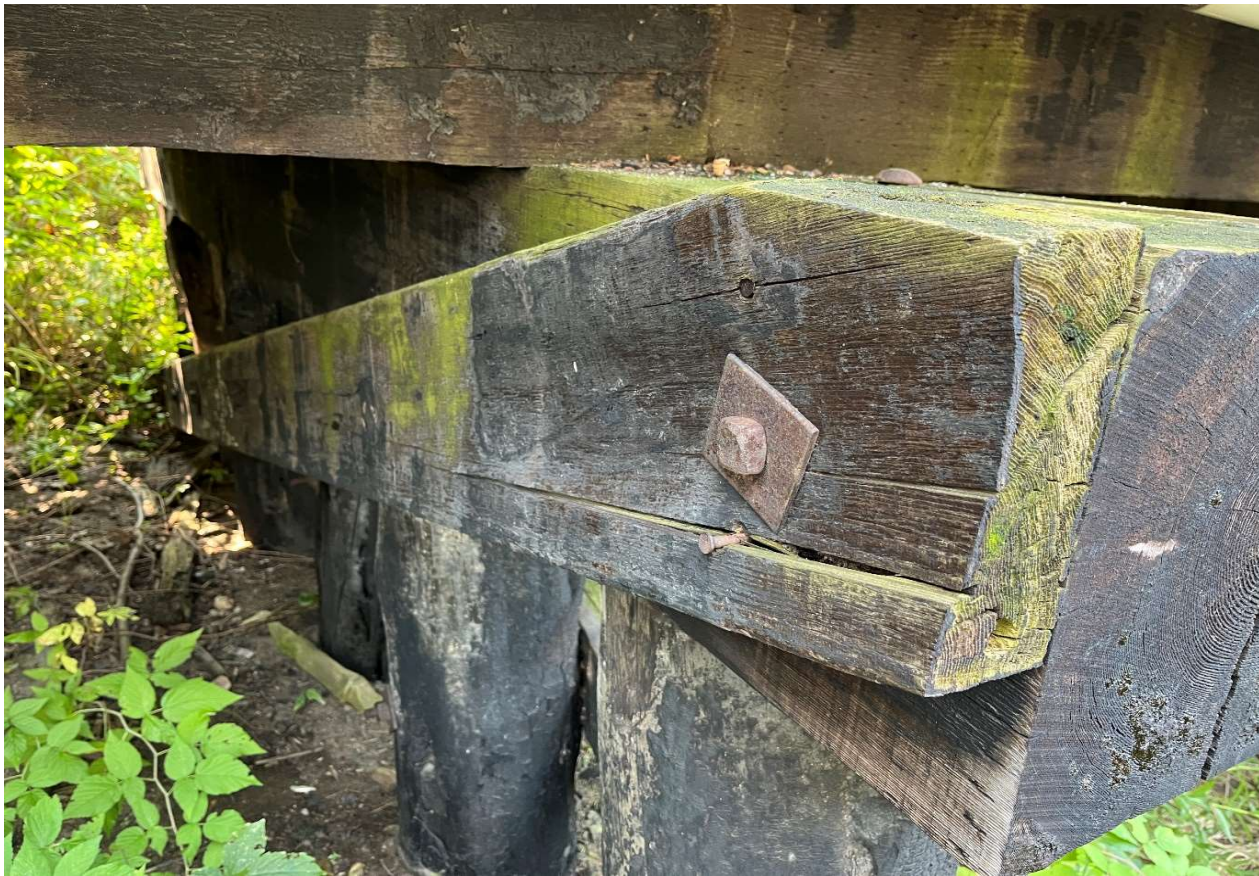
Description of Photo: Pier column bracings

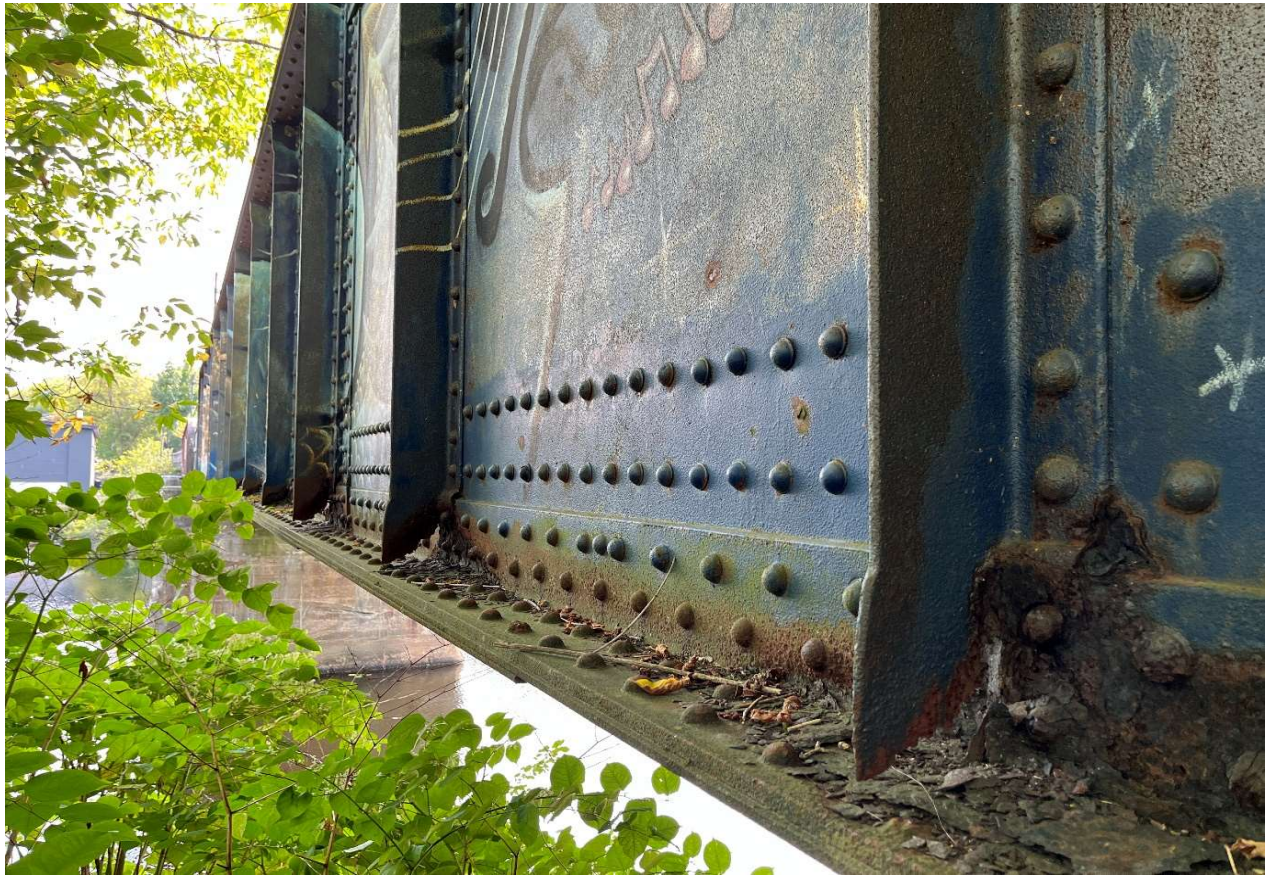
Description of Photo: Coating

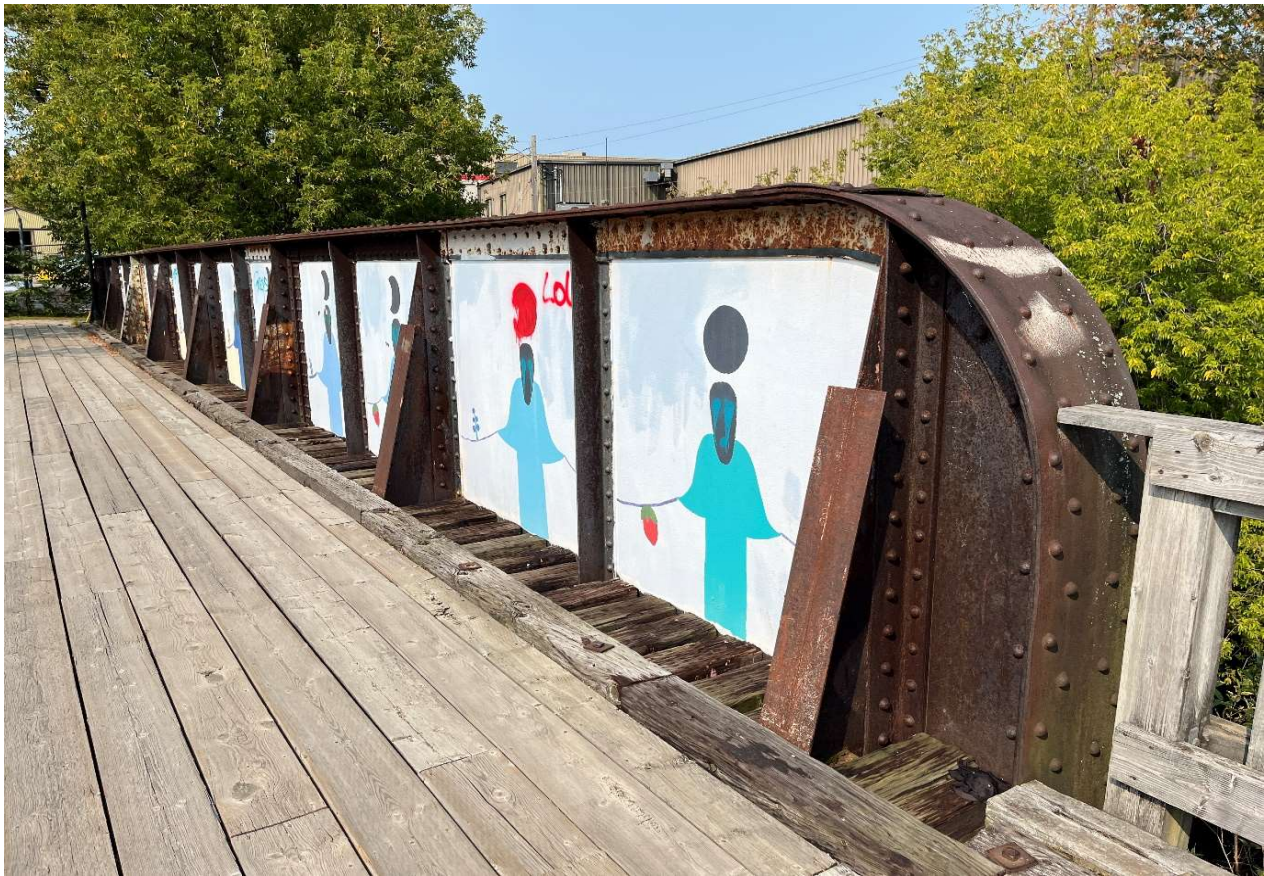
Description of Photo: Coating

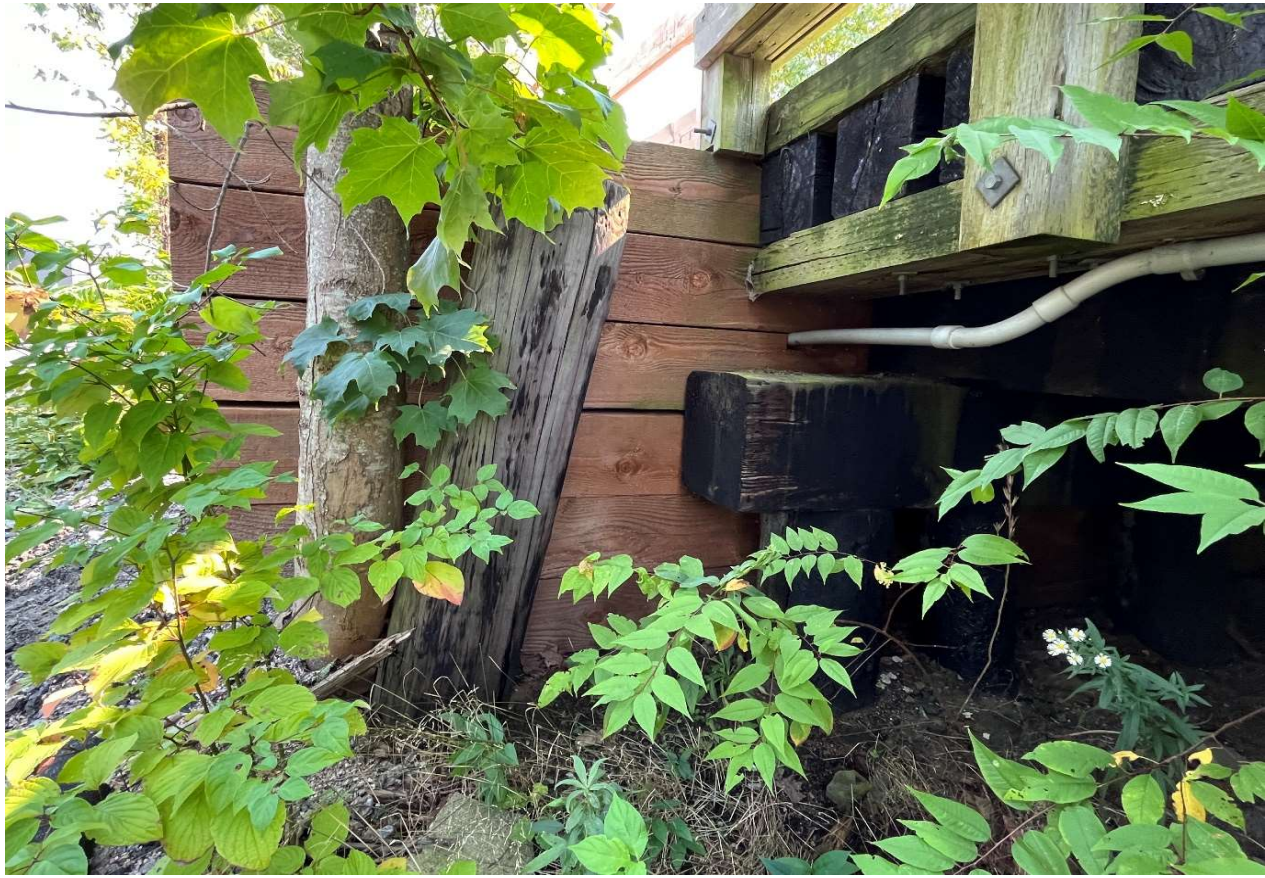
Description of Photo: East abutment

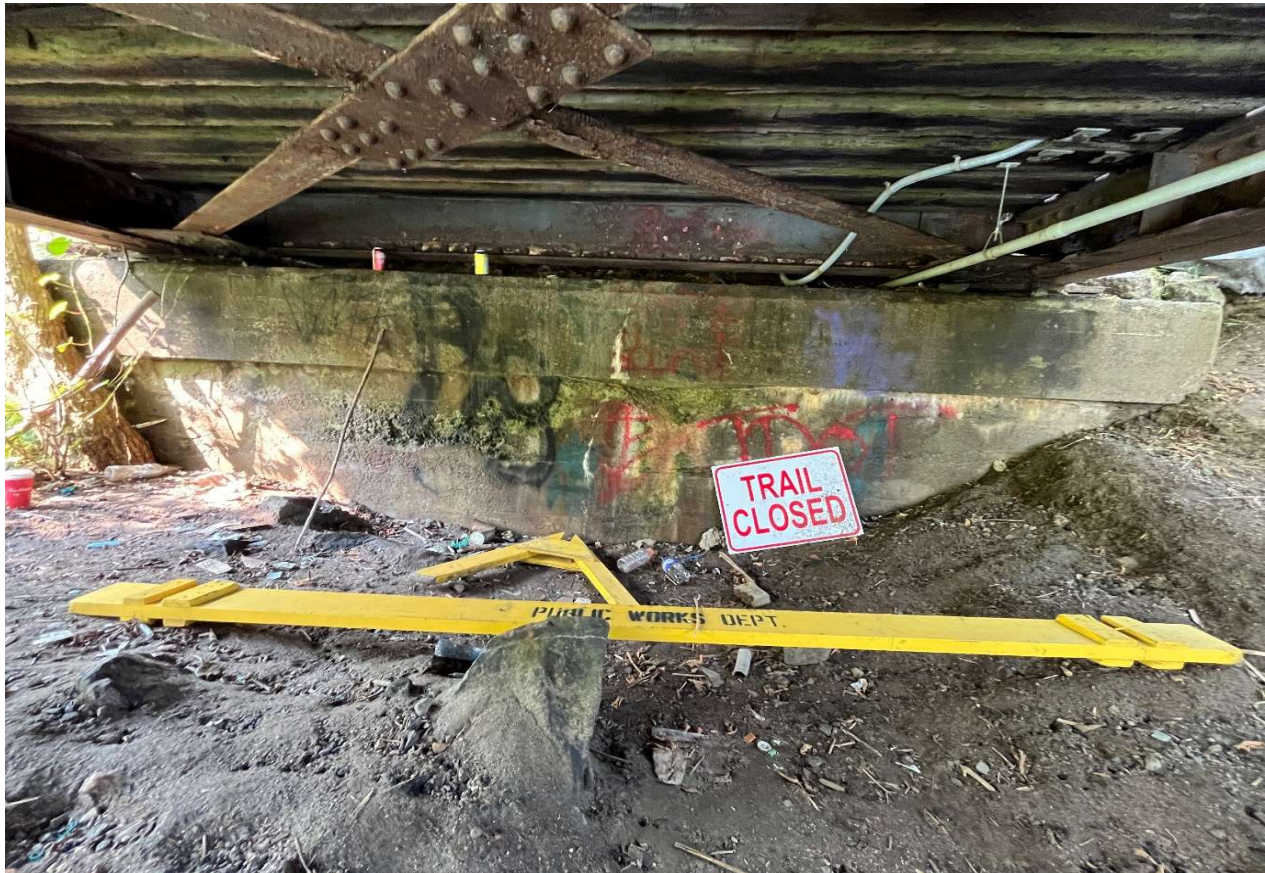
Description of Photo: West abutment

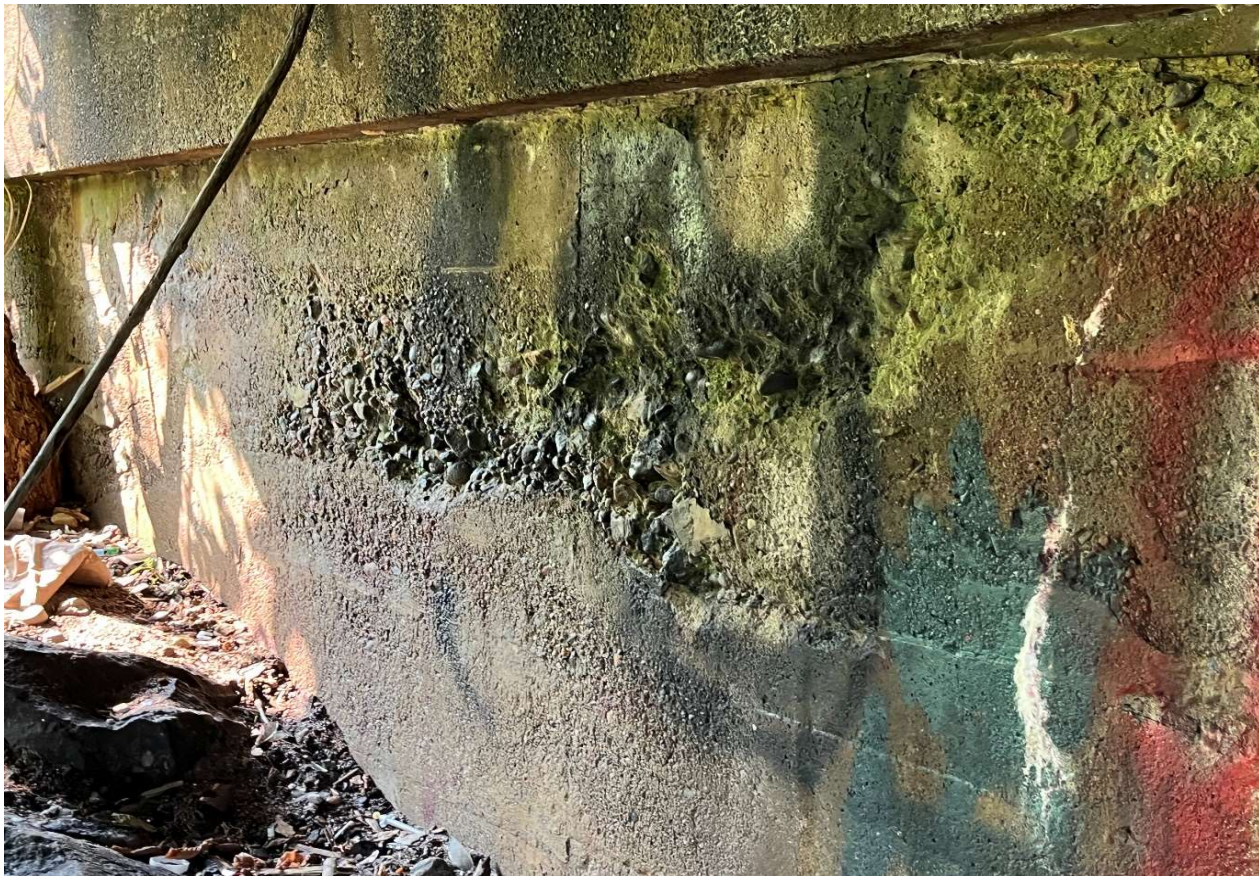
Description of Photo: West abutment

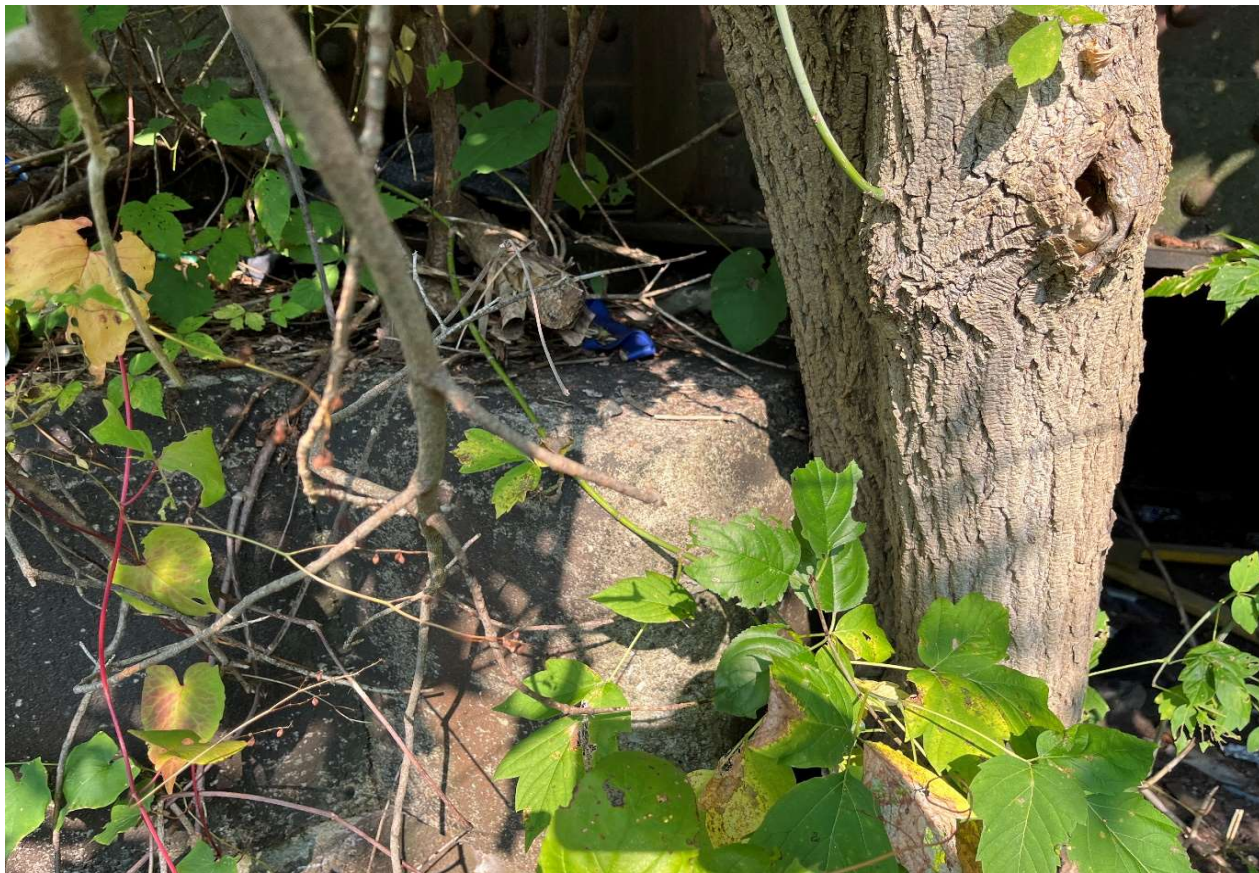
Description of Photo: Wingwall

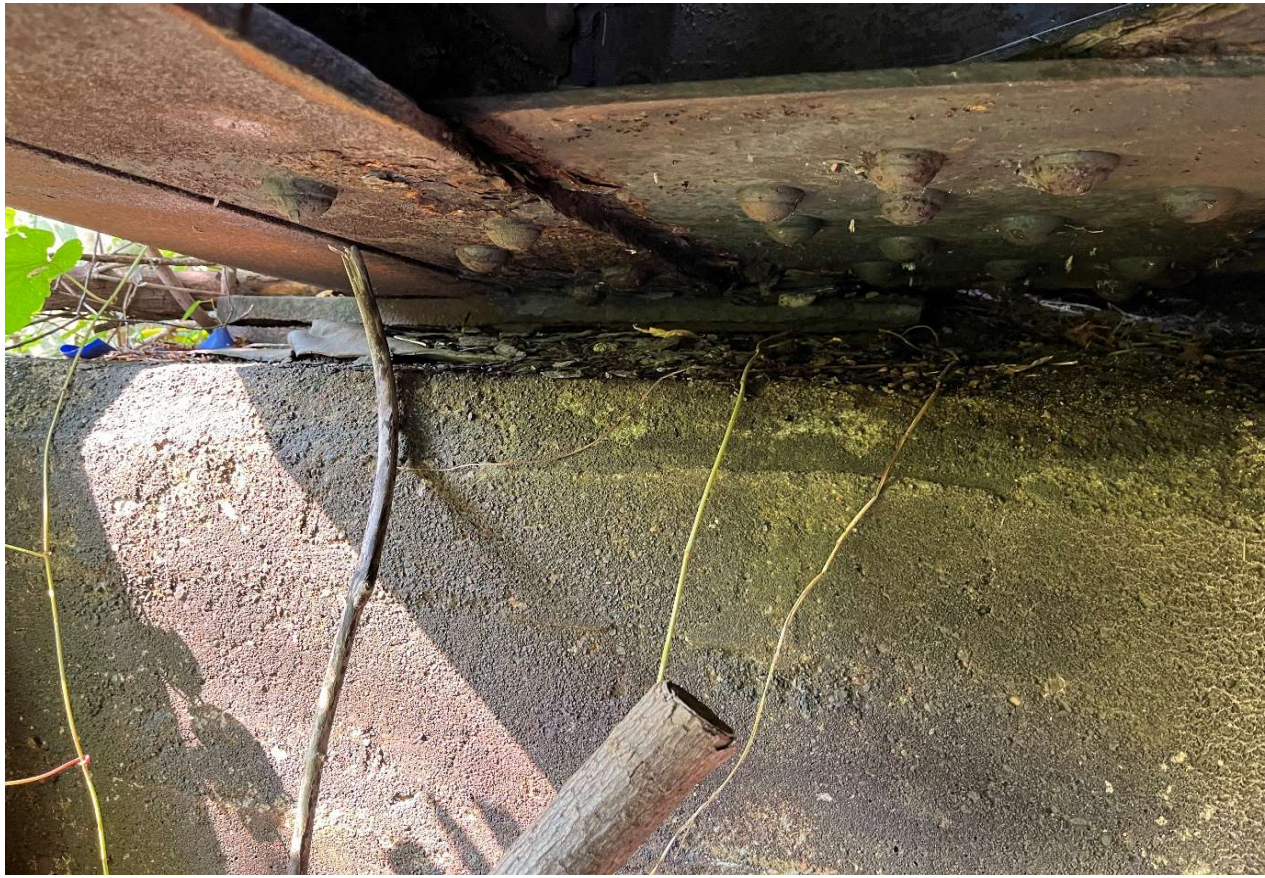
Description of Photo: Bearings

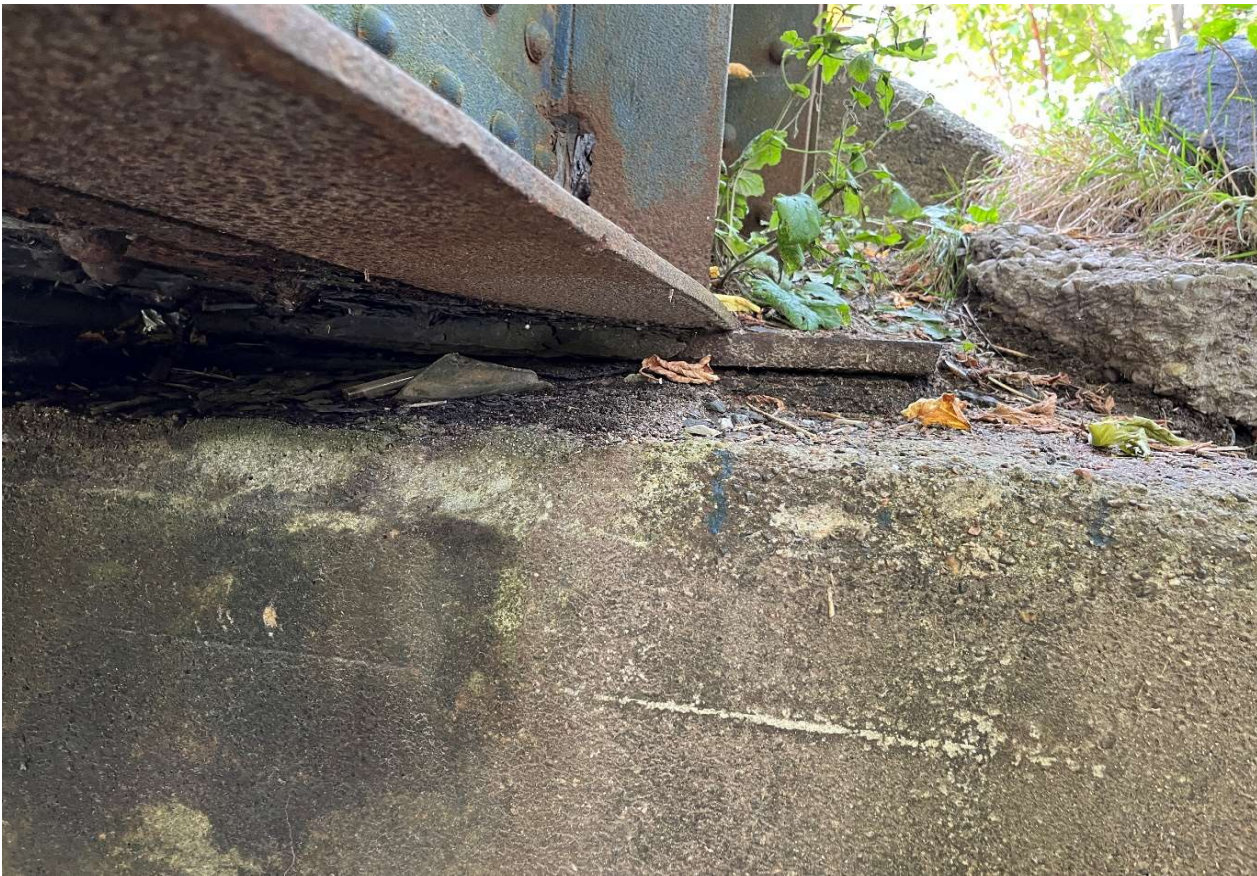
Description of Photo: Bearings

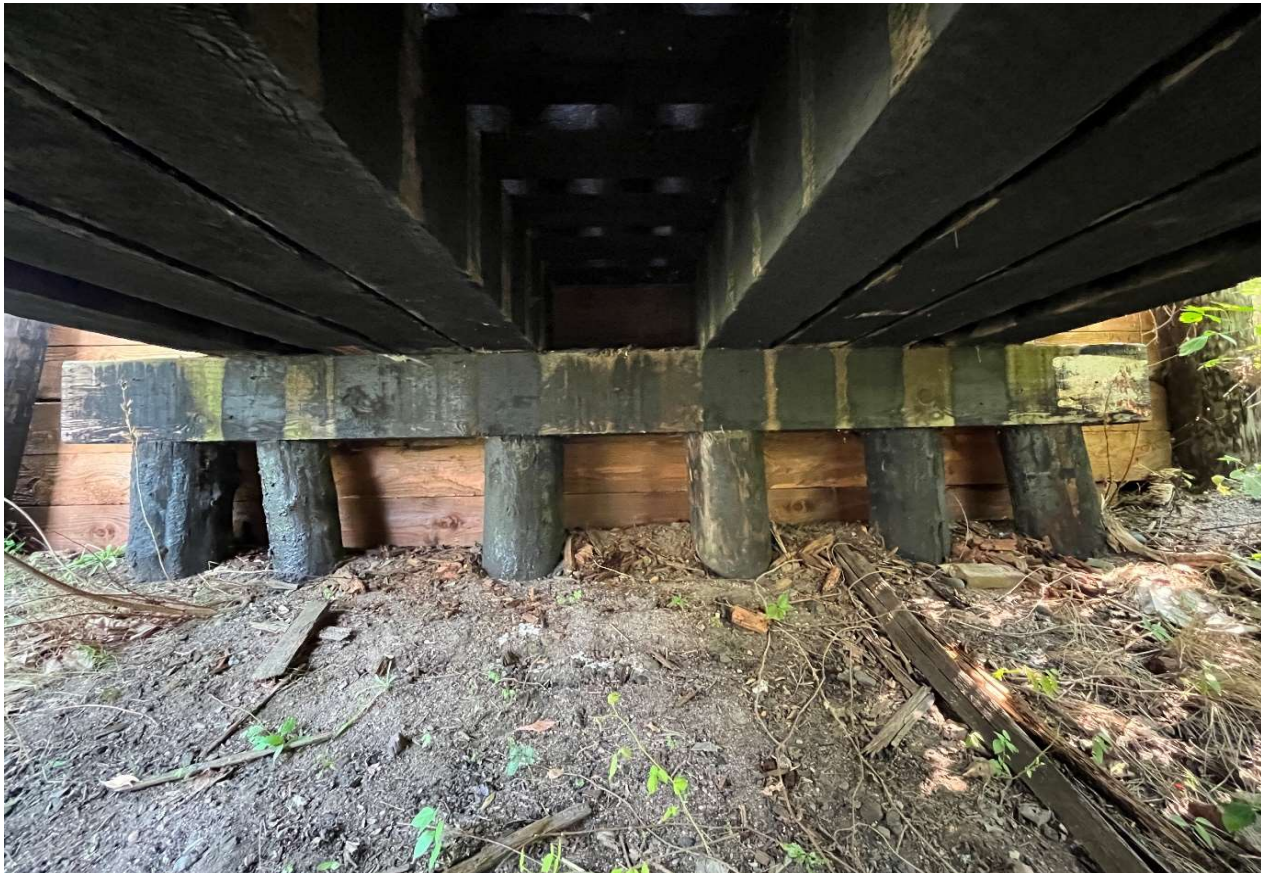
Description of Photo: Abutment piles

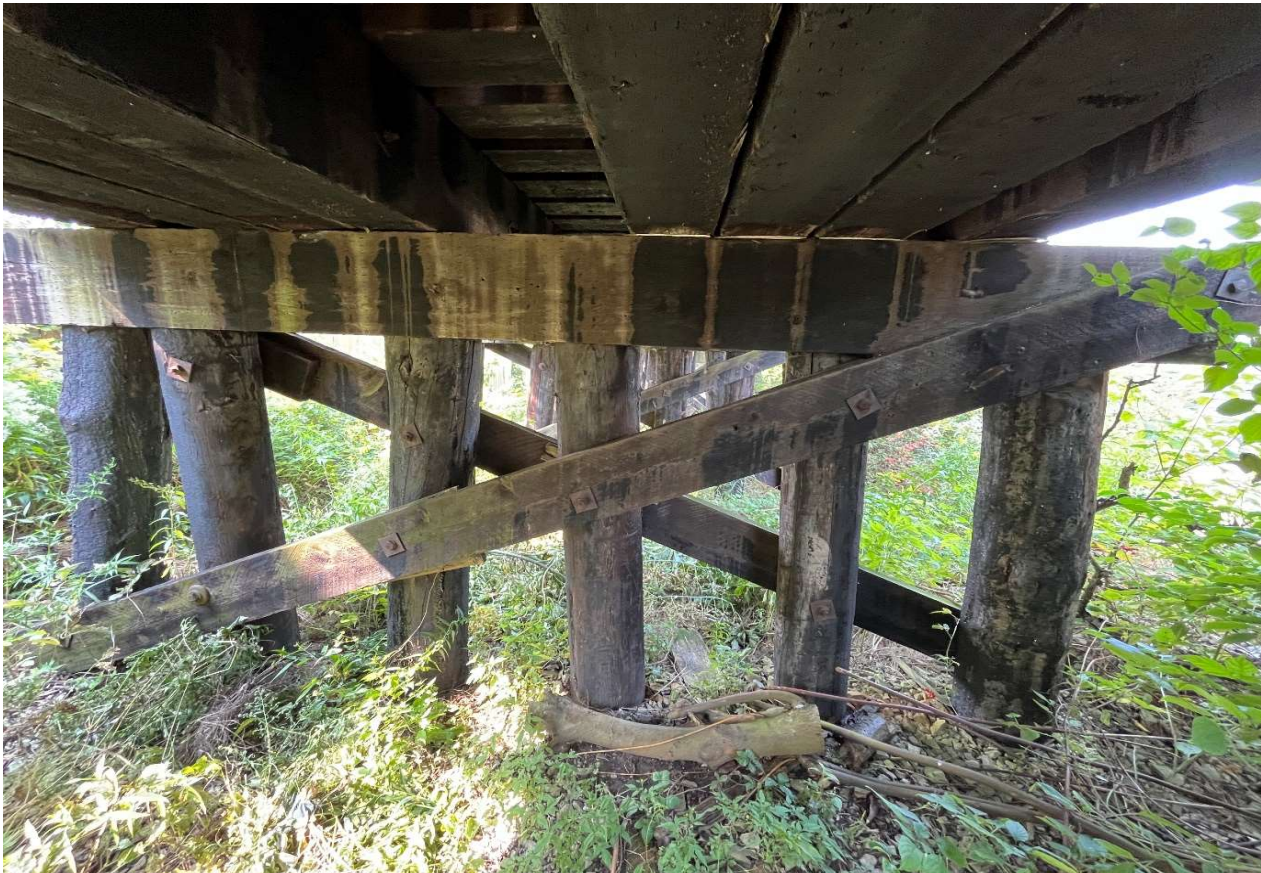
Description of Photo: Pier piles

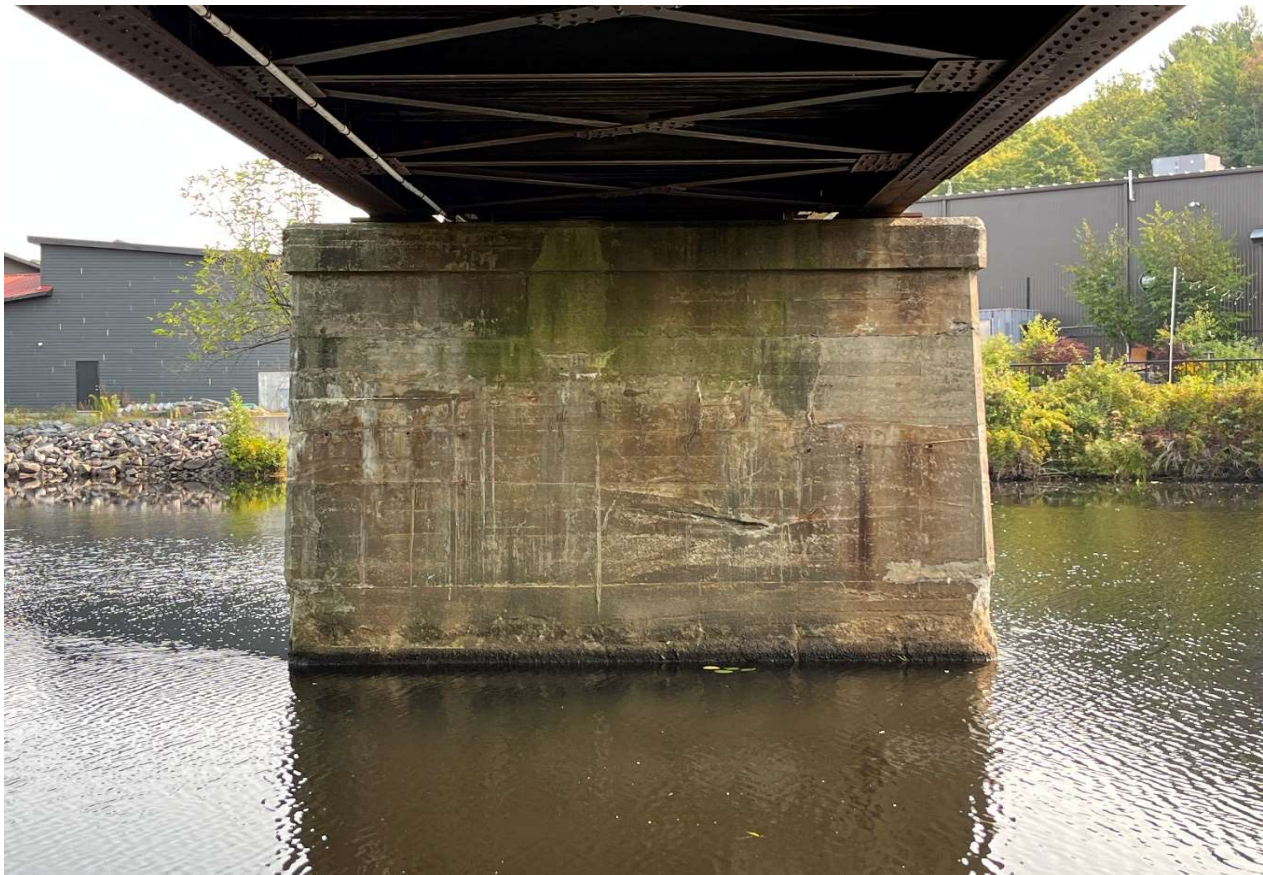
Description of Photo: West pier west face

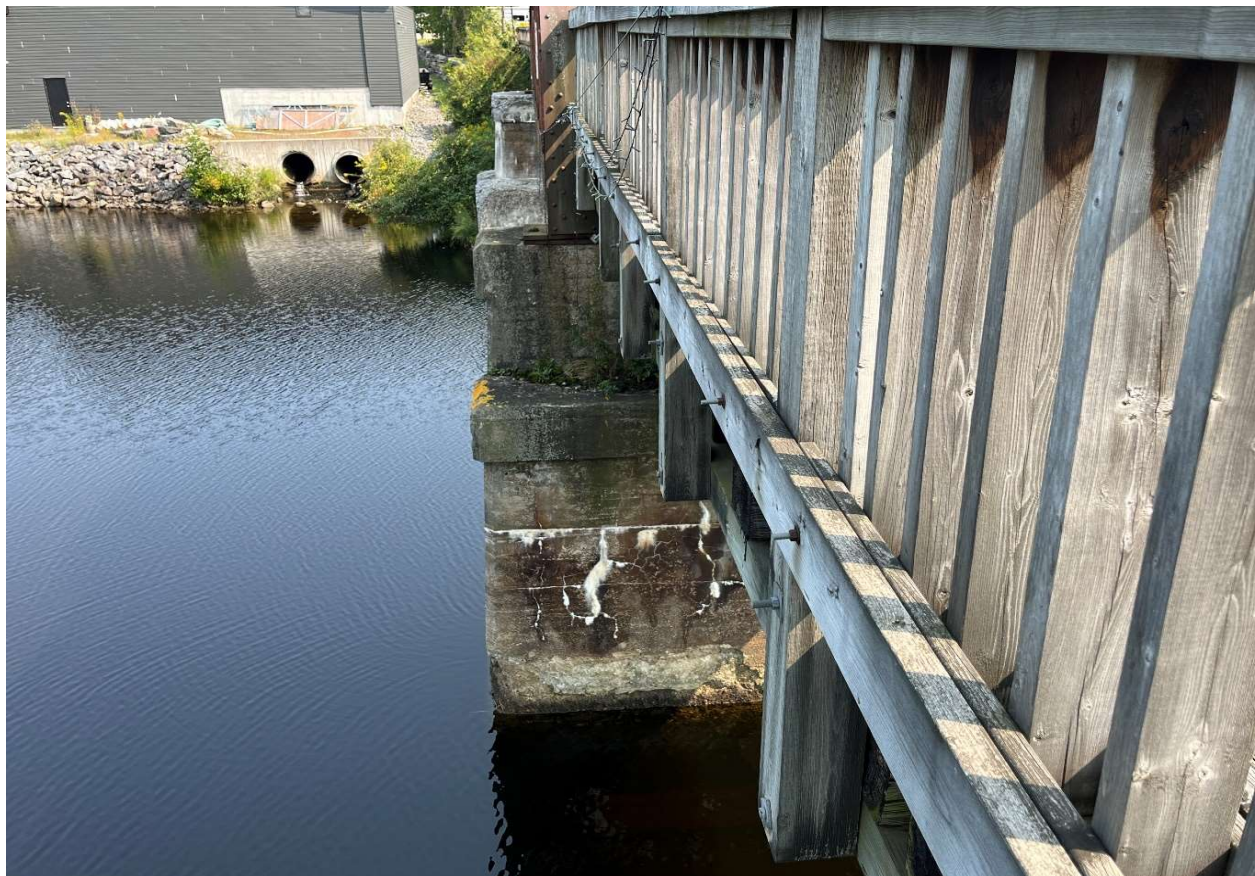
Description of Photo: Middle pier west face

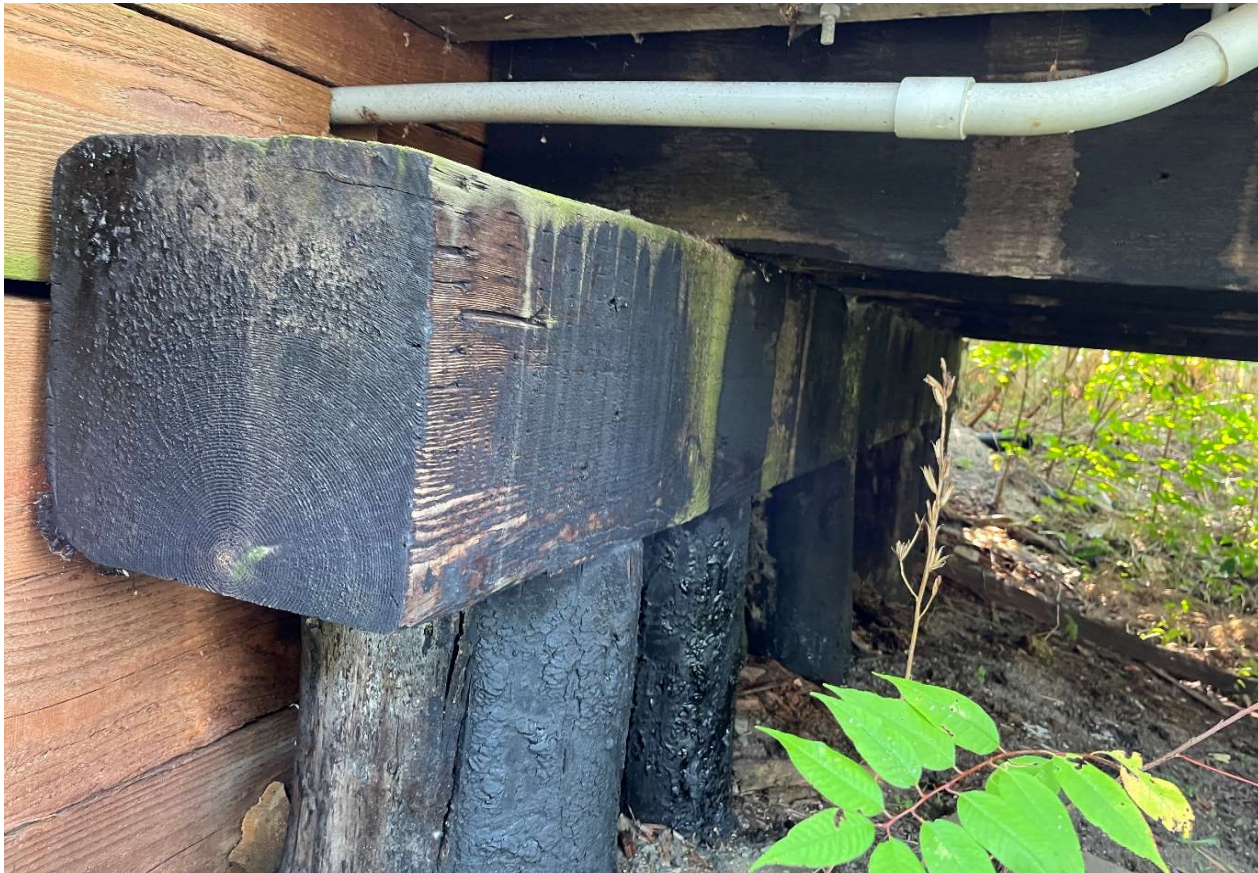
Description of Photo: Abutment cap

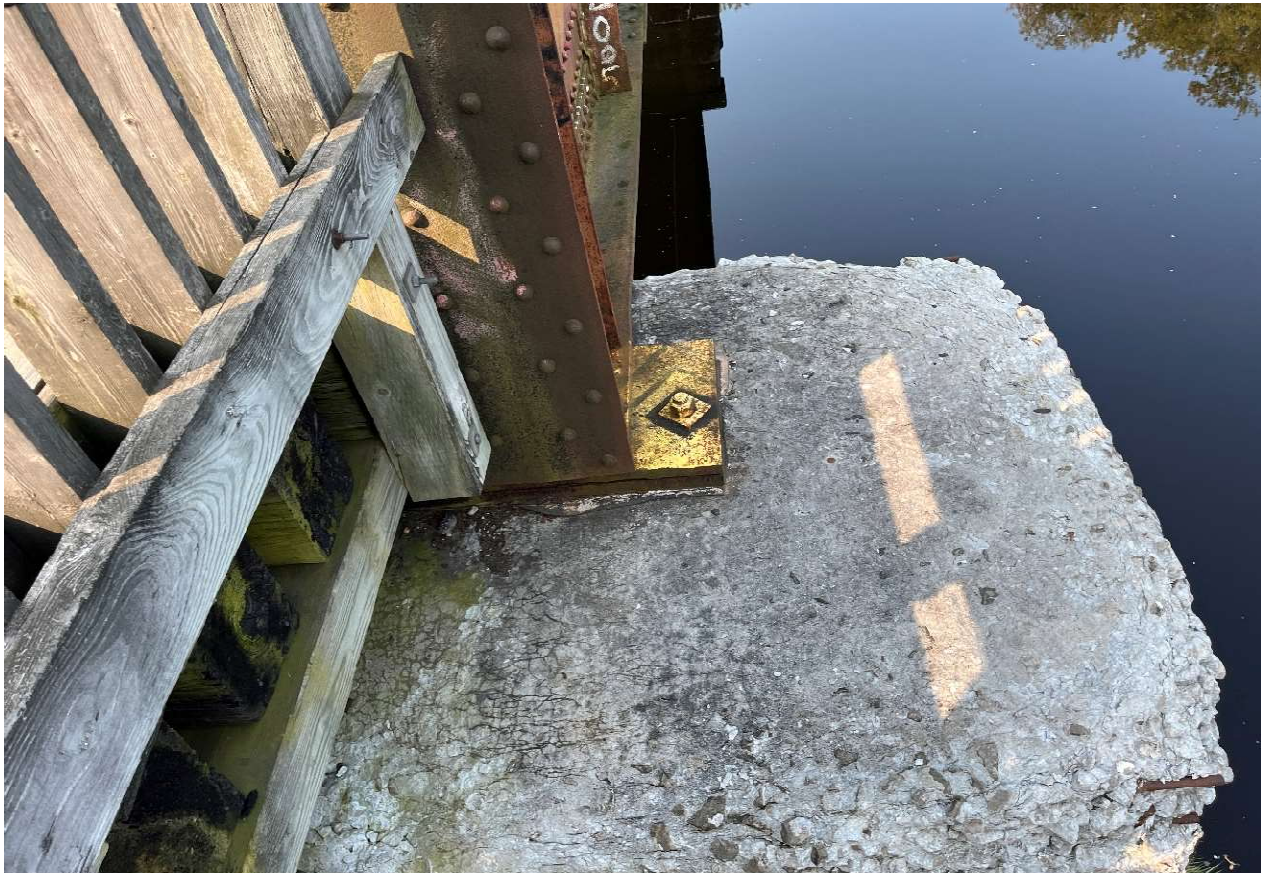
Description of Photo: Pier bearings

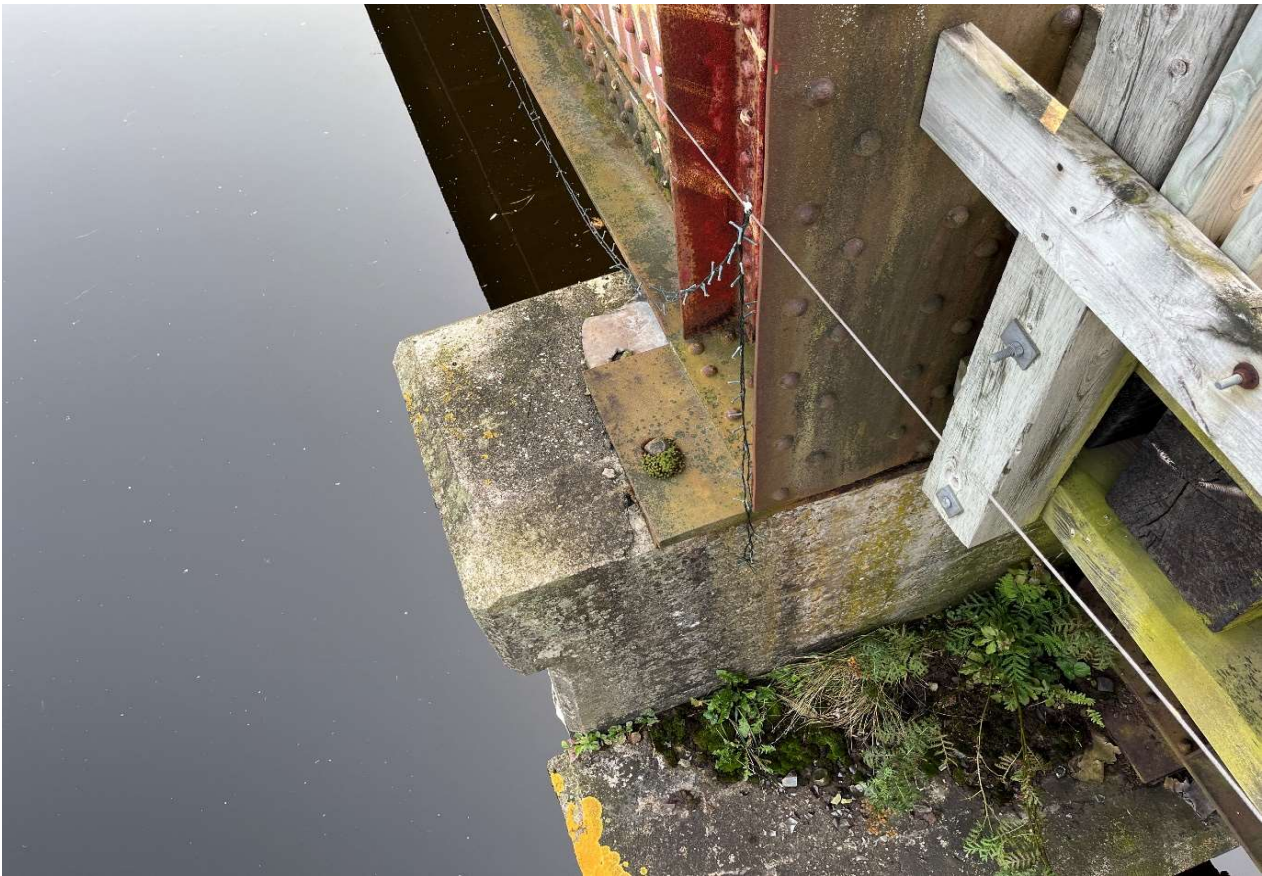
Description of Photo: Pier bearings

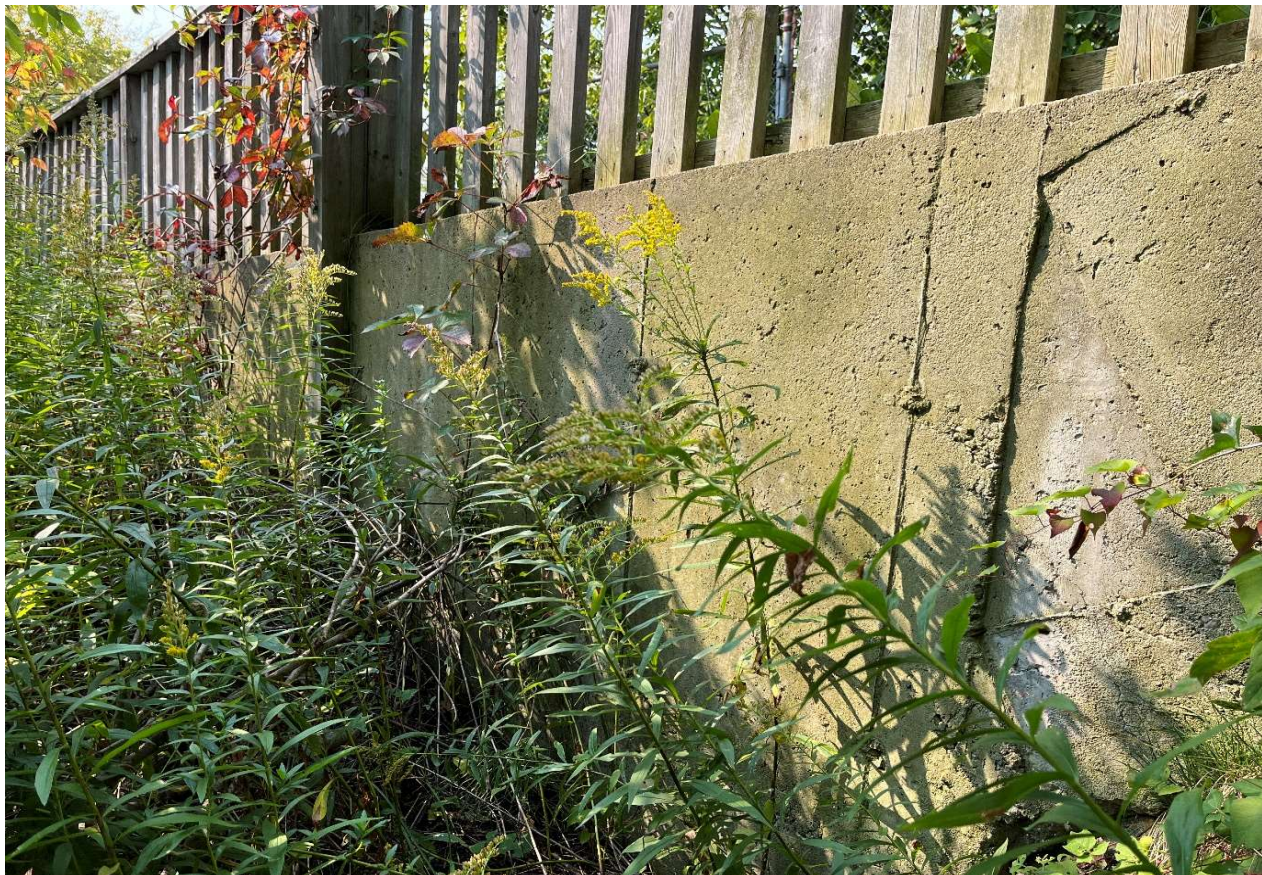
Description of Photo: Retaining wall

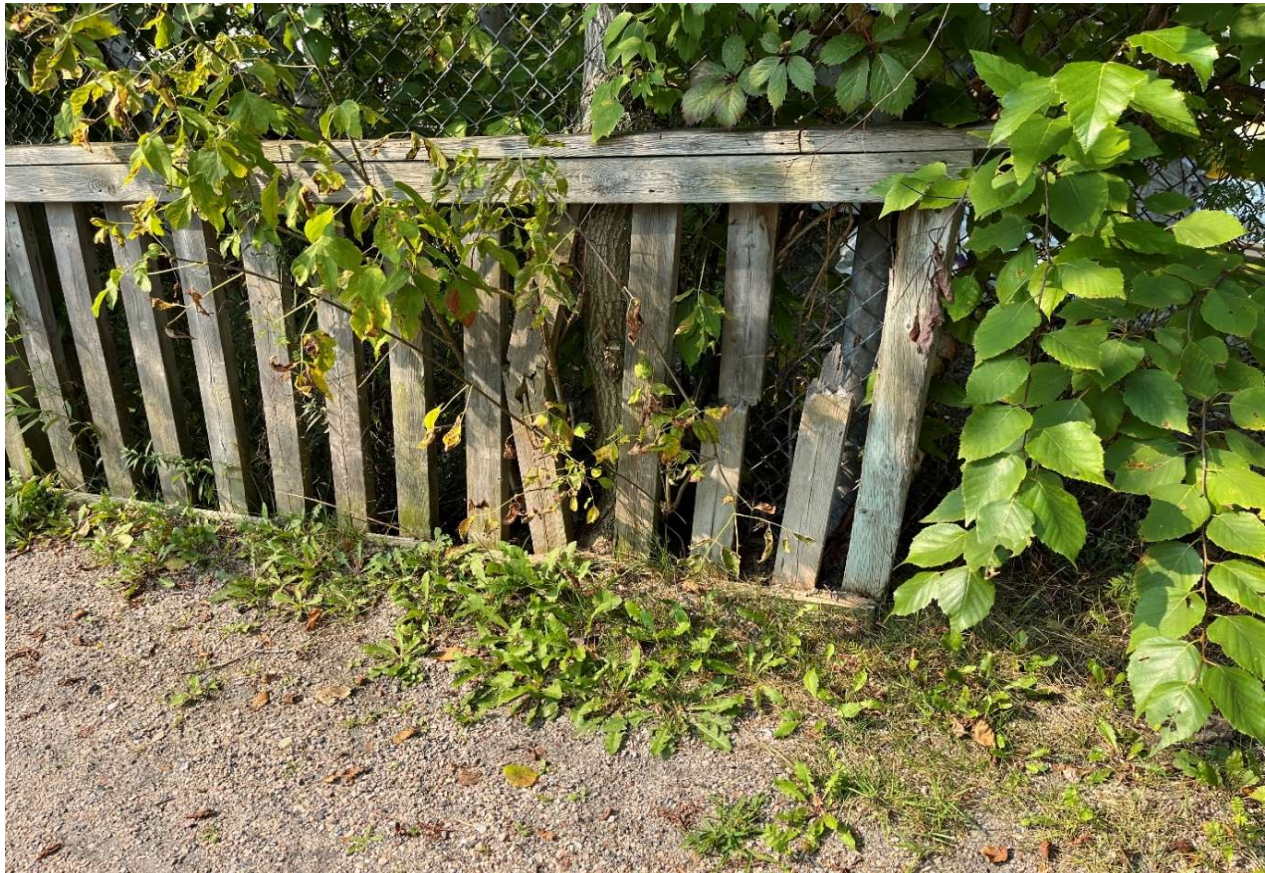
Description of Photo: Railing system

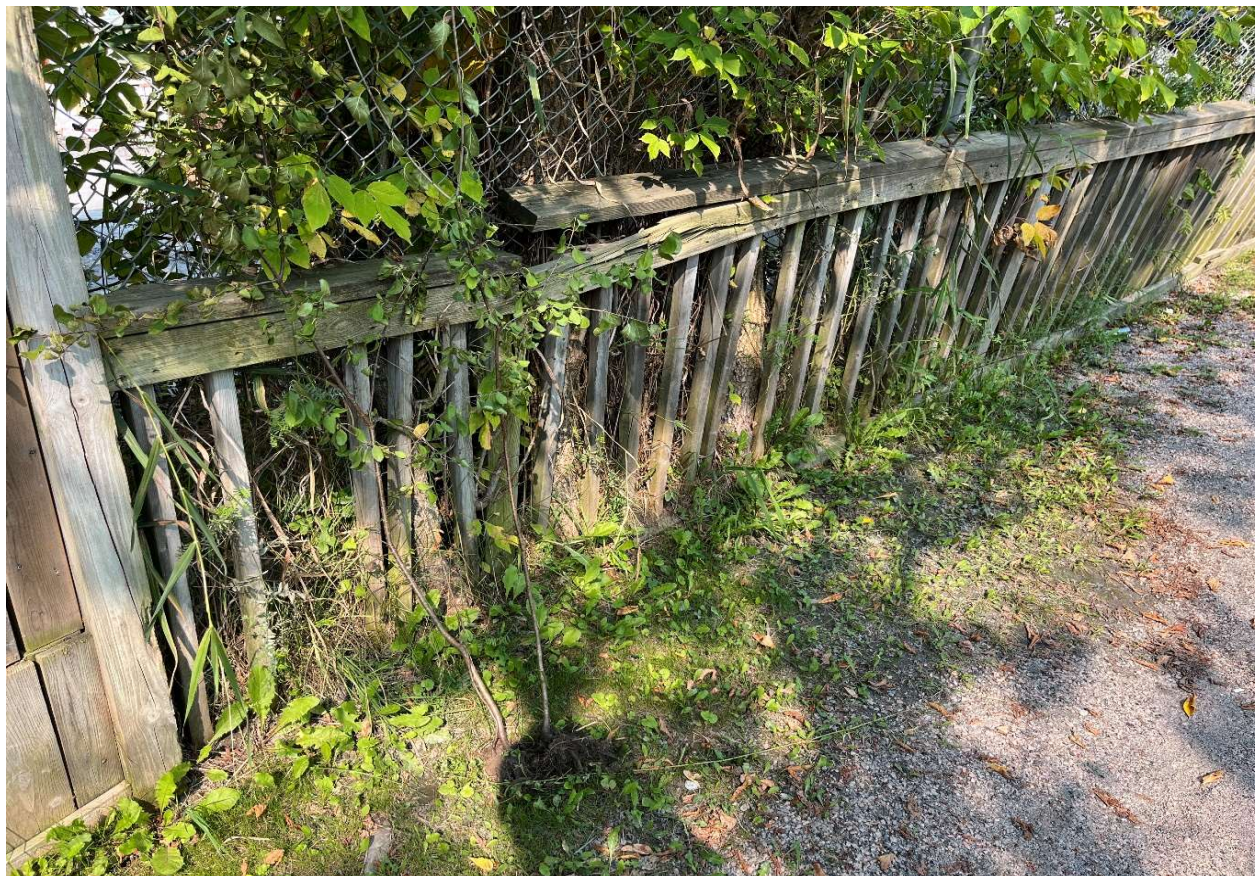
Description of Photo: Railing system

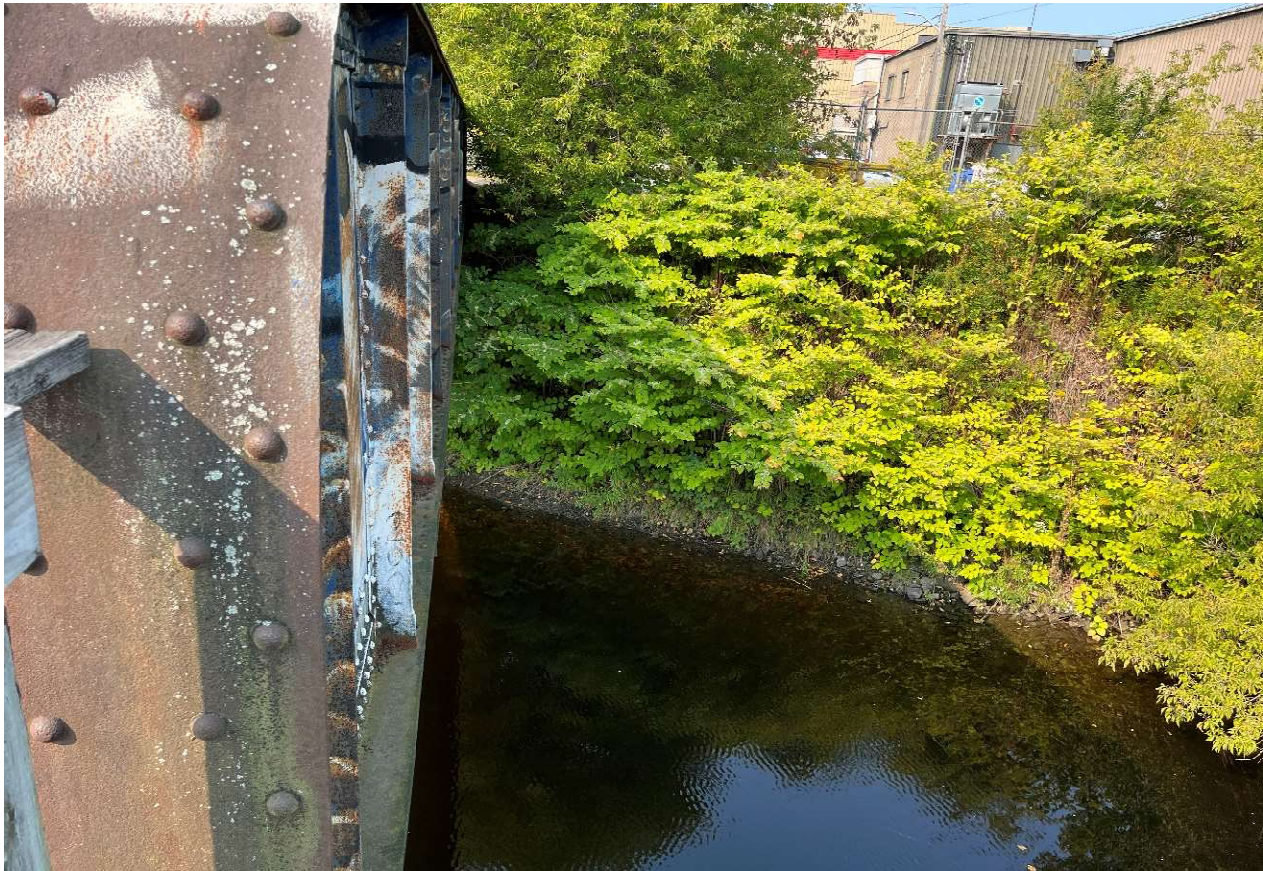
Description of Photo: Embankment

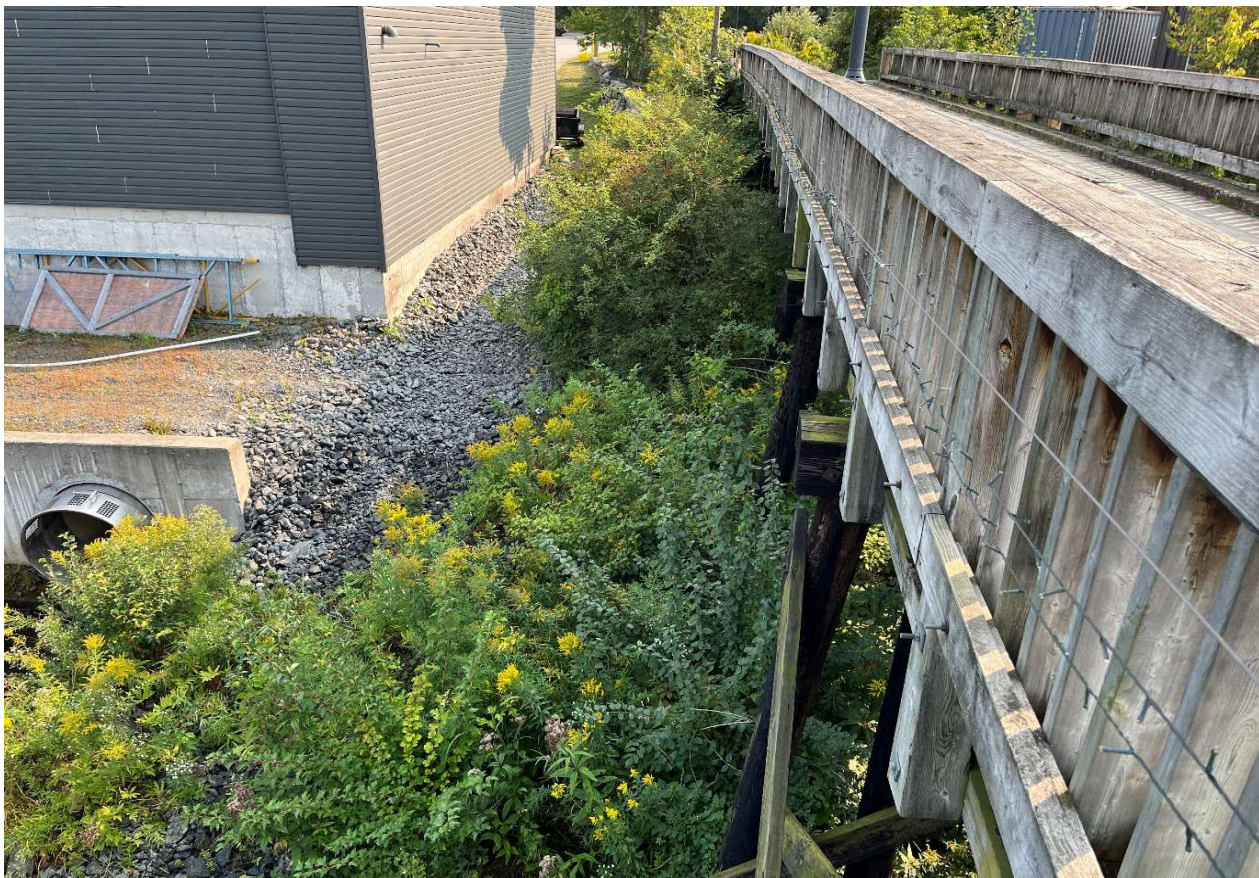
Description of Photo: Embankment
