Bridge Needs Study 2024

INSPECTION SUMMARY REPORT

Town of Parry Sound

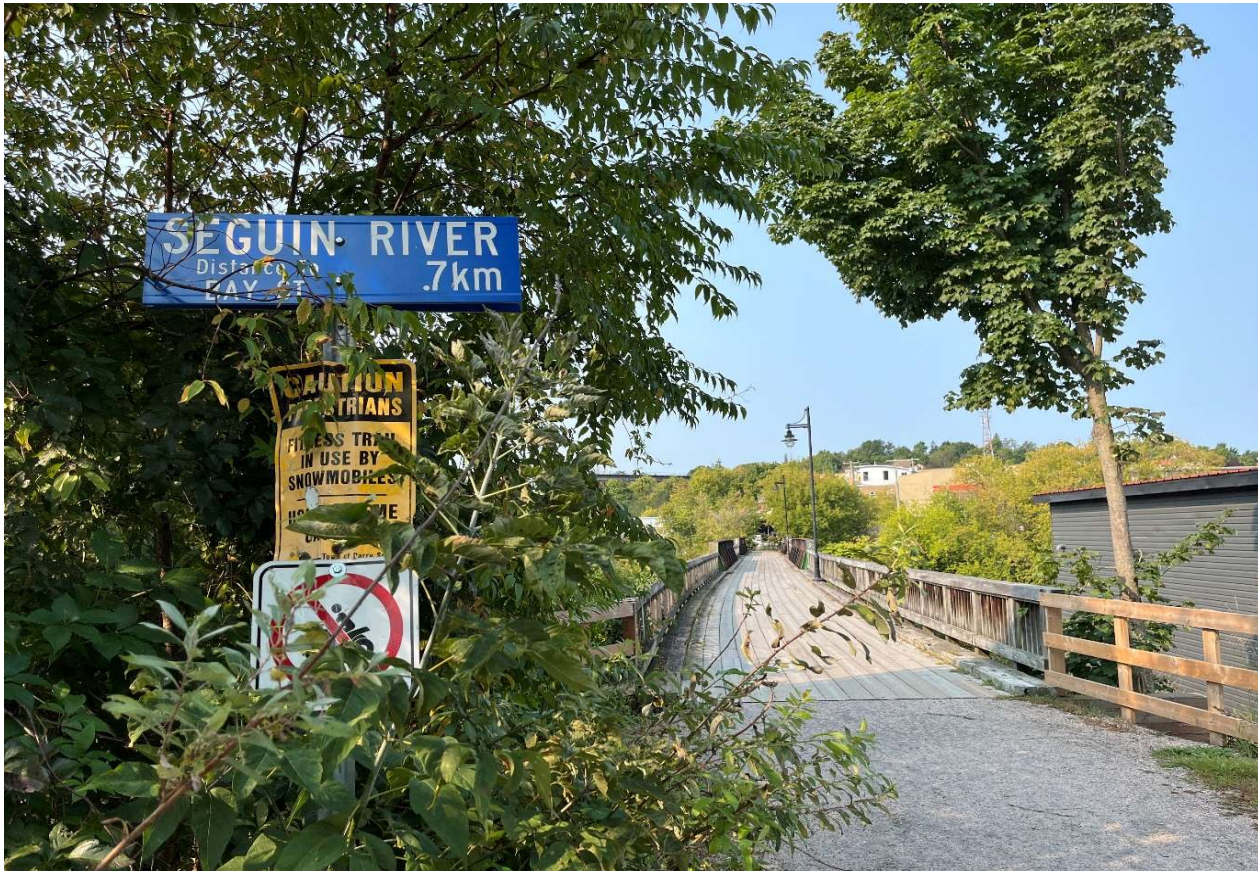
Description of Photo: Signs

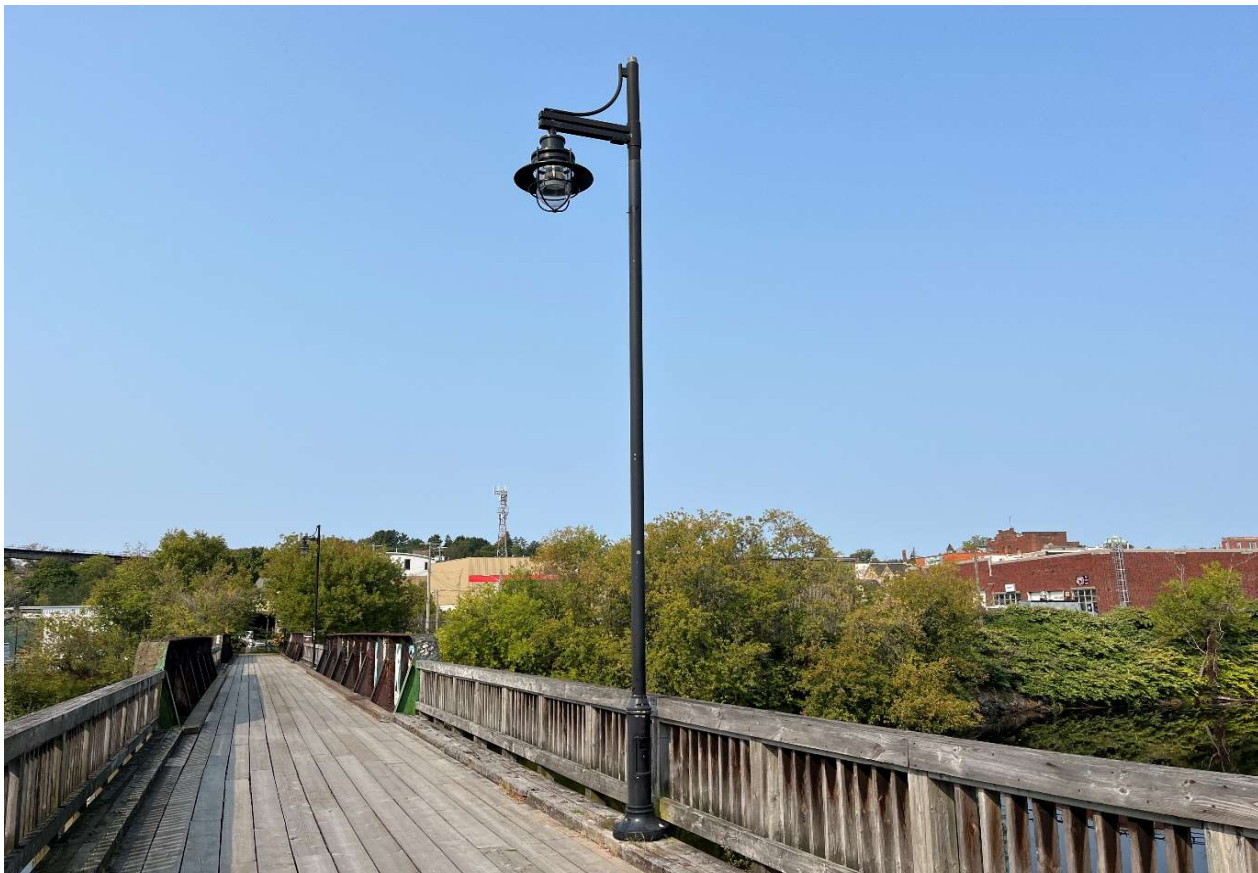
Description of Photo: Light utility

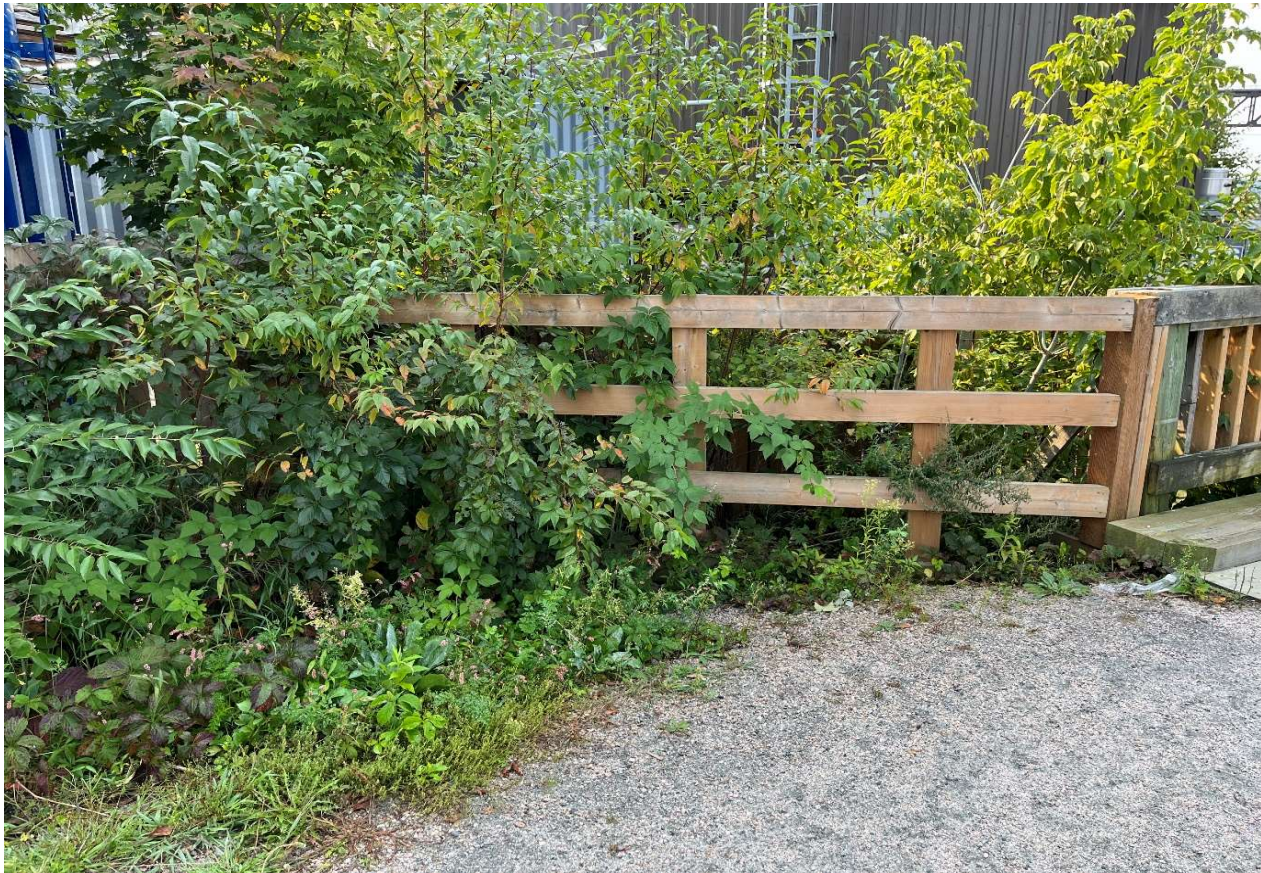
Description of Photo: Approach barrier

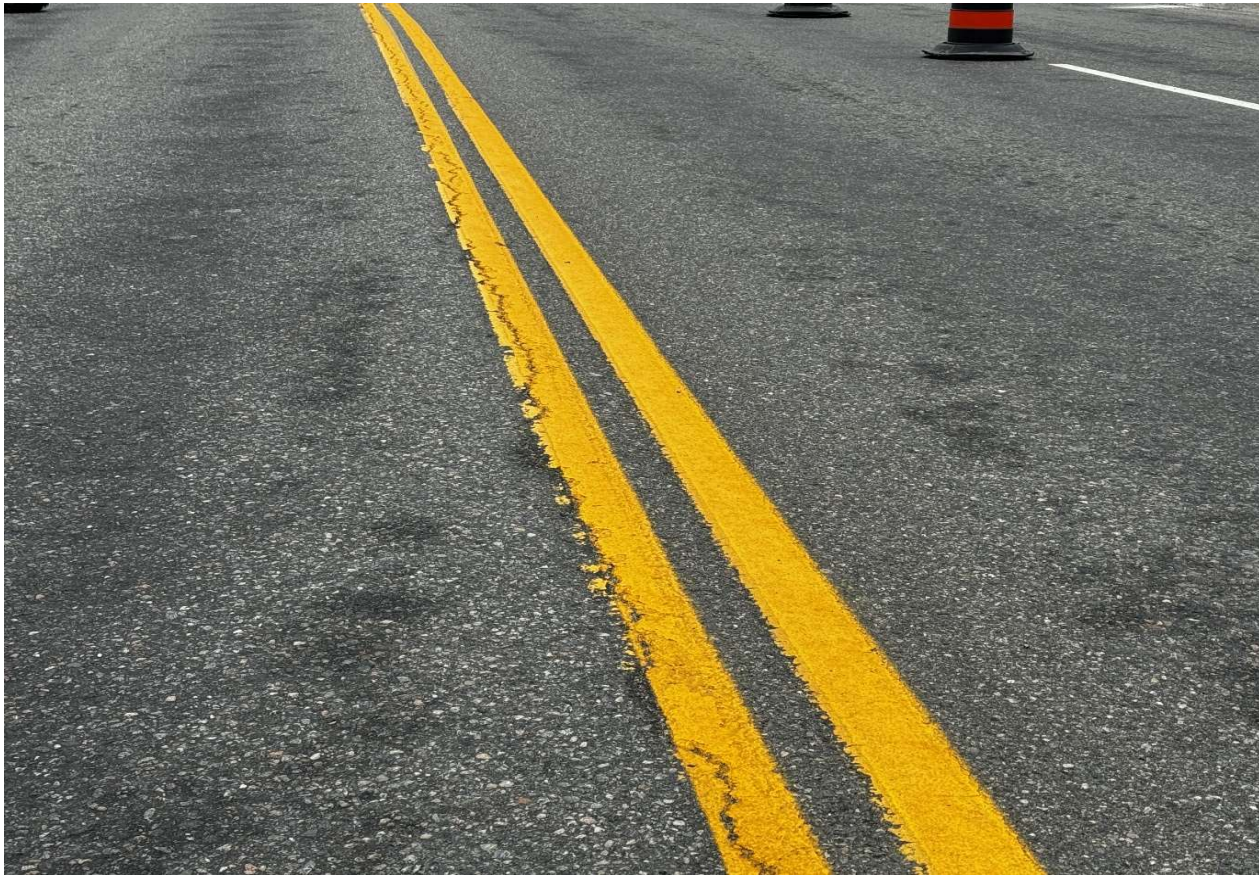
Description of Photo: Crack along centerline

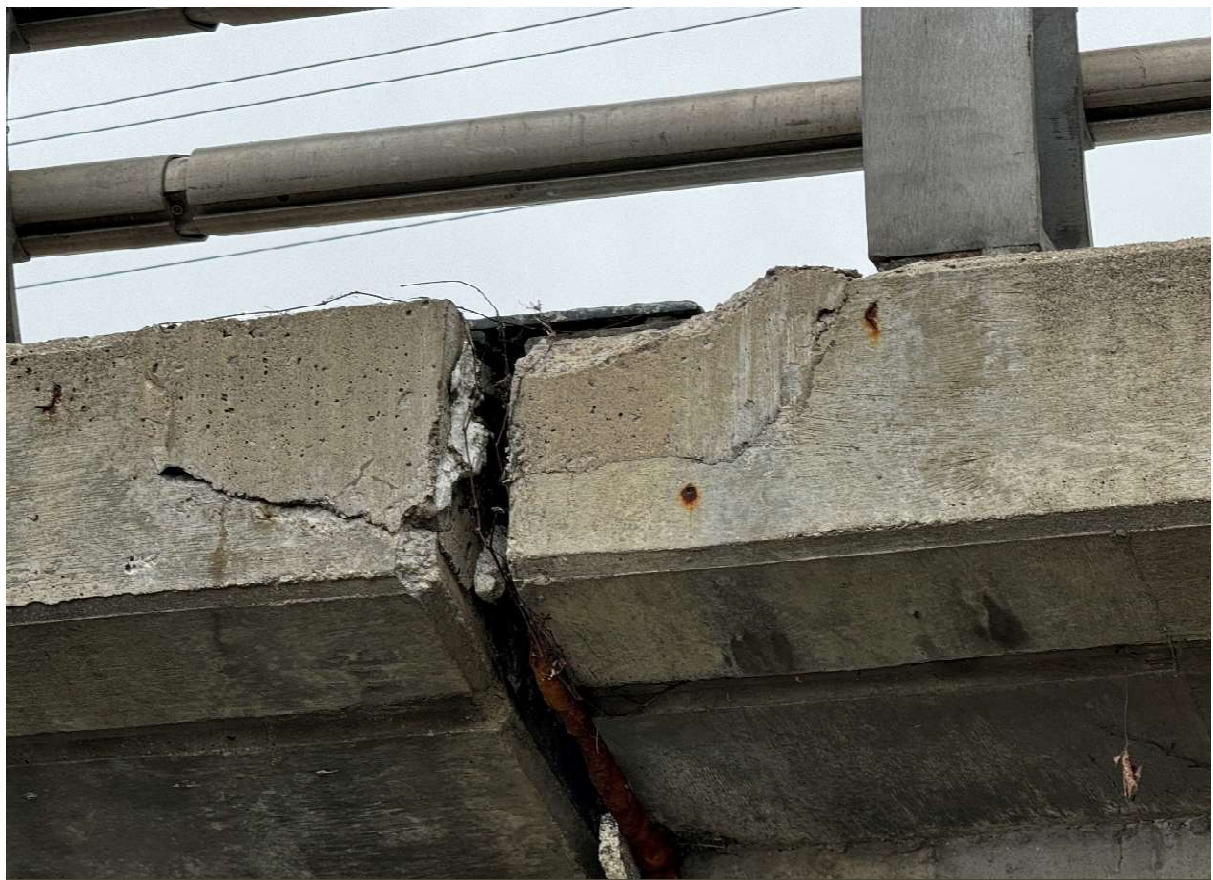
Description of Photo: Exterior soffit

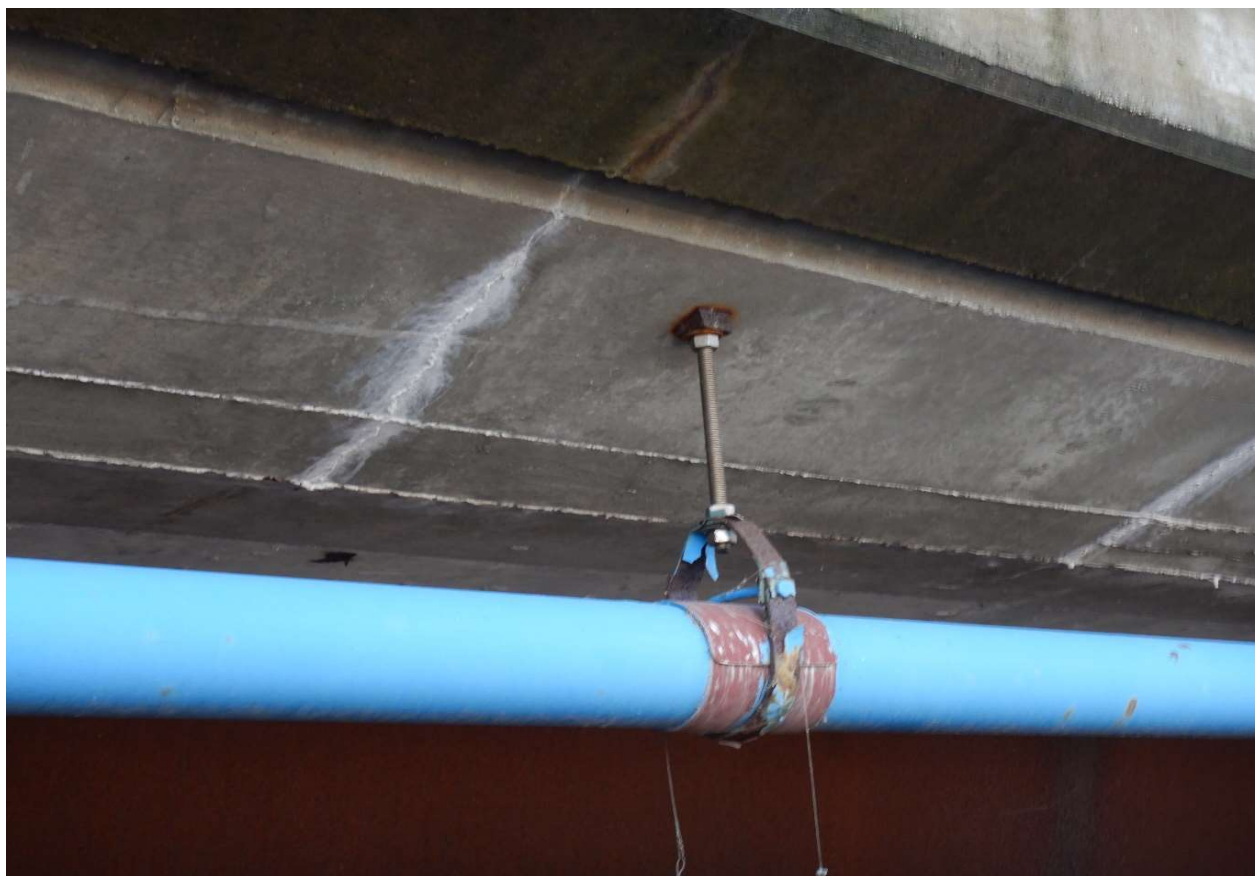
Description of Photo: Crack with efflorescence along exterior soffit

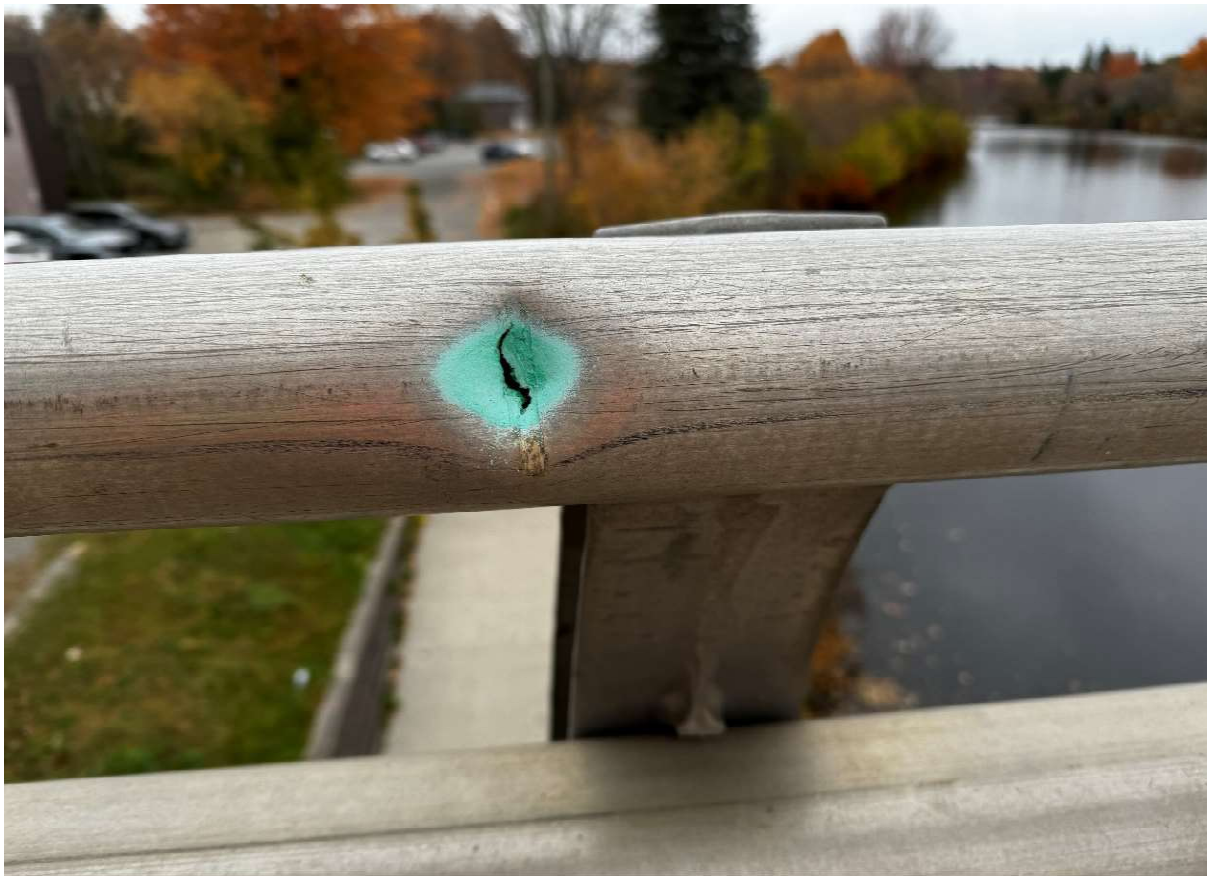
Description of Photo: North rail perforations

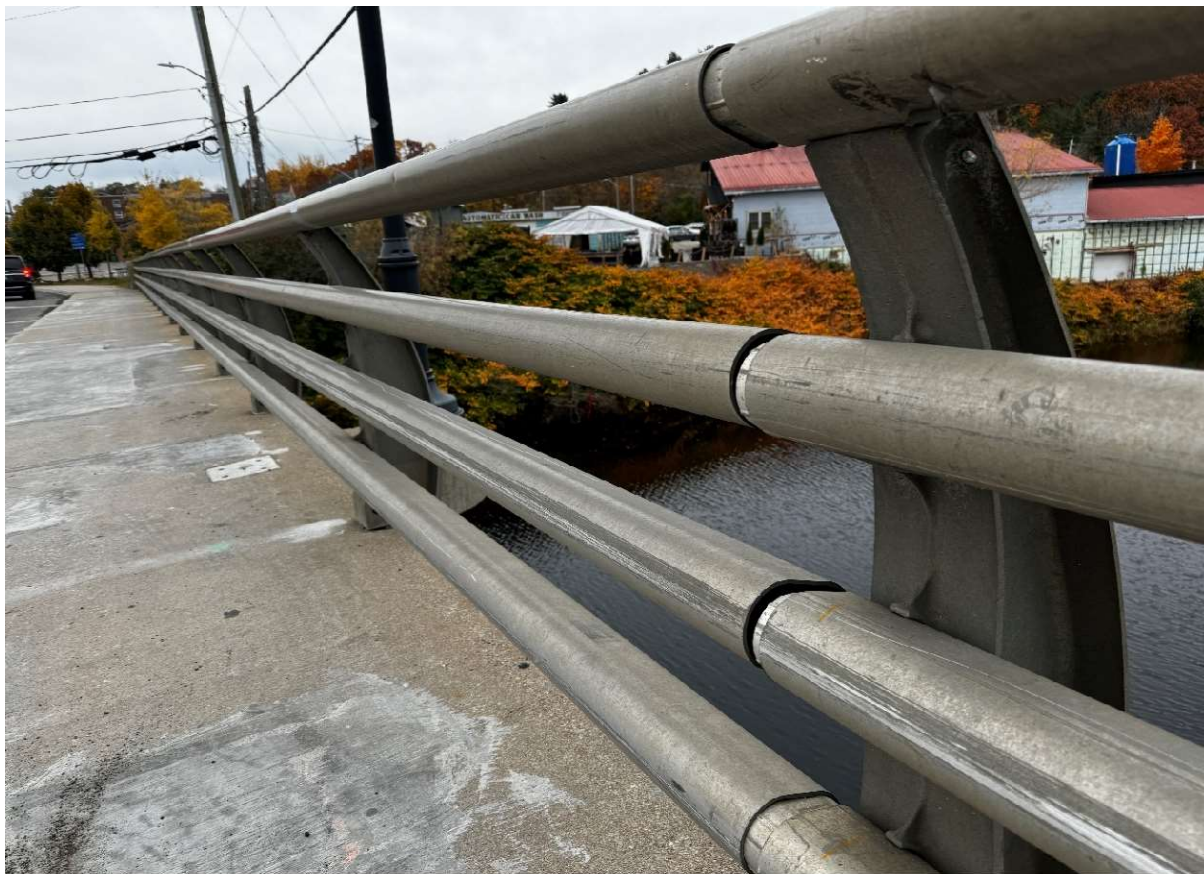
Description of Photo: Railing system

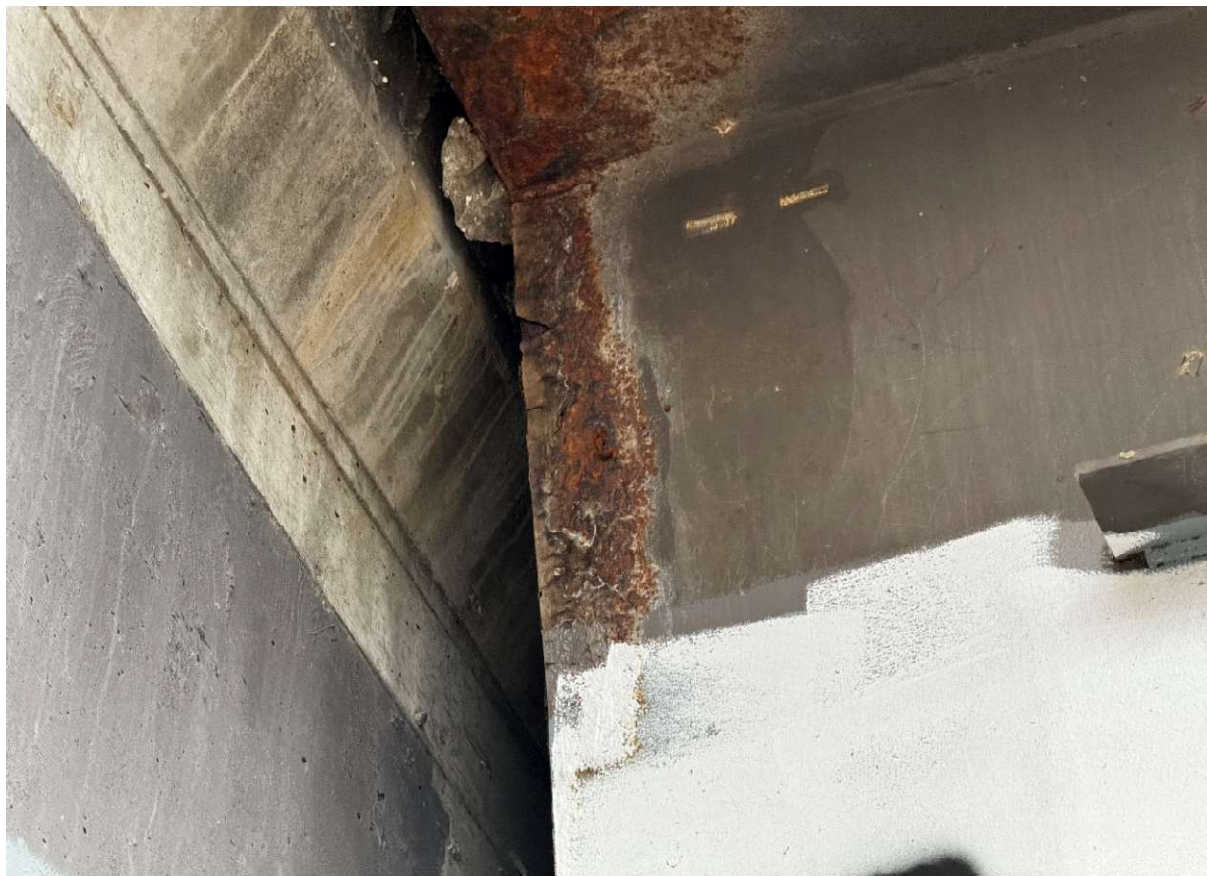
Description of Photo: Girder - Exterior end

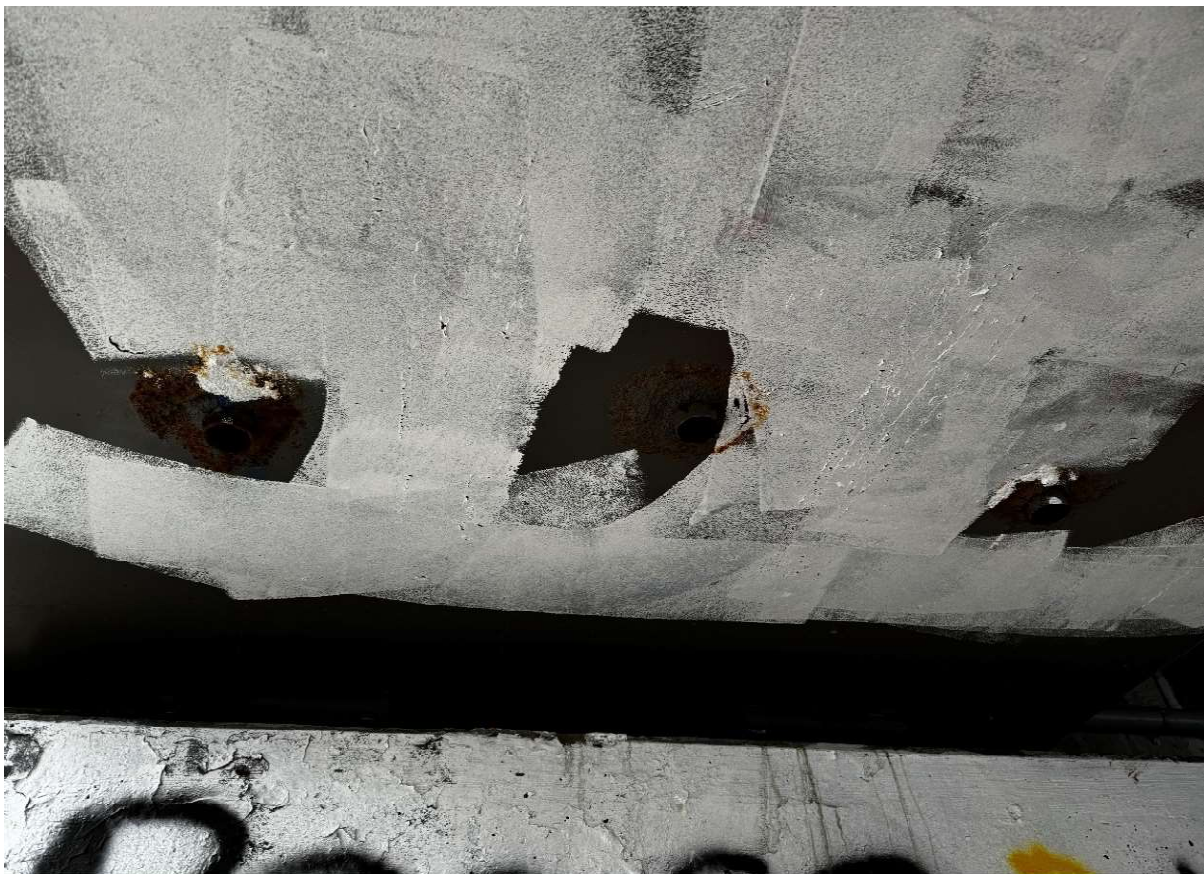
Description of Photo: Girder Exterior end drain holes

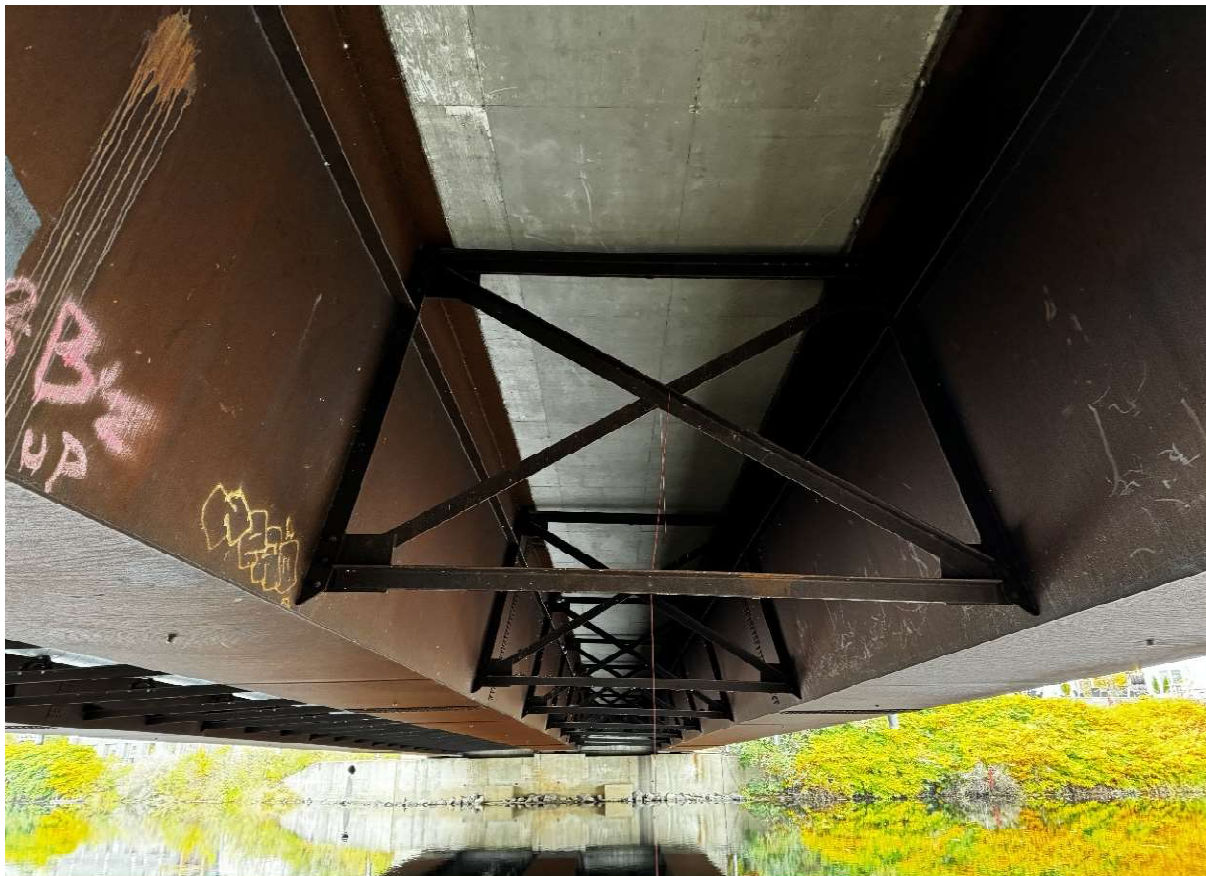
Description of Photo: Diaphragms

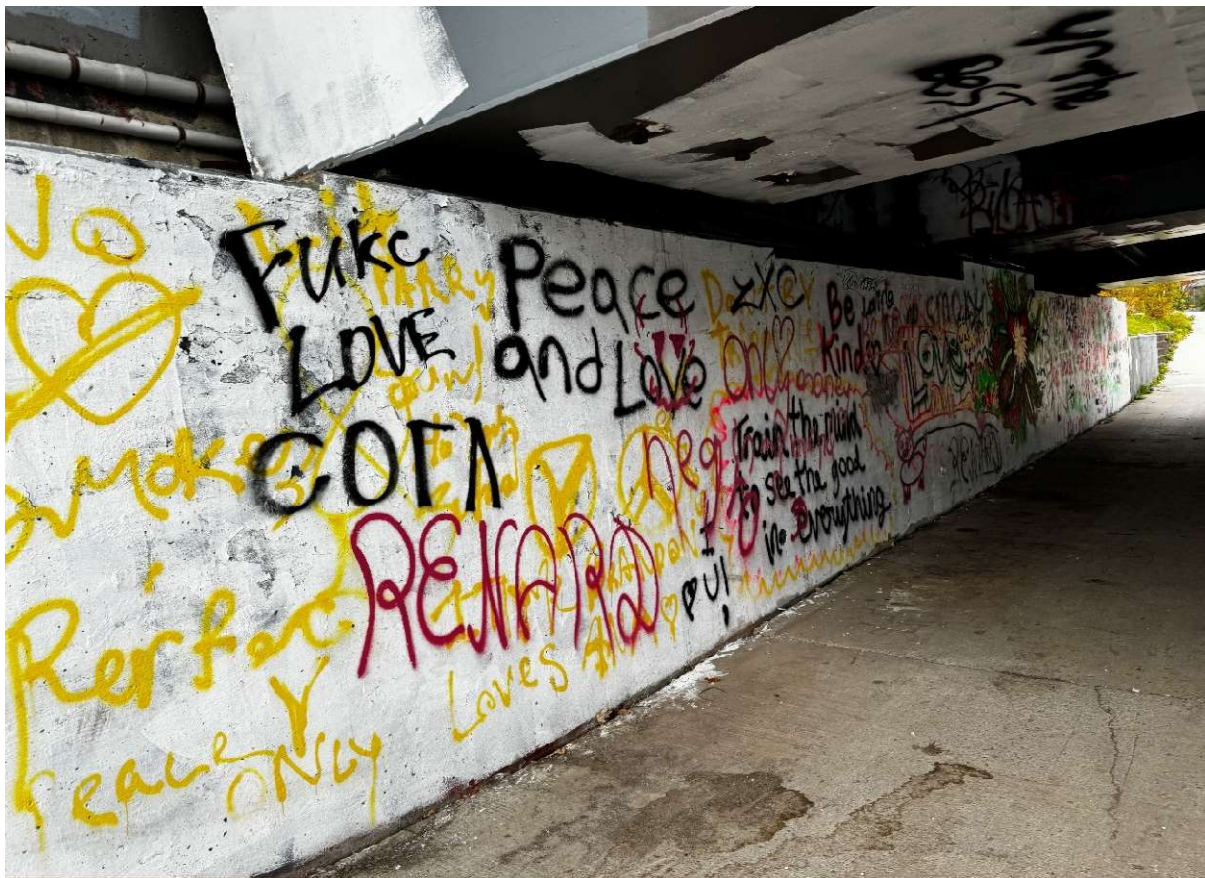
Description of Photo: Abutment wall

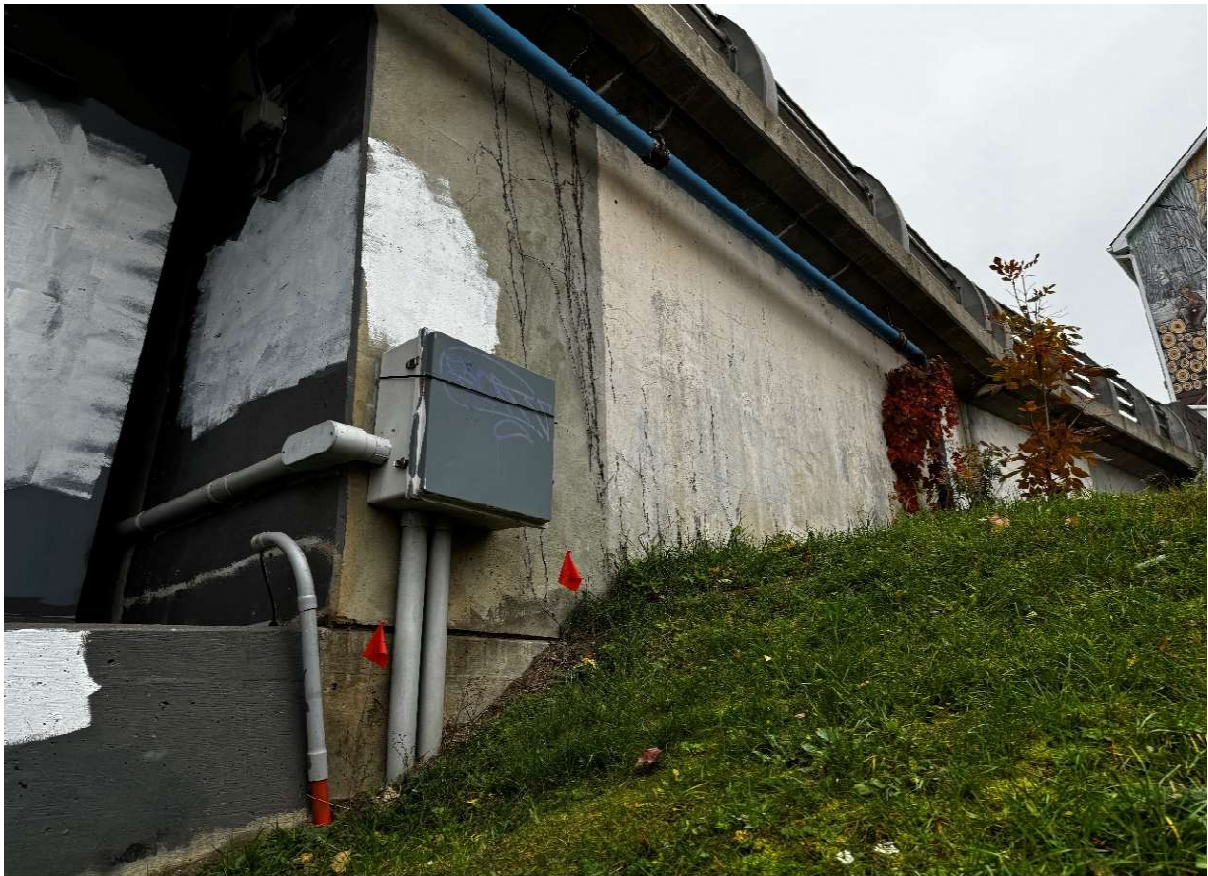
Description of Photo: Wingwall

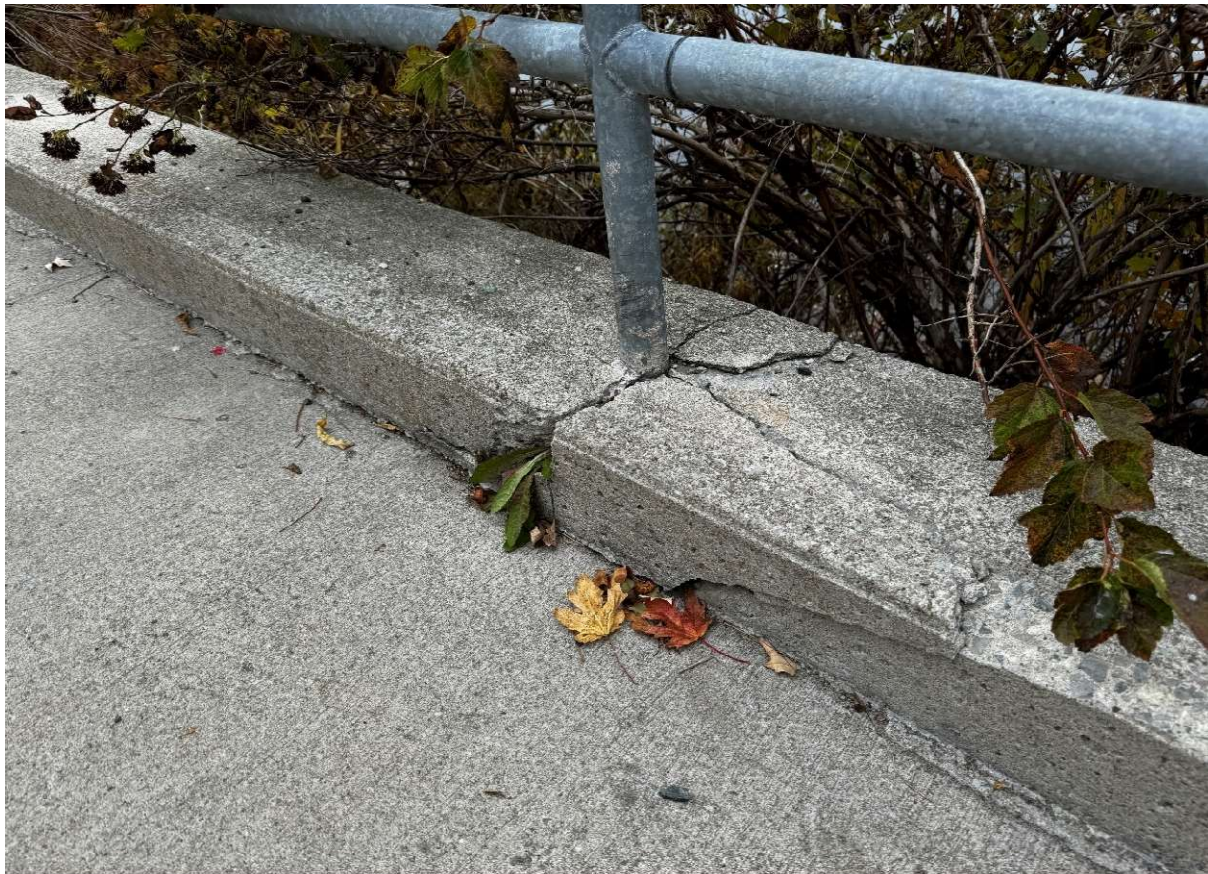
Description of Photo: Retaining wall

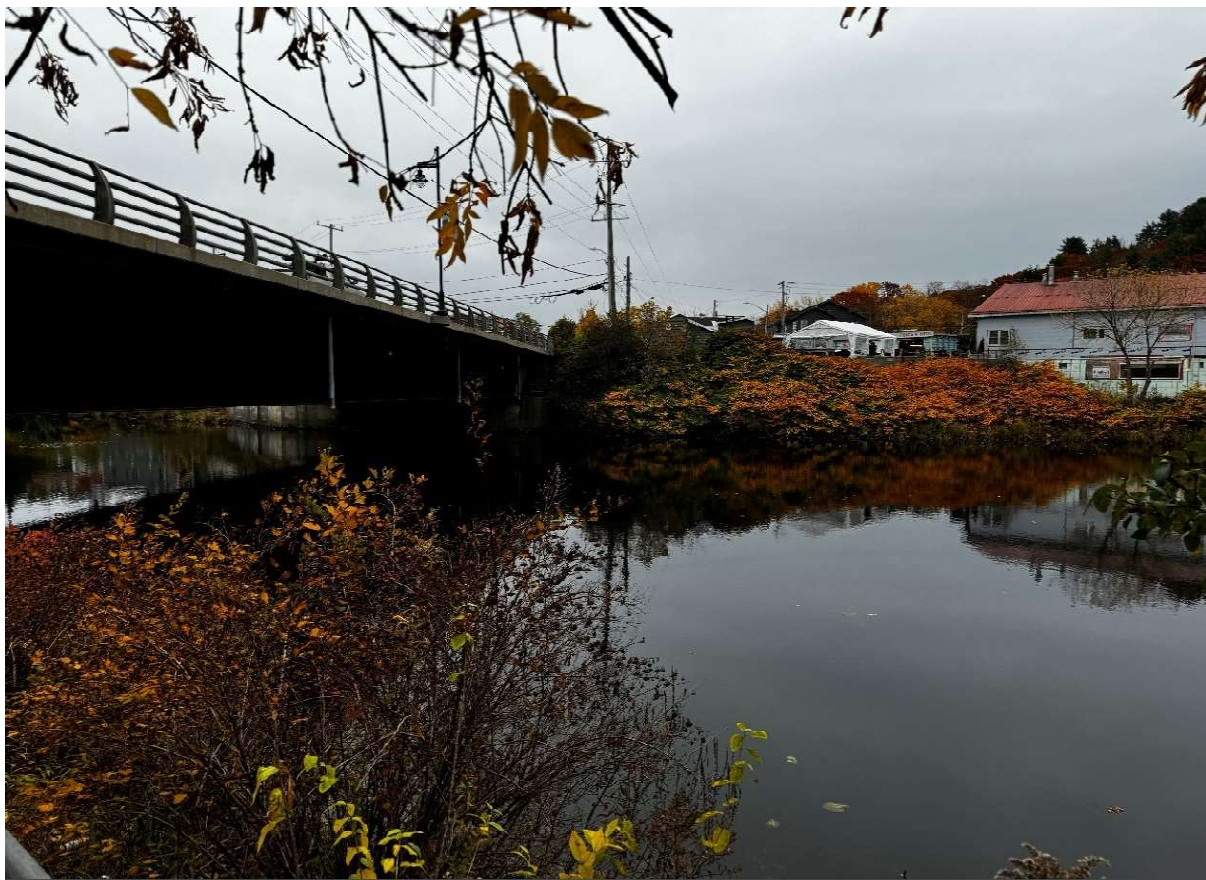
Description of Photo: Embankments

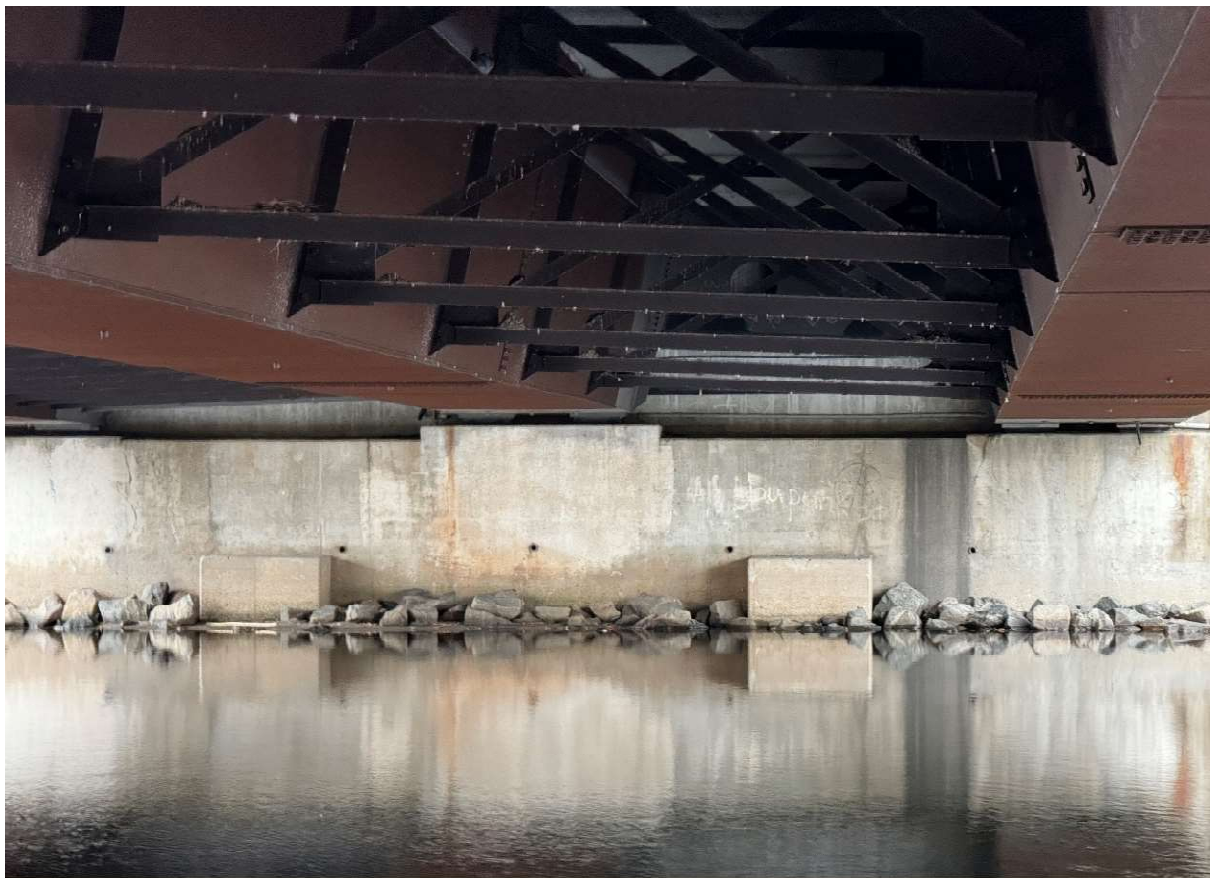
Description of Photo: Rock protection

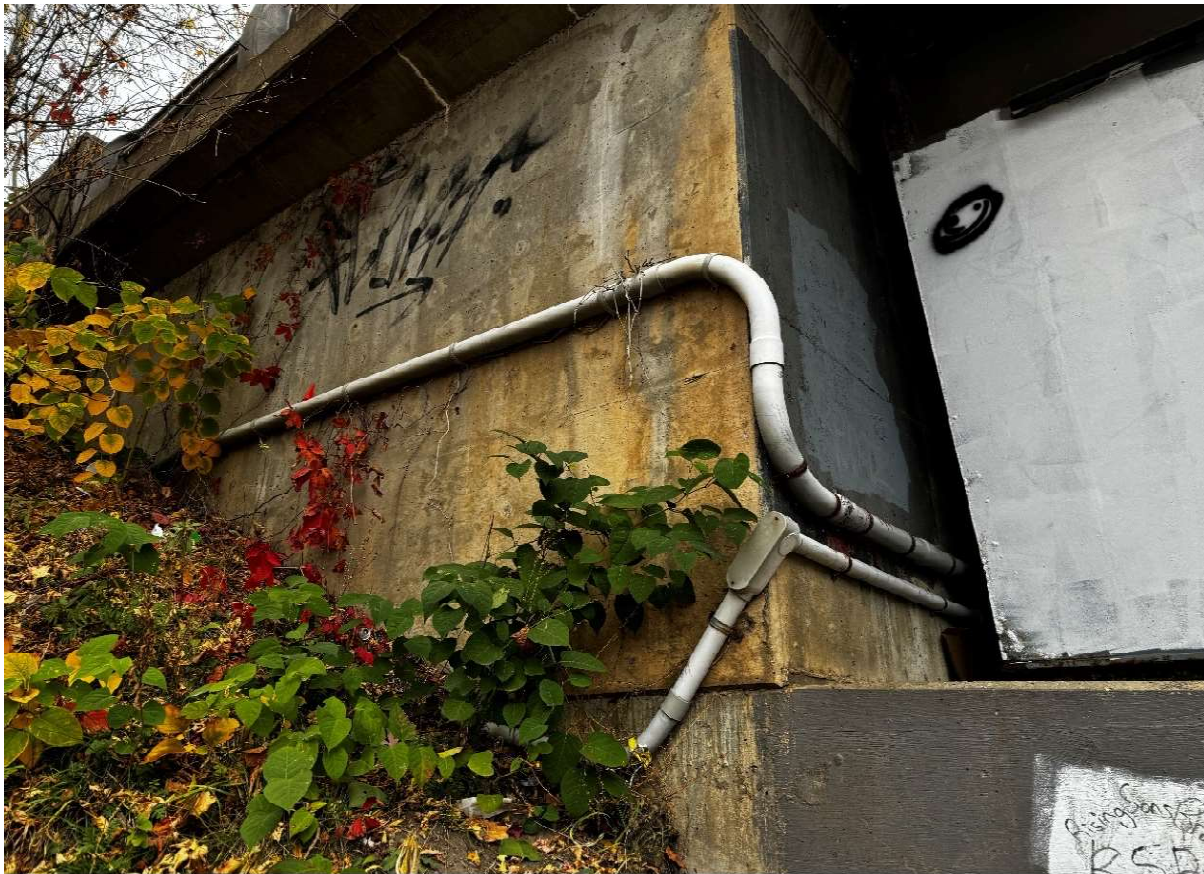
Description of Photo: Utilities

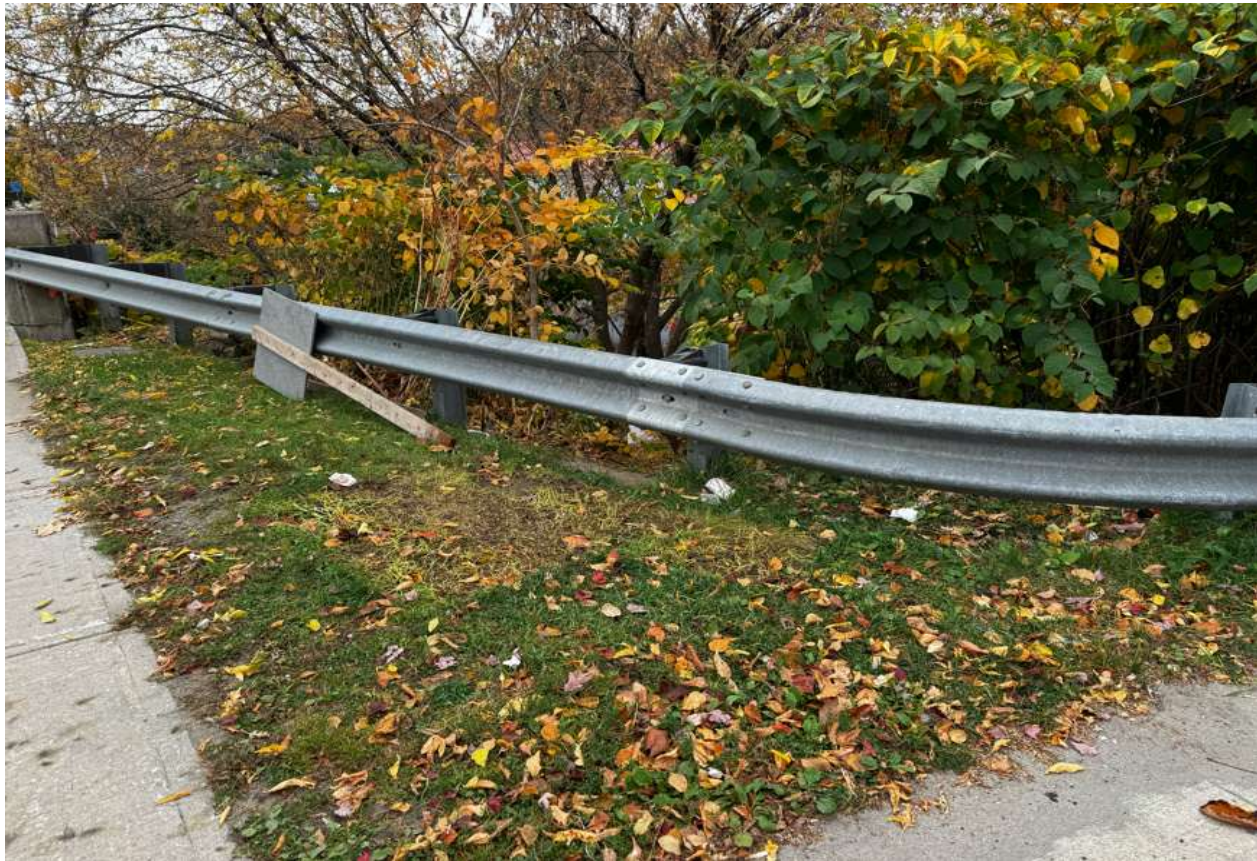
Description of Photo: Southwest approach guide rail

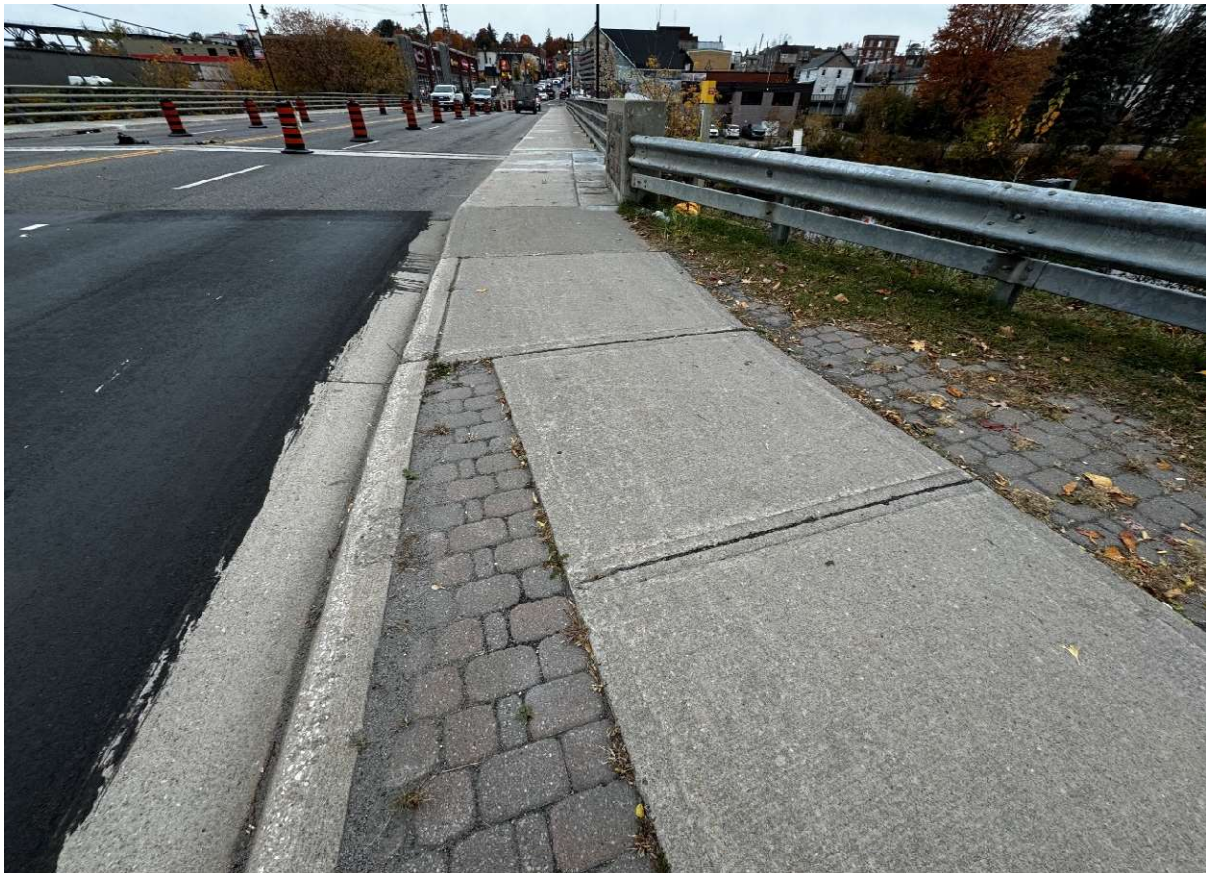
Description of Photo: Approach sidewalk
