# Bridge Inspections

**TOWN OF PARRY SOUND**

Inspection Summary Report

January  
12, 2023

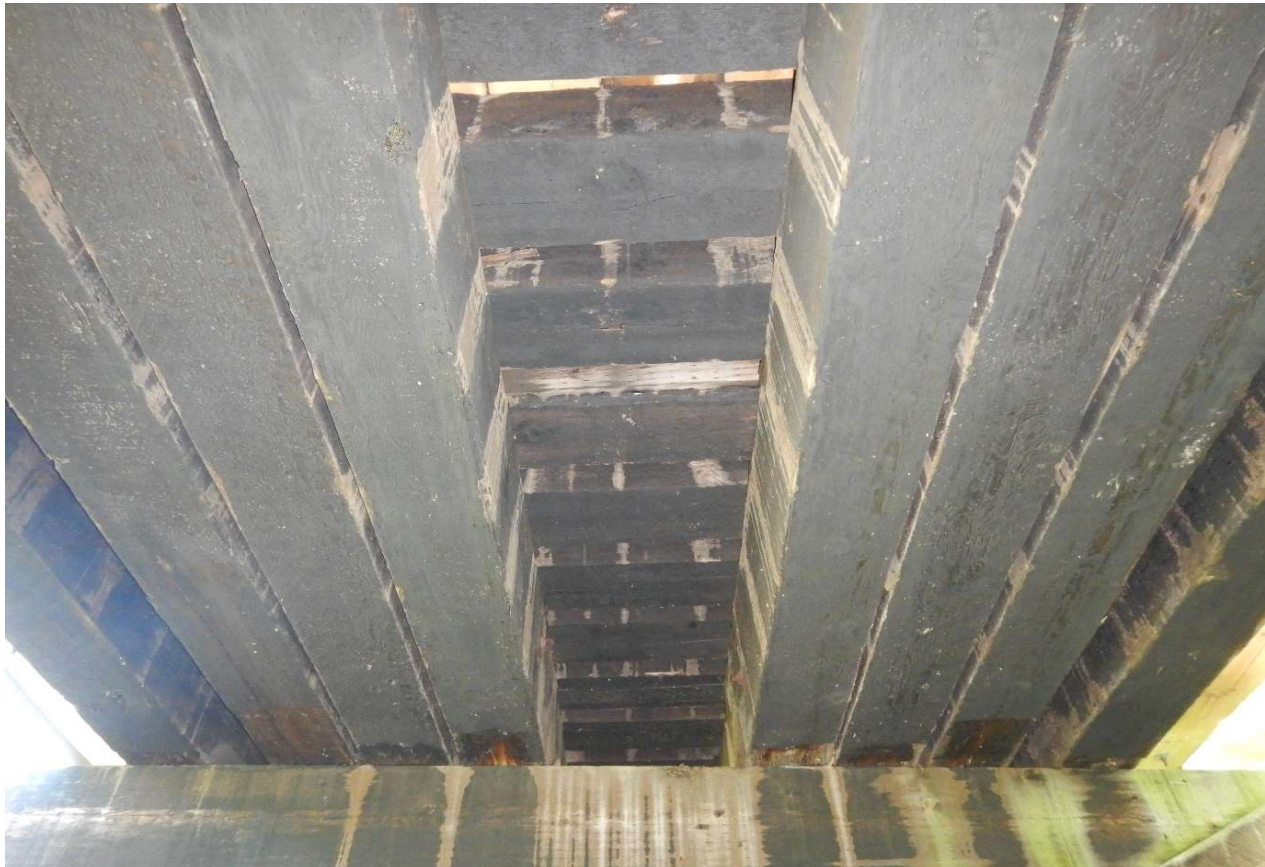
**Description of Photo:** Stringers

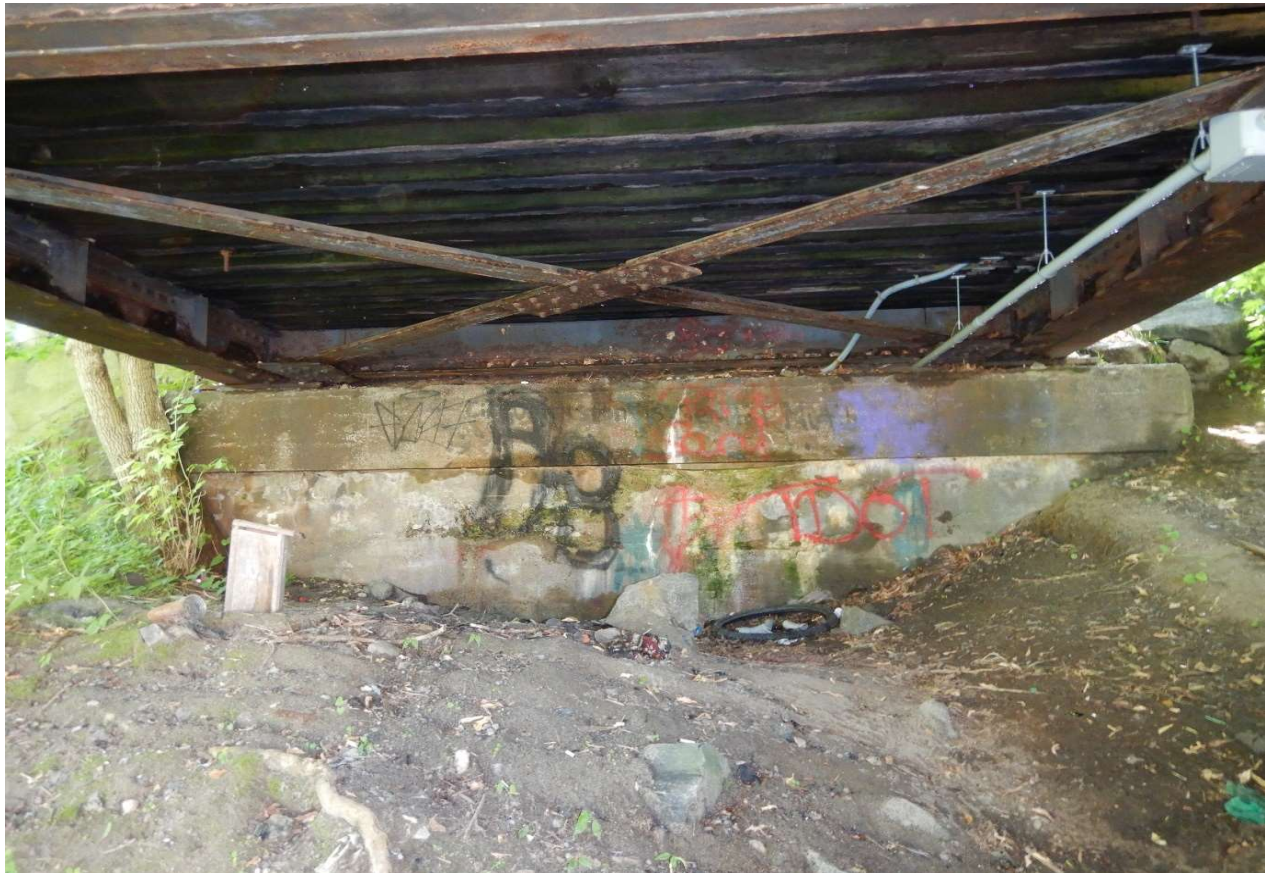
Description of Photo: West Abutment

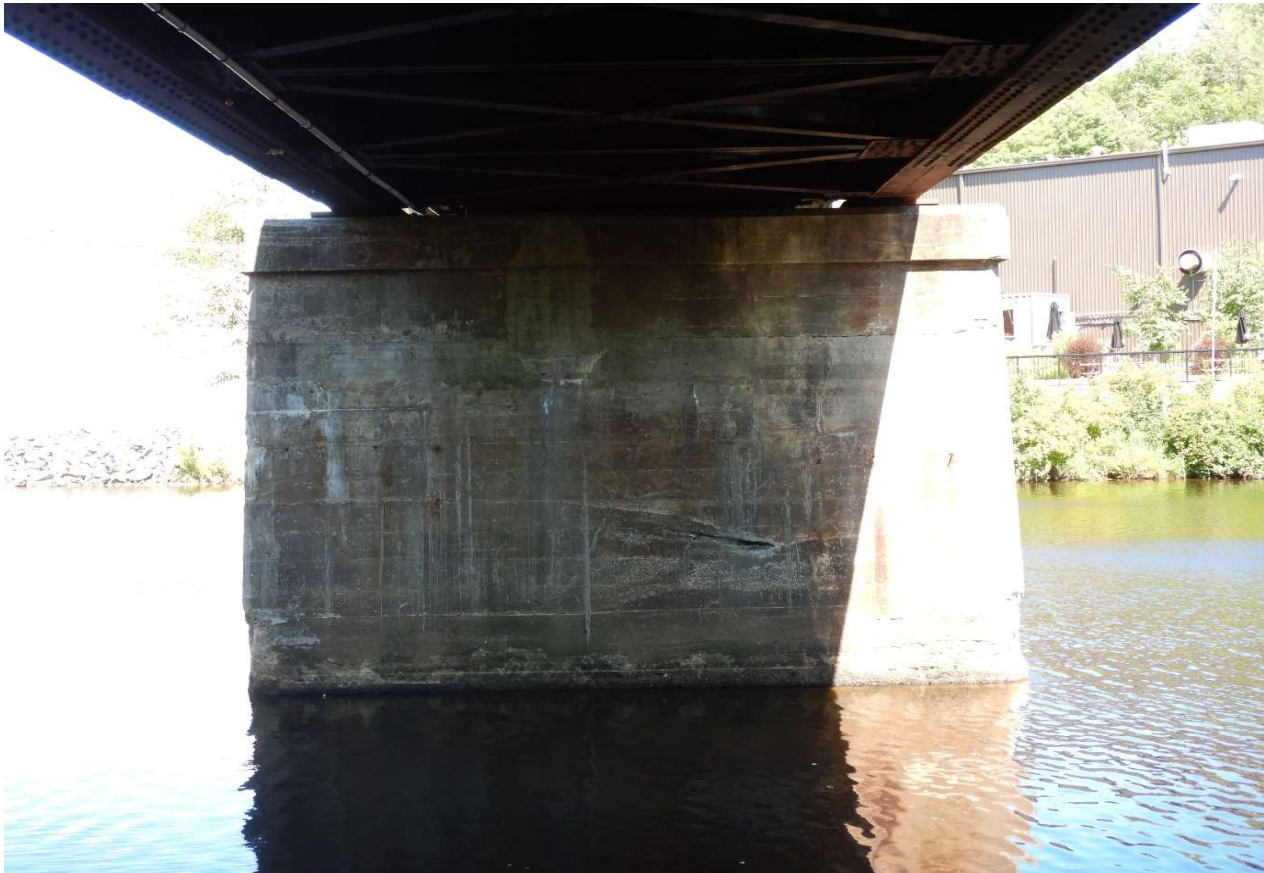
**Description of Photo:** West Pier West Face

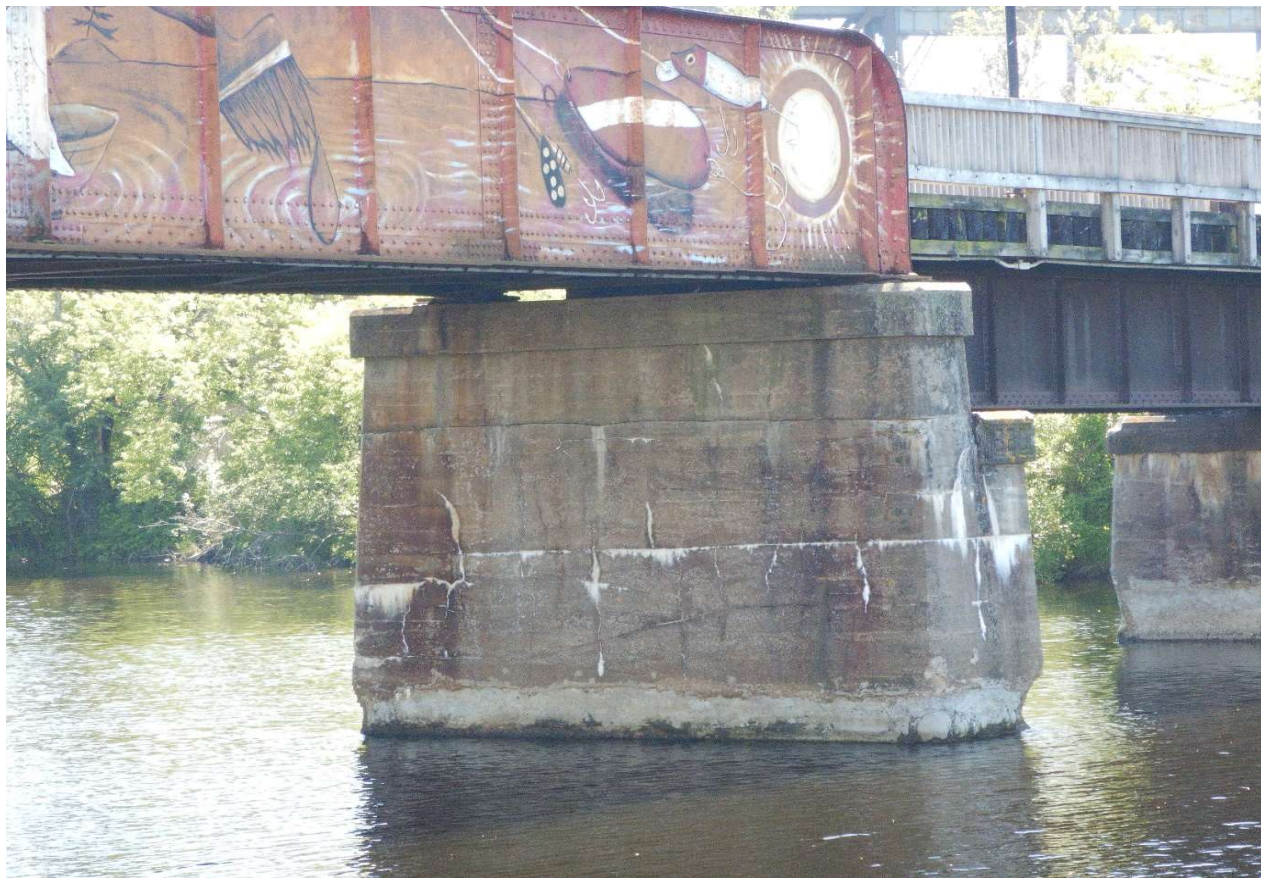
Description of Photo: Centre Pier East Face

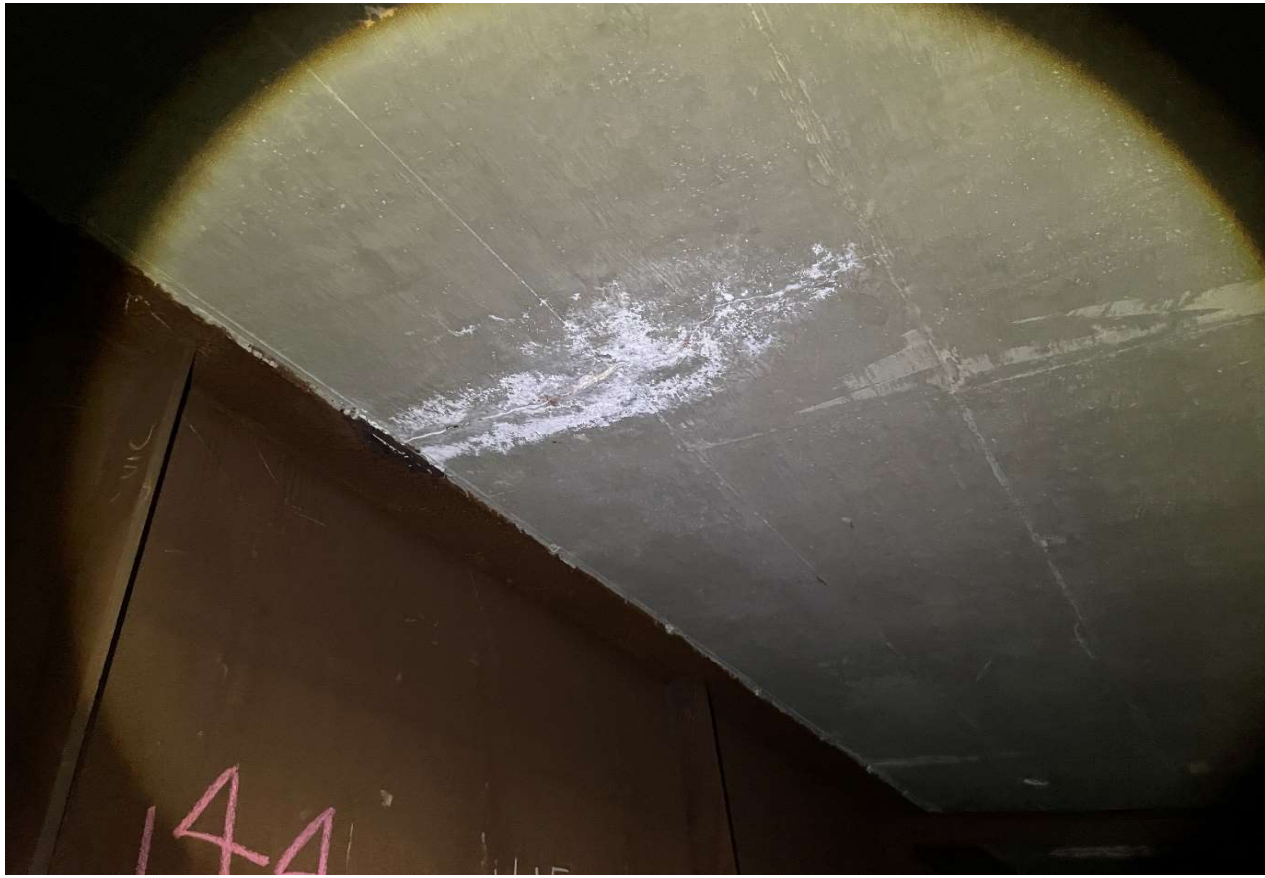
**Description of Photo:** North Girder Interior Soffit

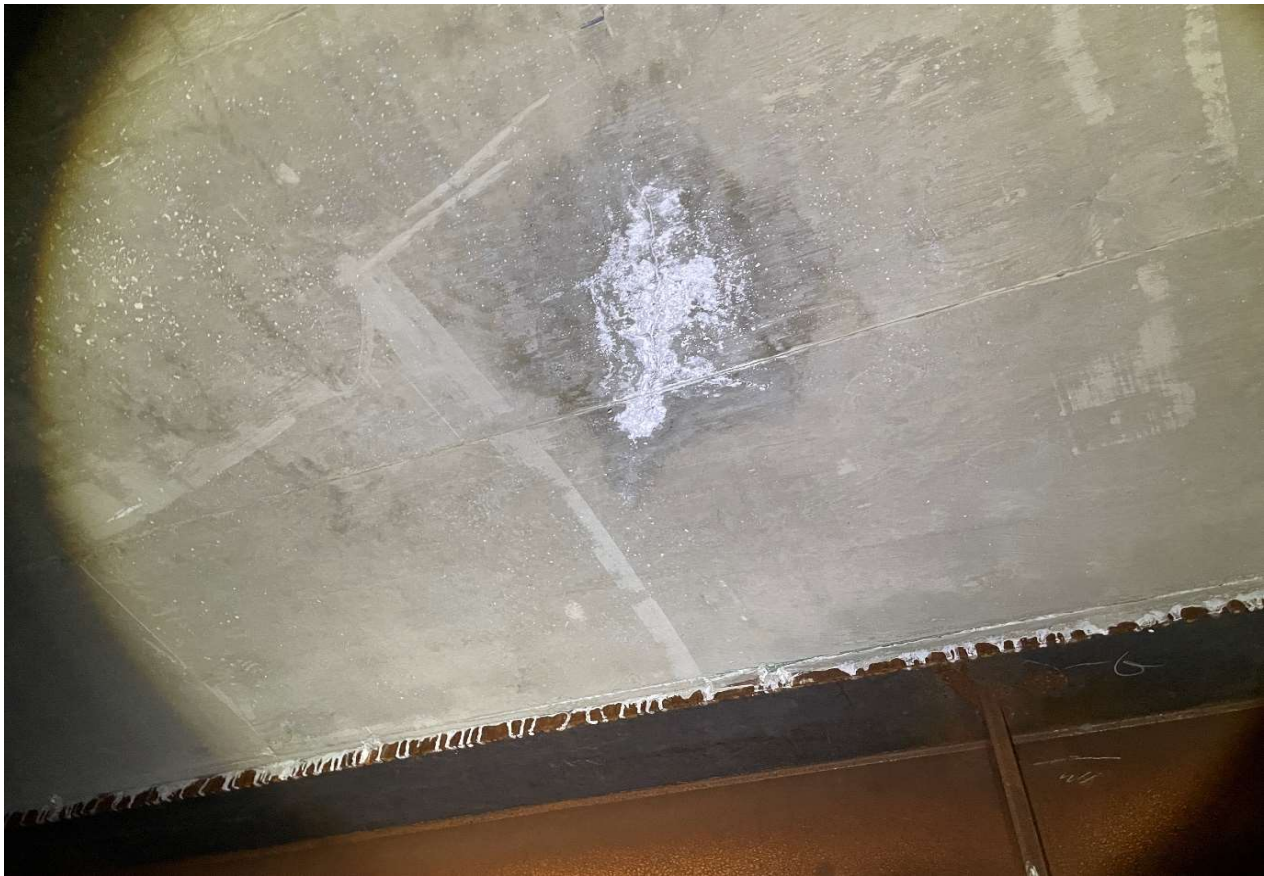
Description of Photo: South Girder Interior Soffit

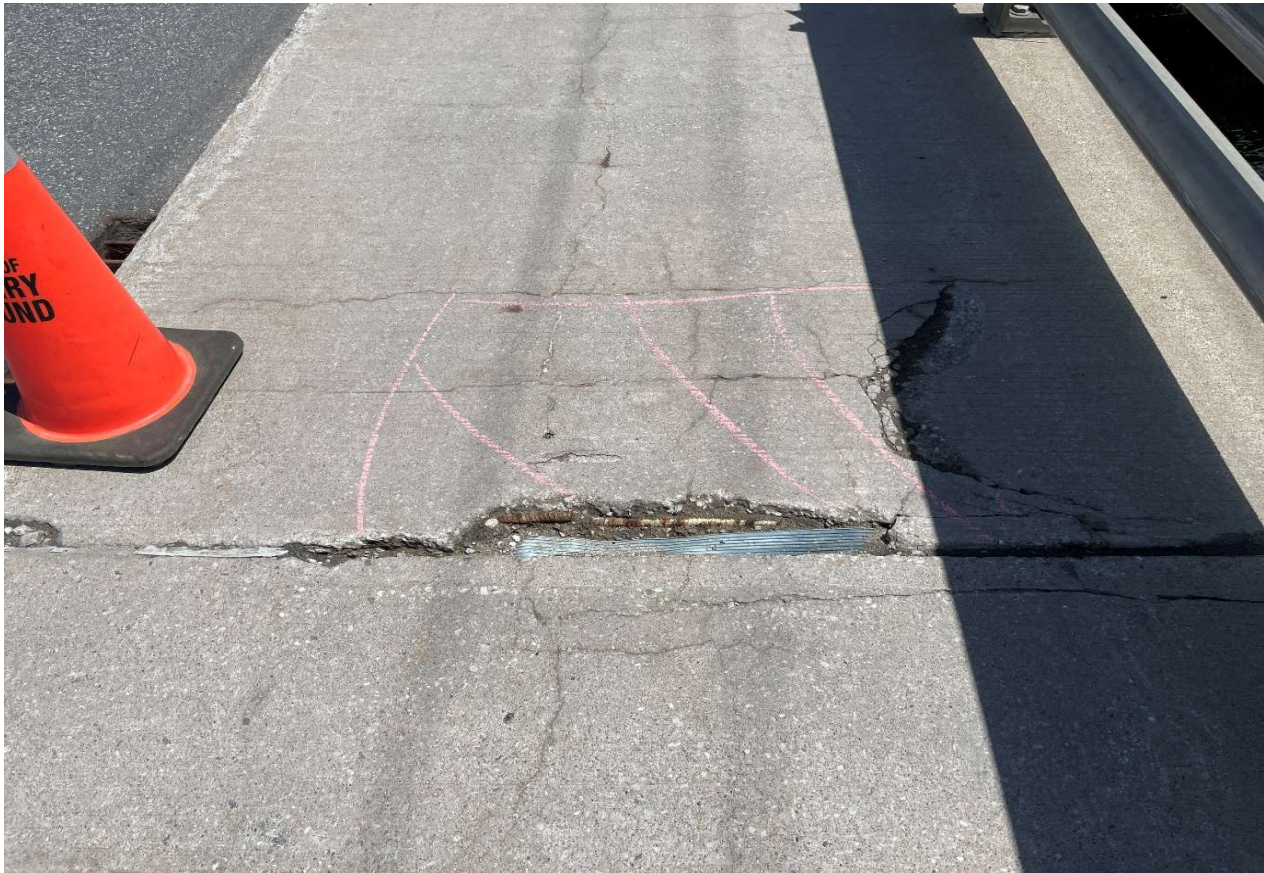
Description of Photo: Sidewalk Concrete Spall and Delamination

- Sidewalk Concrete Repair: Includes spalls and delaminations (1-5 Years).
- Interior Girder Ends: Clean and recoat steel inside boxes to mitigate continued corrosion (1-5 Years).

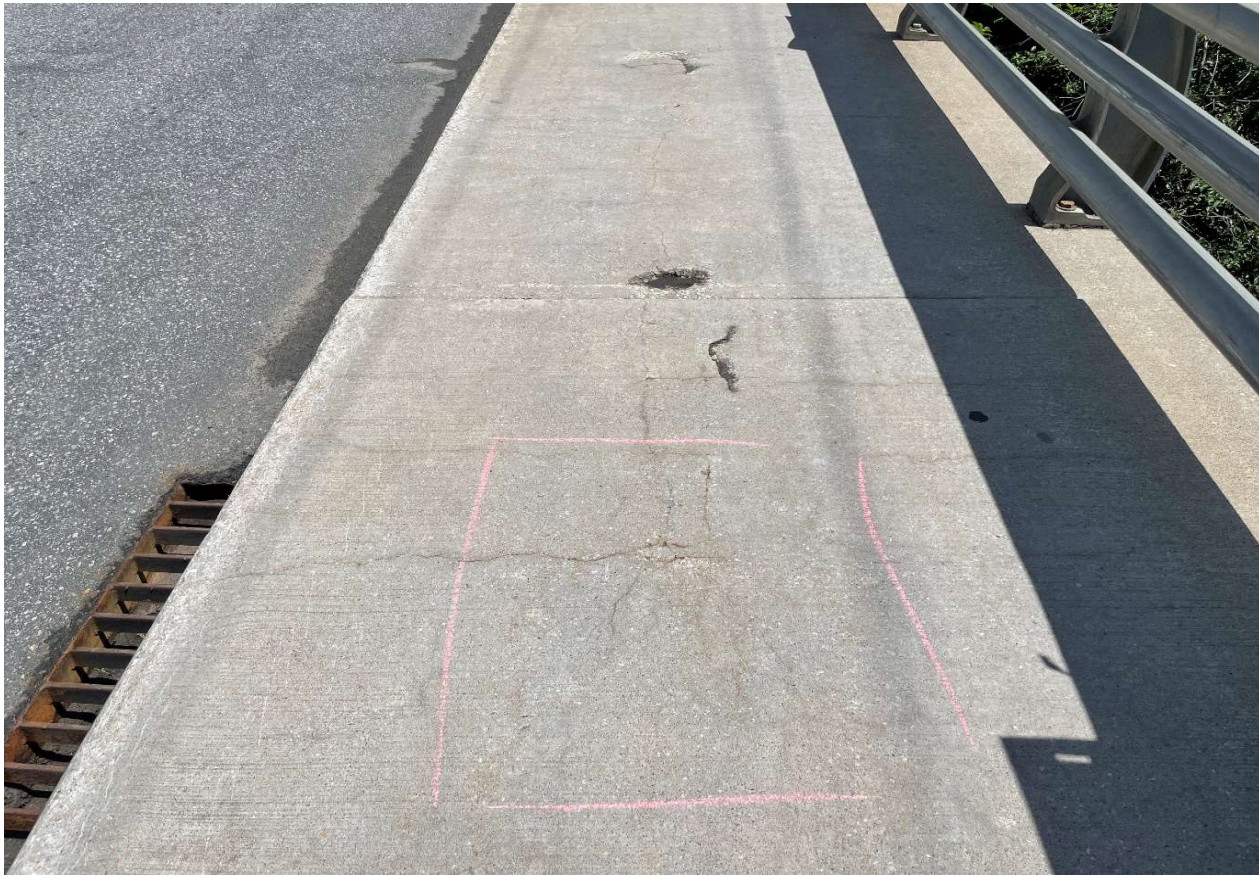
Description of Photo: Sidewalk Concrete Delamination

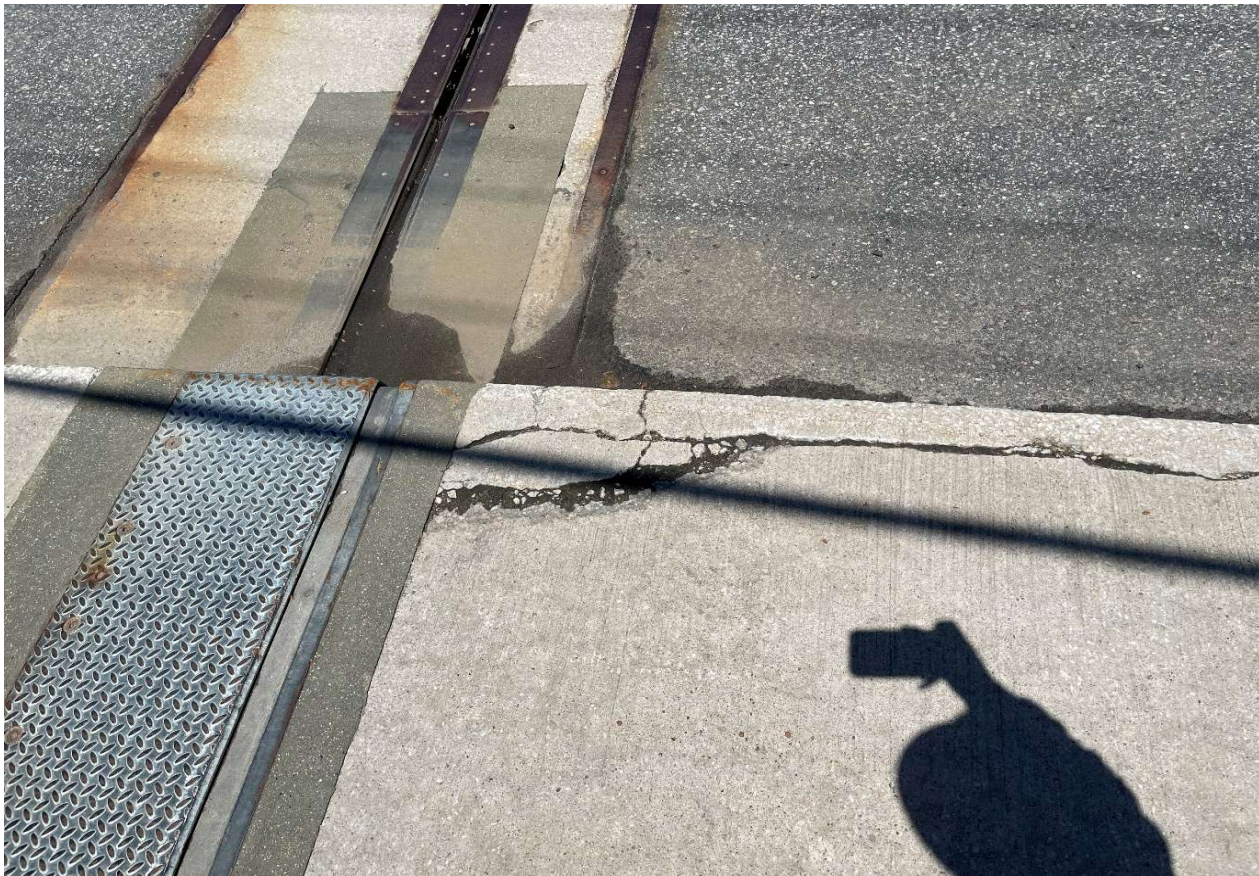
Description of Photo: Sidewalk Concrete Delamination

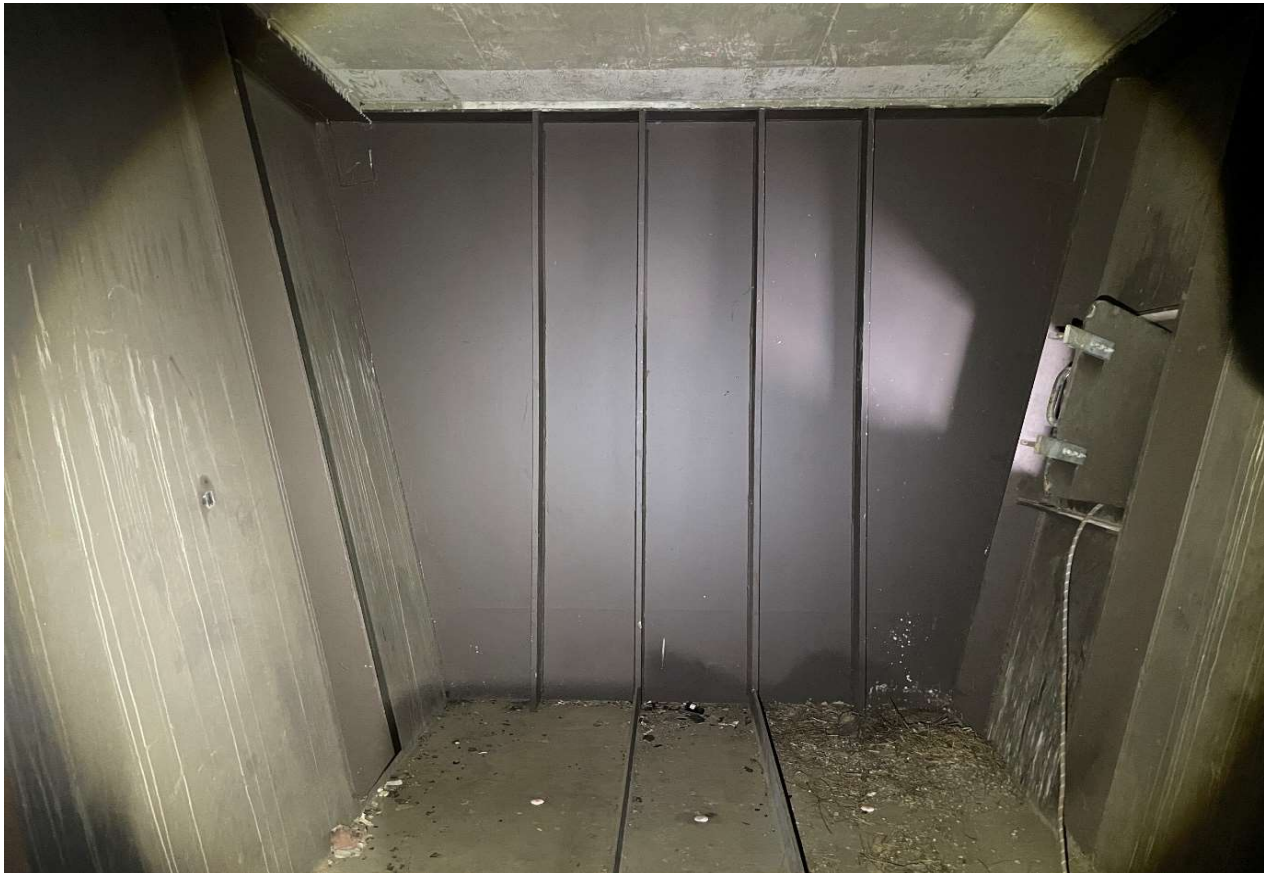
**Description of Photo:** Center Girder West End
