Parry Sound Harbour, Ontario

Bay St. Wharf (#401)
Condition Assessment Report

Small Craft Harbours, Fisheries and Oceans Canada

March 2024

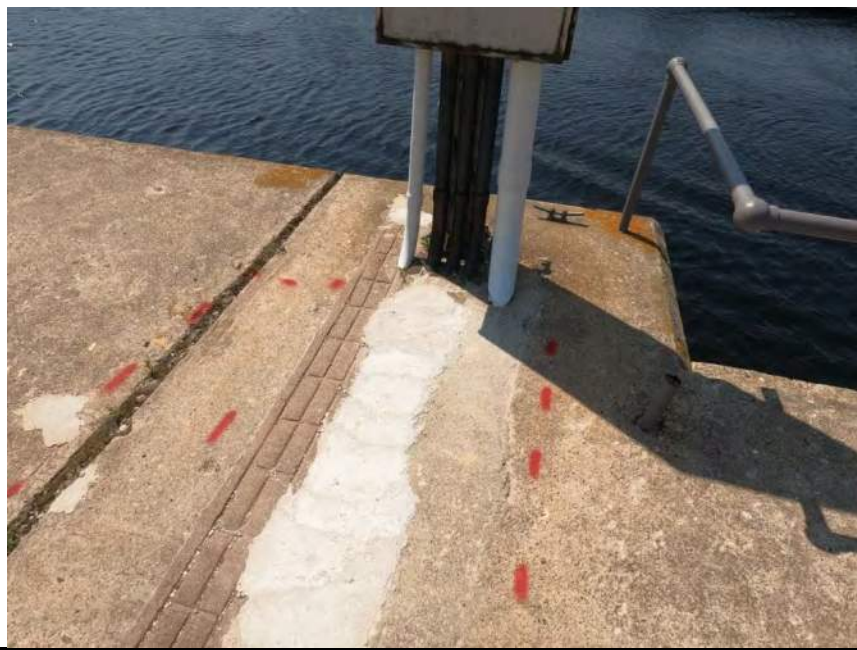
PHOTO # 16

Crack at 0+052 on the west side

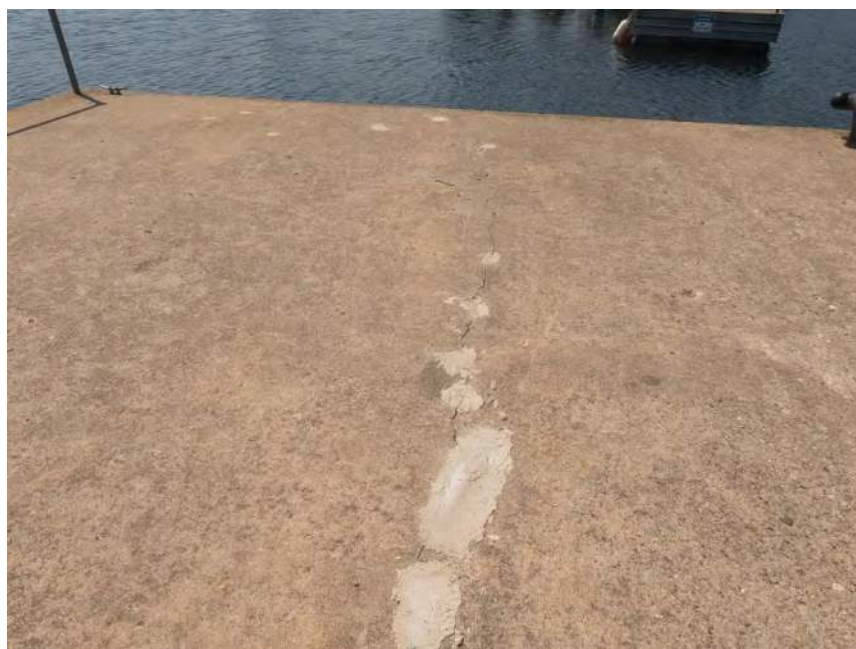
PHOTO # 22

Crack at 0+074 on the west side

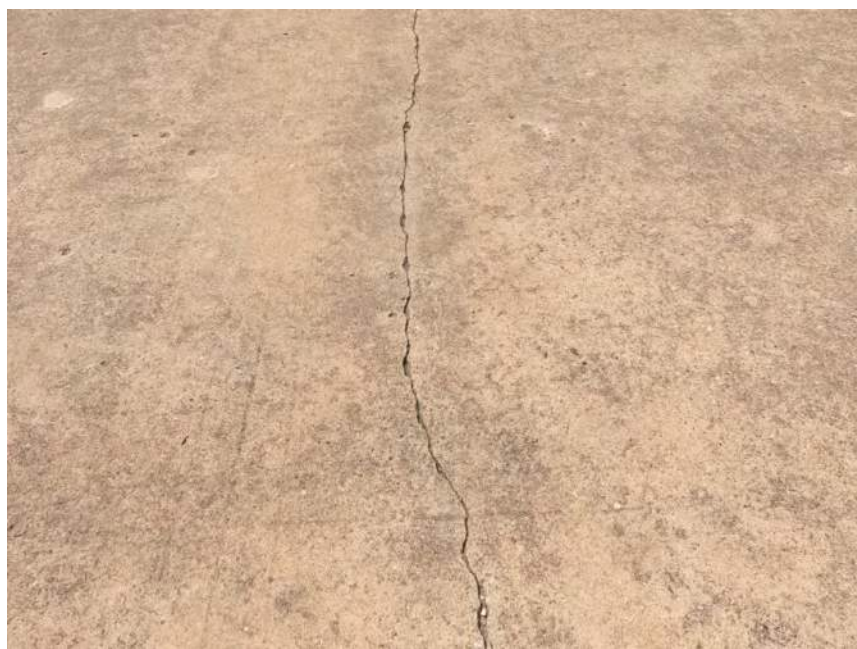
PHOTO # 25

Crack at 0+077 on the west side

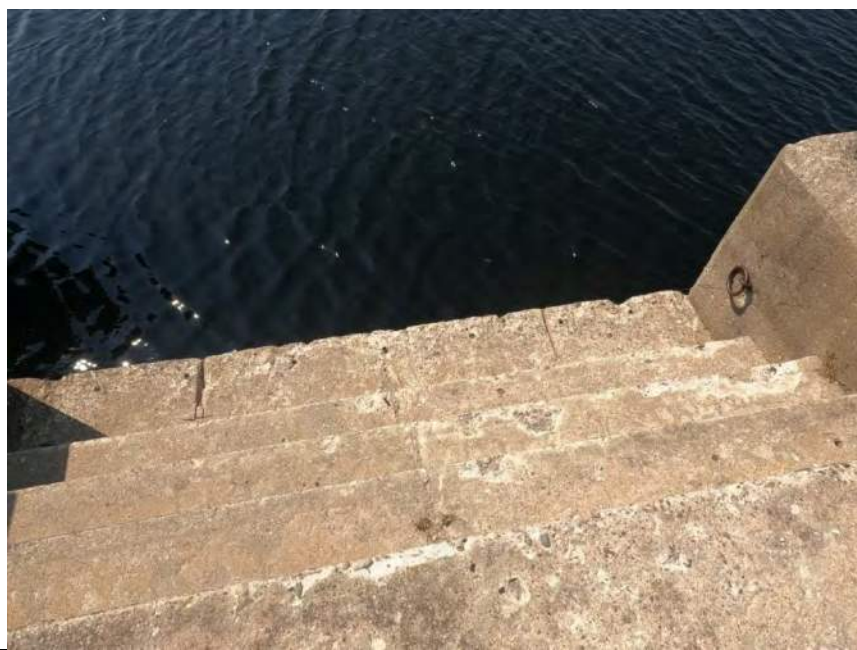
PHOTO # 30

Crack at 0+098 on the west side

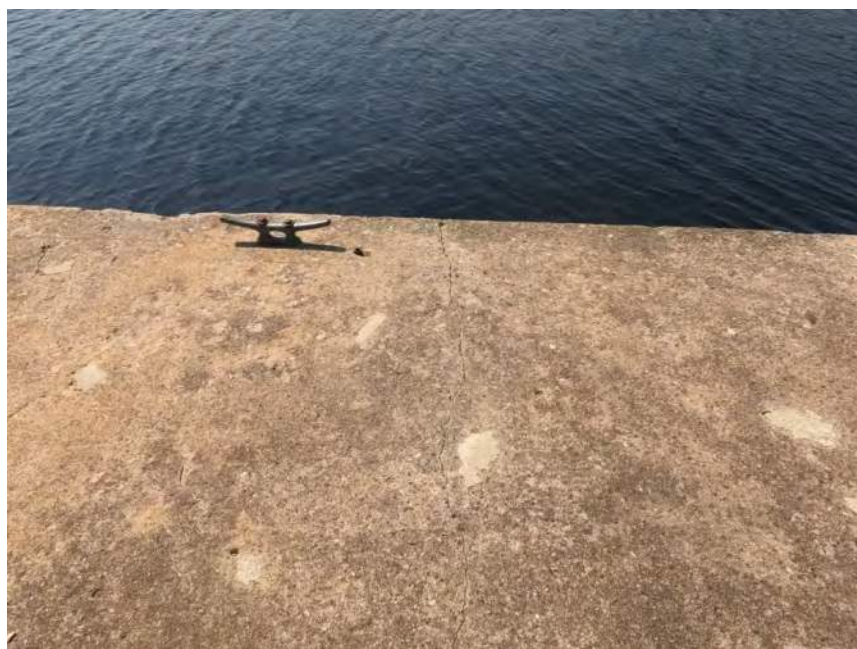
PHOTO # 37

Crack at 0+123 on the west side

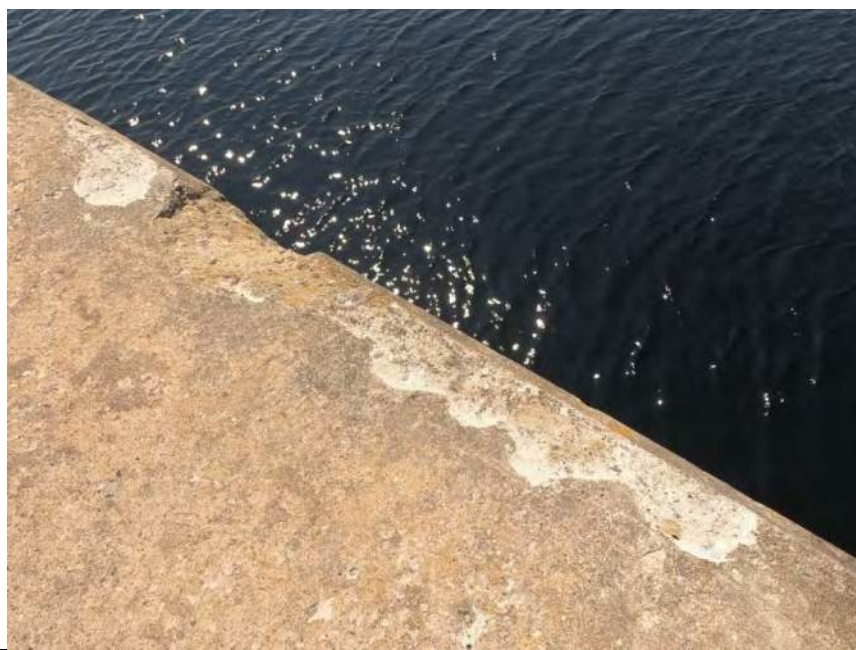
PHOTO # 45

Spalling at 0+132

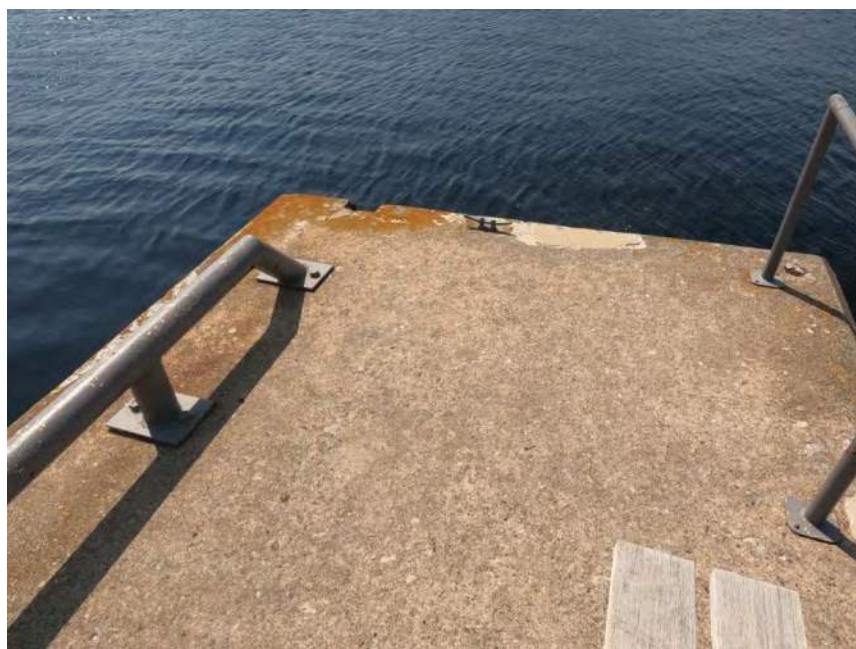
PHOTO # 58

Crack at 0+146 on the west side

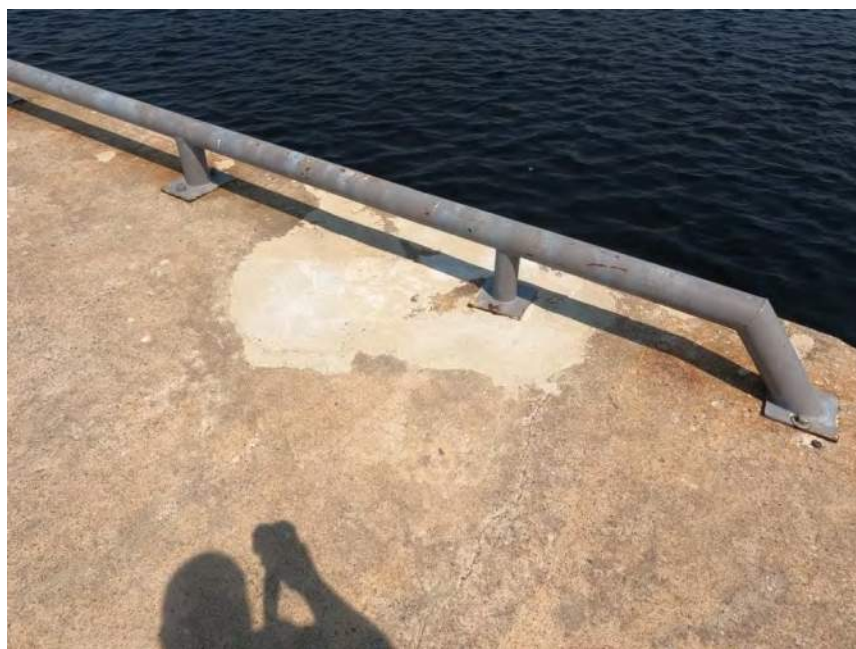
PHOTO # 67

Bollard at 0+112 on the east side

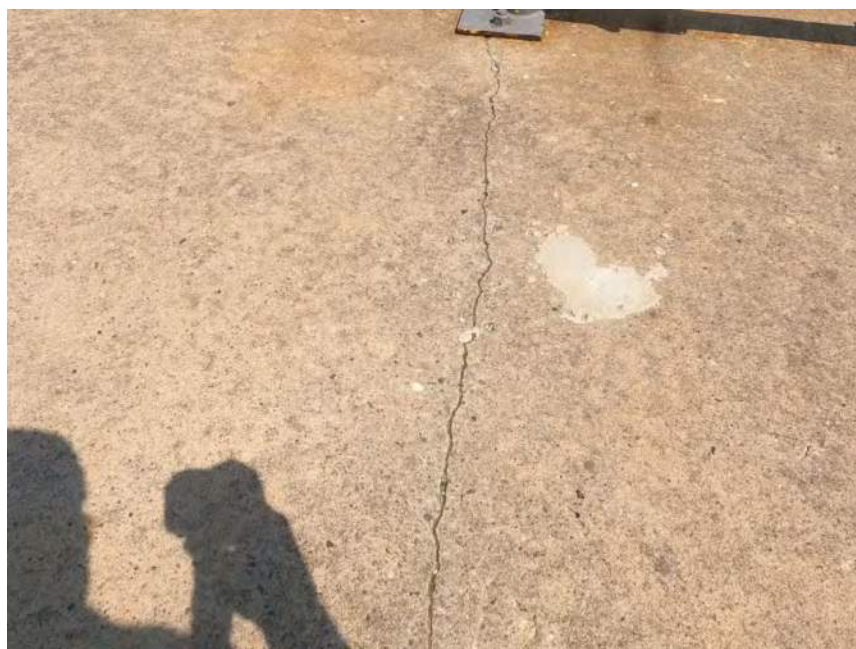
PHOTO # 70

Bollard at 0+096 on the east side

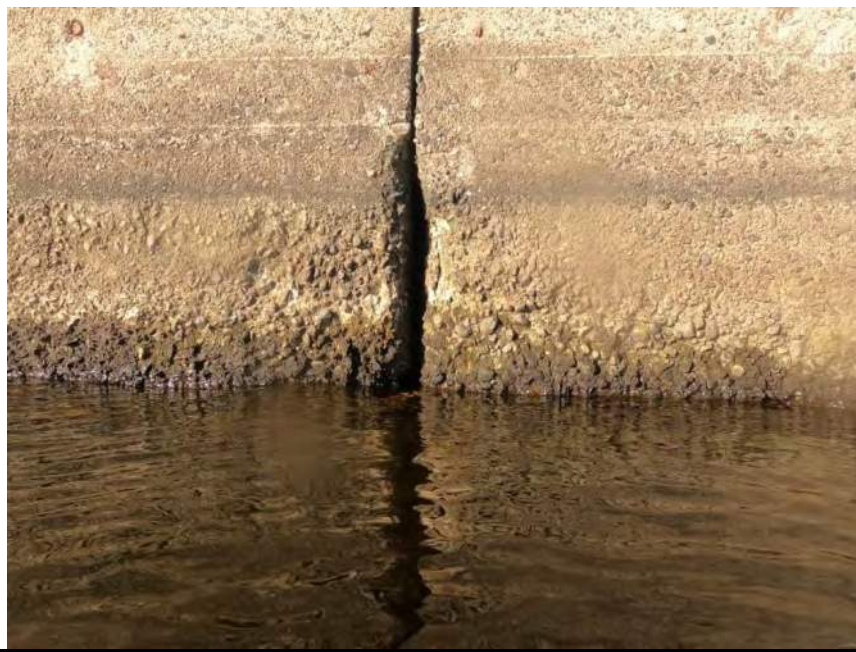
PHOTO # 112

Spalling at -0+109

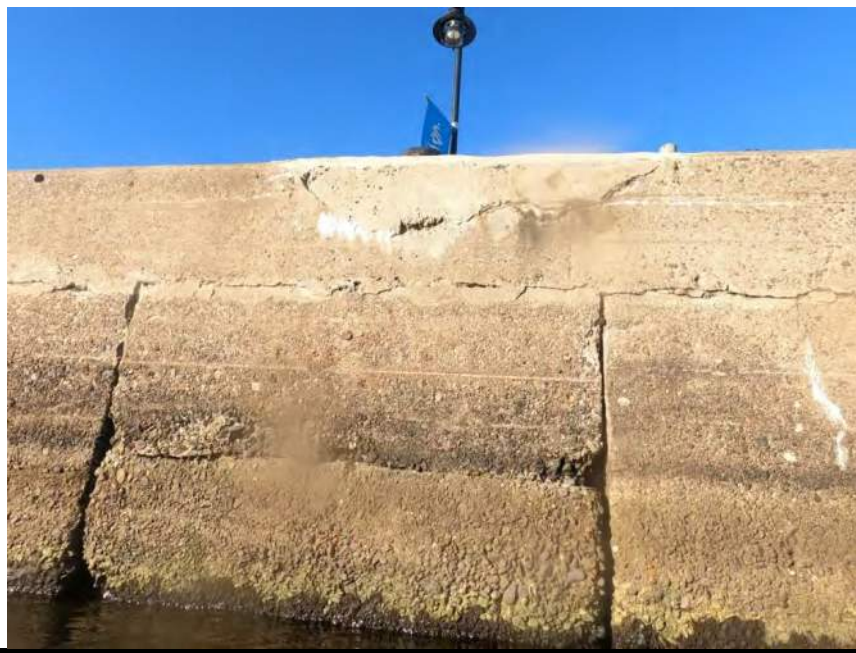
PHOTO # 114

Split in joint at -0+106

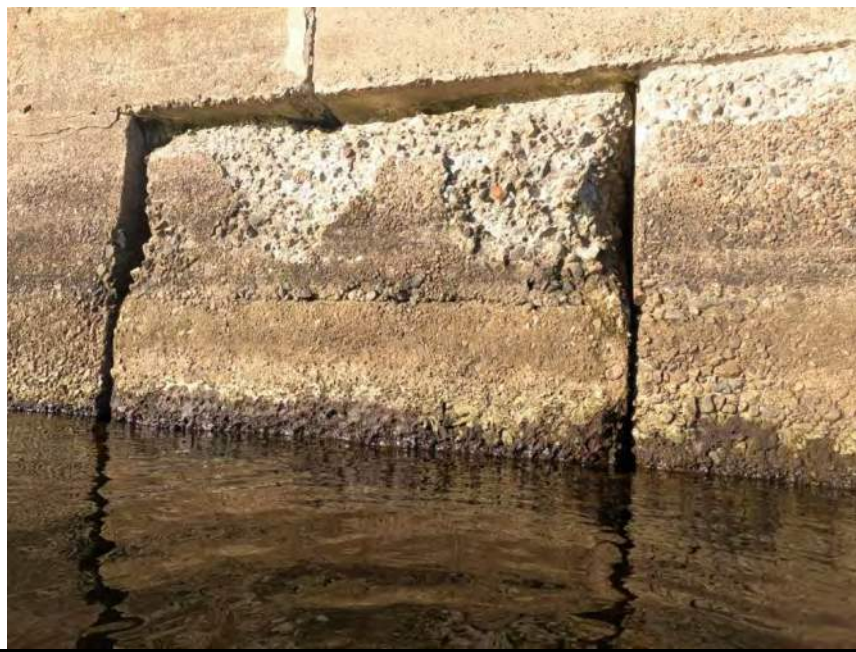
PHOTO # 115

Concrete repair underneath bollard at -0+103

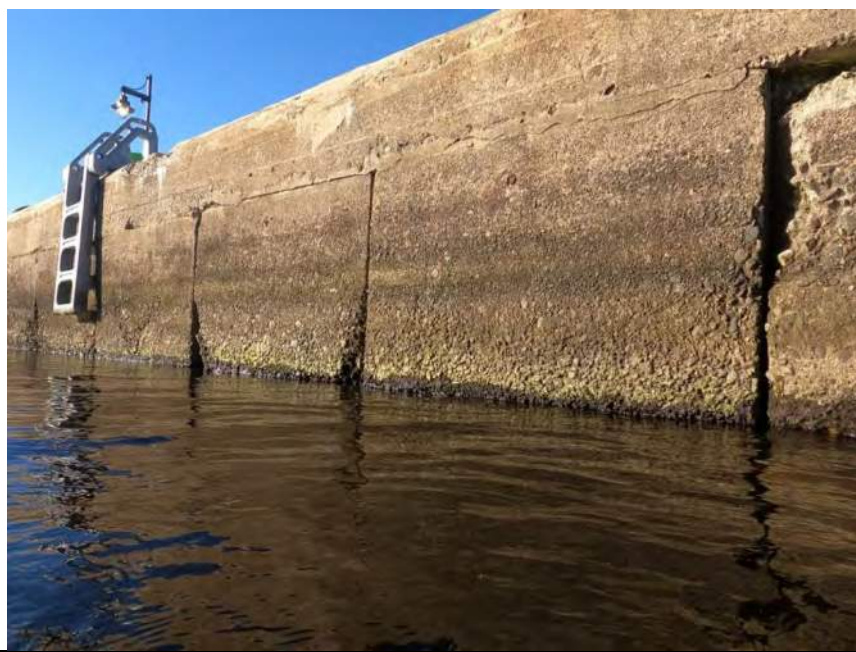
PHOTO # 116

Spalling at -0+099

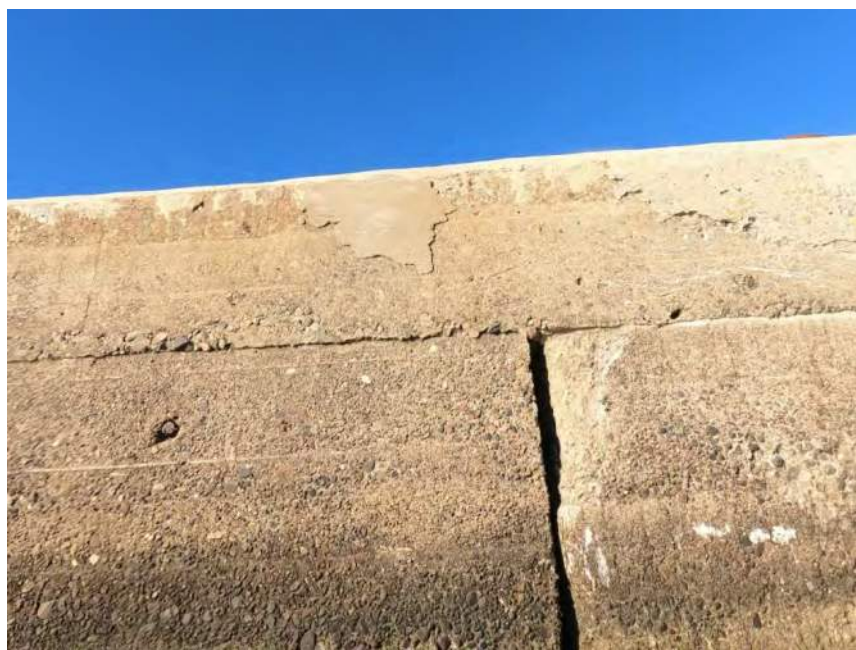
PHOTO # 122

Spalling at 0+091

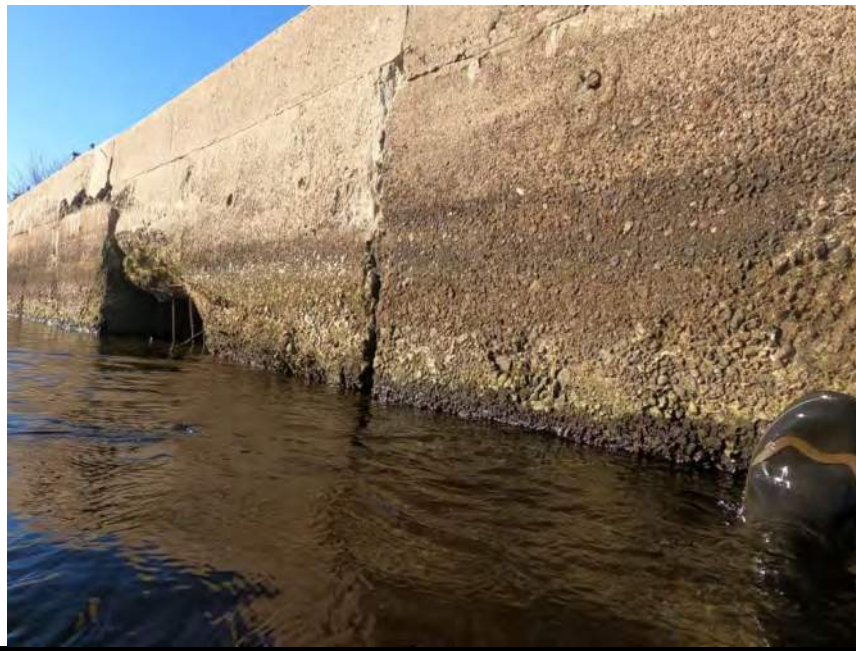
PHOTO # 123

Spalling at 0+090

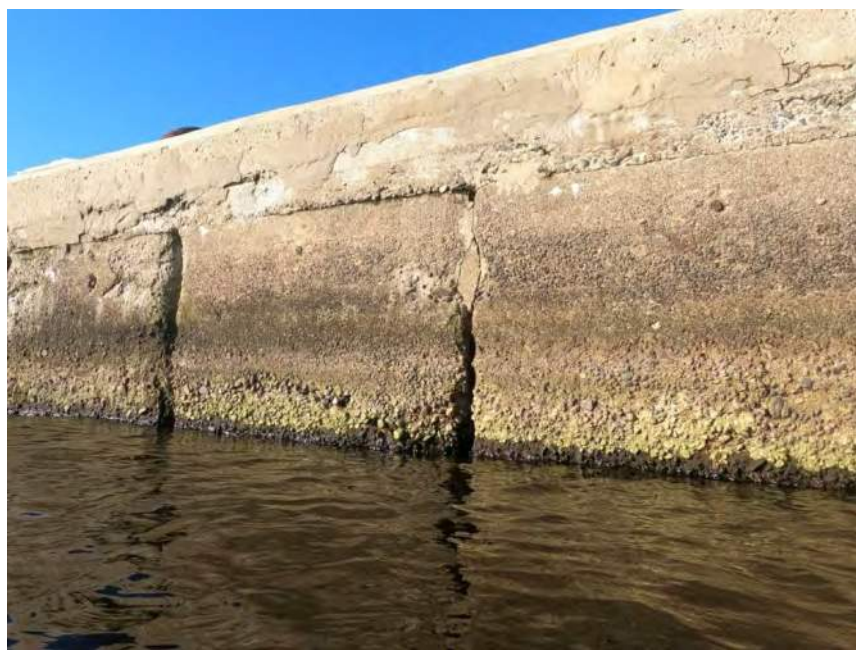
PHOTO # 128

Concrete spalling and
delamination next to the
outfall at -0+083

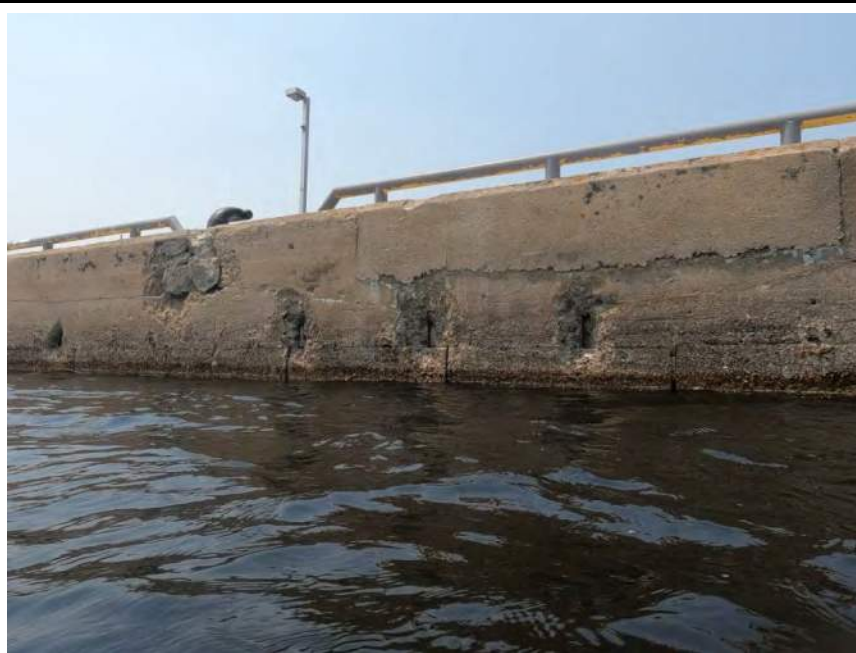
PHOTO # 145

Spalling at 0+040 on the east face

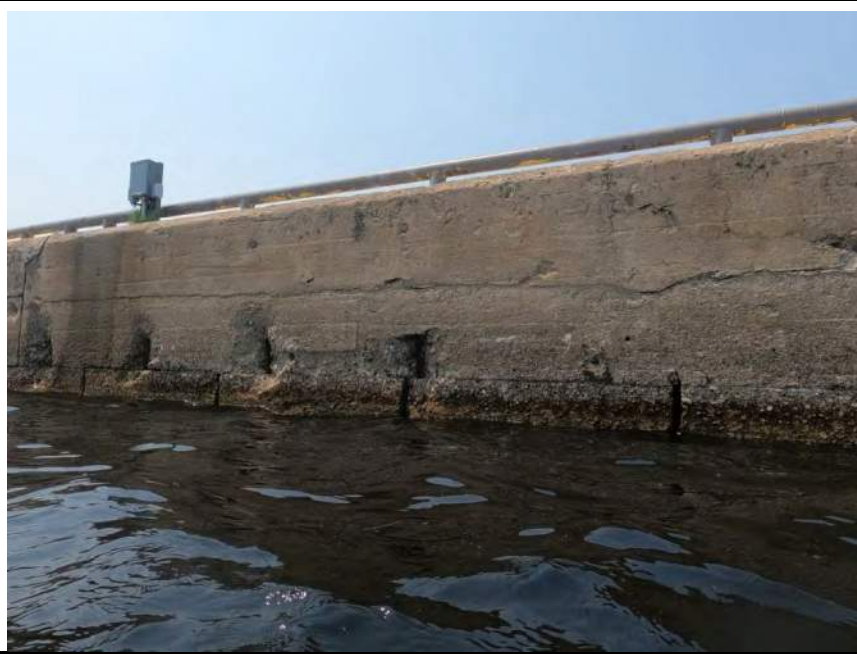
PHOTO # 148

Spalling at 0+060 on the east face

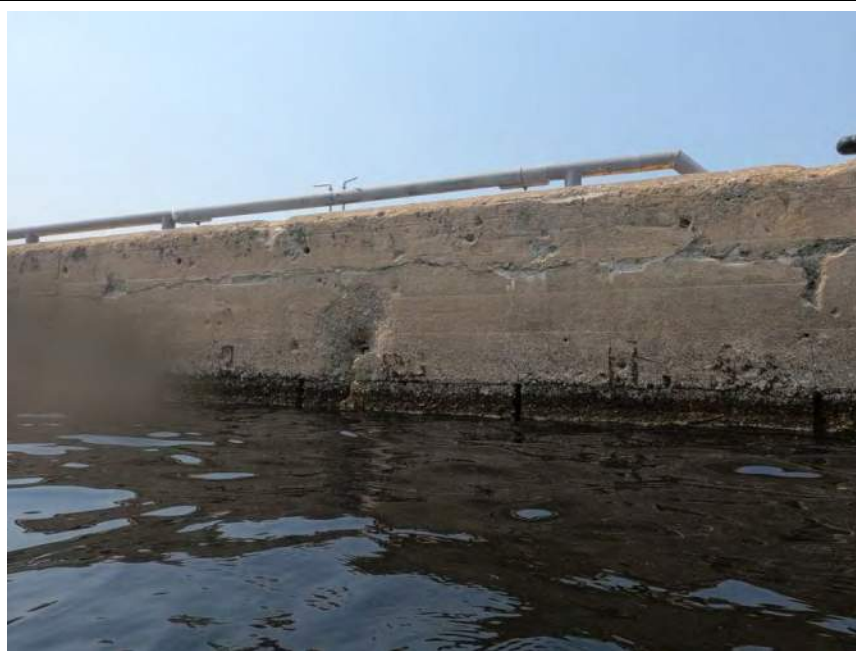
PHOTO # 151

Cracking and spalling at
0+077 on the east face

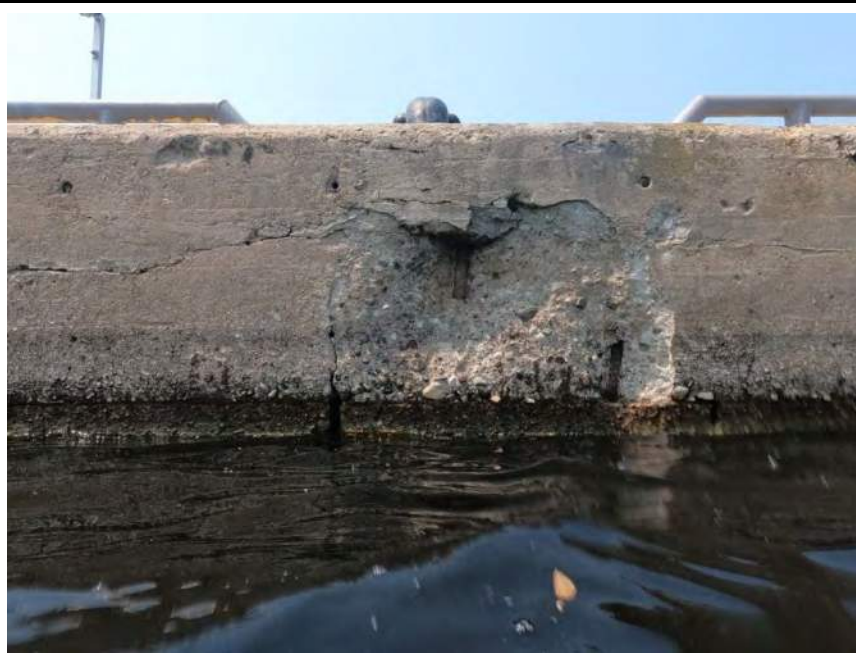
PHOTO # 154

Cracking and spalling at
0+092 on the east face

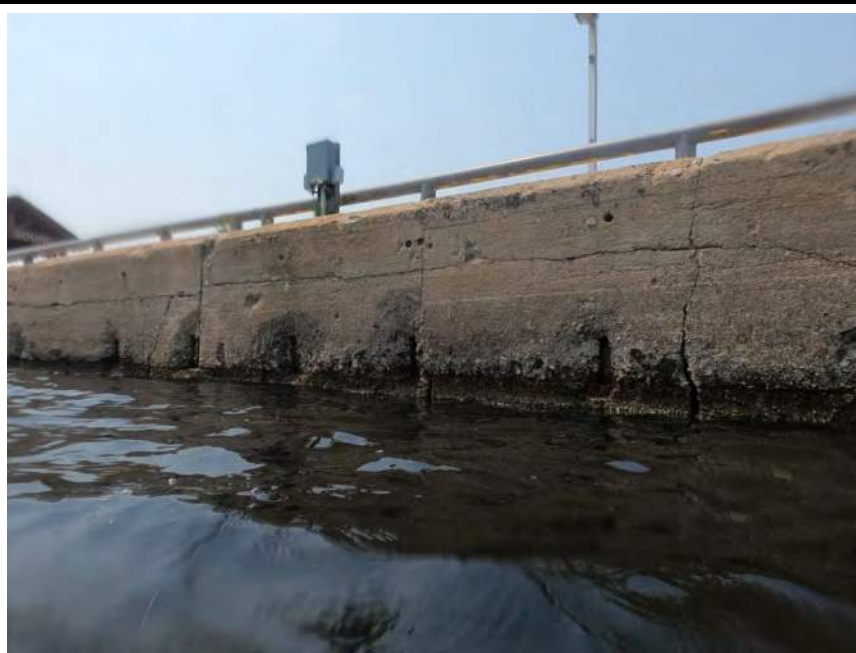
PHOTO # 155

Cracking and spalling at
0+096 on the east face

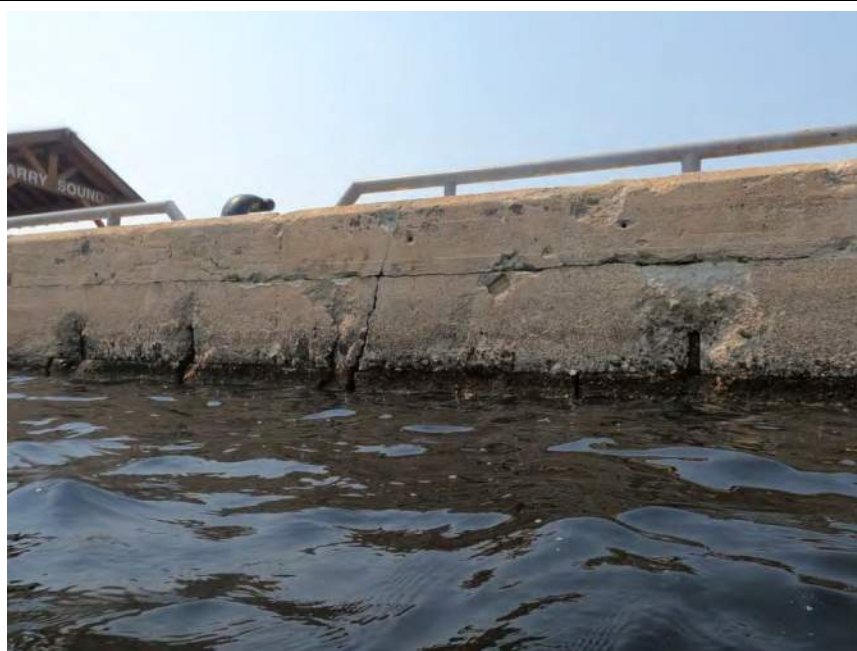
PHOTO # 157

Cracking and spalling at
0+102 on the east face

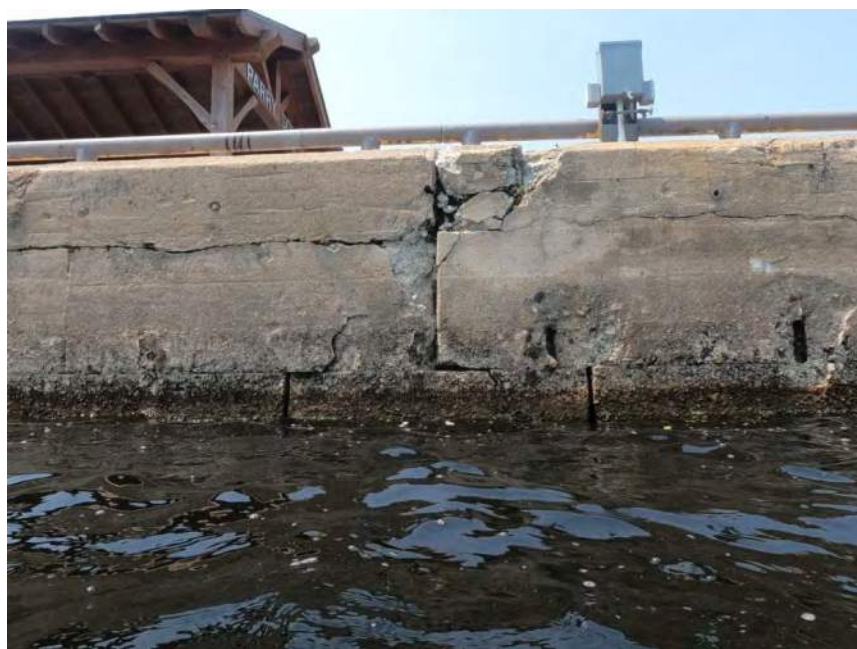
PHOTO # 158

Cracking and spalling at
0+112 on the east face

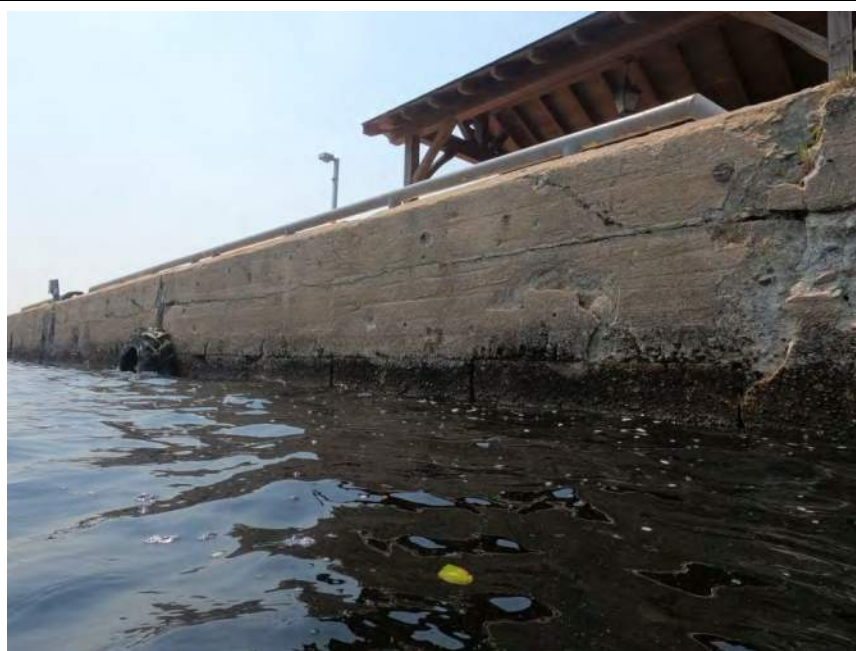
PHOTO # 160

Cracking and spalling at
0+127 on the east face

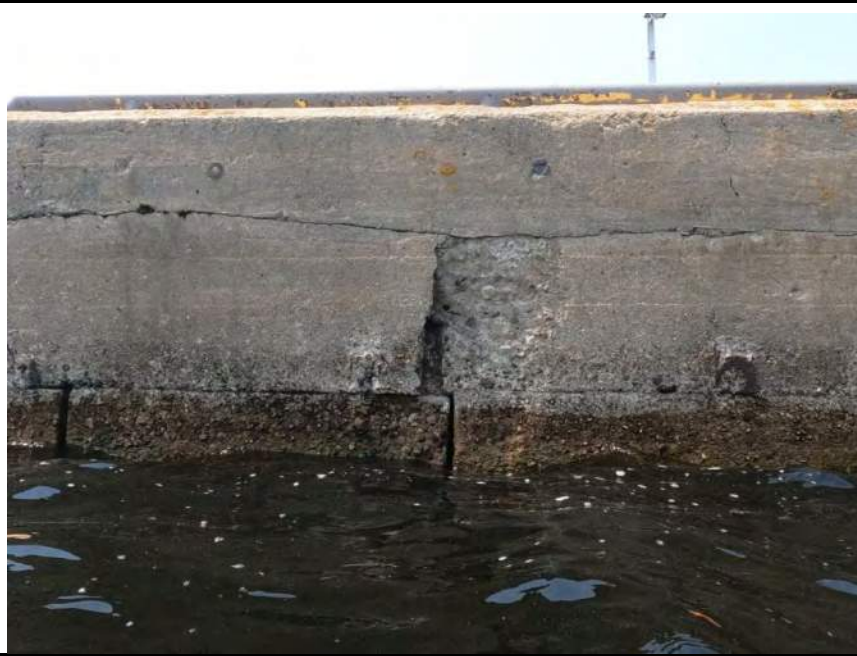
PHOTO # 163

Cracking and spalling at
0+142 on the east face

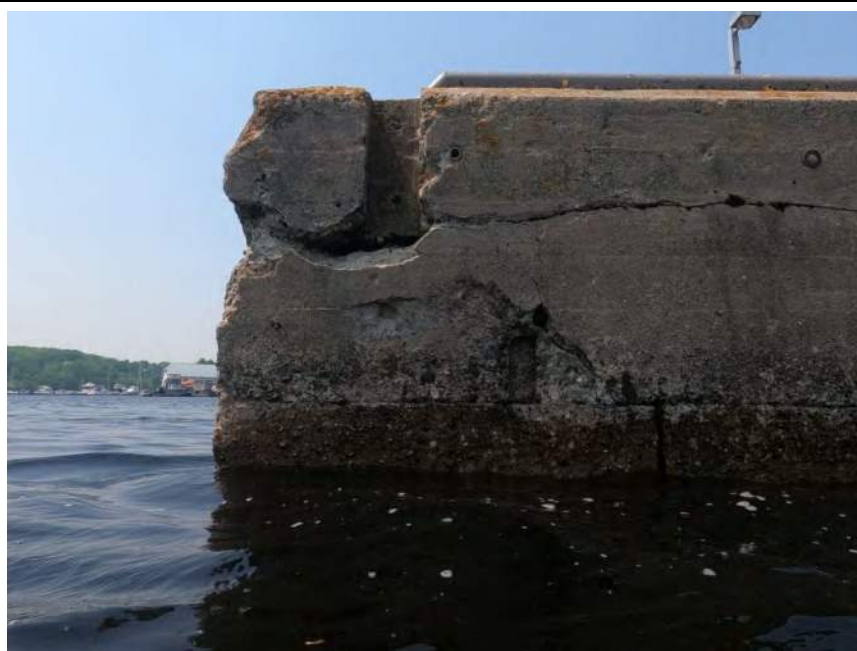
PHOTO # 164

Cracking and spalling at
0+146 on the east face

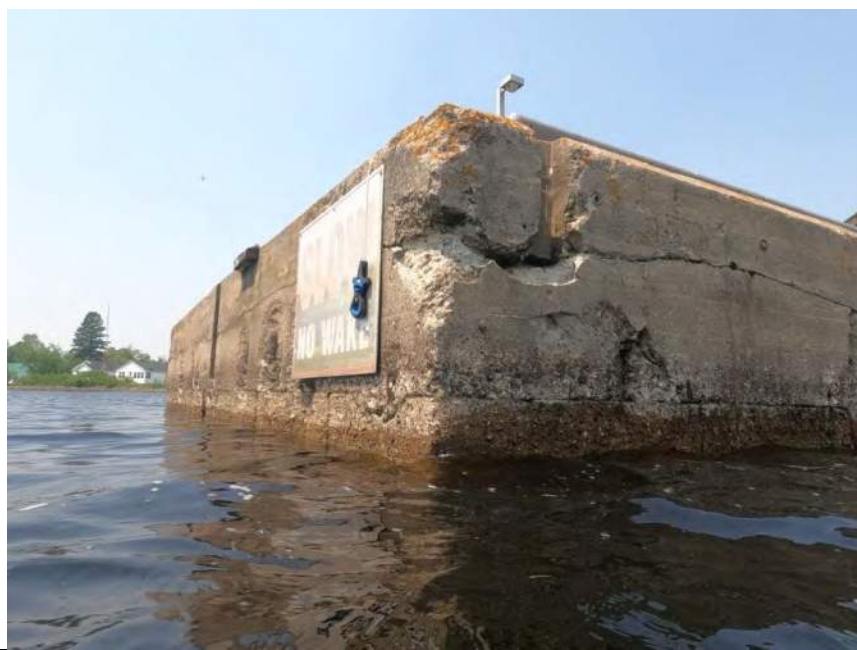
PHOTO # 165

Cracking and spalling at
0+149 on the east face

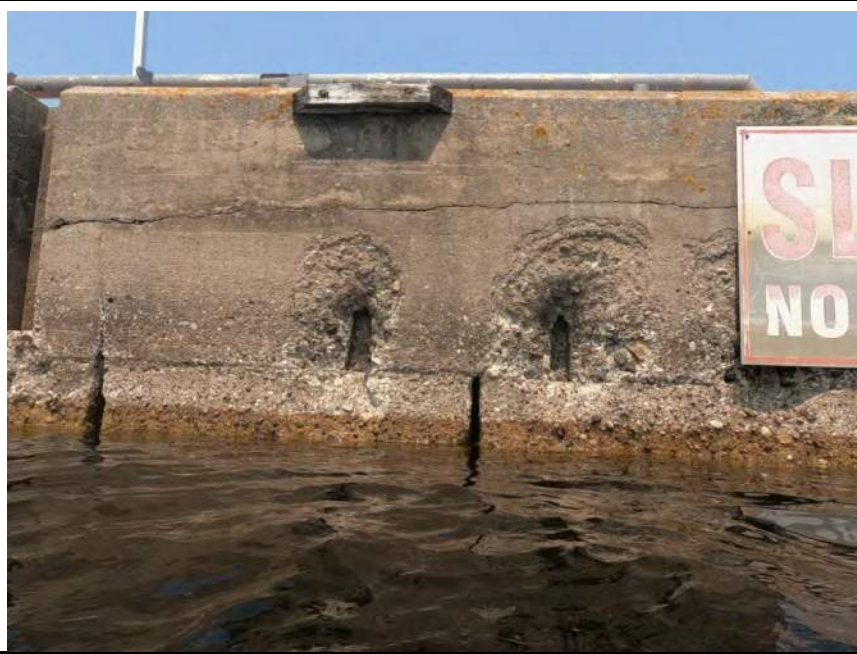
PHOTO # 166

Cracking and spalling at 0+150 on the southeast corner

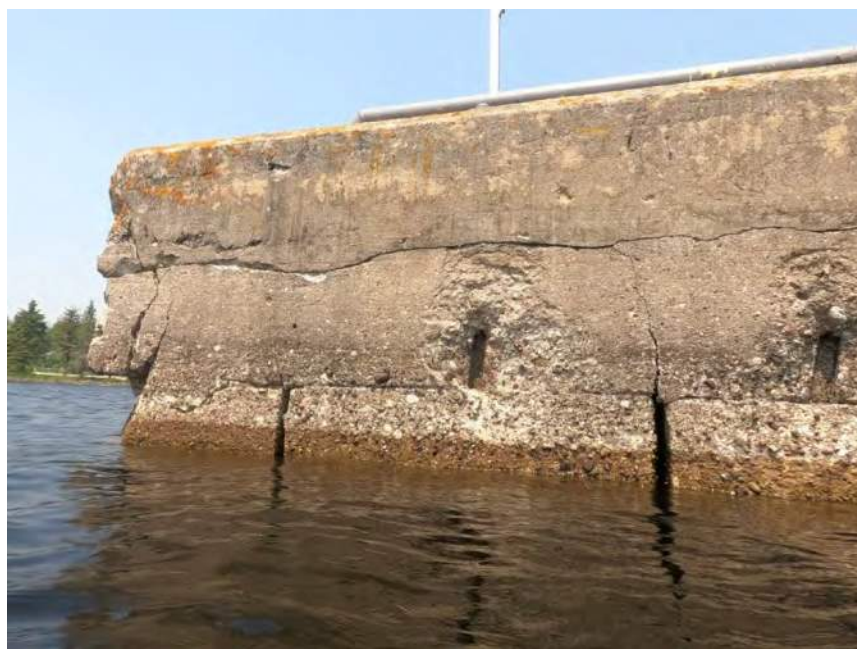
PHOTO # 167

Cracking and spalling on the south face

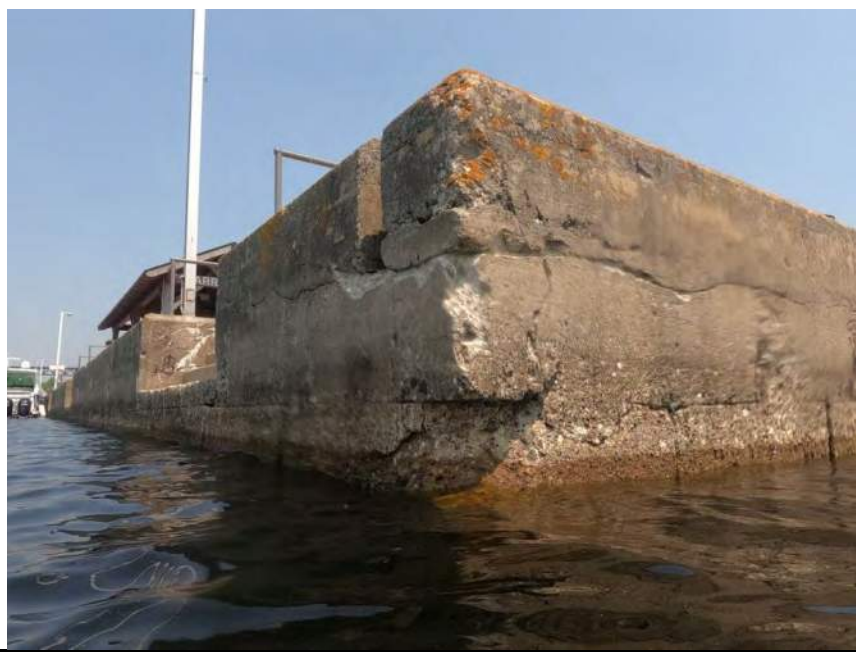
PHOTO # 169

Cracking and spalling on the south face

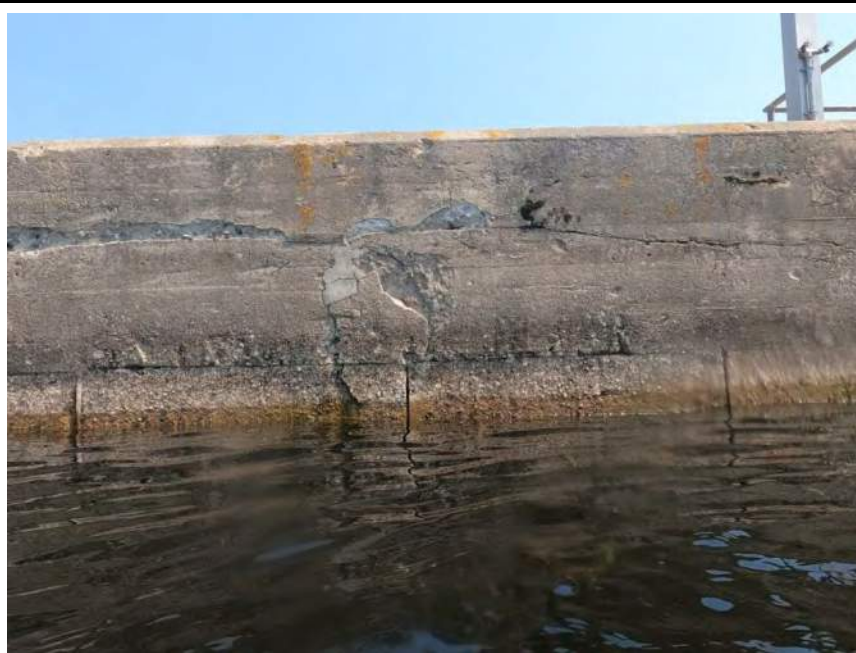
PHOTO # 175

Cracking at 0+144 on the west face

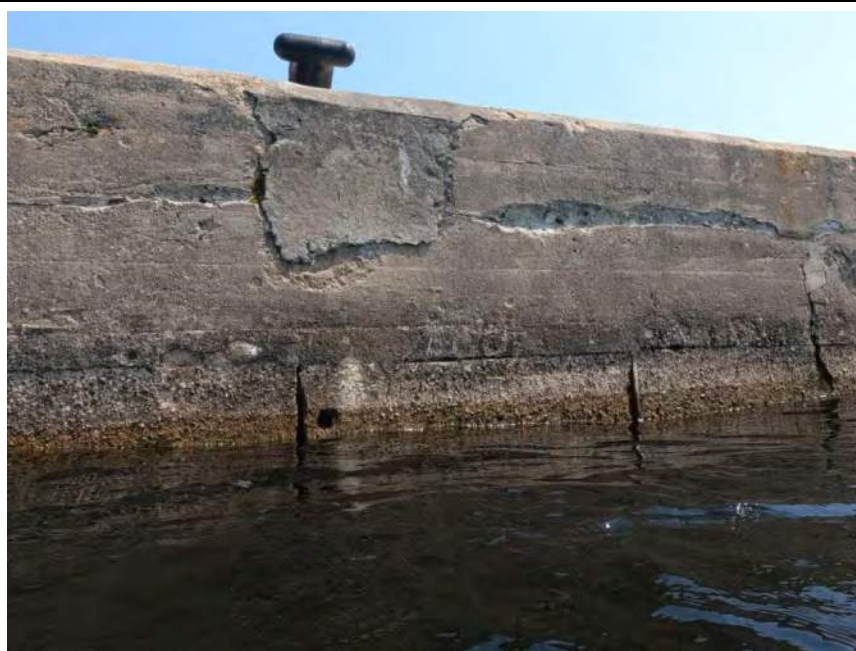
PHOTO # 176

Cracking and spalling at 0+142 on the west face

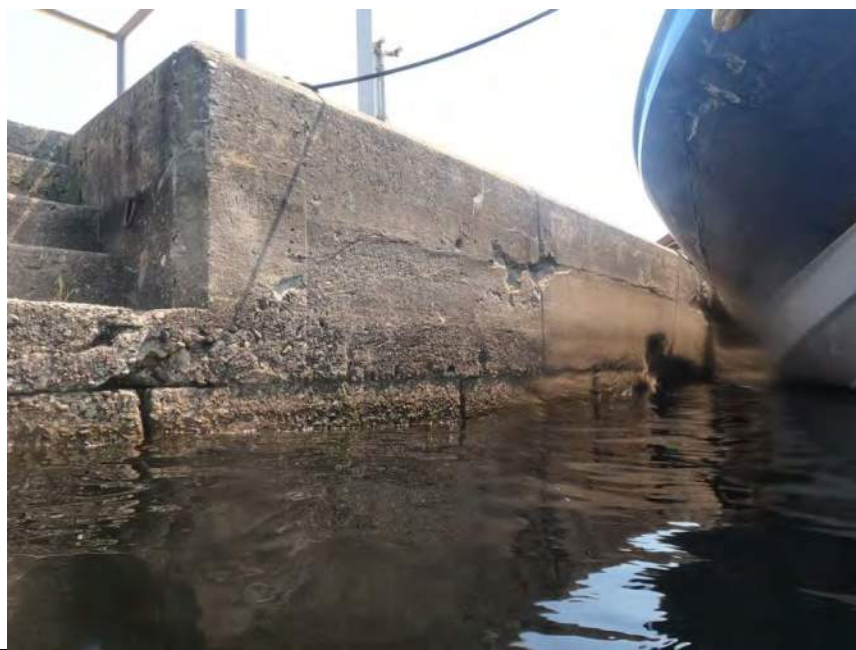
PHOTO # 183

Cracking and spalling at 0+116 on the west face

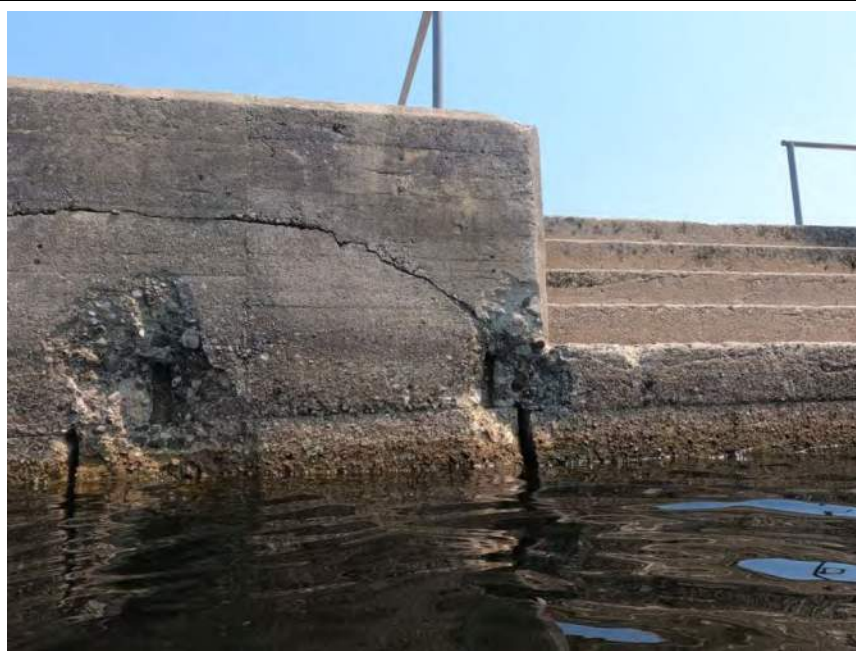
PHOTO # 184

Cracking at 0+101 on the west face

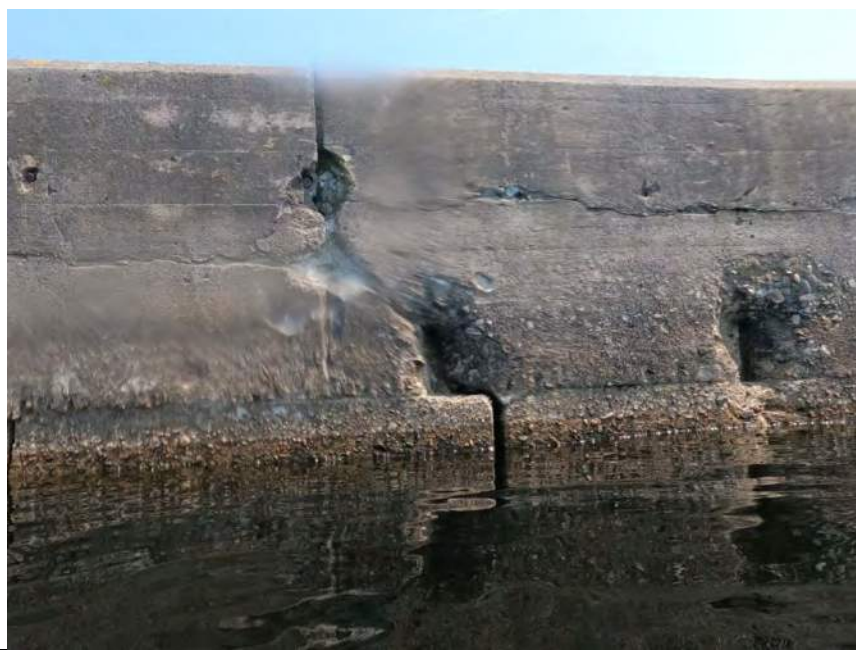
PHOTO # 186

Cracking at 0+092 on the west face

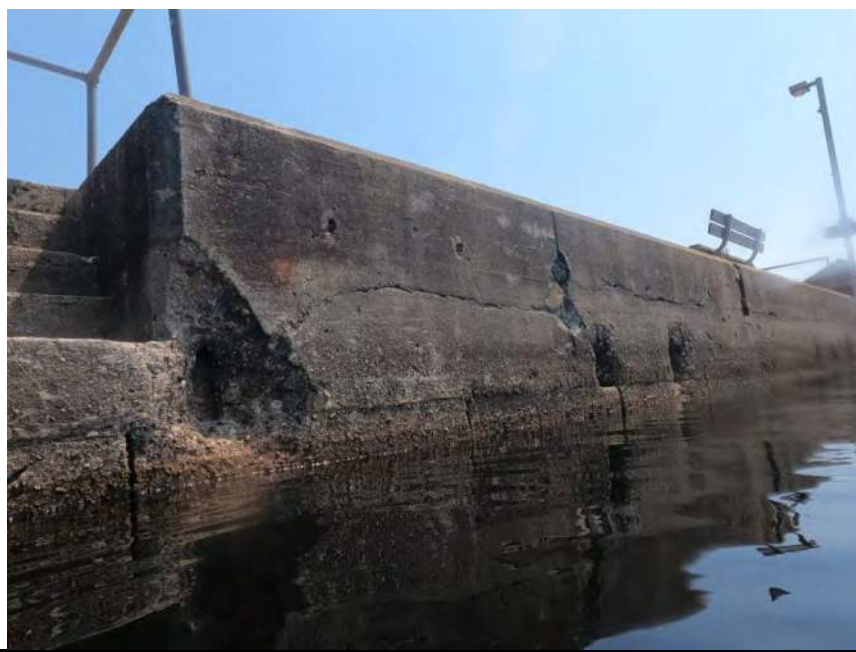
PHOTO # 187

Cracking and spalling at
0+088 on the west face

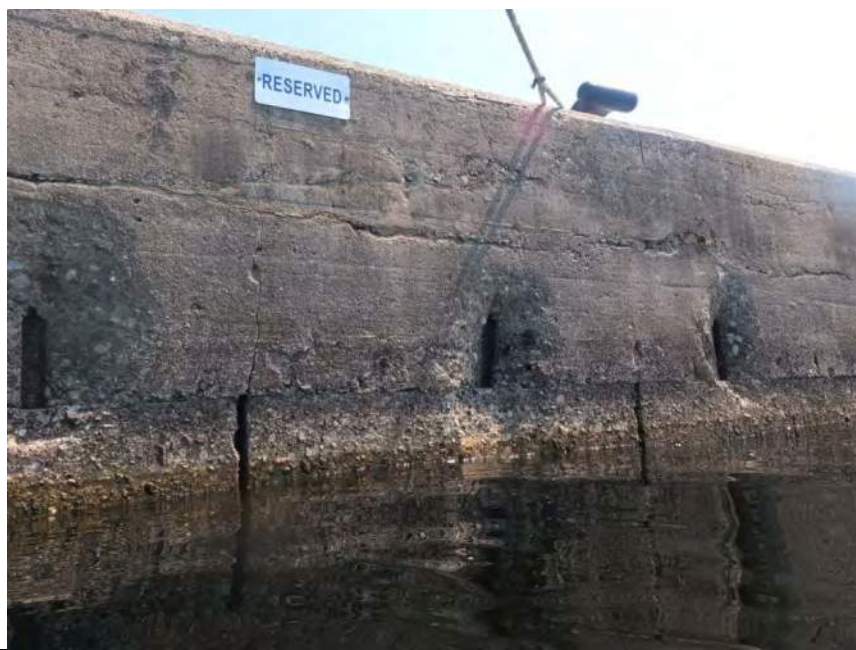
PHOTO # 189

Cracking and spalling at
0+080 on the west face

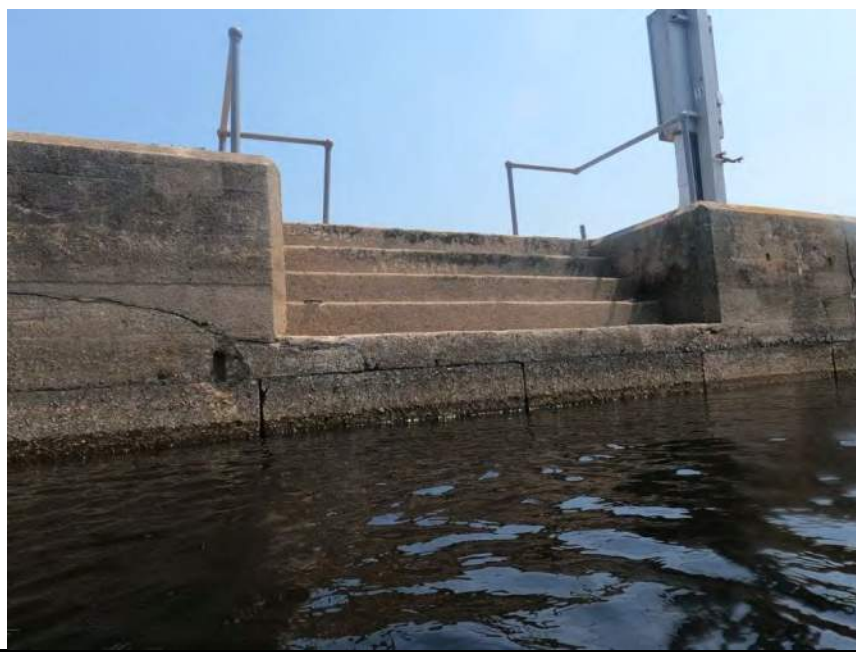
PHOTO # 190

Cracking and spalling at 0+075 on the west face

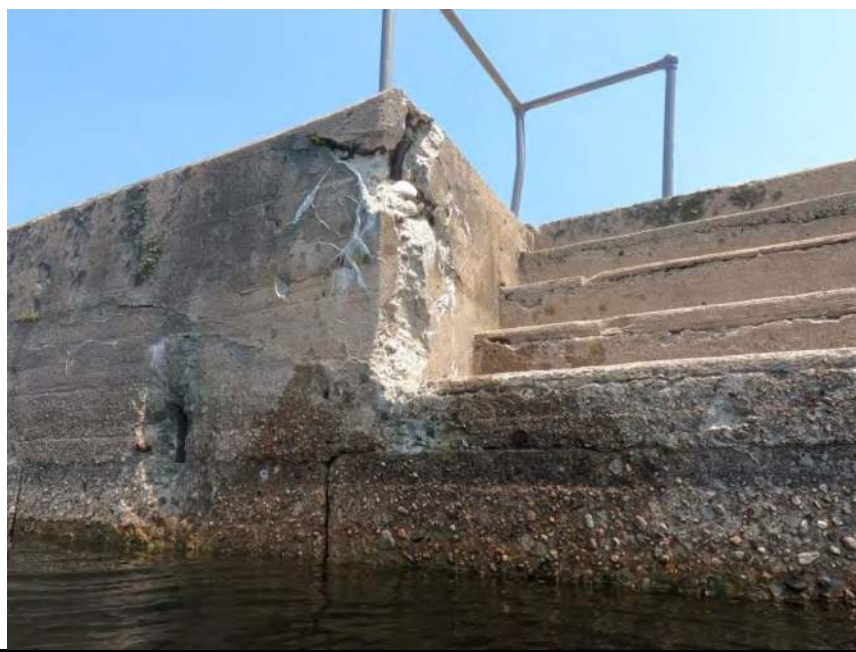
PHOTO # 193

Cracking and spalling at 0+040 on the west face

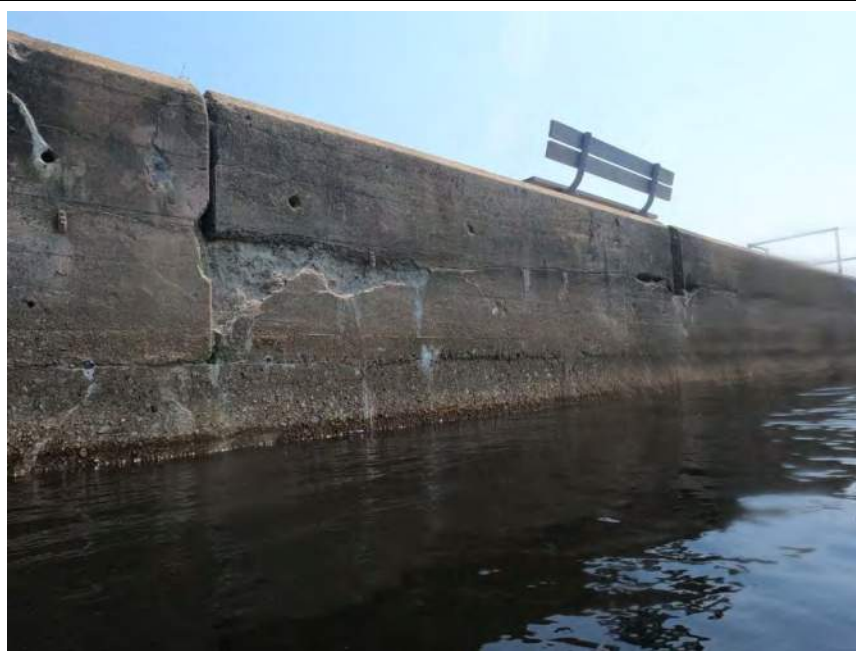
PHOTO # 196

Cracking at 0+030 on the west face
