Parry Sound Harbour, Ontario

Bay St. Wharf (#401)
Condition Assessment Report

Small Craft Harbours, Fisheries and Oceans Canada

March 2024

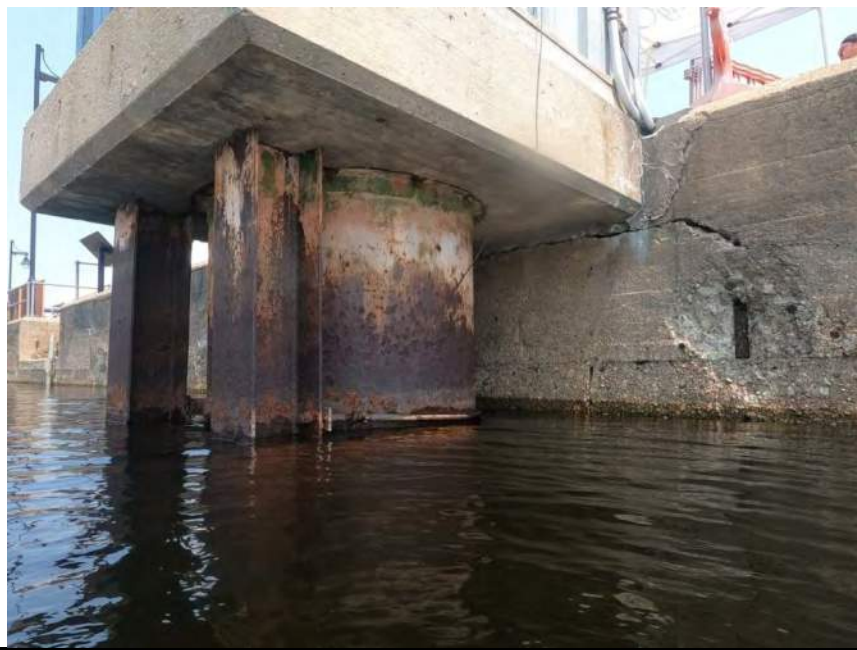
PHOTO # 199

Close up of spalling and looking behind water level gauge station at 0+017

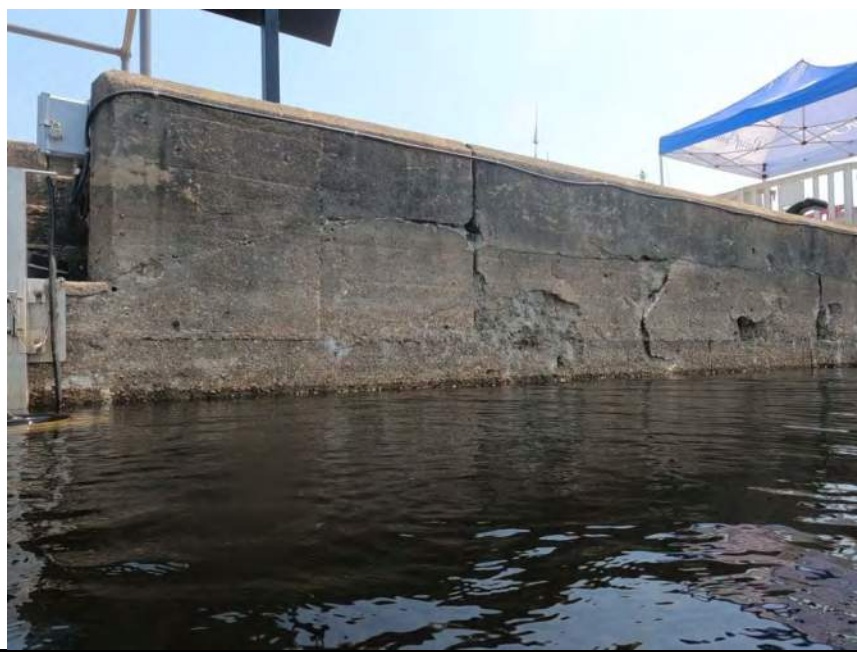
PHOTO # 202

Cracking and spalling at 0+013 on the west face

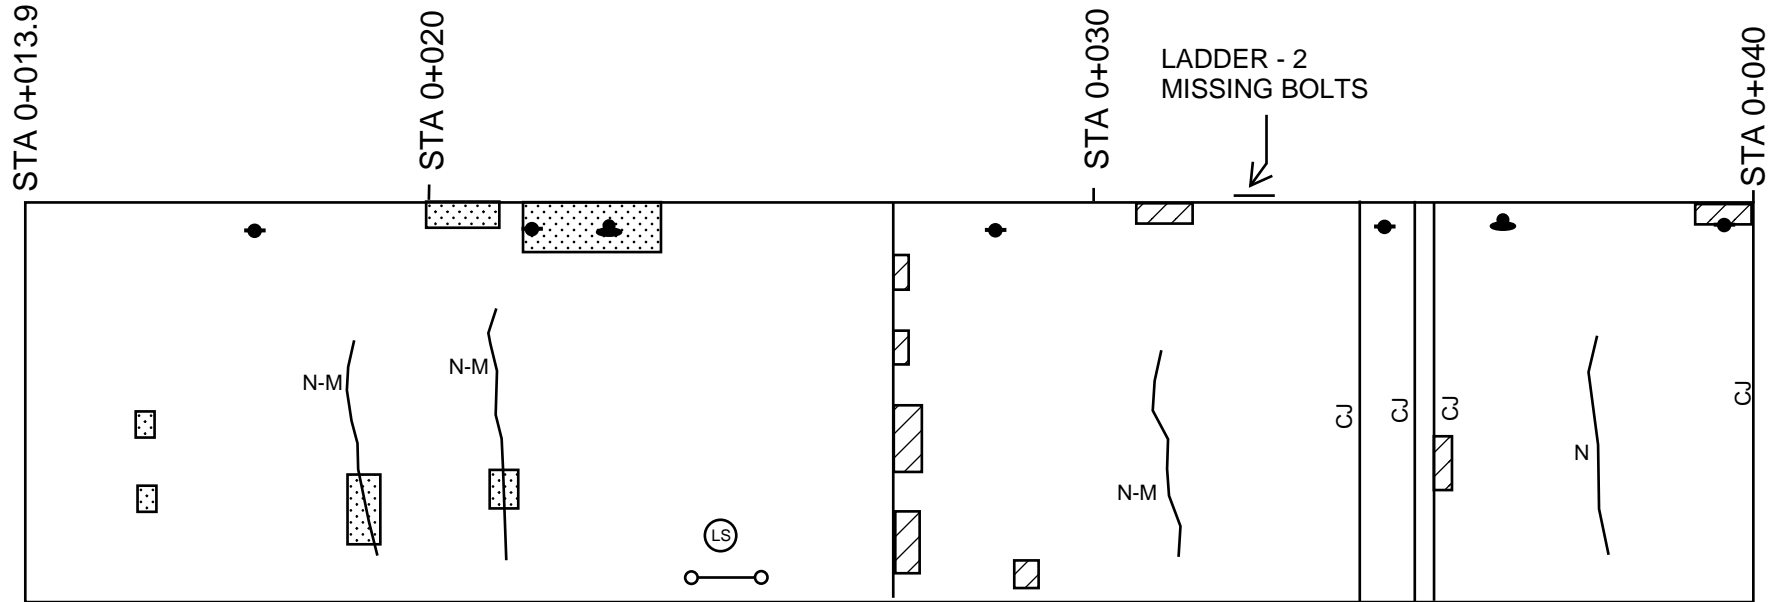
- LIGHT TO MEDIUM SCALING.
- NEWER CONCRETE FROM STA 0+027 TO 0+050.
- HAIRLINE MAP CRACKING TYPICAL IN SECTION OF NEWER CONCRETE.

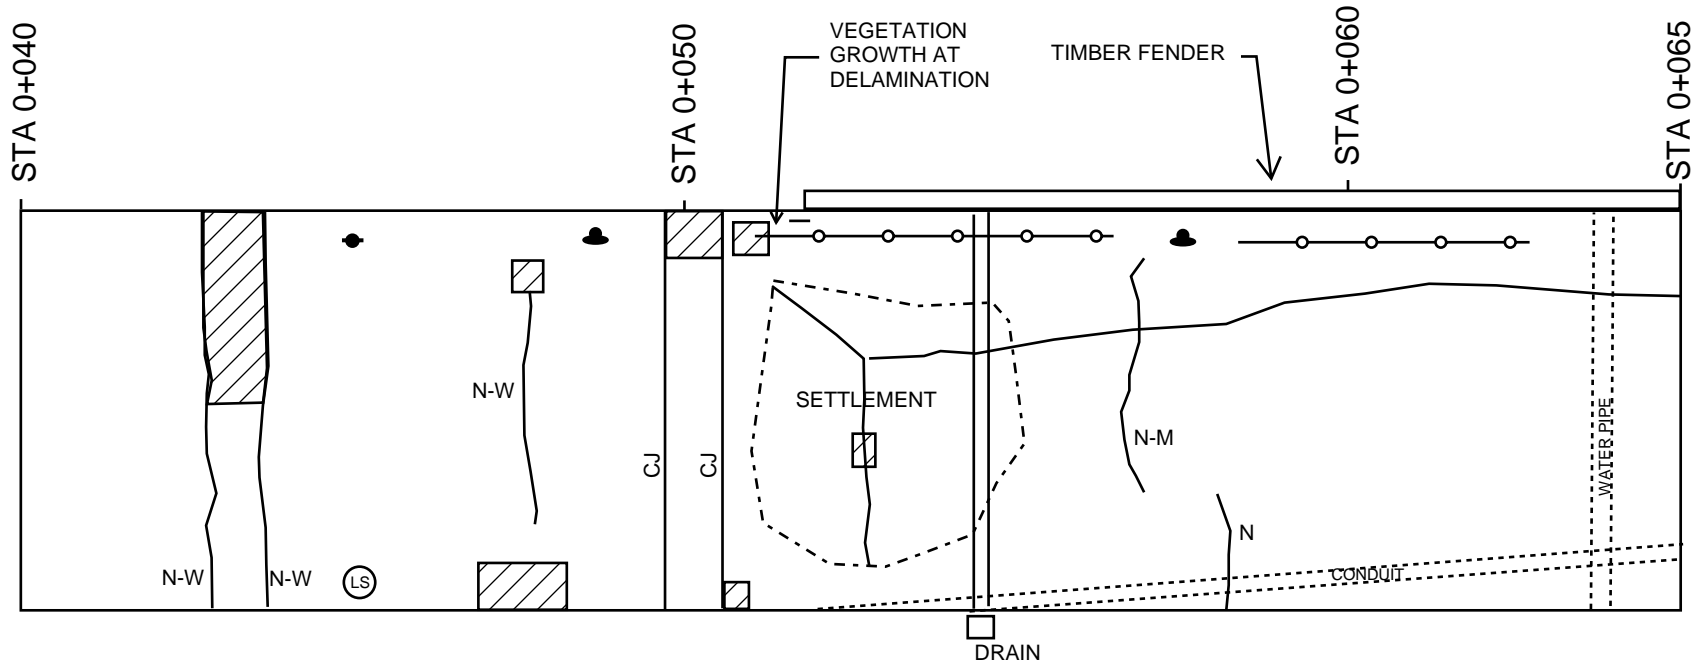
- VEGETATION GROWTH IN CONSTRUCTION JOINTS.
- NEWER CONCRETE FROM STA 0+027 TO 0+050.
- SPRAY FOAM WAS INSTALLED BELOW DECK FROM STA 0+050 TO 0+063 (APPROXIMATELY).
- MAP CRACKING TYPICAL.
- CURB RAIL HAS LOCALIZED COATING LOSS AND SURFACE CORROSION

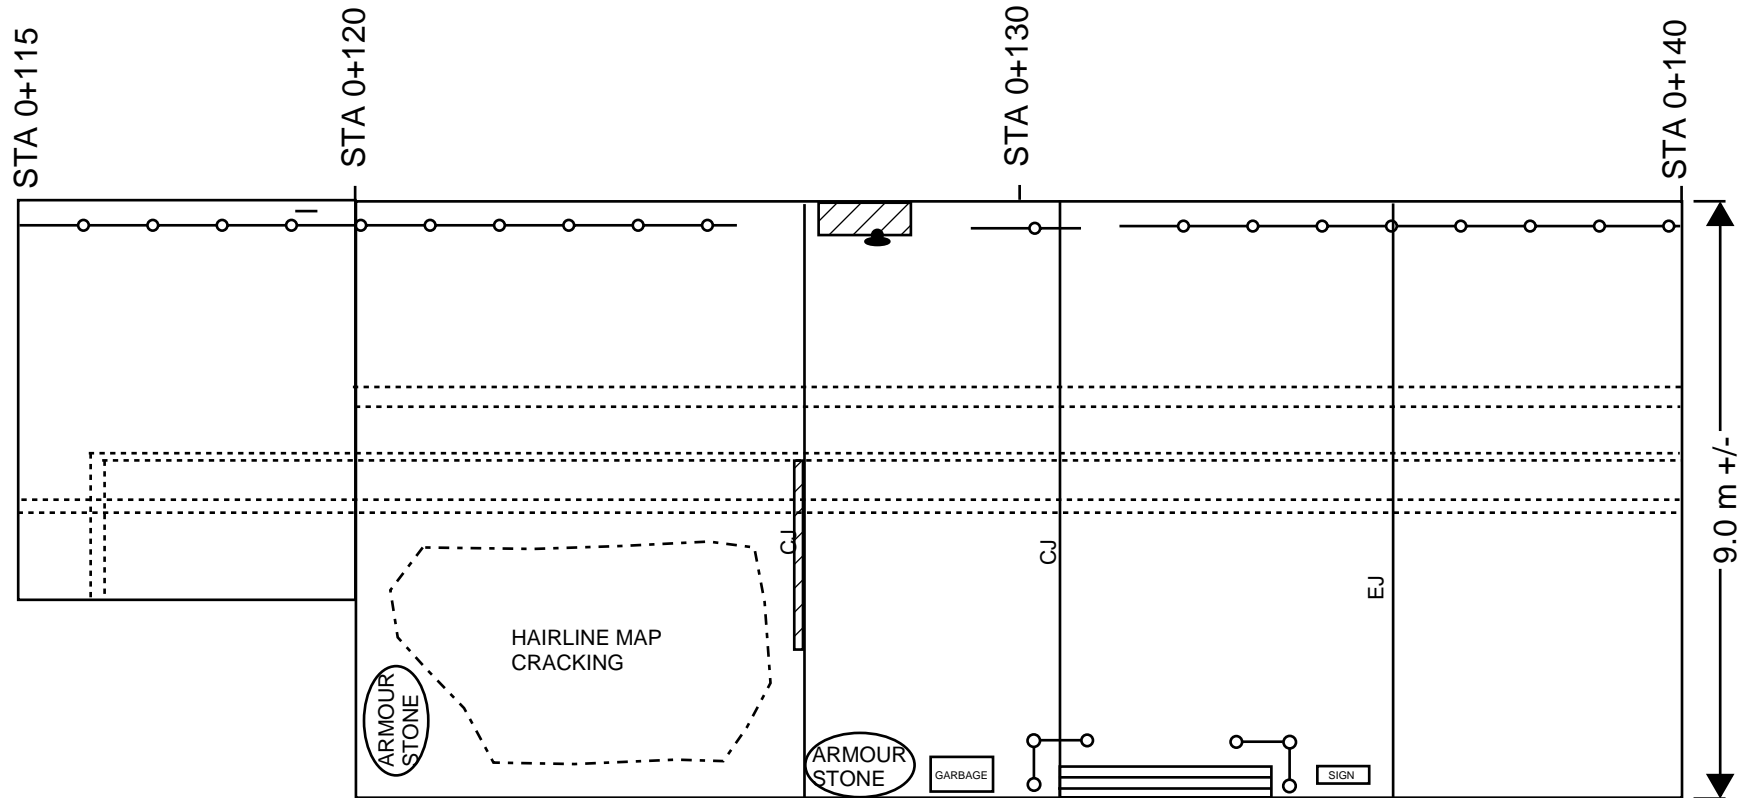
- VEGETATION GROWTH IN EXPANSION JOINT.
- LOCALIZED SPALLING ON STAIRS.
- MEDIUM TO SEVERE SCALING TYPICAL.
- PATCH REPAIRS TYPICAL.
- WATER LEVEL MEASURED AT 1.4m +/- BELOW TOP OF DECK.

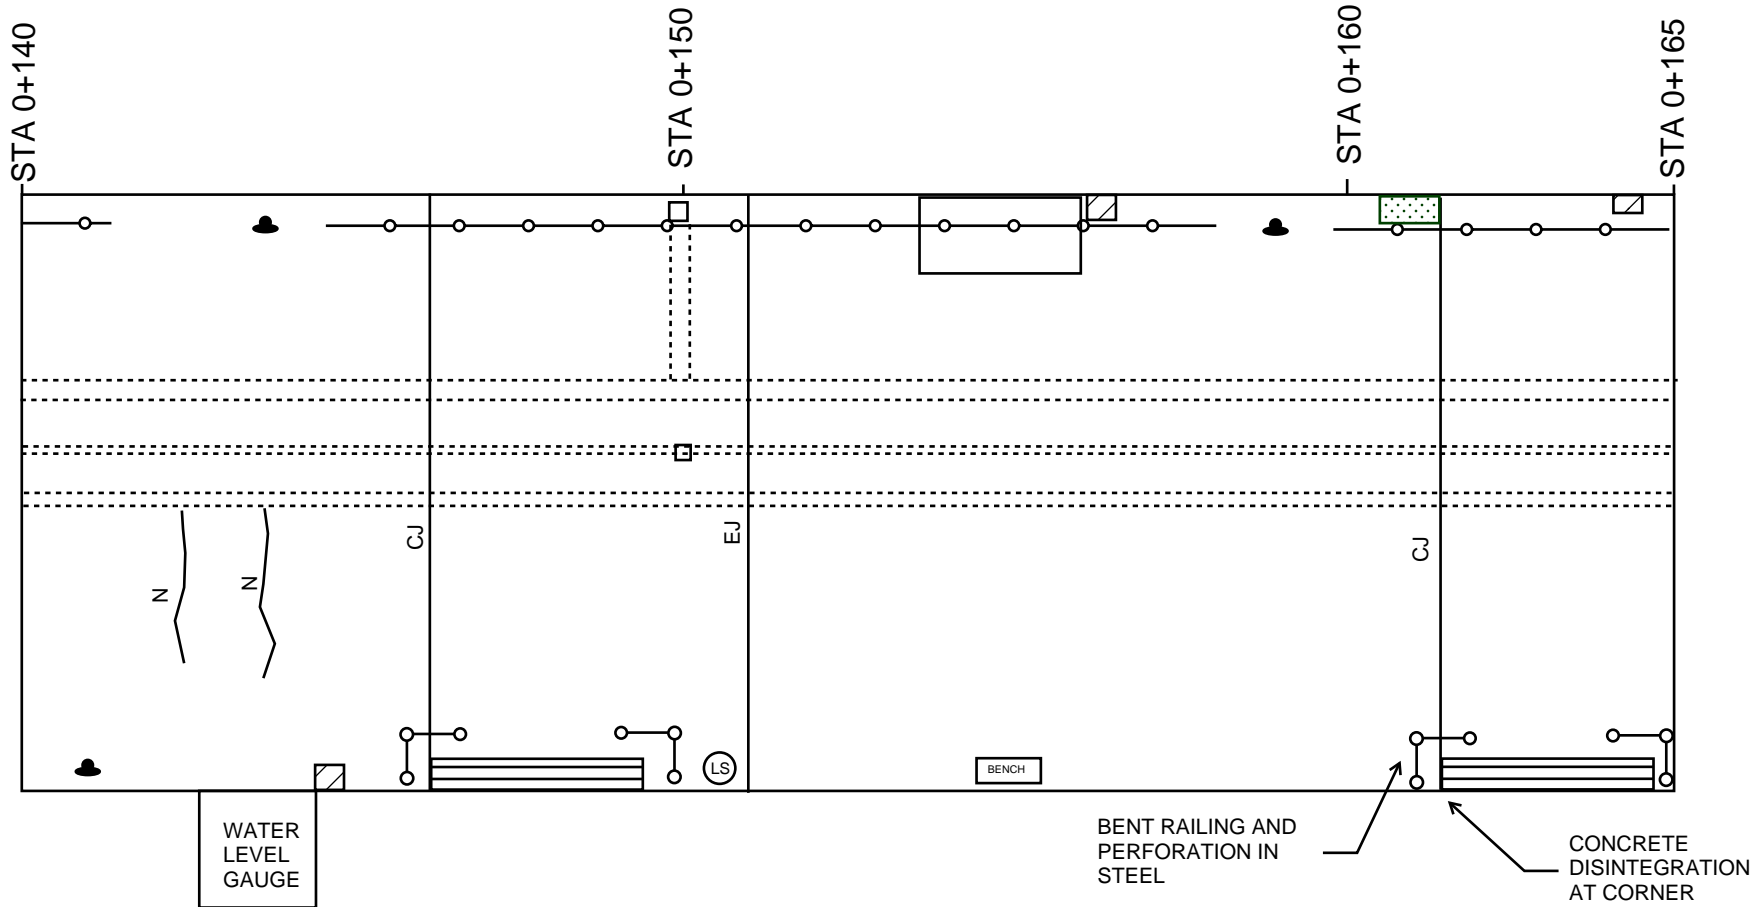
- DELAMINATION AND NARROW TO MEDIUM CRACKING ON STAIRS.
- PATCHES ON STAIRS TYPICAL.
- MEDIUM TO SEVERE SCALING TYPICAL.
- PATCH REPAIRS TYPICAL.
