Bridge Needs Study 2024

INSPECTION SUMMARY REPORT

Town of Parry Sound

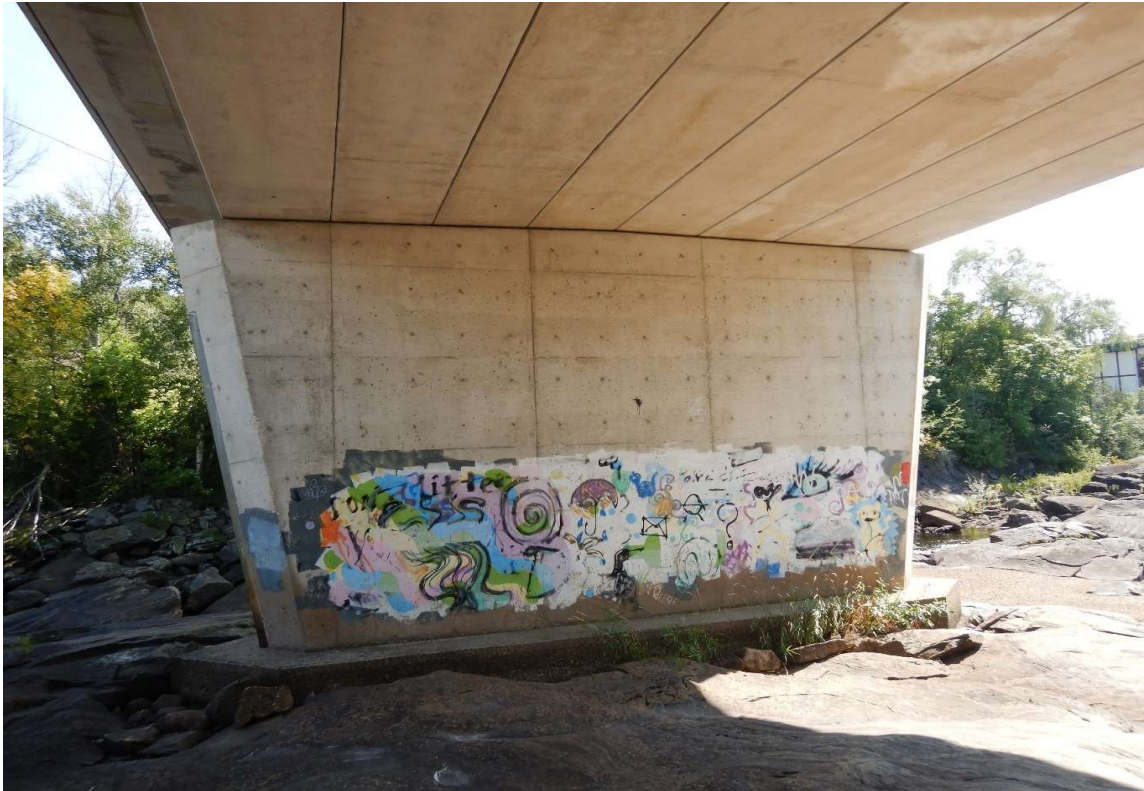
Element Data:						
Element Group:	Piers	Length:	2.2			
Element Name:	Shafts	Width:	11.0			
Location:	Center Pier	Height:	5.5			
Material:	Concrete	Count:	1			
Element Type:	Cast-in-place	Total Quantity:	121.4			
Environment:	Benign	Inspected	Yes <input type="checkbox"/>	No <input type="checkbox"/>	limited <input checked="" type="checkbox"/>	
Protection System:						Performance Deficiencies
Condition Data:	Units	Excellent	Good	Fair	Poor*	
	sq.m		120.8	0.6		
Comments: Light scaling, typ. South side has 1-2.0m and 2-1.0m vertical light cracks near bottom of pier shaft. Steel angle nosing at east side has light corrosion at bottom. Footing has 1-1.2m and 1-1.2m horizontal and vertical medium cracks, south and north sides at centreline.						
Recommended Work:	Rehab: <input type="checkbox"/>		Replace: <input type="checkbox"/>		Maintenance Needs:	
	Urgent: <input type="checkbox"/>	1-5 Years: <input type="checkbox"/>	6-10 Years: <input type="checkbox"/>	None: <input checked="" type="checkbox"/>	Urgent: <input type="checkbox"/>	1 Year: <input type="checkbox"/> 2 Year: <input type="checkbox"/>

Description of Photo: Pier

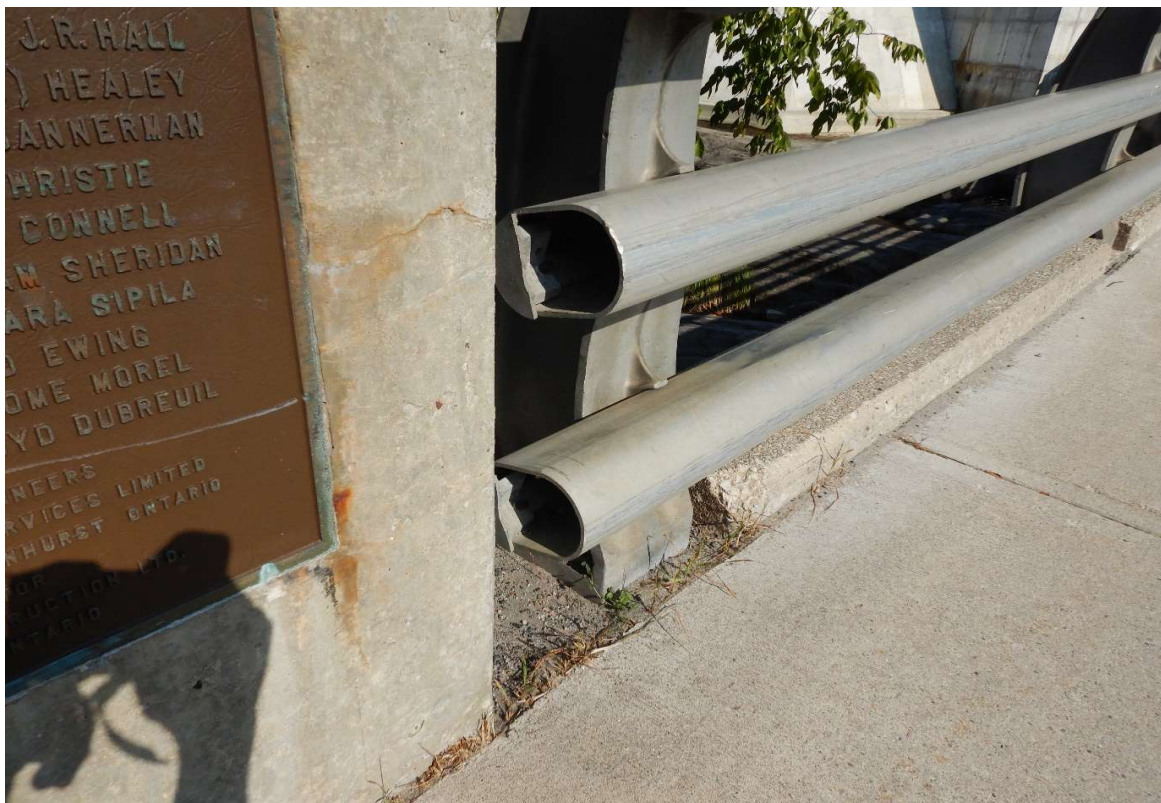
Description of Photo: East Rail, Note Missing End Caps

Replace 2 missing end caps, and reset 2 end caps.

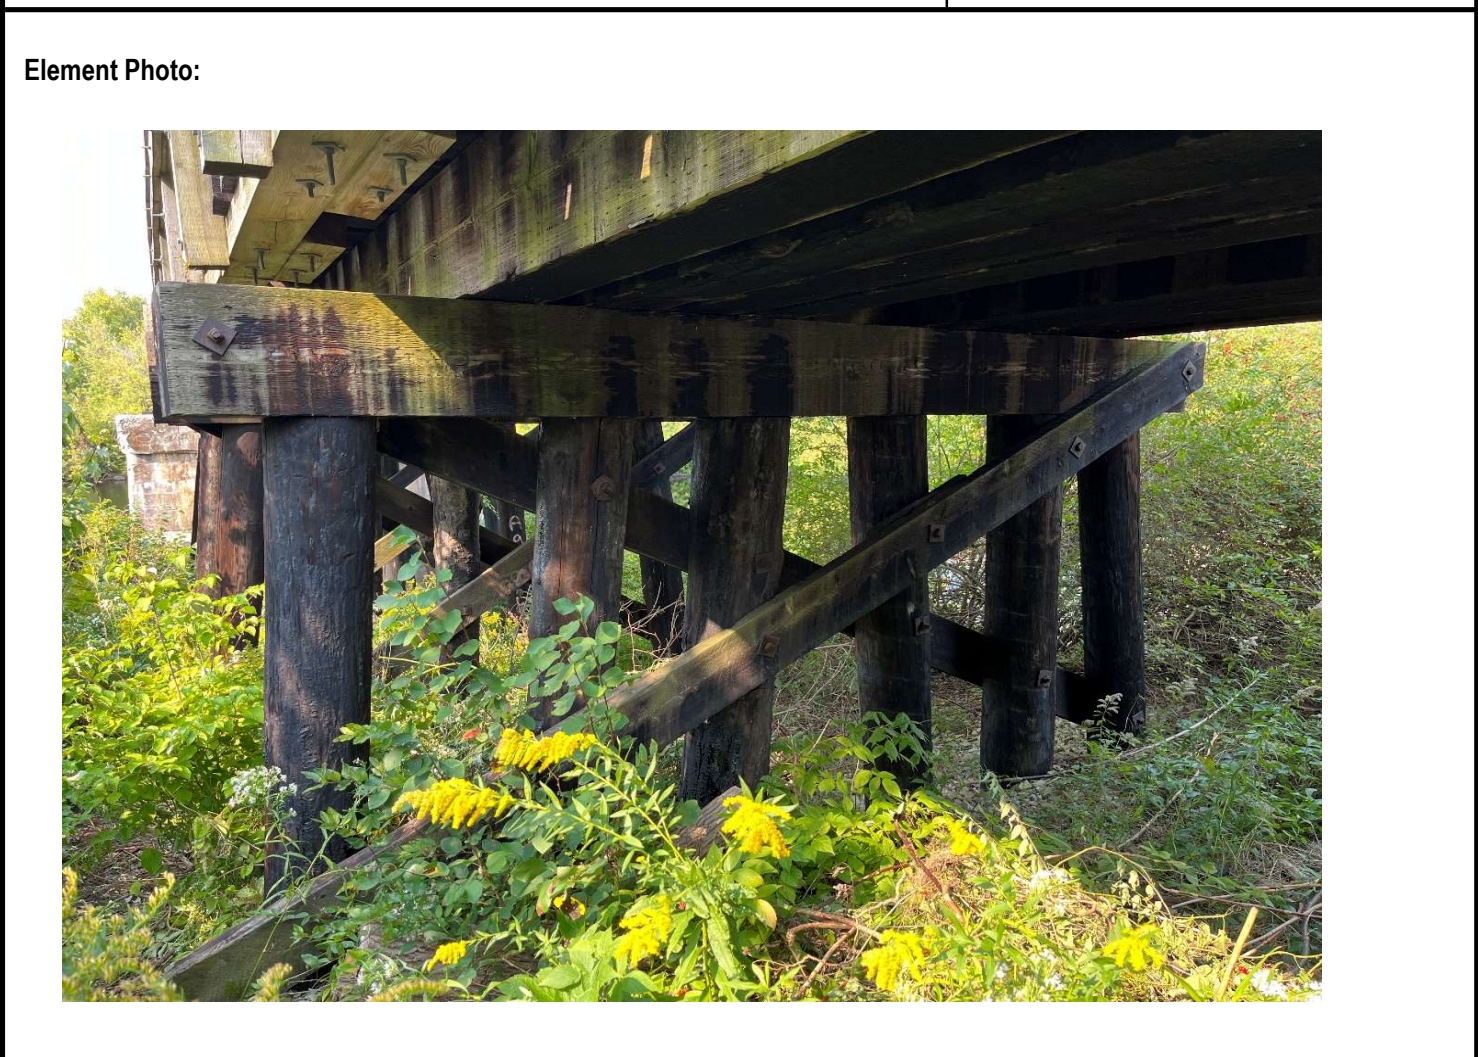
Comments: Light weathering, typ. Localized light to severe medium checks and splits.

Description of Photo: Pier cap

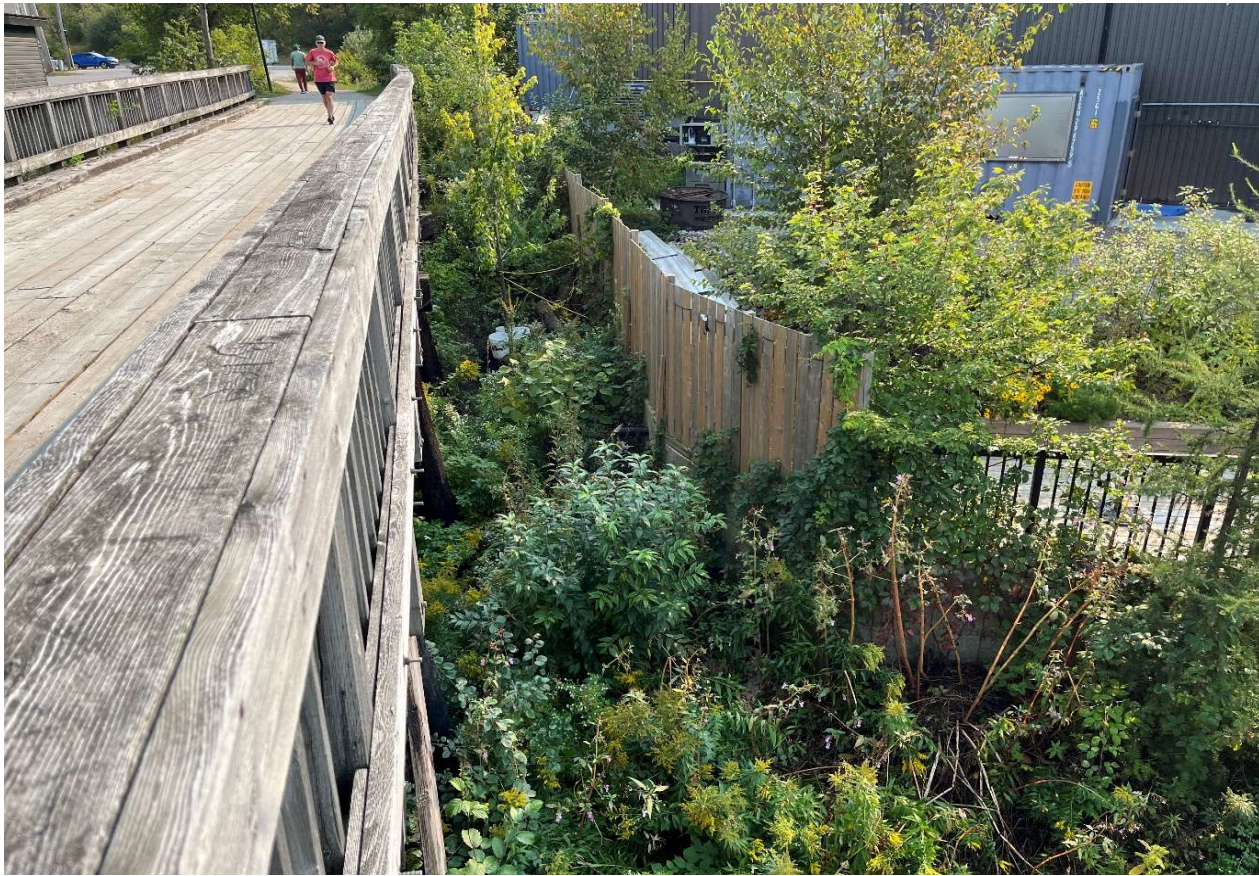
Description of Photo: Embankment

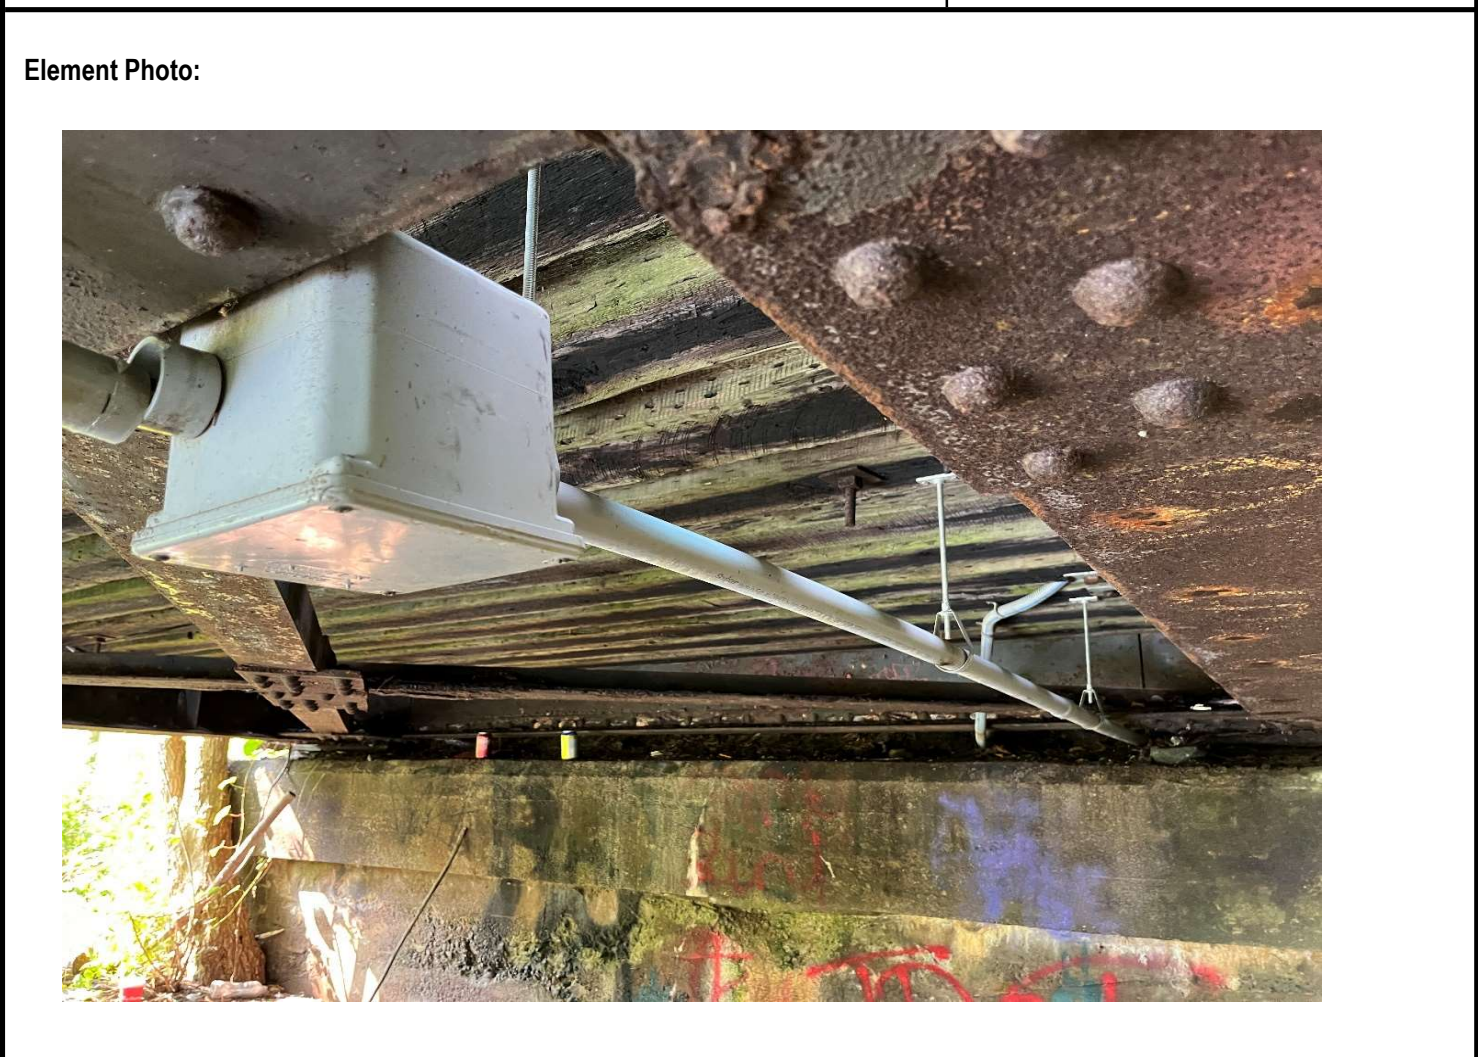
Comments: **Conduit repaired from previous inspection. No observed defects.**

Description of Photo: Electrical utility

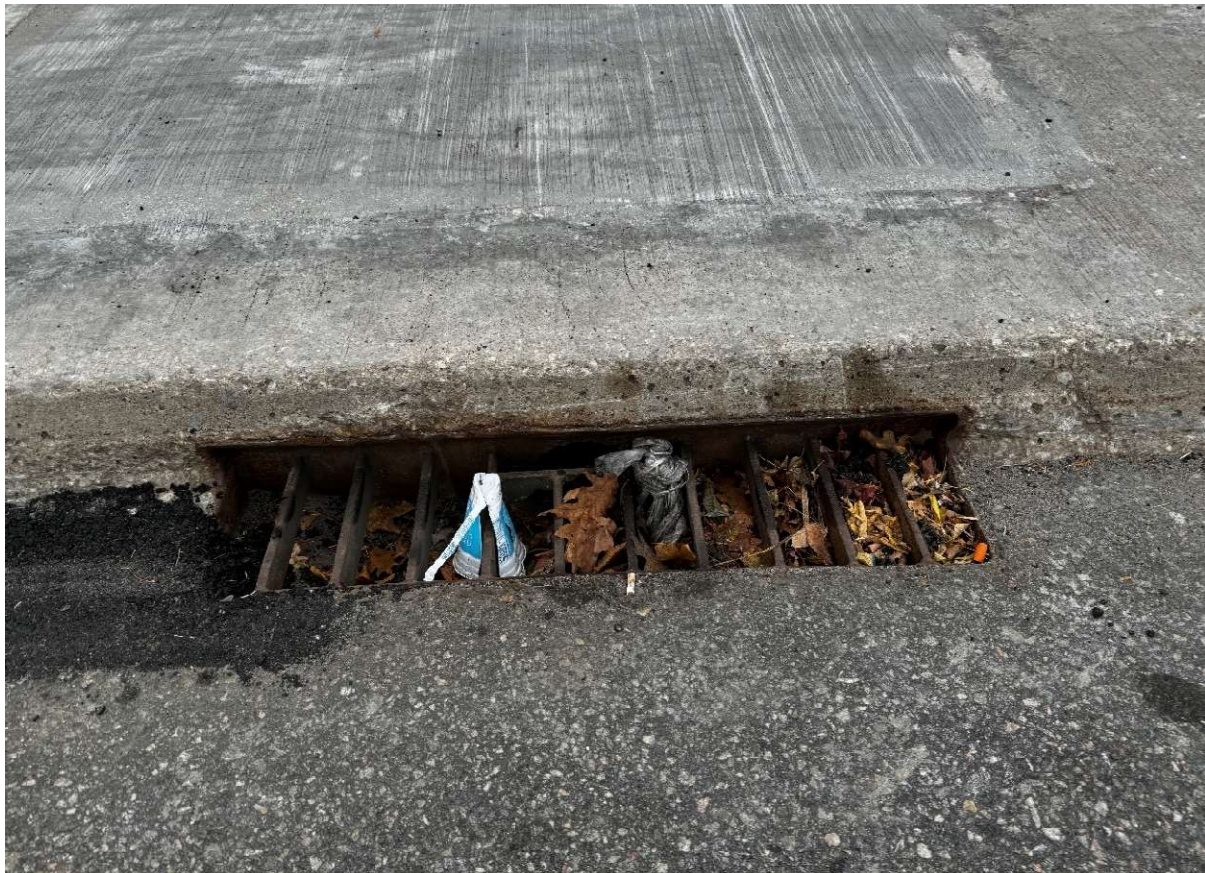
Description of Photo: Drainage

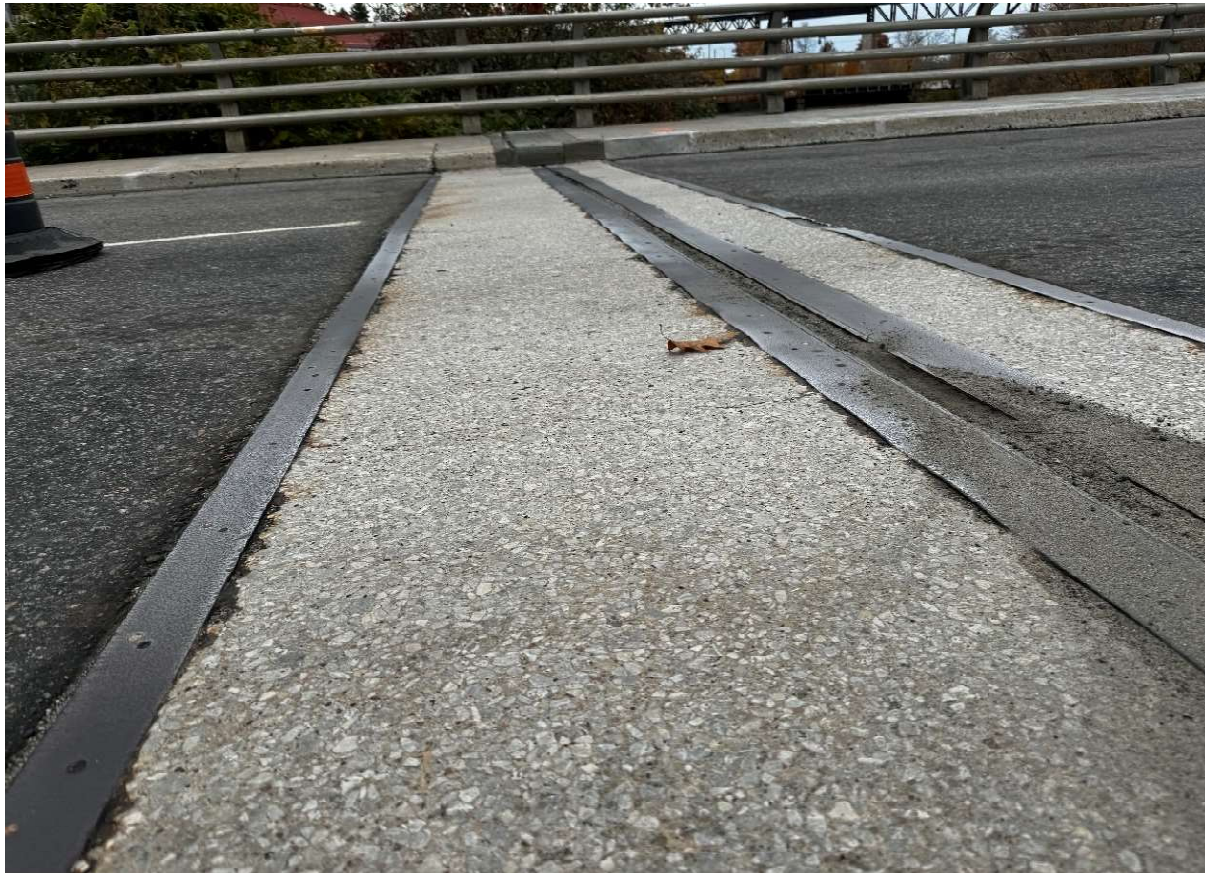
Description of Photo: Concrete end dams

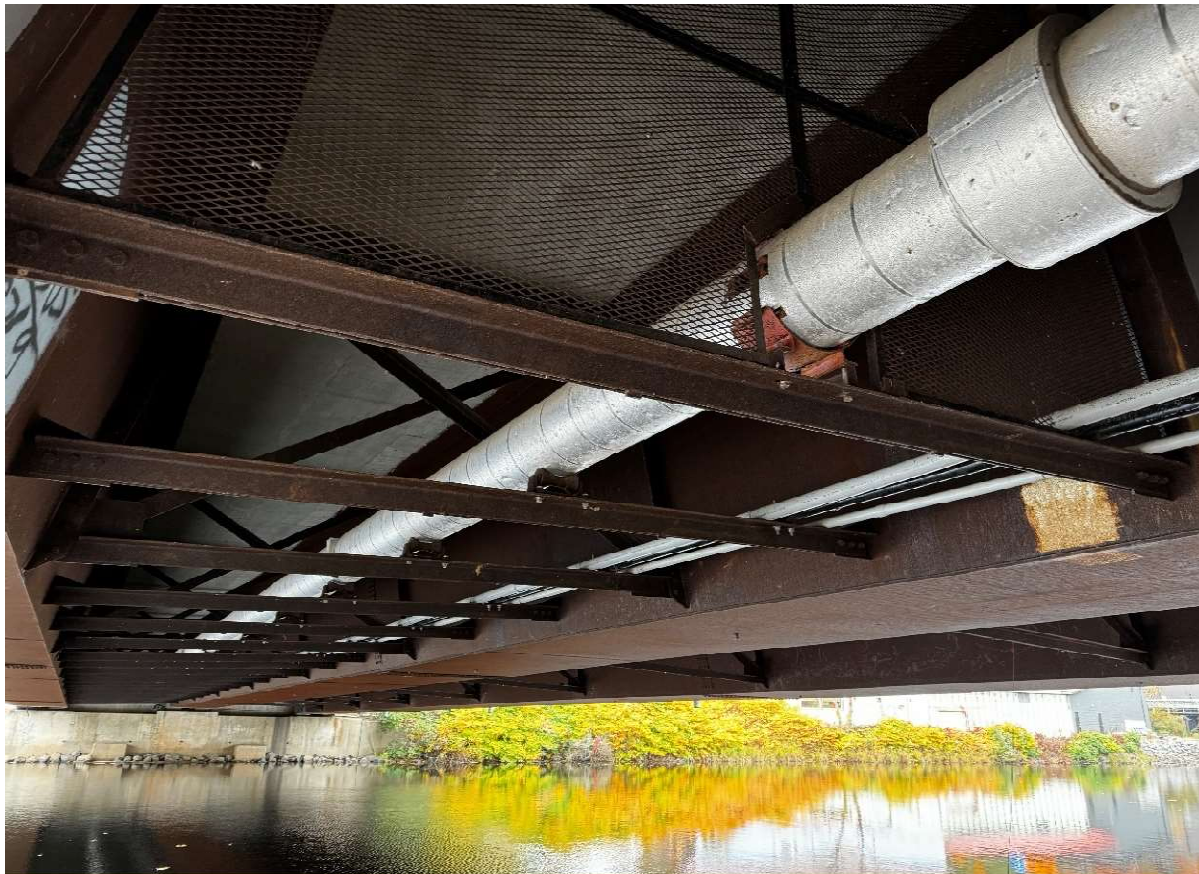
Element Data:						
Element Group:	Accessories		Length:			
Element Name:	Utilities		Width:			
Location:			Height:			
Material:			Count:	14		
Element Type:	Various		Total Quantity:	14		
Environment:			Inspected	Yes <input checked="" type="checkbox"/>	No <input type="checkbox"/>	limited <input type="checkbox"/>
Protection System:						Performance Deficiencies
Condition Data:	Units	Excellent	Good	Fair	Poor*	
	each		13	1		
Comments: There is gas line supported along the north face of the bridge, hangers have exhibited medium to severe corrosion. An insulated pipe (likely a watermain) under the north interior soffit, electrical and bell also appear to be supported under the north interior soffit. There are some punctures in the watermain insulation protective covering. Electrical lines are also supported along both ballast walls. 8-90mm diameter ducts are in each sidewalk. Electrical box at northwest quadrant has a damaged latch and can be opened.

Description of Photo: Utilities

Recommended Work:		Rehab: <input type="checkbox"/>	Replace: <input type="checkbox"/>	Maintenance Needs:		18 - Other Maintenance
Urgent: <input type="checkbox"/>		1-5 Years: <input type="checkbox"/>	6-10 Years: <input type="checkbox"/>	None: <input checked="" type="checkbox"/>	Urgent: <input type="checkbox"/>	1 Year: <input checked="" type="checkbox"/> 2 Year: <input type="checkbox"/>
				Replace latch and ensure electrical box can be closed and locked.

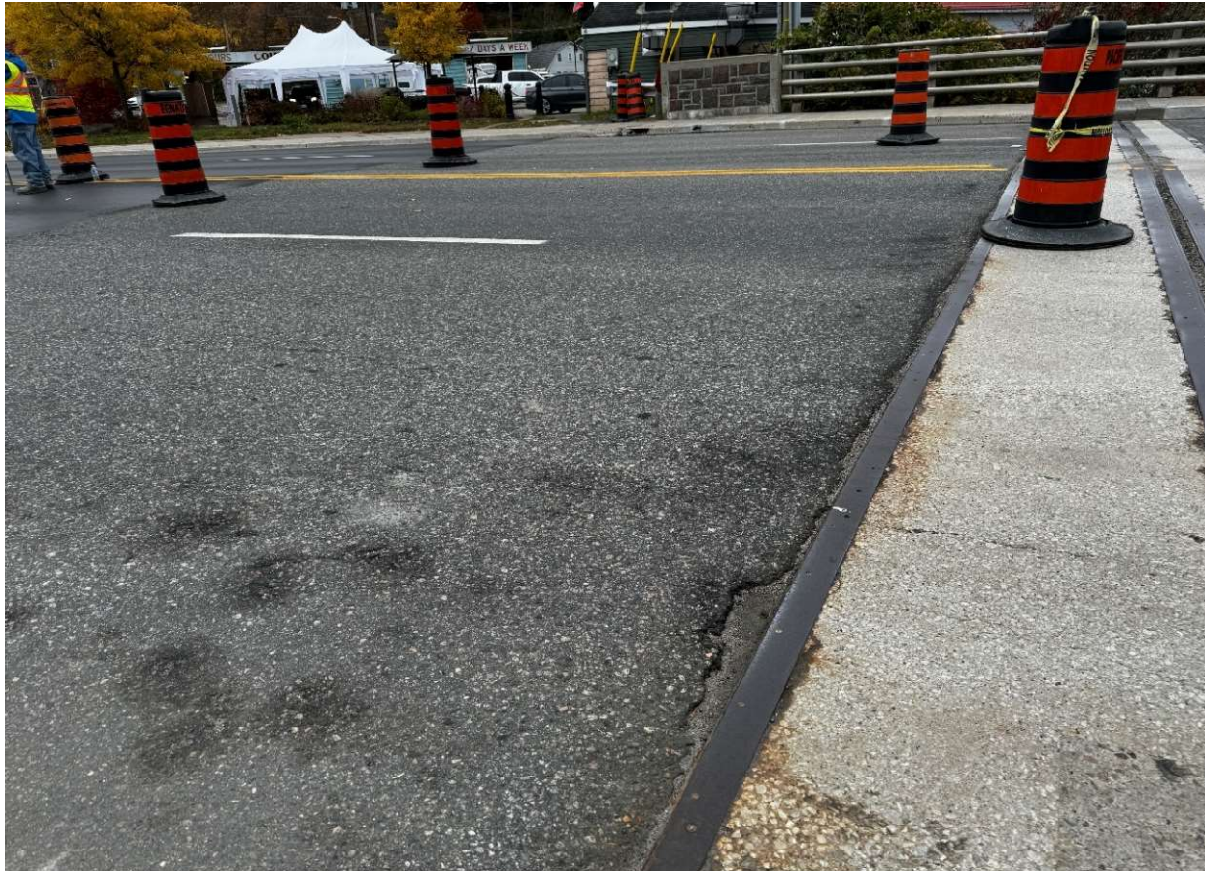
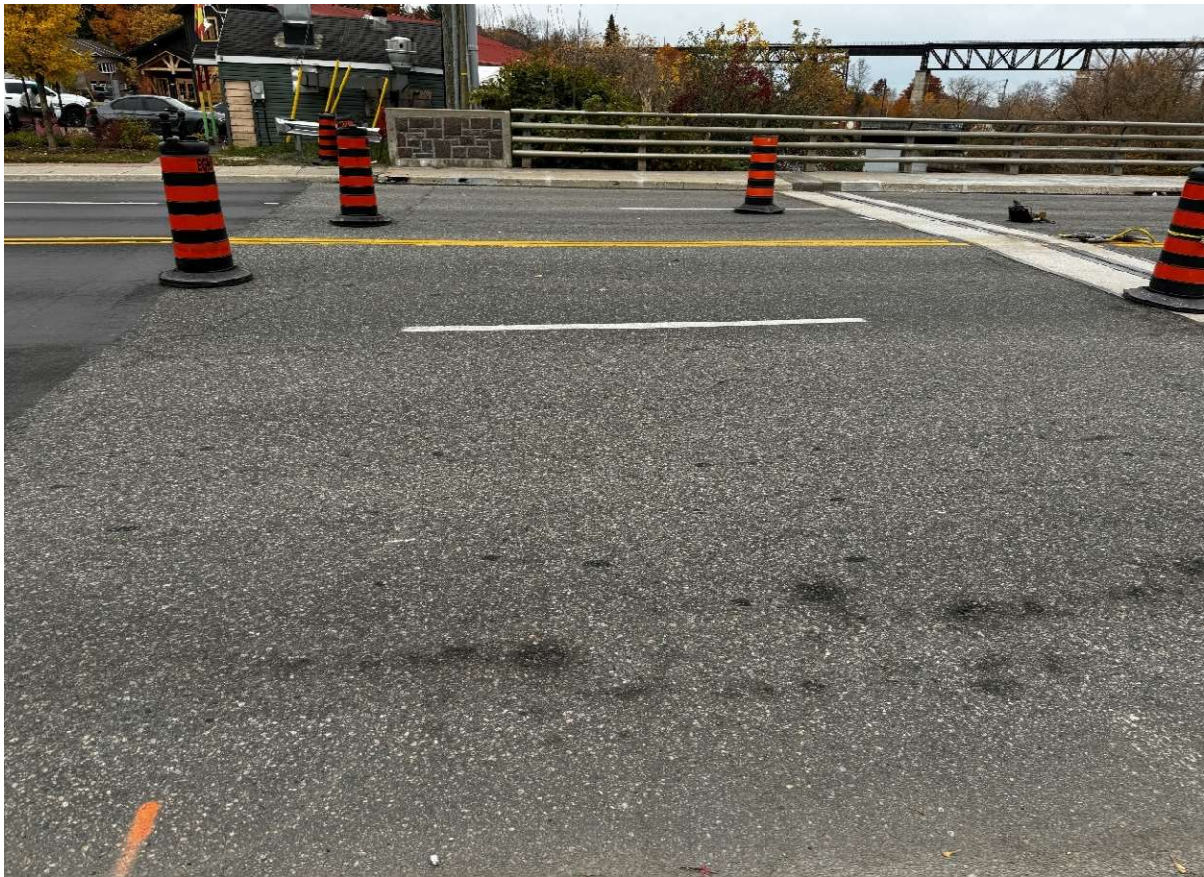
Comments: Light ravelling, typical. West lane has medium wheel rutting 6.0m x 500 x 8mm. Southeast 7m of medium transverse cracks. Medium loss of bond (300mm x 300mm).

Description of Photo: East approach

Description of Photo: West approach

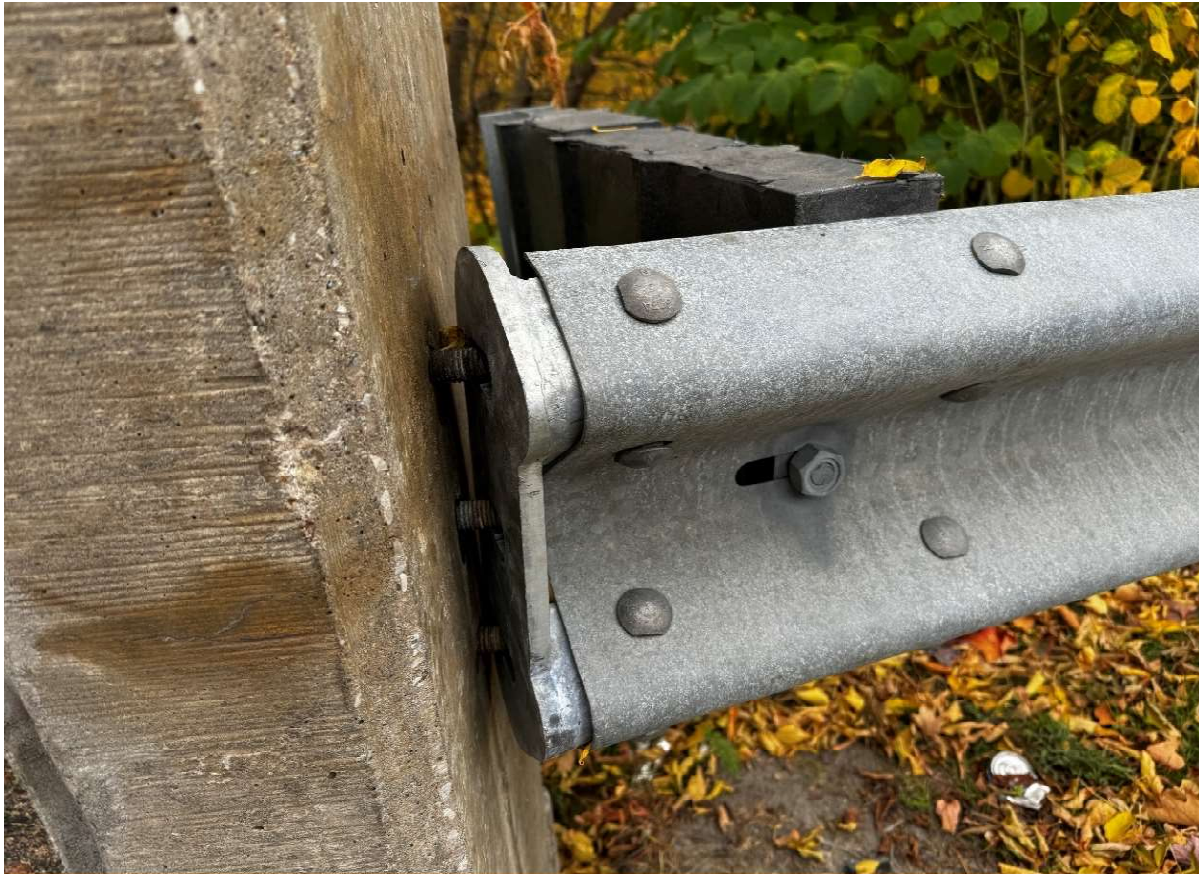
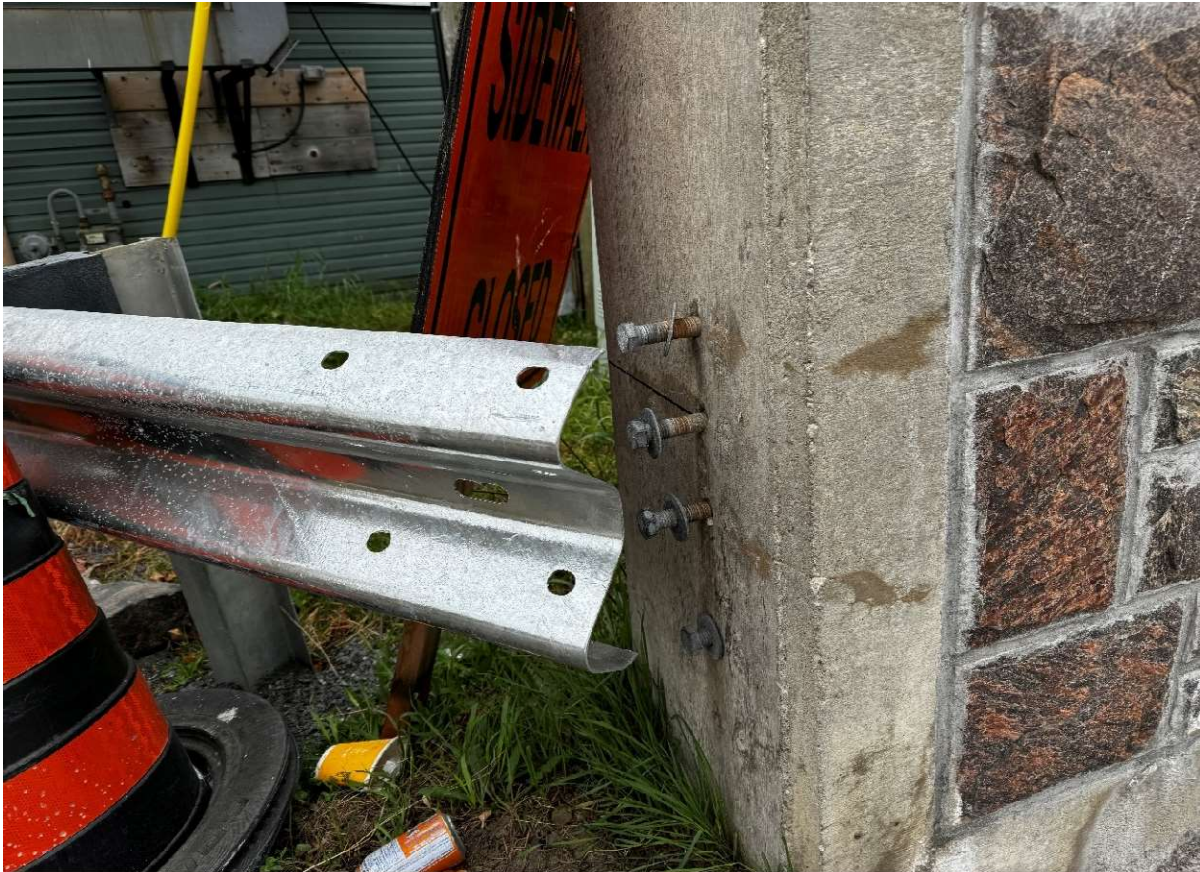
Description of Photo: Northwest approach railing

Description of Photo: Southwest approach railing, to be installed in January 2025

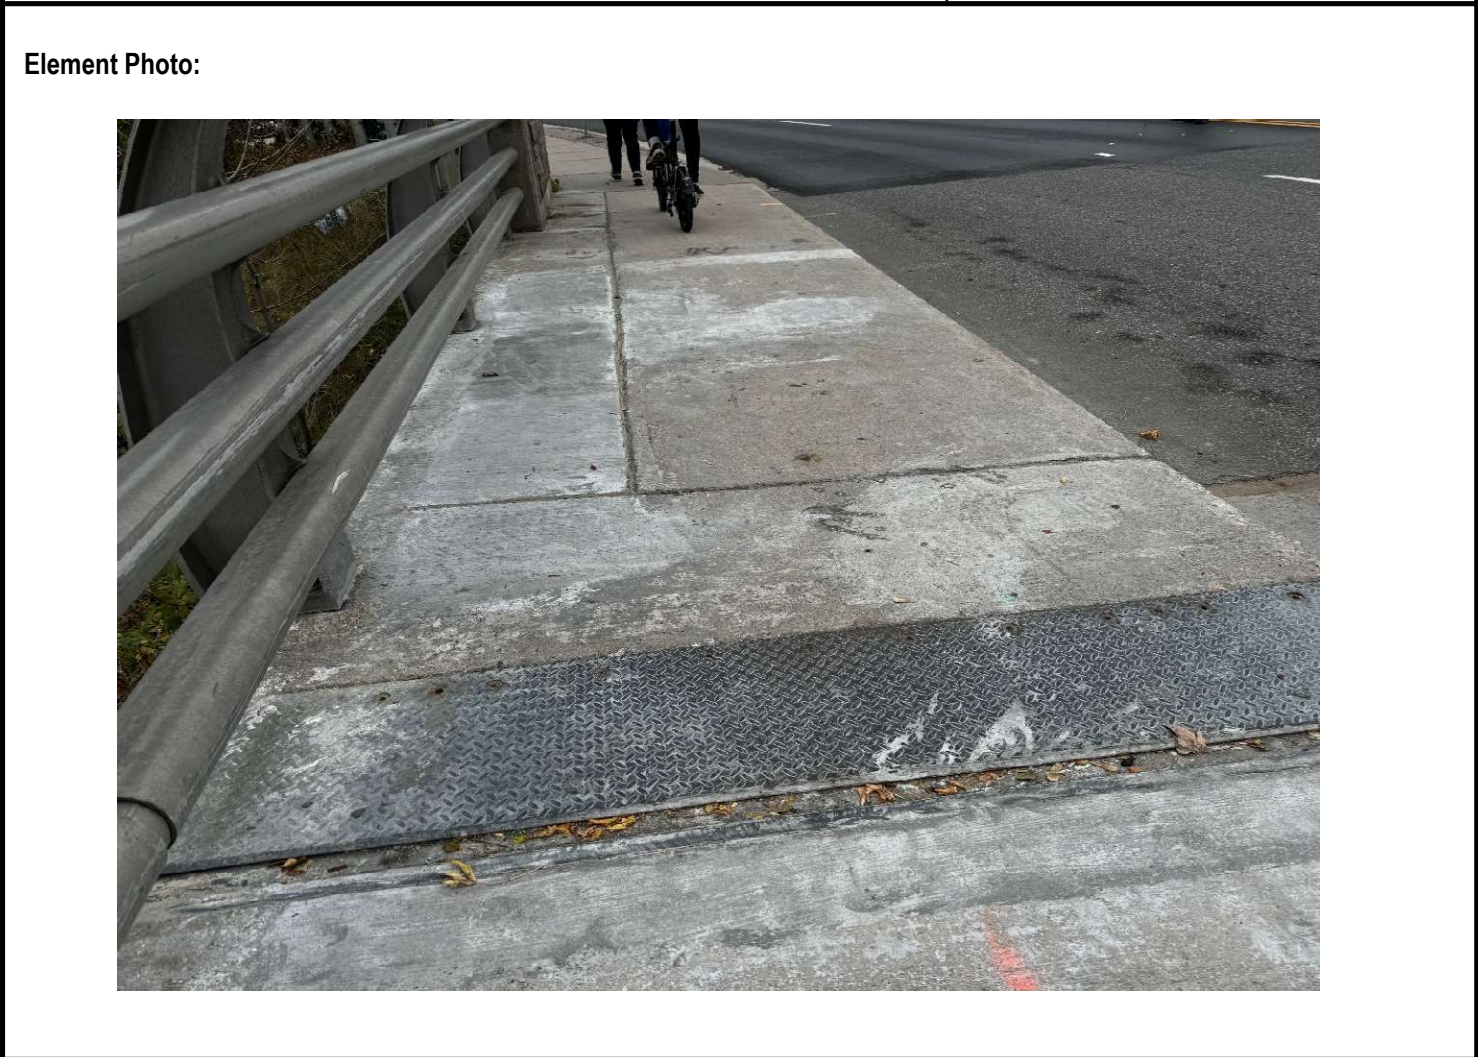
Comments: **Light scaling, typical.**

Description of Photo: Approach sidewalk
