# Bridge Inspections

**TOWN OF PARRY SOUND**

Inspection Summary Report

January  
12, 2023

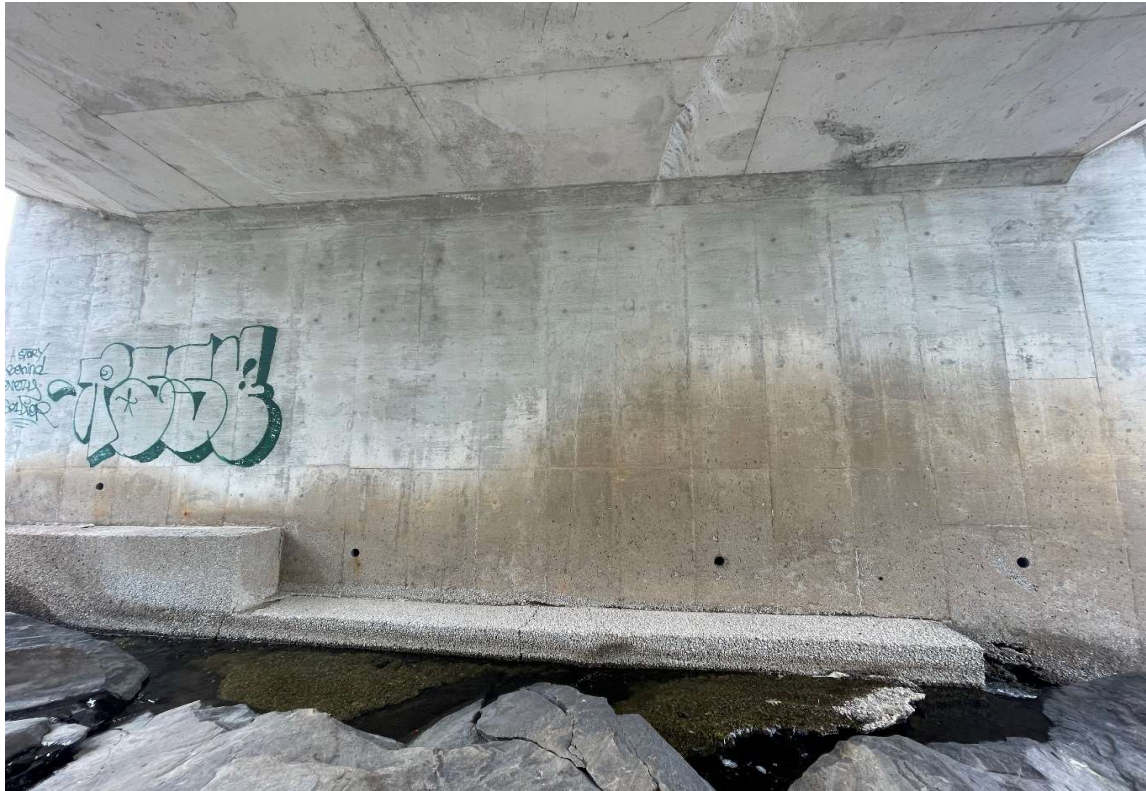
Element Data:						
Element Group:	Abutments		Length:			
Element Name:	Abutment Walls		Width:	11.3		
Location:	North and South		Height:	5.1		
Material:	Concrete		Count:	2		
Element Type:	Cast-in-place		Total Quantity:	115.6		
Environment:	Benign		Inspected	Yes <input checked="" type="checkbox"/>	No <input type="checkbox"/>	limited <input type="checkbox"/>
Protection System:						Performance Deficiencies
Condition Data:	Units	Excellent	Good	Fair	Poor*	
	sq.m		106.7	5.0	5.0	
Comments: Light scaling, typical. Light erosion at both ends of the footings. 4.0m of light cracking. 15.0m of medium cracking. 800mm of severe cracking at center of footing. Bottom of south wall has localized area of very severe scouring with a 500mm x 300mm x 100mm deep void with water churning within the void. 300mm x 100mm light scouring @ northwest corner. Severe scaling 200mm from bottom of wall for the full length on bridge on both sides. 400mm x 200mm spall at south footing.

**Description of Photo:** South Abutment

Recommended Work:	Rehab: <input type="checkbox"/> Replace: <input type="checkbox"/>		Maintenance Needs:	8 - Concrete Repair		
Urgent: <input type="checkbox"/>	1-5 Years: <input type="checkbox"/>	6-10 Years: <input type="checkbox"/>	None: <input checked="" type="checkbox"/>	Urgent: <input type="checkbox"/>	1 Year: <input type="checkbox"/>	2 Year: <input checked="" type="checkbox"/>
				Repair concrete void.

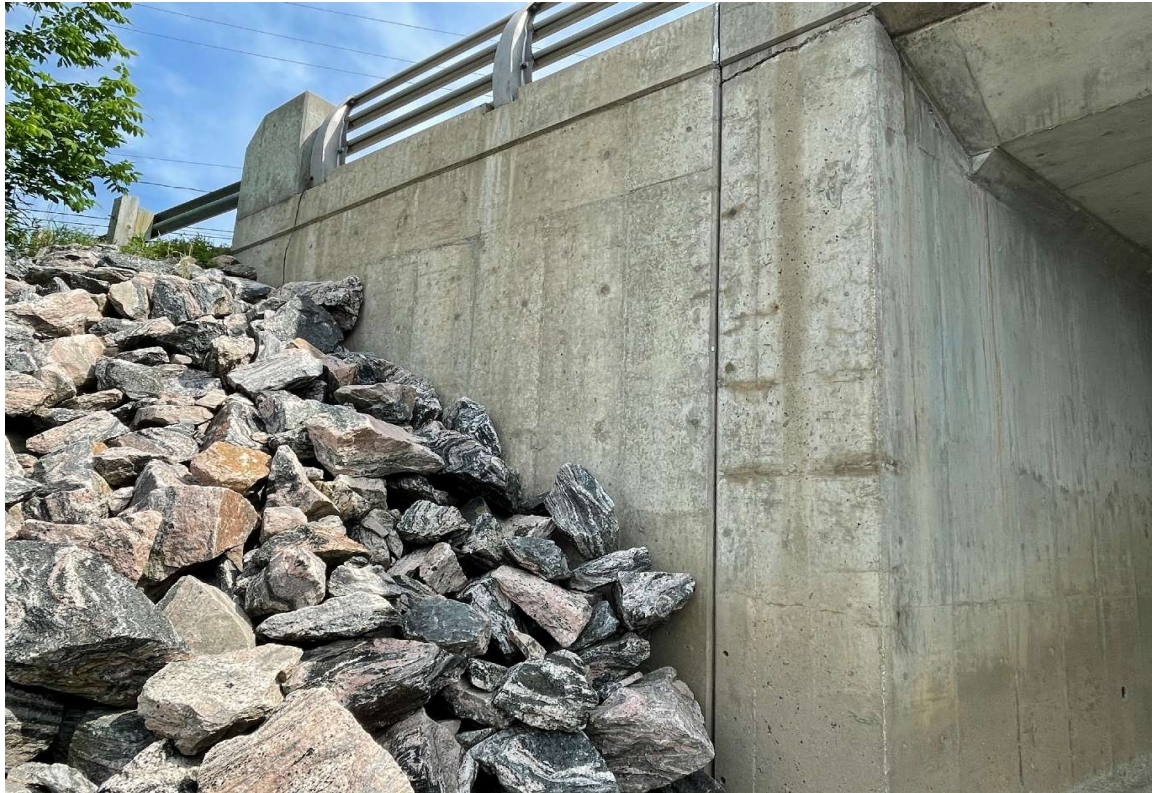
**Description of Photo:** Northwest wingwall

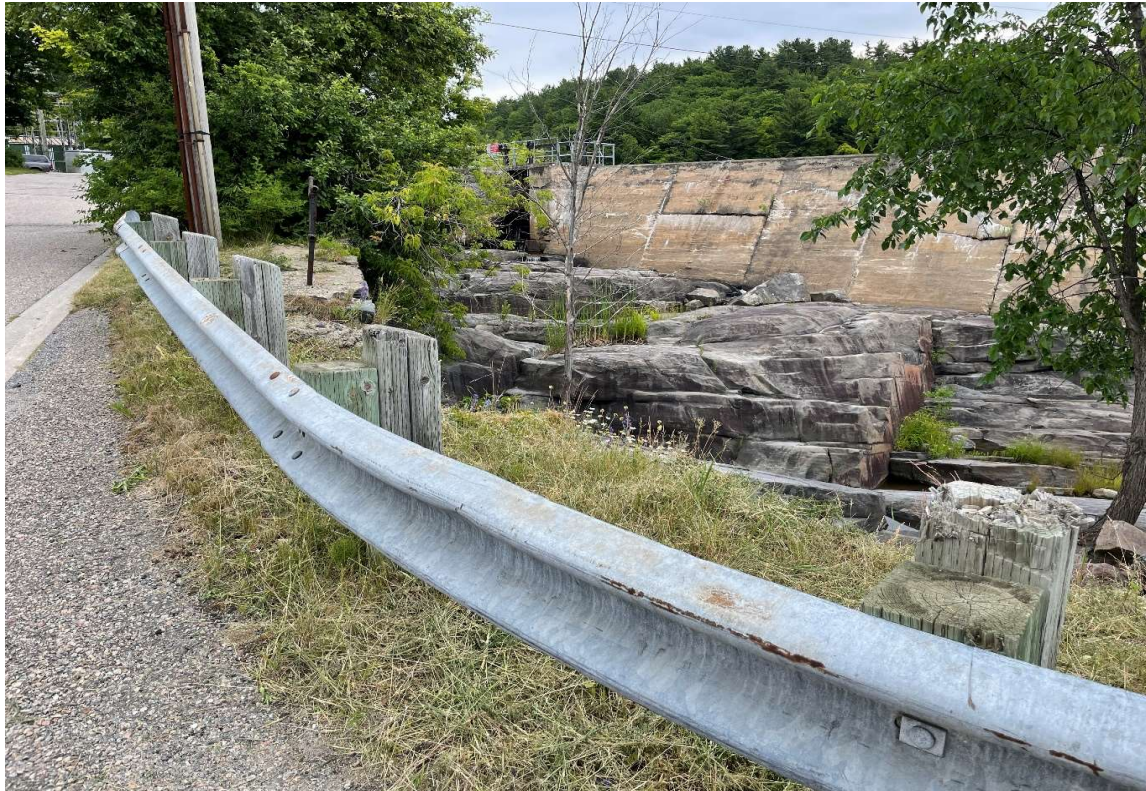
**Description of Photo:** Northeast approach barrier

Recommended Work:	Rehab: <input type="checkbox"/>	Replace: <input type="checkbox"/>	Maintenance Needs:	3 - Railing System Repair		
Urgent: <input type="checkbox"/>	1-5 Years: <input type="checkbox"/>	6-10 Years: <input type="checkbox"/>	None: <input checked="" type="checkbox"/>	Urgent: <input type="checkbox"/>	1 Year: <input type="checkbox"/>	2 Year: <input checked="" type="checkbox"/>
				Upgrade NE and NW barrier to bridge connection

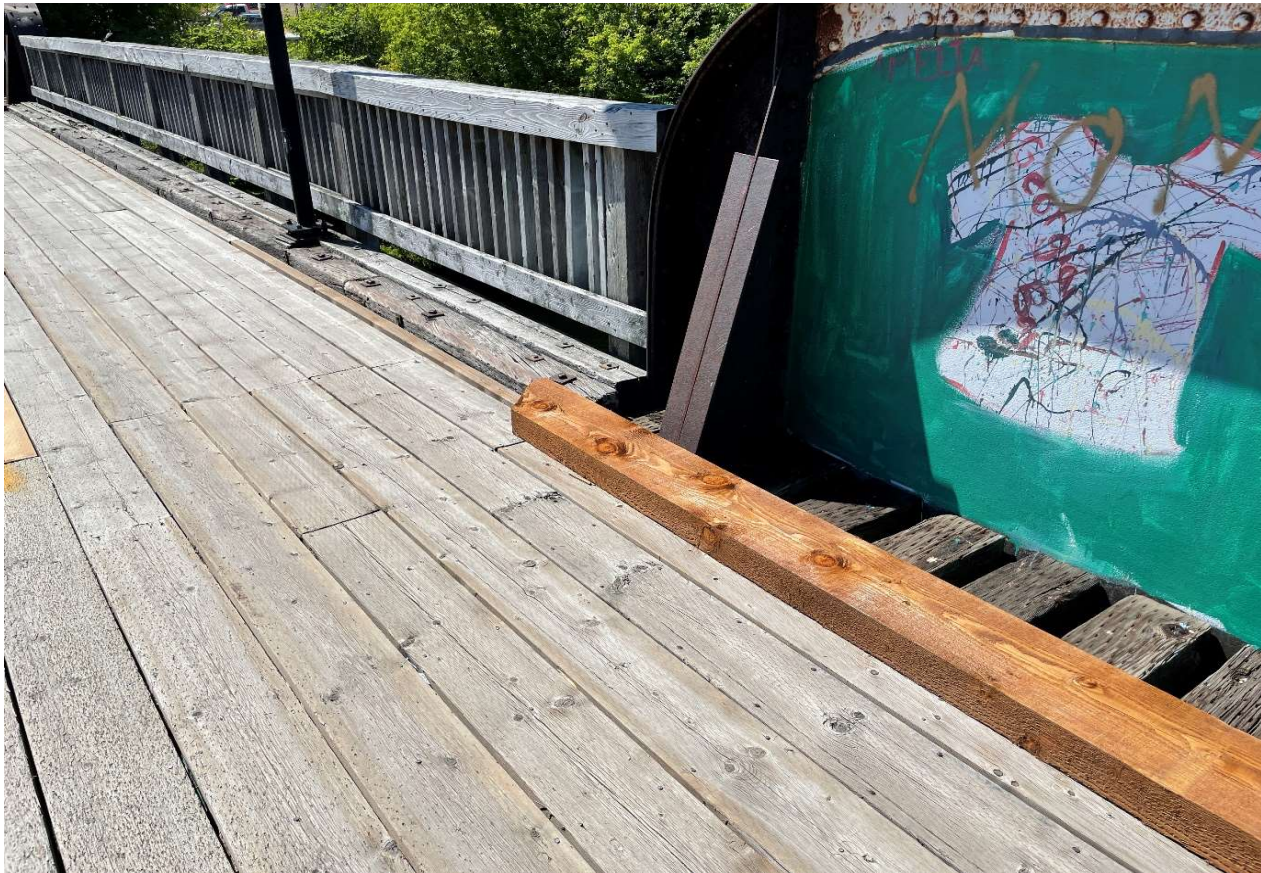
**Description of Photo:** Curb

Description of Photo: Curb

Replace rotten timbers

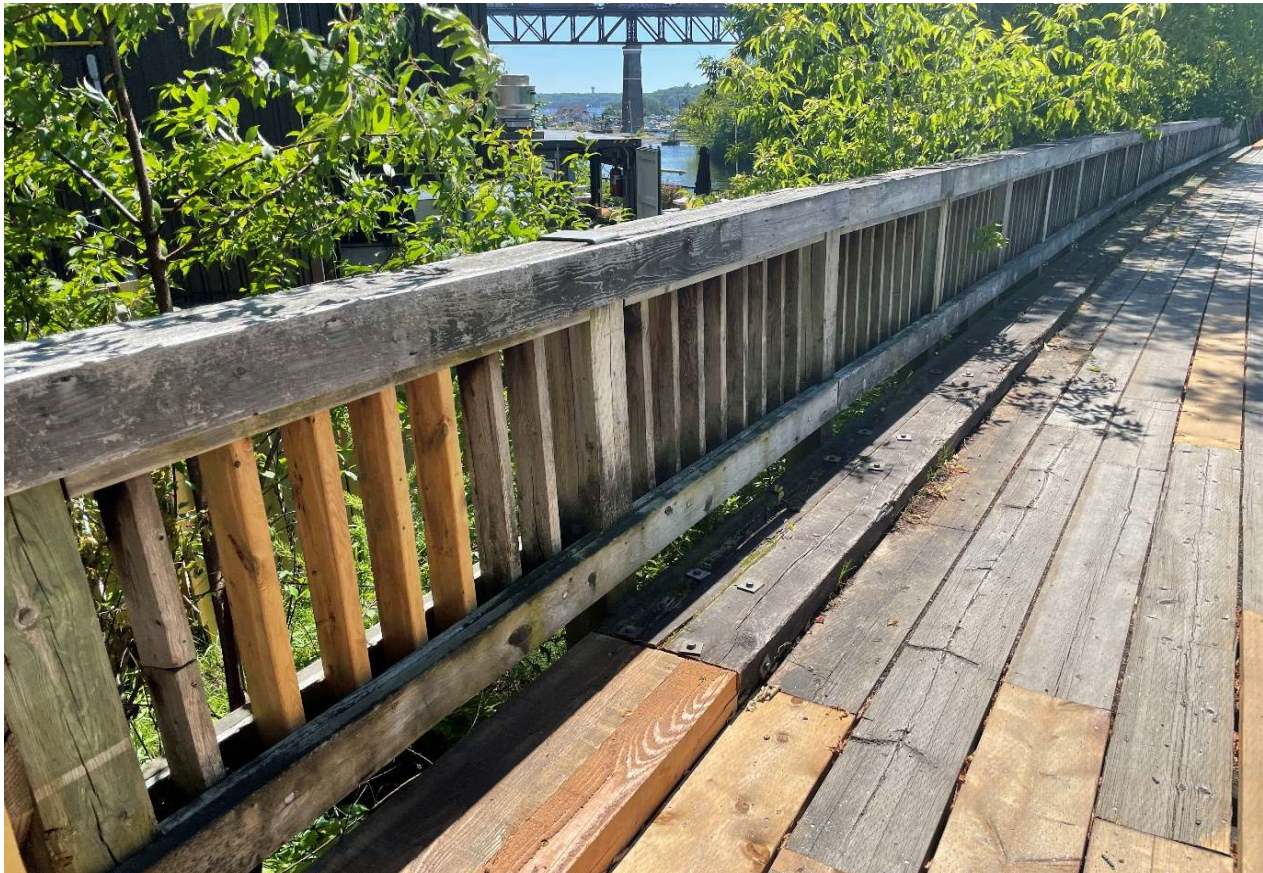
Comments: Timber railing system is in generally good condition. 1 missing timber post at northeast and 1 split timber post at southeast. Isolated areas of light splintering at bolt hole locations. Steel through girder span girders acts as railing system and is in generally good condition with light corrosion, typical. Consider increasing timber barrier height to 1.37 m to meet current code requirements for cyclists, however 1.2m can be used based on owner approval.

**Description of Photo:** Railing System

Description of Photo: Railing System

Recommended Work:	Rehab: <input type="checkbox"/>	Replace: <input type="checkbox"/>	Maintenance Needs:	3 - Railing System Repair		
Urgent: <input type="checkbox"/>	1-5 Years: <input type="checkbox"/>	6-10 Years: <input type="checkbox"/>	None: <input checked="" type="checkbox"/>	Urgent: <input type="checkbox"/>	1 Year: <input checked="" type="checkbox"/>	2 Year: <input type="checkbox"/>
				Replace 2 timber posts.

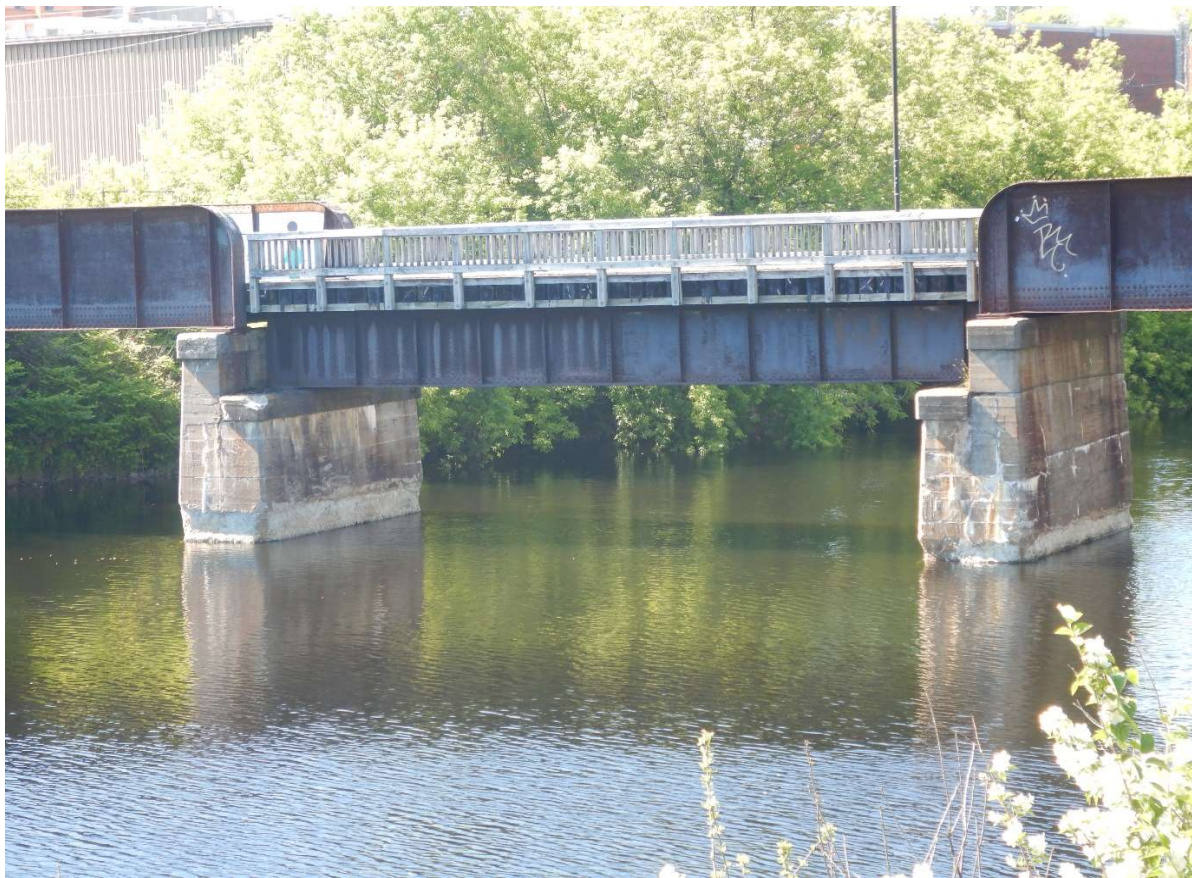
**Description of Photo:** Elevation View

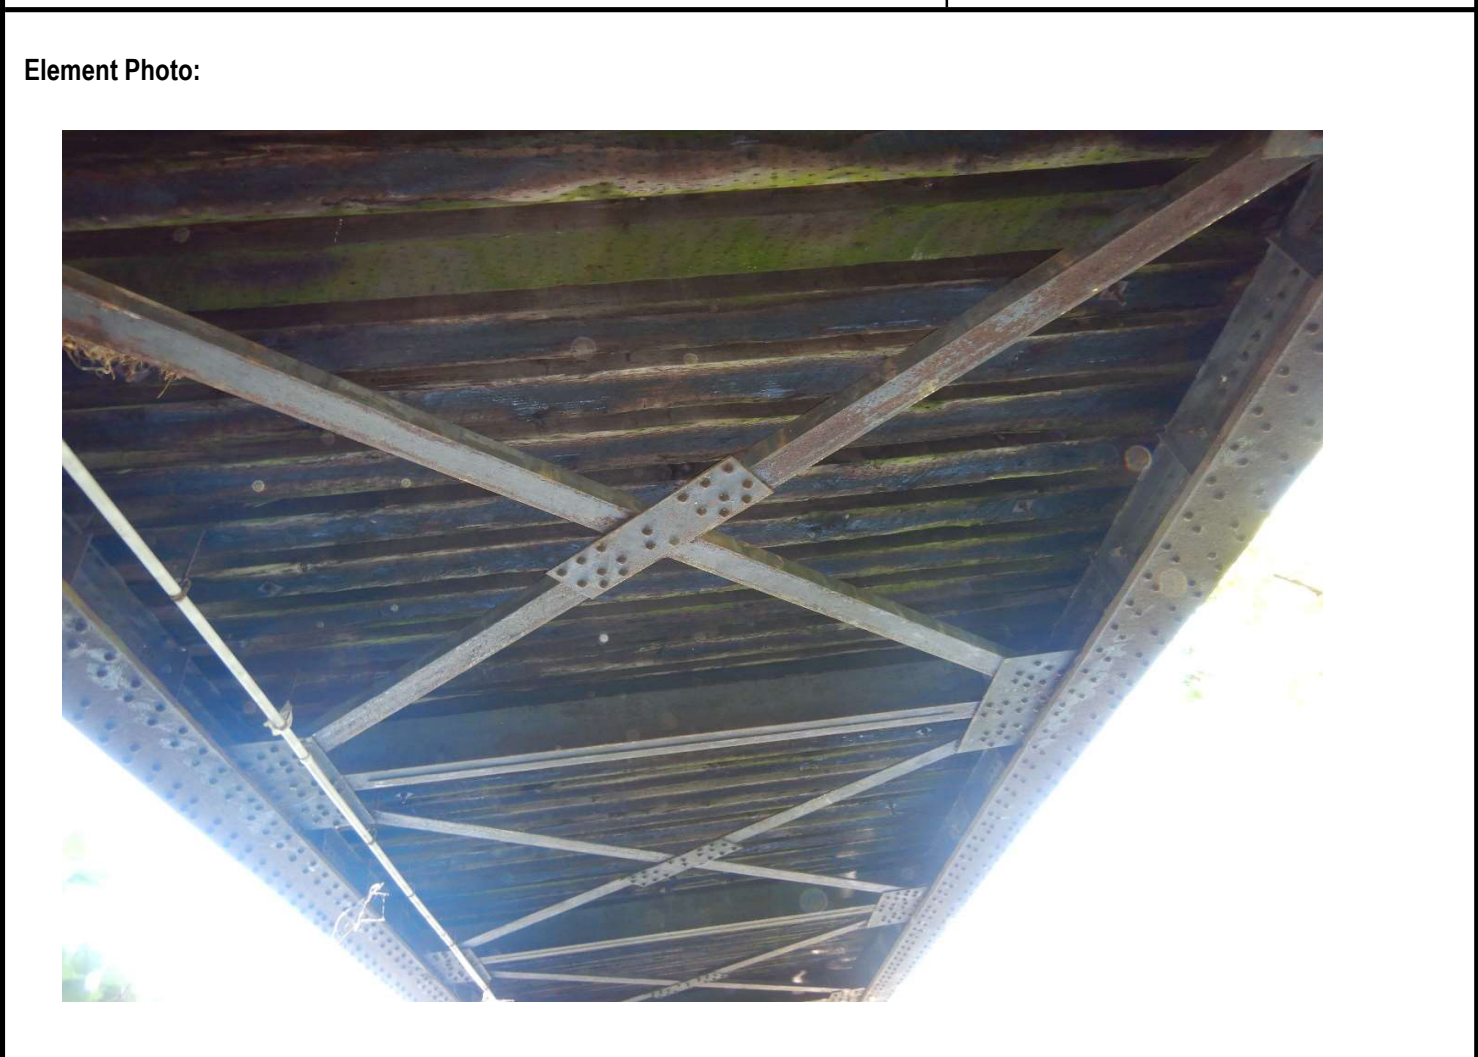
Comments: **Limited inspection due to lack of access. Light corrosion, typical. Assumed isolated areas of medium corrosion.**

**Description of Photo:** Floor Beams

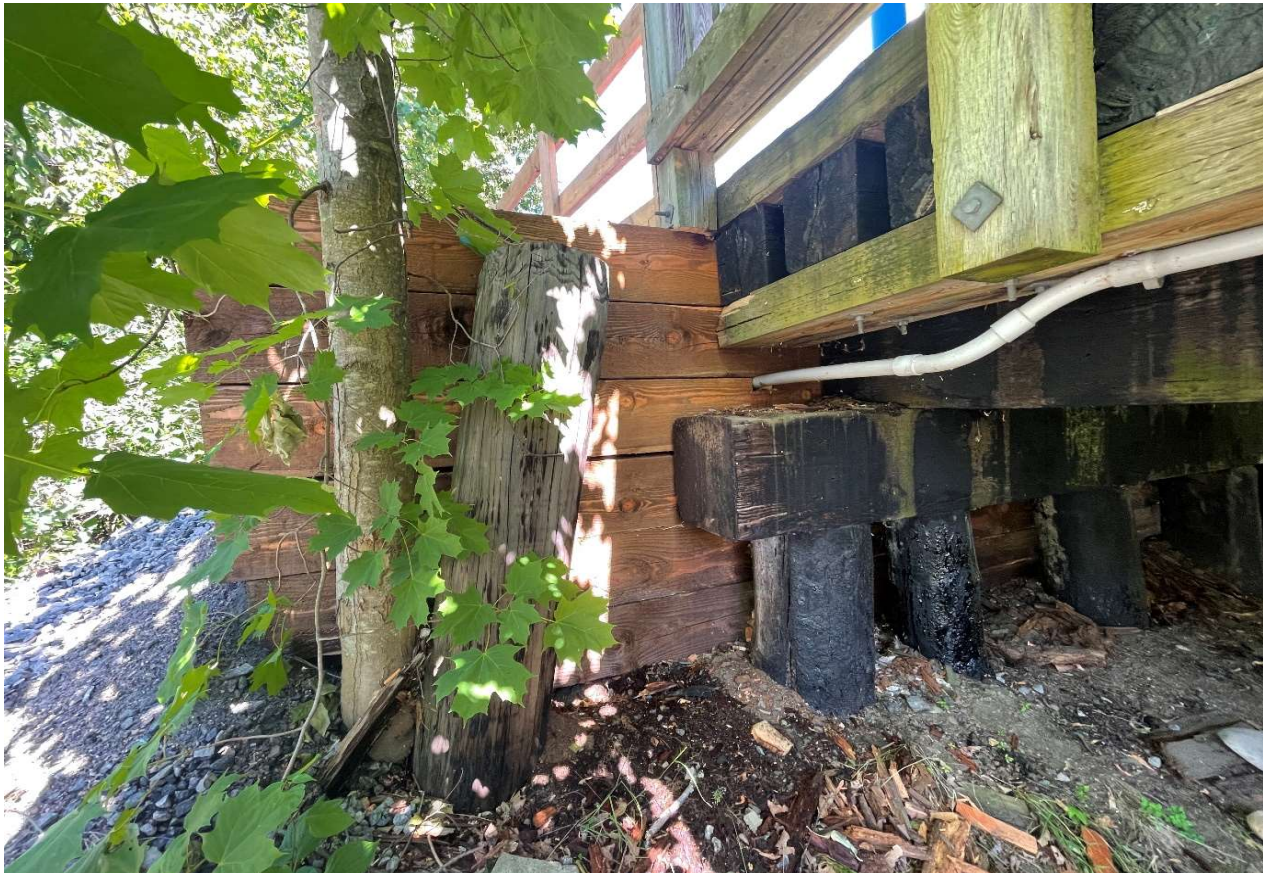
Comments: Recently replaced. Isolated areas of light checks.

**Description of Photo:** East Abutment

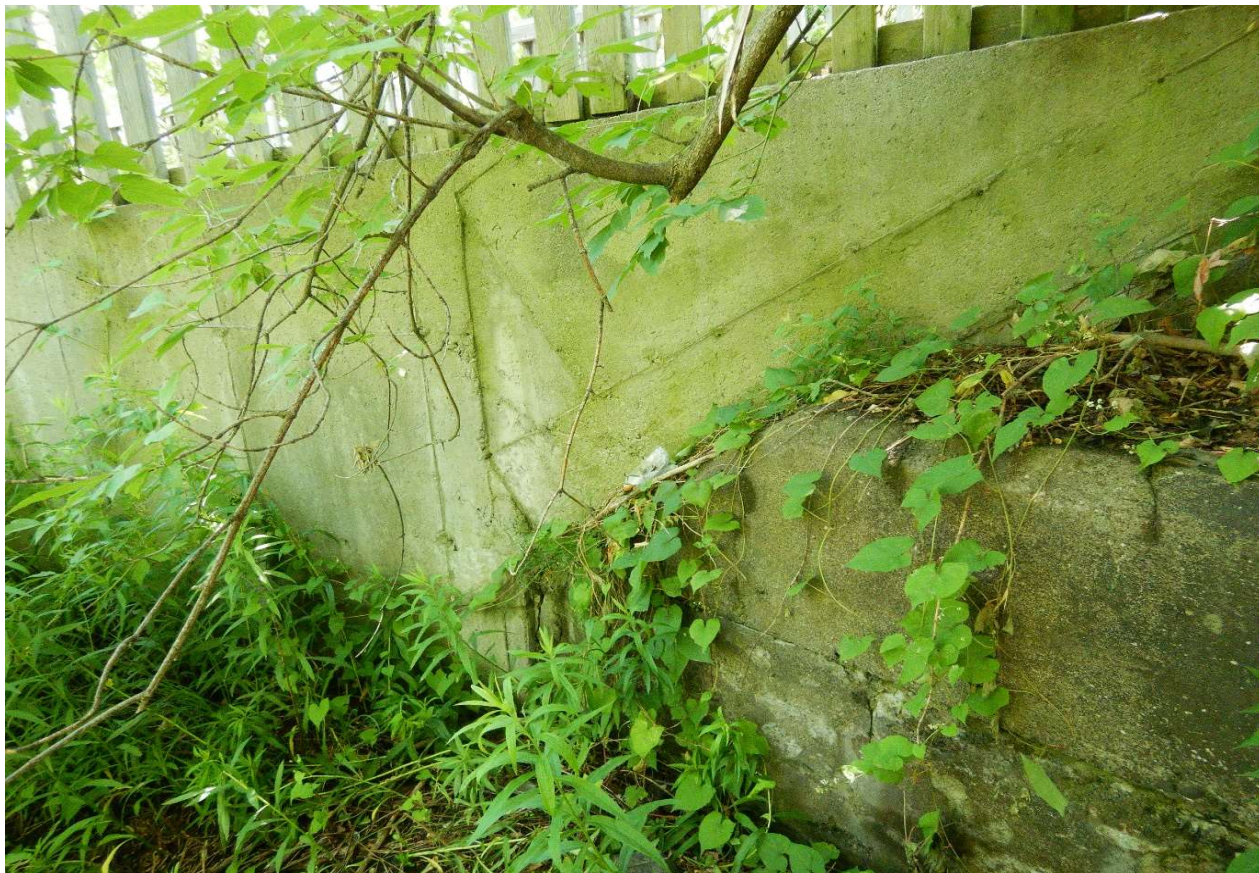
**Description of Photo:** Wingwall

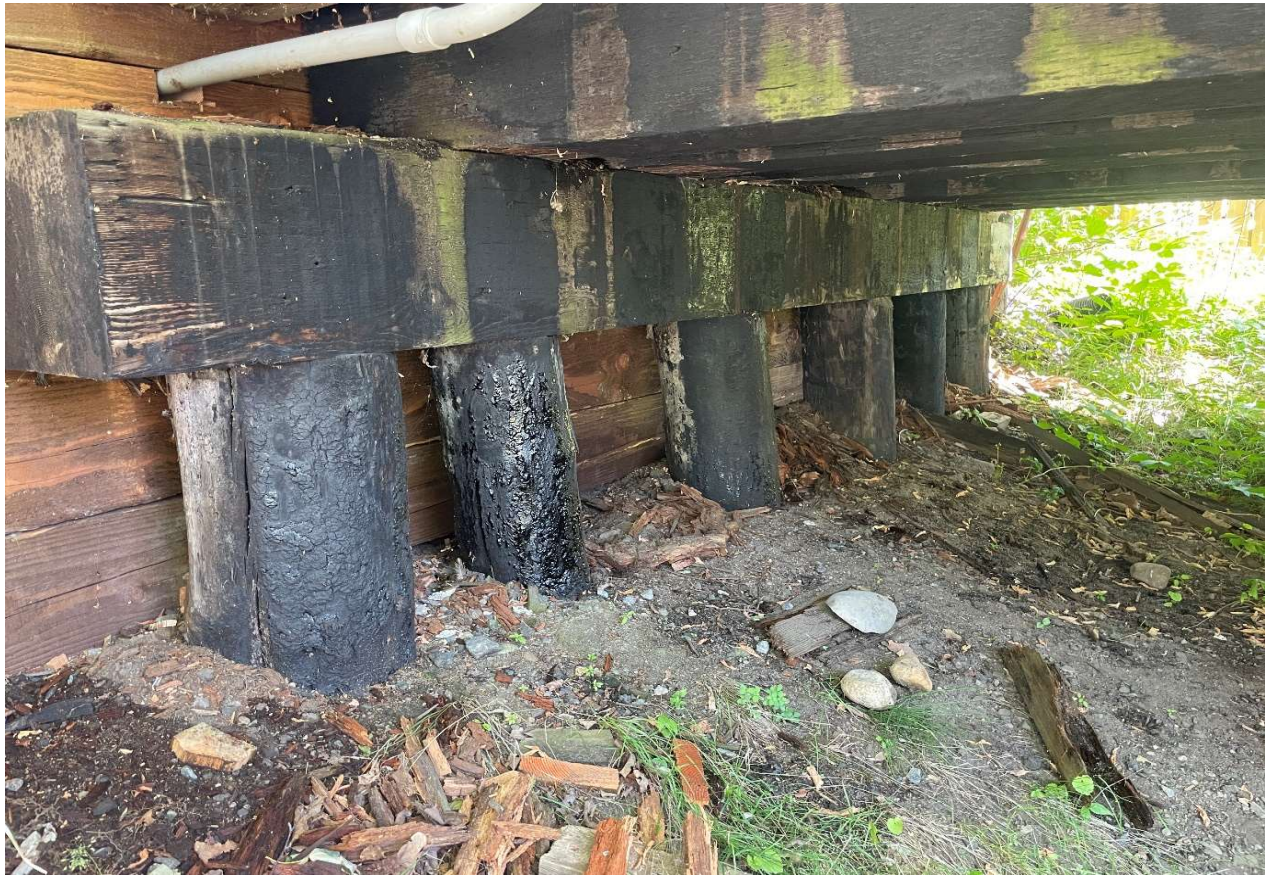
Description of Photo: Piles

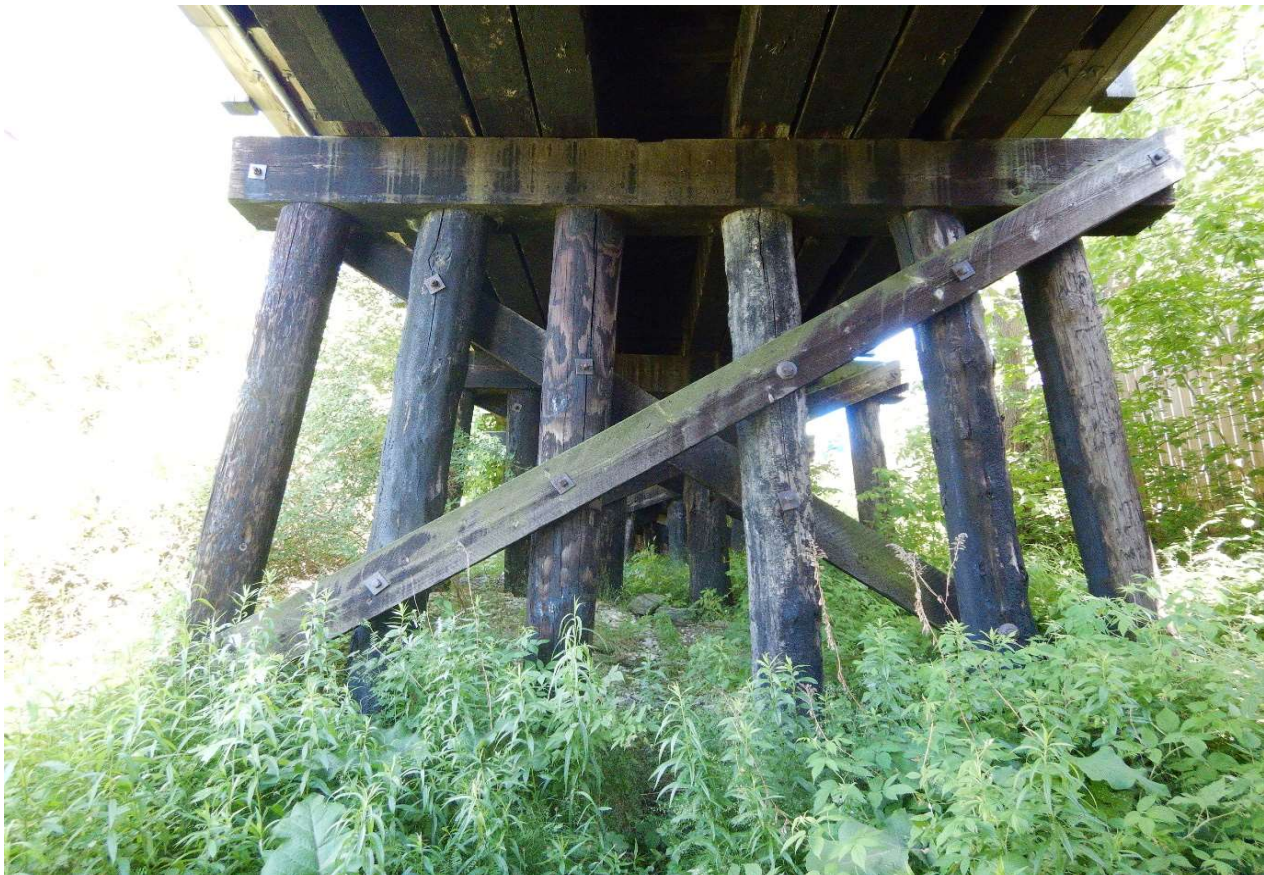
Description of Photo: Piles

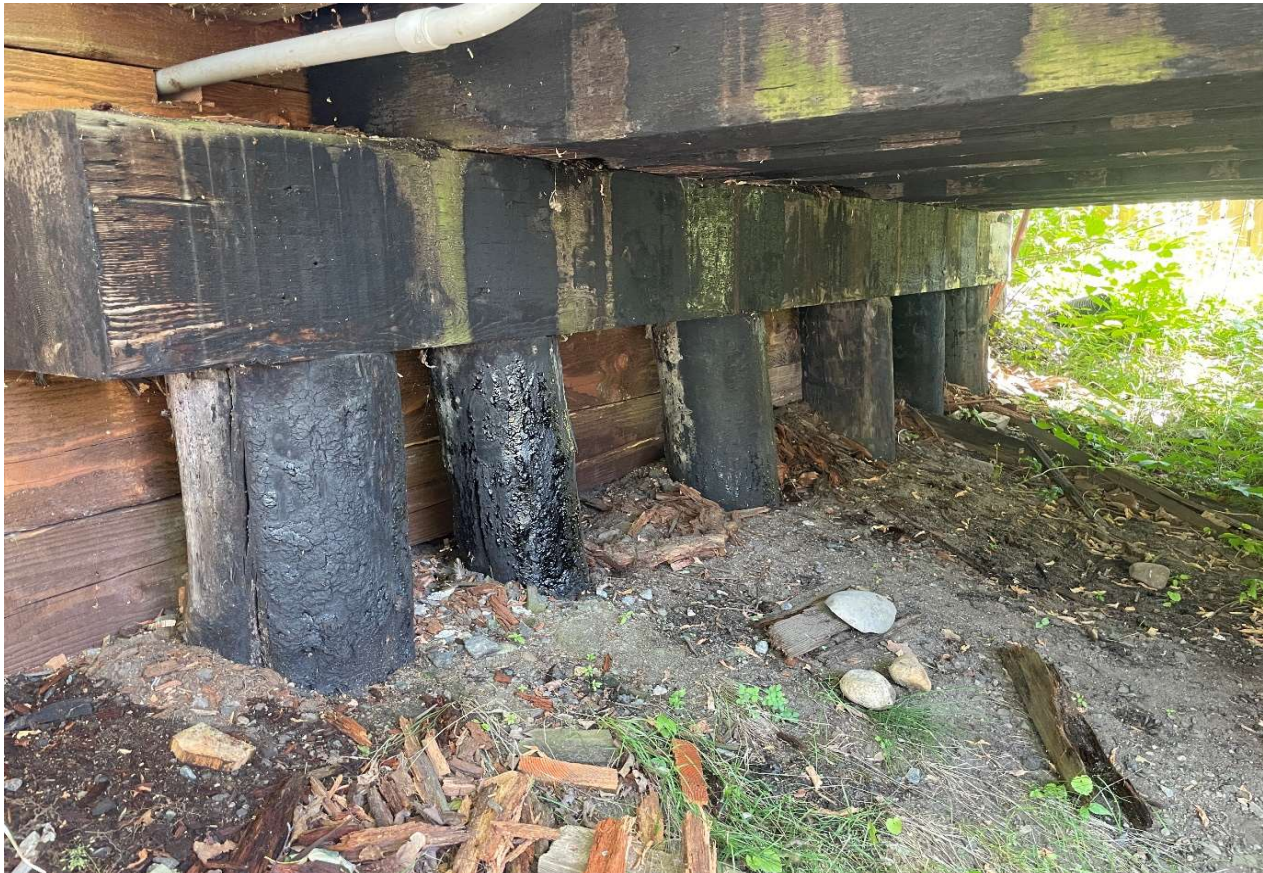
Description of Photo: Pile Cap

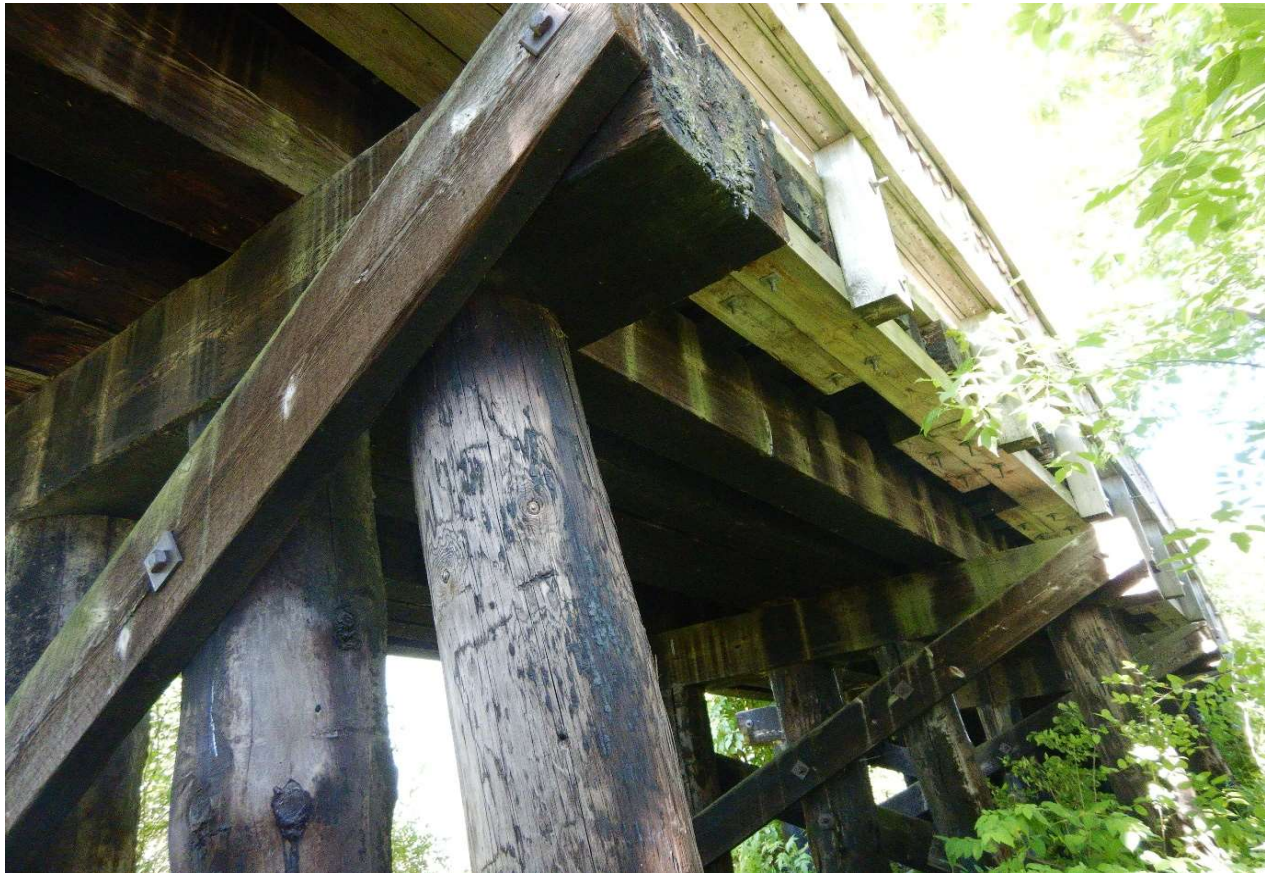
**Description of Photo:** Pile Cap

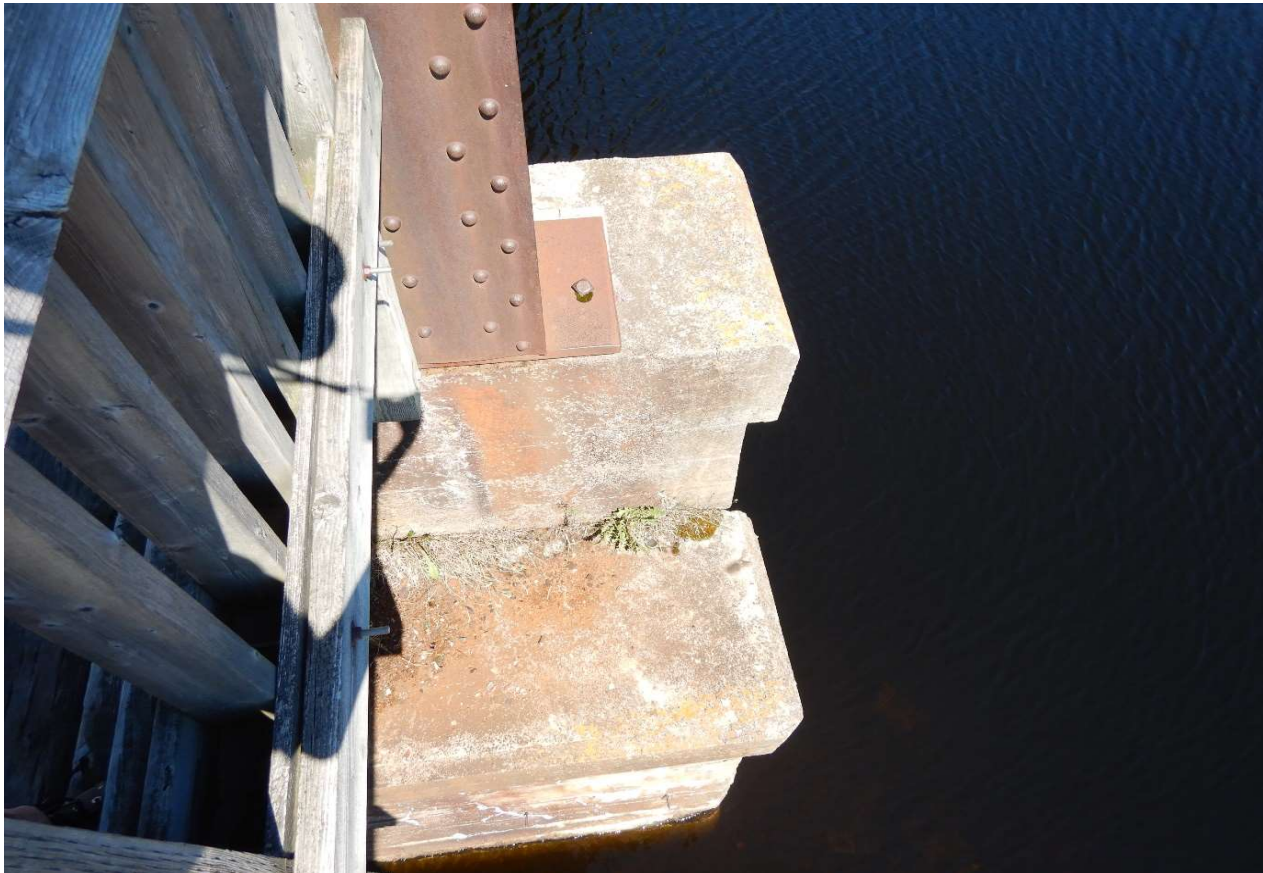
**Description of Photo:** Pier Bearings

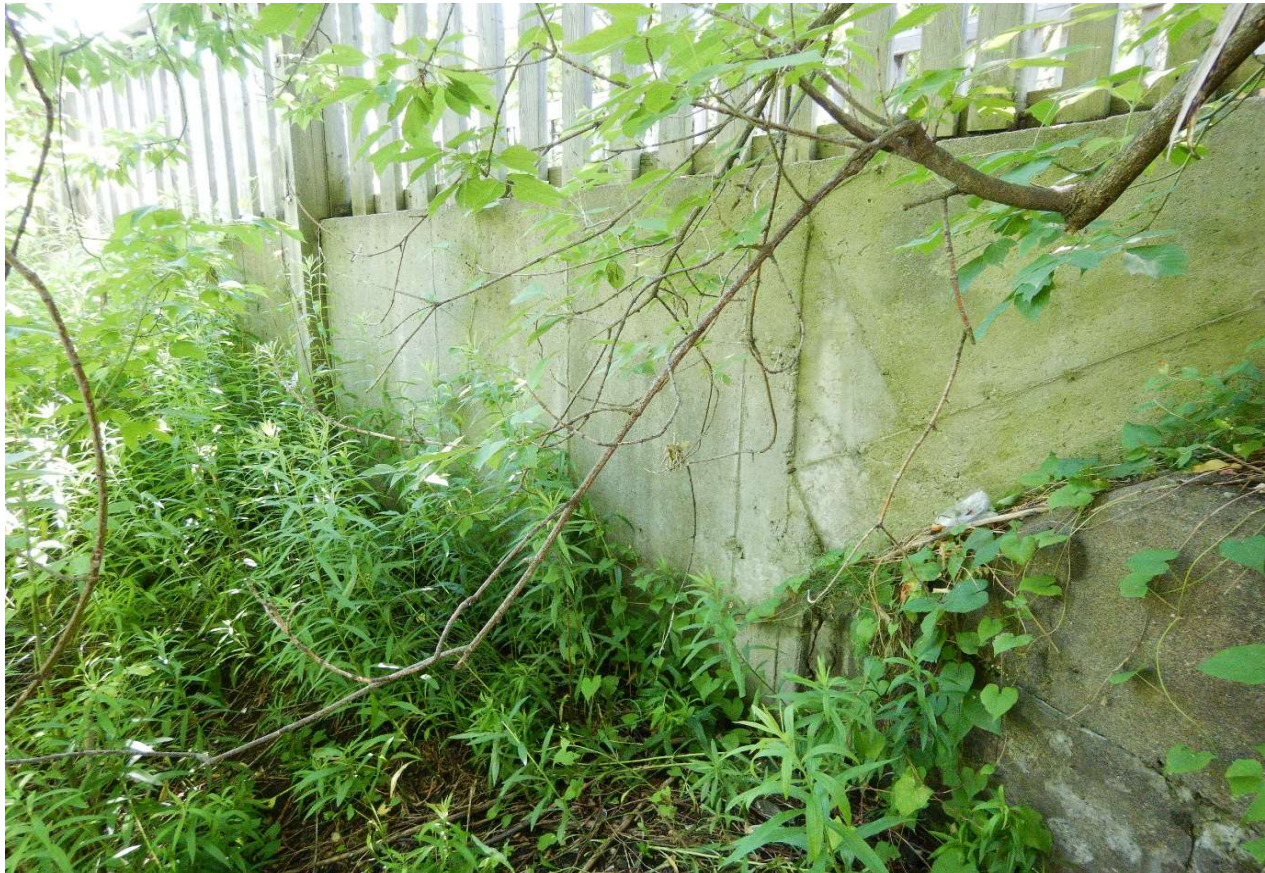
**Description of Photo:** Retaining Wall

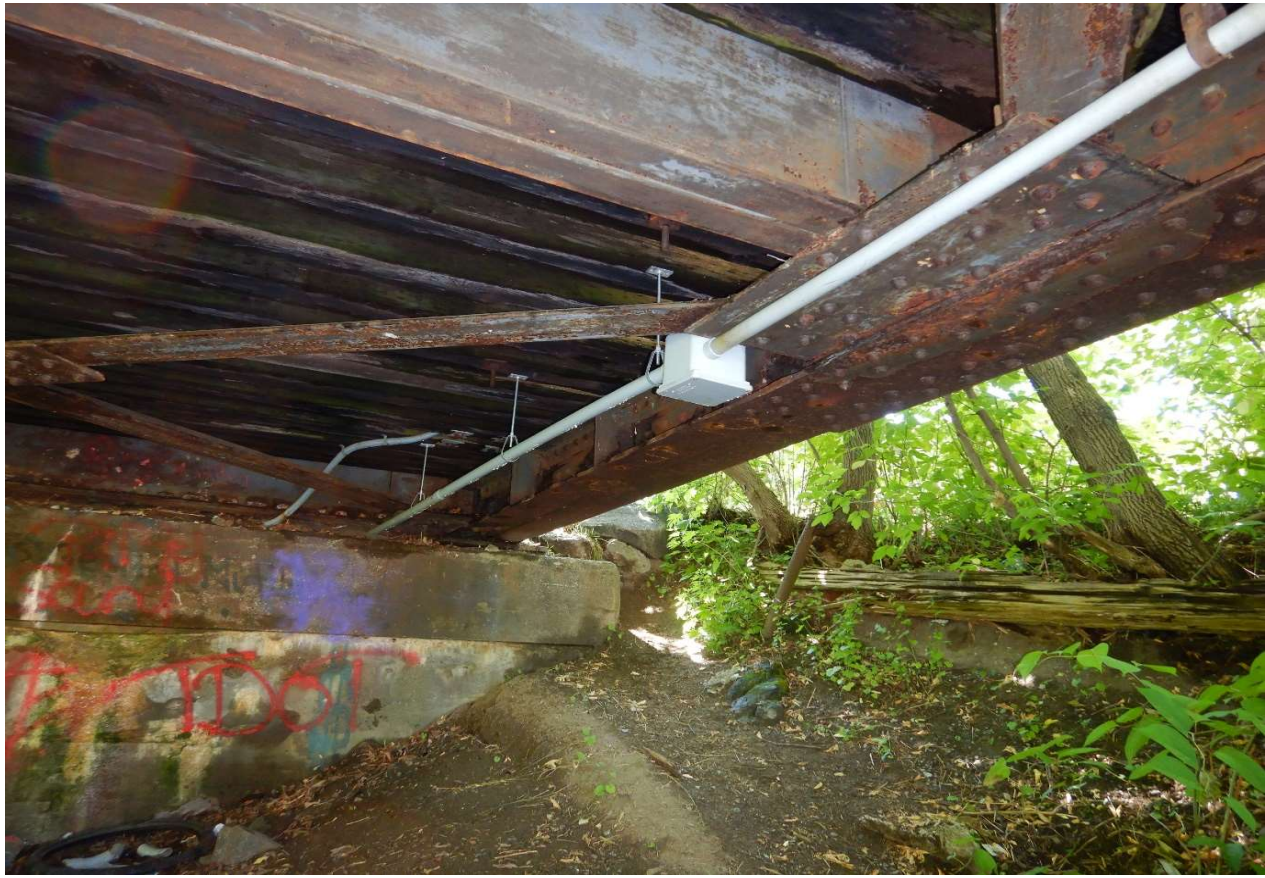
Comments: **Conduit repaired from previous inspection. No observed defects.**

**Description of Photo:** Electrical Utilities

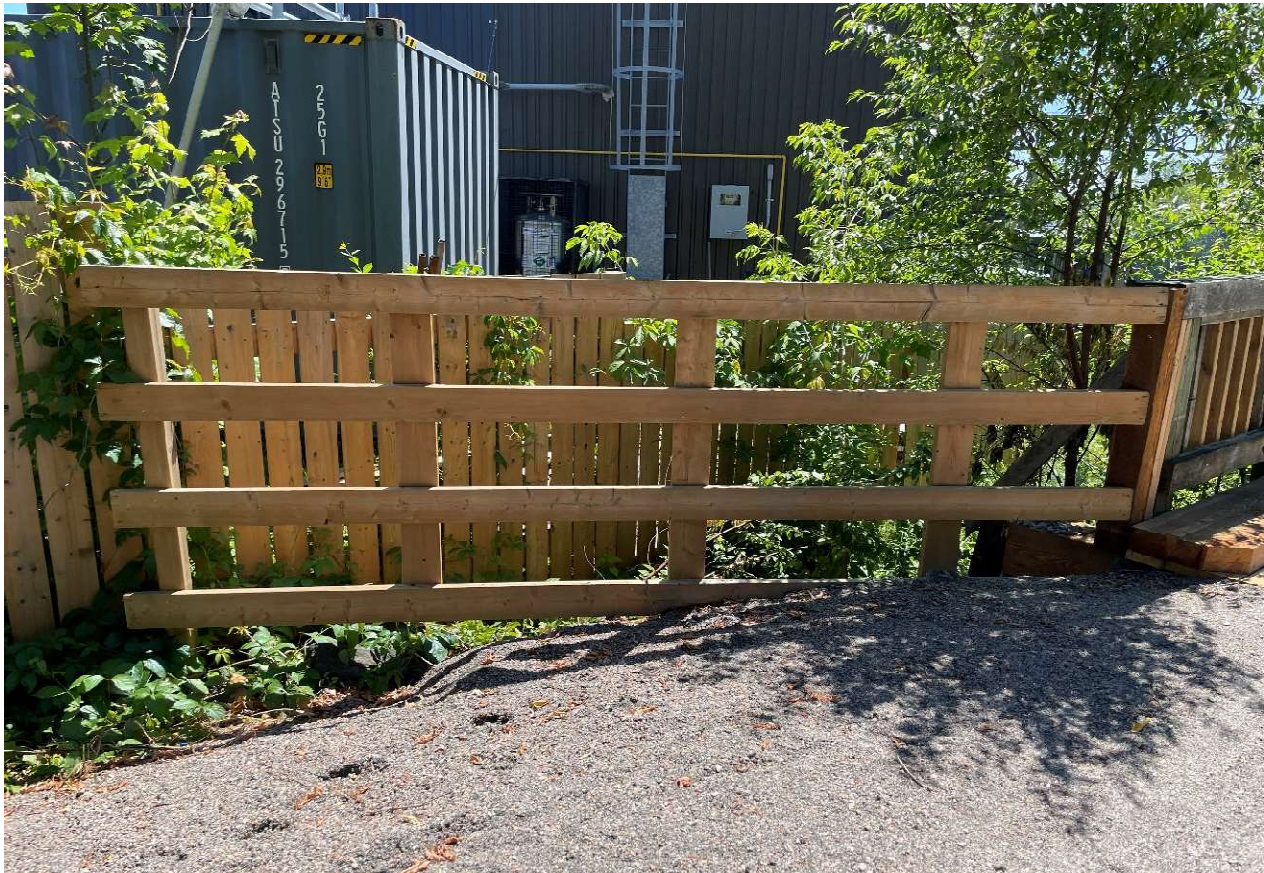
Comments: One 3.0m light check at southeast top timber. No other observed defects.

Description of Photo: Approach Barrier

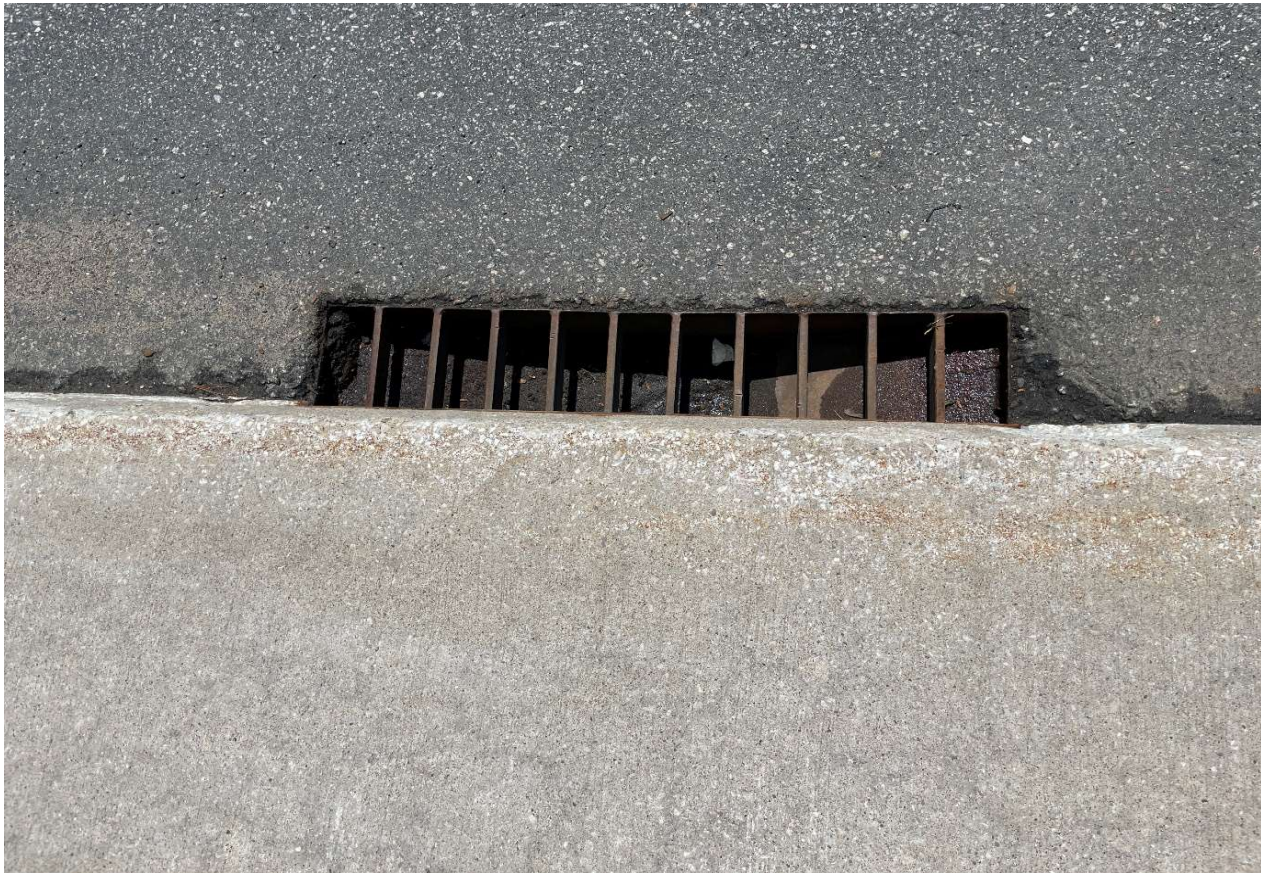
Comments: Light corrosion at bottom of drain pipes, typical. No other observed defects. No debris buildup in drain grates.

**Description of Photo:** Drainage

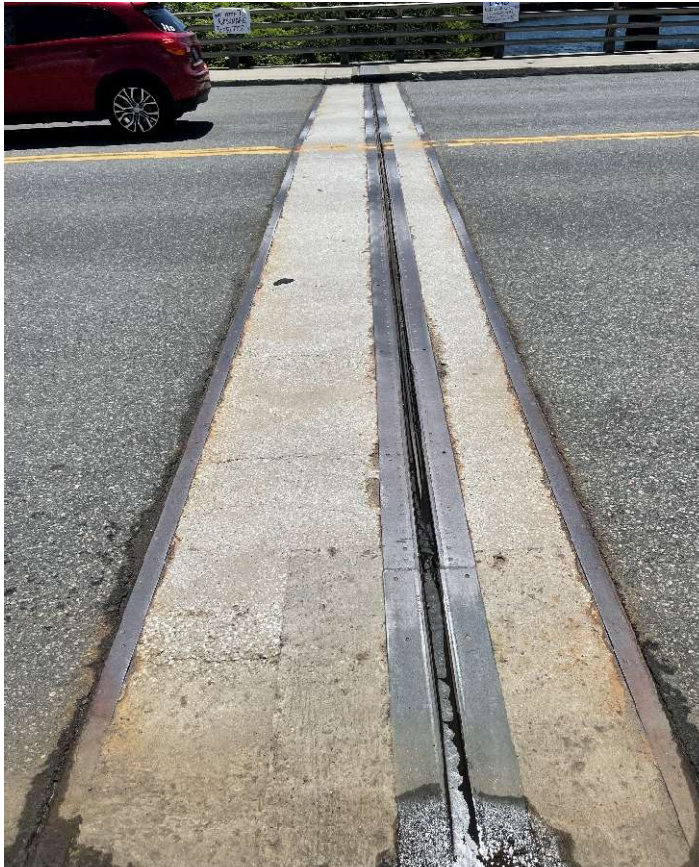
Comments: Light scaling and abrasions typical. Light 300 x100 x15mm spall on east side and 2 light 300x100x15mm spall on west side. Approximately 1.0m of light cracks.

**Description of Photo:** Joint Concrete End Dam

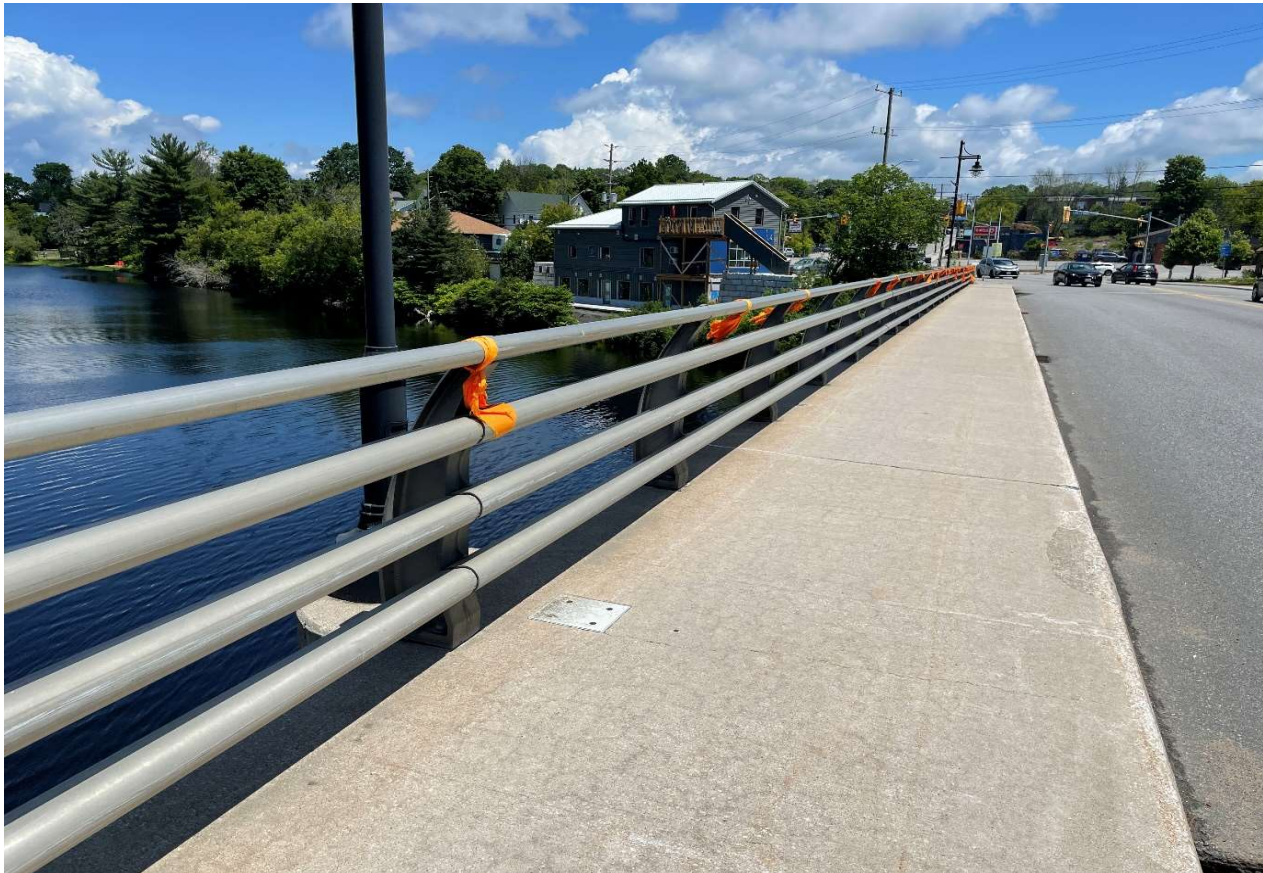
Comments: Two 100x100mm deformations with perforations on north rail. Localized abrasions throughout with some wear of aluminum surface.

**Description of Photo:** Railing System
