# Bridge Inspections

**TOWN OF PARRY SOUND**

Inspection Summary Report

January  
12, 2023

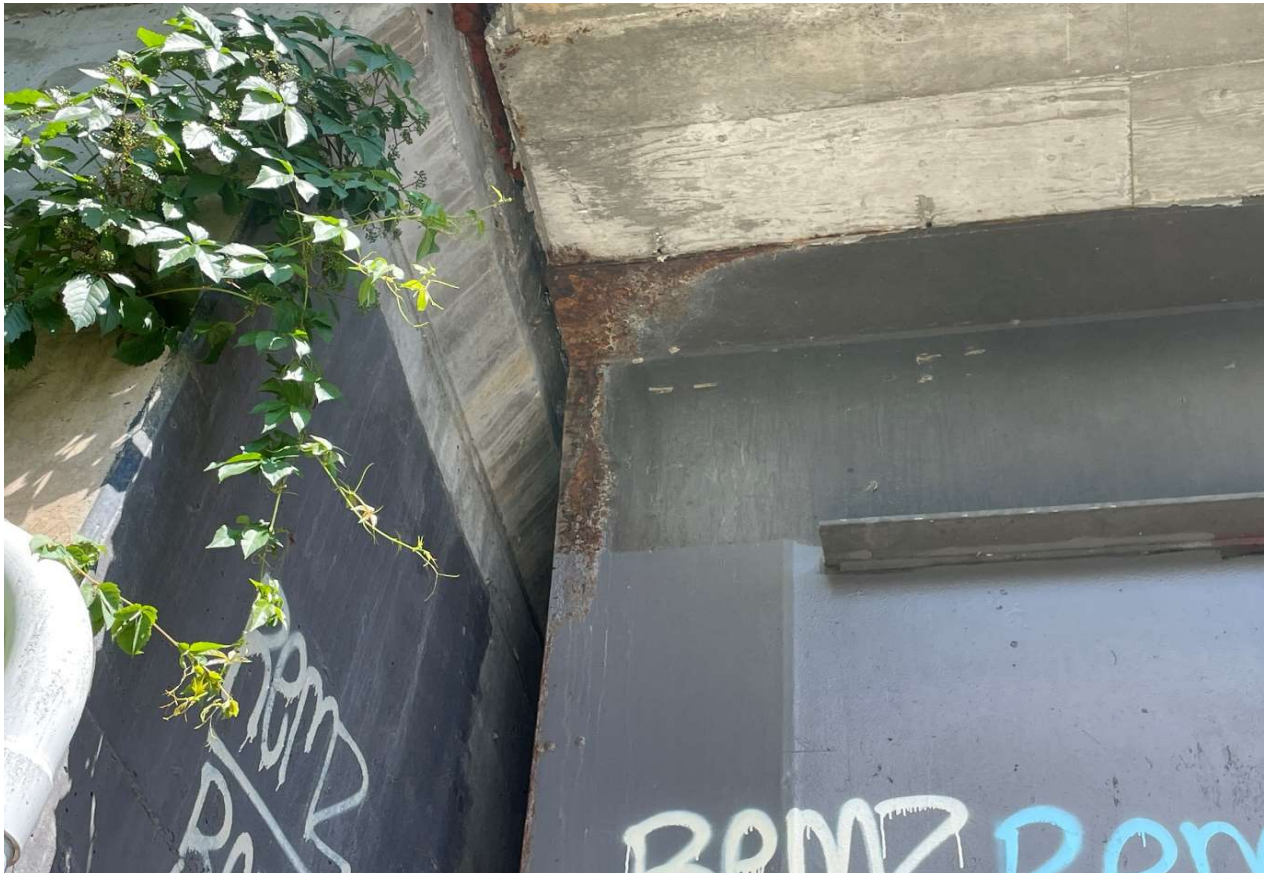
Comments: Five 200x200mm areas of medium corrosion at the bottom flange at drain holes. Light corrosion at top of southwest girder.

**Description of Photo:** Girder - Exterior End

Recommended Work:	Rehab: <input checked="" type="checkbox"/>	Replace: <input type="checkbox"/>	Maintenance Needs:	
Urgent: <input type="checkbox"/>	1-5 Years: <input type="checkbox"/>	6-10 Years: <input checked="" type="checkbox"/>	None: <input type="checkbox"/>	Urgent: <input type="checkbox"/> 1 Year: <input type="checkbox"/> 2 Year: <input type="checkbox"/>
Clean and recoat in conjunction with interior cleaning. Refer to Beams - Inside Boxes regarding cleaning.

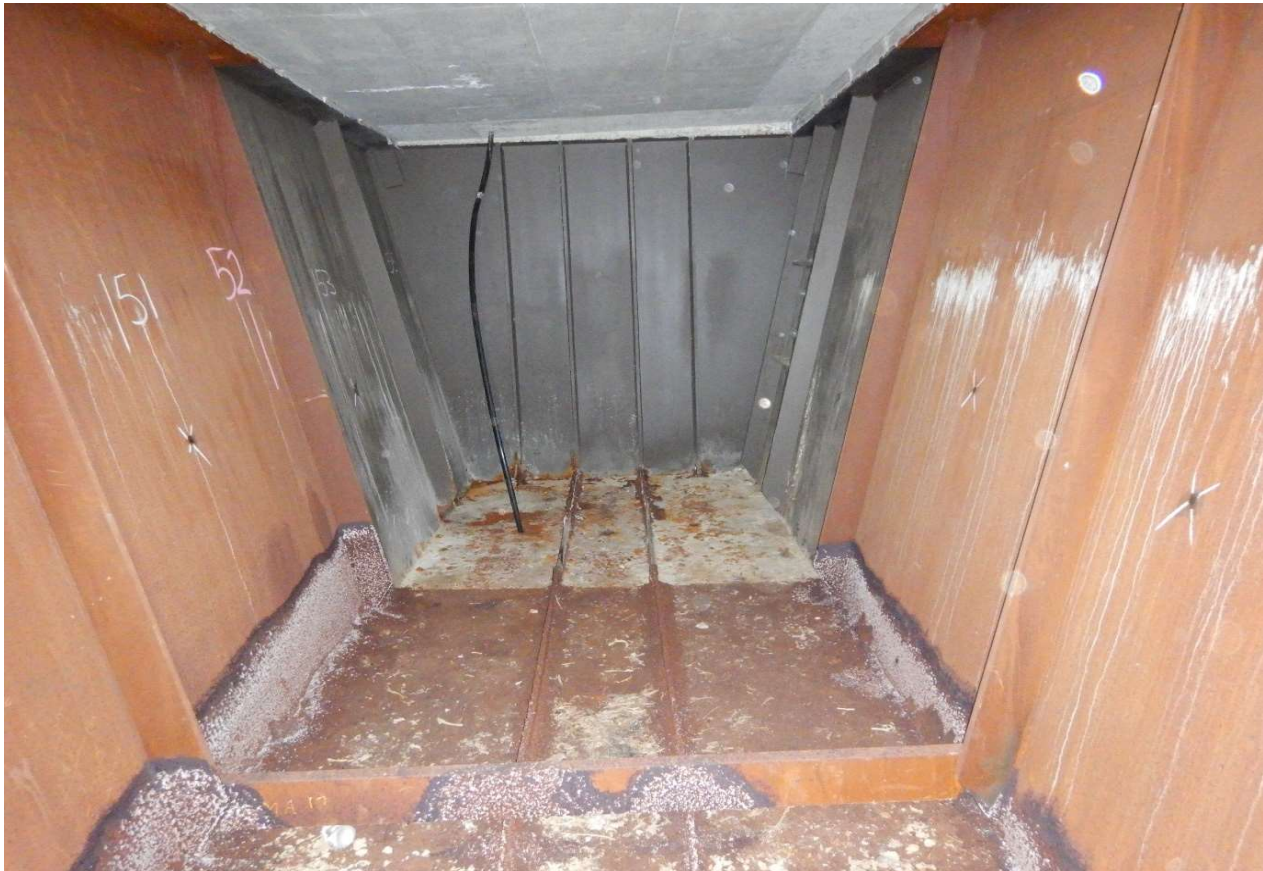
Comments: Medium corrosion along bottom, 8.0mx200mm at west and east end of girder. The coating along the bottom flange and stiffeners has failed exhibiting Category 2 to 4 surface rust at west end. 1 sq.m of white deposits on bottom. Steel stiffeners have areas of localized severe corrosion with section loss at ends of girder. 20m from west end 4.0m of efflorescence deposits at top flange and deck interface. Both ends have significant build-up of debris.

**Description of Photo:** East Girder End

Recommended Work:	Rehab: <input checked="" type="checkbox"/>	Replace: <input type="checkbox"/>	Maintenance Needs:	
Urgent: <input type="checkbox"/>	1-5 Years: <input checked="" type="checkbox"/>	6-10 Years: <input type="checkbox"/>	None: <input type="checkbox"/>	Urgent: <input type="checkbox"/> 1 Year: <input type="checkbox"/> 2 Year: <input type="checkbox"/>
Clean debris from girder ends, recoat the girder ends.

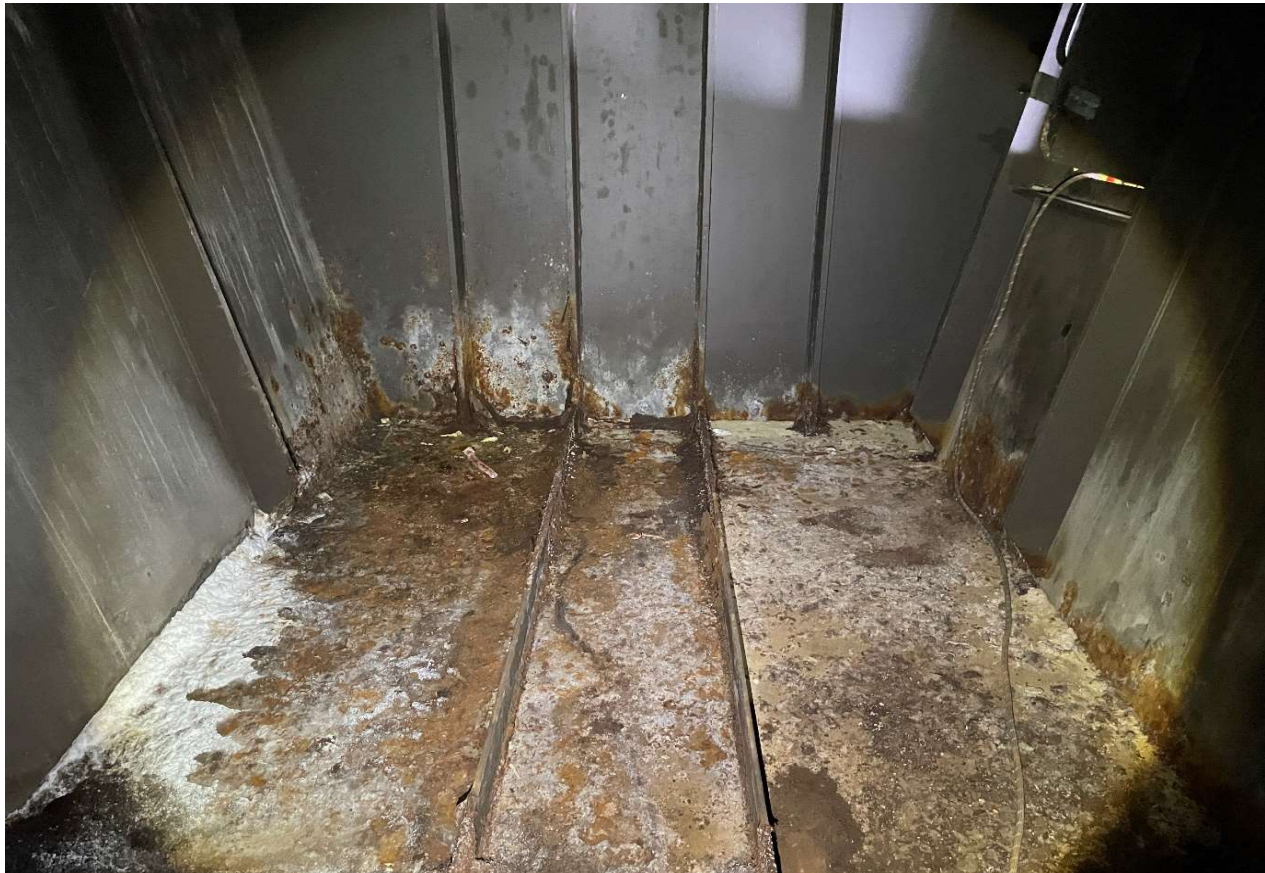
Comments: Light to medium corrosion along bottom, 15.0mx200mm at west and 6.0mx100mm at east end of girder. The coating along the bottom flange and stiffeners has failed exhibiting Category 2 to 4 surface rust at west end. One section of girder has light corrosion (4.0x2.2m) on bottom. Steel stiffeners have areas of localized severe corrosion with section loss at ends of girder. 20m from west end 4.0m of efflorescence at top flange and deck interface. Isolated areas of efflorescence deposits with corrosion on webs and top flange. Both ends have significant build-up of debris.

**Description of Photo:** Girder West End

Clean debris from girder ends, recoat the girder ends.

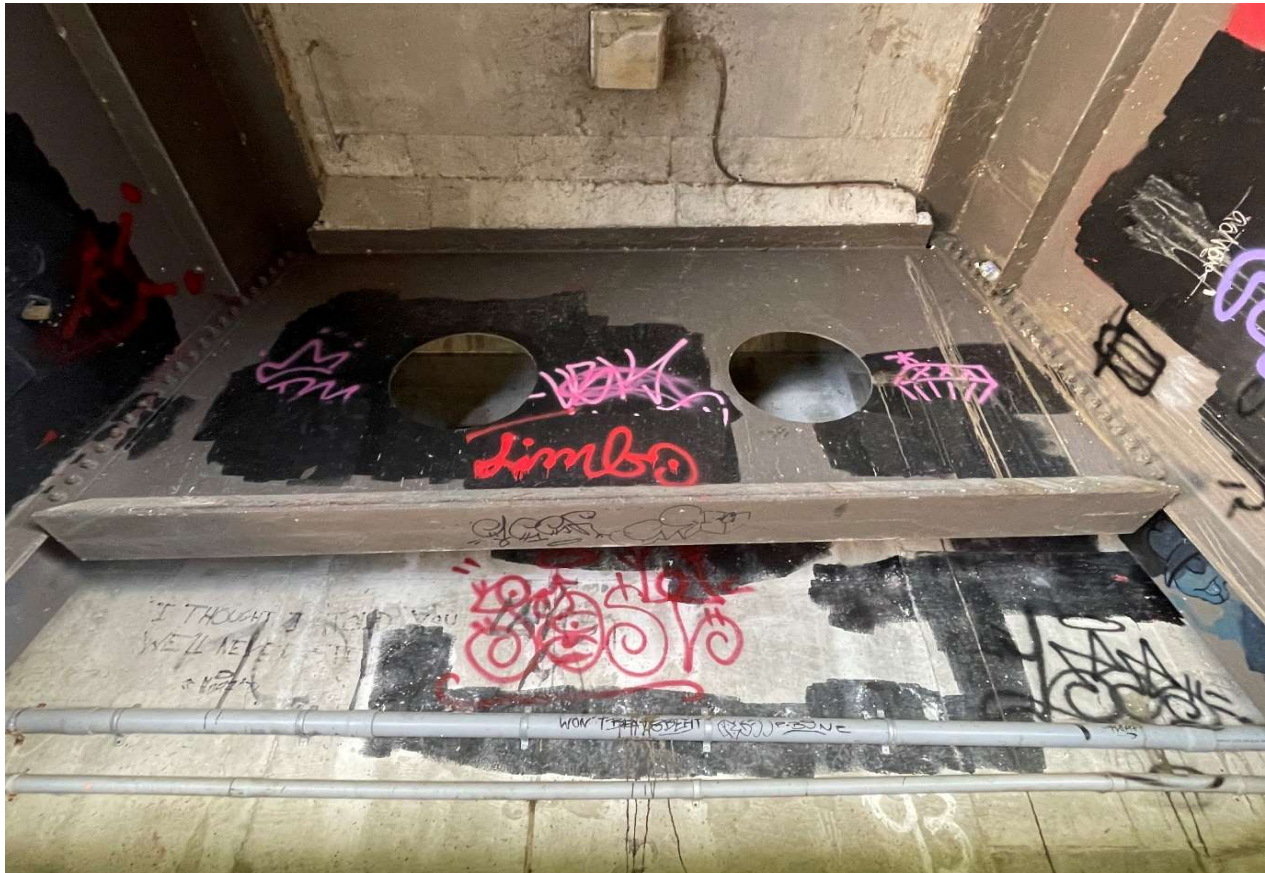
Comments: Graffiti was present at the west end, but no deterioration of the steel was noted. The coating appears to still be in good condition. Northwest end diaphragm bottom flange has areas of light corrosion.

Description of Photo: End Diaphragms

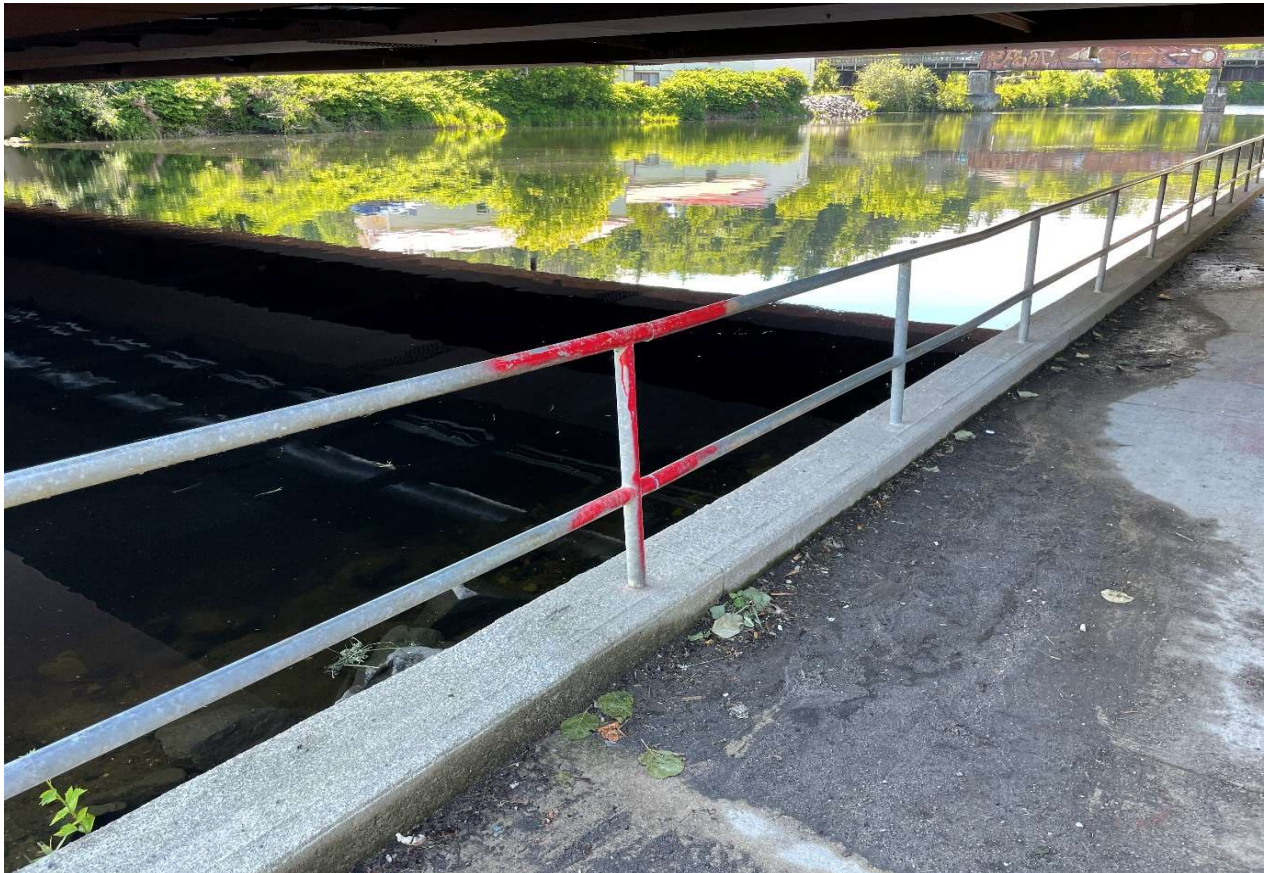
Comments: Pedestrian handrail along path under the west end of the bridge. Localized light corrosion and abrasion throughout. 0.5 mm narrow crack in the concrete base of a post.

**Description of Photo:** Retaining Wall Railing

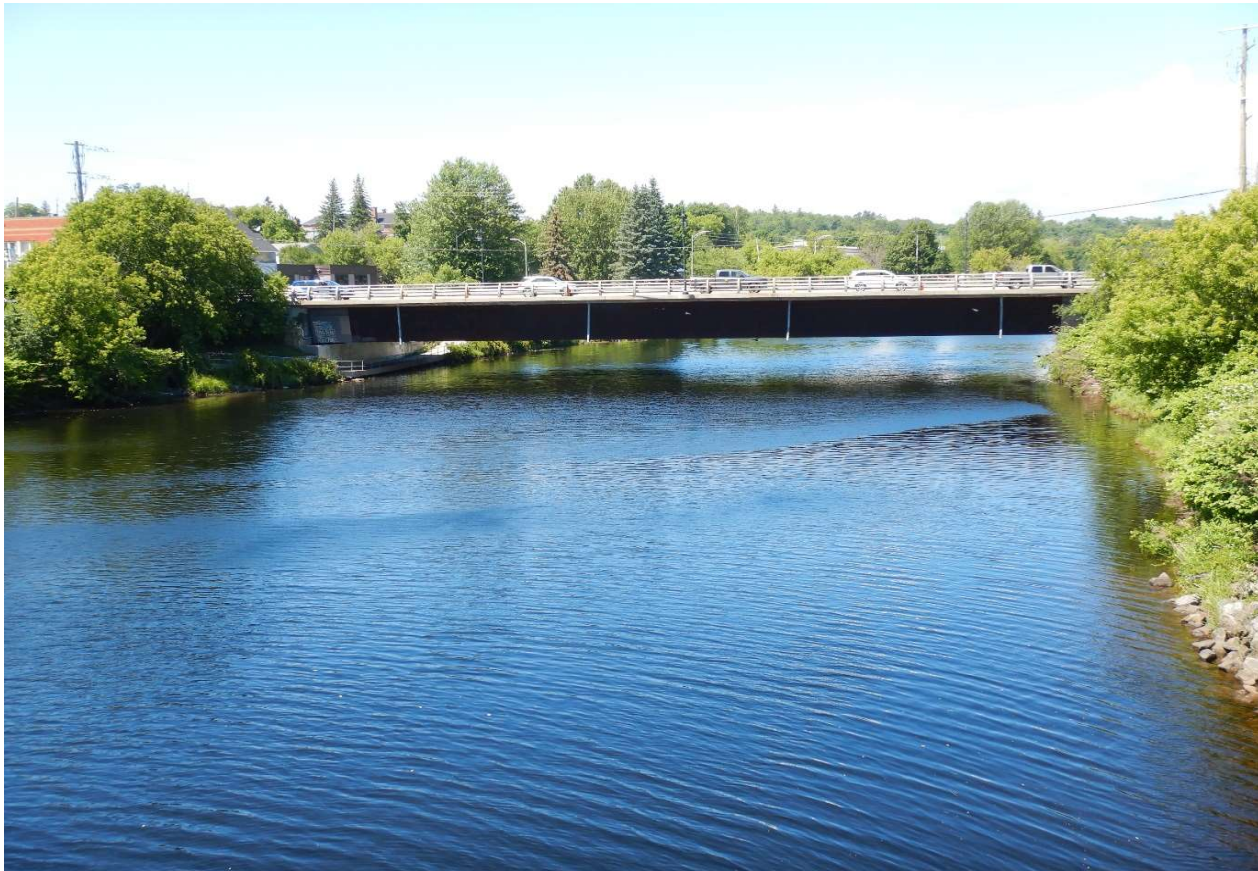
Comments: **No observed defects.**

**Description of Photo:**      Embankments

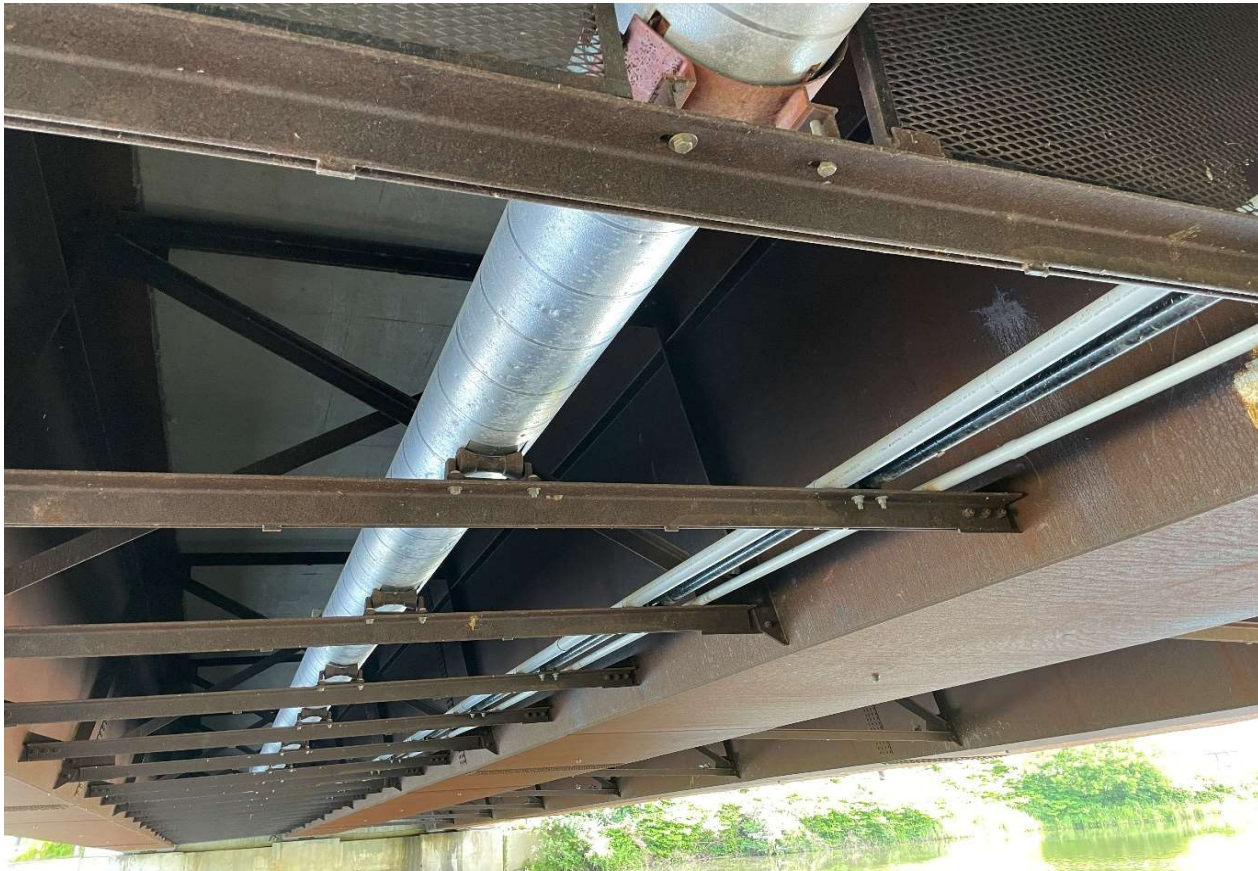
<b>Element Data:</b>						
Element Group:	Accessories		Length:			
Element Name:	Utilities		Width:			
Location:			Height:			
Material:			Count:	6		
Element Type:	Various		Total Quantity:	6		
Environment:			Inspected	Yes <input type="checkbox"/>	No <input type="checkbox"/>	limited <input checked="" type="checkbox"/>
Protection System:						Performance Deficiencies
Condition Data:	Units	Excellent	Good	Fair	Poor*	
	each		6			
Comments: Limited inspection due to access. There is gas line supported along the north face of the bridge, insulated pipe (likely a watermain) under the north interior soffit, electrical and bell also appear to be supported under the north interior soffit. There are some punctures in the watermain insulation protective covering. Electrical lines are also supported along both ballast walls. The drawings indicate that there could also be hydro ducts within the sidewalks. Electrical box at northwest quadrant has a damaged latch and can be opened.

**Description of Photo:** Utilities

Recommended Work:		Rehab: <input type="checkbox"/>	Replace: <input type="checkbox"/>	Maintenance Needs:		18 - Other Maintenance
Urgent: <input type="checkbox"/>	1-5 Years: <input type="checkbox"/>	6-10 Years: <input type="checkbox"/>	None: <input checked="" type="checkbox"/>	Urgent: <input type="checkbox"/>	1 Year: <input checked="" type="checkbox"/>	2 Year: <input type="checkbox"/>
				Replace latch and ensure electrical box can be closed and locked.

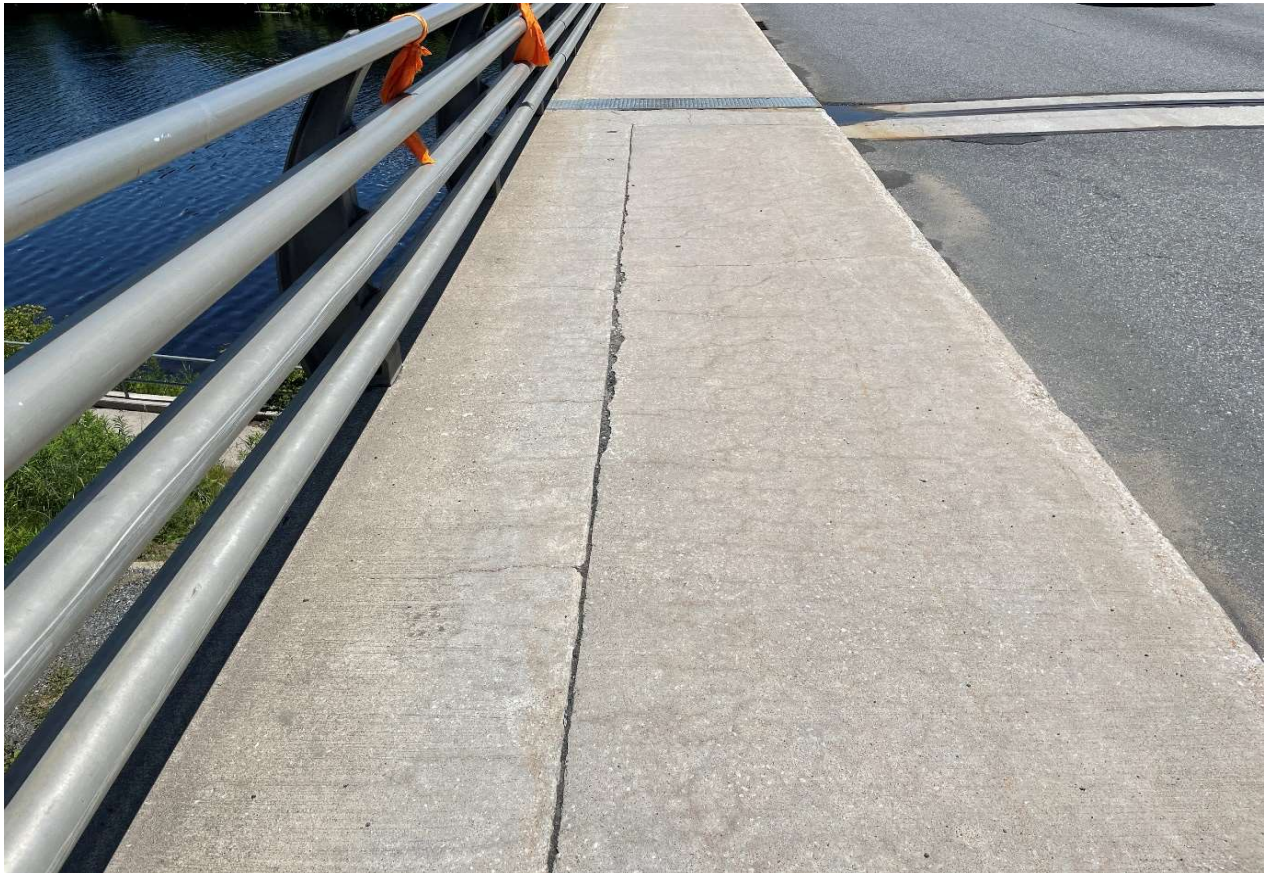
Comments: Light scaling, typical. 4 medium 200x200x 25mm spalls on northeast approach. 200x200x25mm medium spall, 4.5m of medium cracks and 2 - 400 x 400mm spalls on southeast approach. 7.5 of medium cracks on southwest approach. 3.0m of medium cracks and 2.0x 50mm medium spall on northwest approach. 300mm of narrow cracking at the edge of wingwalls.

**Description of Photo:** Approach Sidewalk

Justification:
Interior girder ends recommended to be cleaned and re-coated to mitigate continued corrosion. The approach guide rail connections to the bridge should be replaced with standard connections. The sidewalk concrete should be repaired to prevent tripping hazard to pedestrians and to maintain its safe use.
