Parry Sound Harbour, Ontario

Bay St. Wharf (#401)
Condition Assessment Report

Small Craft Harbours, Fisheries and Oceans Canada

March 2024

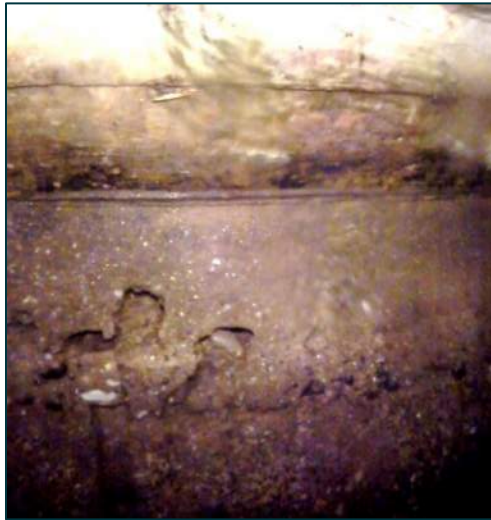
Table 2. Findings from Coring Concrete Deck at Structure D

Location: STA 0+129.7
Transverse Distance to Nearest Edge: 1.65 m to East
Concrete Deck Thickness: ± 508 mm
Fill Level to Top of Concrete: ± 1.5 m
Observations: Severe void due to deteriorating concrete on parapet.

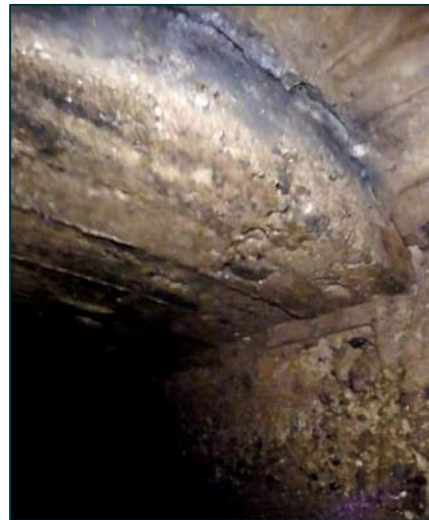
Location: STA 0+198.6
Transverse Distance to Nearest Edge: 1.59 m to West
Concrete Deck Thickness: ± 508 mm
Fill Level to Top of Concrete: ± 2.2 m
Observations: Underside of south corner of buried slipway at 0+200.

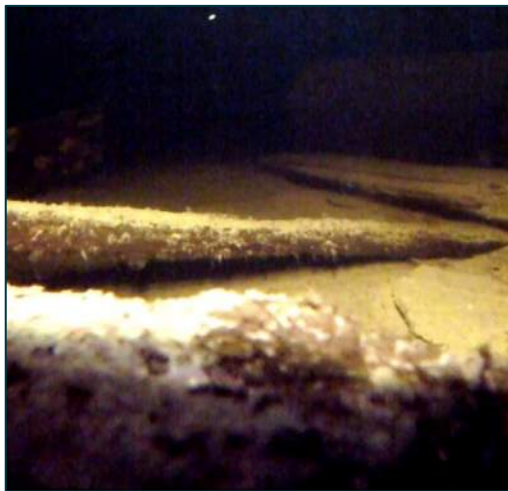
Location: STA 0+228.6
Transverse Distance to Nearest Edge: 3.04 m to West
Concrete Deck Thickness: ± 508 mm
Fill Level to Top of Concrete: ± 2.2 m
Observations: Unidentified timber debris above fill.

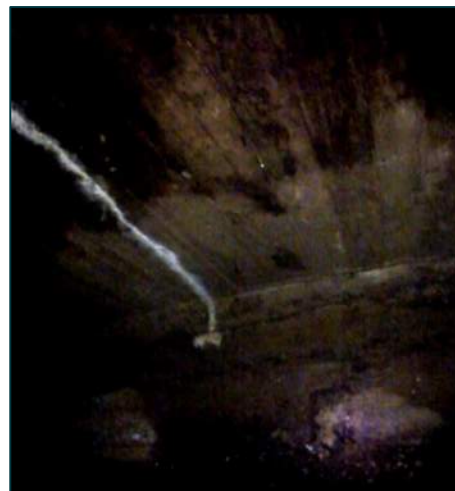
Location: STA 0+248.2
Transverse Distance to Nearest Edge: 2.31 m to East
Concrete Deck Thickness: ± 508 mm
Fill Level to Top of Concrete: ± 2.2 m
Observations: Efflorescence, underside of medium crack at 0+251.

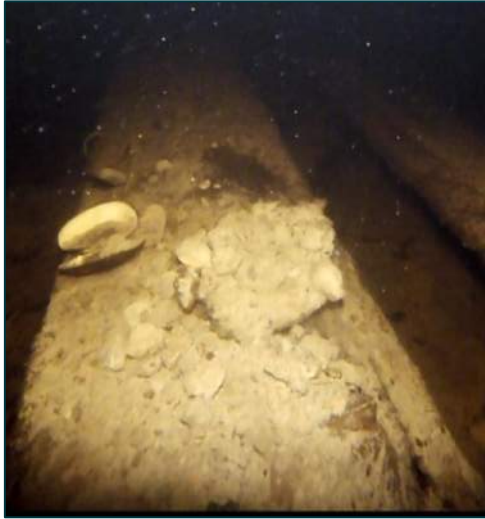
Location: STA 0+258.5
Transverse Distance to Nearest Edge: 2.71 m to West
Concrete Deck Thickness: ± 508 mm
Fill Level to Top of Concrete: ± 2.4 m
Observations: Top of Pile Cap.

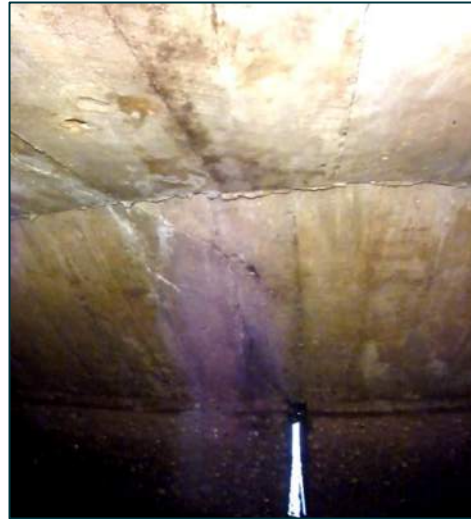
Location: STA 0+261.7
Transverse Distance to Nearest Edge: 2.31 m to West
Concrete Deck Thickness: ± 508 mm
Fill Level to Top of Concrete: ± 2.4 m
Observations: Very wide crack at 0+271 noted in above water inspection. Visibility here indicates crack penetrates all the way through the concrete deck

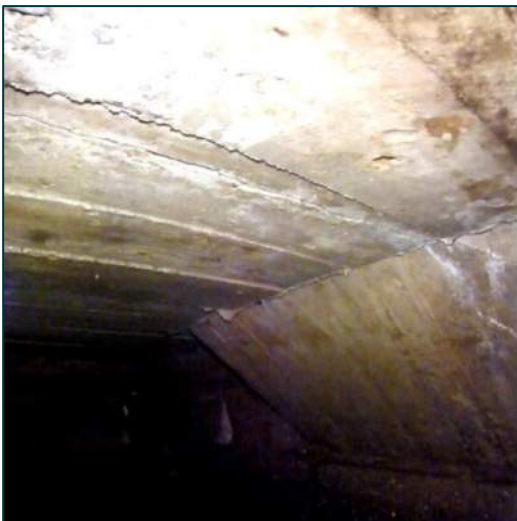
Location: STA 0+261.7
Transverse Distance to Nearest Edge: 2.31 m to West
Concrete Deck Thickness: ± 508 mm
Fill Level to Top of Concrete: ± 2.4 m
Observations: Very wide crack at 0+271 noted in above water inspection. Also visible is the transition in haunch dimensions from stairs to copewall.

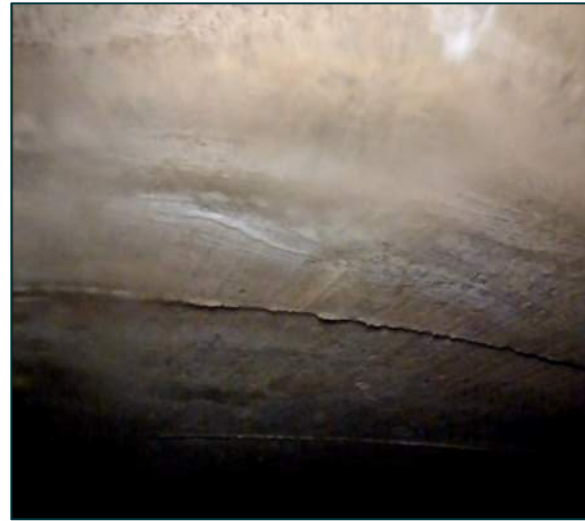
Location: STA 0+263.4
Transverse Distance to Nearest Edge: 2.44 m to West
Concrete Deck Thickness: ± 508 mm
Fill Level to Top of Concrete: ± 2.2 m
Observations: Underside of deck, typical.

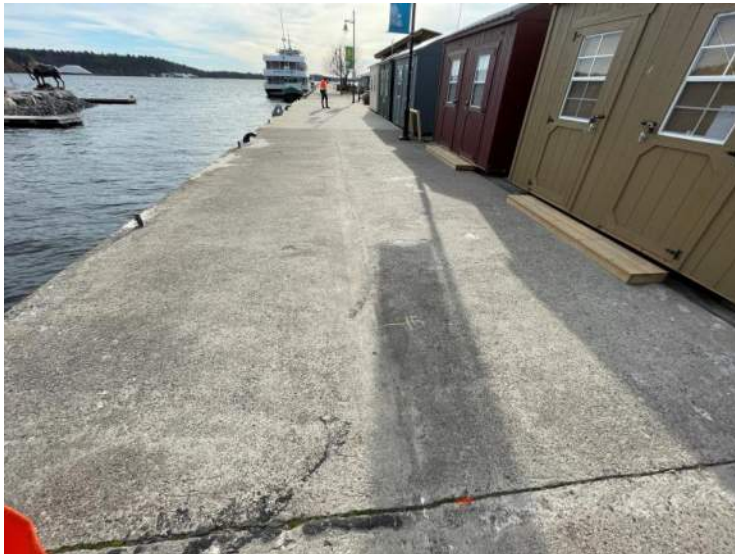
The first section of the Bay St. Wharf, identified as STA 0+000 to 0+013.7, measured approximately 6.06 m in width. The concrete deck at this location was found to be in fair condition. General observations noted light-to-medium scaling, efflorescence-stained cracking and delaminations on the concrete edge. A large area of narrow map cracking was found near STA 0+000, along with a severe spall at the eastern edge. A medium-to-wide transverse crack running approximately 75% the width of the deck was observed further along the section. Between STA 0+005 to 0+010, a large patch area with hairline map cracking was observed. A large, patched area was observed around the small bollard located between STA 0+010 to 0+013.7. Vegetation growth was noted at the control joint at STA 0+013.7.

3- Structure A – Concrete Deck

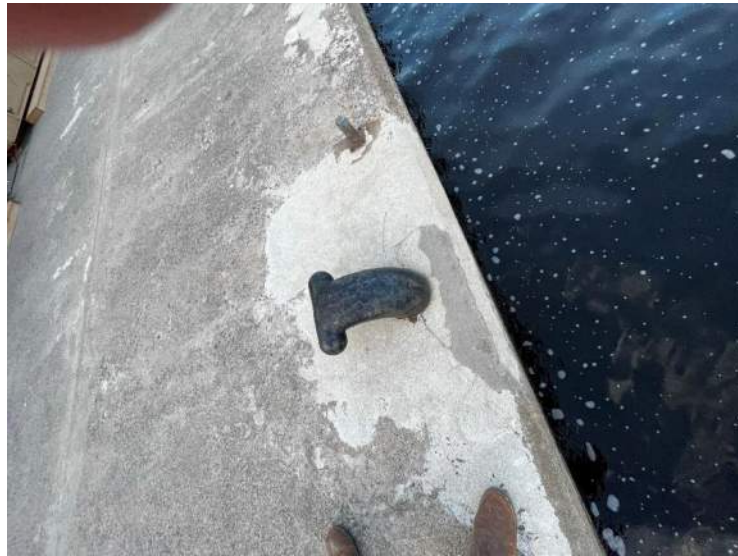
Within STA 0+013.7 to 0+025, localized patch locations were identified including a large patch around the bollard at STA 0+023. Two narrow to medium cracks were noted around STA 0+020, with some patchwork on each.

4- Structure B – East Bollard, Stn 0+023

5- Structure B – East Bollard, Stn 0+023

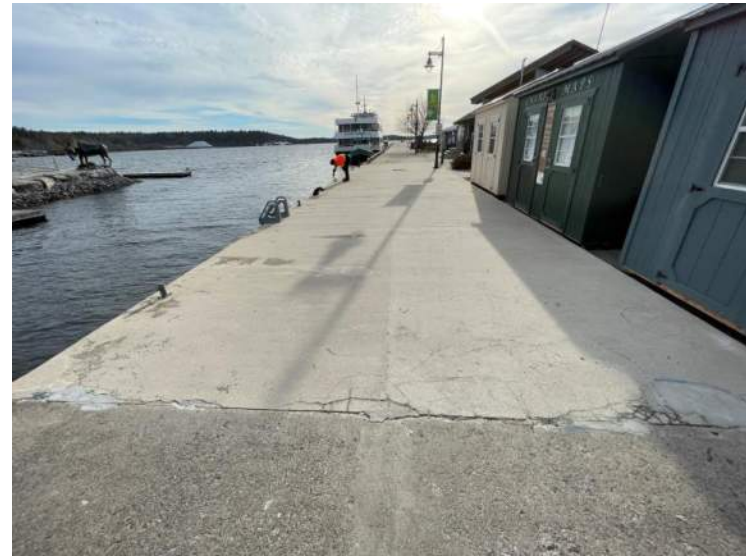
6- Structure B – Newer Concrete Deck Transition, Stn 0+026

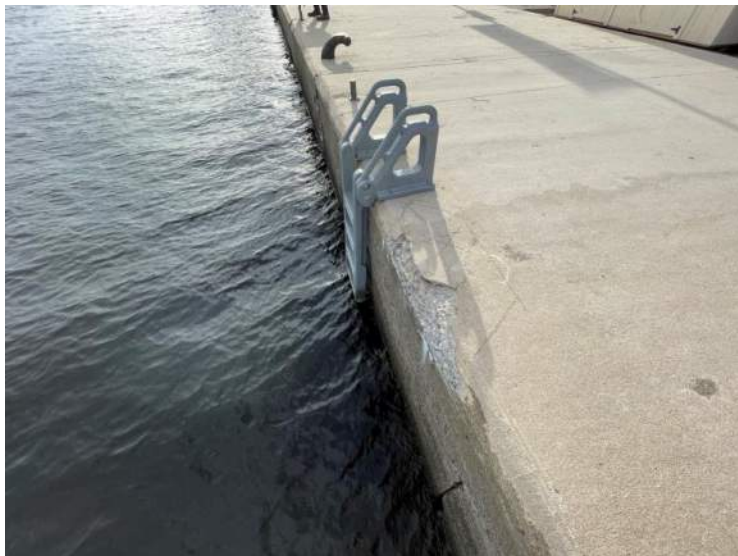
7- Structure B – Plastic Ladder and Delamination, Stn 0+32

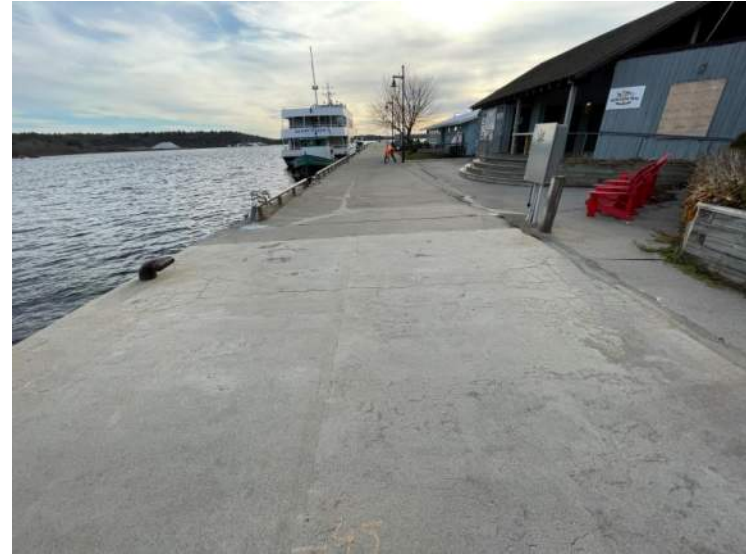
10- Structure B – Map Cracking at Concrete Deck, Stn 0+045

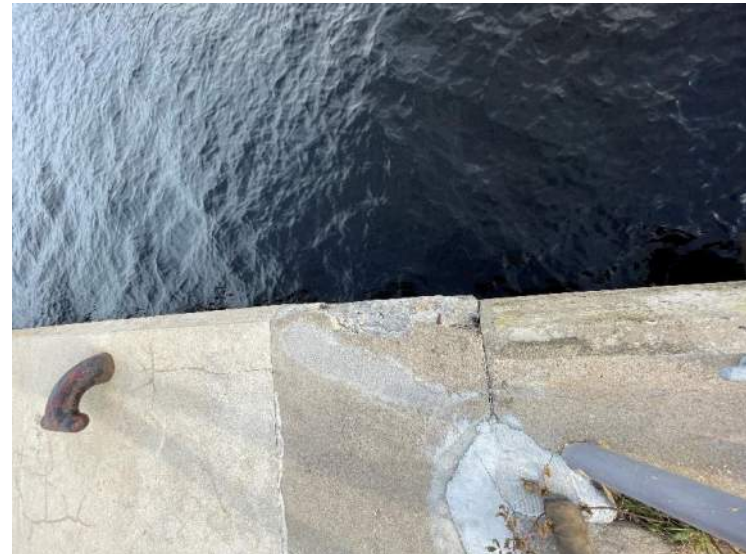
12- Structure B – Spall and Patch at Transition, Stn 0+048.3

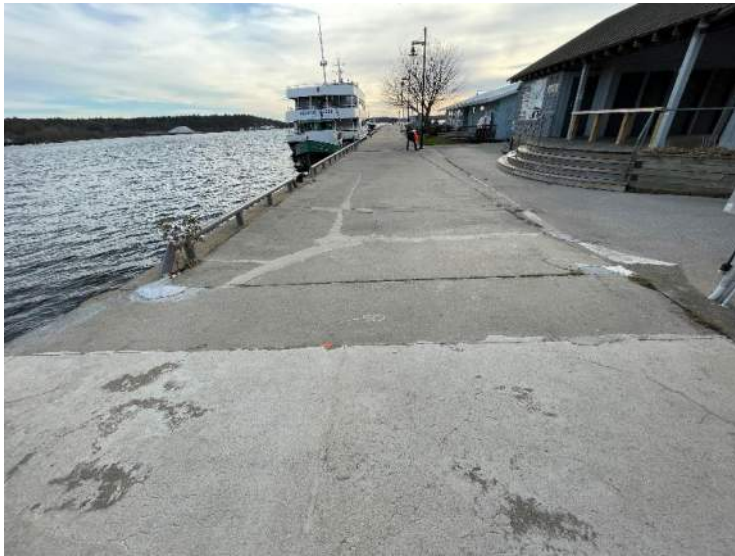
13- Structure C – Settled Area, Stn 0+048.3 to 0+069

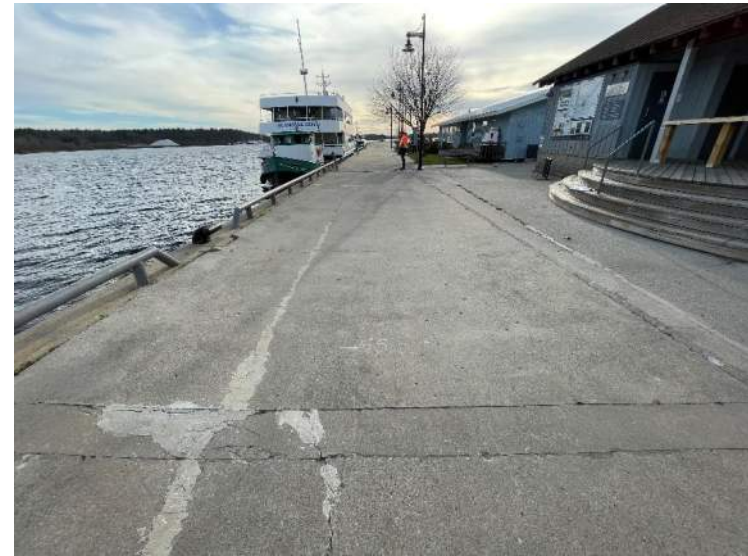
14- Structure C – Longitudinal Crack extending past Settlement

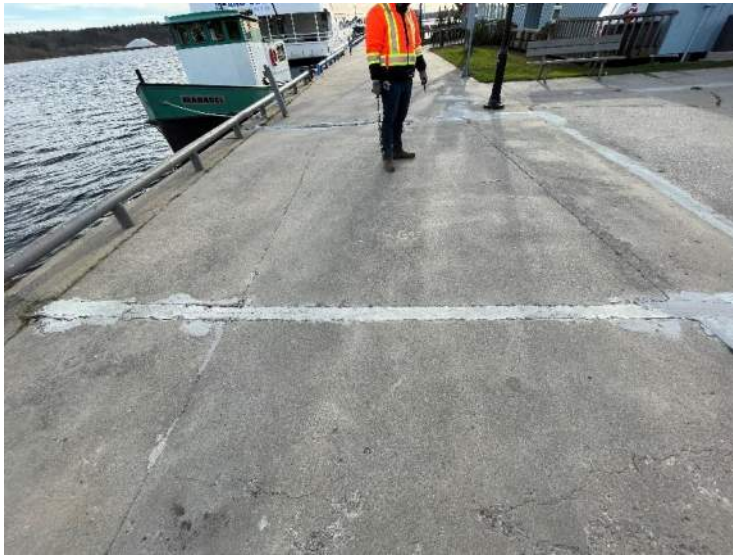
17- Structure C – Buried Conduit, Stn 0+064

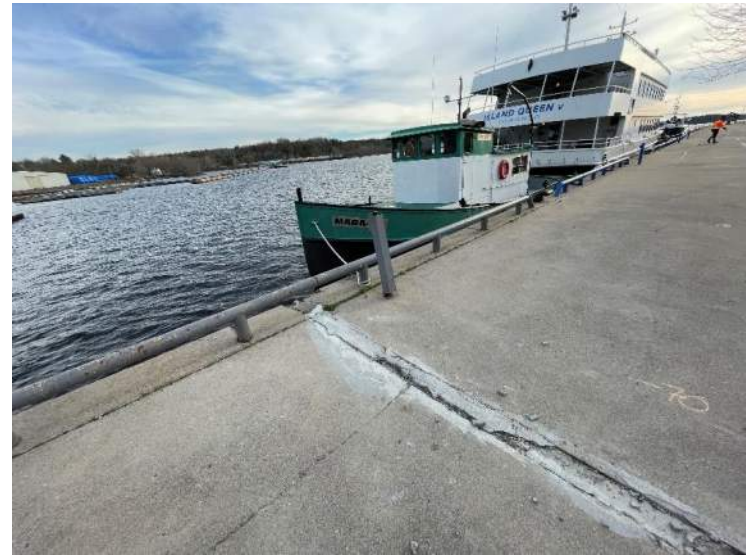
18- Structure C – Buried Conduit, Stn 0+069

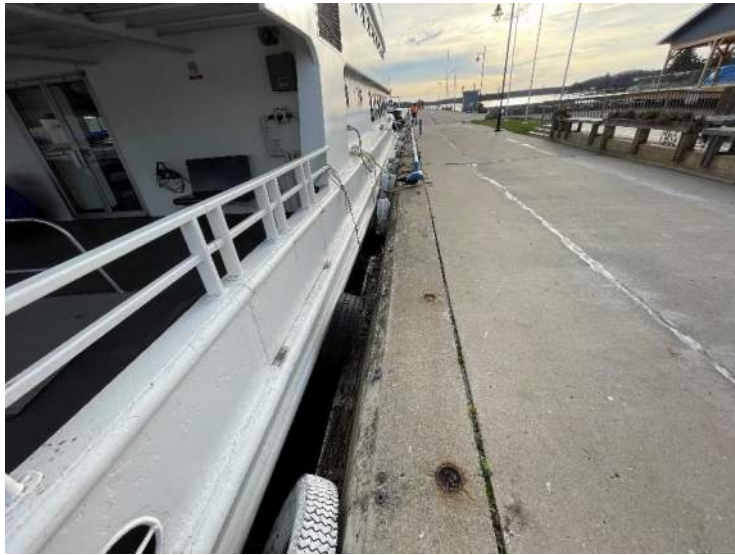
Curb rail was noted along the east and south side of the wharf, but not along the west side. In addition, the curb rail was observed to be cut and deformed in some areas.

25- Structure C – Removed Curb Railing, Stn 0+087 to 0+093

- Install curb rail for enhanced safety.
- Dredge lakebed locally at outfall.
- Localized concrete repair of cope wall.
- Encapsulate Structure B with Steel Sheet Pile.

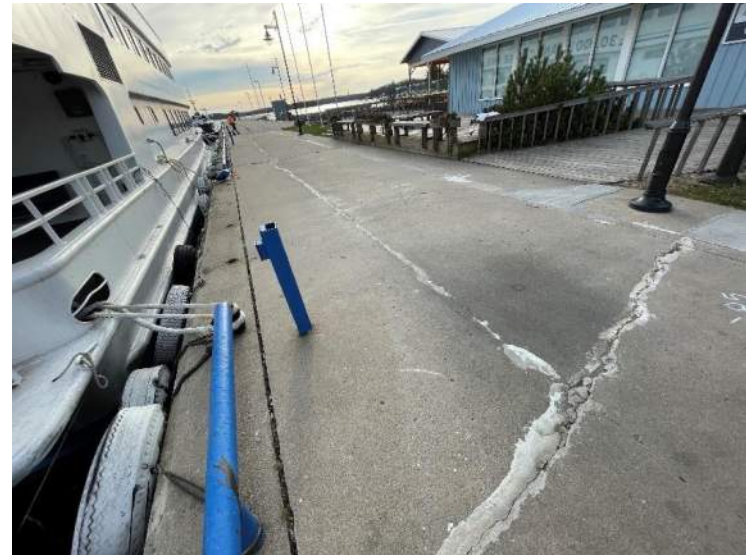
26- Structure C – Settled Area, Stn 0+085 to 0+117.8

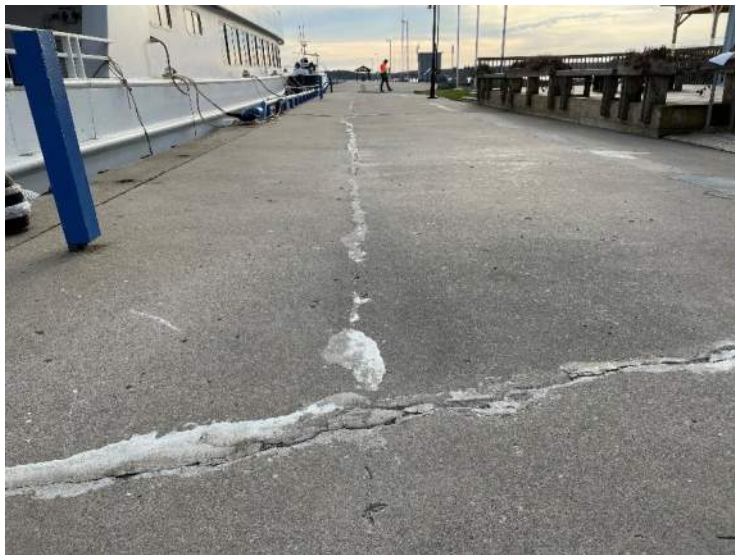
27- Structure C – Settled Area, Stn 0+085 to 0+117.8

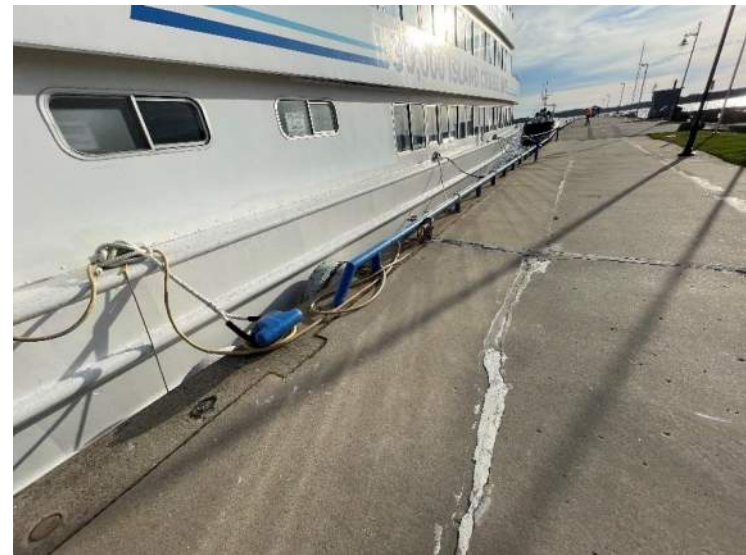
28- Structure C – Settled Area, Stn 0+095

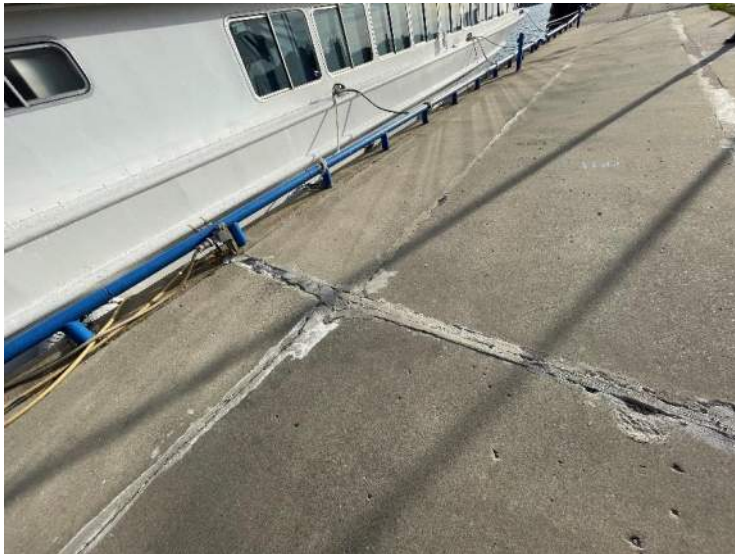
31- Structure C – Delamination over Buried Conduit, Stn 0+097

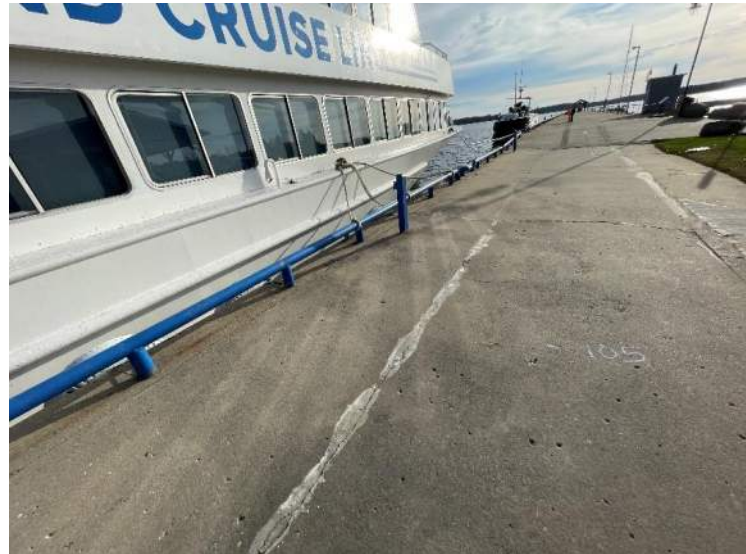
32- Structure C – Longitudinal Crack from Settlement, Stn 0+105

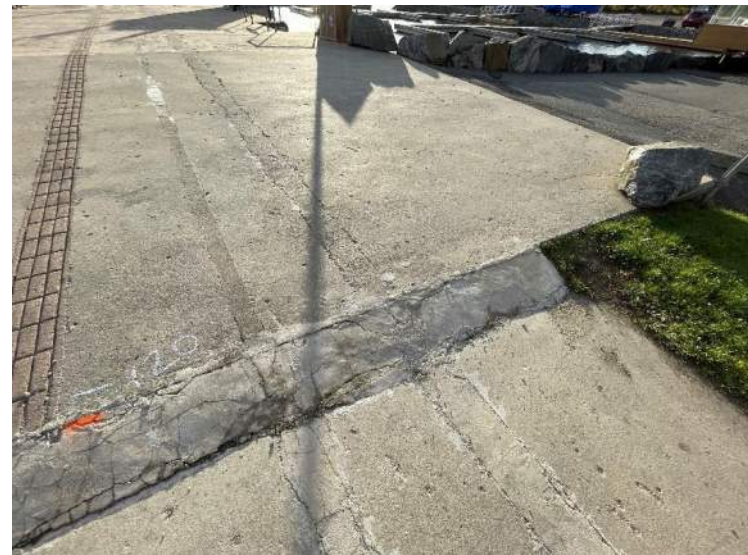
36- Structure C – Delamination at Transition to Structure D

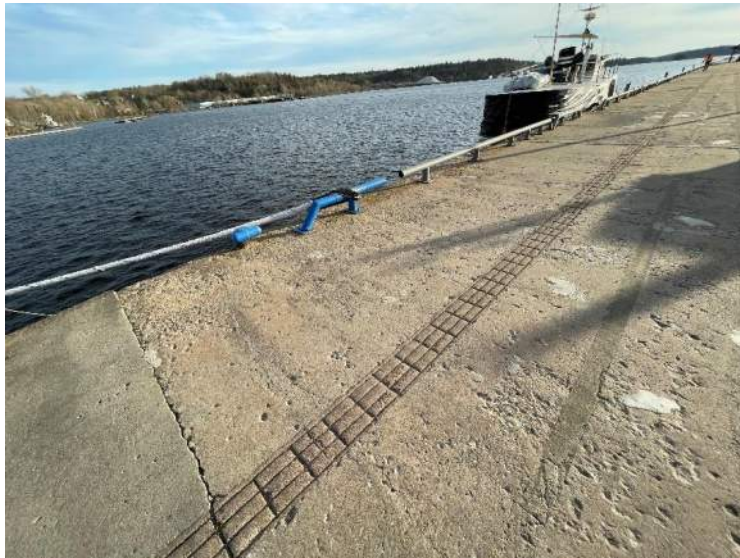
41- Structure D – Section of Curb Rail removed, Stn 0+131

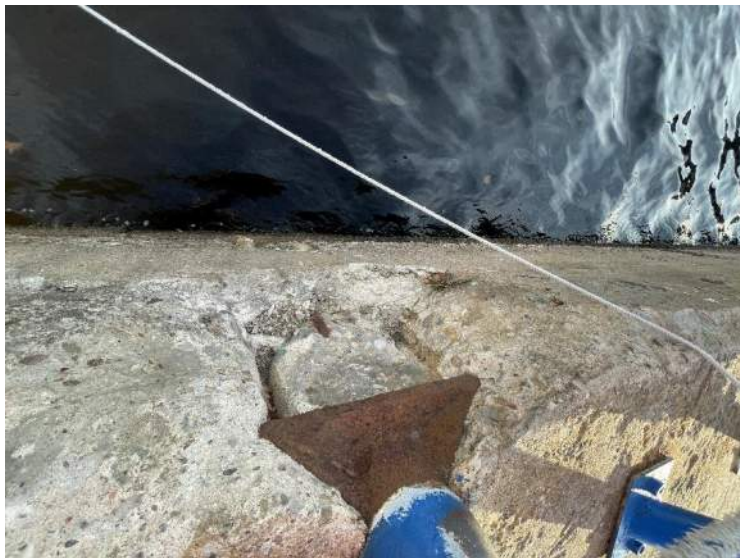
43- Structure D – East Face Bollard condition, Stn 0+129

- Restrict mooring at Structure D to vessels that are no larger than the Island Queen V, as governed by bollard capacity.
- Restrict berthing at Structure D to a fendering force of 200 kN.
- Reconstruct sections of deck around bollards, install fully developed 20M edge reinforcing and weld anchors to bollard plates to increase bollard capacity..
- Repair concrete stairs and existing railing guards, as well as installation of a handrail on both sides of each stairway.
- Monitor crack at south end of Structure D.
- Install proper fenders for vessels.
- Encapsulate Structure D with Steel Sheet Pile.

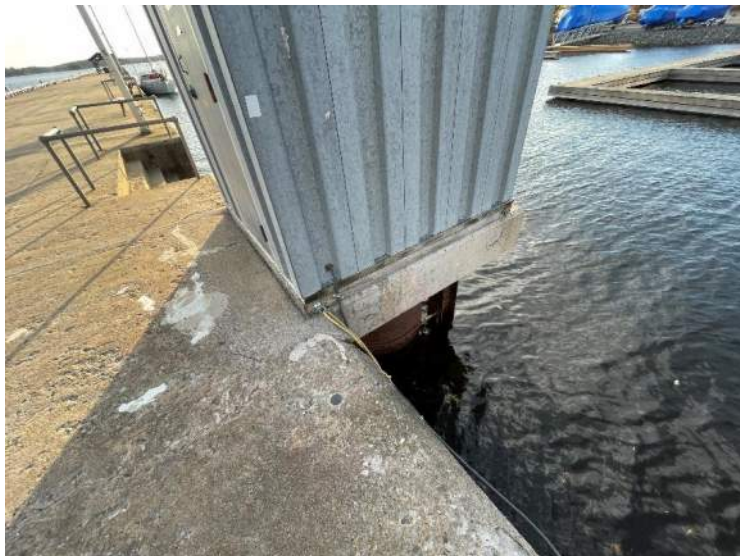
One of the "I" beams at the water level gauge station was observed to have significant section loss and pitting and may require some additional investigation and repair.

51- Structure D – Water Gage Station Slab (North Face), Stn 0+144

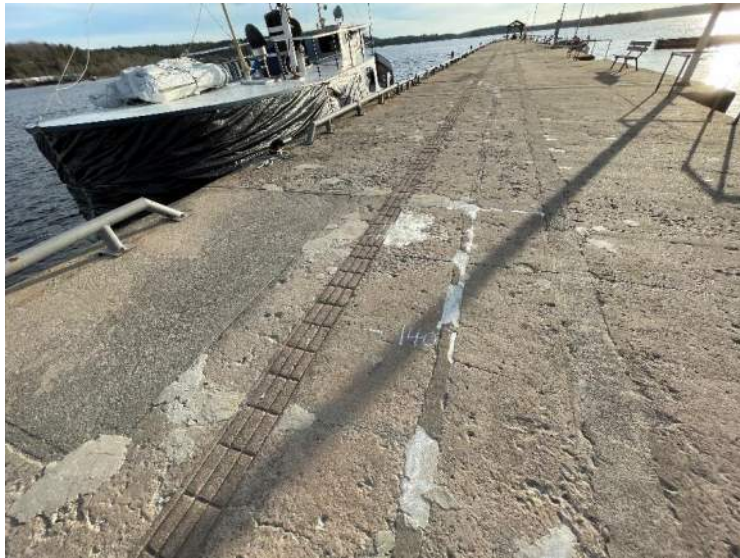
57- Structure D – Buried East Slipway, Stn 0+139 to 0+141

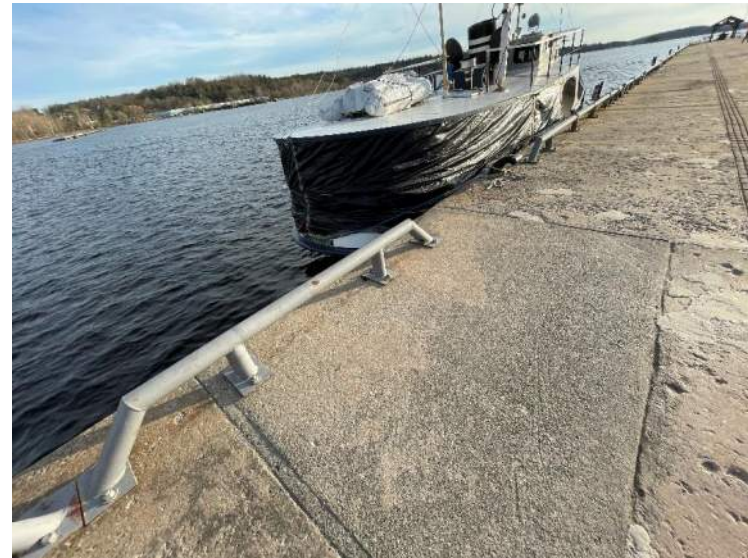
58- Structure D – Buried East Slipway, Stn 0+139 to 0+142

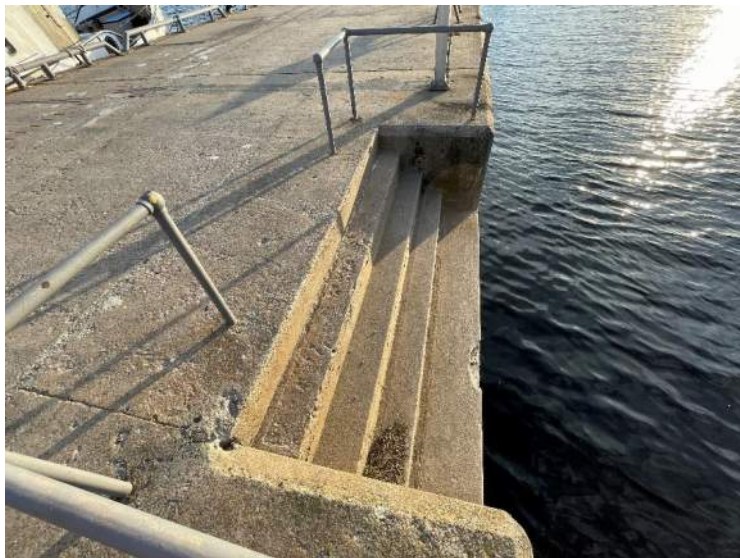
59- Structure D – West Steps (Looking South), Stn 0+146 to 0+150

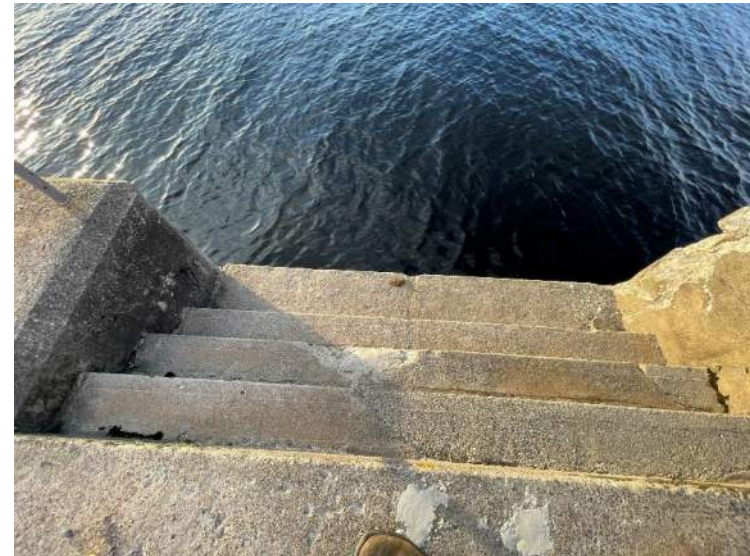
71- Structure D – Bent Railing at West Steps, Stn 0+161 to 0+164

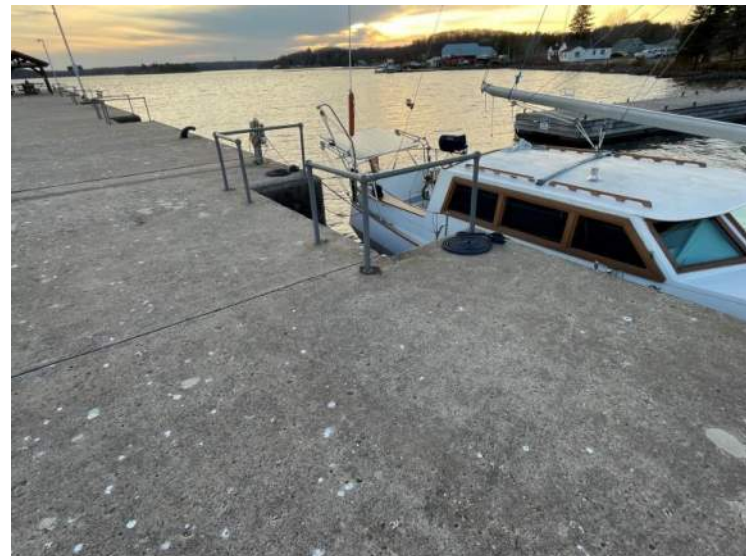
91- Structure D – East Bollard condition, Stn 0+190

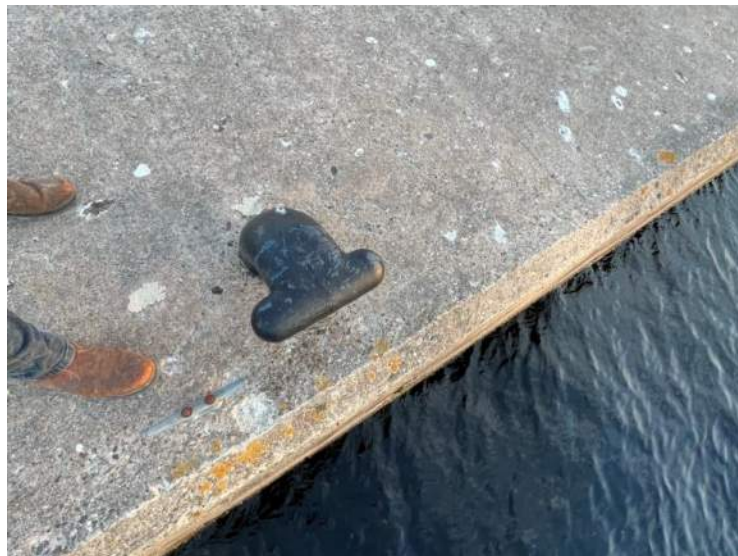
98- Structure D – West Bollard, Stn 0+201

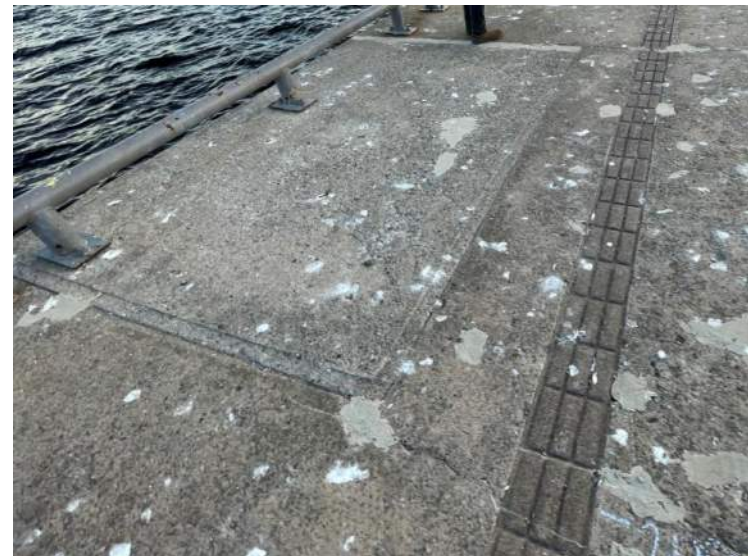
99- Structure D – West Bollard, Stn 0+201

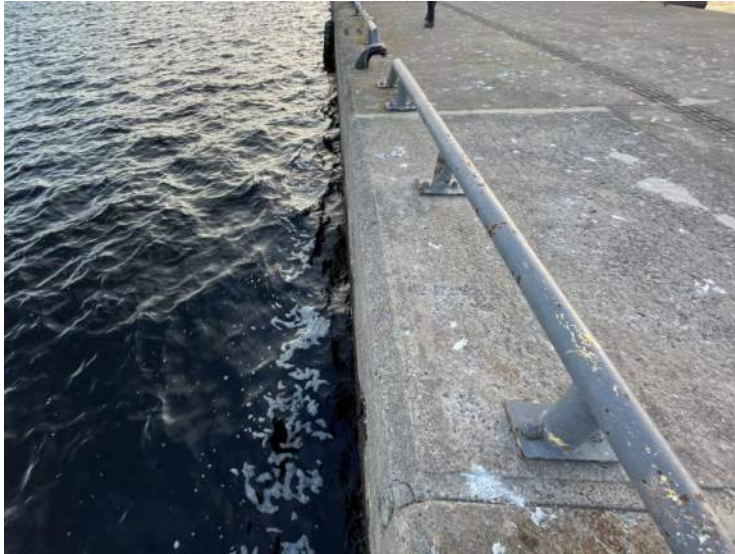
100- Structure D – Buried East Slipway, 0+200 to 0+203

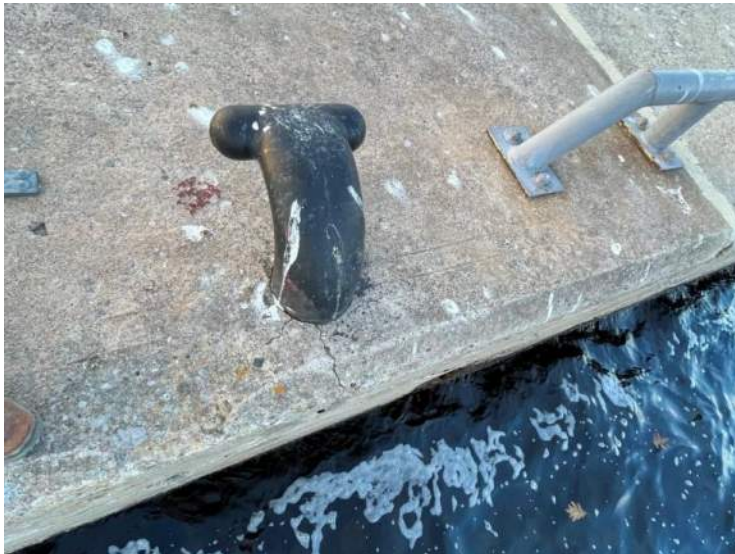
102- Structure D – East Bollard, Stn 0+206

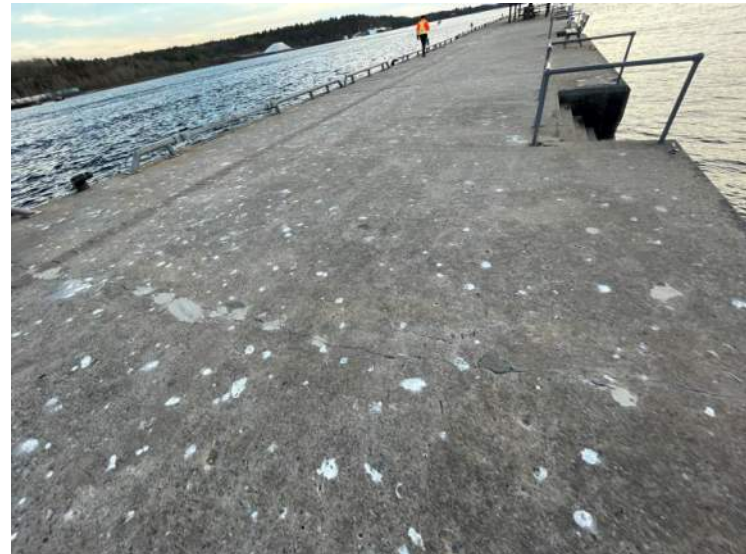
103- Structure D – East Bollard, Stn 0+206

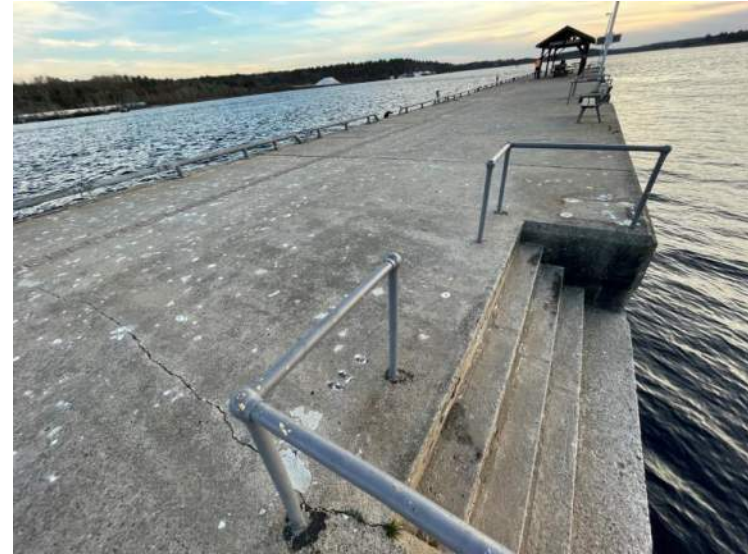
105- Structure D – West Steps, Stn 0+206 to 0+211

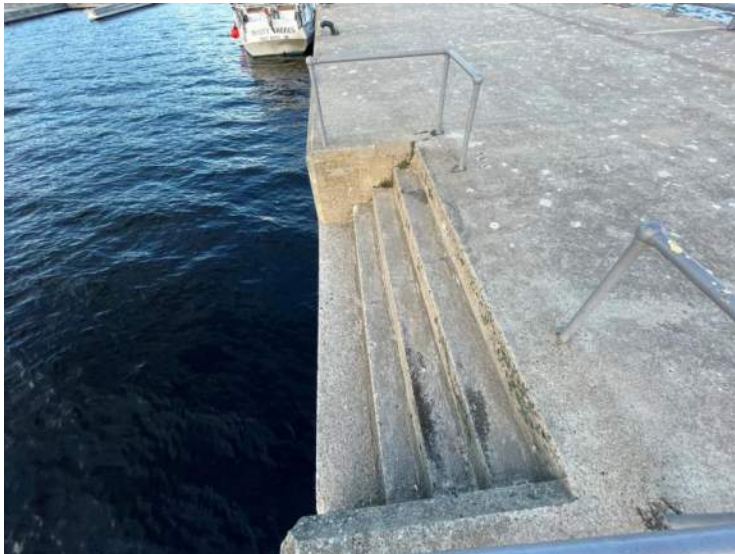
106- Structure D – West Steps (looking South), Stn 0+206 to 0+211

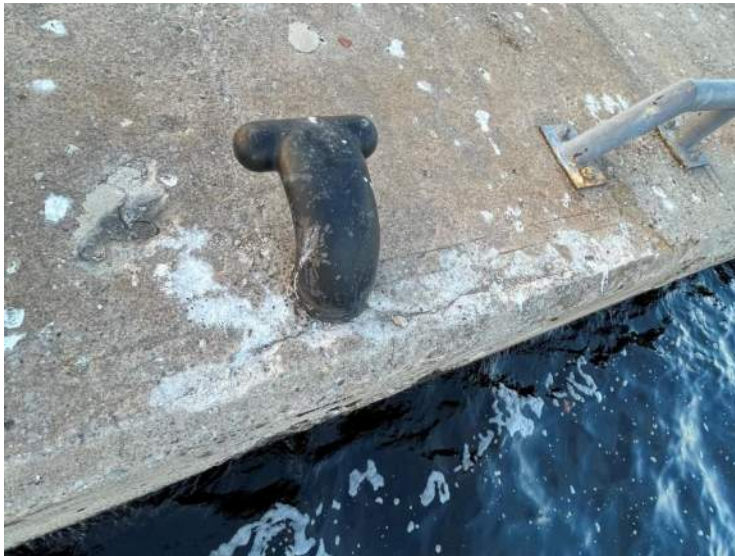
110- Structure D – East Bollard, Stn 0+221

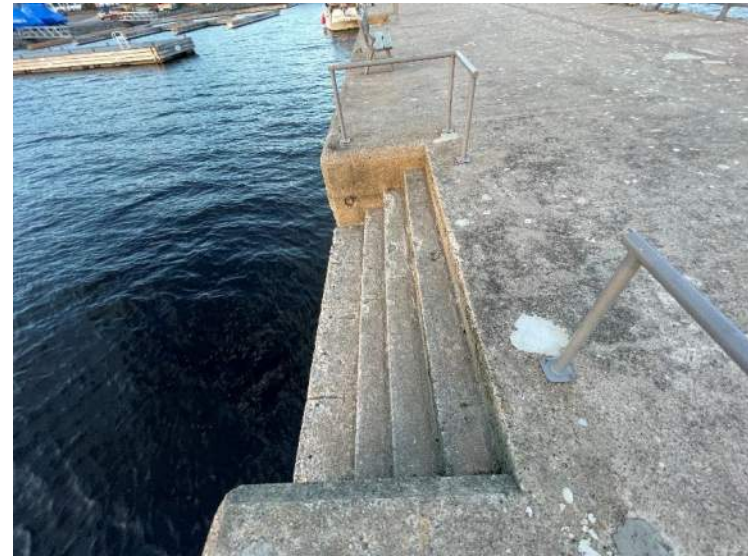
113- Structure D – West Steps (looking South), Stn 0+222 to 0+226

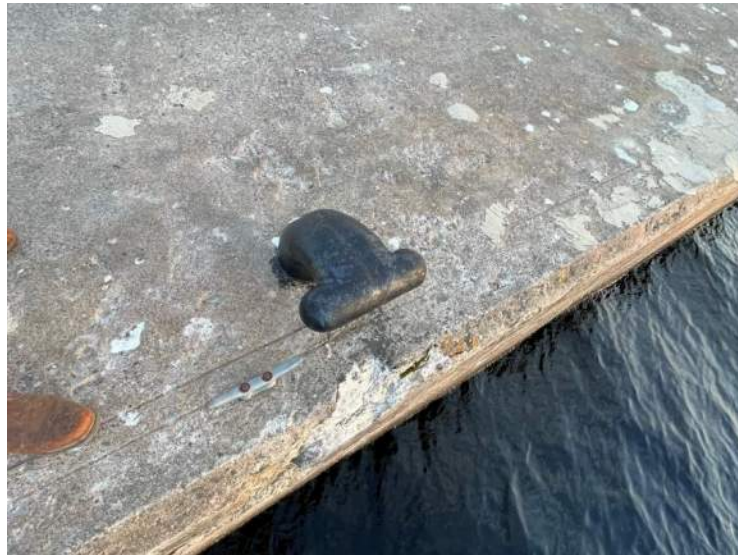
116- Structure D – West Bollard, Stn 0+232

The deterioration of the copewall face on the east side is the worst at the location of the tie up bollards (see Photographs 115-116, 122, 128-131, 141 to 148, 154-155, 160 and 163 in the above water photographs). The bollard concrete appears to have been stressed and is heavily cracked and spalled.

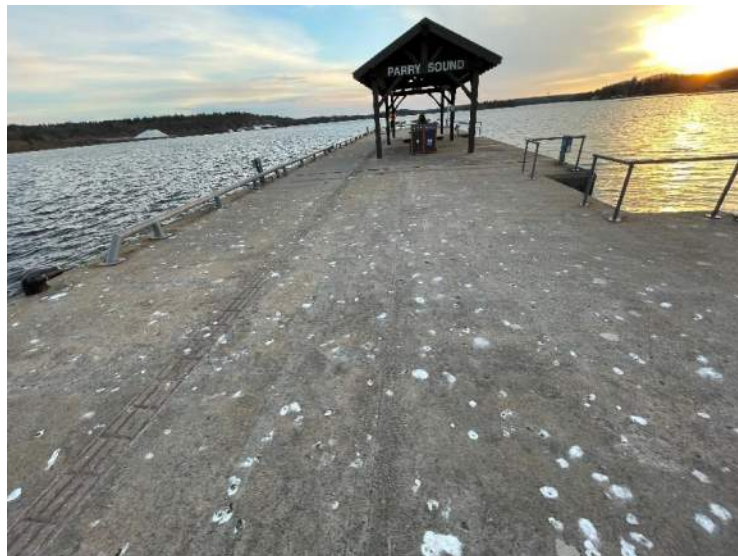
118- Structure D – Severe Delamination at West Edge, Stn 0+235

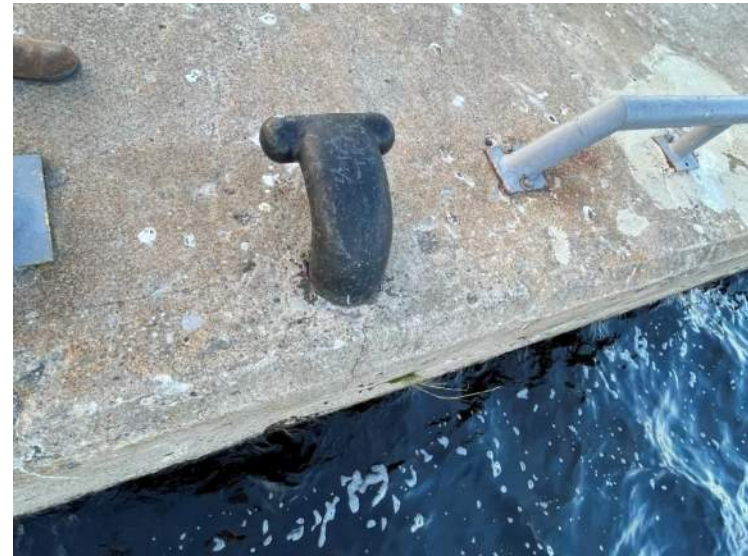
121- Structure D – East Bollard, Stn 0+236

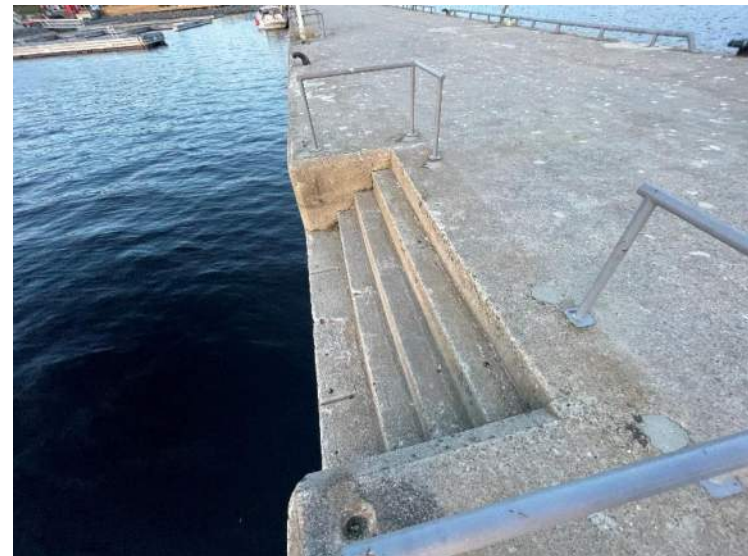
123- Structure D – West Steps (looking South), Stn 0+238 to 0+242

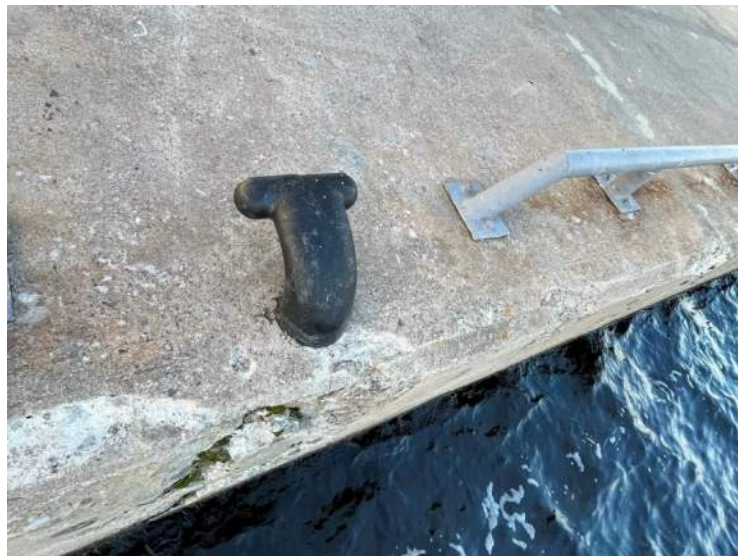
126- Structure D – East Bollard, Stn 0+251

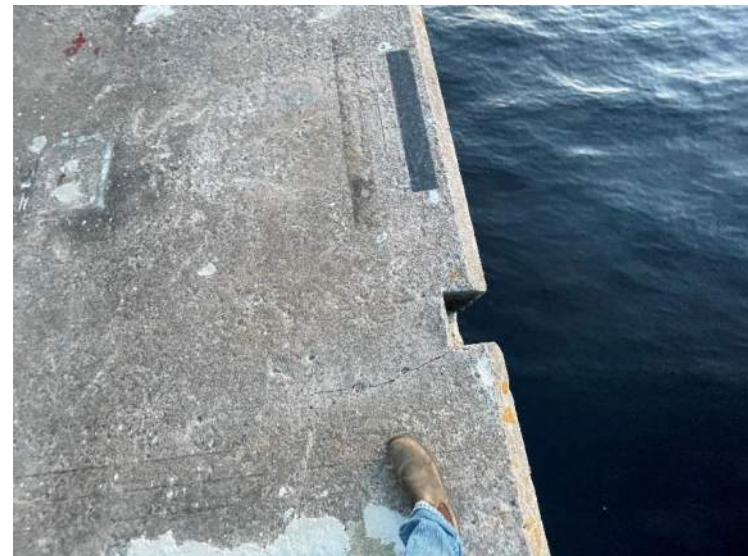
127- Structure D – East Bollard, Stn 0+251

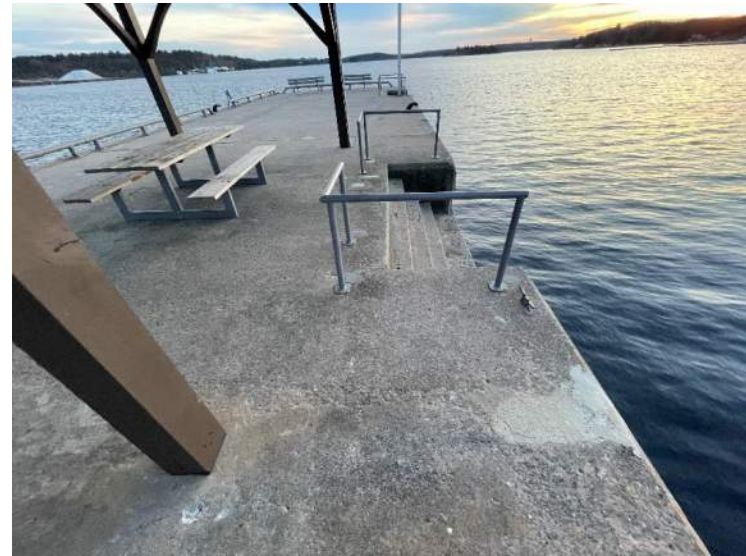
129- Structure D – Concrete Deck, Stn 0+250

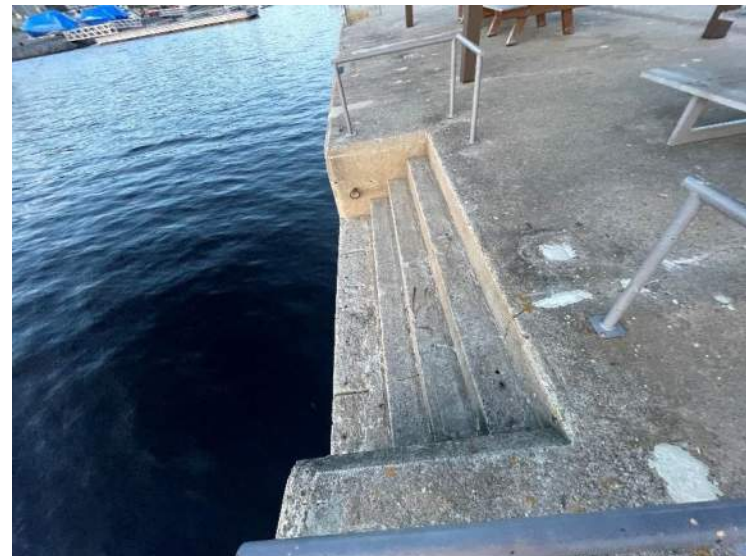
131- Structure D – West Steps (looking South), Stn 0+254 to 0+256

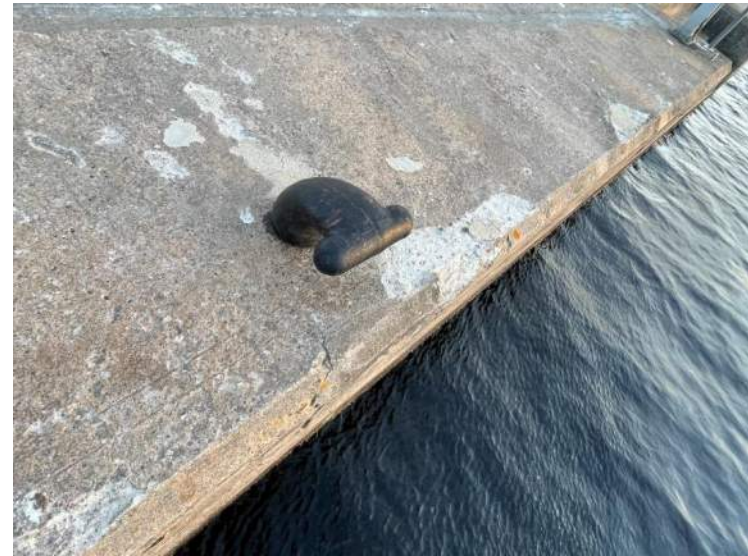
133- Structure D – Severe Scaling at West Edge, Stn 0+262

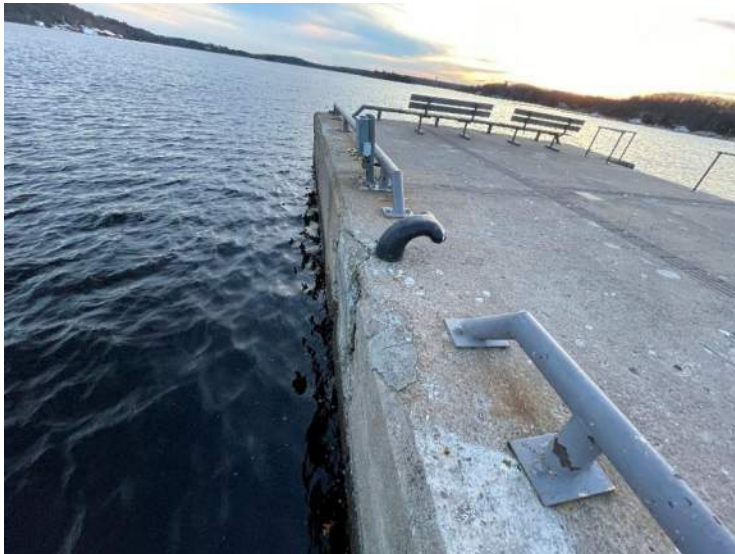
134- Structure D – West Bollard, Stn 0+264

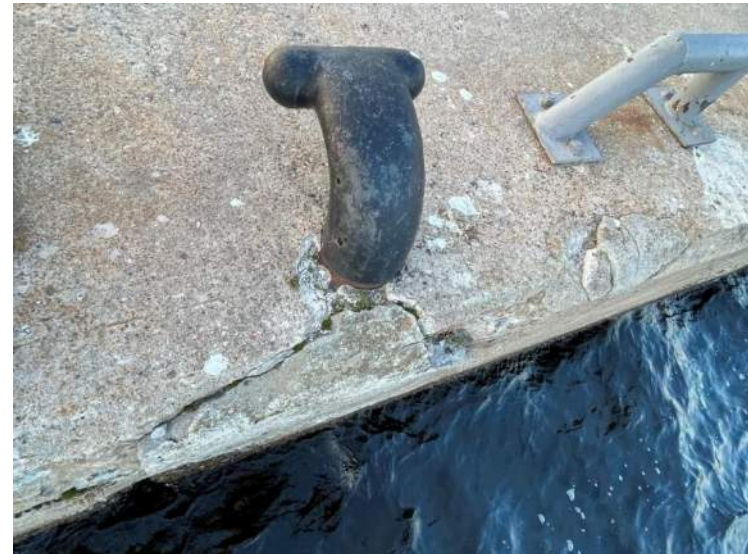
135- Structure D – East Bollard, Stn 0+266

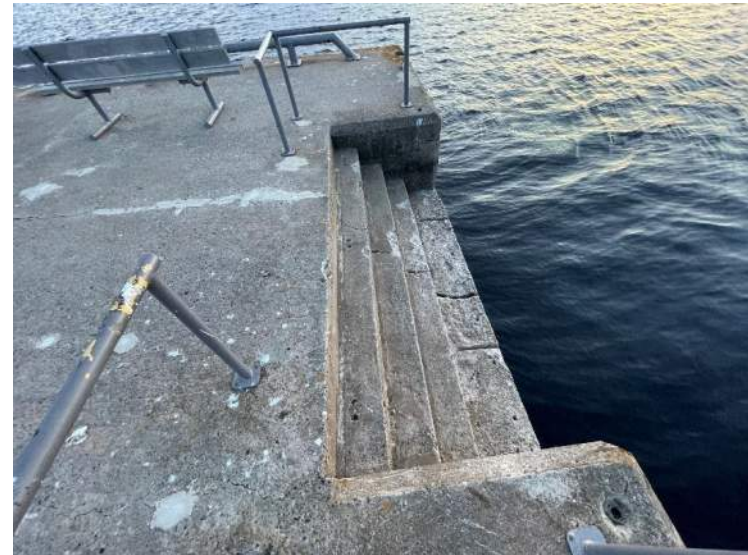
137- Structure D – West Steps, Stn 0+268 to 0+272
