Parry Sound Harbour, Ontario

Bay St. Wharf (#401)
Condition Assessment Report

Small Craft Harbours, Fisheries and Oceans Canada

March 2024

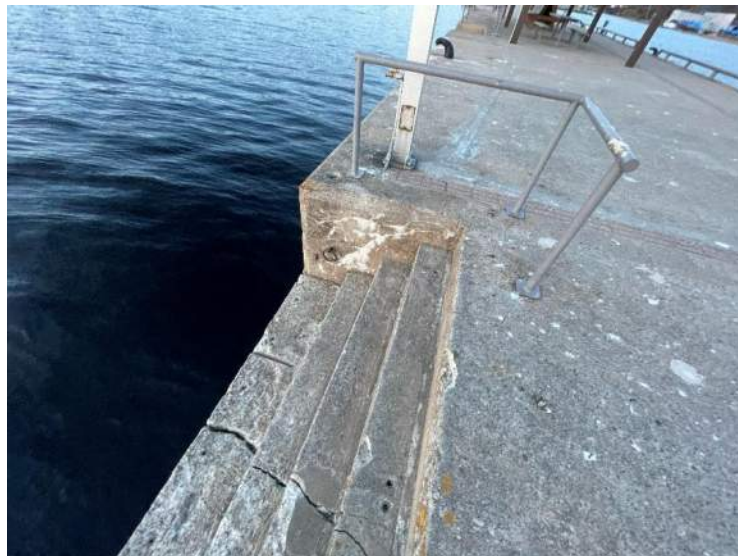
139- Structure D – West Steps (looking North), Stn 0+268 to 0+272

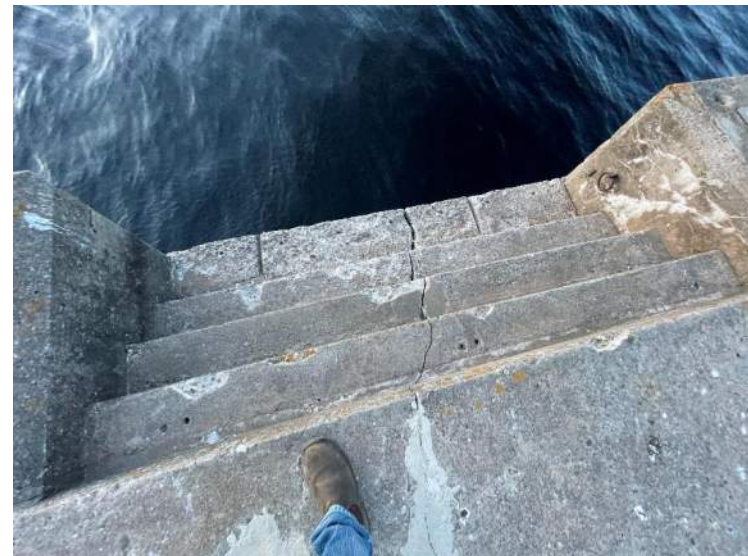
140- Structure D – Wide Crack at West Steps, Stn 0+270

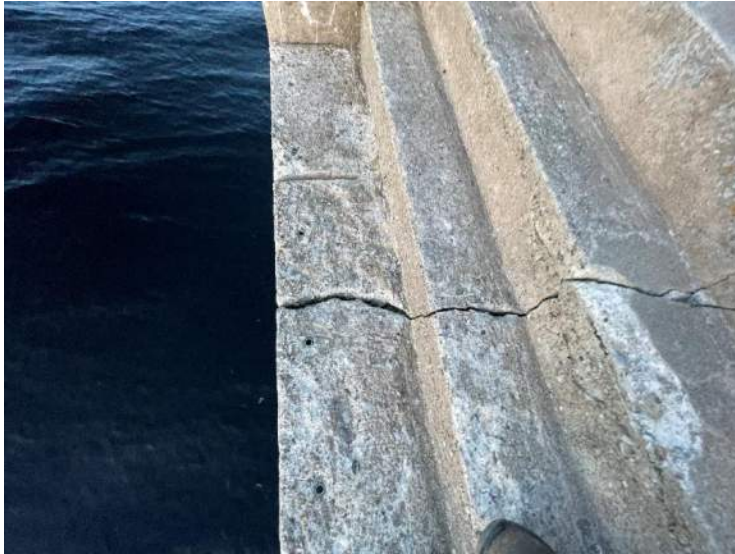
141- Structure D – Wide Crack at West Steps, Stn 0+270

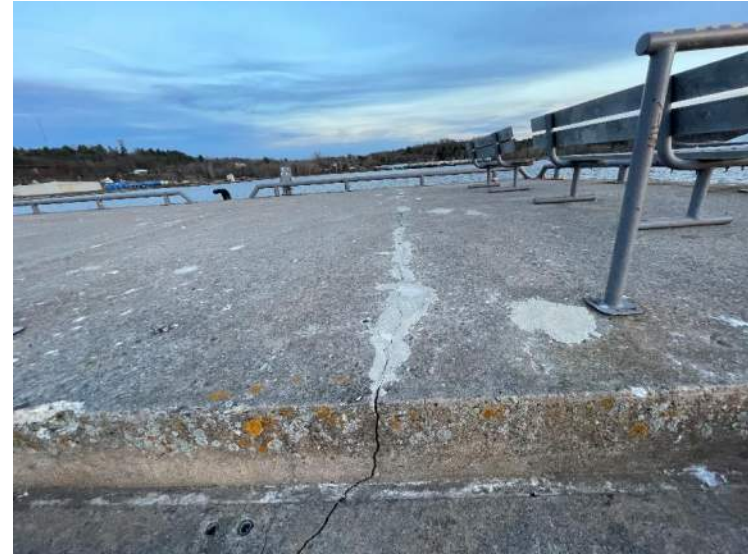
142- Structure D – Crack at West Steps extending East, Stn 0+270

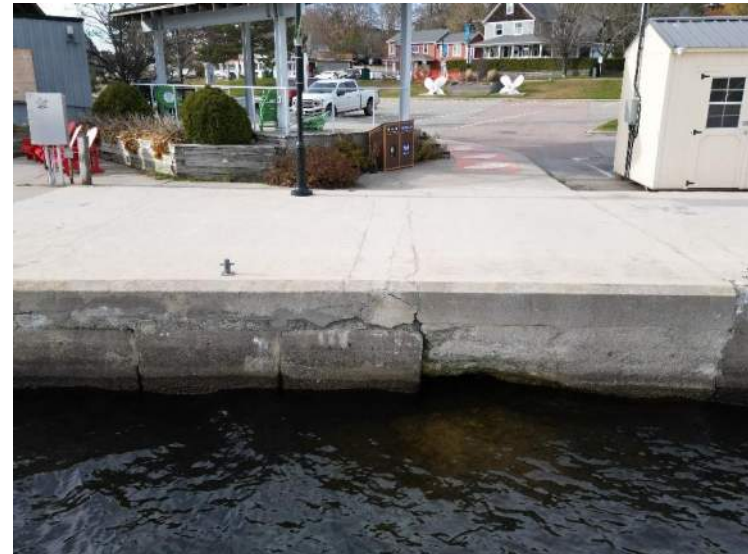
144- Structure B – Fill Washout from Deteriorated Wall, Stn 0+039.5

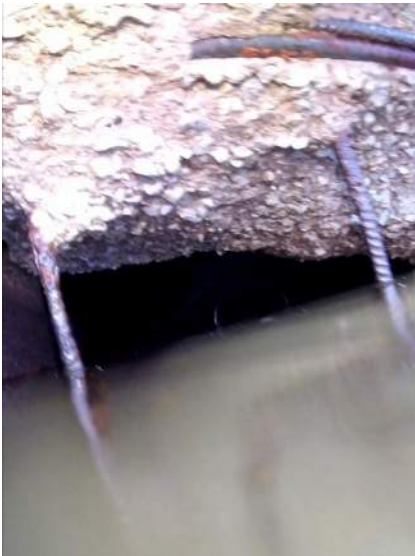
145- Structure B – Closeup of Wall Opening, Exposed Rebar, Stn 0+039.5

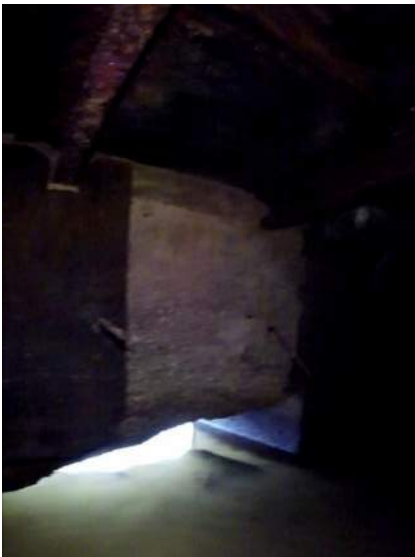
147- Structure B – Wall Opening (view from inside Deck), Stn 0+039.5

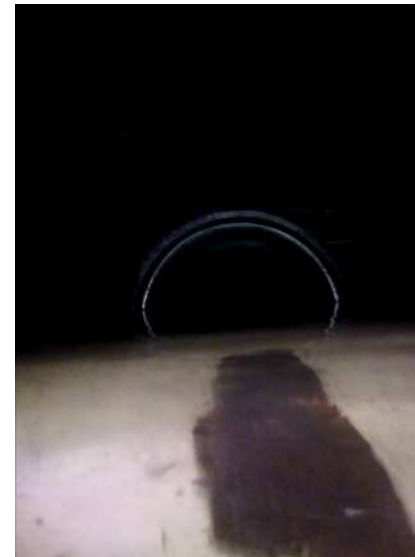
148- Structure B – Culvert Outfall inside Deck, Stn 0+039.5
