Bridge Needs Study 2024

INSPECTION SUMMARY REPORT

Town of Parry Sound

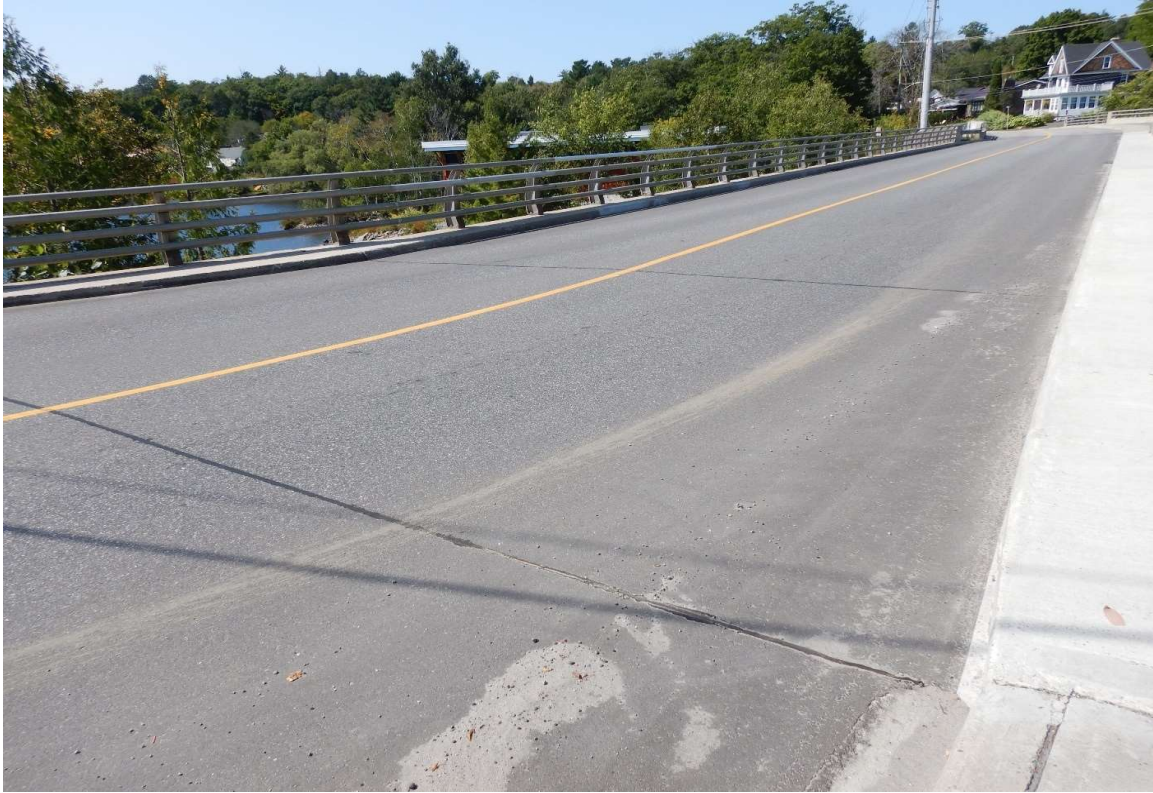
Element Data:						
Element Group:	Decks		Length:	52.8		
Element Name:	Wearing Surface		Width:	8.5		
Location:			Height:	0.1		
Material:	Asphalt		Count:			
Element Type:			Total Quantity:	448.8		
Environment:	Severe		Inspected	Yes <input checked="" type="checkbox"/>	No <input type="checkbox"/>	limited <input type="checkbox"/>
Protection System:						Performance Deficiencies
Condition Data:	Units	Excellent	Good	Fair	Poor*	
	sq.m	448.8				
Comments: No observed defects.						
Recommended Work:		Rehab: <input type="checkbox"/>	Replace: <input type="checkbox"/>	Maintenance Needs:		
Urgent: <input type="checkbox"/>	1-5 Years: <input type="checkbox"/>	6-10 Years: <input type="checkbox"/>	None: <input checked="" type="checkbox"/>	Urgent: <input type="checkbox"/>	1 Year: <input type="checkbox"/>	2 Year: <input type="checkbox"/>
Element Photo:

Description of Photo: Deck Wearing Surface

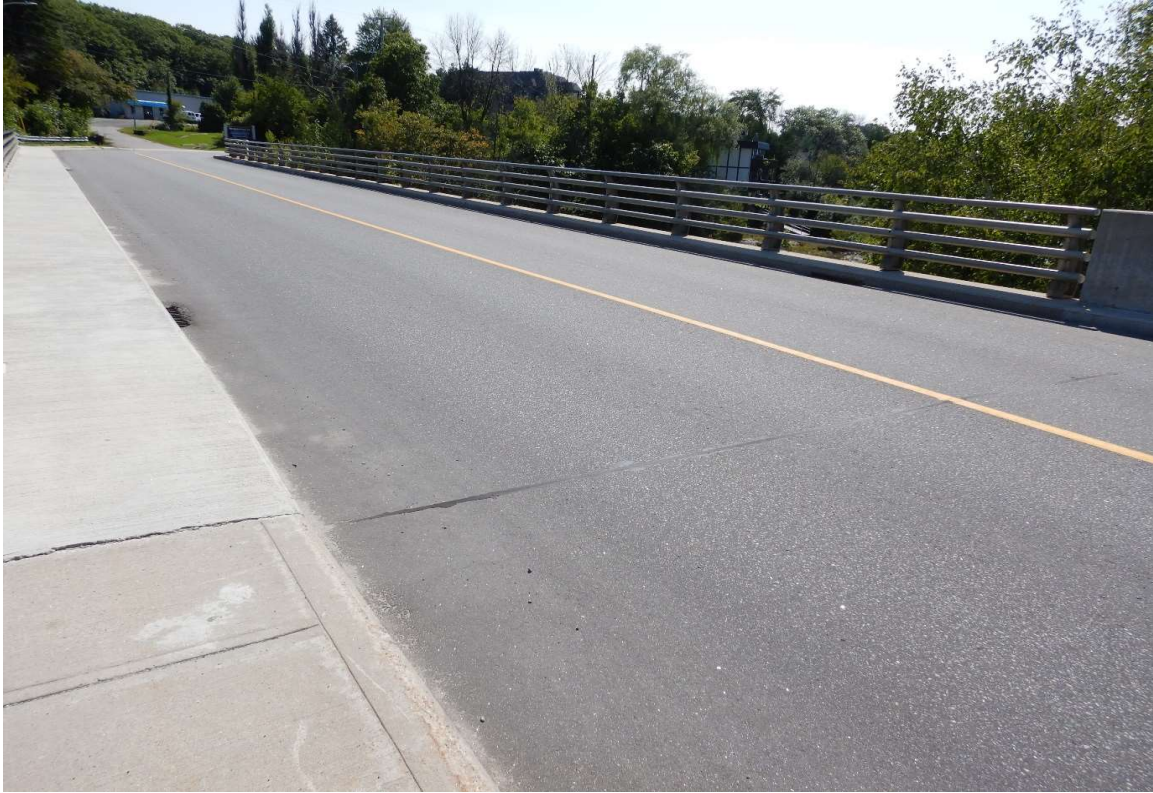
Element Data:						
Element Group:	Decks	Length:	52.8			
Element Name:	Deck Top	Width:	11.2			
Location:		Height:	0.13			
Material:	Concrete	Count:				
Element Type:	Cast-in-Place	Total Quantity:	591.4			
Environment:	Moderate	Inspected	Yes <input checked="" type="checkbox"/>	No <input type="checkbox"/>	limited <input type="checkbox"/>	
Protection System:	Waterproofing and Asphalt					Performance Deficiencies
Condition Data:	Units	Excellent	Good	Fair	Poor*	
	sq.m		591.4			
Comments: Not visible for inspection. Drawings indicate a concrete distribution slab cast onto the precast concrete girders. In good condition based on the 2023 rehabilitation.						
Recommended Work:		Rehab: <input type="checkbox"/>	Replace: <input type="checkbox"/>	Maintenance Needs:		
Urgent: <input type="checkbox"/>	1-5 Years: <input type="checkbox"/>	6-10 Years: <input type="checkbox"/>	None: <input checked="" type="checkbox"/>	Urgent: <input type="checkbox"/>	1 Year: <input type="checkbox"/>	2 Year: <input type="checkbox"/>

Description of Photo:		Deck Top

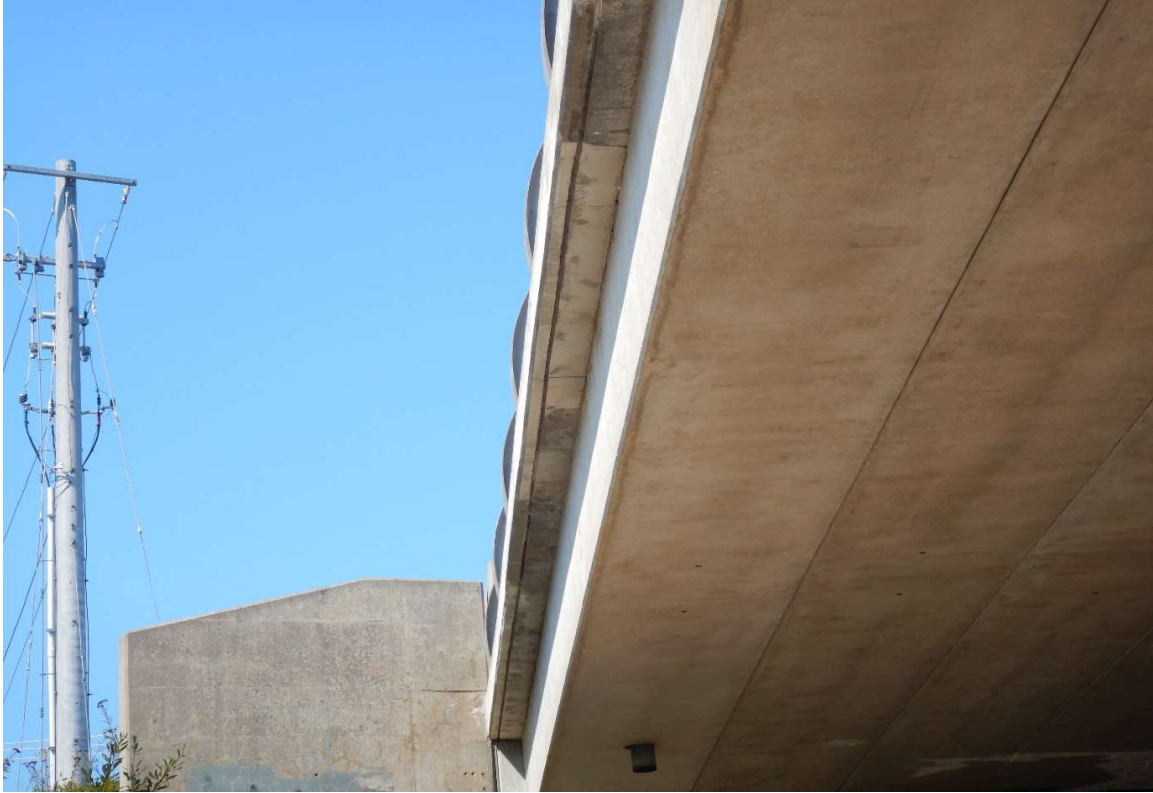
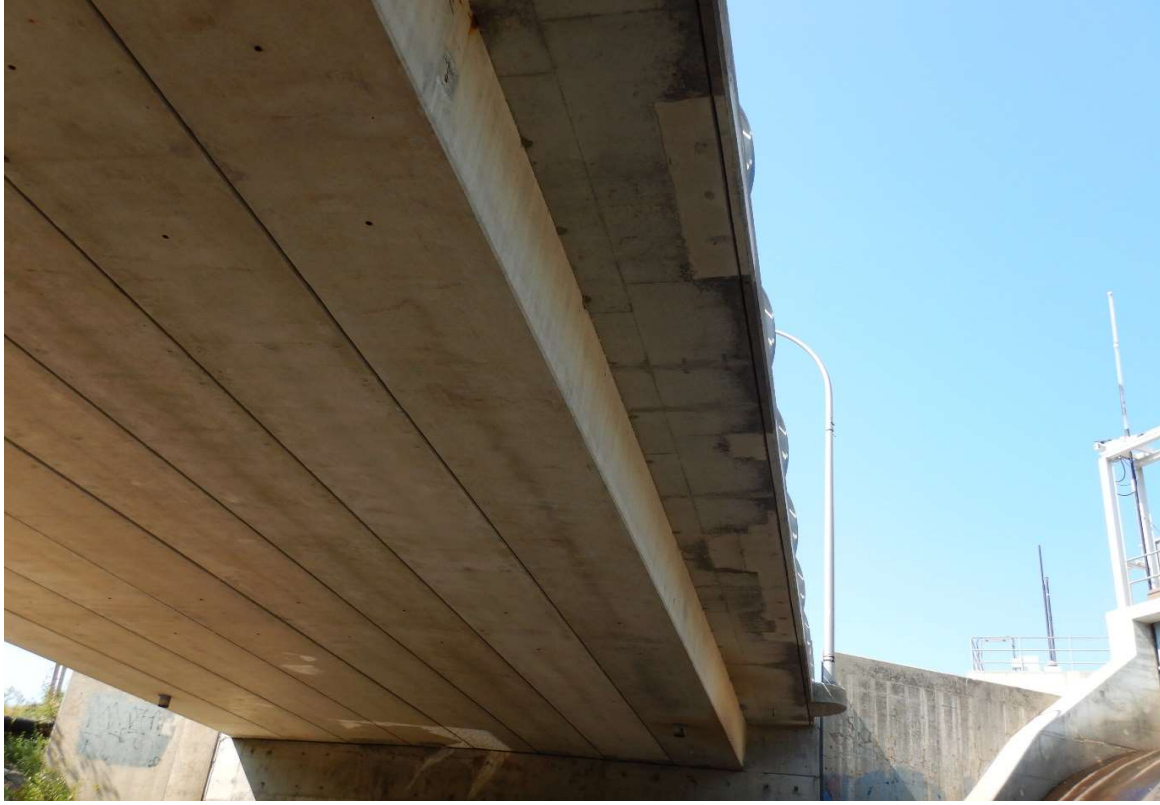
Element Data:						
Element Group:	Decks		Length:	52.9		
Element Name:	Soffit		Width:	11.2		
Location:			Height:	N/A		
Material:	Concrete and Precast Concrete		Count:			
Element Type:	Cast-in-place ext. soffits, Precast Girders		Total Quantity:	592.5		
Environment:	Benign		Inspected	Yes <input type="checkbox"/>	No <input type="checkbox"/>	limited <input checked="" type="checkbox"/>
Protection System:						Performance Deficiencies
Condition Data:	Units	Excellent	Good	Fair	Poor*	
	sq.m	22.2	570.3			
Comments: Limited inspection due to height. Light scaling, typ. 2023 repaired areas have no observed defects.						
Recommended Work:		Rehab: <input type="checkbox"/>	Replace: <input type="checkbox"/>	Maintenance Needs:		
Urgent: <input type="checkbox"/>	1-5 Years: <input type="checkbox"/>	6-10 Years: <input type="checkbox"/>	None: <input checked="" type="checkbox"/>	Urgent: <input type="checkbox"/>	1 Year: <input type="checkbox"/>	2 Year: <input type="checkbox"/>

Description of Photo: Exterior and Girder Soffit, Typical

Description of Photo: Exterior and Girder Soffit, typ.

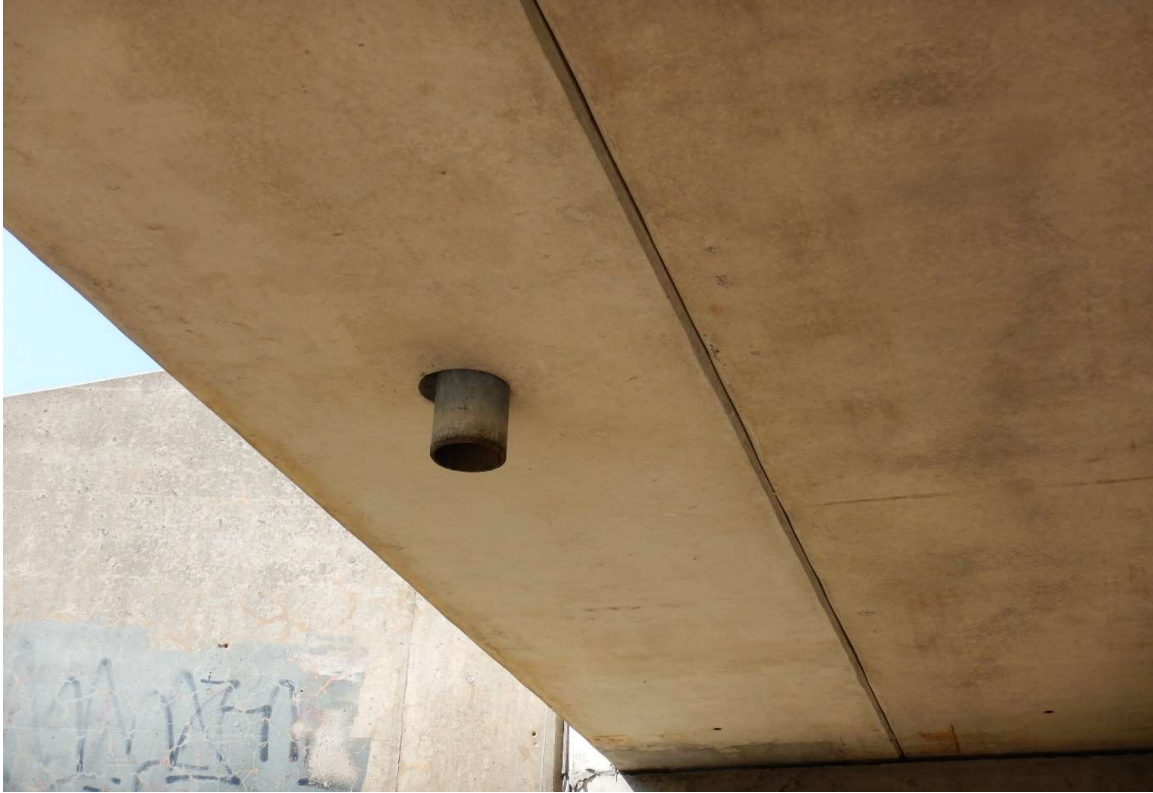
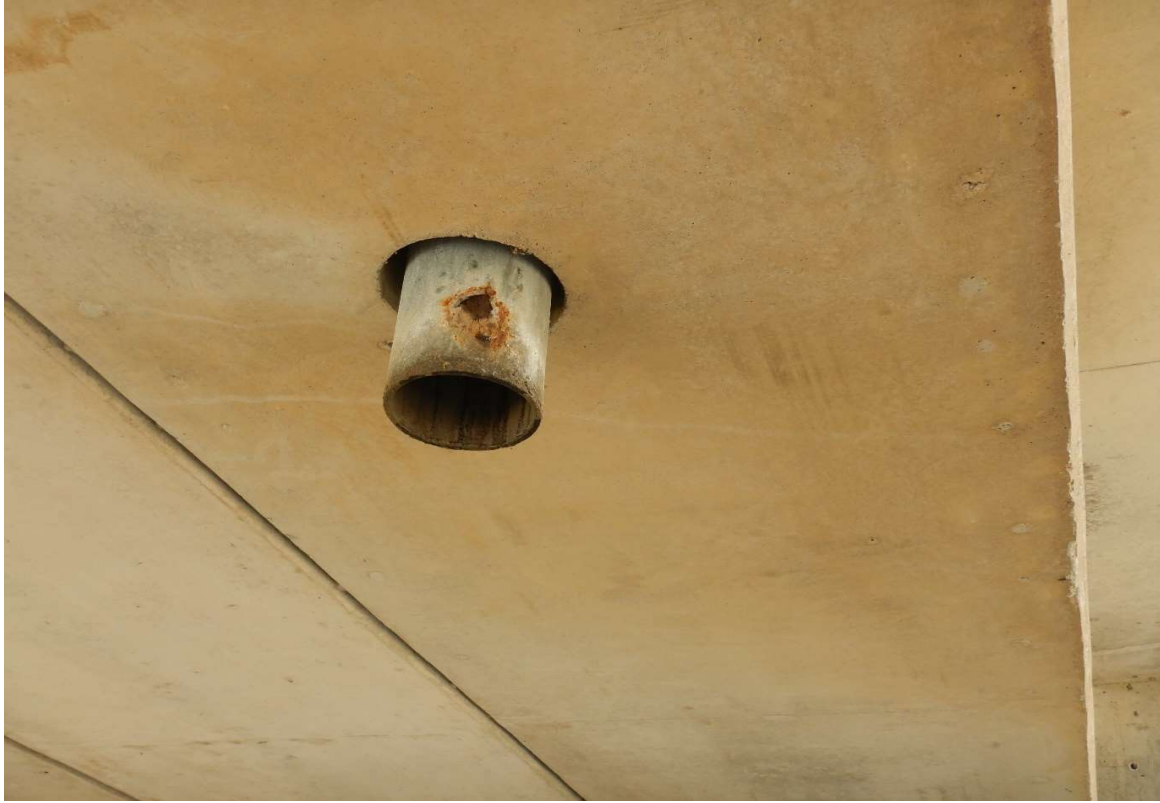
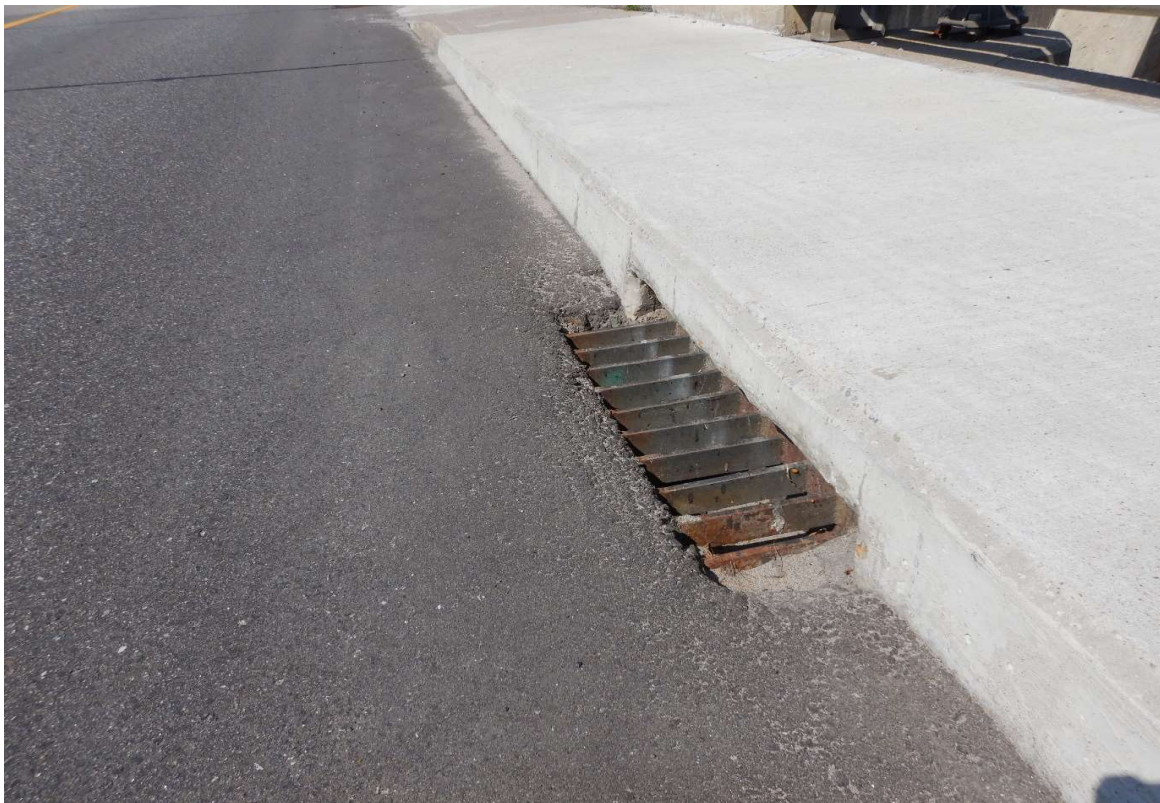
Element Data:						
Element Group:	Decks		Length:			
Element Name:	Drainage System		Width:			
Location:	East and West Side		Height:			
Material:	Steel Grate + CSP Pipe		Count:			
Element Type:			Total Quantity:	4		
Environment:	Severe		Inspected	Yes <input checked="" type="checkbox"/>	No <input type="checkbox"/>	limited <input type="checkbox"/>
Protection System:	Pipes are galvanized.					Performance Deficiencies
Condition Data:	Units	Excellent	Good	Fair	Poor*	
	each		4			
Comments: Light corrosion, typ. All drains clear.						
Recommended Work:		Rehab: <input type="checkbox"/>	Replace: <input type="checkbox"/>	Maintenance Needs:		
Urgent: <input type="checkbox"/>	1-5 Years: <input type="checkbox"/>	6-10 Years: <input type="checkbox"/>	None: <input checked="" type="checkbox"/>	Urgent: <input type="checkbox"/>	1 Year: <input type="checkbox"/>	2 Year: <input type="checkbox"/>
Element Photo:

Description of Photo: Deck Drain

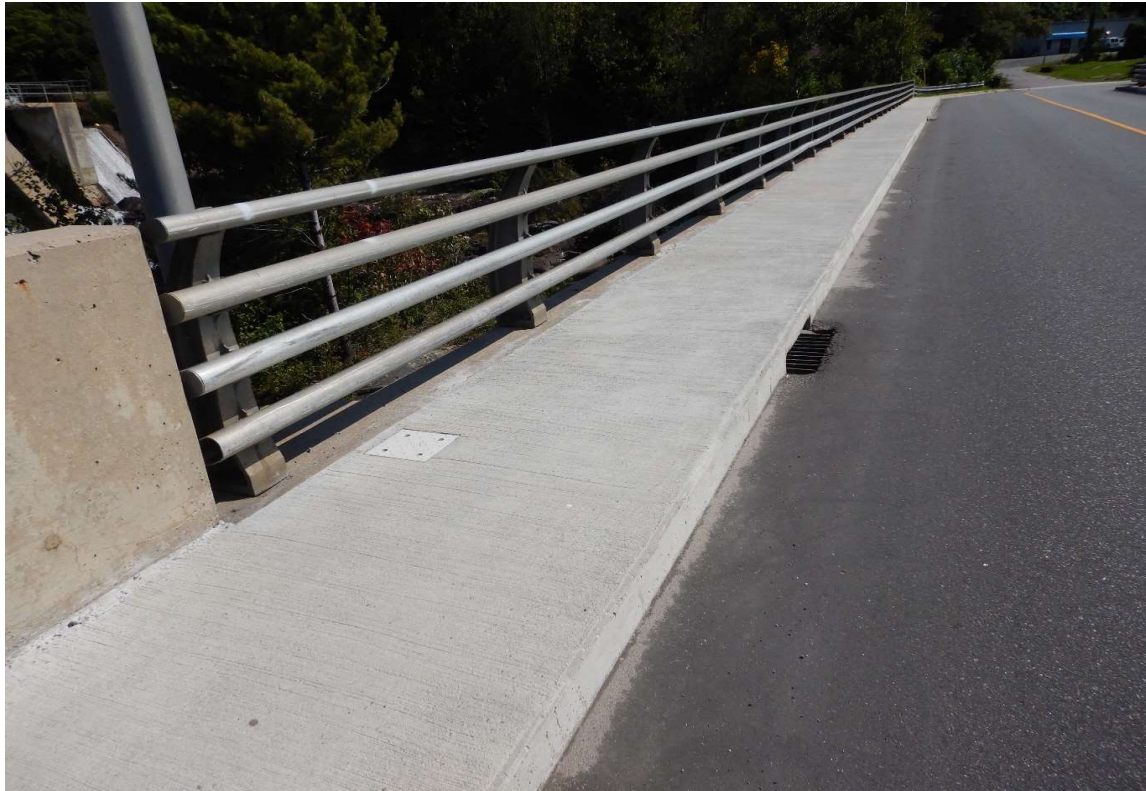
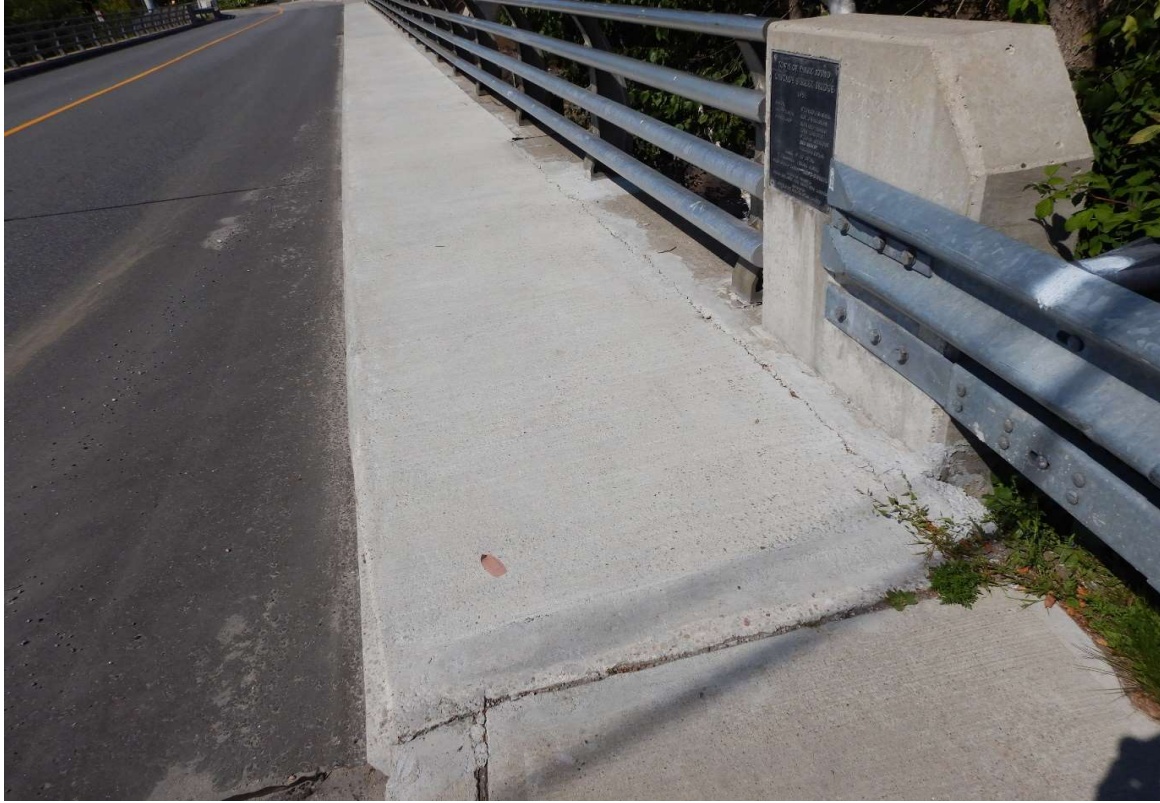
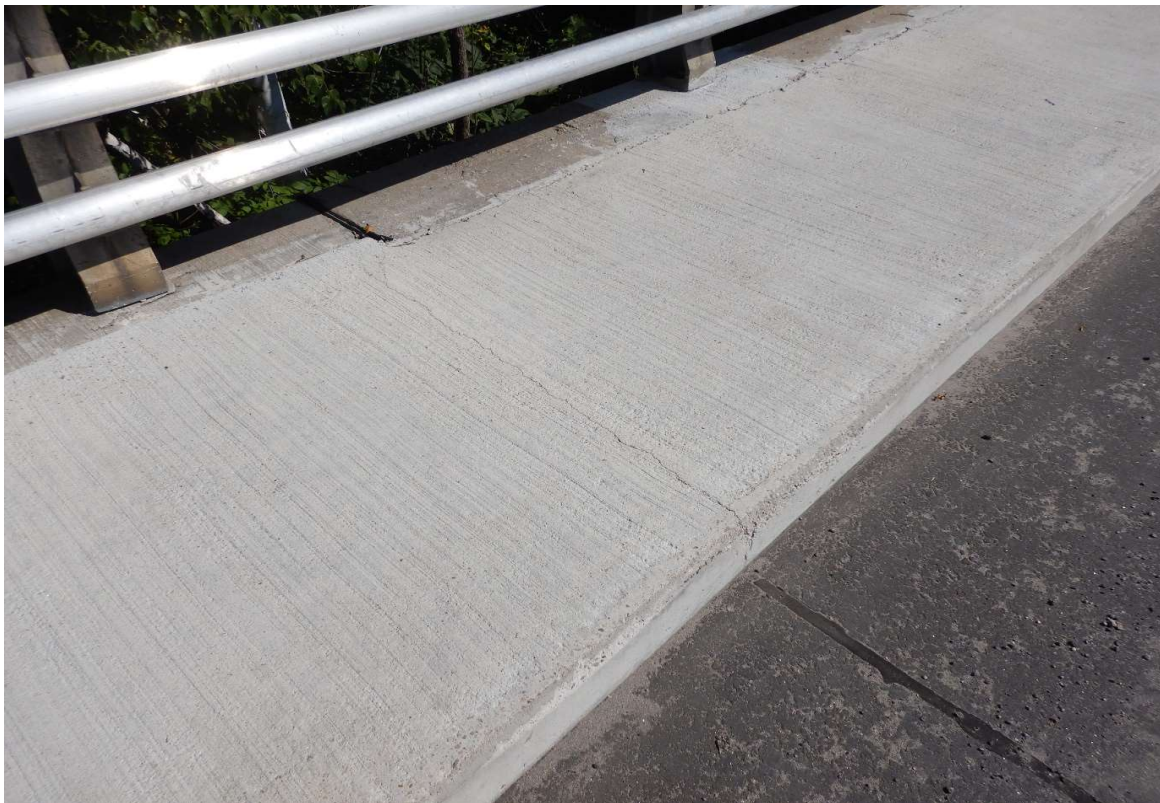
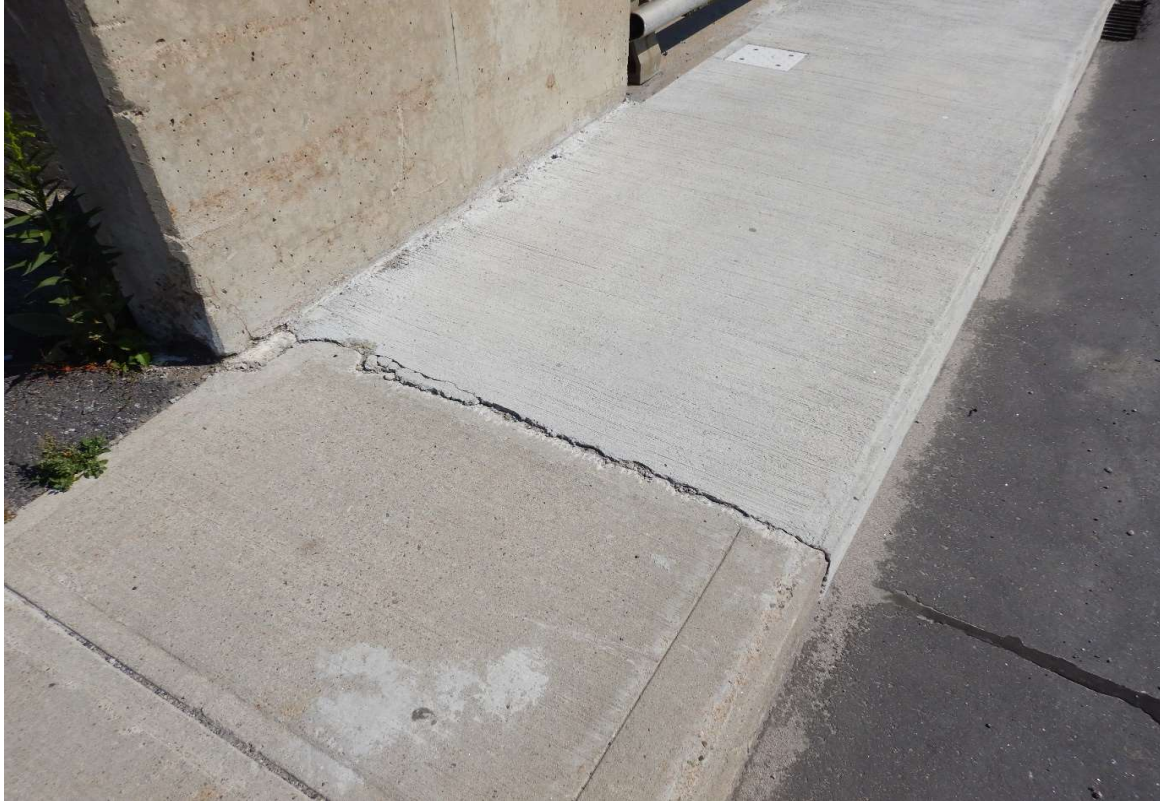
Element Data:						
Element Group:	Sidewalk/Curb	Length:	52.8			
Element Name:	Sidewalks	Width:	1.8			
Location:	East Side	Height:	0.15			
Material:	Concrete	Count:	1			
Element Type:	Cast-in-place	Total Quantity:	103.0			
Environment:	Severe	Inspected	Yes	<input checked="" type="checkbox"/>	No	<input type="checkbox"/> limited <input type="checkbox"/>
Protection System:						Performance Deficiencies
Condition Data:	Units	Excellent	Good	Fair	Poor*	
	sq.m	80.0	22.6	0.4		
Comments: Light scaling, typ. Sidewalk east end at asphalt joint has one medium transverse crack. 2023 repaired areas have no other observed defects.						
Recommended Work:	Rehab: <input type="checkbox"/>	Replace: <input type="checkbox"/>	Maintenance Needs:			
Urgent: <input type="checkbox"/>	1-5 Years: <input type="checkbox"/>	6-10 Years: <input type="checkbox"/>	None: <input checked="" type="checkbox"/>	Urgent: <input type="checkbox"/>	1 Year: <input type="checkbox"/>	2 Year: <input type="checkbox"/>

Description of Photo: Sidewalk

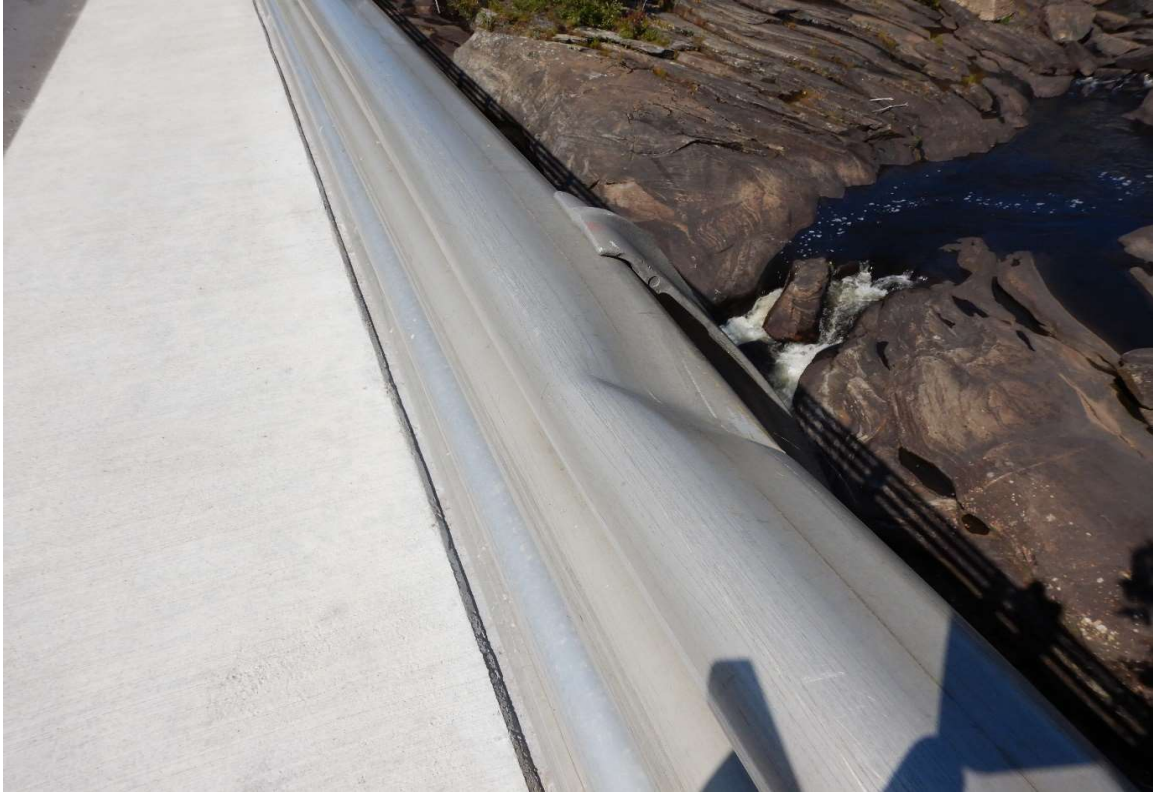
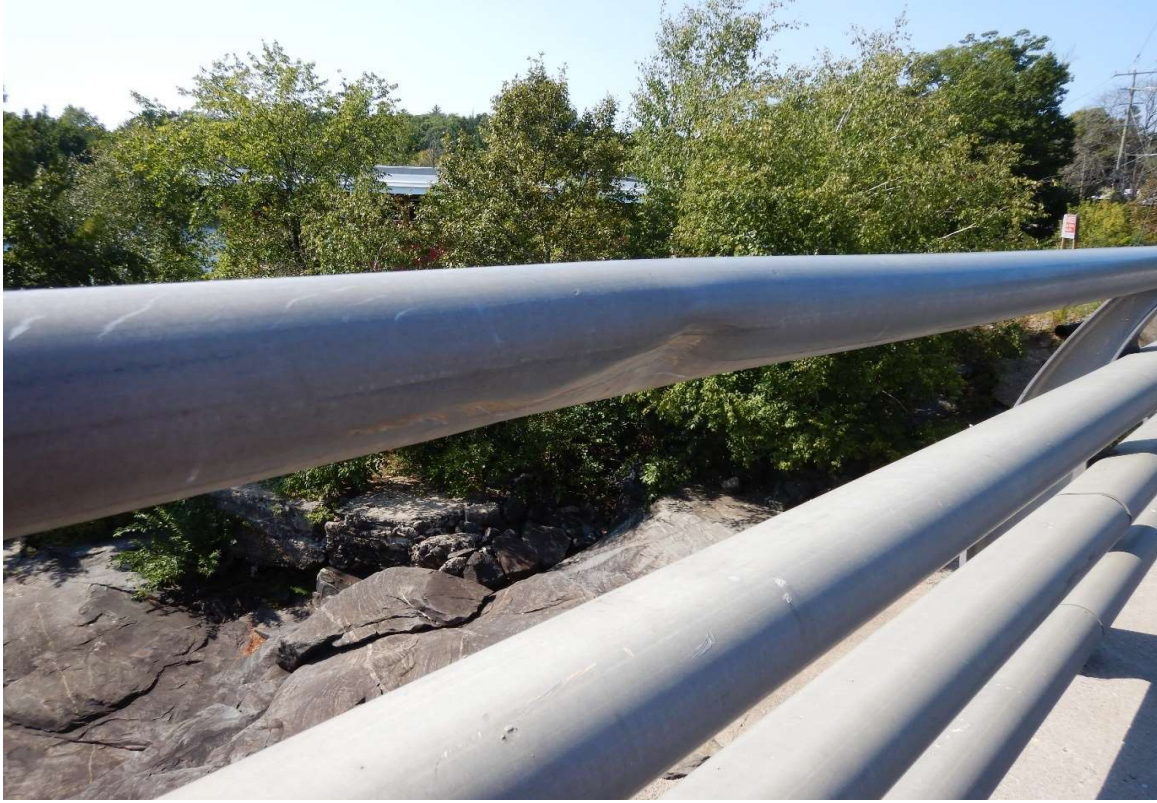
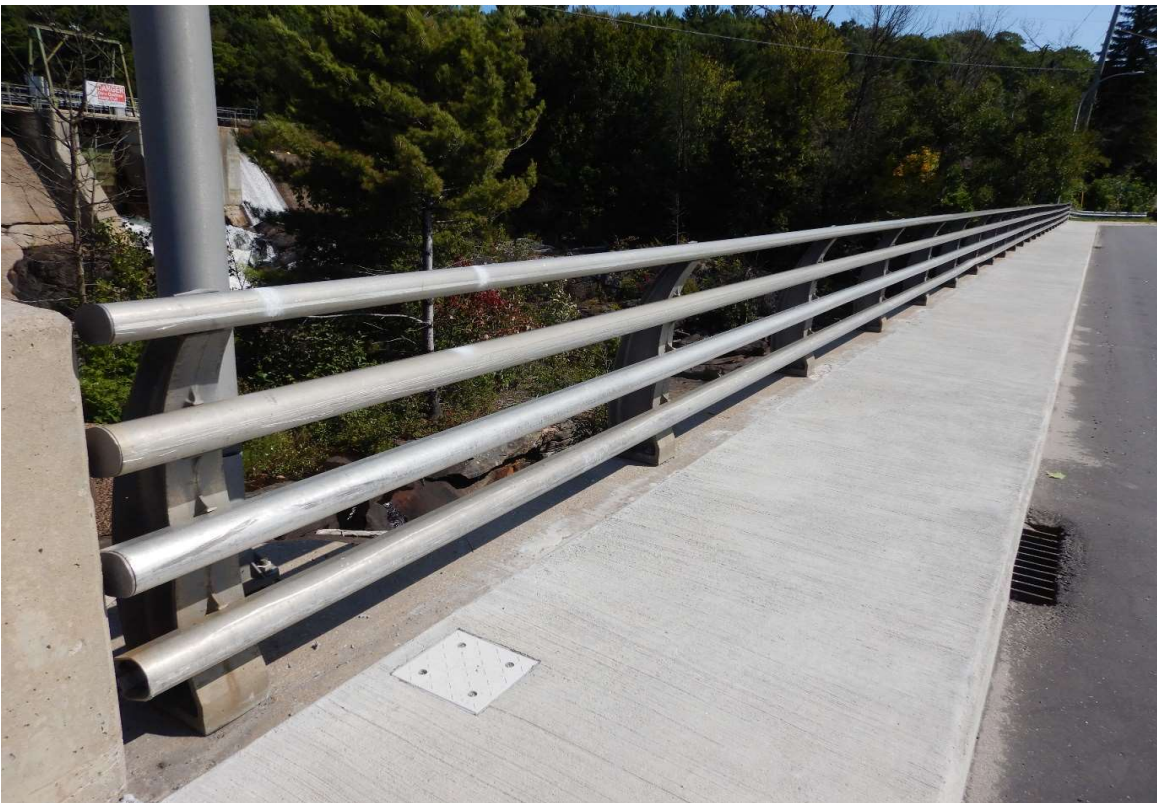
Element Data:						
Element Group:	Barriers		Length:	2.36		
Element Name:	Railing Systems		Width:			
Location:	East and West Side		Height:	1.12		
Material:	Aluminum		Count:	48		
Element Type:	4 Rail		Total Quantity:	113.3		
Environment:	Severe		Inspected	Yes <input type="checkbox"/>	No <input type="checkbox"/>	limited <input type="checkbox"/>
Protection System:						Performance Deficiencies
Condition Data:	Units	Excellent	Good	Fair	Poor*	
	m		112.9		0.4	
Comments: Light corrosion, typ. East top rail has 1 x 0.2m length deformation at south end. West top rail has 1 x 0.2m length deformation at pier location.						
Recommended Work:		Rehab: <input type="checkbox"/>	Replace: <input type="checkbox"/>	Maintenance Needs:		
Urgent: <input type="checkbox"/>	1-5 Years: <input type="checkbox"/>	6-10 Years: <input type="checkbox"/>	None: <input checked="" type="checkbox"/>	Urgent: <input type="checkbox"/>	1 Year: <input type="checkbox"/>	2 Year: <input type="checkbox"/>

Description of Photo:		West Railing System

Description of Photo: West railing system

Description of Photo: East railing system

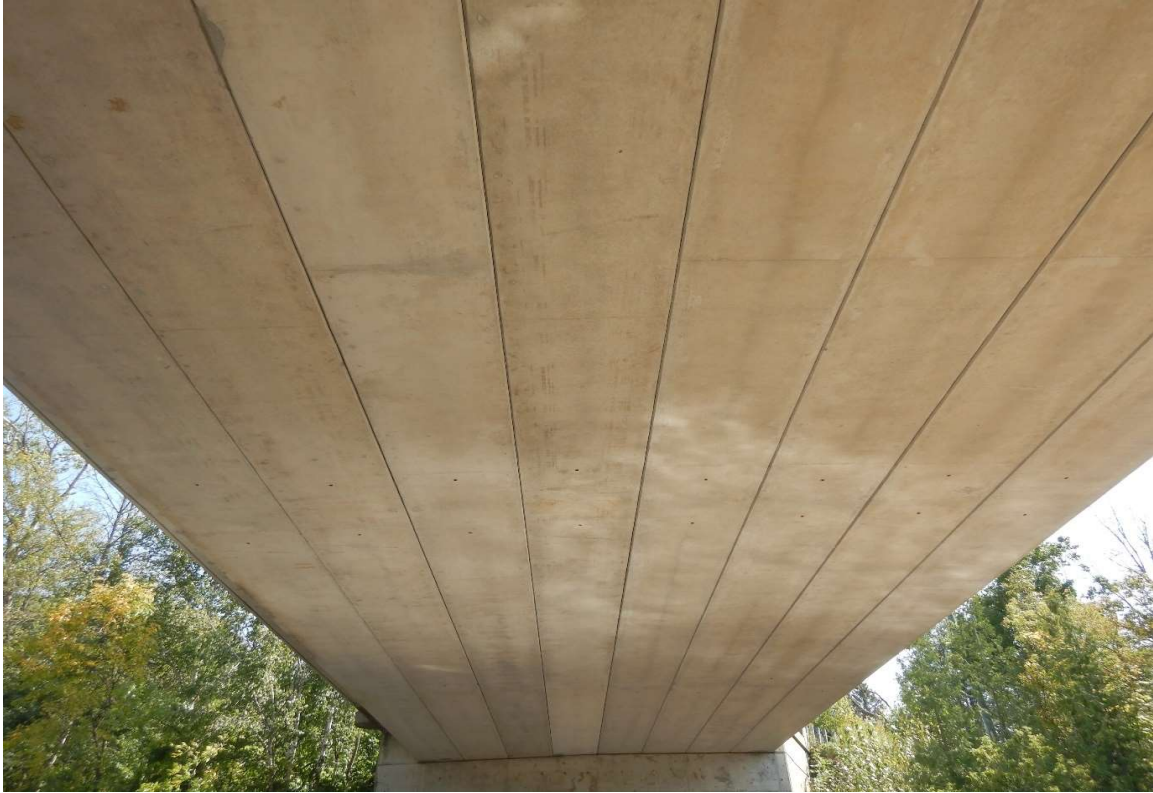
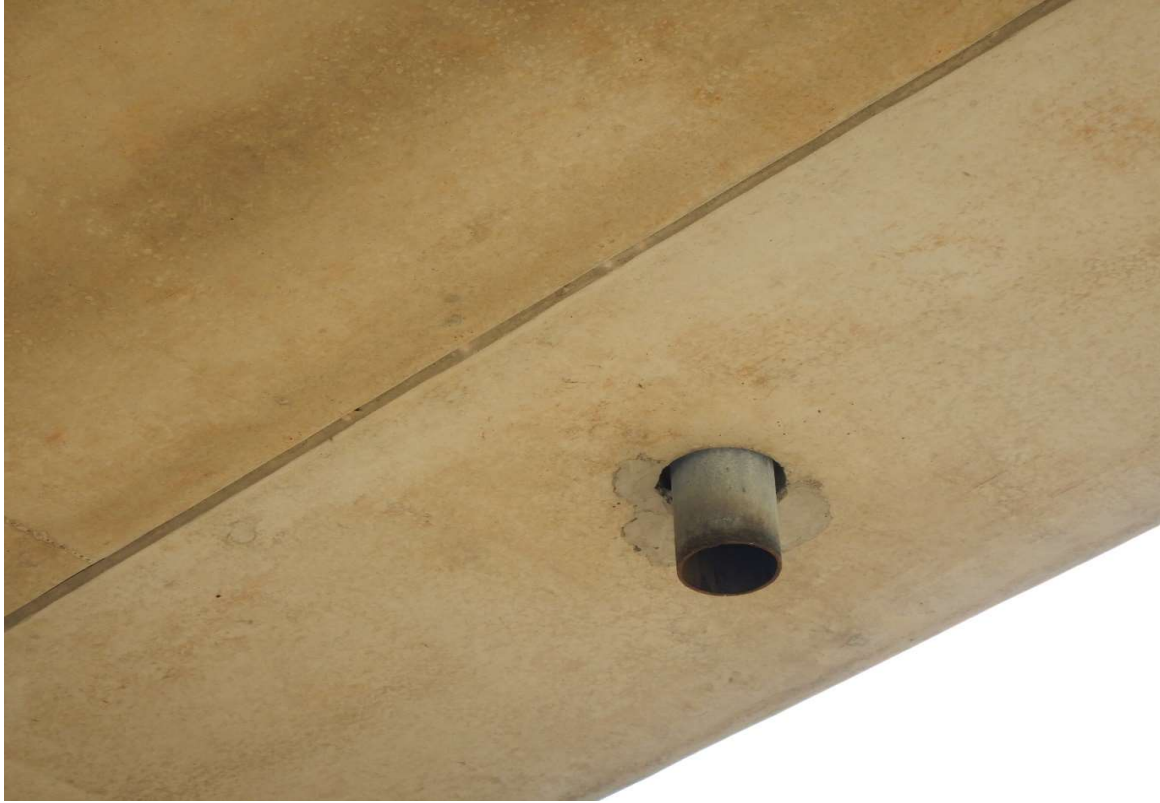
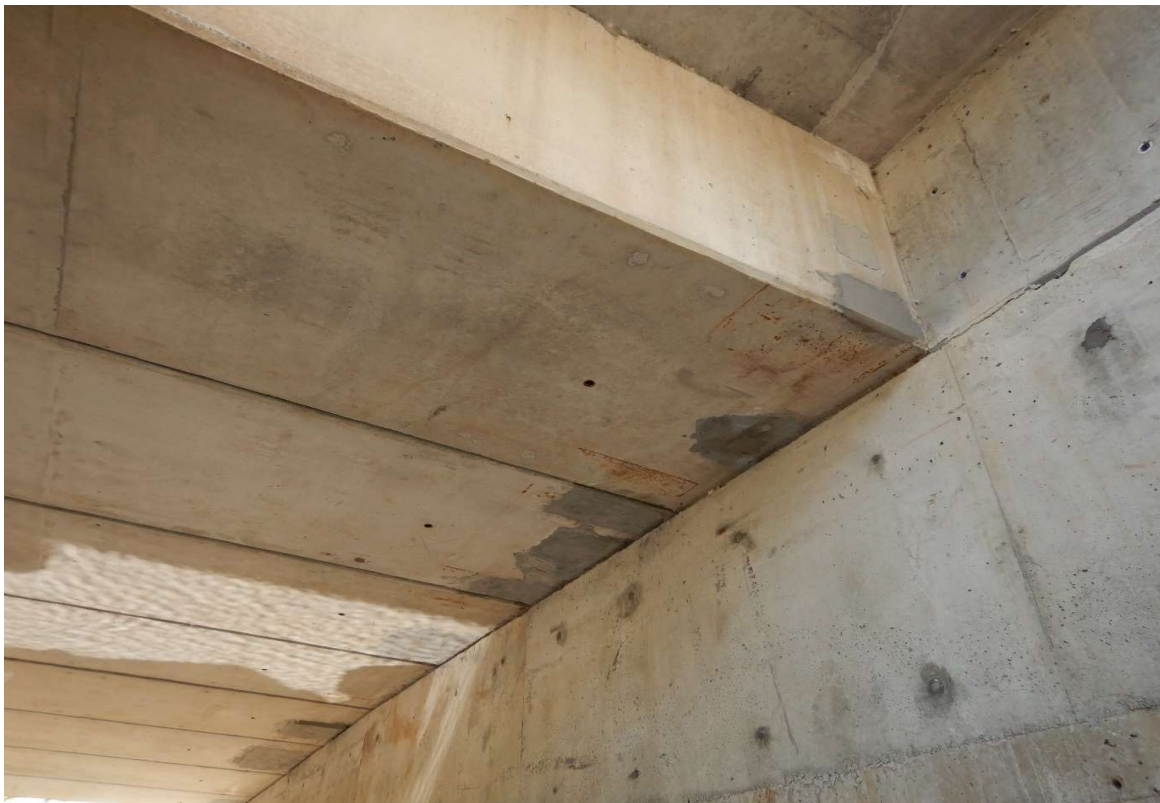
Element Data:						
Element Group:	Beams/Main Longitudinal Elements		Length:	26.45		
Element Name:	Girders		Width:	1.20		
Location:			Height:	0.84		
Material:	Precast Concrete		Count:	16		
Element Type:	Box Girder		Total Quantity:	298.3		
Environment:	Benign		Inspected	Yes <input type="checkbox"/>	No <input type="checkbox"/>	limited <input checked="" type="checkbox"/>
Protection System:						Performance Deficiencies
Condition Data:	Units	Excellent	Good	Fair	Poor*	
	sq.m	1.5	296.8			
Comments: Light scaling, typ. 2023 repaired areas have no observed defects.						
Recommended Work:		Rehab: <input type="checkbox"/>	Replace: <input type="checkbox"/>	Maintenance Needs:		
Urgent: <input type="checkbox"/>	1-5 Years: <input type="checkbox"/>	6-10 Years: <input type="checkbox"/>	None: <input checked="" type="checkbox"/>	Urgent: <input type="checkbox"/>	1 Year: <input type="checkbox"/>	2 Year: <input type="checkbox"/>

Description of Photo:		Girder Soffit

Description of Photo: Girder Soffit

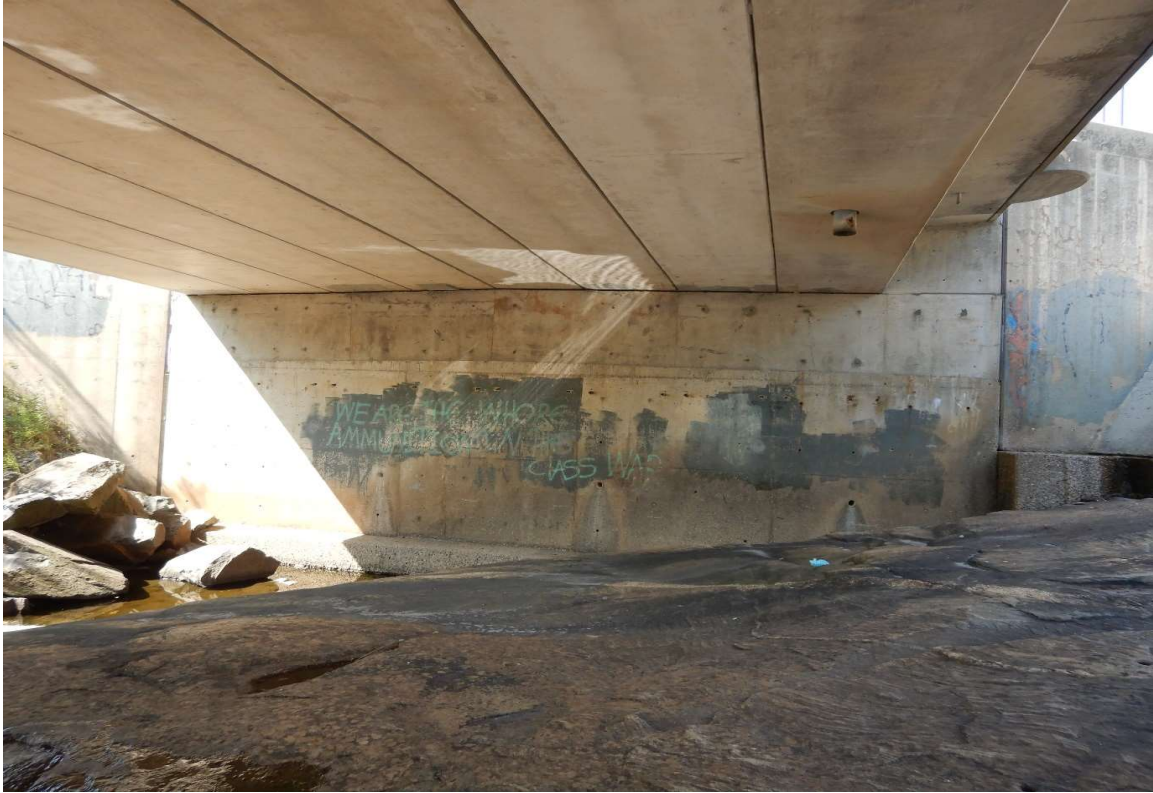
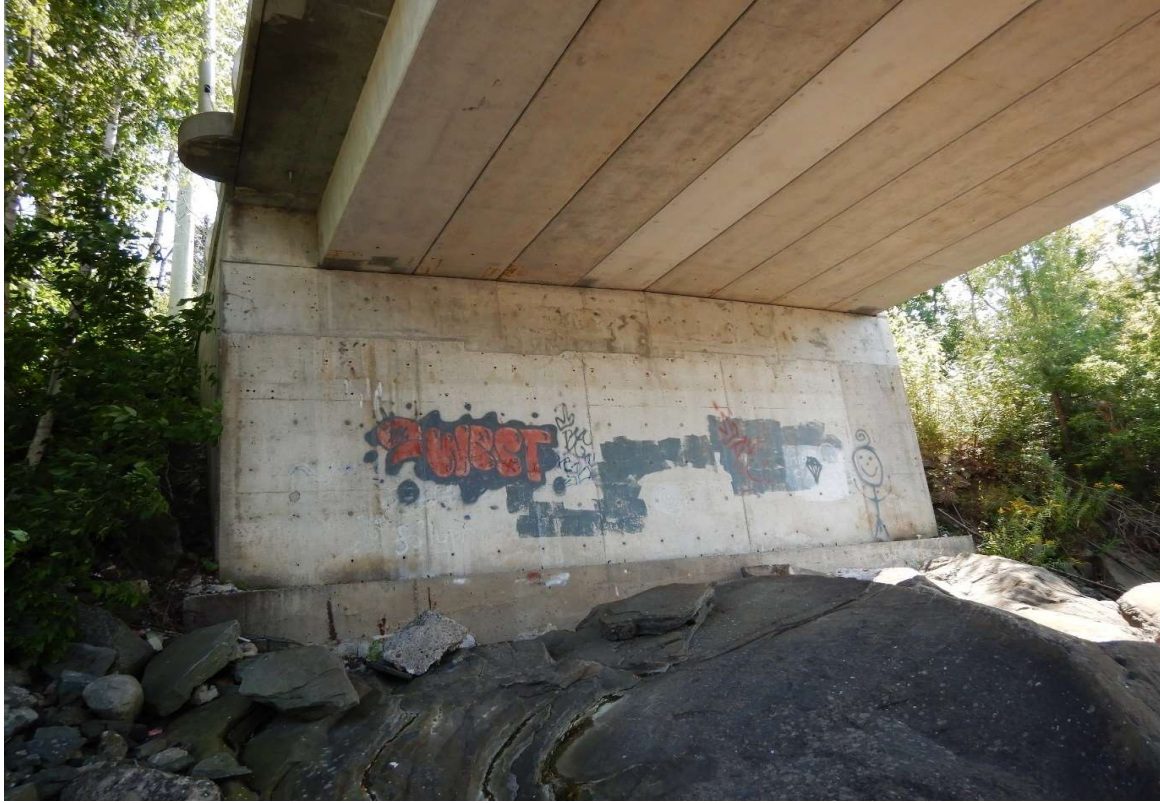
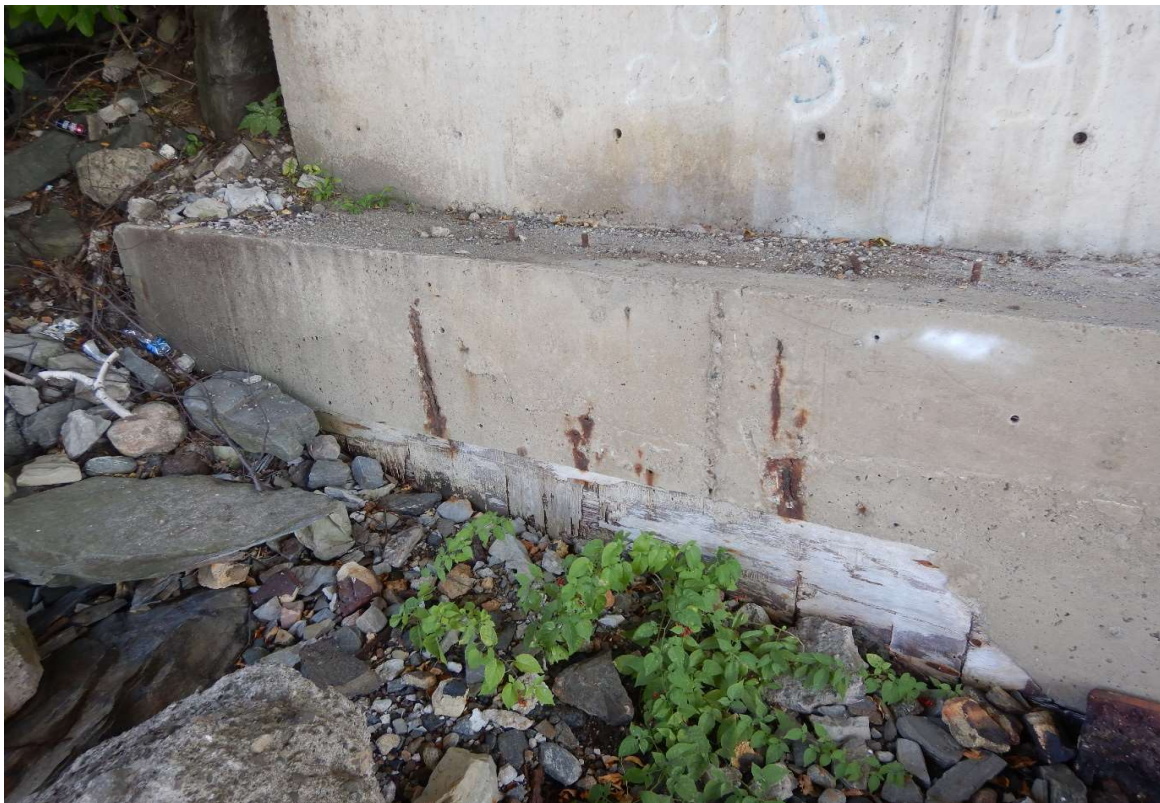
Element Data:						
Element Group:	Abutments		Length:			
Element Name:	Abutment Walls		Width:	11.1		
Location:			Height:	4.3		
Material:	Concrete		Count:	2		
Element Type:	Cast-in-place		Total Quantity:	95.5		
Environment:	Benign		Inspected	Yes <input checked="" type="checkbox"/>	No <input type="checkbox"/>	limited <input type="checkbox"/>
Protection System:						Performance Deficiencies
Condition Data:	Units	Excellent	Good	Fair	Poor*	
	sq.m		81.9	13.5	0.1	
Comments: Light scaling, typ. with medium scaling generally within 1 m from bottom of wall. North abutment has 2 x 3.0m vertical medium cracks on older concrete section. South abutment has 1 x 3.0m vertical medium crack and 2 x 300mm vertical light cracks. 100 x 300 x25mm medium spall with medium corroded rebar at bottom of south abutment.						
Recommended Work:		Rehab: <input type="checkbox"/>	Replace: <input type="checkbox"/>	Maintenance Needs:

Description of Photo:		North Abutment

Description of Photo: South Abutment
