Bridge Needs Study 2024

INSPECTION SUMMARY REPORT

Town of Parry Sound

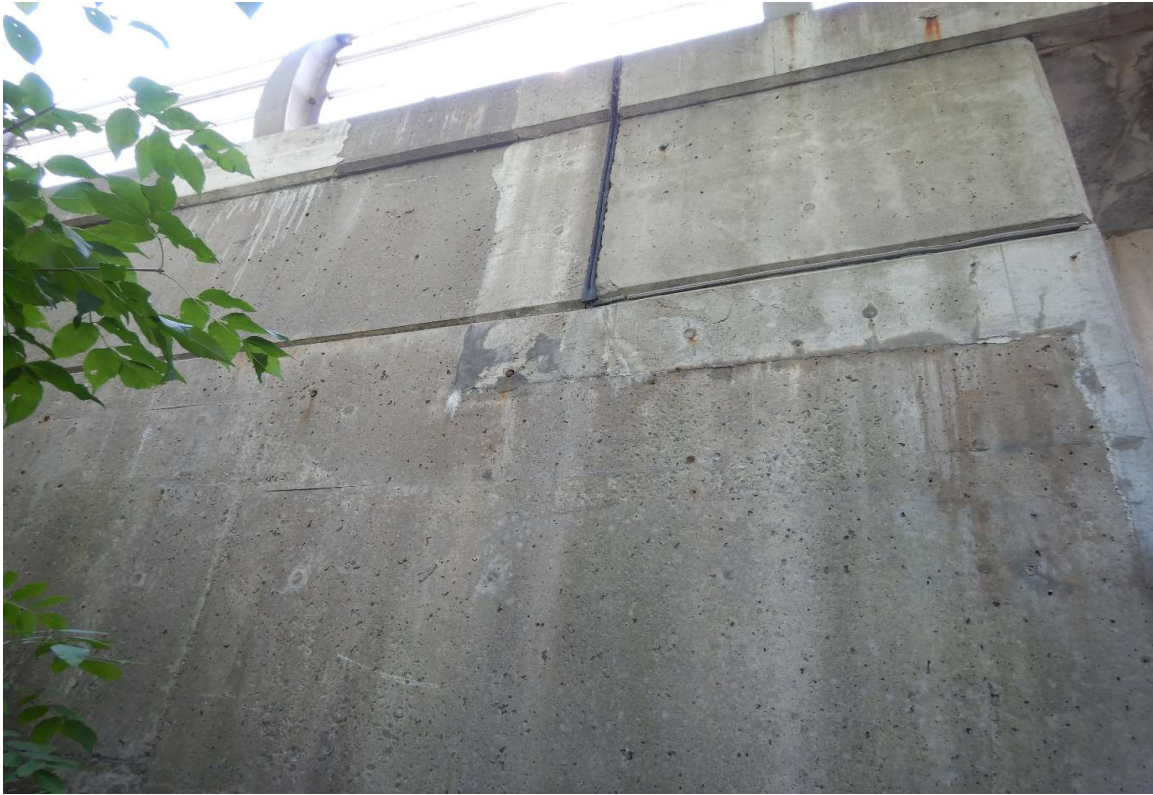
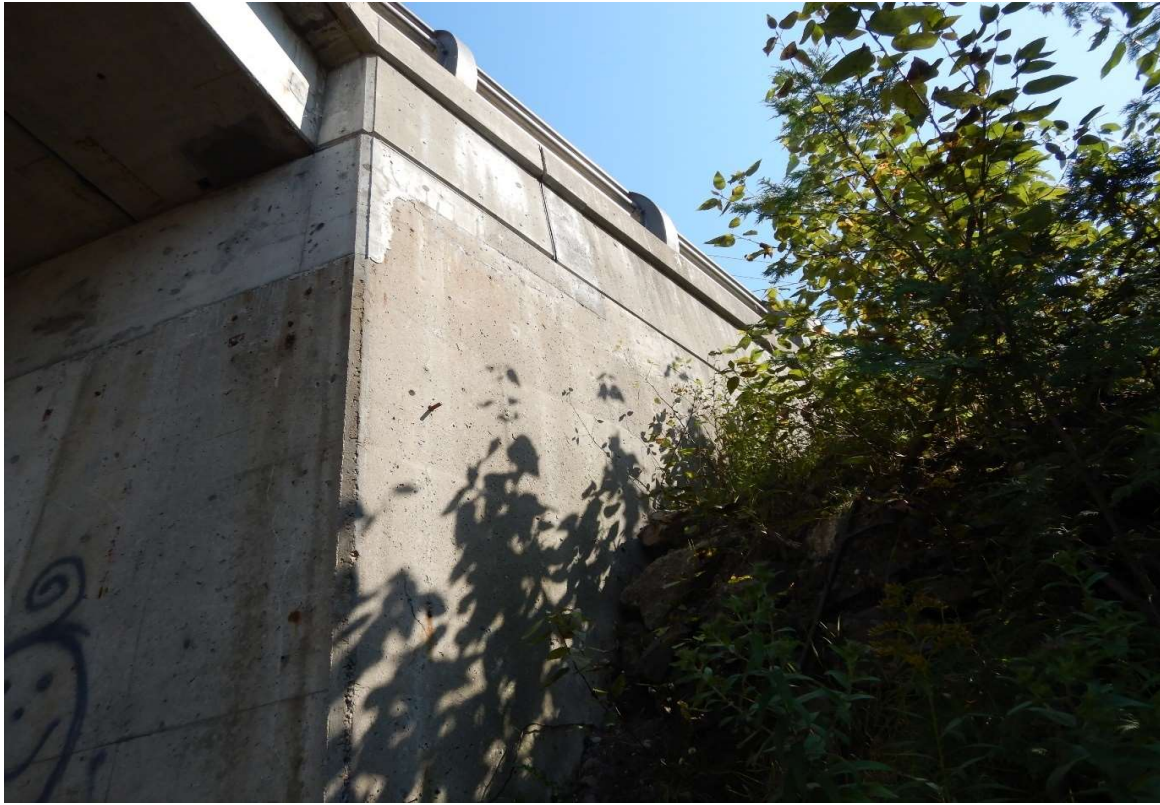
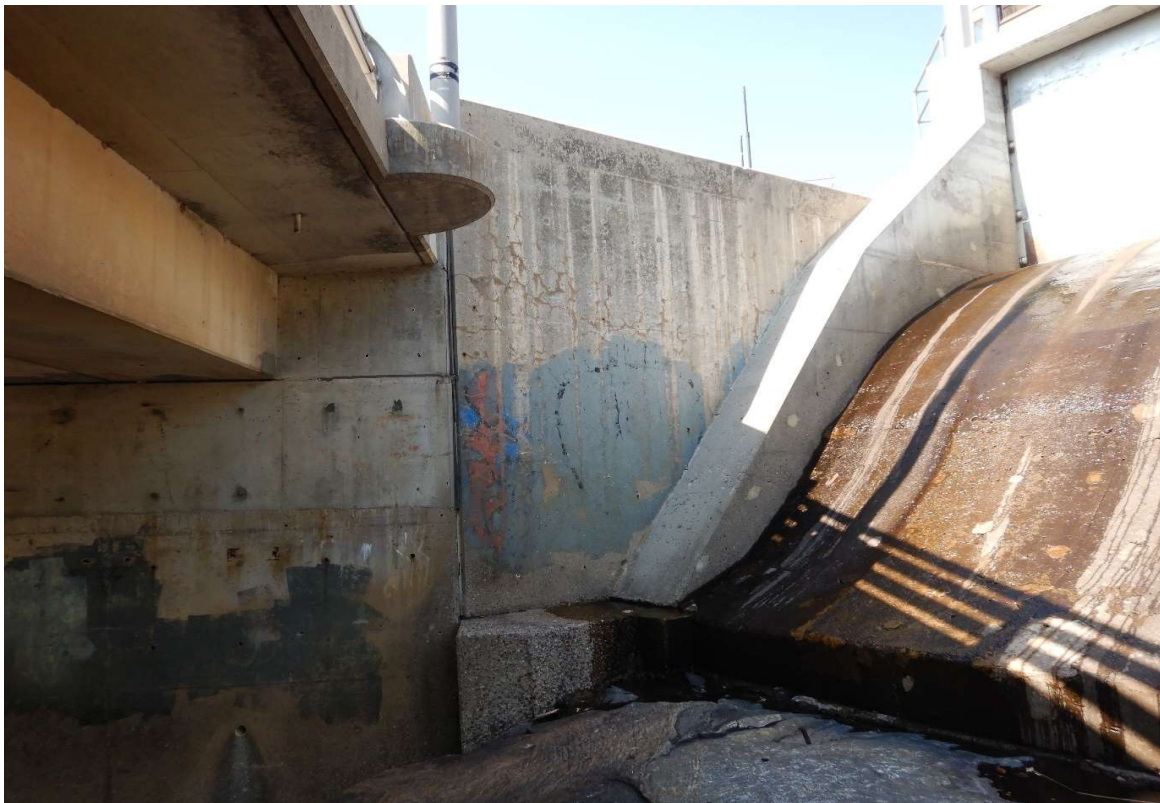
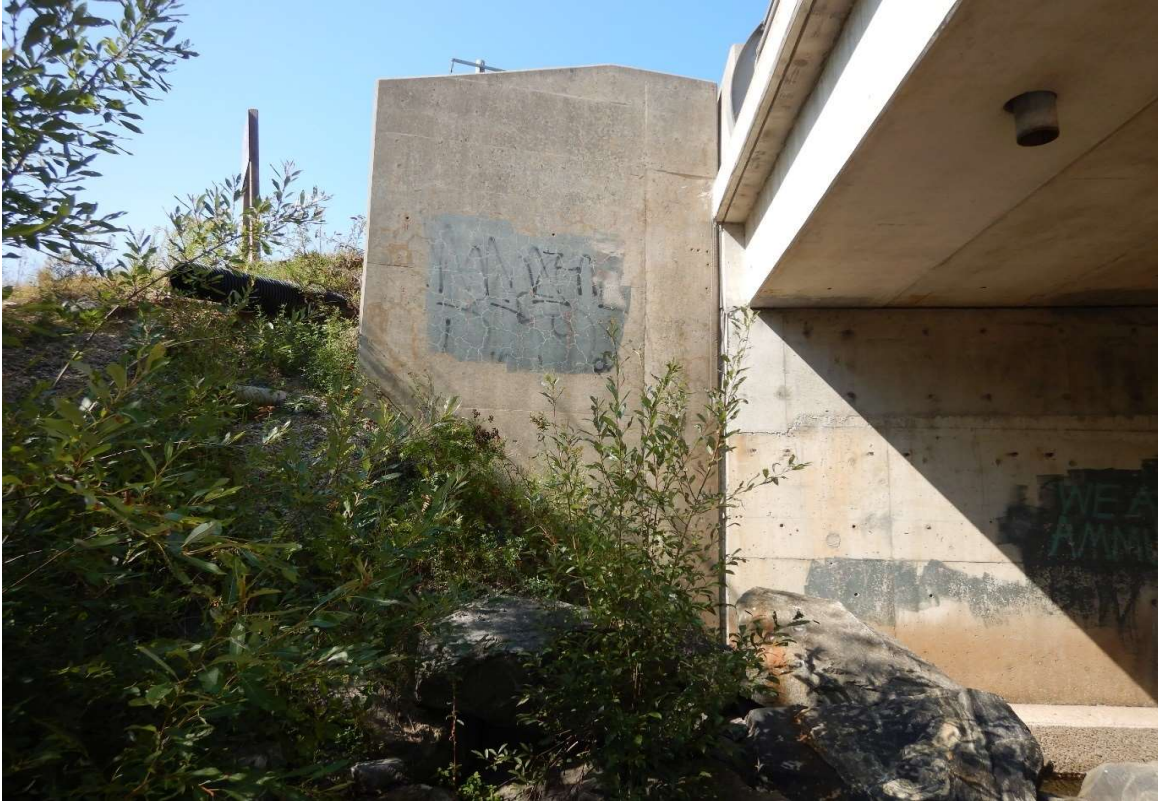
Element Data:						
Element Group:	Abutments	Length:	6.7			
Element Name:	Wingwalls	Width:				
Location:	All Quadrants	Height:	4.3			
Material:	Concrete	Count:	4			
Element Type:	Cast-in-place	Total Quantity:	114.4			
Environment:	Benign	Inspected	Yes <input type="checkbox"/>	No <input type="checkbox"/>	limited <input checked="" type="checkbox"/>	
Protection System:						Performance Deficiencies
Condition Data:	Units	Excellent	Good	Fair	Poor*	
	sq.m		114.3	0.1		
Comments: Northwest and northeast walls have light map cracking. Northeast wall has light erosion at base of wall. Southeast wall has light scaling. Southwest wall has a 300mm medium crack.						
Recommended Work:	Rehab: <input type="checkbox"/>		Replace: <input type="checkbox"/>		Maintenance Needs:	
	Urgent: <input type="checkbox"/>	1-5 Years: <input type="checkbox"/>	6-10 Years: <input type="checkbox"/>	None: <input checked="" type="checkbox"/>	Urgent: <input type="checkbox"/>	1 Year: <input type="checkbox"/> 2 Year: <input type="checkbox"/>

Description of Photo: Southeast wingwall

Description of Photo: Southwest wingwall

Description of Photo: Northeast wingwall

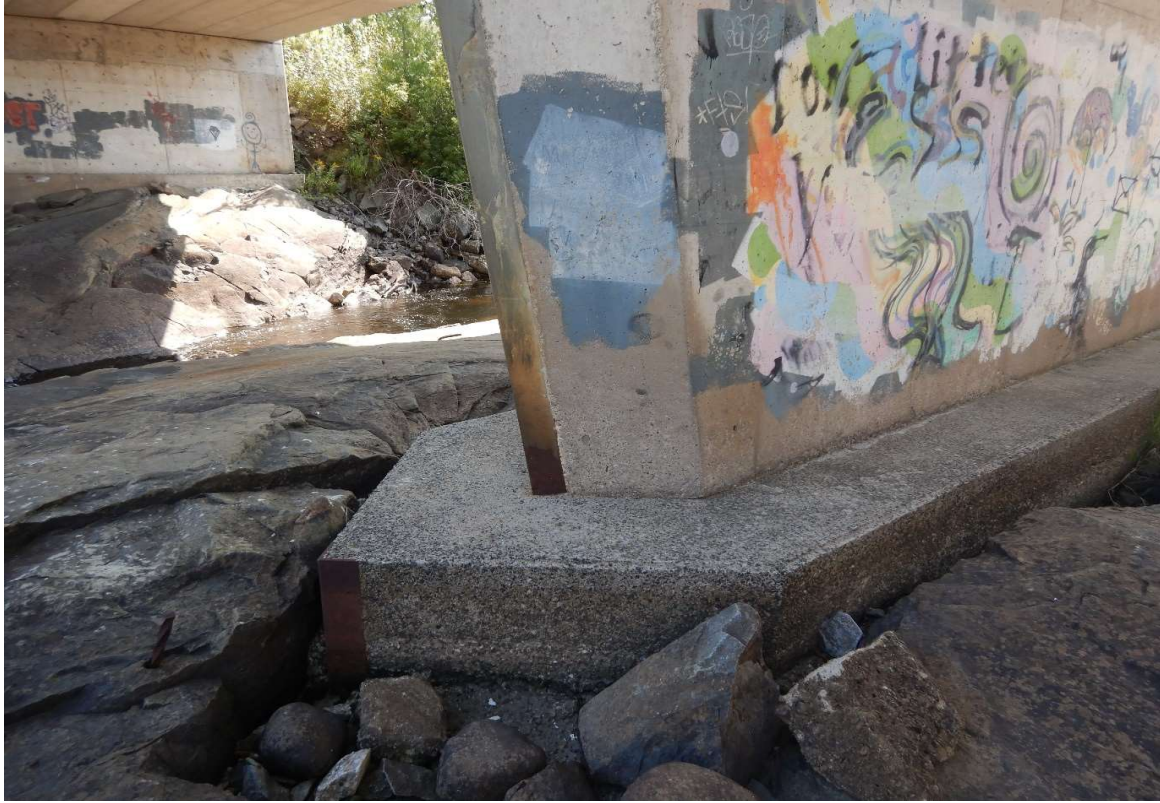
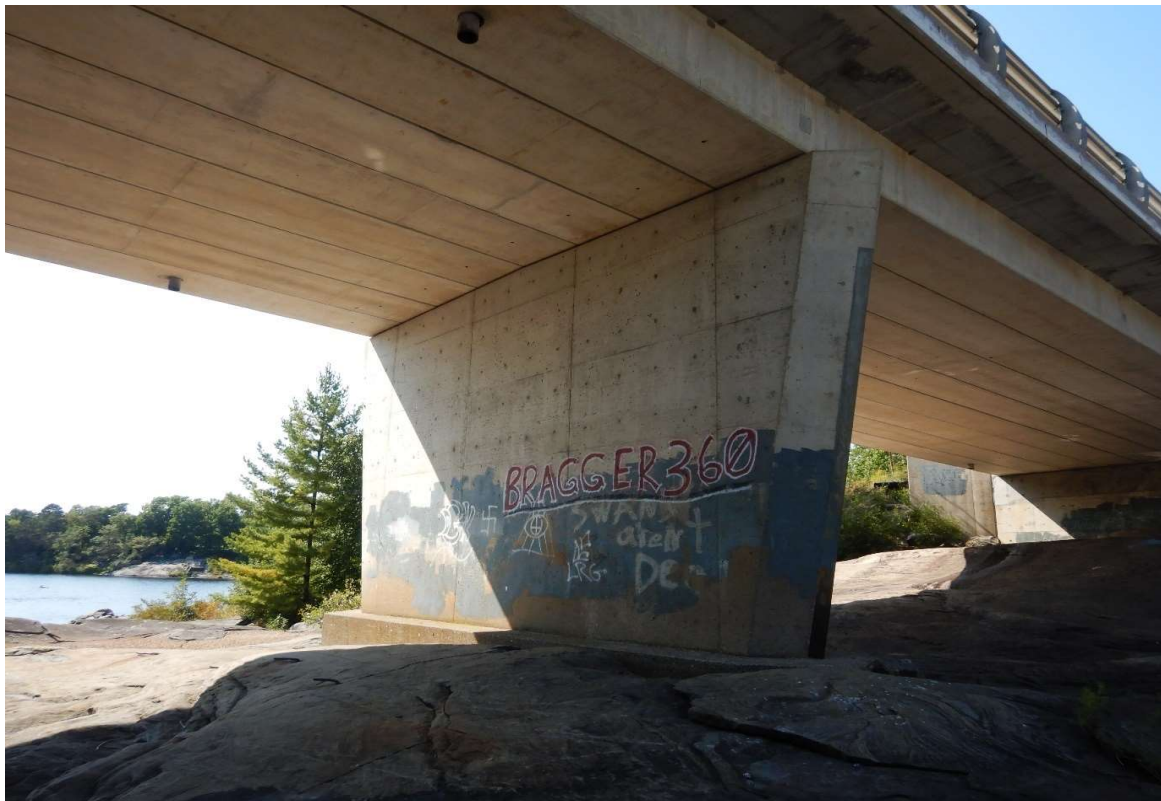
Element Data:						
Element Group:	Piers	Length:	2.2			
Element Name:	Shafts	Width:	11.0			
Location:	Center Pier	Height:	5.5			
Material:	Concrete	Count:	1			
Element Type:	Cast-in-place	Total Quantity:	121.4			
Environment:	Benign	Inspected	Yes <input type="checkbox"/>	No <input type="checkbox"/>	limited <input checked="" type="checkbox"/>	
Protection System:						Performance Deficiencies
Condition Data:	Units	Excellent	Good	Fair	Poor*	
	sq.m		120.8	0.6		
Comments: Light scaling, typ. South side has 1-2.0m and 2-1.0m vertical light cracks near bottom of pier shaft. Steel angle nosing at east side has light corrosion at bottom. Footing has 1-1.2m and 1-1.2m horizontal and vertical medium cracks, south and north sides at centreline.						
Recommended Work:	Rehab: <input type="checkbox"/>		Replace: <input type="checkbox"/>		Maintenance Needs:	
	Urgent: <input type="checkbox"/>	1-5 Years: <input type="checkbox"/>	6-10 Years: <input type="checkbox"/>	None: <input checked="" type="checkbox"/>	Urgent: <input type="checkbox"/>	1 Year: <input type="checkbox"/> 2 Year: <input type="checkbox"/>

Description of Photo: Pier

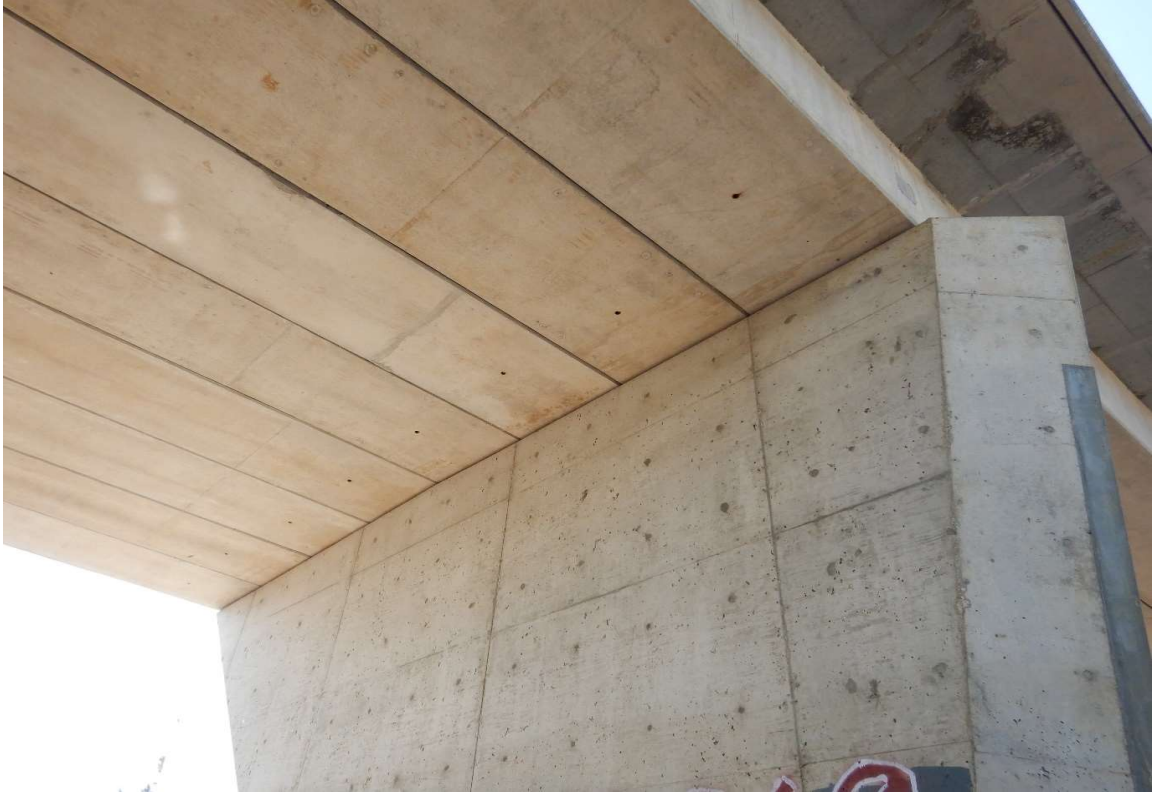
Element Data:						
Element Group:	Piers		Length:			
Element Name:	Bearings		Width:			
Location:	Center Pier		Height:			
Material:	Elastomeric		Count:	8		
Element Type:			Total Quantity:	8		
Environment:	Moderate		Inspected	Yes <input type="checkbox"/>	No <input type="checkbox"/>	limited <input checked="" type="checkbox"/>
Protection System:						Performance Deficiencies
Condition Data:	Units	Excellent	Good	Fair	Poor*	
	each		8			
Comments: Not accessible for inspection. Assumed to be in good condition.						
Recommended Work:		Rehab: <input type="checkbox"/>	Replace: <input type="checkbox"/>	Maintenance Needs:		
Urgent: <input type="checkbox"/>	1-5 Years: <input type="checkbox"/>	6-10 Years: <input type="checkbox"/>	None: <input checked="" type="checkbox"/>	Urgent: <input type="checkbox"/>	1 Year: <input type="checkbox"/>	2 Year: <input type="checkbox"/>
<div style="border: 1px solid black; height: 150px; width: 100%;"></div>

Description of Photo:		Pier Bearings

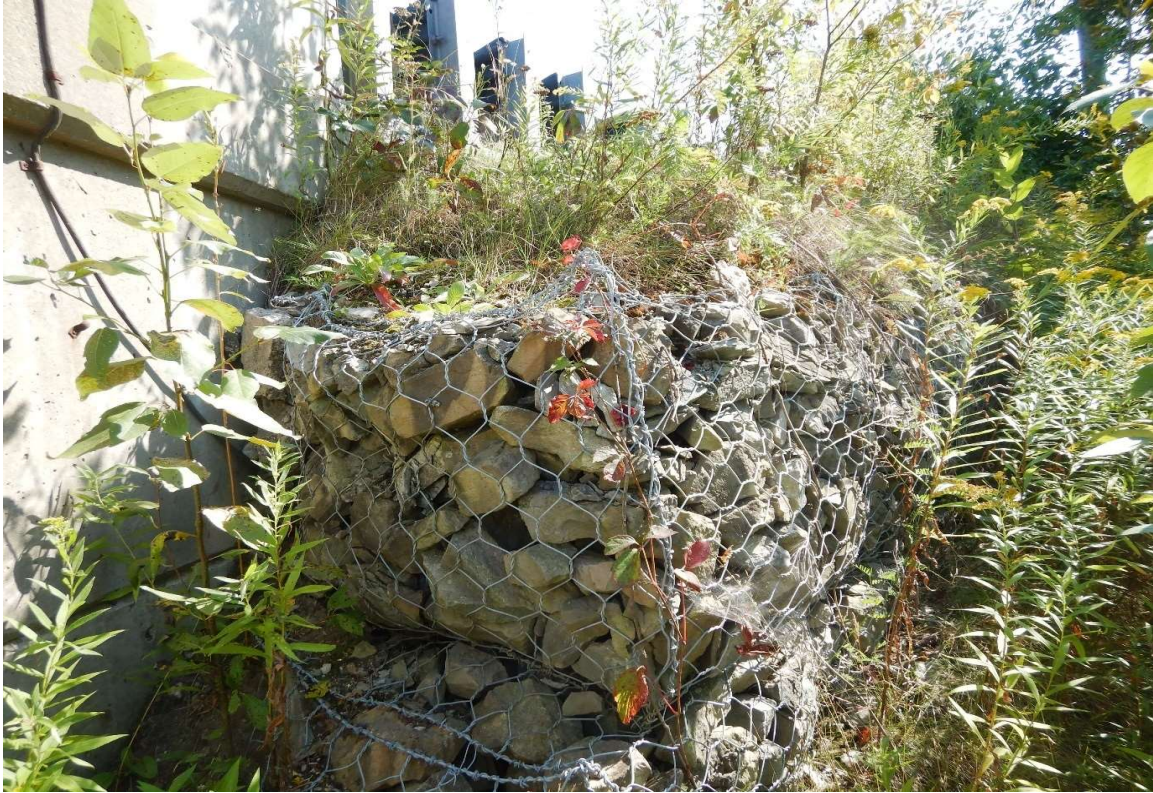
Element Data:						
Element Group:	Retaining Walls	Length:	10.0			
Element Name:	Walls	Width:				
Location:	SW Embankment	Height:	1.2			
Material:	Gabion Baskets	Count:	1			
Element Type:	Rock	Total Quantity:	12.0			
Environment:	Benign	Inspected	Yes <input checked="" type="checkbox"/>	No <input type="checkbox"/>	limited <input type="checkbox"/>	
Protection System:						Performance Deficiencies
Condition Data:	Units	Excellent	Good	Fair	Poor*	
	sq.m		12.0			
Comments: No evidence of settlement or sliding. Minor deviations in horizontal alignment.						
Recommended Work:	Rehab: <input type="checkbox"/>	Replace: <input type="checkbox"/>	Maintenance Needs:			
Urgent: <input type="checkbox"/>	1-5 Years: <input type="checkbox"/>	6-10 Years: <input type="checkbox"/>	None: <input checked="" type="checkbox"/>	Urgent: <input type="checkbox"/>	1 Year: <input type="checkbox"/>	2 Year: <input type="checkbox"/>
Element Photo:

Description of Photo:	Retaining Wall

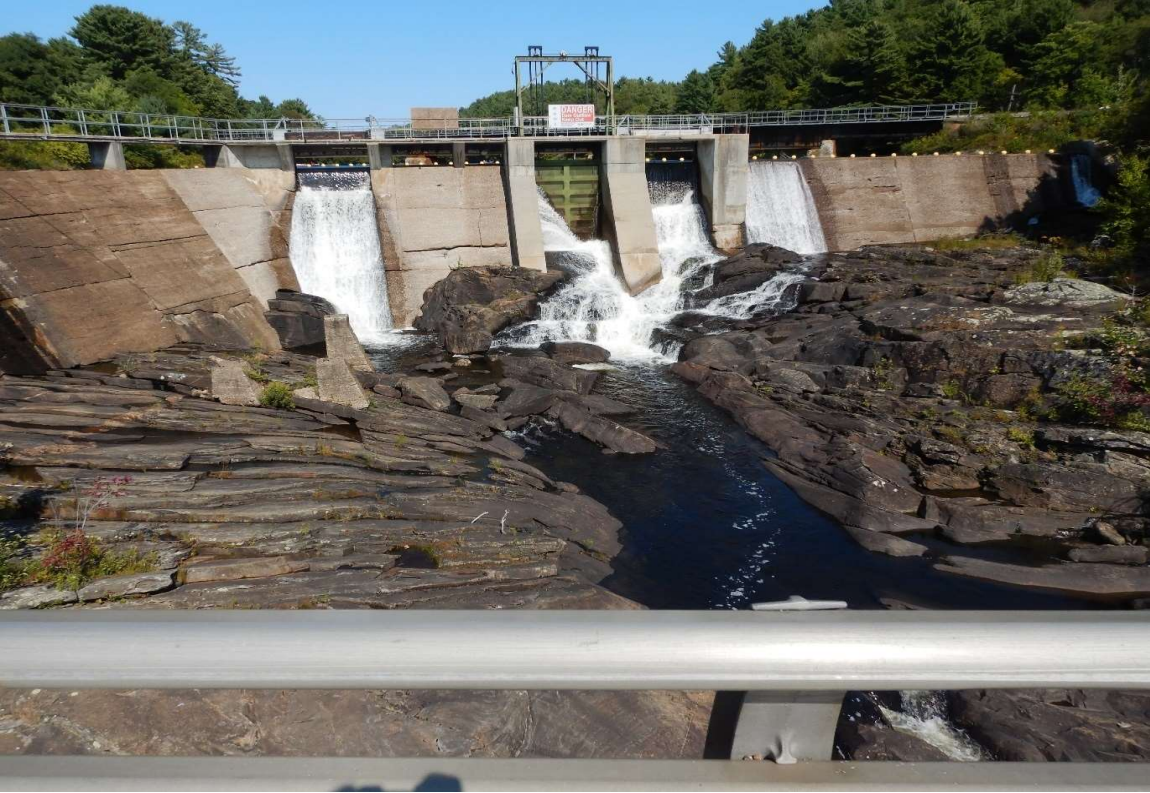
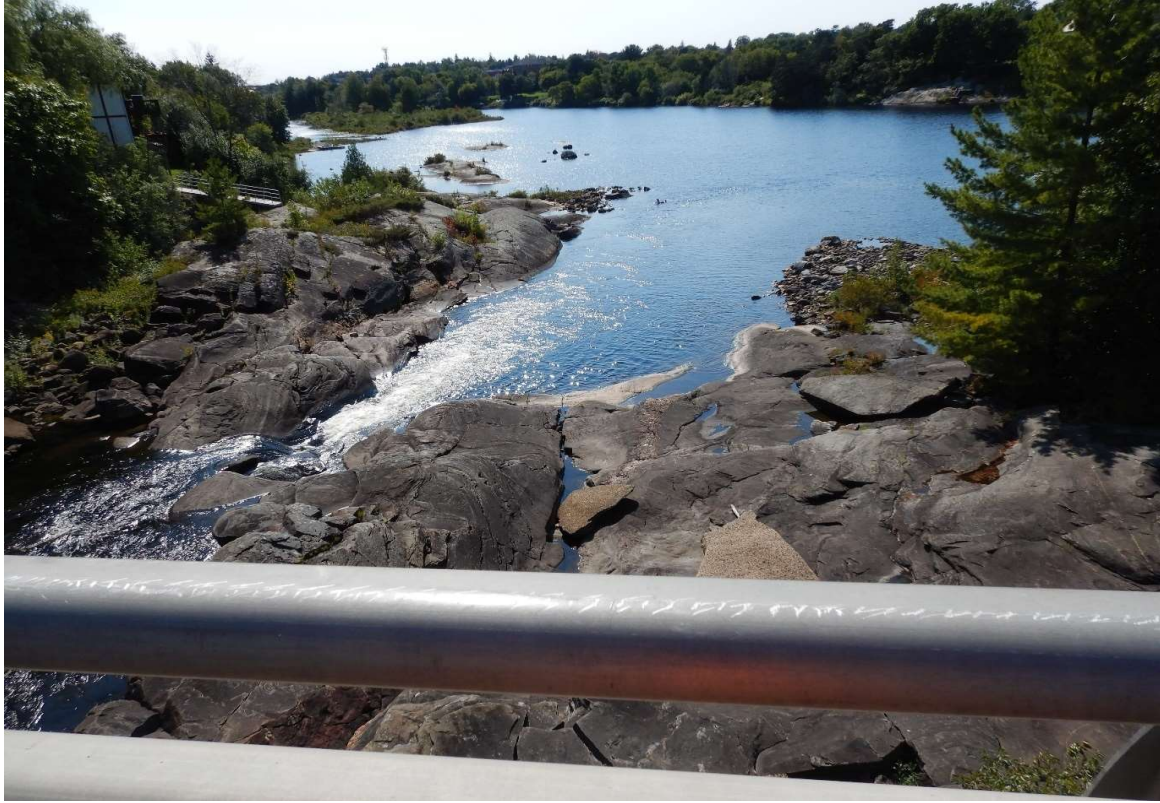
Element Data:						
Element Group:	Embankments & Streams		Length:			
Element Name:	Streams and Waterways		Width:			
Location:			Height:			
Material:			Count:	All		
Element Type:			Total Quantity:	All		
Environment:	Benign		Inspected	Yes <input checked="" type="checkbox"/>	No <input type="checkbox"/>	limited <input type="checkbox"/>
Protection System:						Performance Deficiencies
Condition Data:	Units	Excellent	Good	Fair	Poor*	
	all	X				
Comments: No observed defects.						
Recommended Work:		Rehab: <input type="checkbox"/>	Replace: <input type="checkbox"/>	Maintenance Needs:		
Urgent: <input type="checkbox"/>	1-5 Years: <input type="checkbox"/>	6-10 Years: <input type="checkbox"/>	None: <input checked="" type="checkbox"/>	Urgent: <input type="checkbox"/>	1 Year: <input type="checkbox"/>	2 Year: <input type="checkbox"/>
Element Photo:

Description of Photo: Streams and Waterways

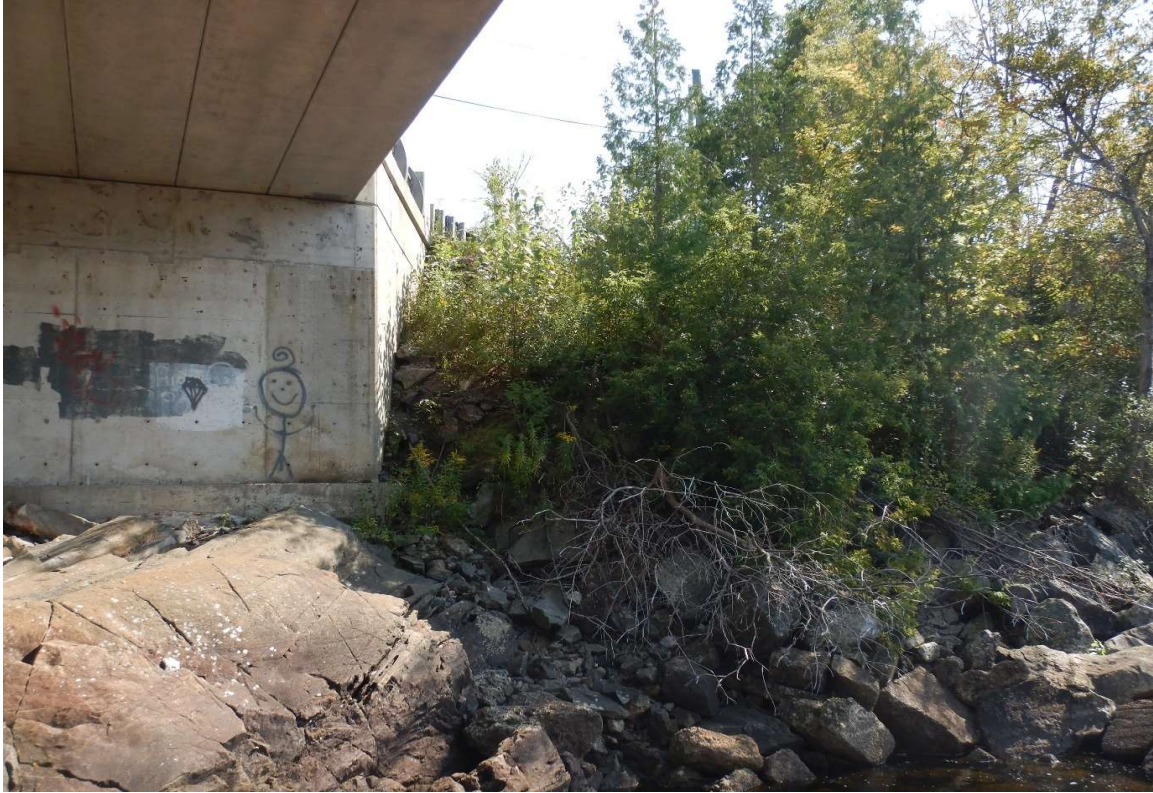
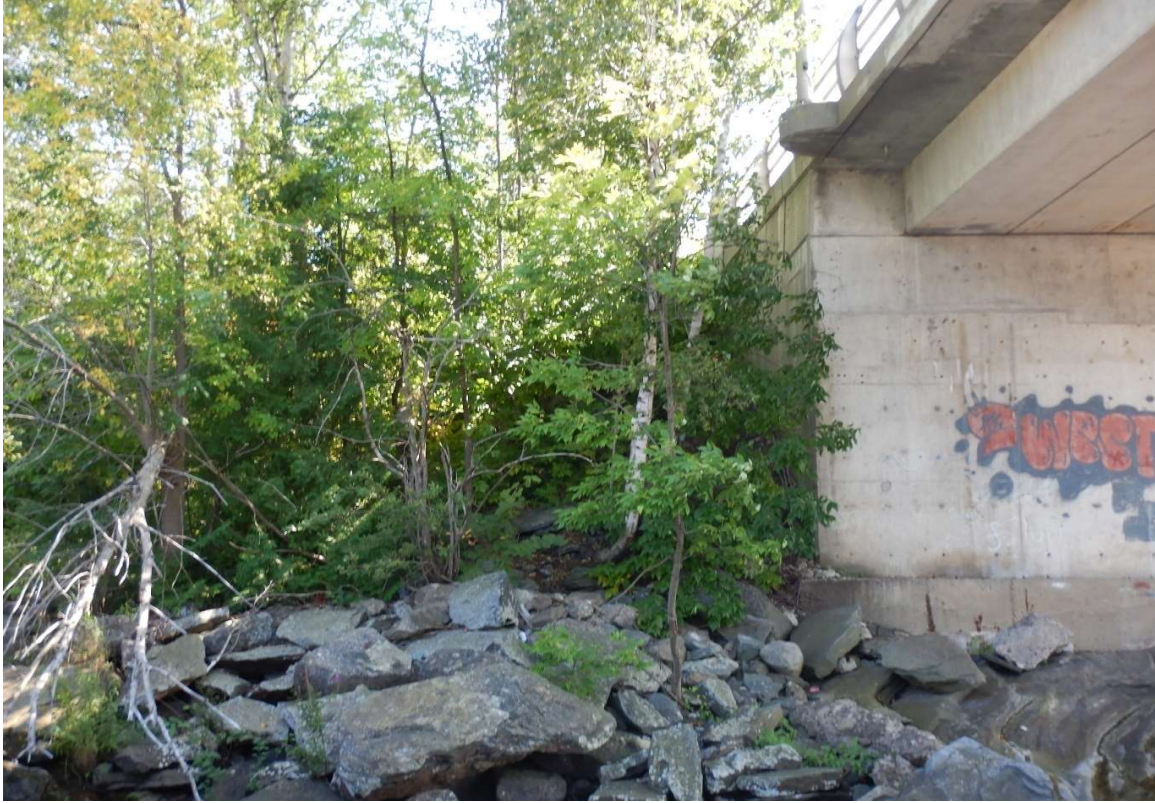
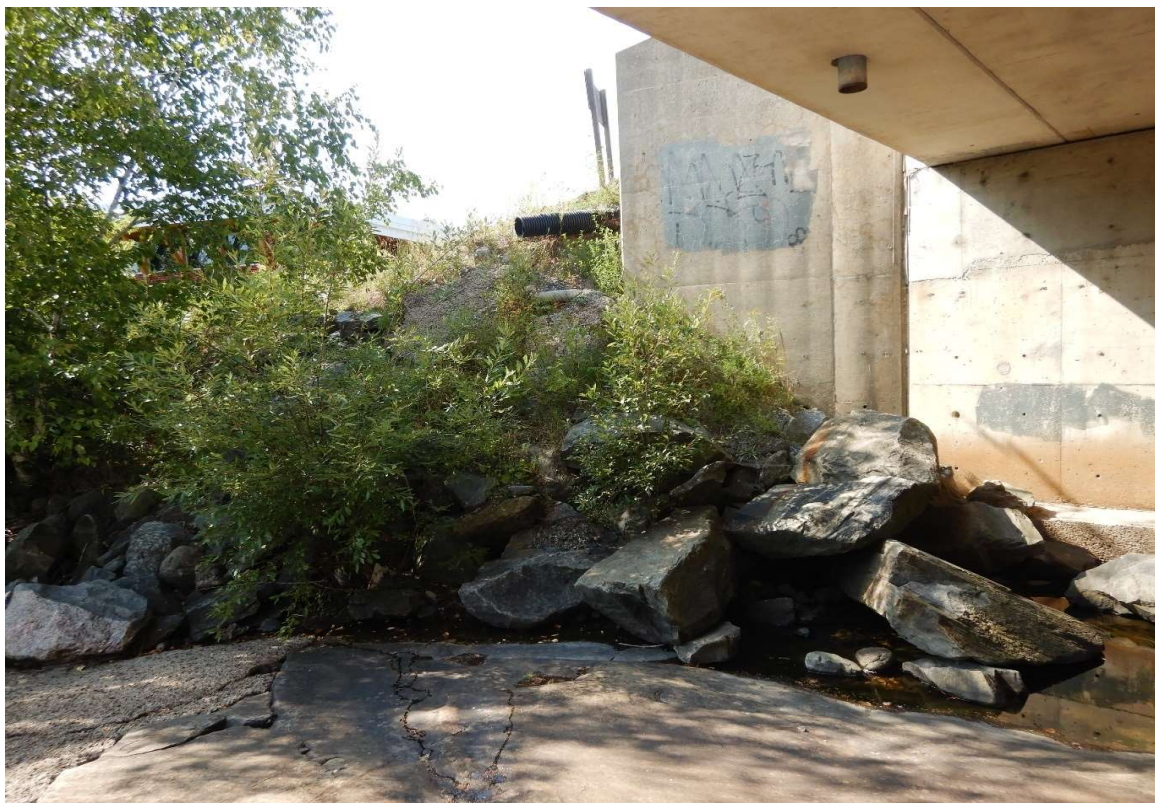
Element Data:						
Element Group:	Embankments & Streams		Length:			
Element Name:	Embankments		Width:			
Location:	SW, SE and NW Quadrants		Height:			
Material:	Trees, Shrubs and Earth		Count:	3		
Element Type:	Vegetation		Total Quantity:	3		
Environment:	Benign		Inspected	Yes <input checked="" type="checkbox"/>	No <input type="checkbox"/>	limited <input type="checkbox"/>
Protection System:						Performance Deficiencies
Condition Data:	Units	Excellent	Good	Fair	Poor*	
	each		3			
Comments: All 3 embankments are heavily vegetated. Light erosion on northwest quadrant. No embankment element present on northeast quadrant as it's part of the upstream dam.						
Recommended Work:		Rehab: <input type="checkbox"/>	Replace: <input type="checkbox"/>	Maintenance Needs:		
Urgent: <input type="checkbox"/>	1-5 Years: <input type="checkbox"/>	6-10 Years: <input type="checkbox"/>	None: <input checked="" type="checkbox"/>	Urgent: <input type="checkbox"/>	1 Year: <input type="checkbox"/>	2 Year: <input type="checkbox"/>

Description of Photo:		Southwest Embankment

Description of Photo: Southeast Embankment

Description of Photo: Northwest Embankment

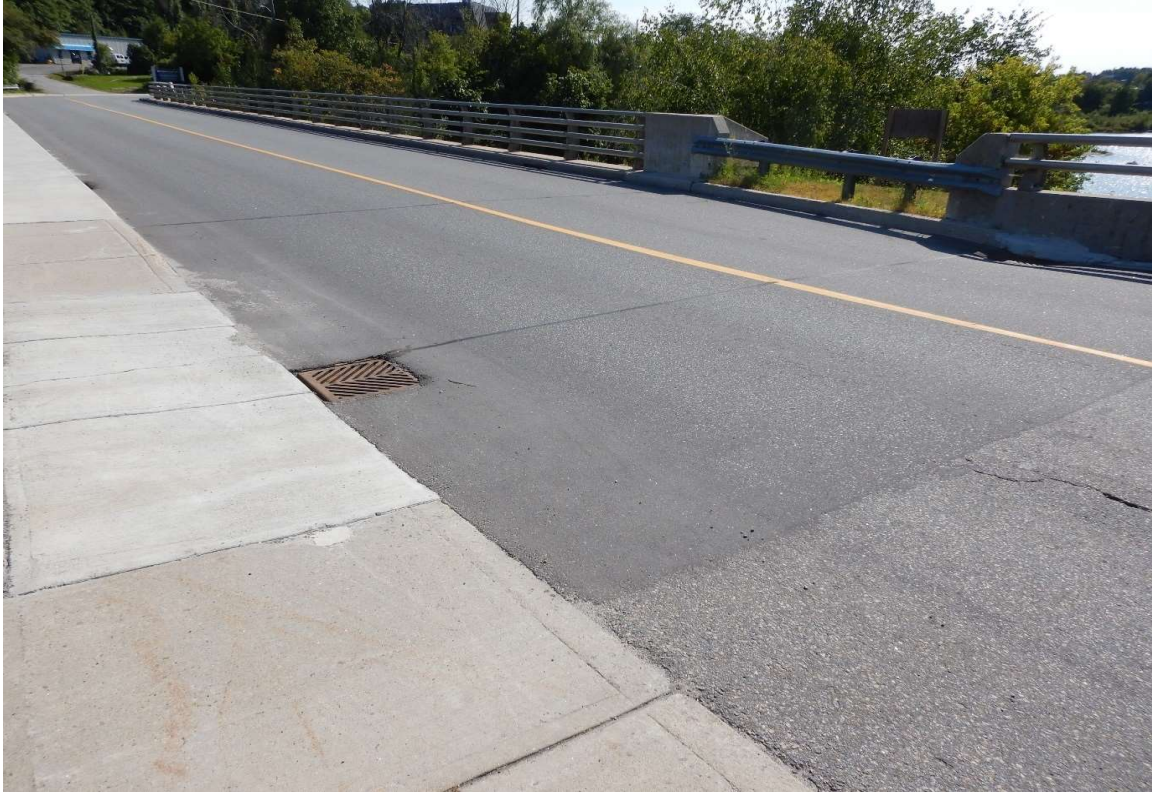
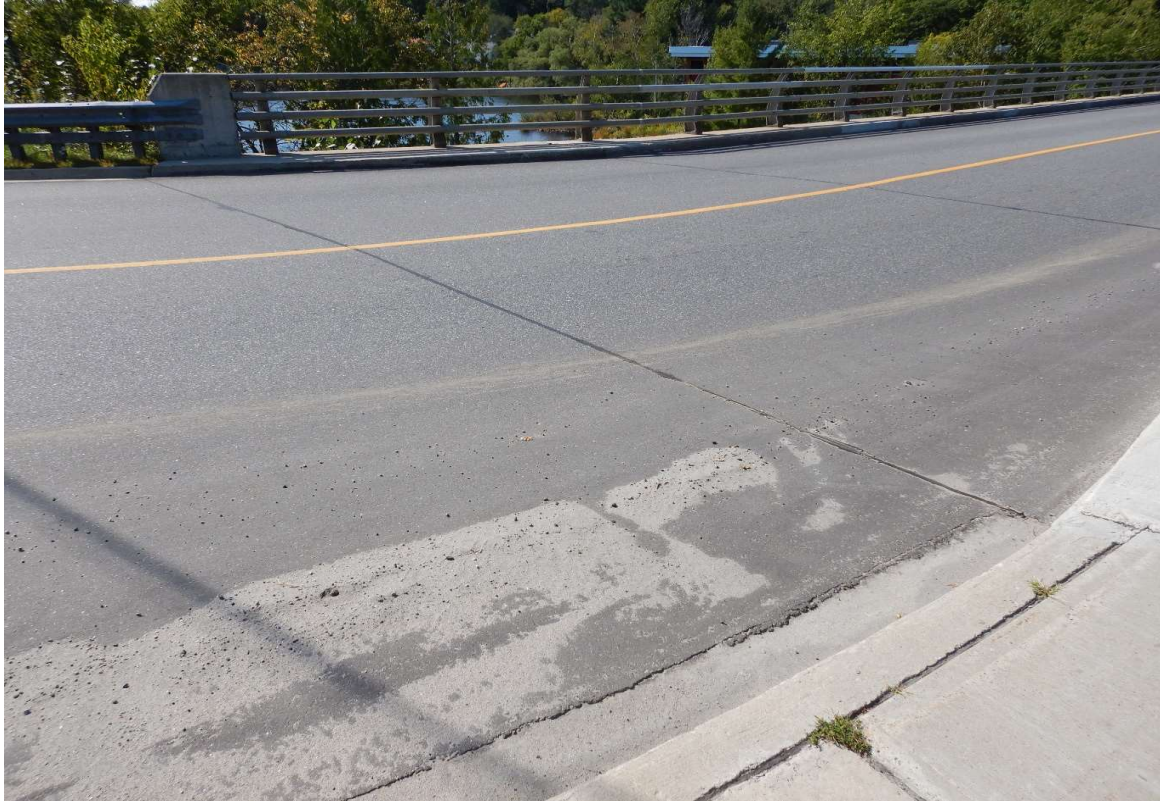
Element Data:						
Element Group:	Approaches		Length:	6.9		
Element Name:	Wearing Surface		Width:	8.5		
Location:			Height:	0.10		
Material:	Asphalt		Count:	2		
Element Type:			Total Quantity:	116.5		
Environment:	Severe		Inspected	Yes <input checked="" type="checkbox"/>	No <input type="checkbox"/>	limited <input type="checkbox"/>
Protection System:						Performance Deficiencies
Condition Data:	Units	Excellent	Good	Fair	Poor*	
	sq.m	116.5				
Comments: No observed defects.						
Recommended Work:		Rehab: <input type="checkbox"/>	Replace: <input type="checkbox"/>	Maintenance Needs:		
Urgent: <input type="checkbox"/>	1-5 Years: <input type="checkbox"/>	6-10 Years: <input type="checkbox"/>	None: <input checked="" type="checkbox"/>	Urgent: <input type="checkbox"/>	1 Year: <input type="checkbox"/>	2 Year: <input type="checkbox"/>
Element Photo:

Description of Photo: North approach

Description of Photo: South approach

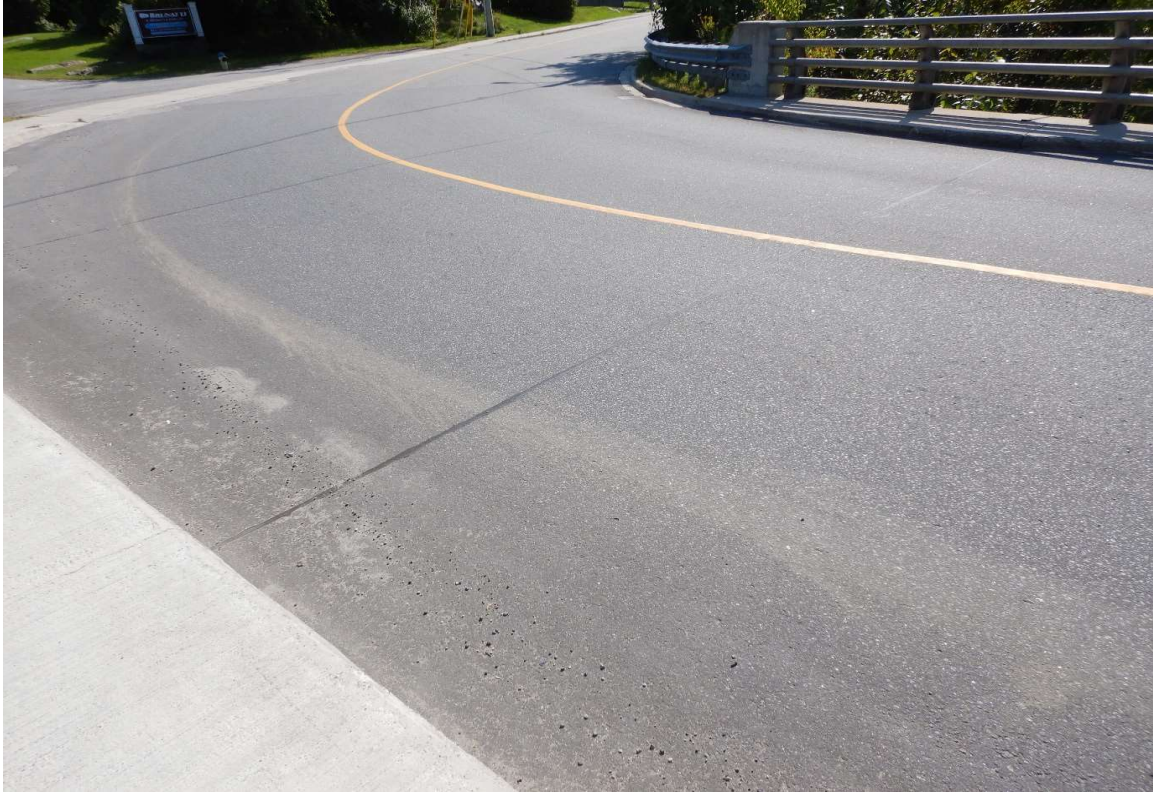
Description of Photo:		Approach slab

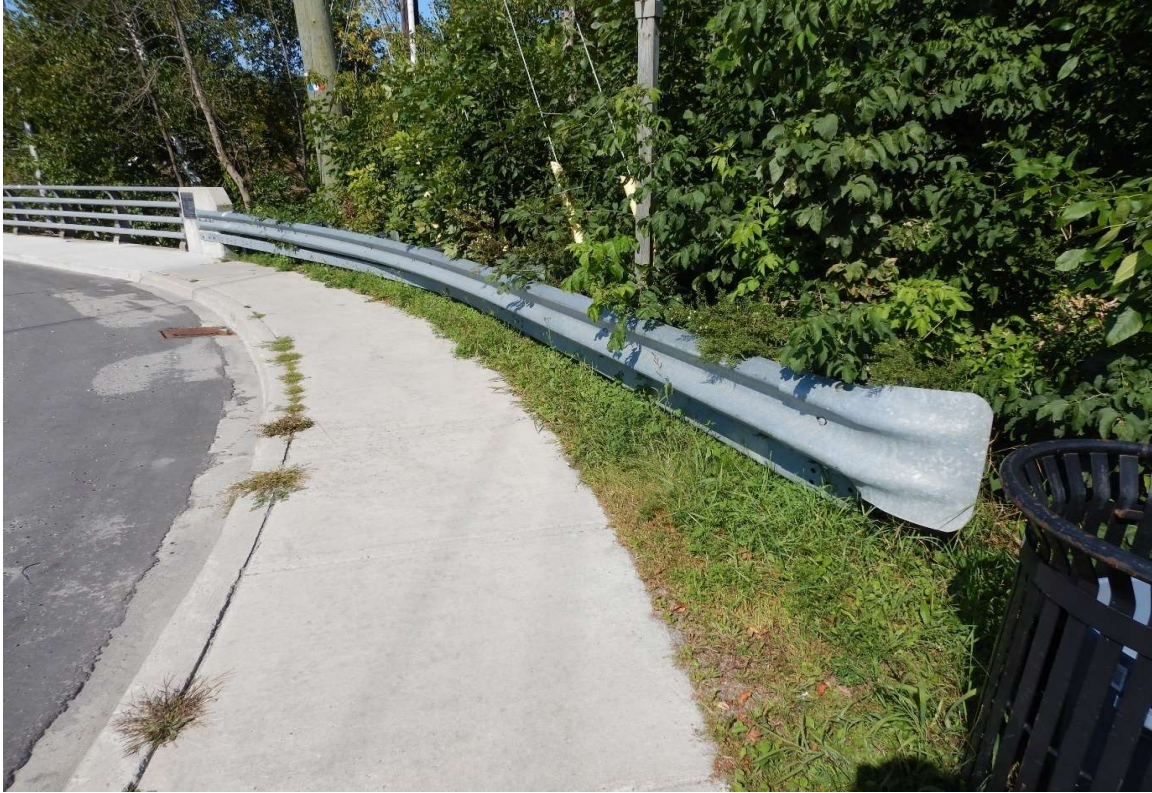
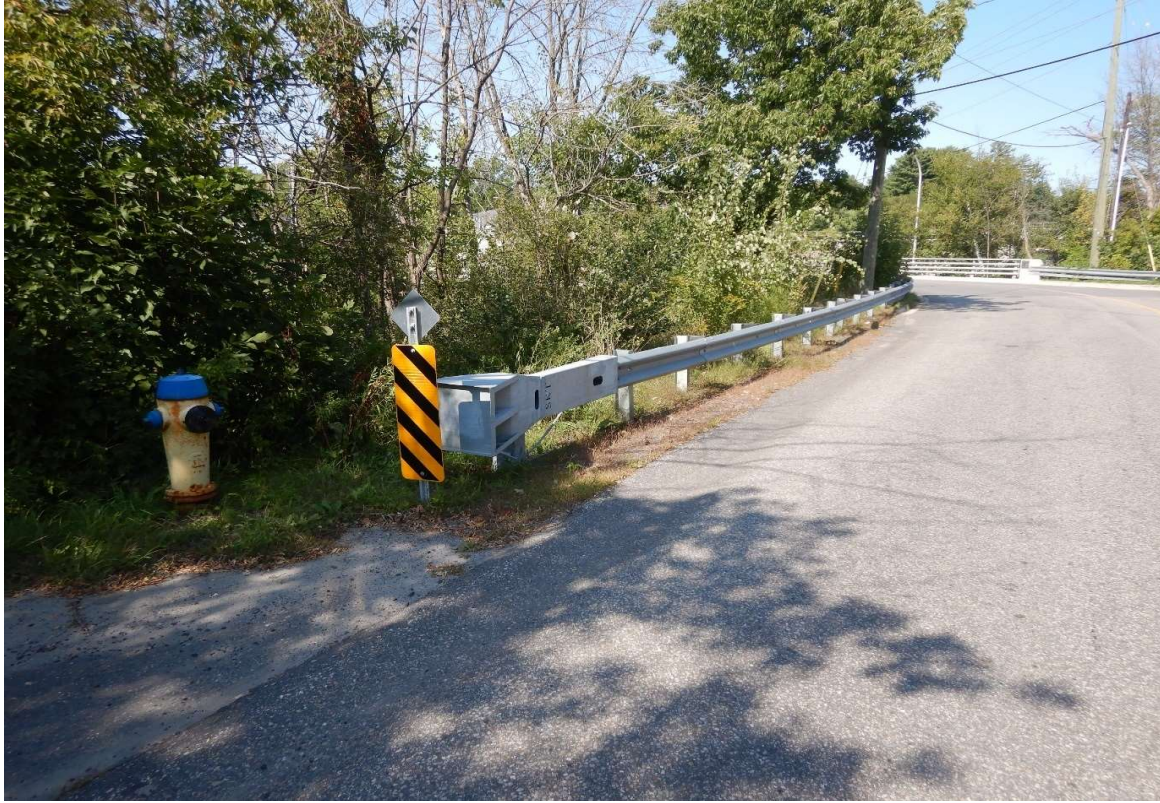
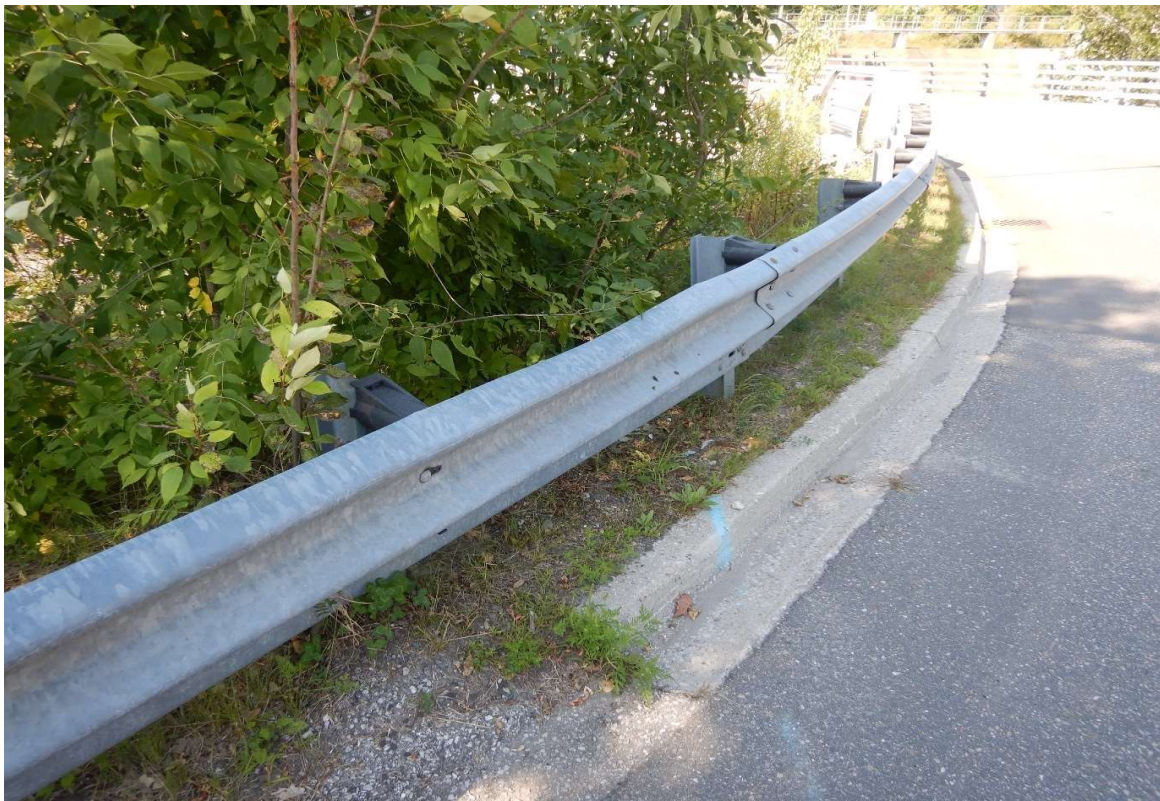
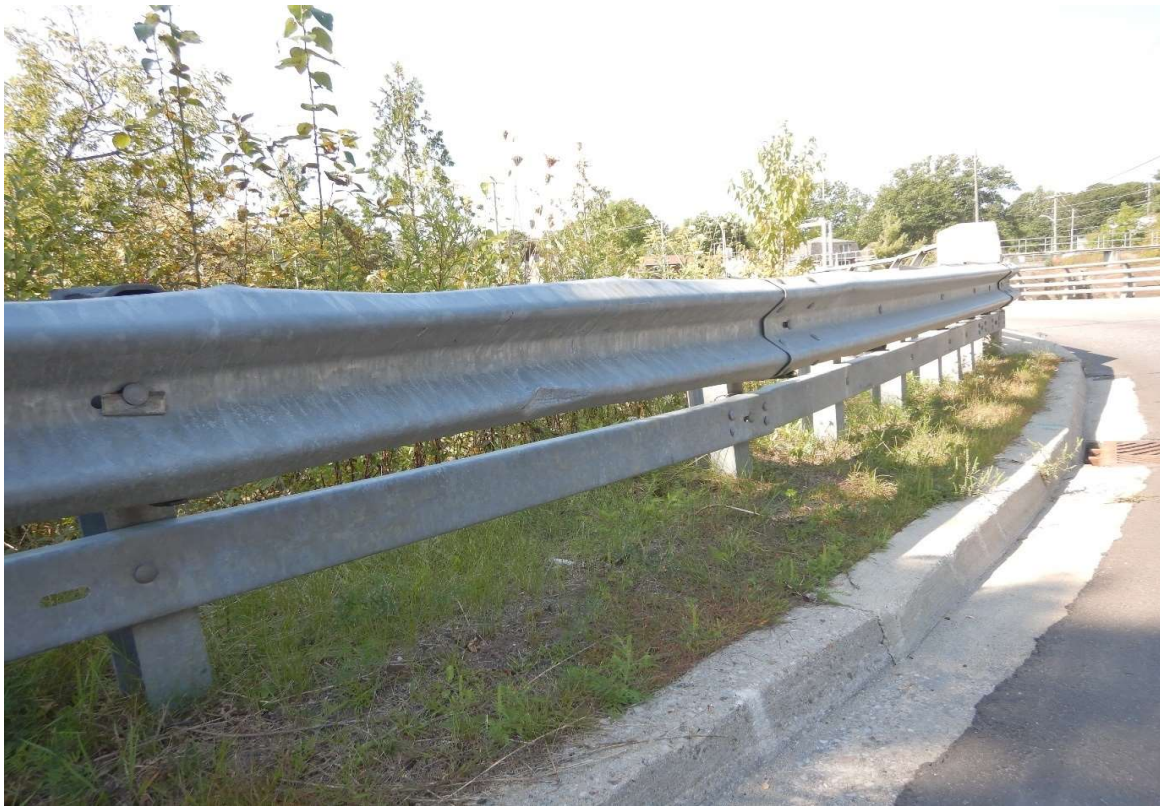
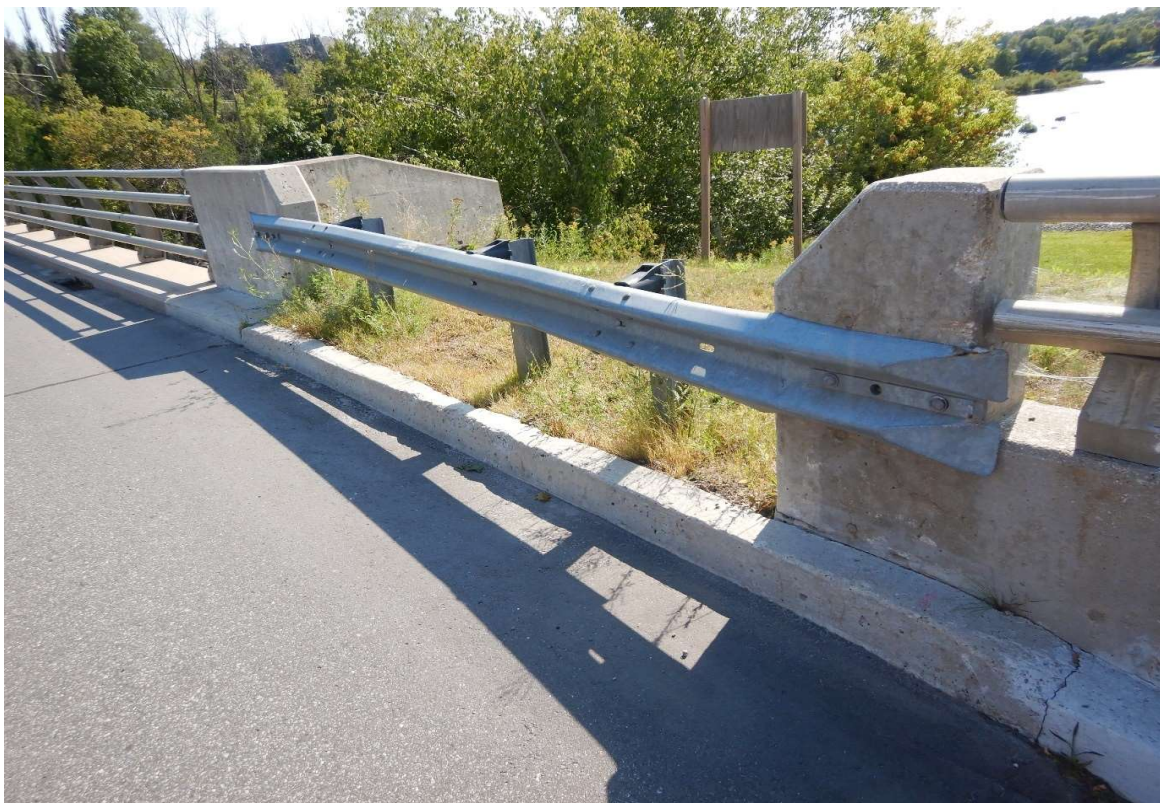
Description of Photo:		Approach Barrier

Description of Photo: Approach Barrier

Associated Work	Comments	Estimated Associated Work Cost
Approaches	Replace damaged rail sections, install end treatment	
Detours		
Traffic Control		
Utilities		
Other	Engineering and Contingency	
	General, Mobilization/Demobilization, Access, General	
Total Associated Work Cost		\$0
Total Construction Cost		\$0
