Bridge Needs Study 2024

INSPECTION SUMMARY REPORT

Town of Parry Sound

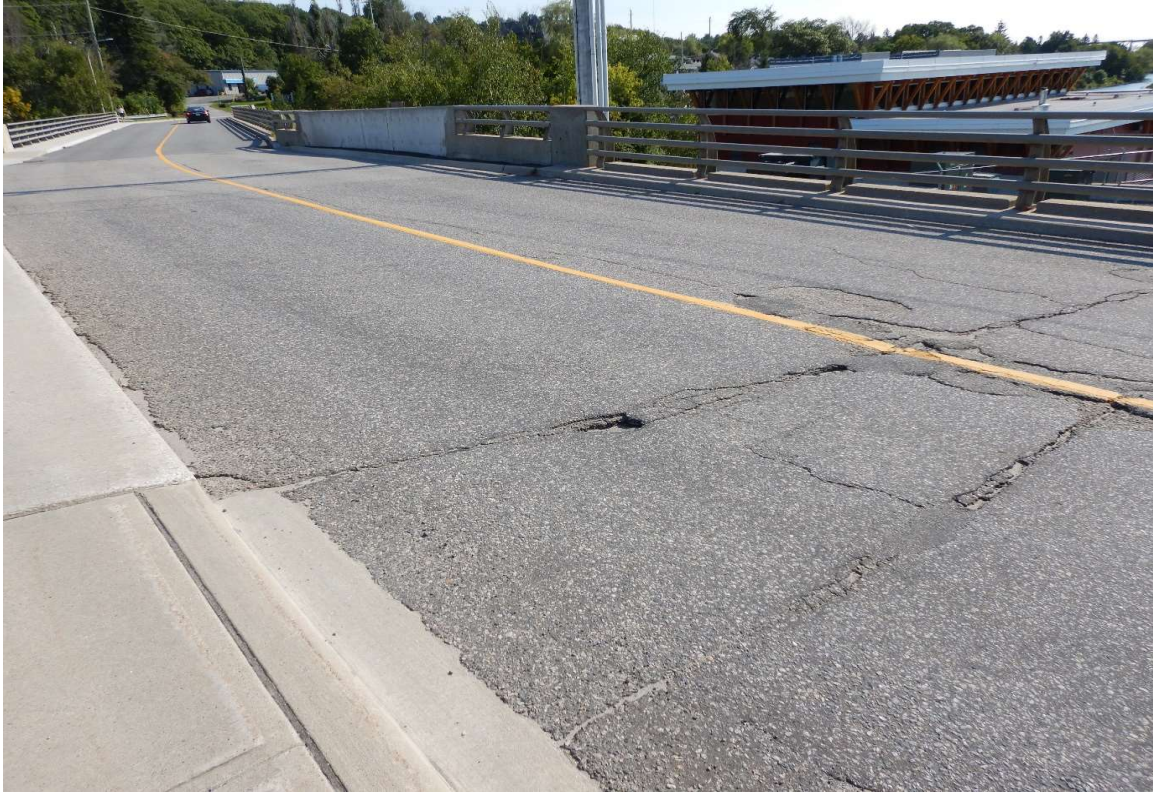
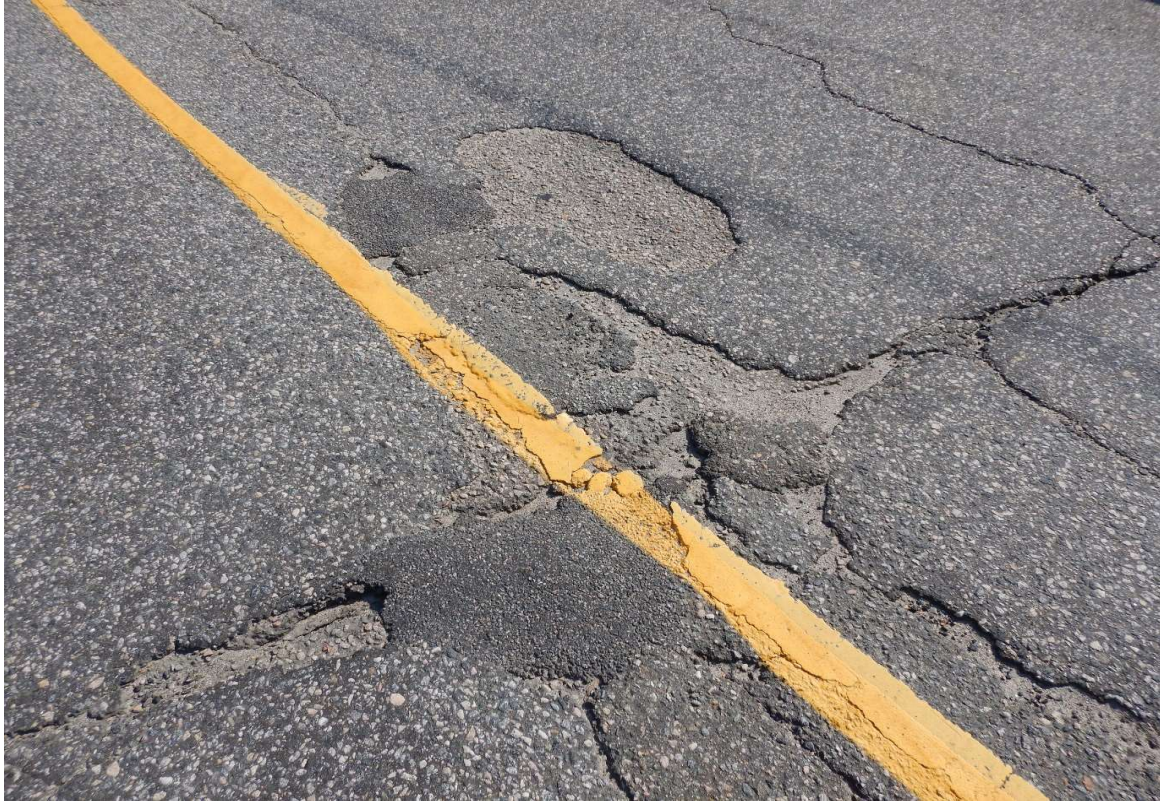
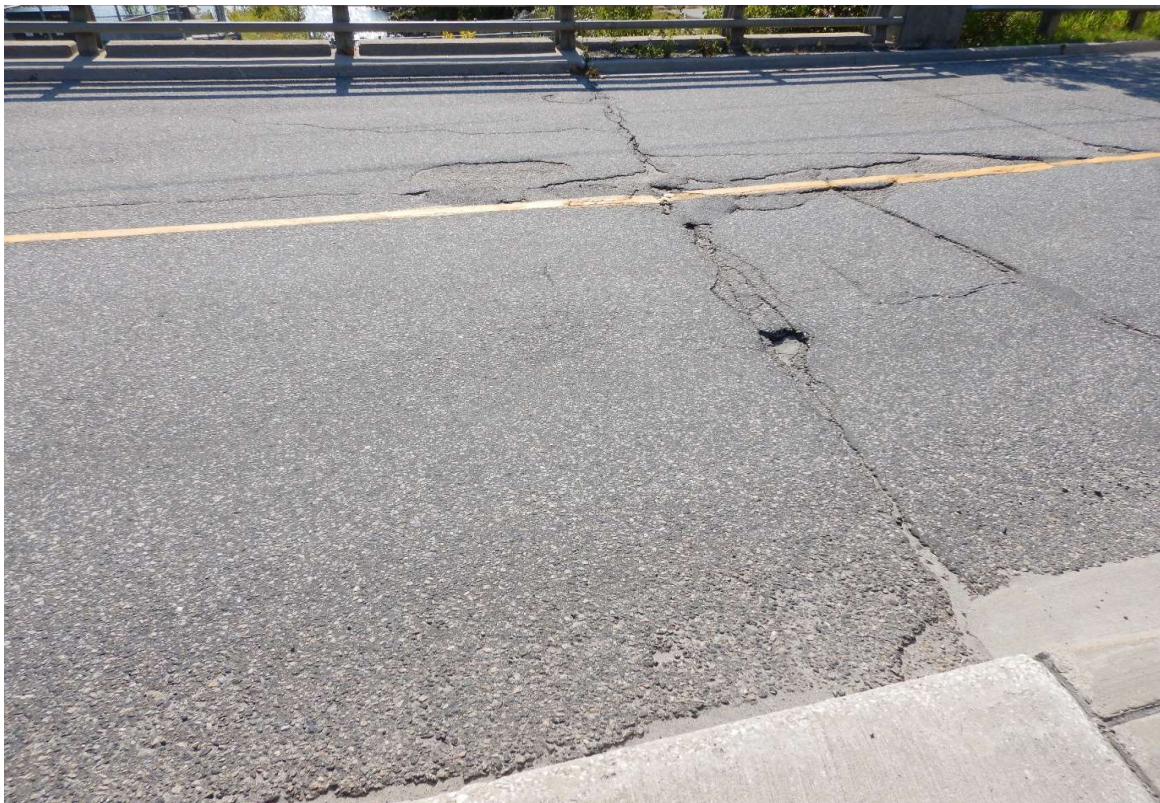
Description of Photo: Deck wearing surface

Repave asphalt			Repair Asphalt.			
Element Photo:

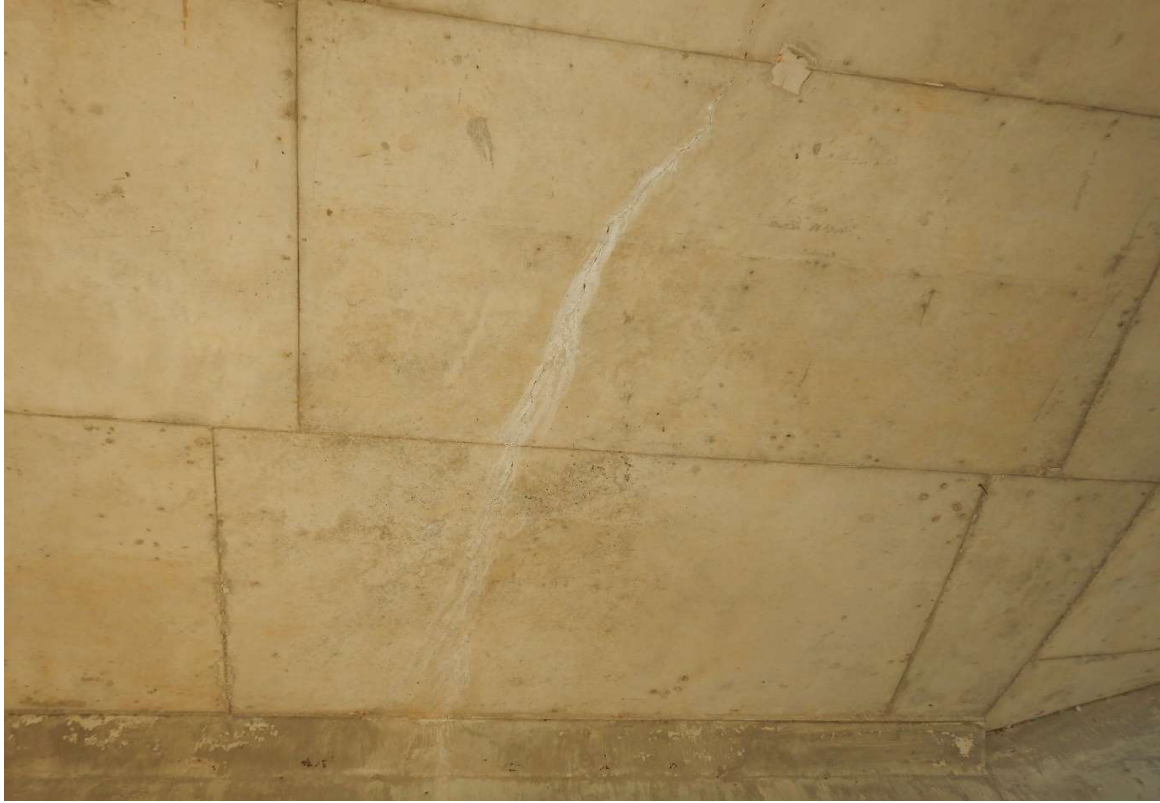
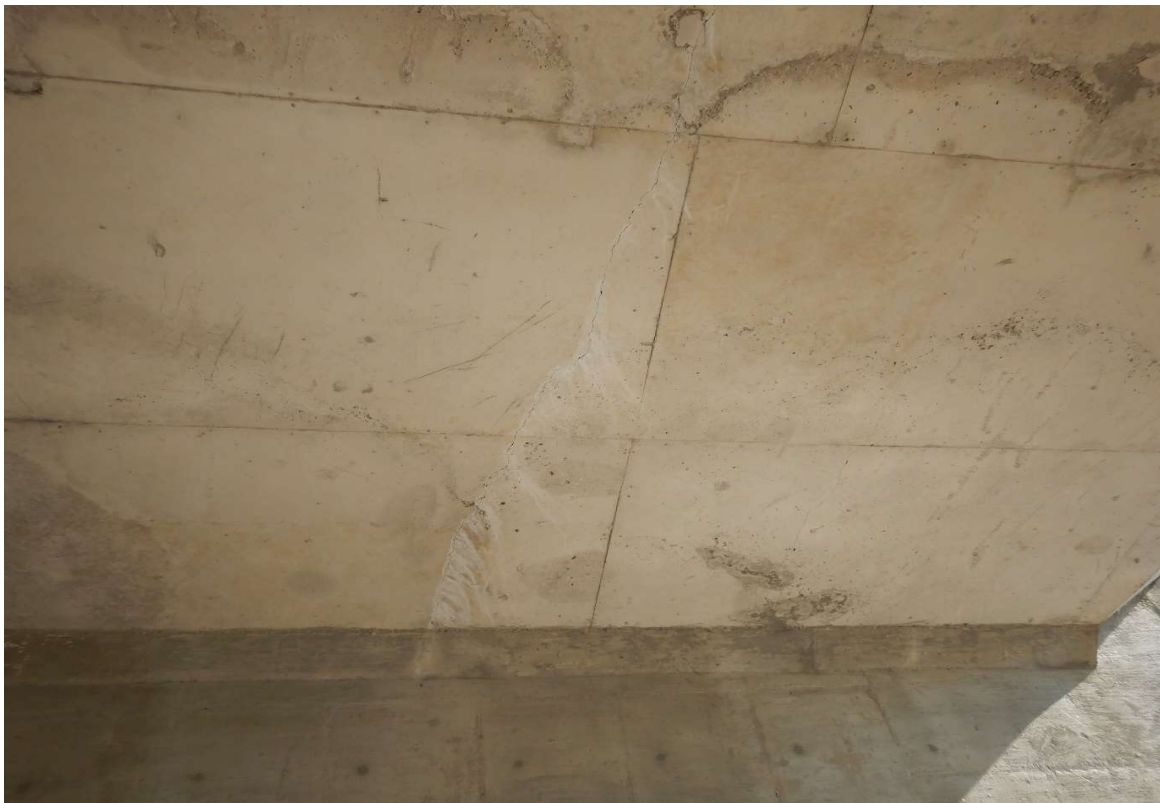
Description of Photo: Cracks with Efflorescence

Urgent: <input type="checkbox"/>	1-5 Years: <input type="checkbox"/>	6-10 Years: <input checked="" type="checkbox"/>	None: <input type="checkbox"/>	Urgent: <input type="checkbox"/>	1 Year: <input type="checkbox"/>	2 Year: <input type="checkbox"/>
Crack repair						
Element Photo:

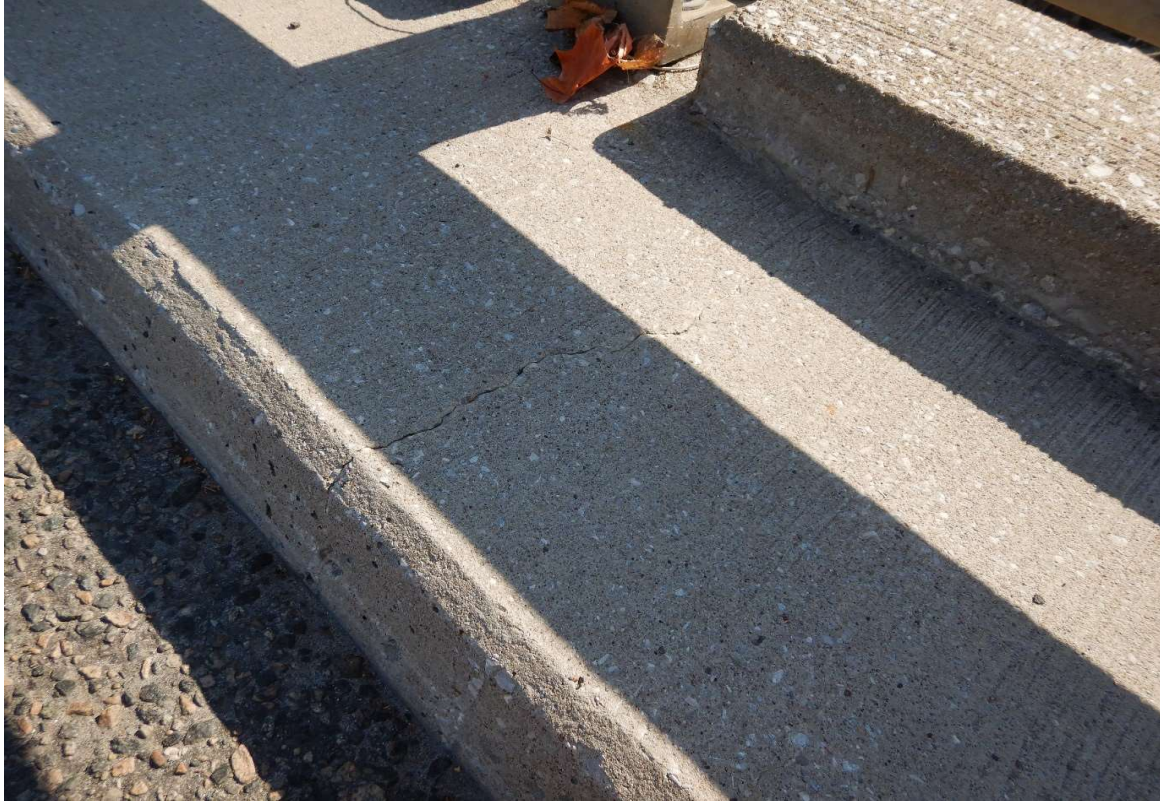
Description of Photo: West curb light cracks

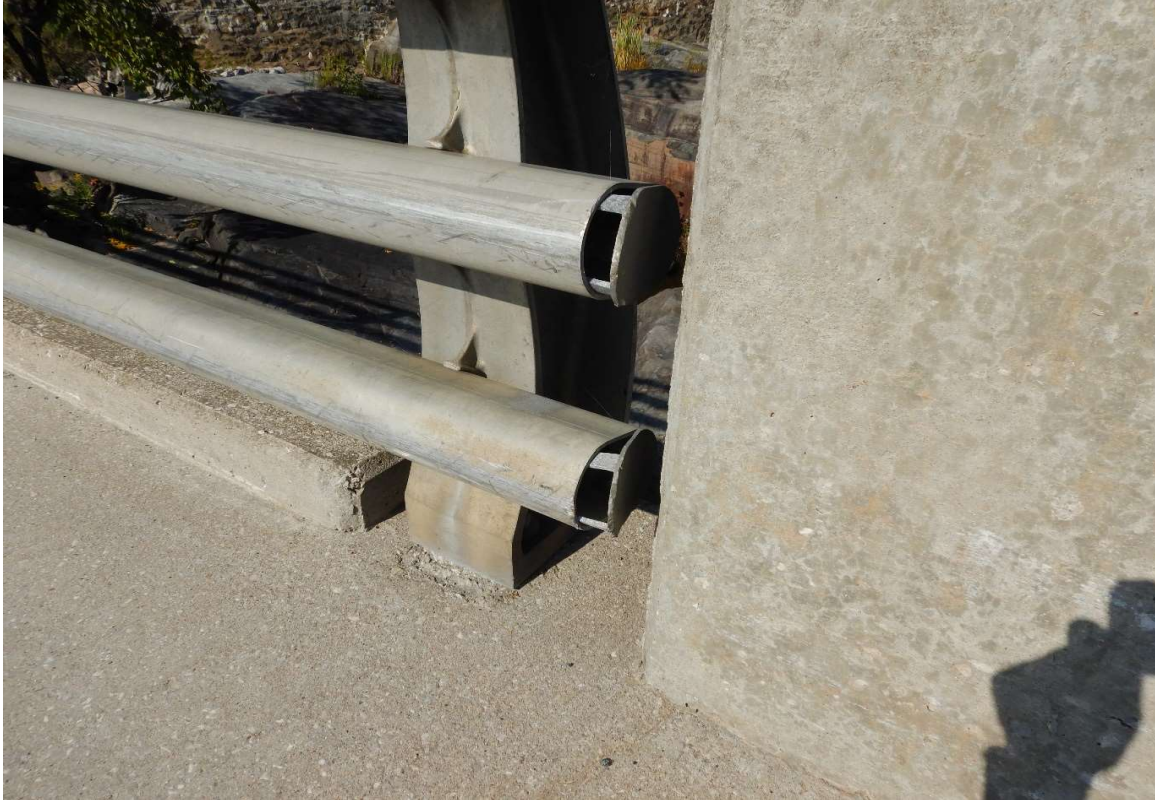
Description of Photo: East Rail, Note Dislodged End Caps

Replace 2 missing end caps, and reset 2 end caps.

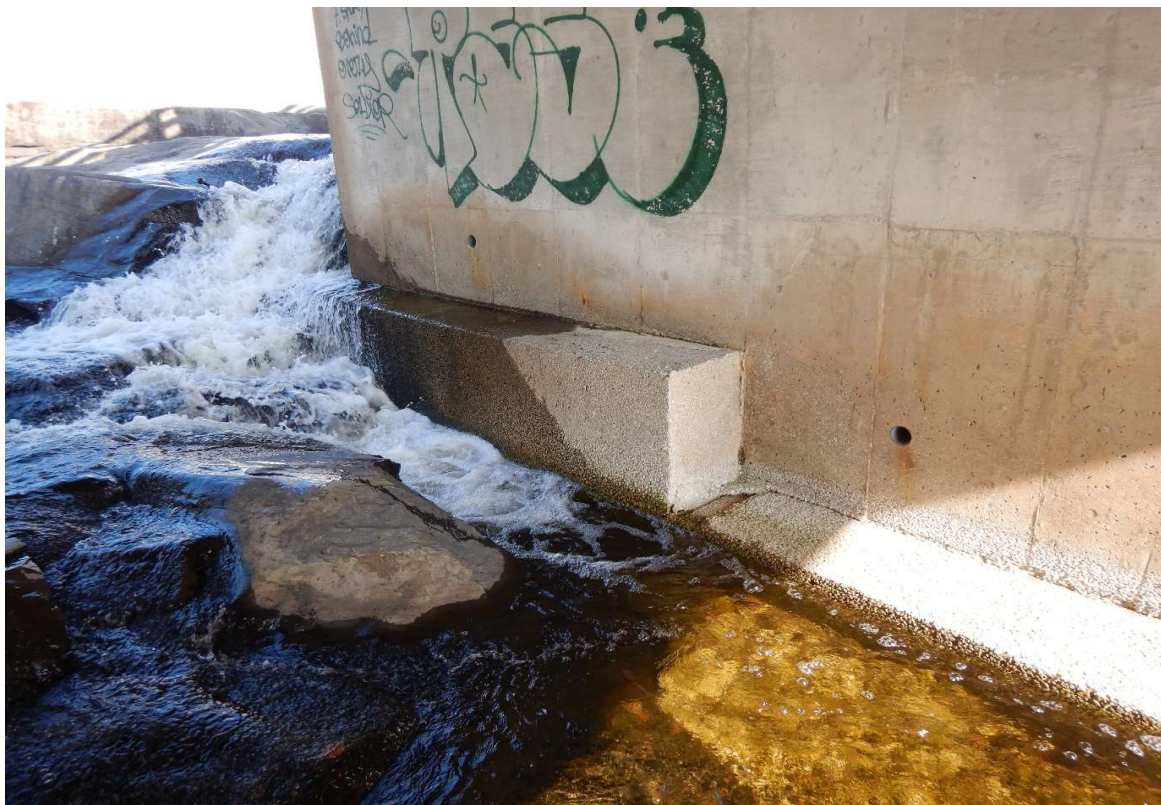
Description of Photo: South Footing

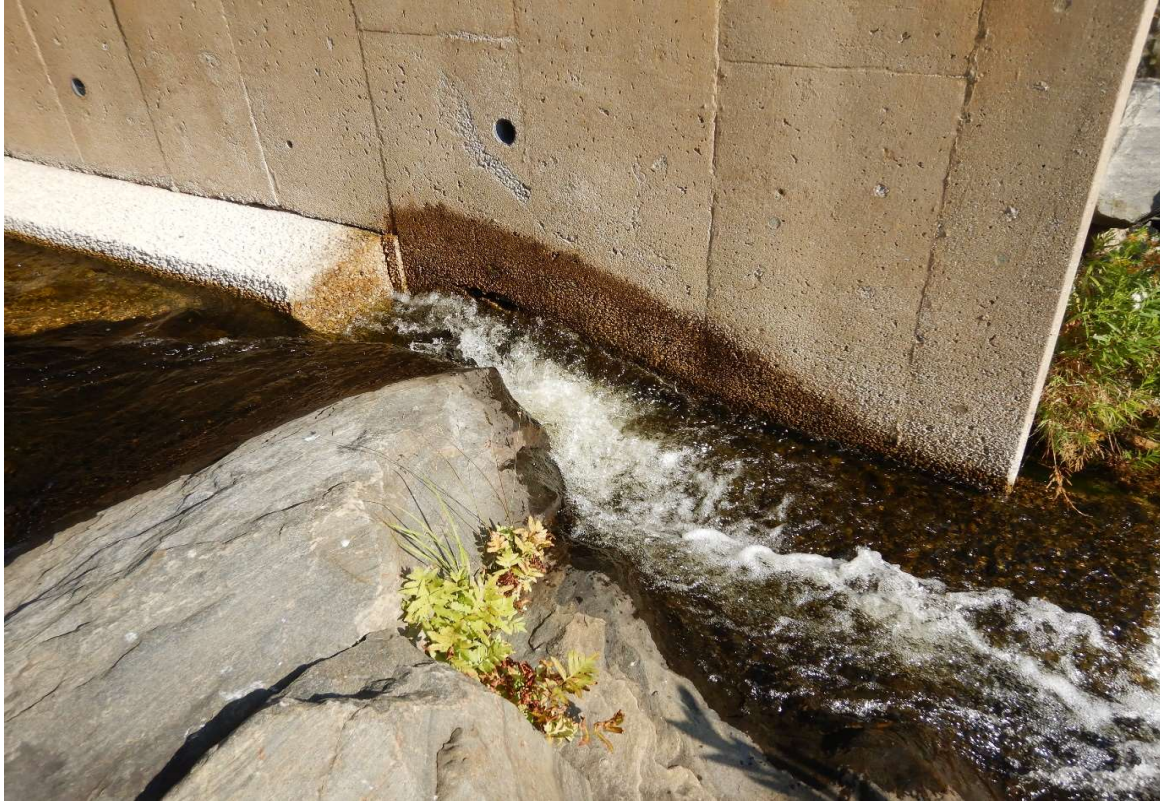
Element Data:						
Element Group:	Abutments		Length:			
Element Name:	Abutment Walls		Width:	11.3		
Location:	North and South		Height:	5.1		
Material:	Concrete		Count:	2		
Element Type:	Cast-in-place		Total Quantity:	115.6		
Environment:	Benign		Inspected	Yes <input checked="" type="checkbox"/>	No <input type="checkbox"/>	limited <input type="checkbox"/>
Protection System:						Performance Deficiencies
Condition Data:	Units	Excellent	Good	Fair	Poor*	
	sq.m		106.7	5.0	5.0	
Comments: Light scaling, typical. Light erosion at both ends of the footings. 4.0m of light cracking. 15.0m of medium cracking. 800mm of severe cracking at center of footing. Bottom of south wall has localized area of very severe scouring with a 500mm x 300mm x 100mm deep void with water churning within the void. 300mm x 100mm light scouring @ northwest corner. Severe scaling 200mm from bottom of wall for the full length on bridge on both sides. 400mm x 200mm spall at south footing.

Description of Photo: Void in South Footing, Water Churning

Recommended Work:		Rehab: <input type="checkbox"/>	Replace: <input type="checkbox"/>	Maintenance Needs:		8 - Concrete Repair
Urgent: <input type="checkbox"/>	1-5 Years: <input type="checkbox"/>	6-10 Years: <input type="checkbox"/>	None: <input checked="" type="checkbox"/>	Urgent: <input type="checkbox"/>	1 Year: <input type="checkbox"/>	2 Year: <input checked="" type="checkbox"/>
				Repair concrete void.

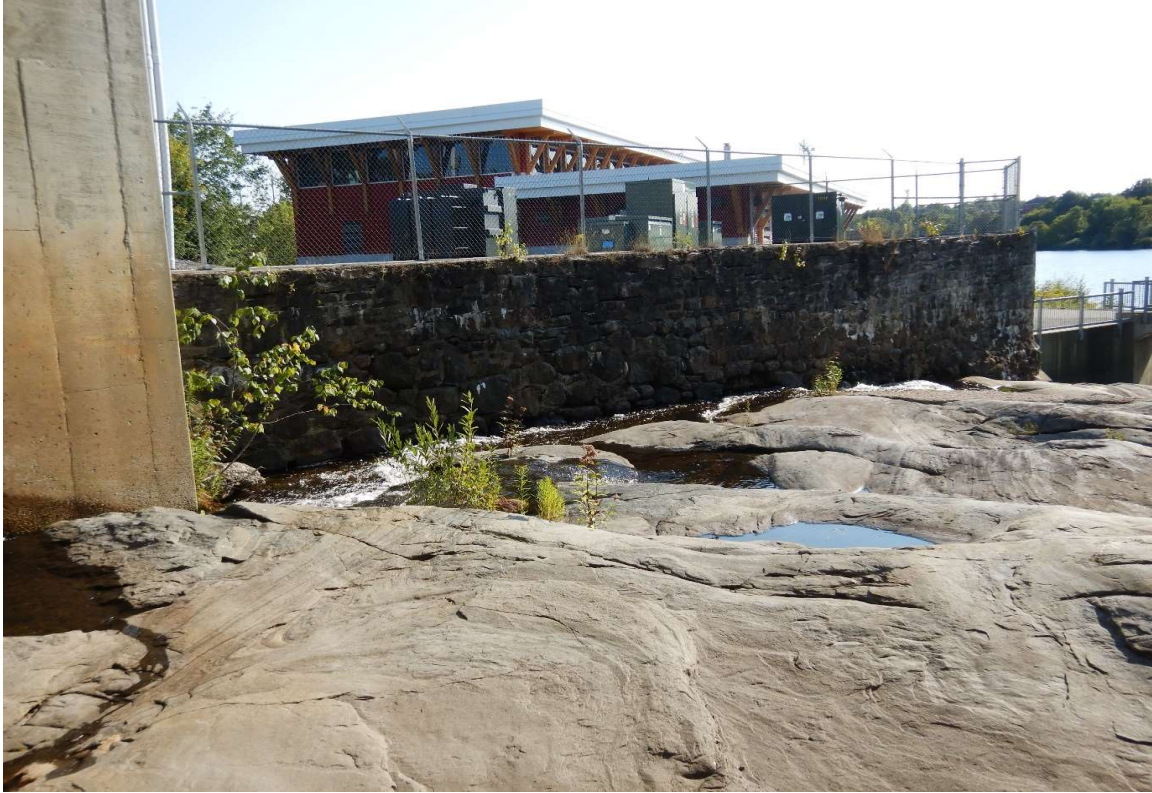
Description of Photo: Retaining wall

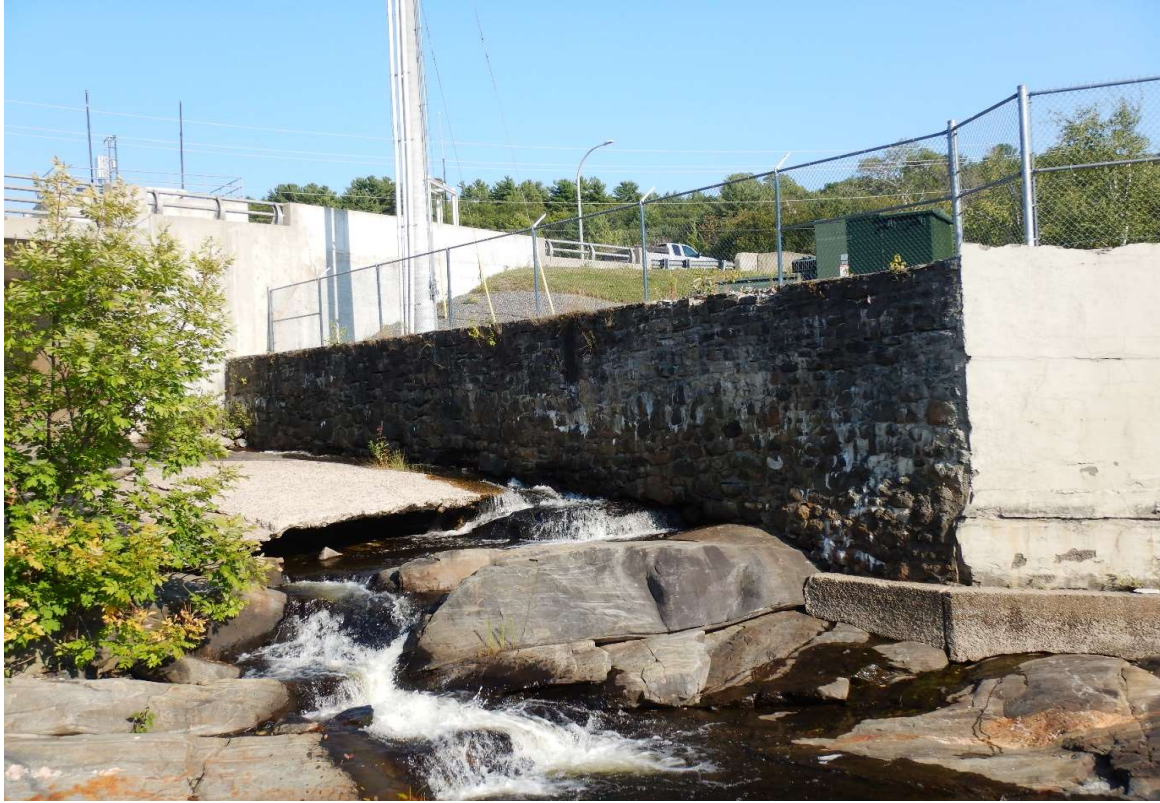
Description of Photo: Retaining wall

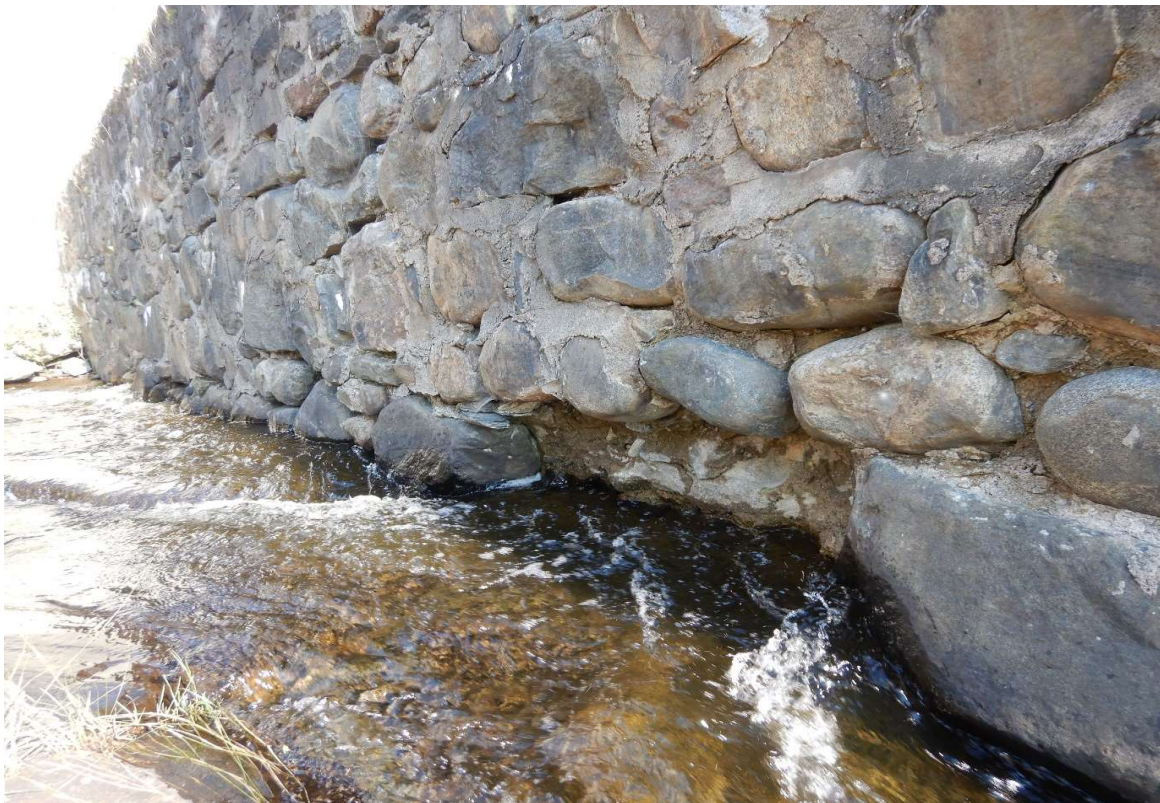
Description of Photo: Scouring in retaining wall

Urgent: <input type="checkbox"/>	1-5 Years: <input type="checkbox"/>	6-10 Years: <input type="checkbox"/>	None: <input checked="" type="checkbox"/>	Urgent: <input type="checkbox"/>	1 Year: <input type="checkbox"/>	2 Year: <input checked="" type="checkbox"/>
				Repair scouring at bottom of retaining wall. Confirm if this element belongs to the generation facility prior to undertaking repairs.		
Element Photo:

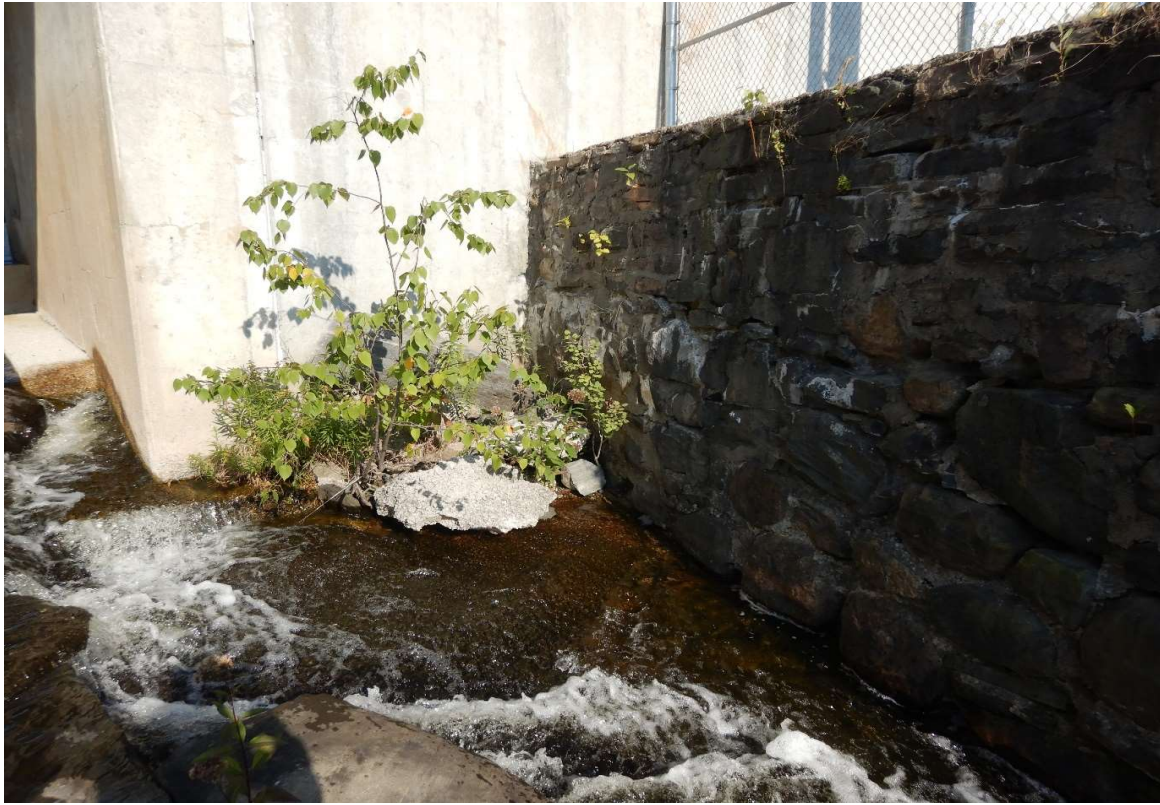
Description of Photo: Retaining wall

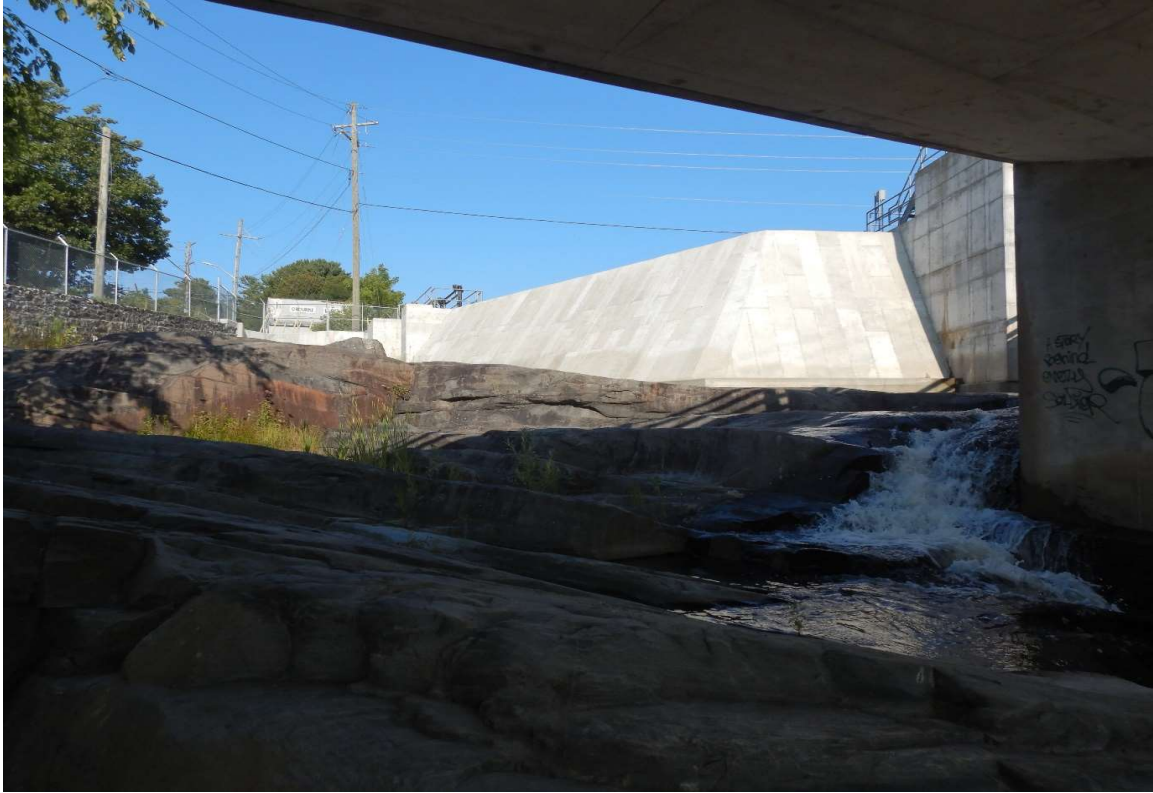
Description of Photo: Waterway

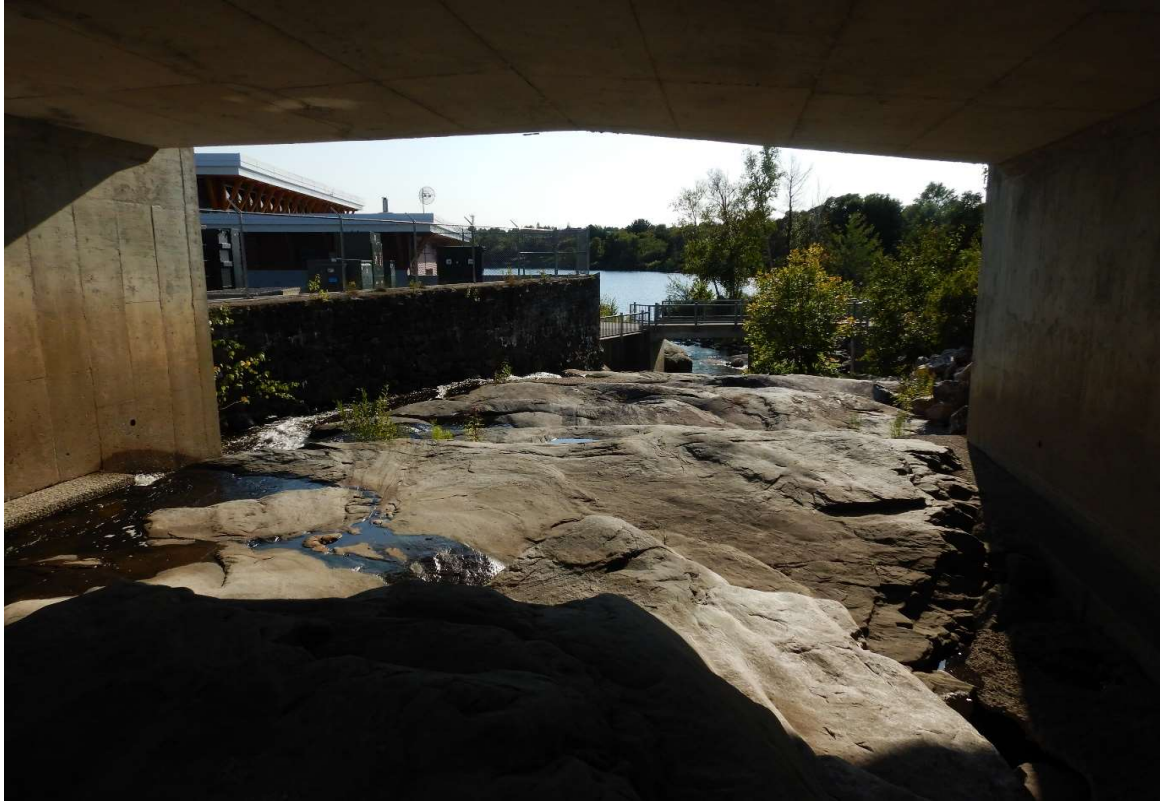
Description of Photo: Waterway

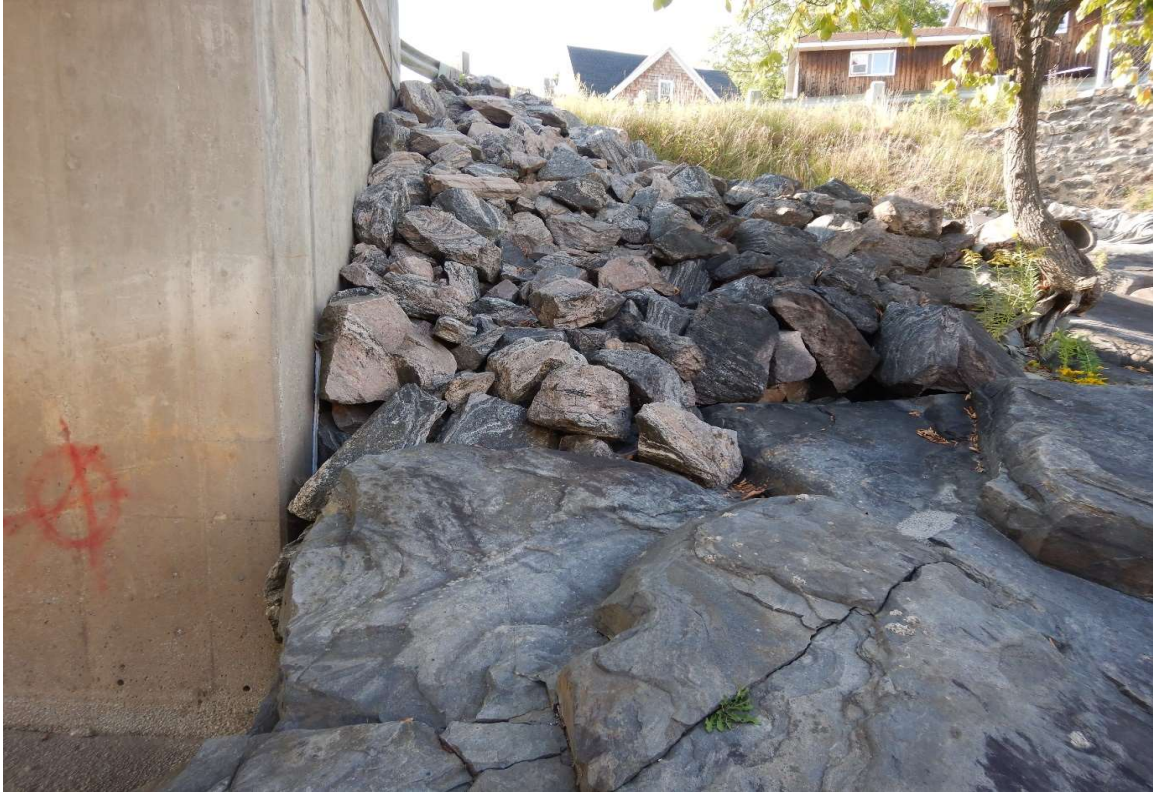
Description of Photo:		Northeast embankment

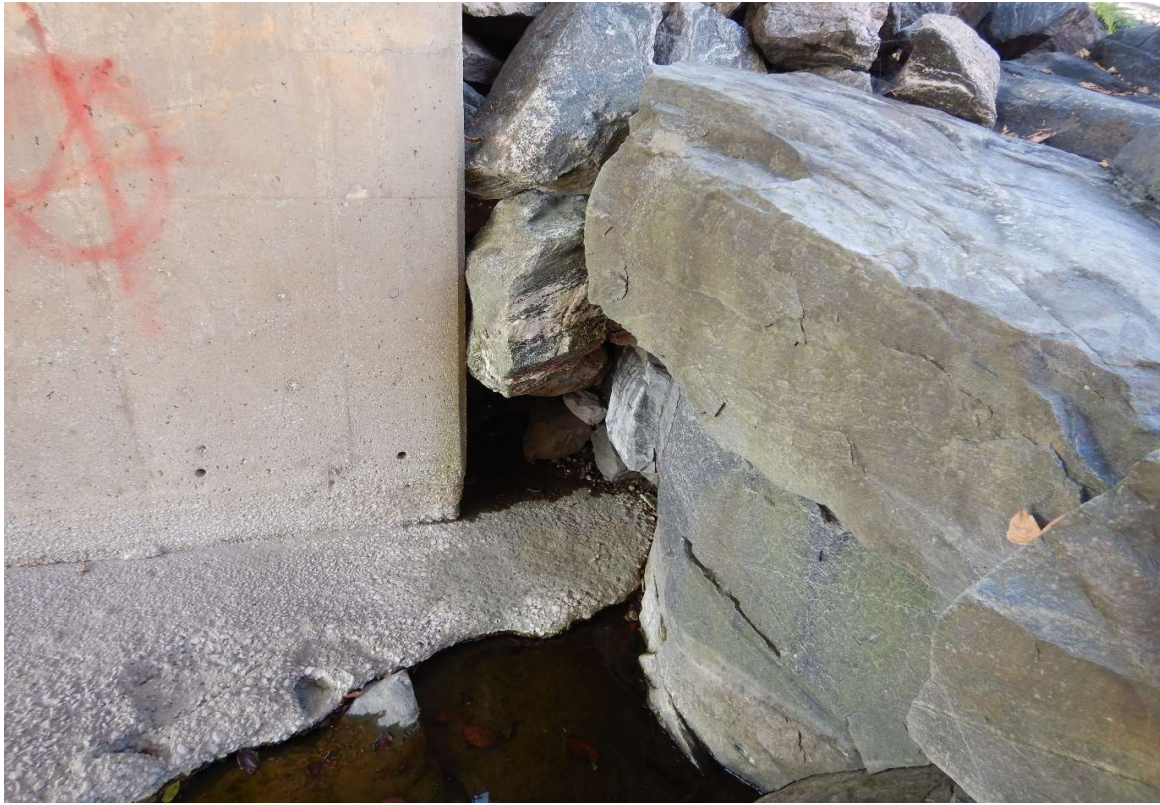
Description of Photo: Void at northeast embankment

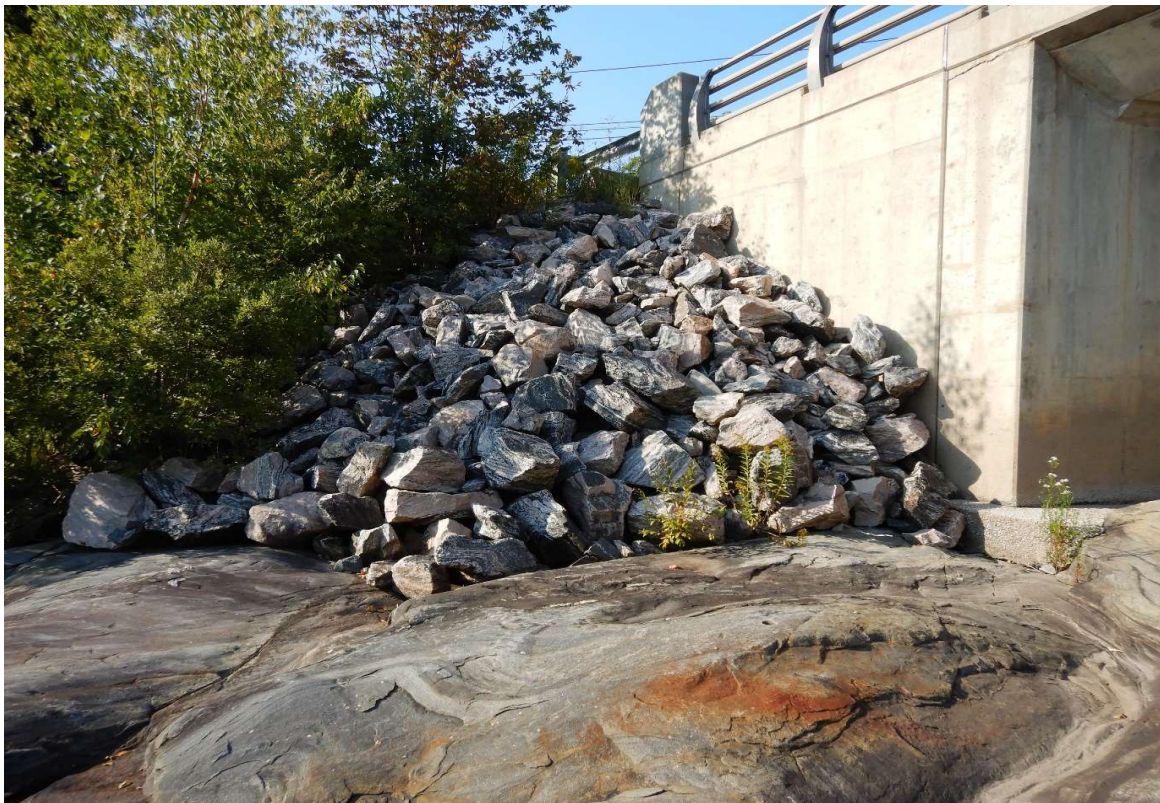
Description of Photo: Northwest embankment

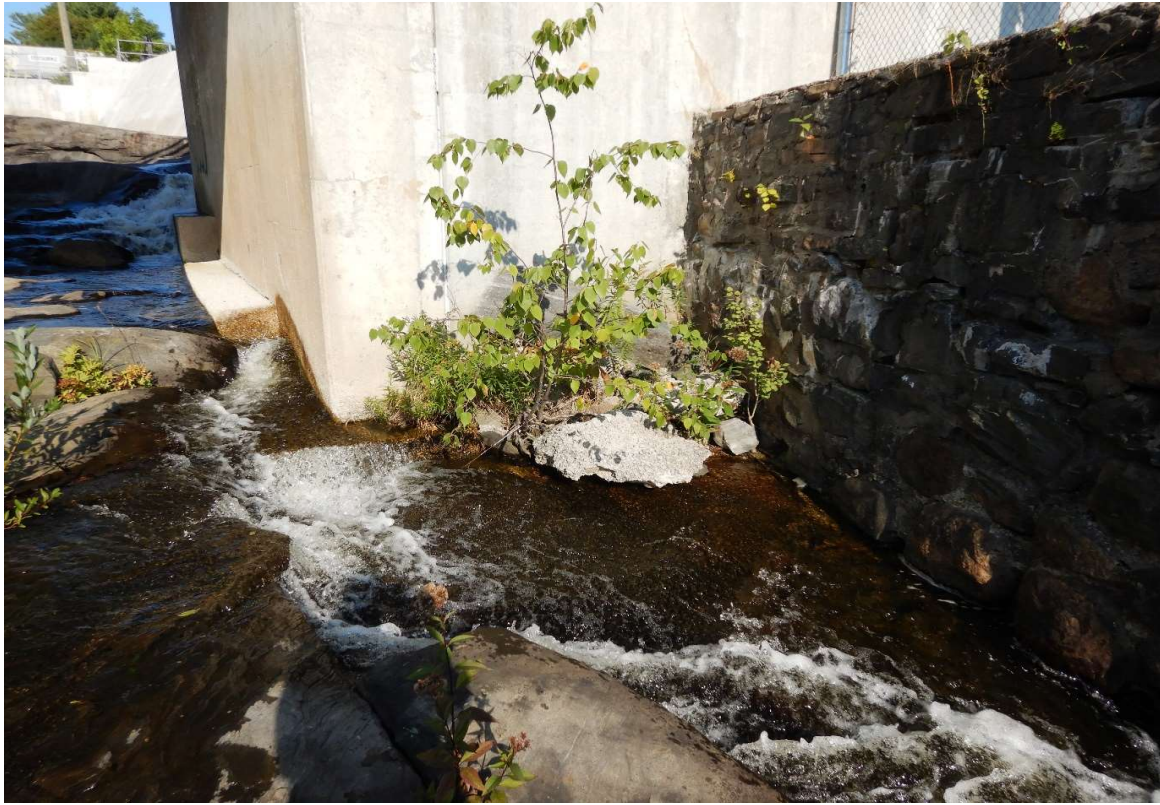
Description of Photo: Southwest embankment

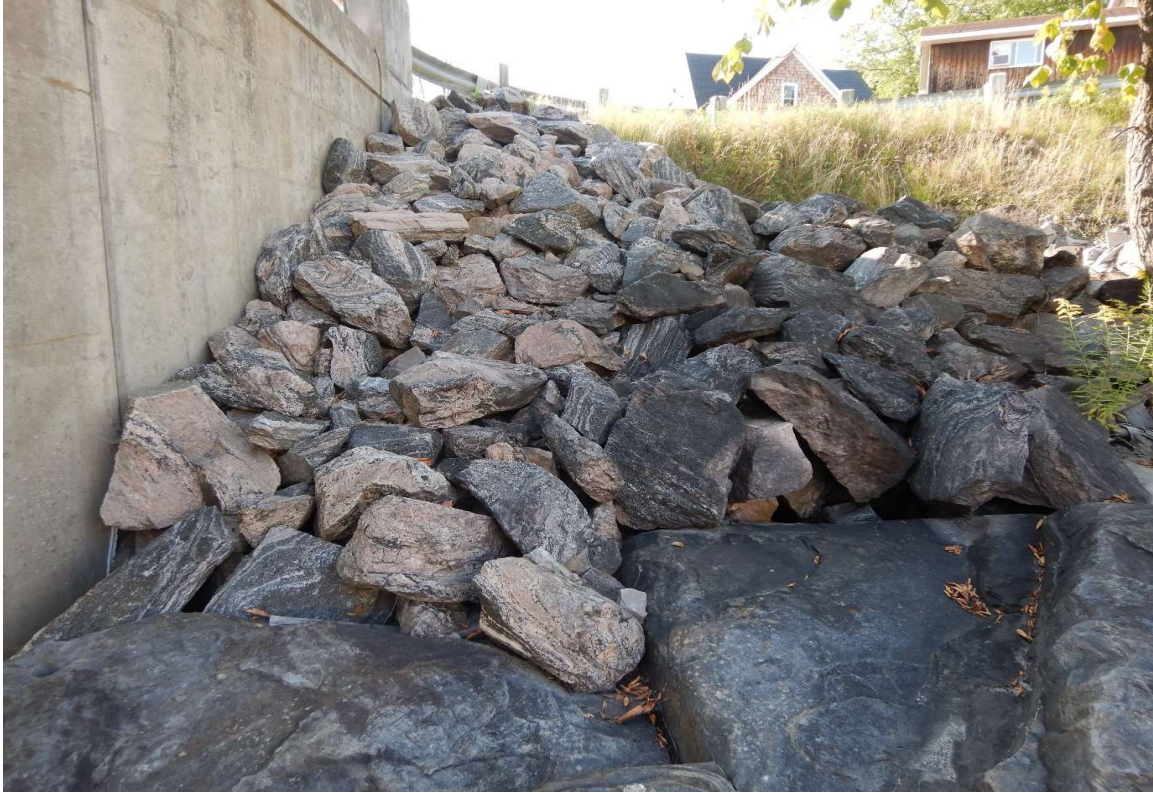
Description of Photo: Slope Protection

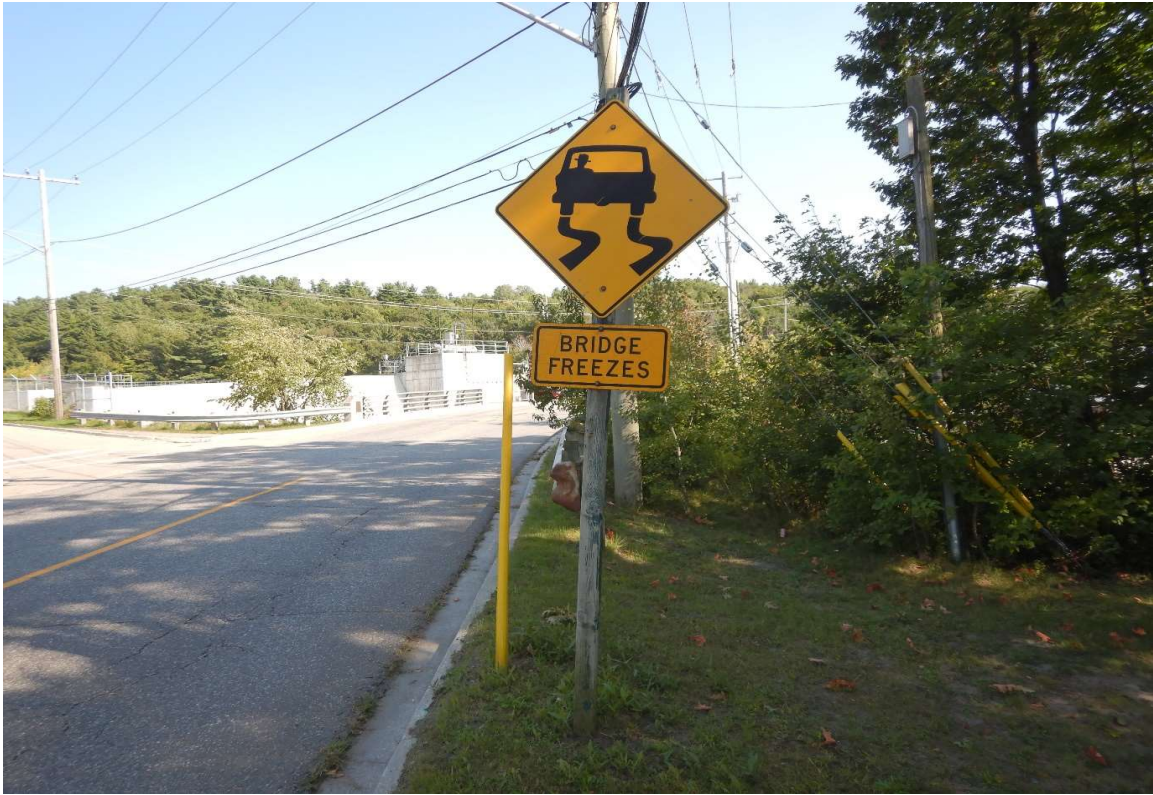
Description of Photo:		Sign

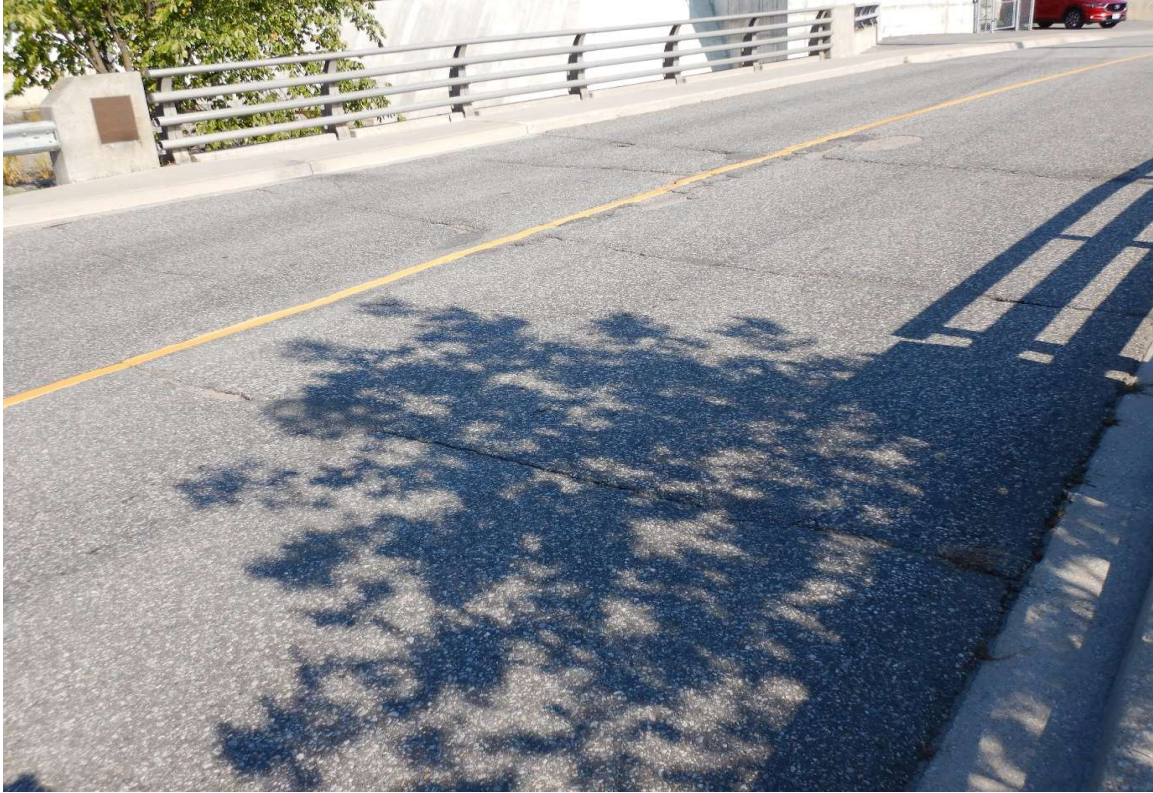
Description of Photo: North Approach

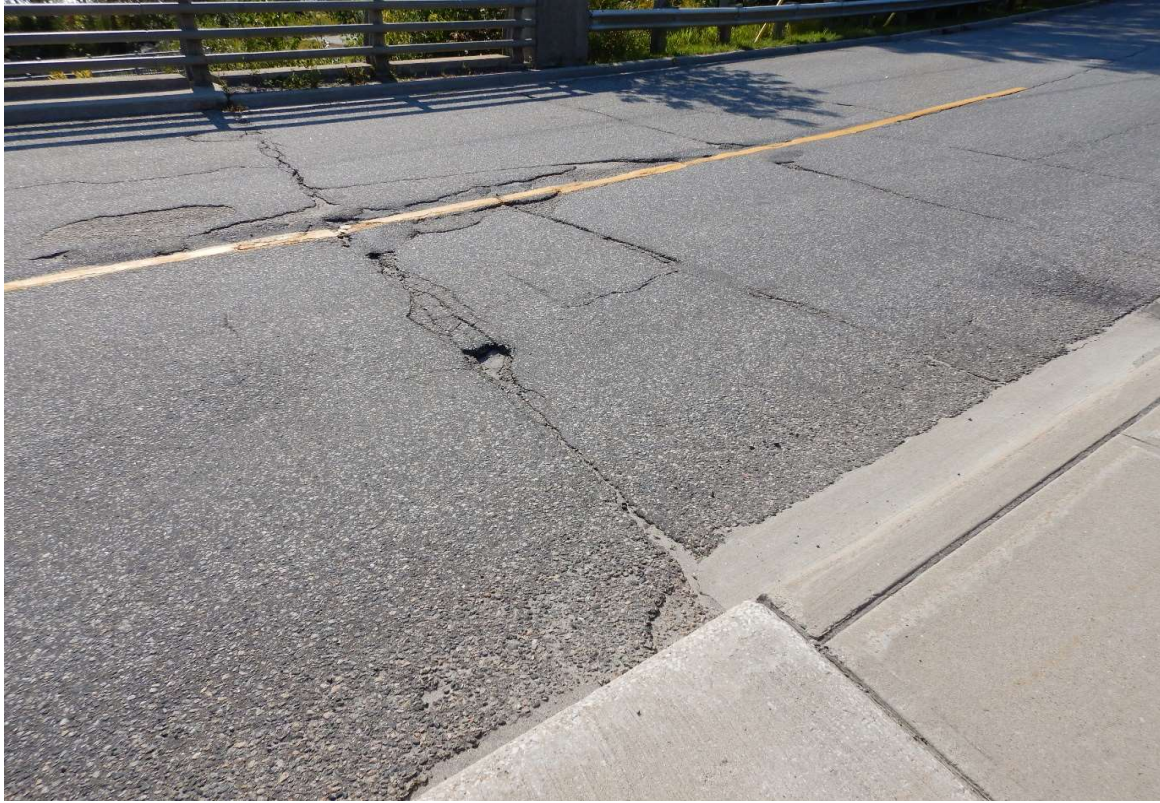
Description of Photo: Cracking in North Approach

Repair asphalt		
Element Photo:

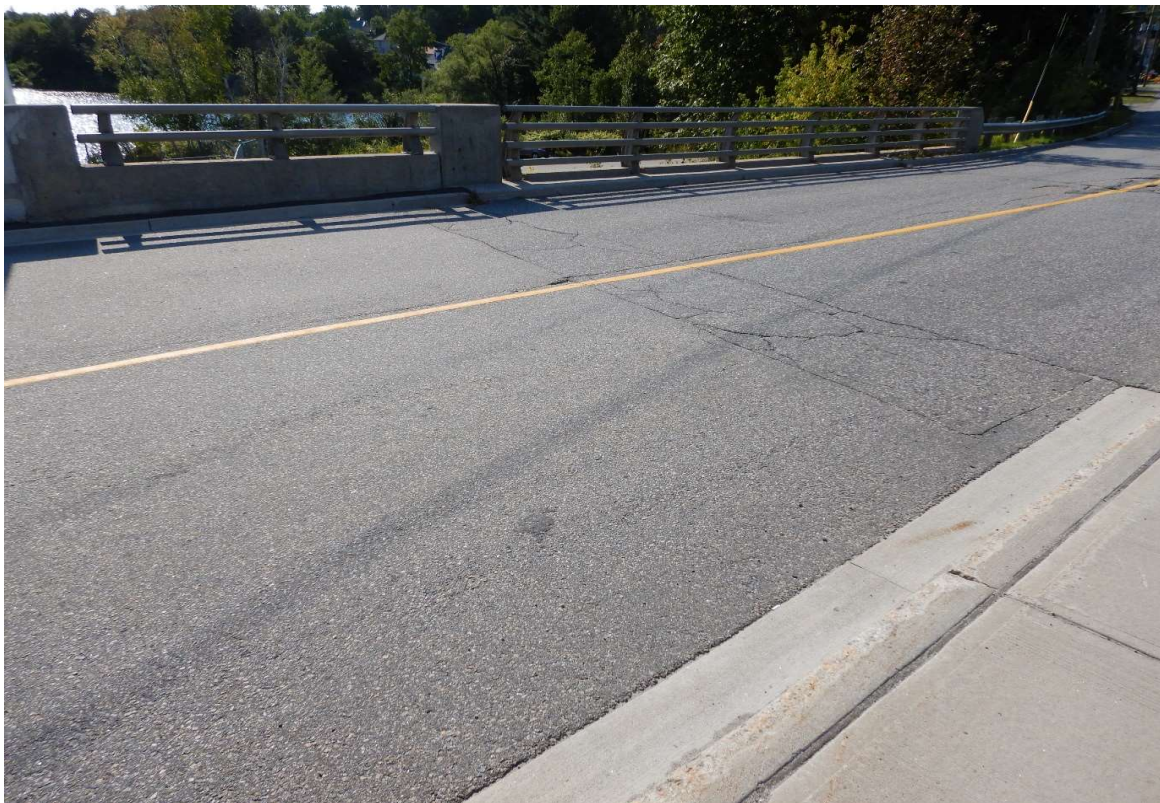
Description of Photo: South Approach
