Bridge Needs Study 2024

INSPECTION SUMMARY REPORT

Town of Parry Sound

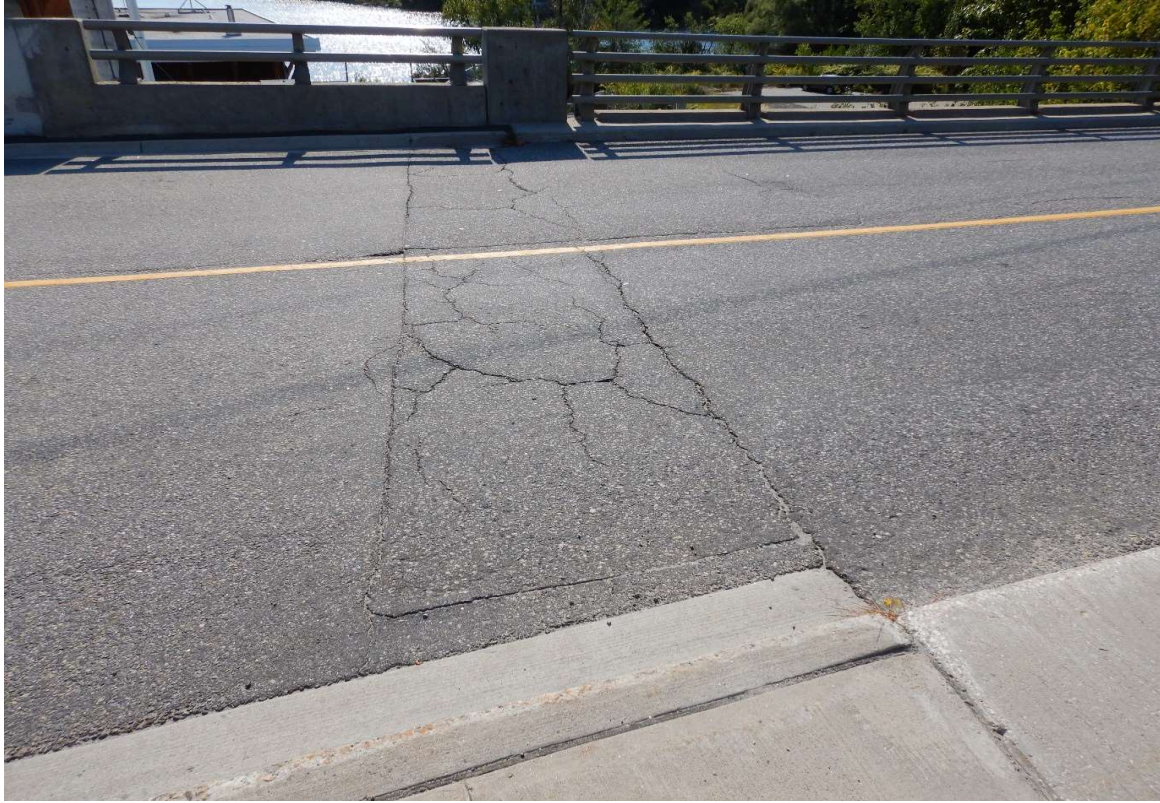
Description of Photo: Cracking in South Approach

Repair asphalt		
Element Photo:

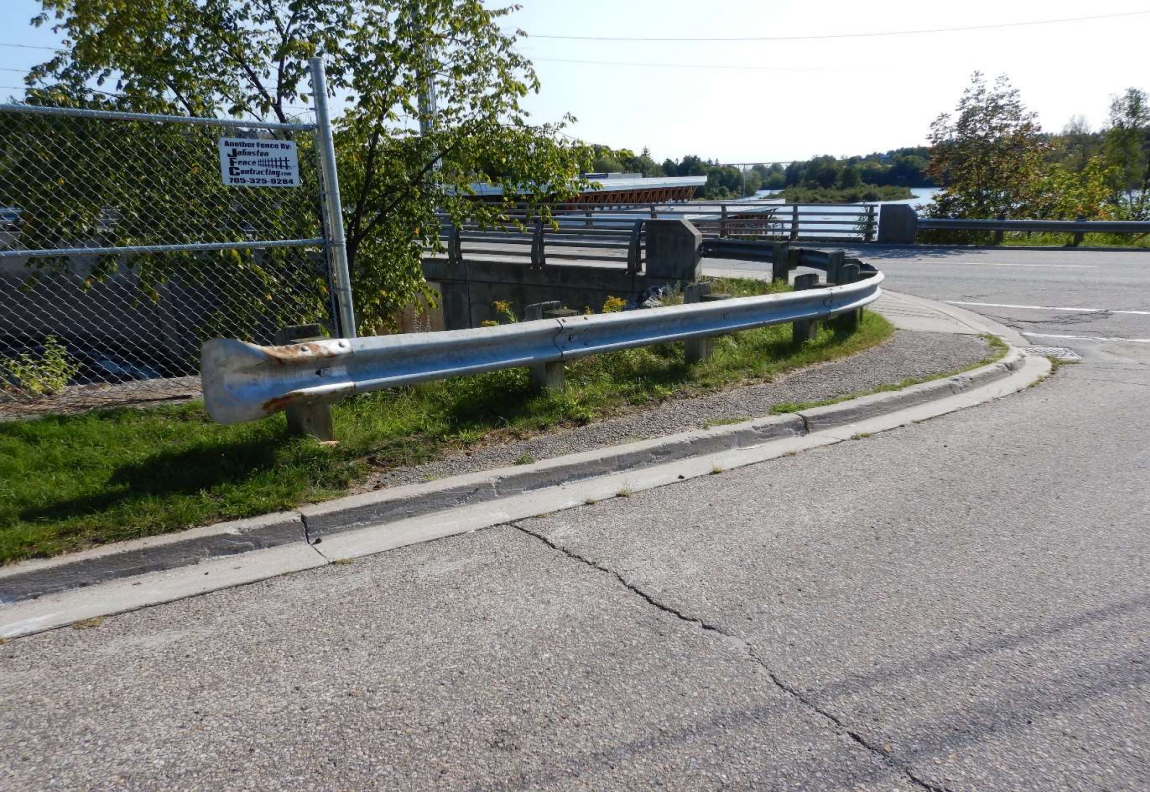
Description of Photo: Northeast approach barrier

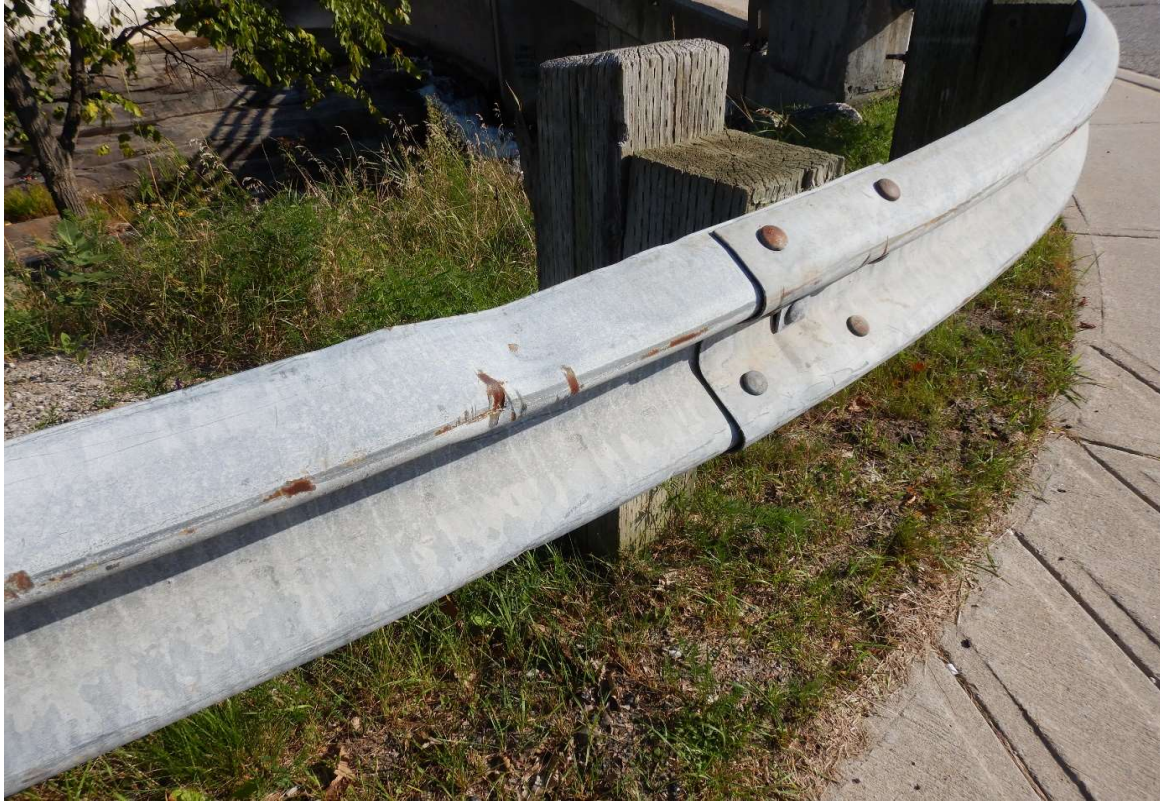
Description of Photo: Damage on northeast approach barrier

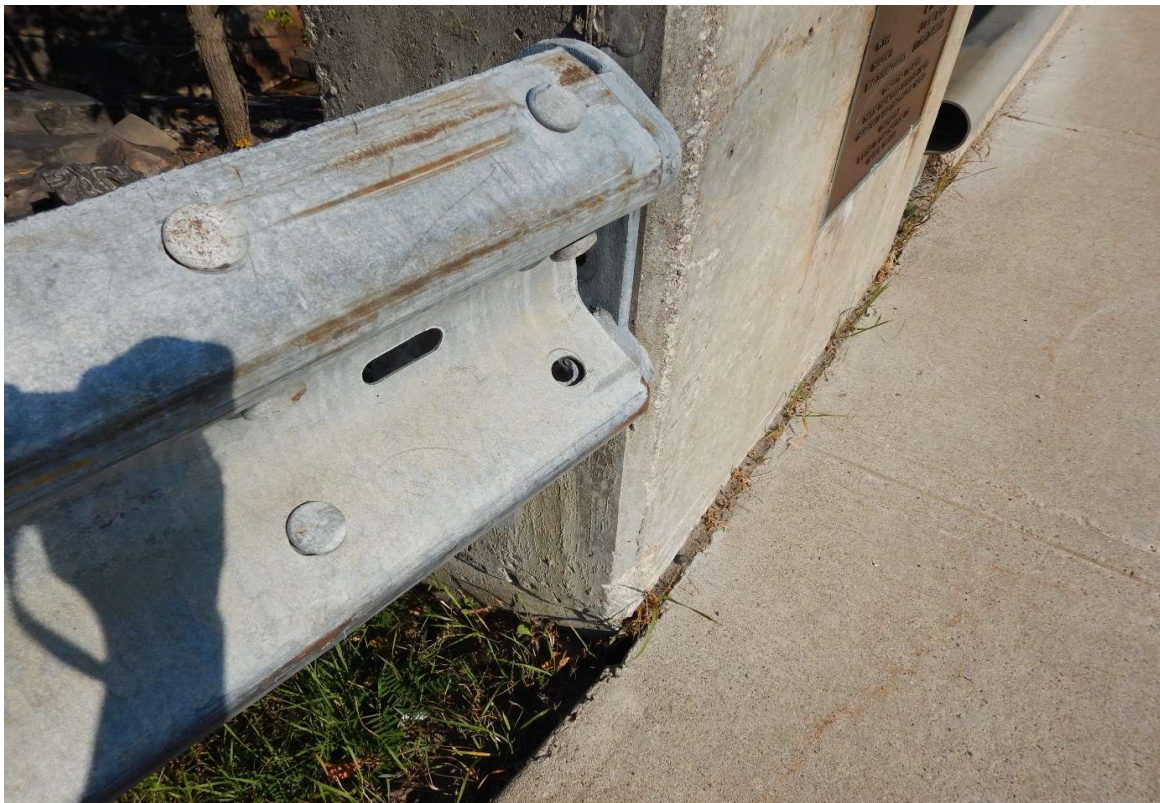
Description of Photo: Northeast approach barrier, note substandard connection and missing bolt

Urgent: <input type="checkbox"/>	1-5 Years: <input type="checkbox"/>	6-10 Years: <input checked="" type="checkbox"/>	None: <input type="checkbox"/>	Urgent: <input type="checkbox"/>	1 Year: <input type="checkbox"/>	2 Year: <input type="checkbox"/>
Upgrade NE and NW barrier to bridge connection						
Element Photo:

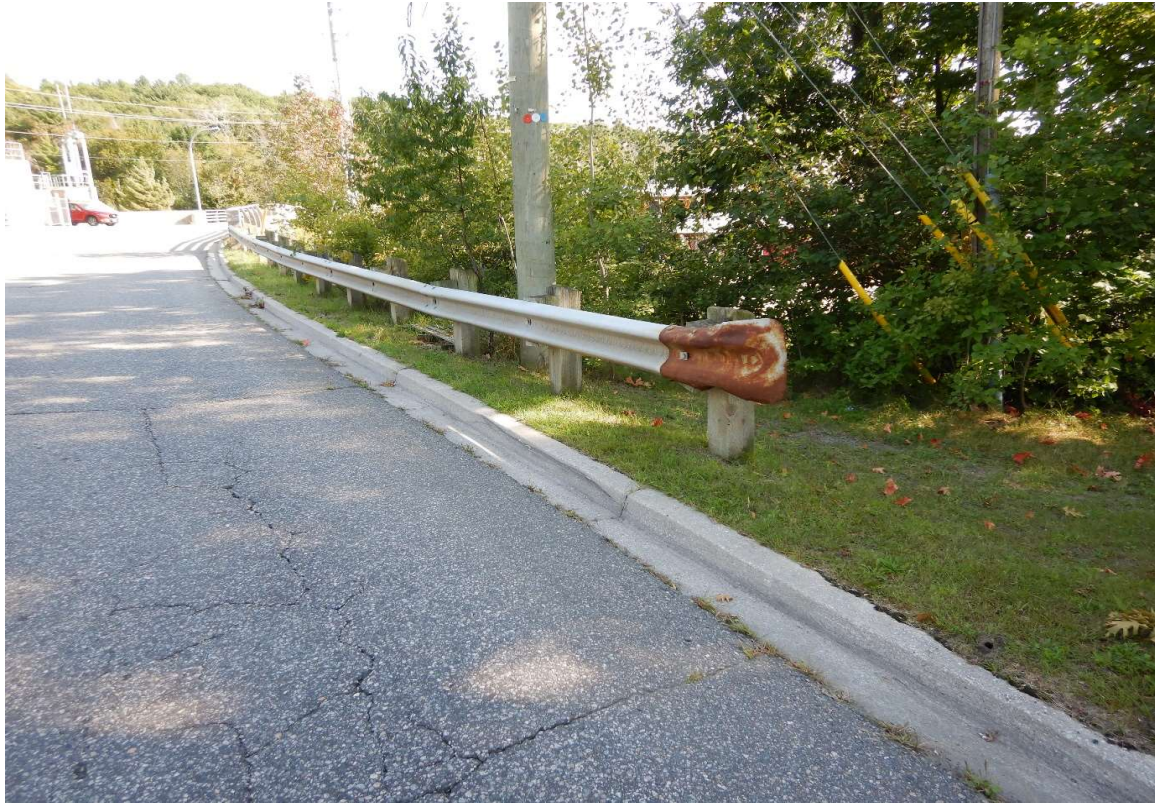
Description of Photo: Northwest approach barrier

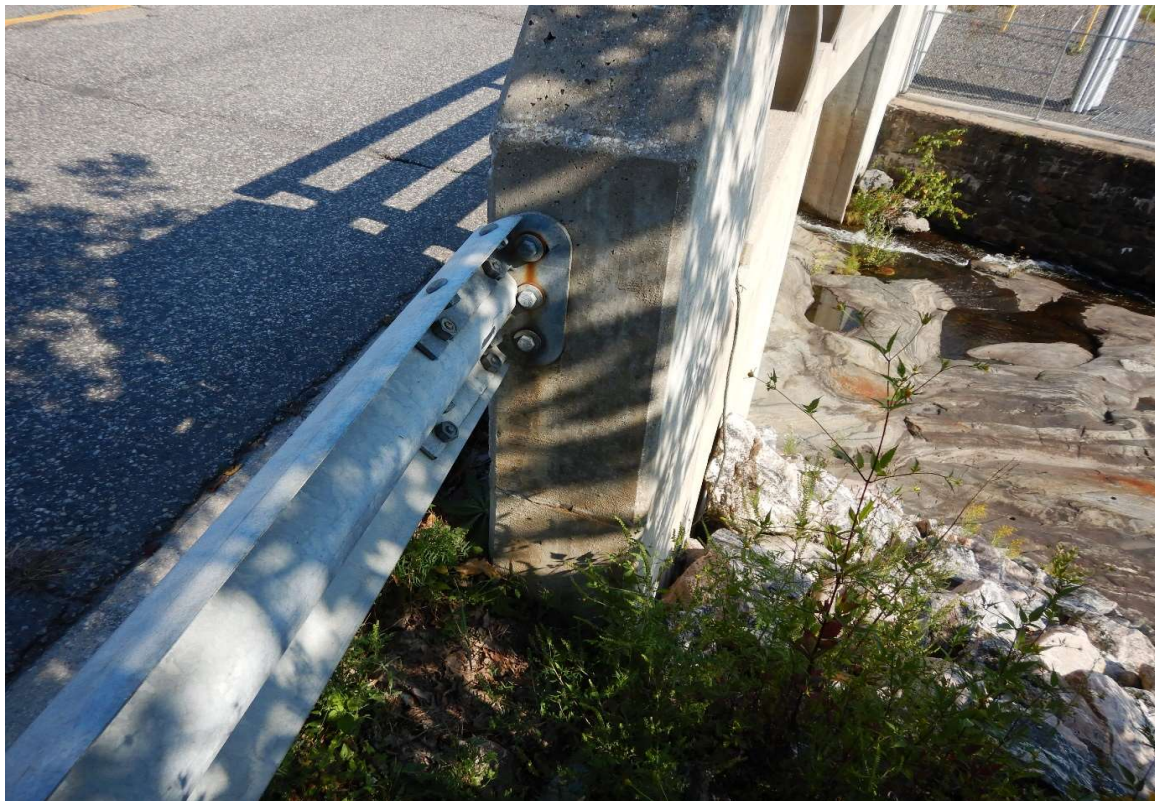
Description of Photo: Northwest approach barrier, note corrosion

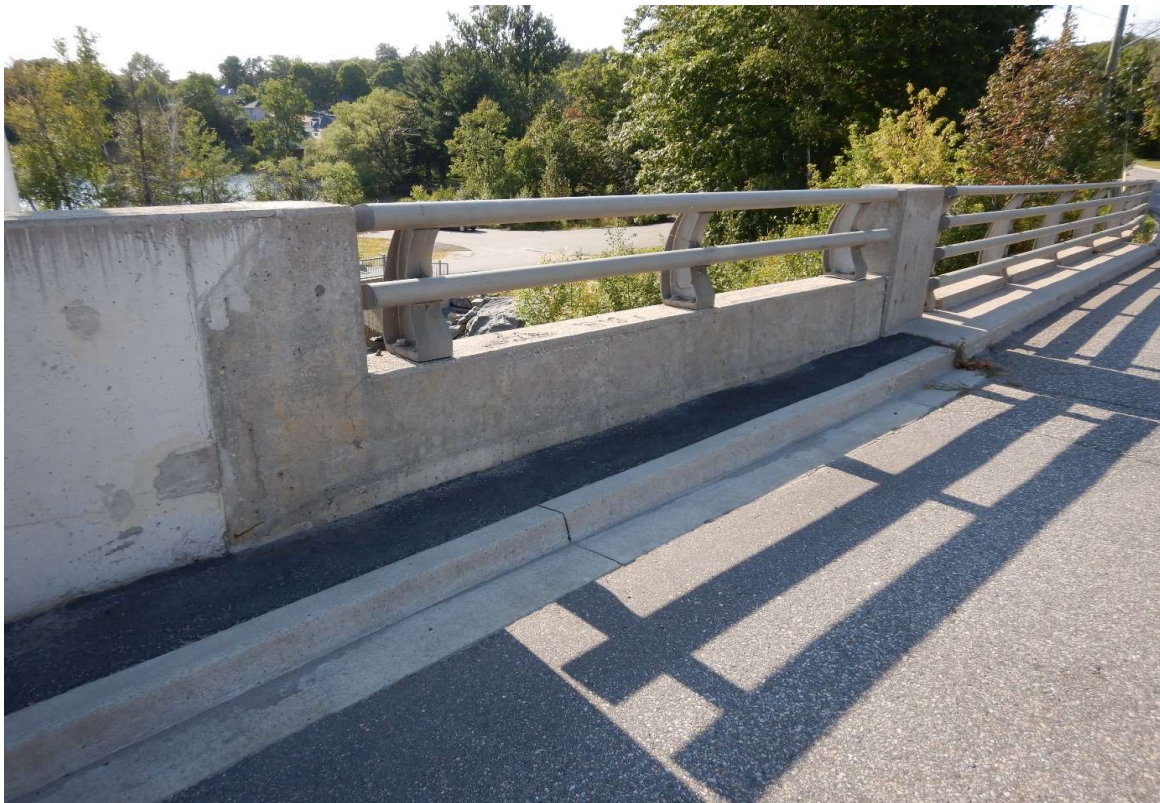
Description of Photo: Southwest approach barrier, note light scaling

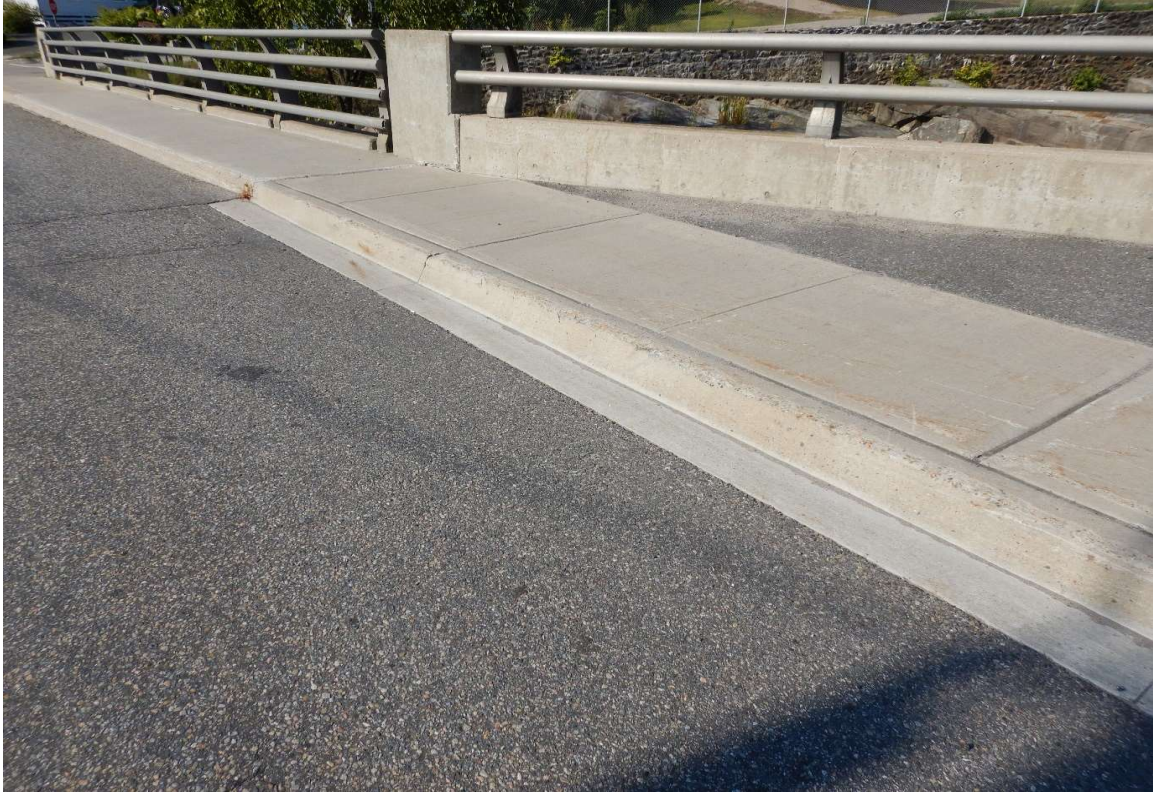
Description of Photo: Approach curb

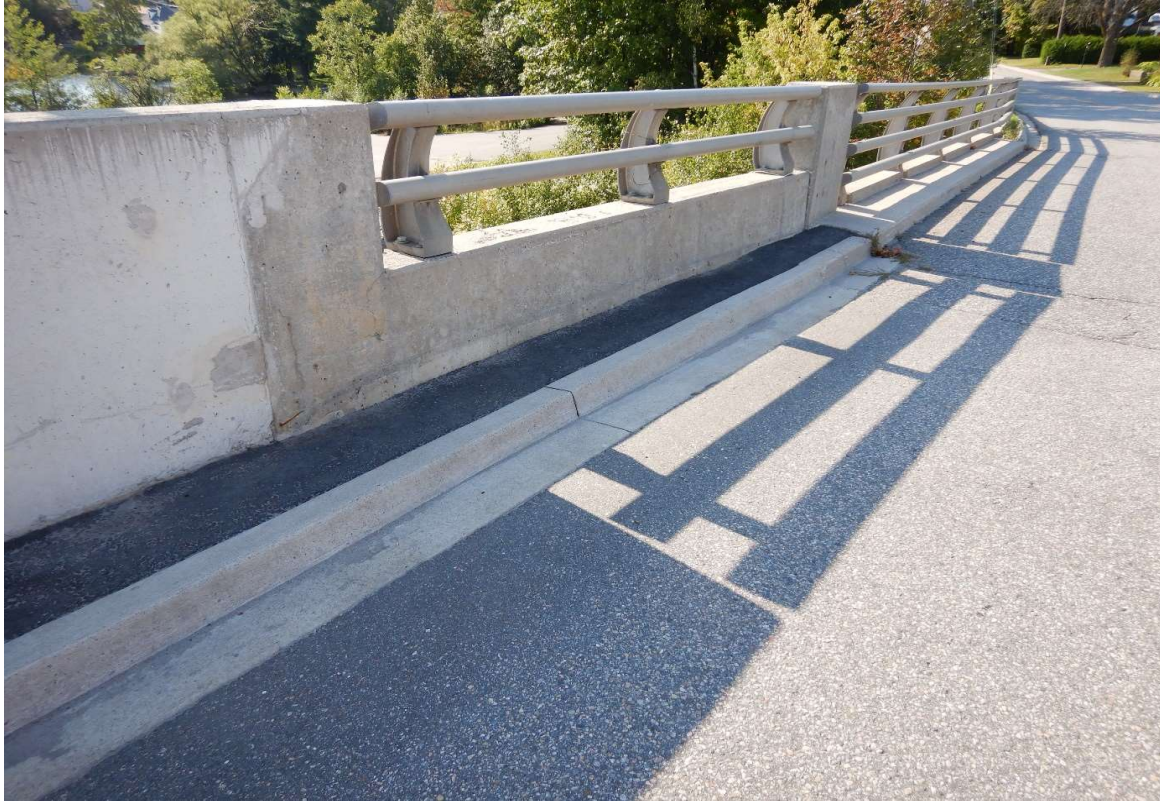
Description of Photo: Approach curb

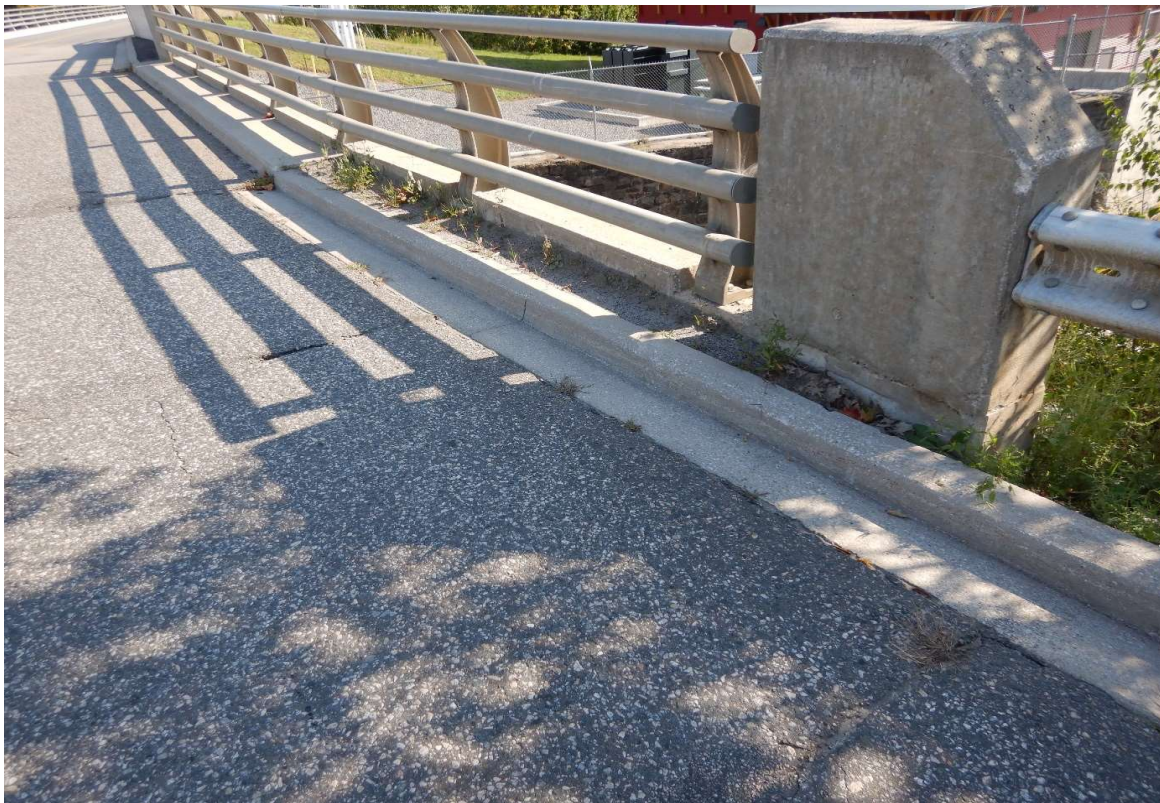
Description of Photo: Approach curb

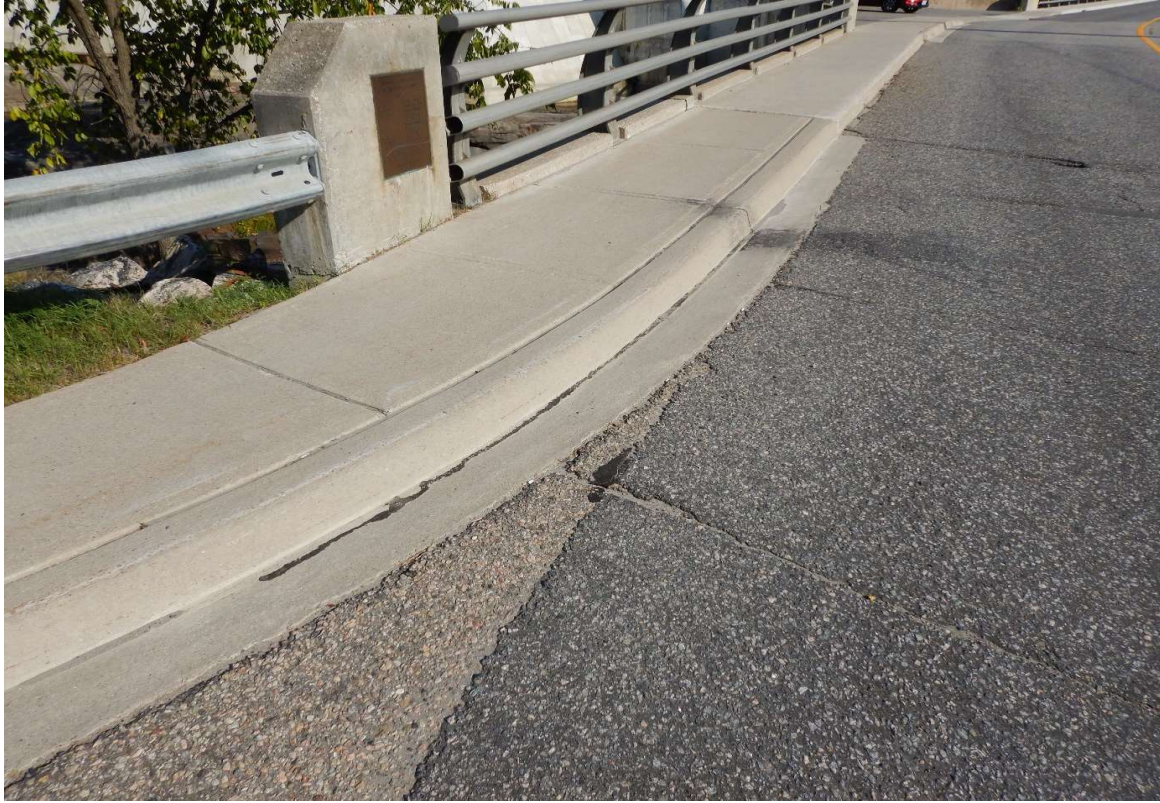
Description of Photo: Approach curb

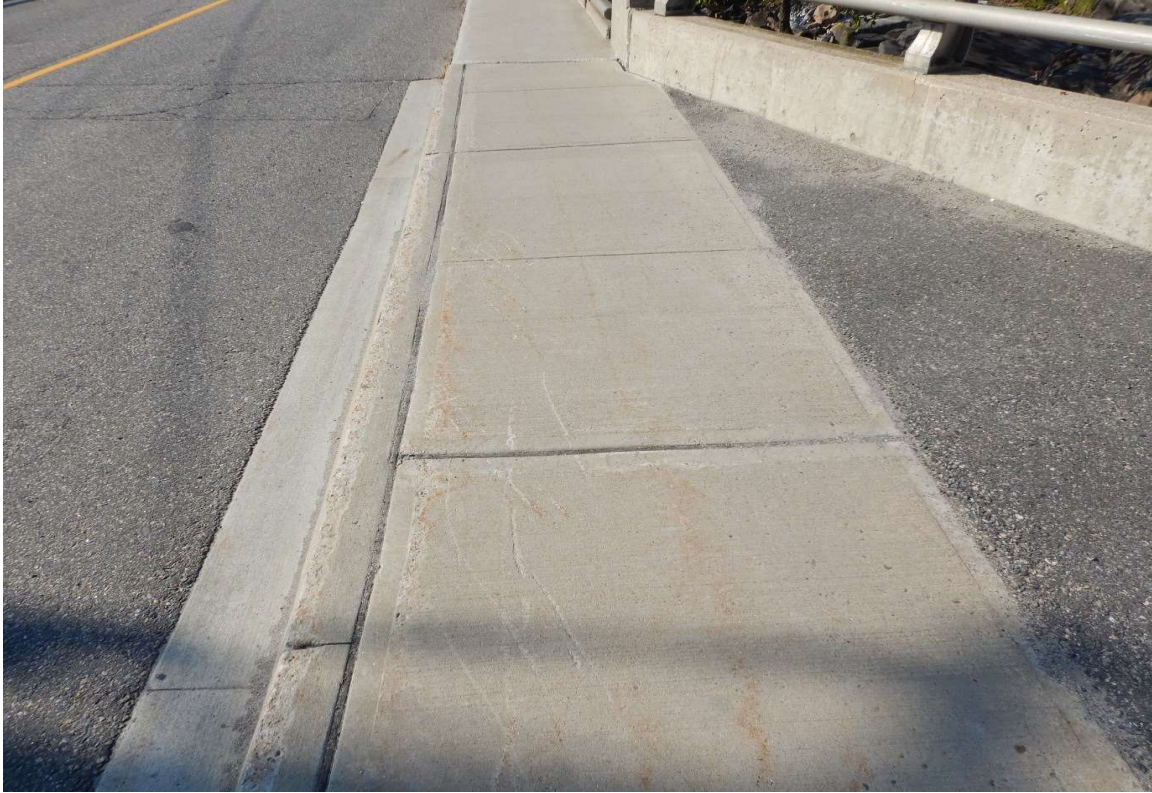
Description of Photo: Approach sidewalk

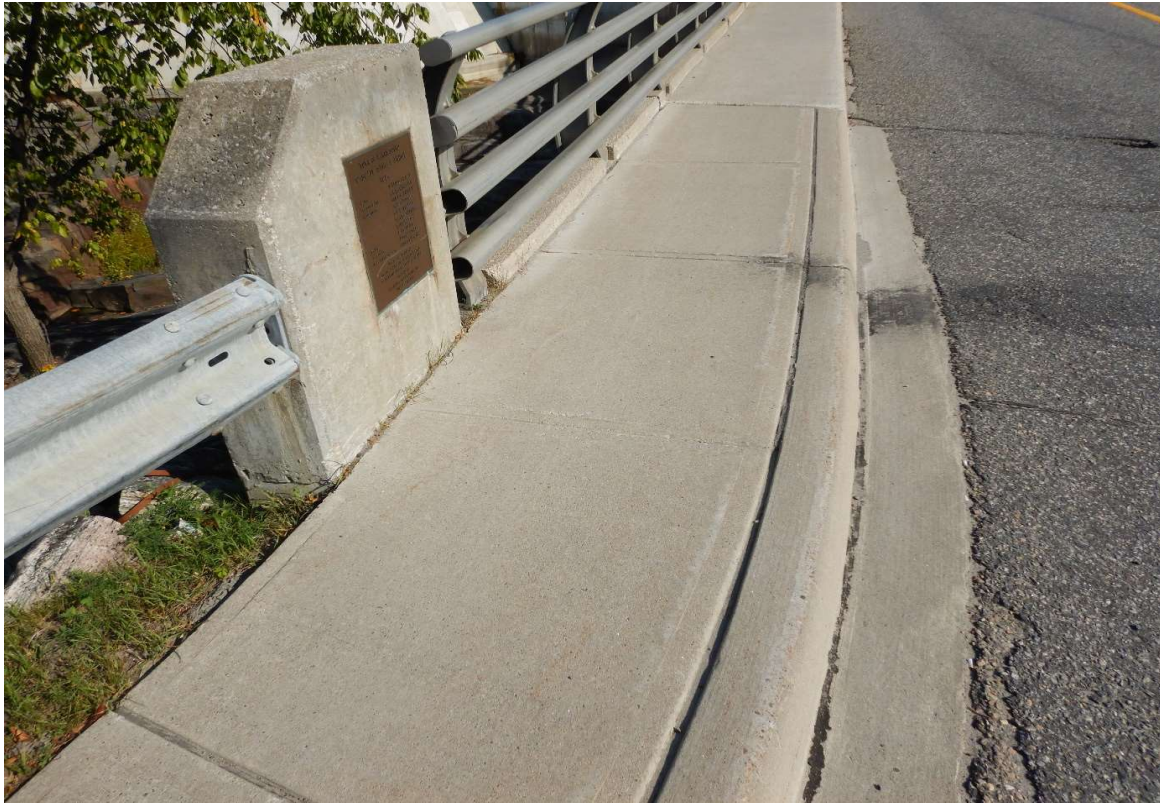
Description of Photo: Approach sidewalk

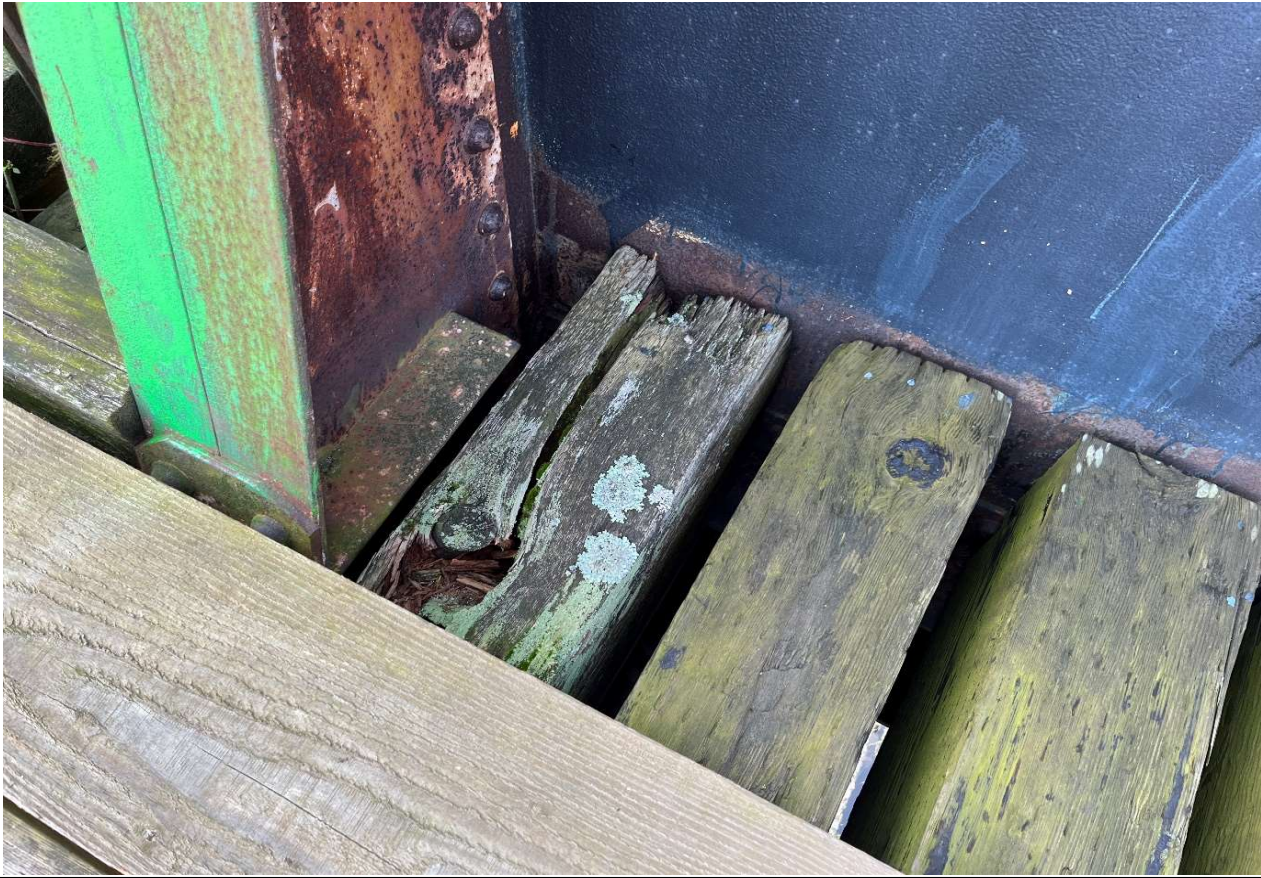
Comments: Light weathering typ. Localized light to severe checks and splits, typ . Moisture indicated in timbers. East end, one cross ties has severe rot at end of member. Limited inspection due to middle section of timbers covered by timber deck.

Description of Photo: Rotten timber

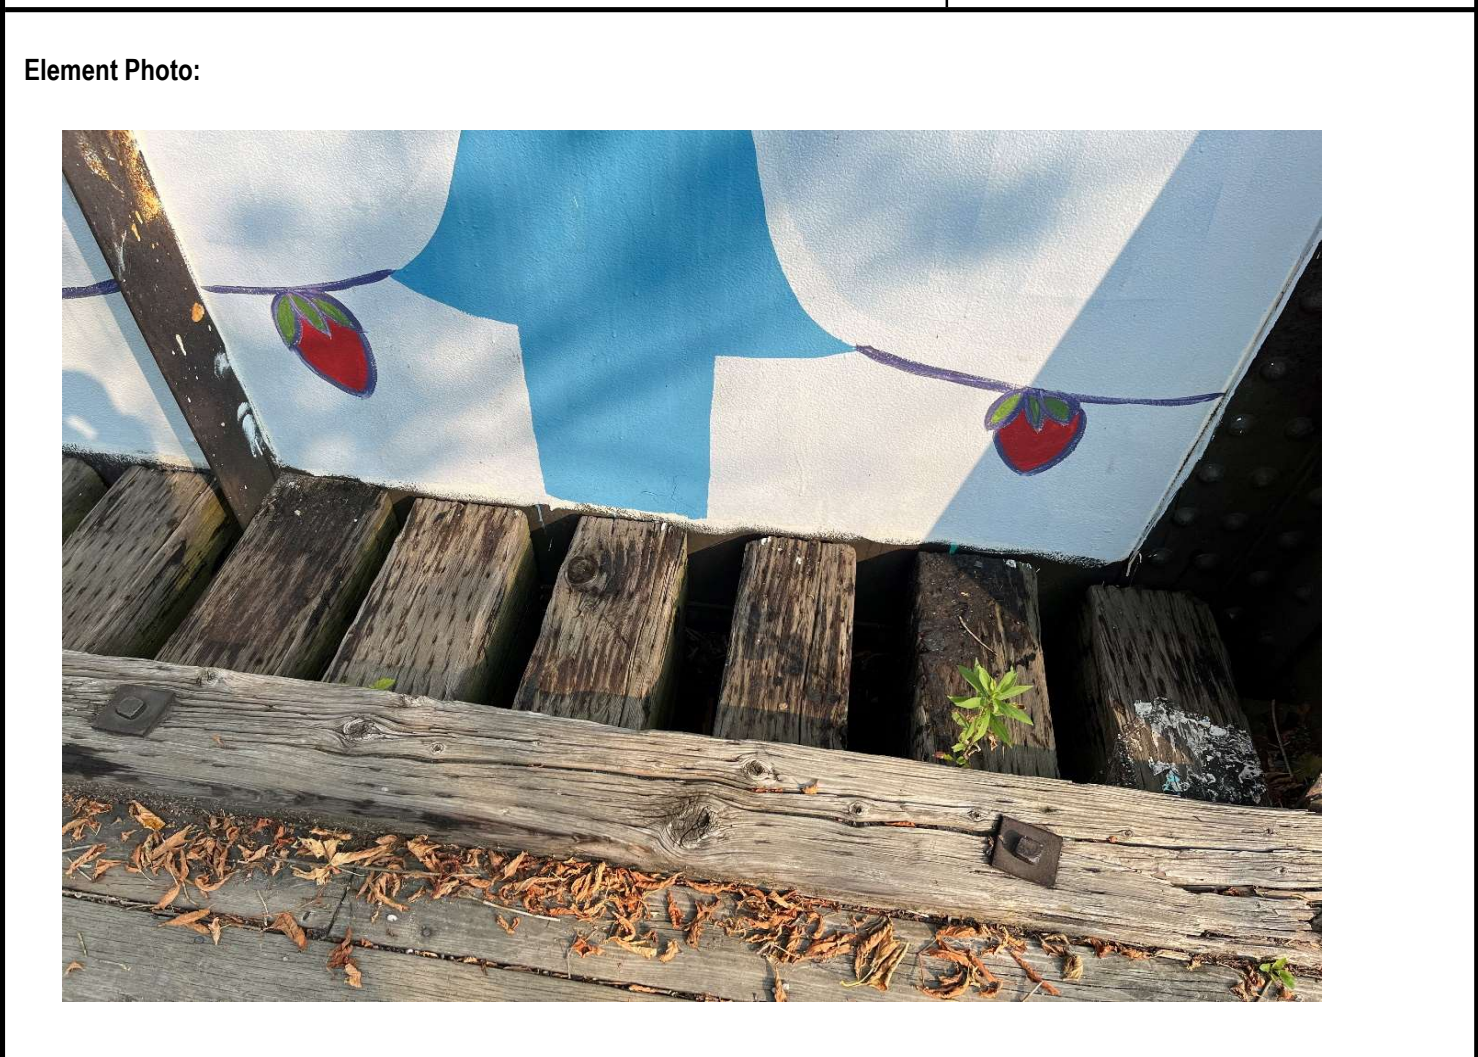
Description of Photo: Deck top

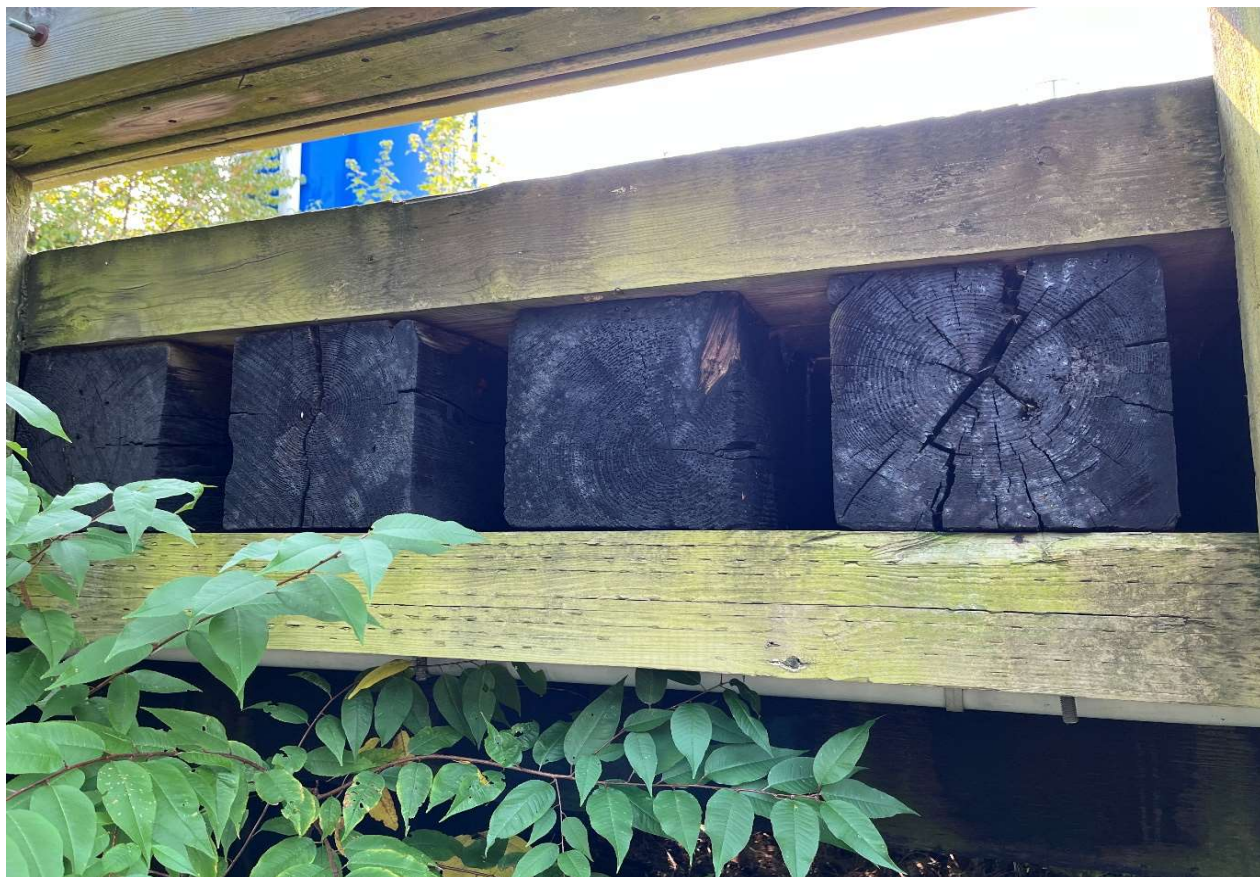
Comments: Light weathering typical. Localized light to medium checks and splits, typical. Isolated severe checks and splits.

Description of Photo: Crossies

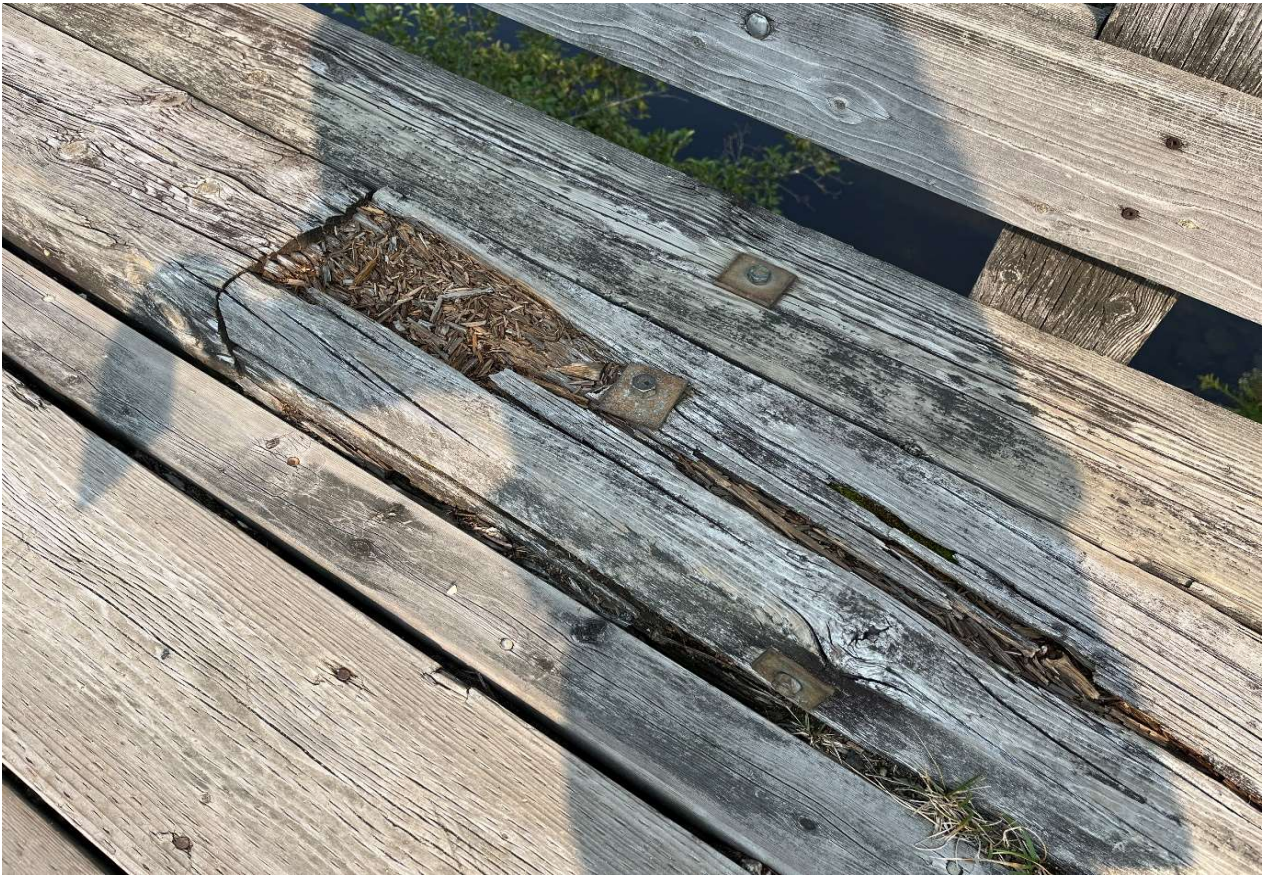
Description of Photo: Rotten curb

Replace rotten timbers

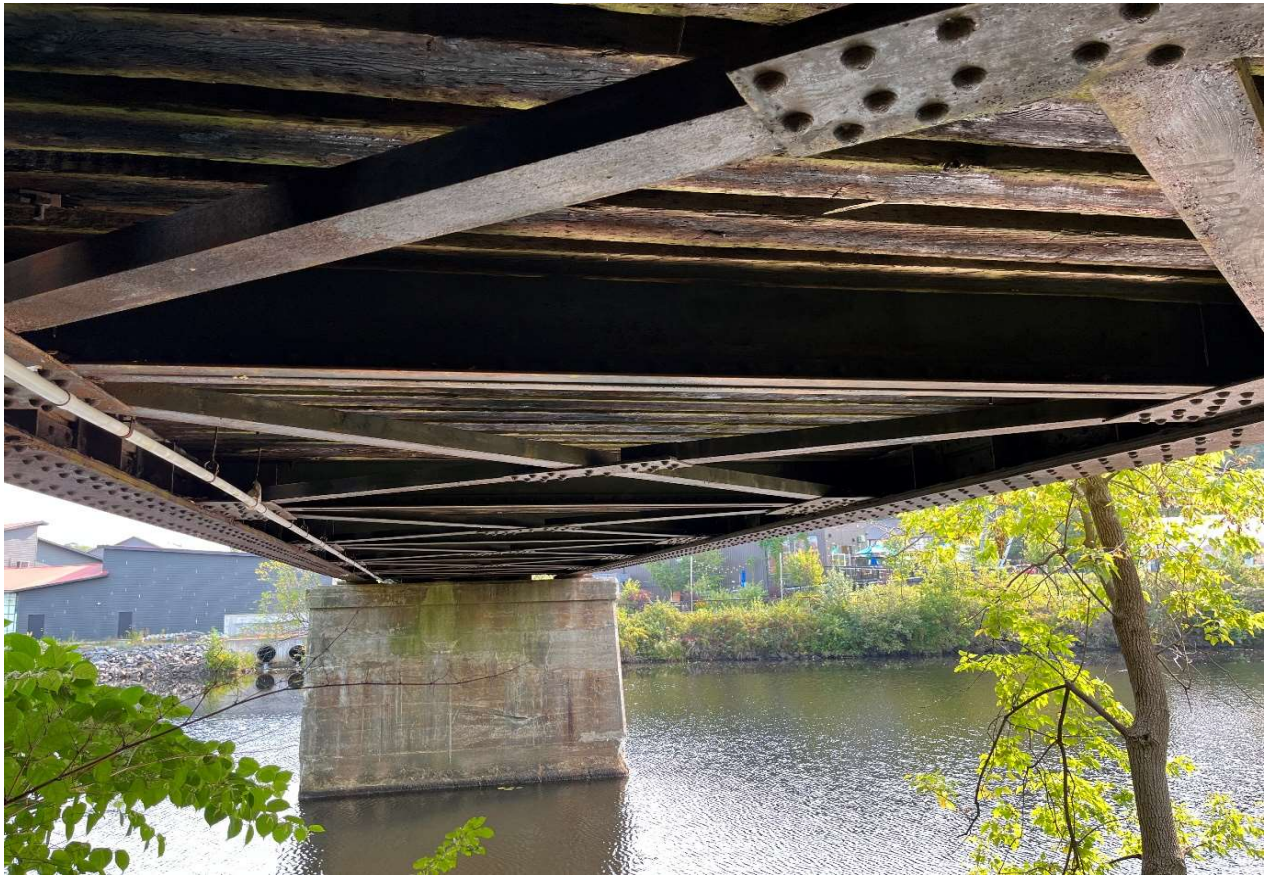
Description of Photo: Floor beams

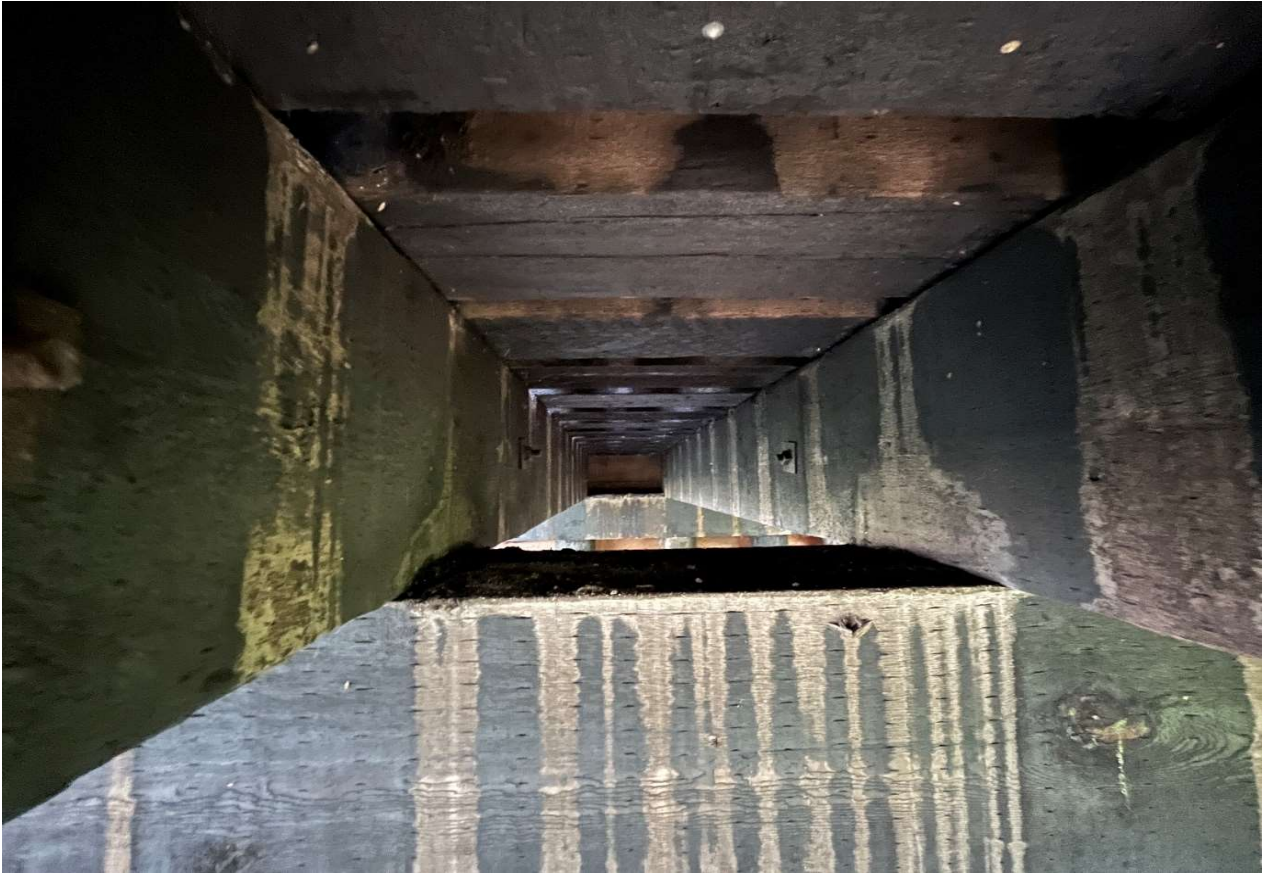
Description of Photo: Stringers

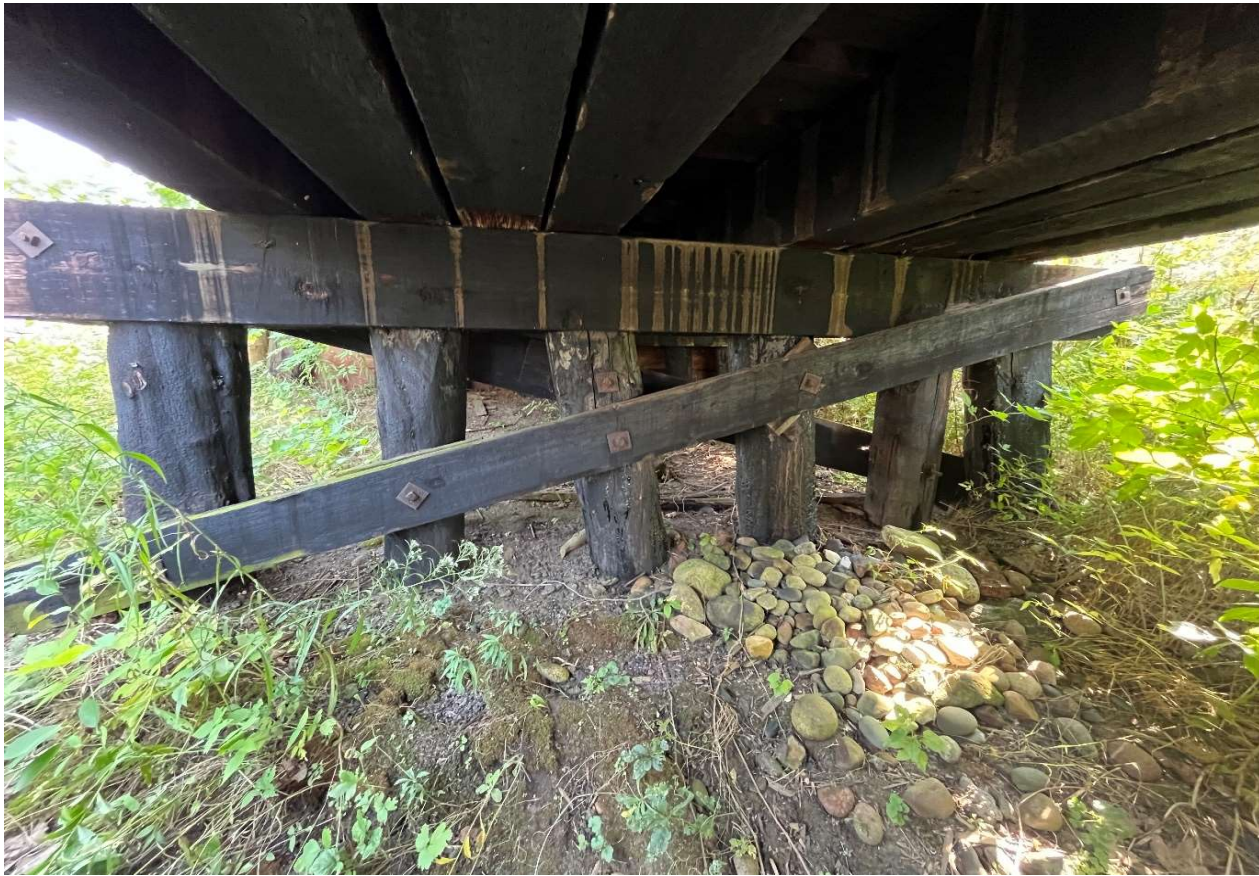
Description of Photo: Pier column bracings

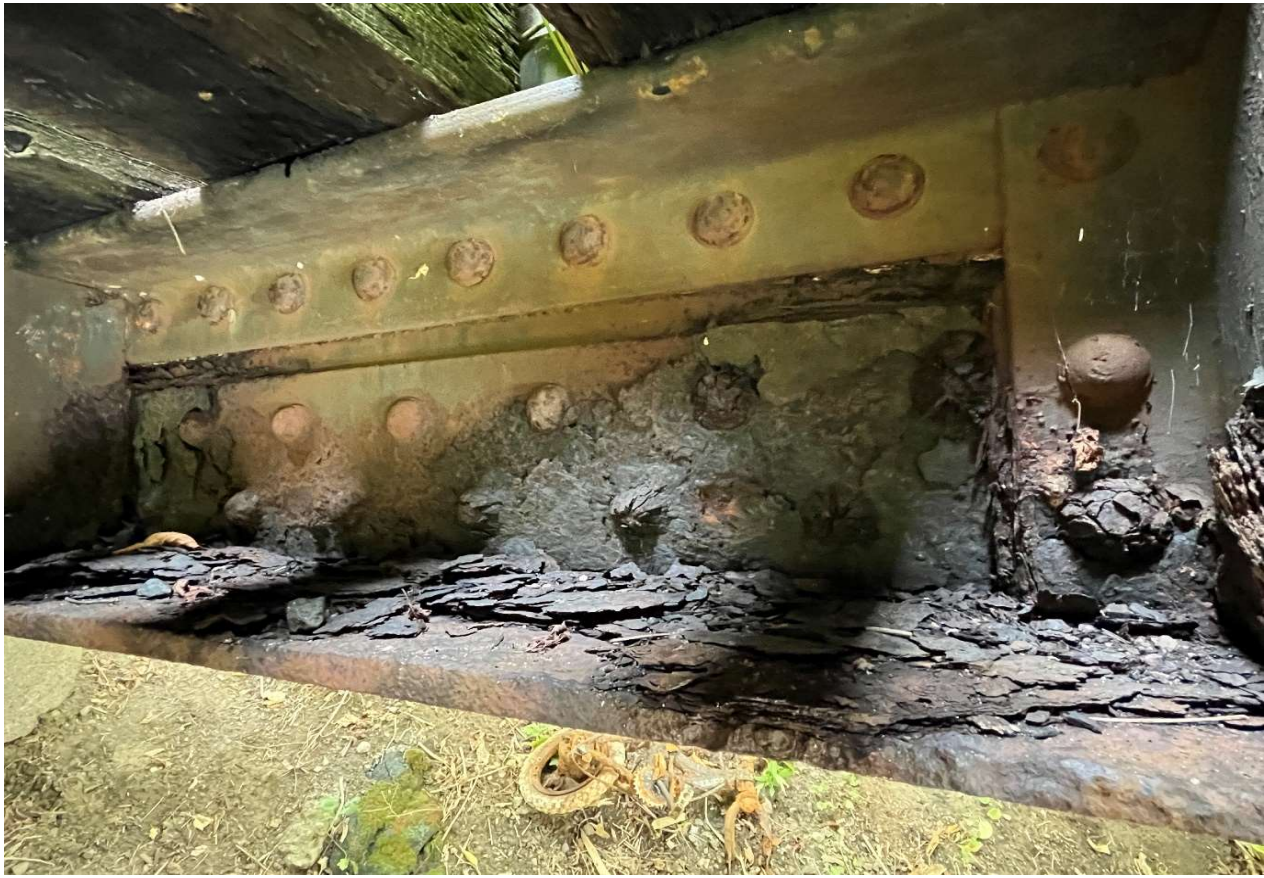
Description of Photo: Coating at inside of span 12

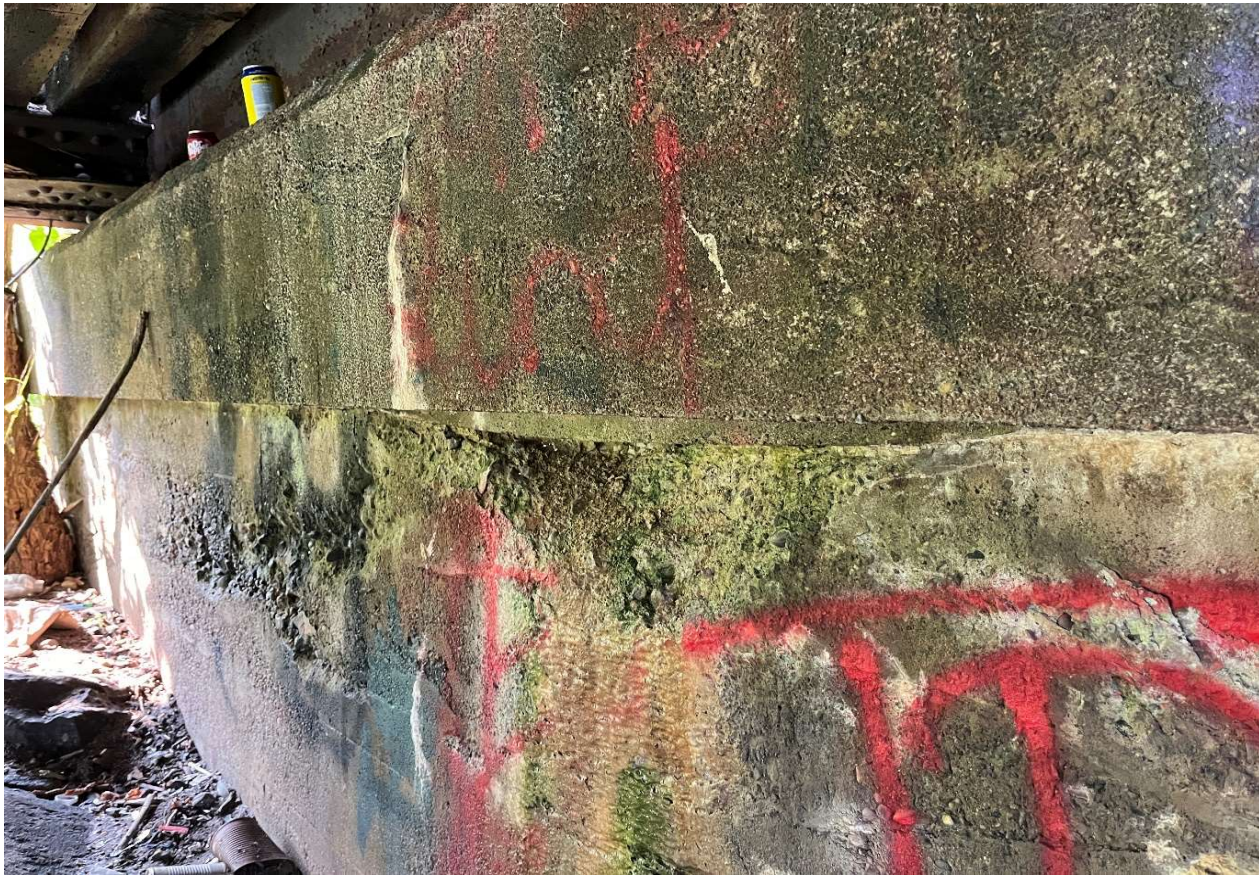
Description of Photo: West abutment
