Bridge Needs Study 2024

INSPECTION SUMMARY REPORT

Town of Parry Sound

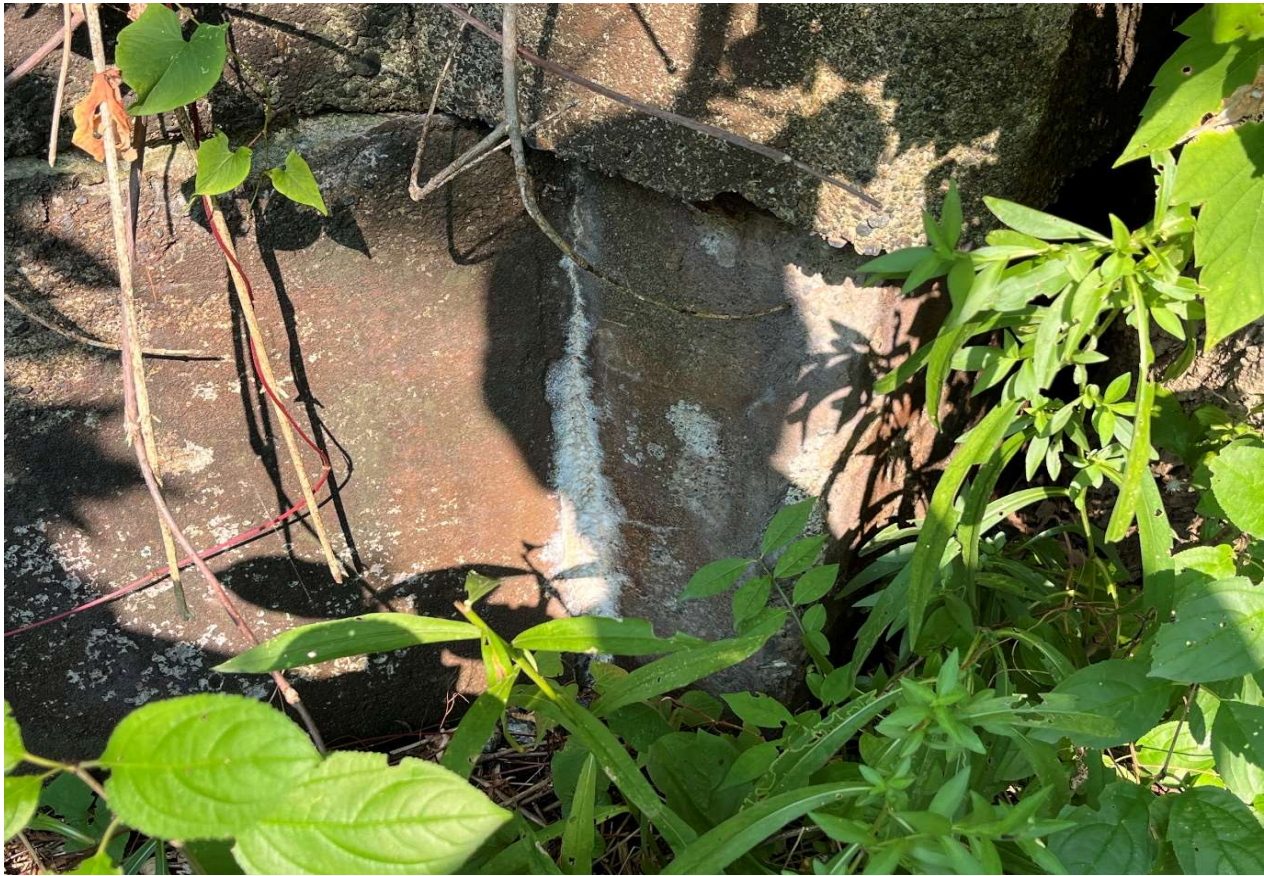
Description of Photo: Efflorescence at interface with abutment

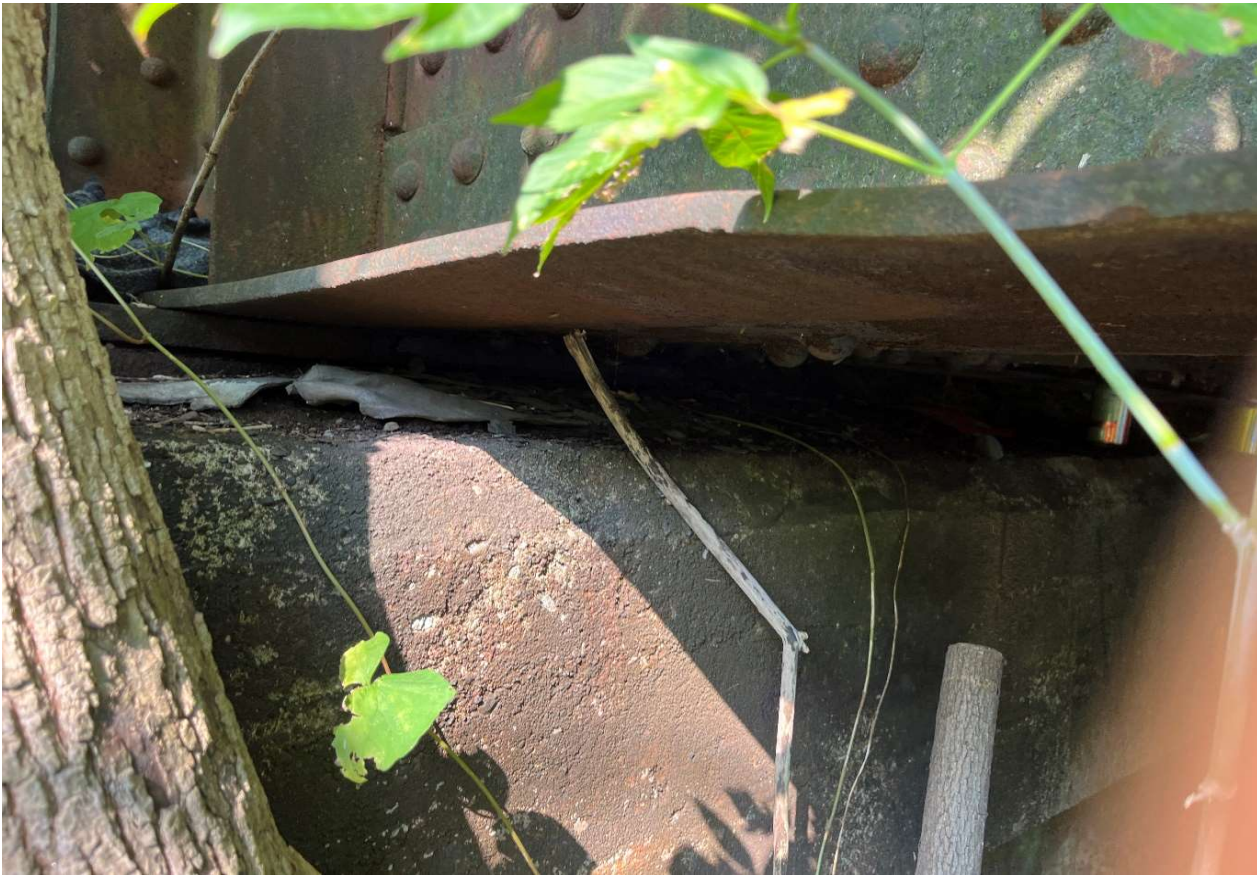
Description of Photo: Bearings

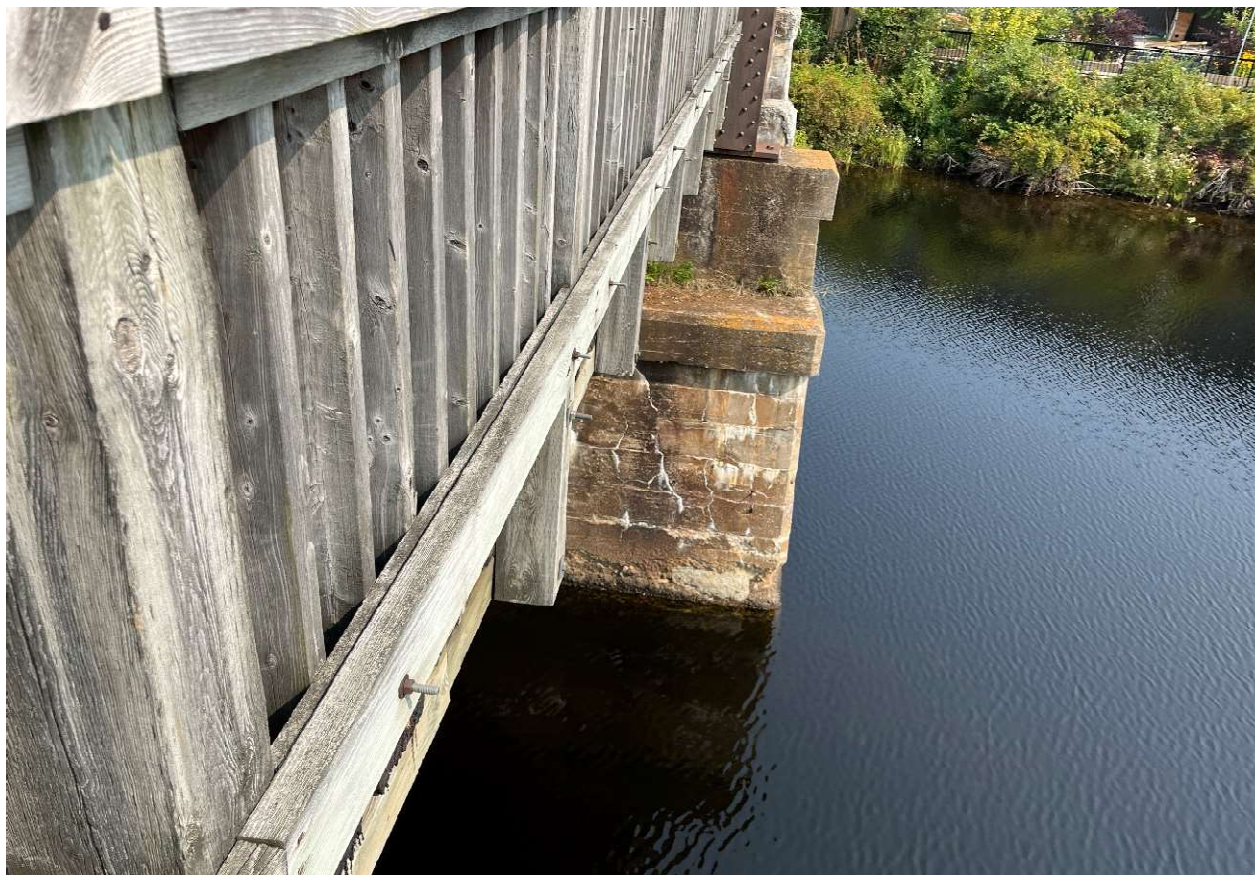
Description of Photo: Middle pier west face

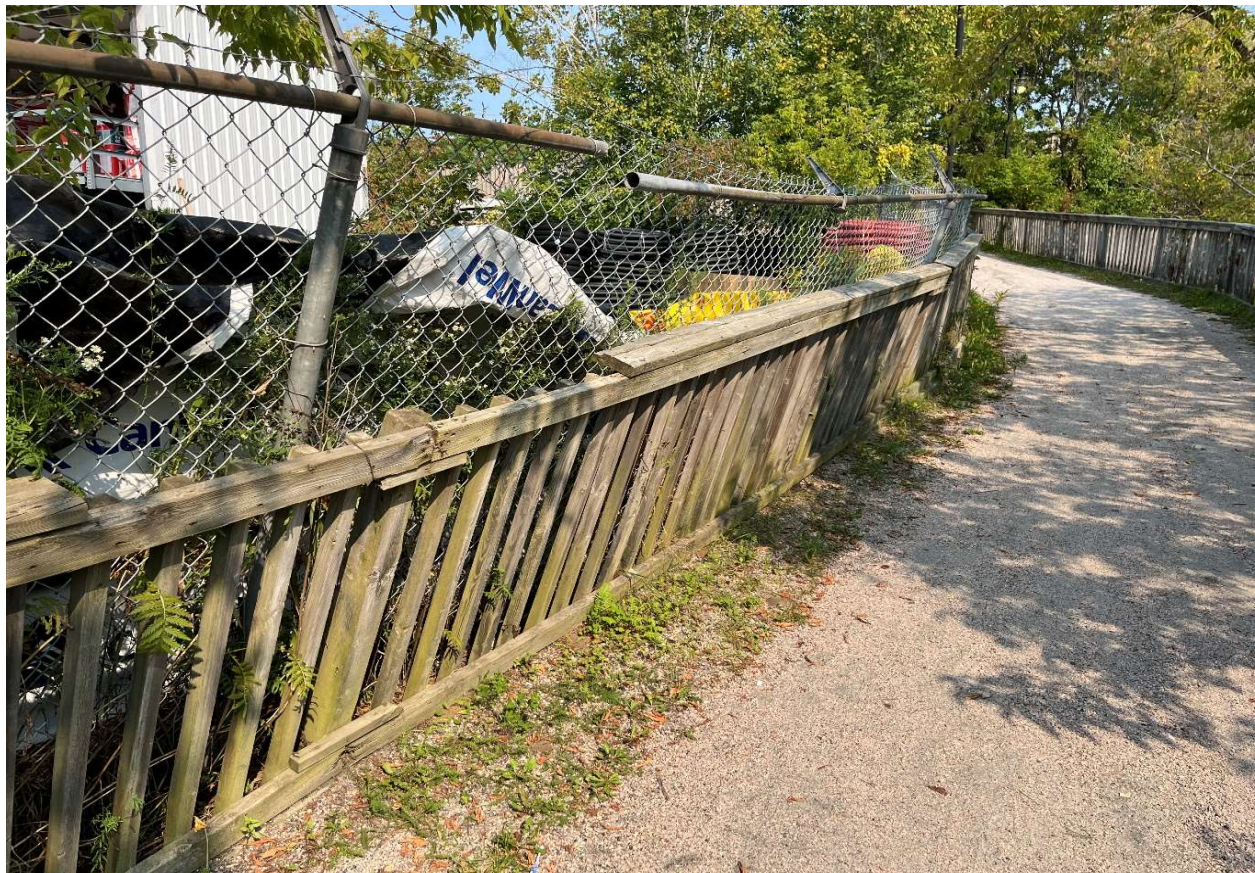
Comments: Light weathering, typ. 18 broken post or missing posts. 3.0m of top rail is missing. Several post anchors have become unattached. West railing next to the steel chain link fence has tilted, provide potential risks of falling. Top rail is not aligned at southwest end.

Description of Photo: Railing system

Recommended Work:	Rehab: <input checked="" type="checkbox"/>	Replace: <input type="checkbox"/>	Maintenance Needs:	3 - Railing System Repair		
Urgent: <input type="checkbox"/>	1-5 Years: <input checked="" type="checkbox"/>	6-10 Years: <input type="checkbox"/>	None: <input type="checkbox"/>	Urgent: <input type="checkbox"/>	1 Year: <input checked="" type="checkbox"/>	2 Year: <input type="checkbox"/>
Repair Railing system				Replace missing and broken pickets, anchors and top rail.

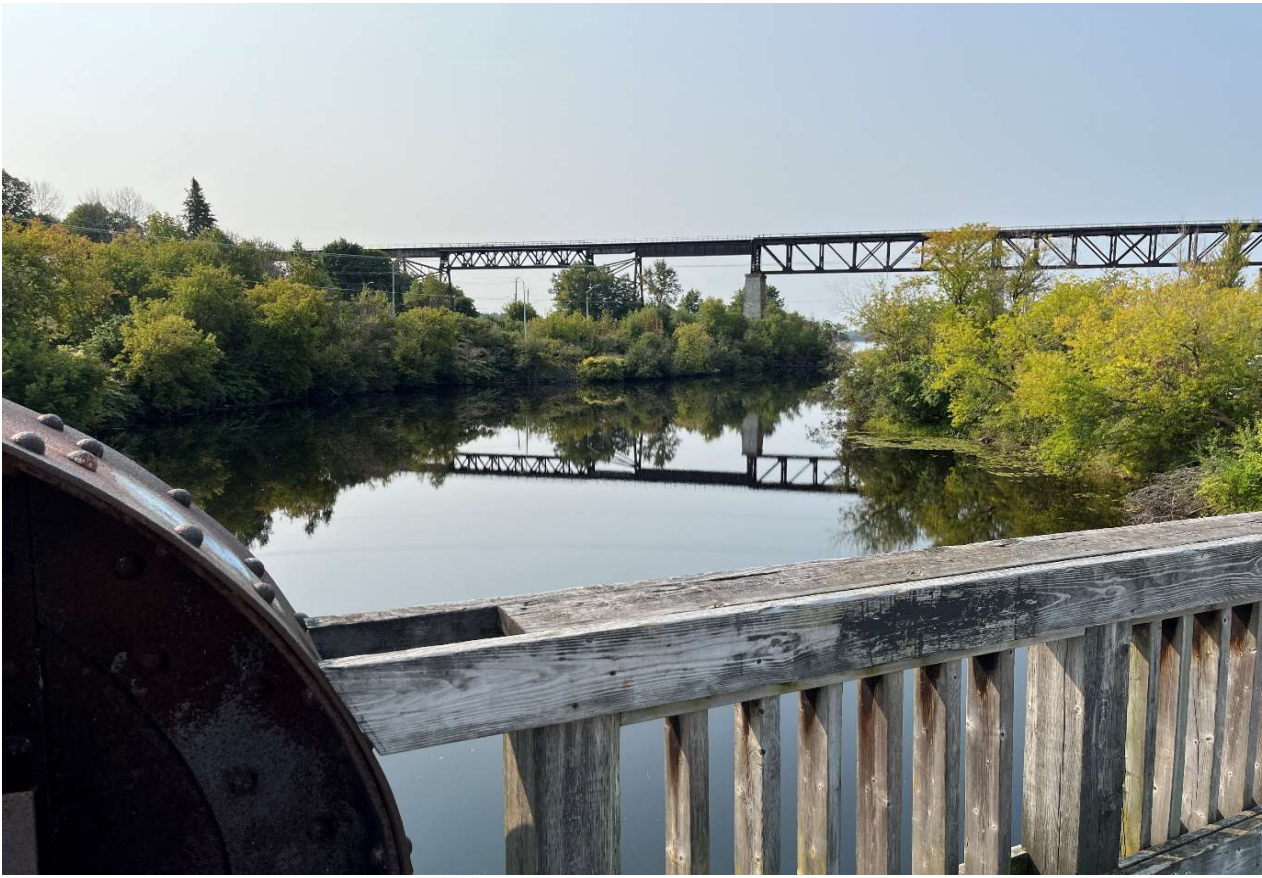
Description of Photo: Watercourse downstream

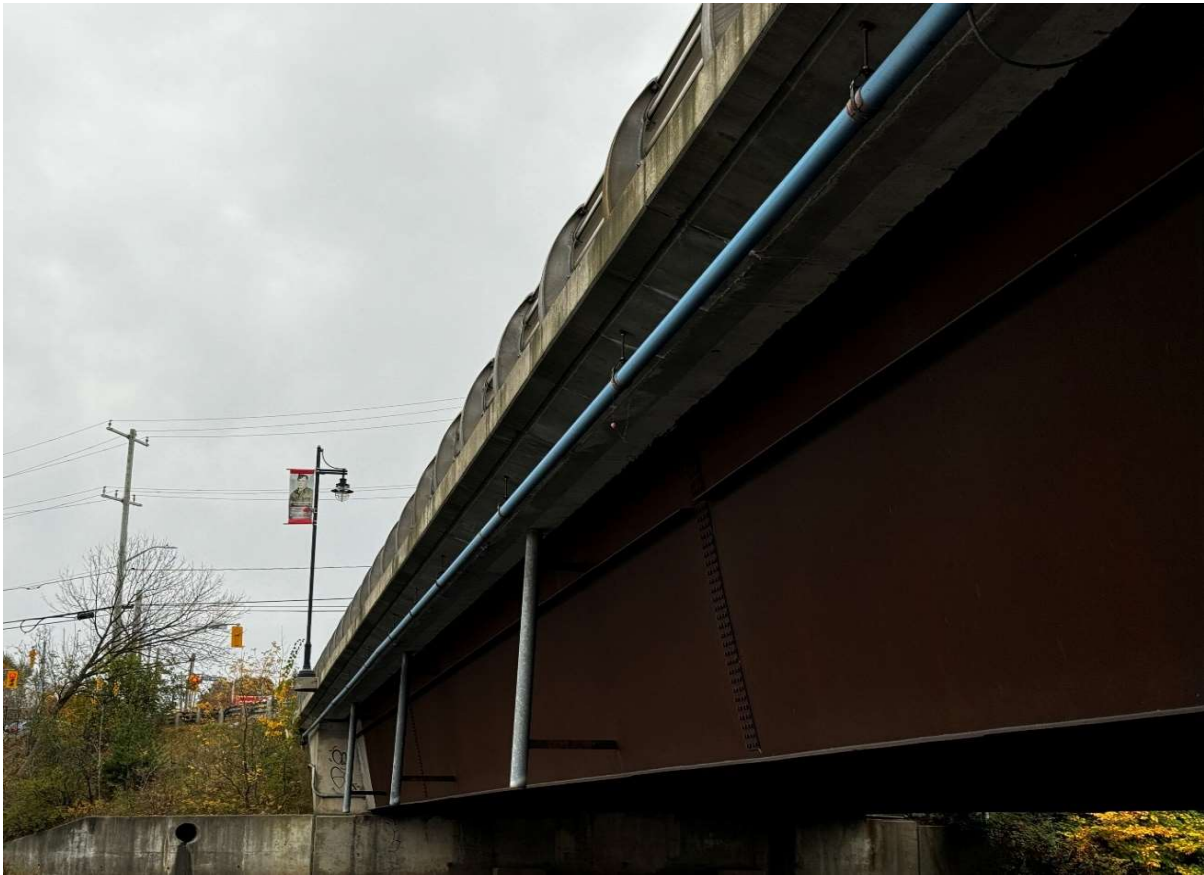
Description of Photo: Exterior soffit

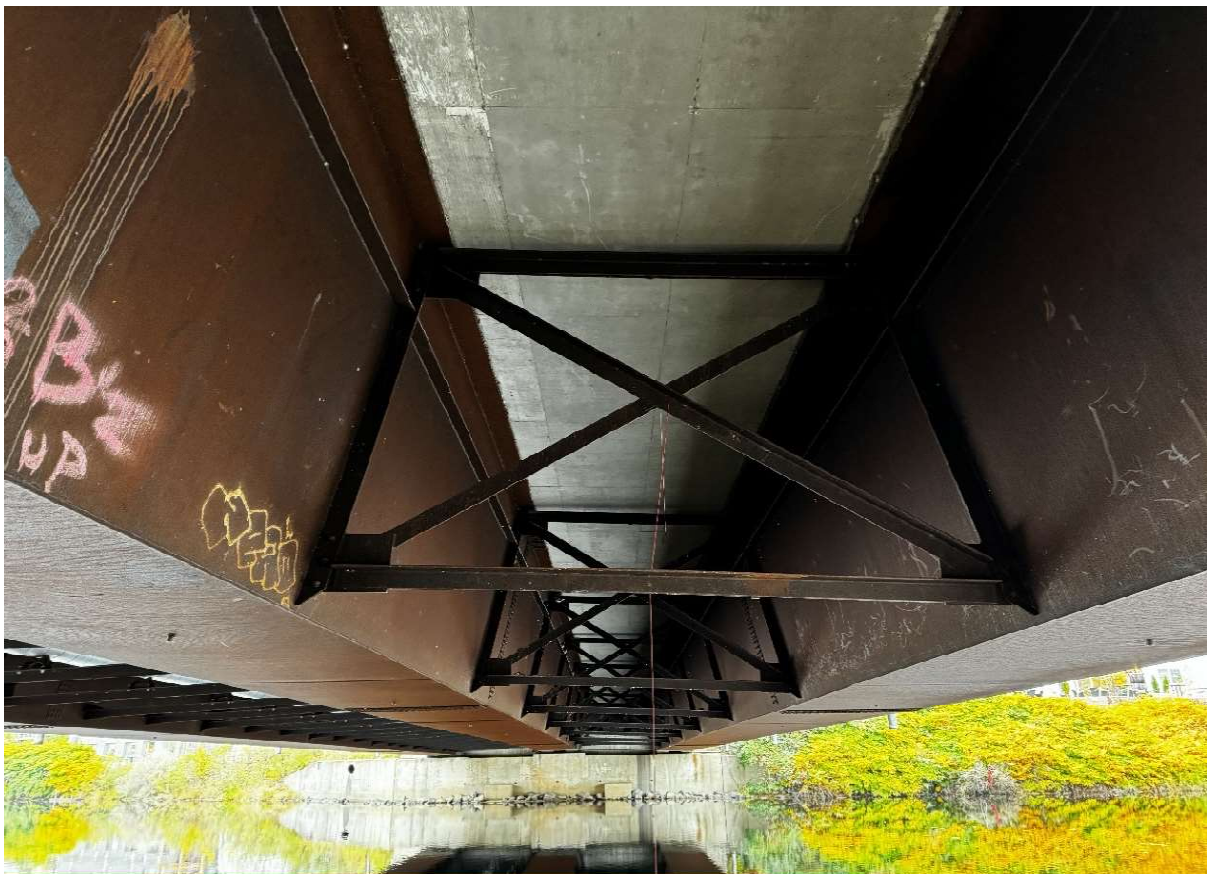
Description of Photo: Interior soffit

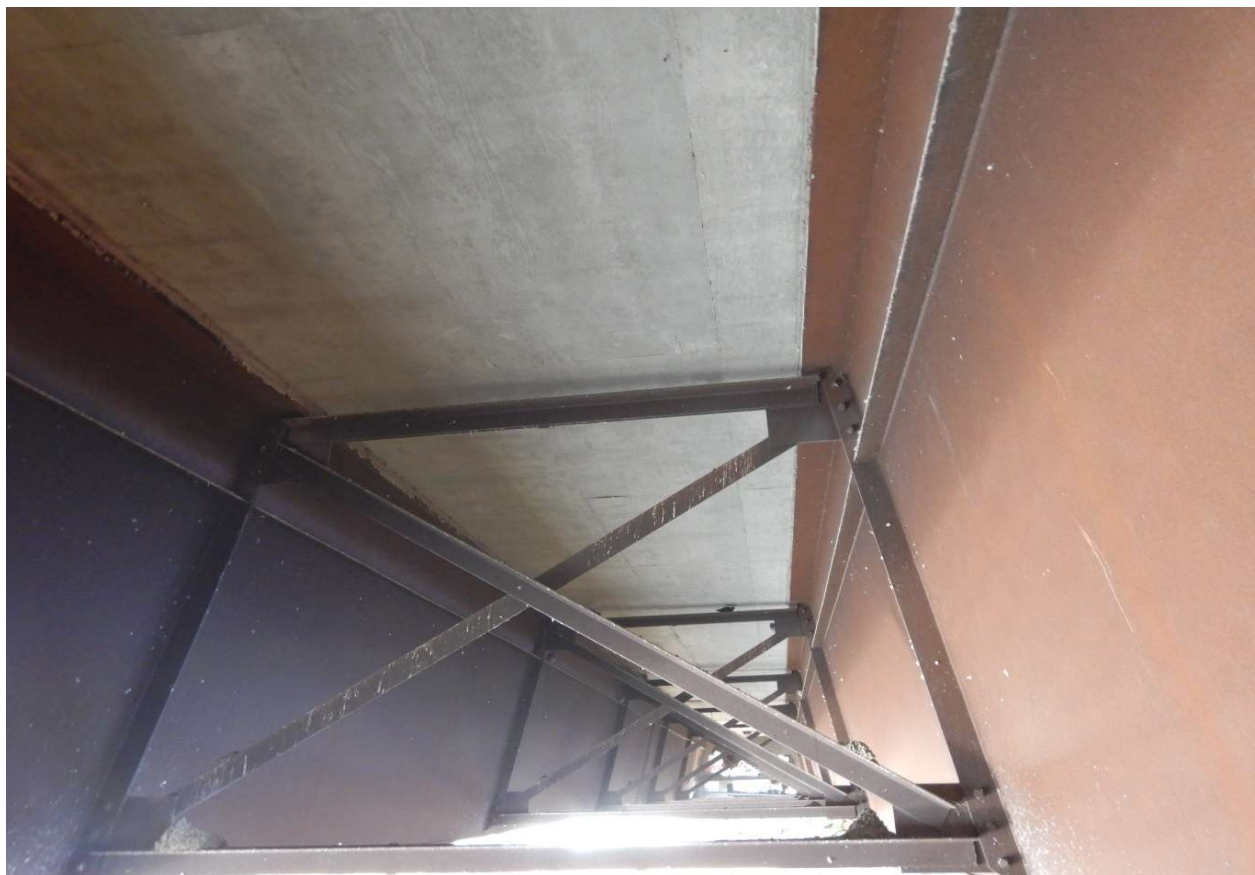
Description of Photo: Deck soffit, typ.

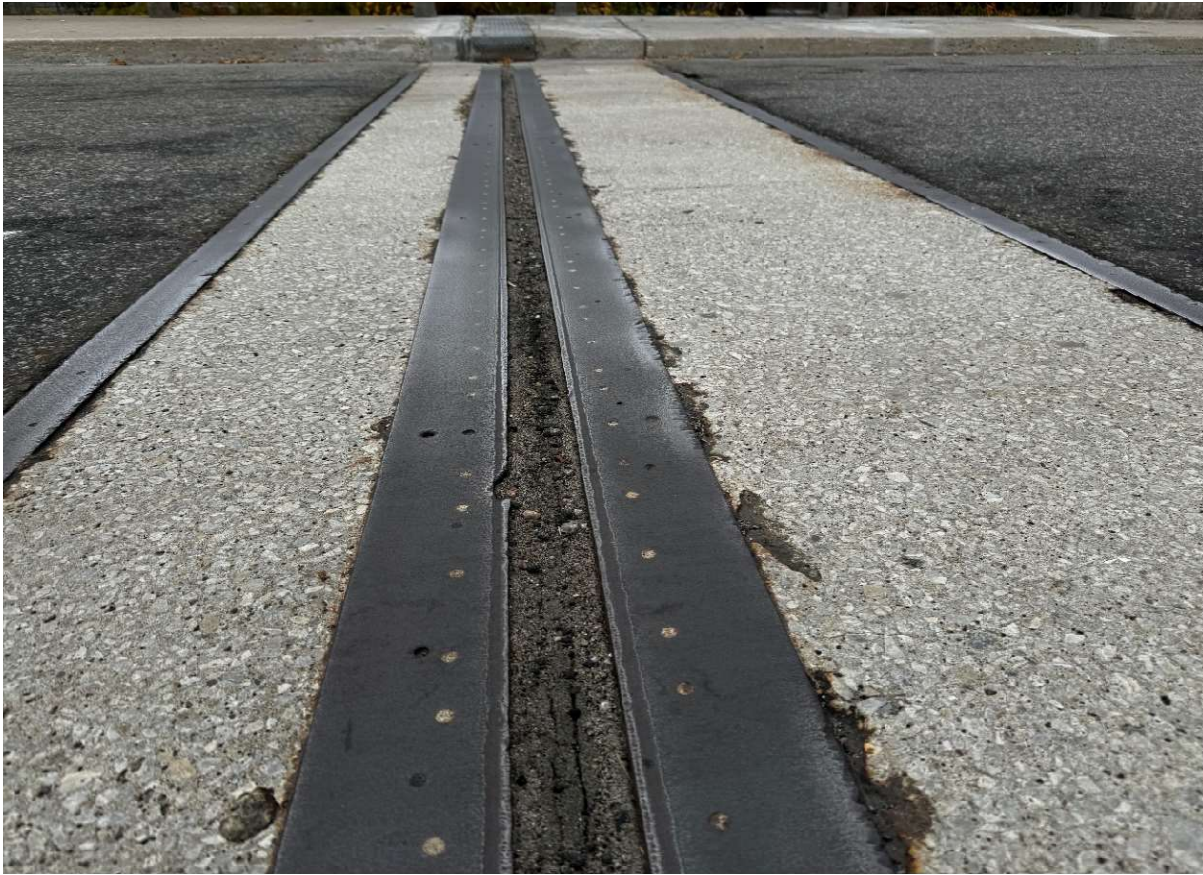
Description of Photo: Concrete end dam

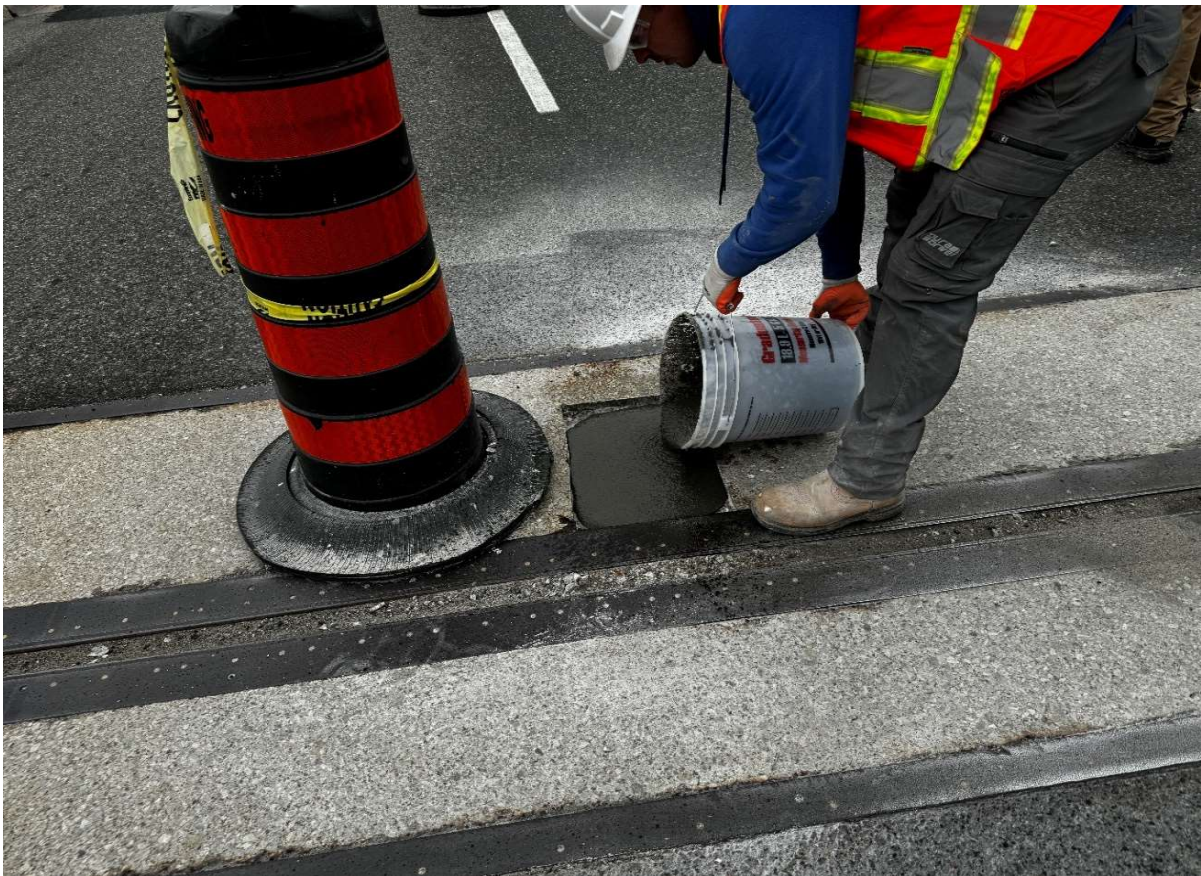
Description of Photo: Concrete end dams rehab patch work

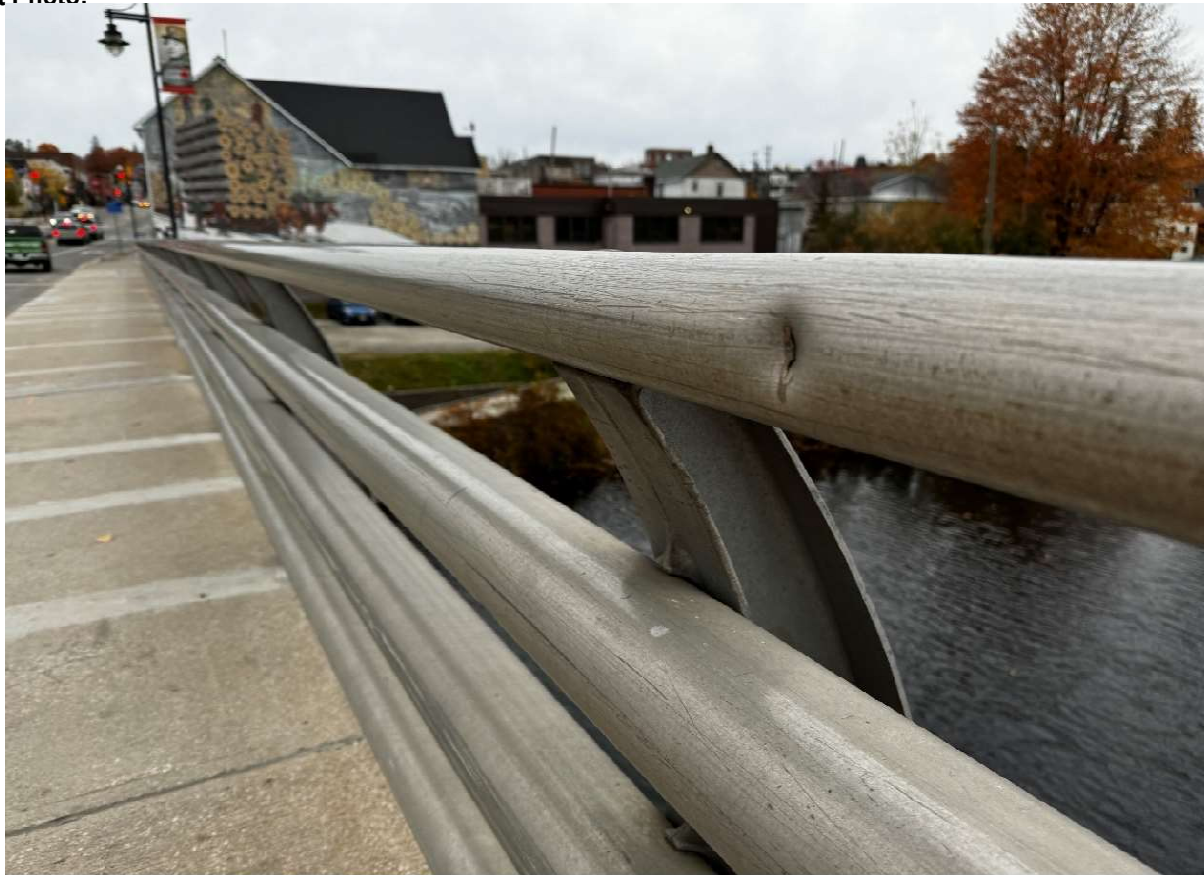
Description of Photo: North railing perforations

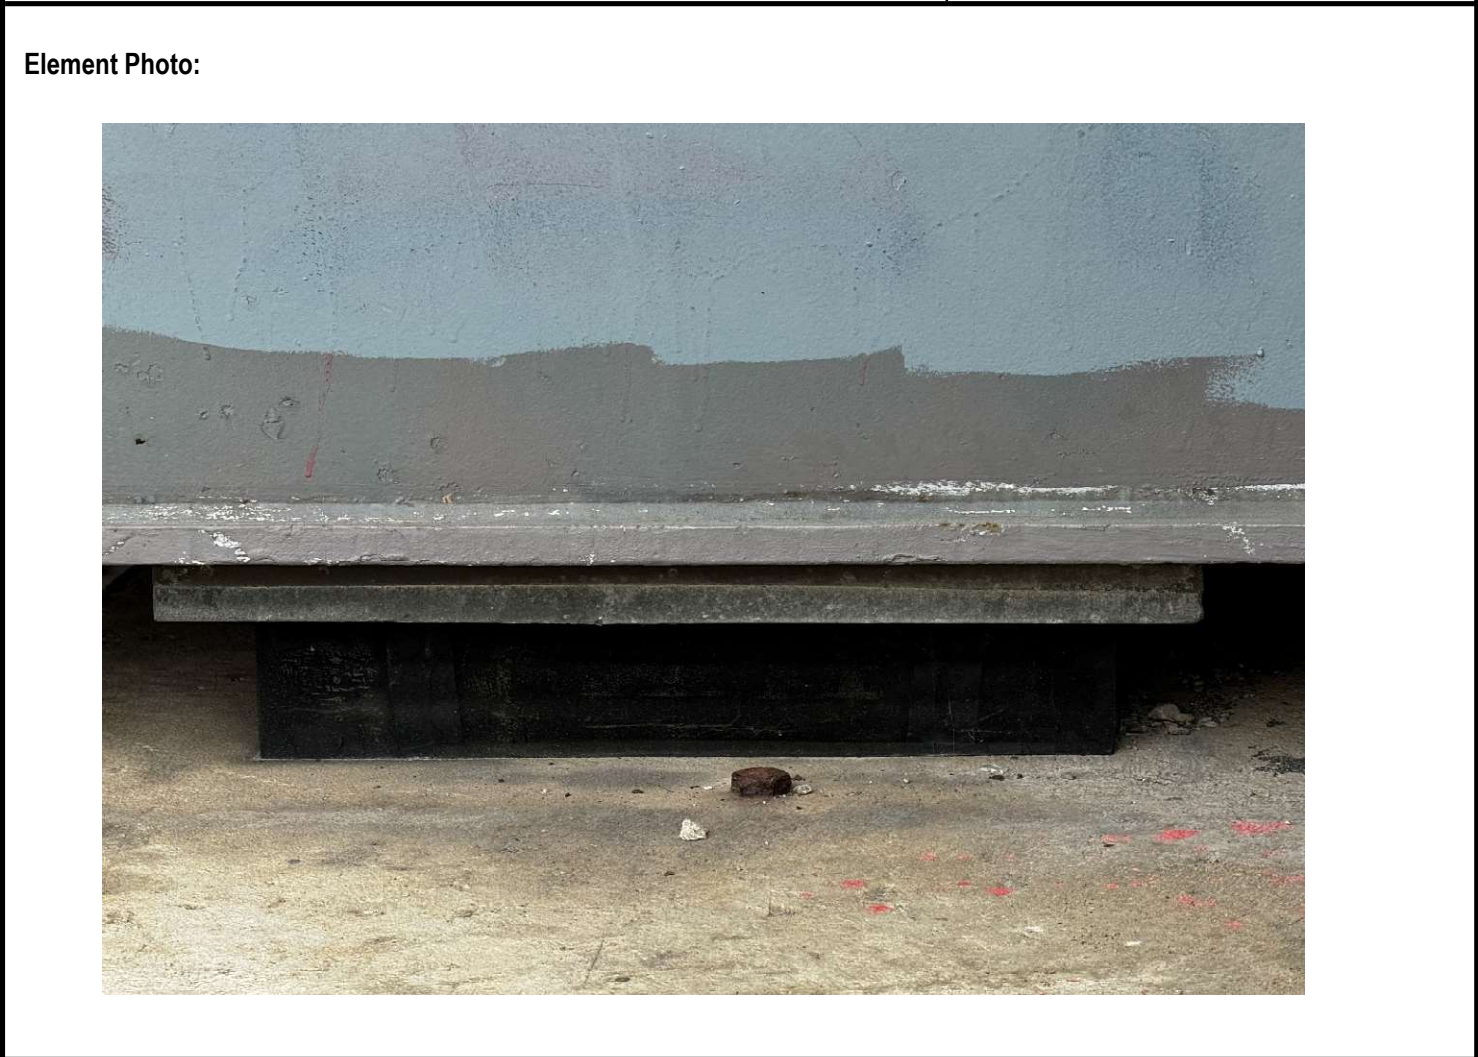
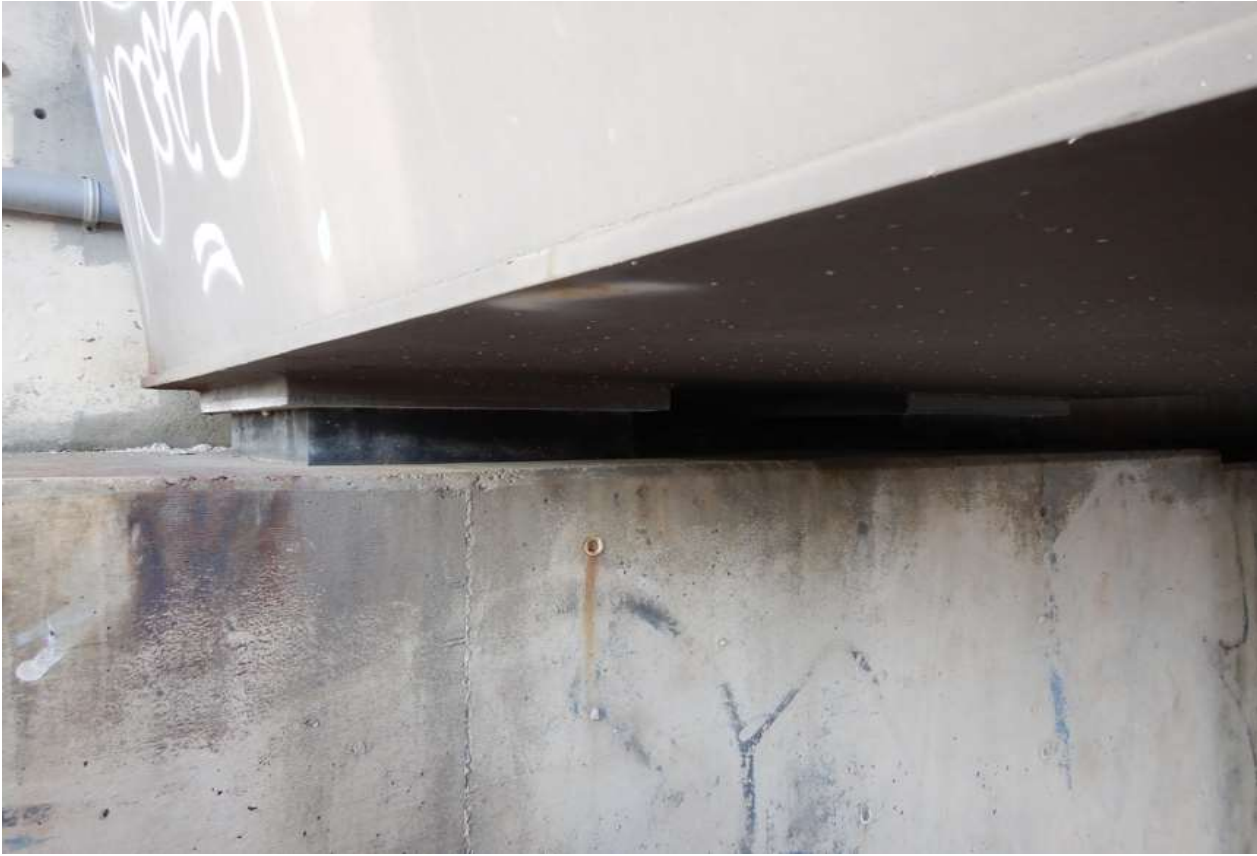
Comments: **Light weathering, typ.**

Description of Photo: Bearings

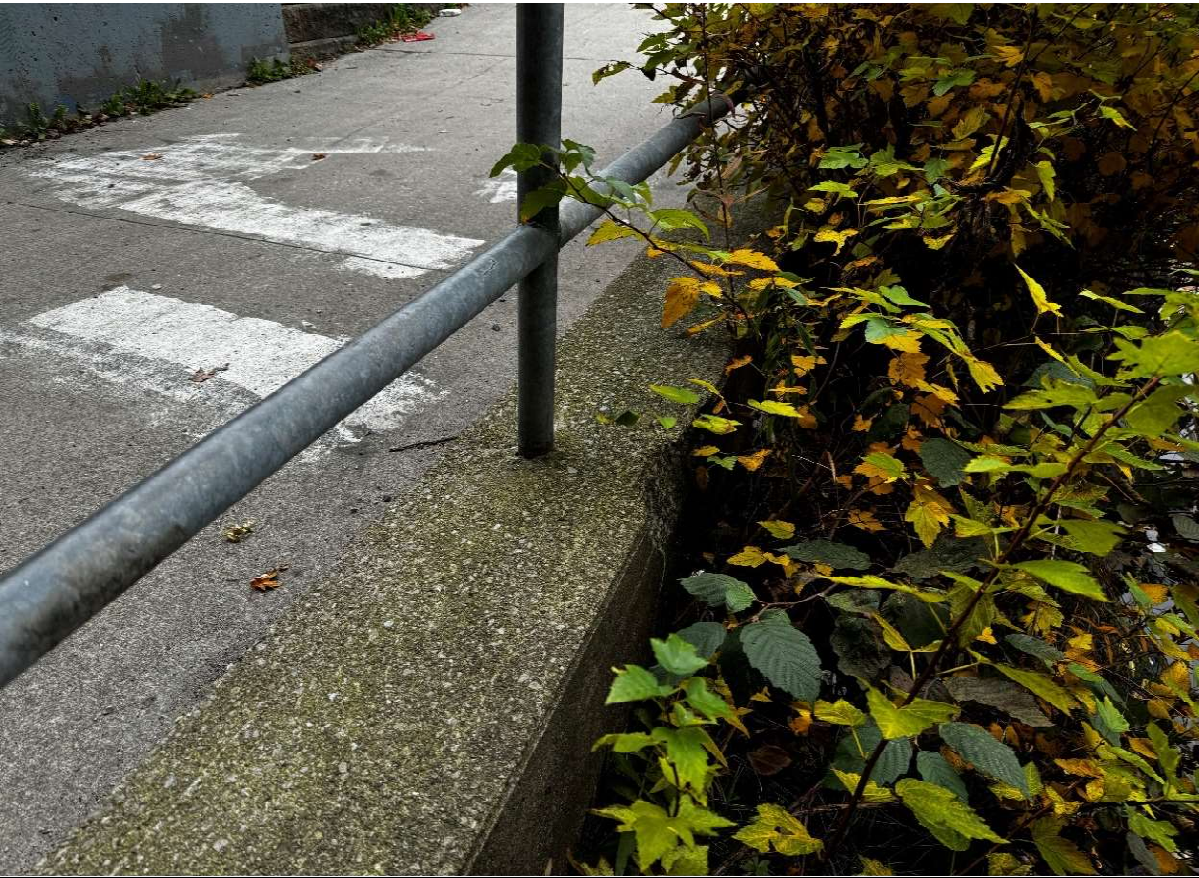
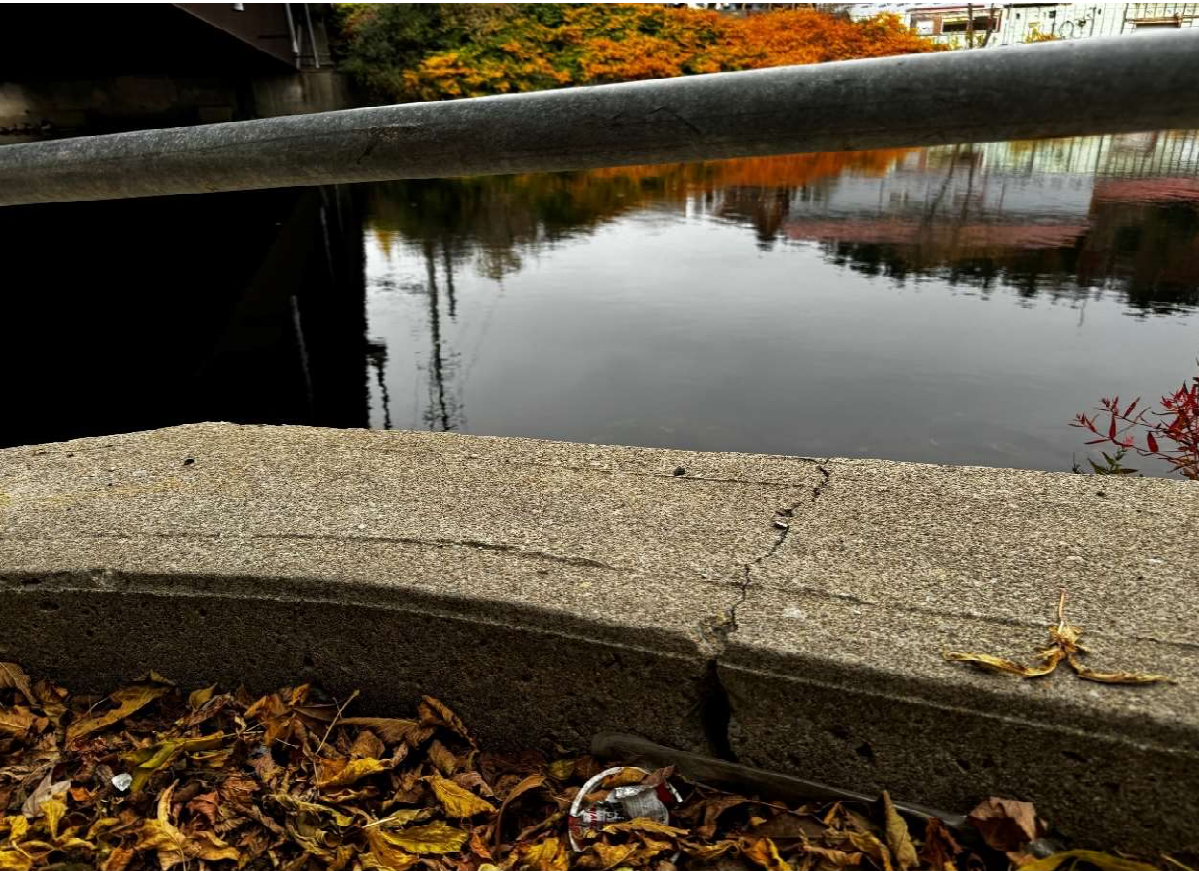
Comments: Light scaling, typical. Northwest side has cracks at 7th and 11th railing post and one 300x500mm light spall. Southwest side has medium cracks at 1st, 2nd and 7th railing post.

Description of Photo: Retaining wall

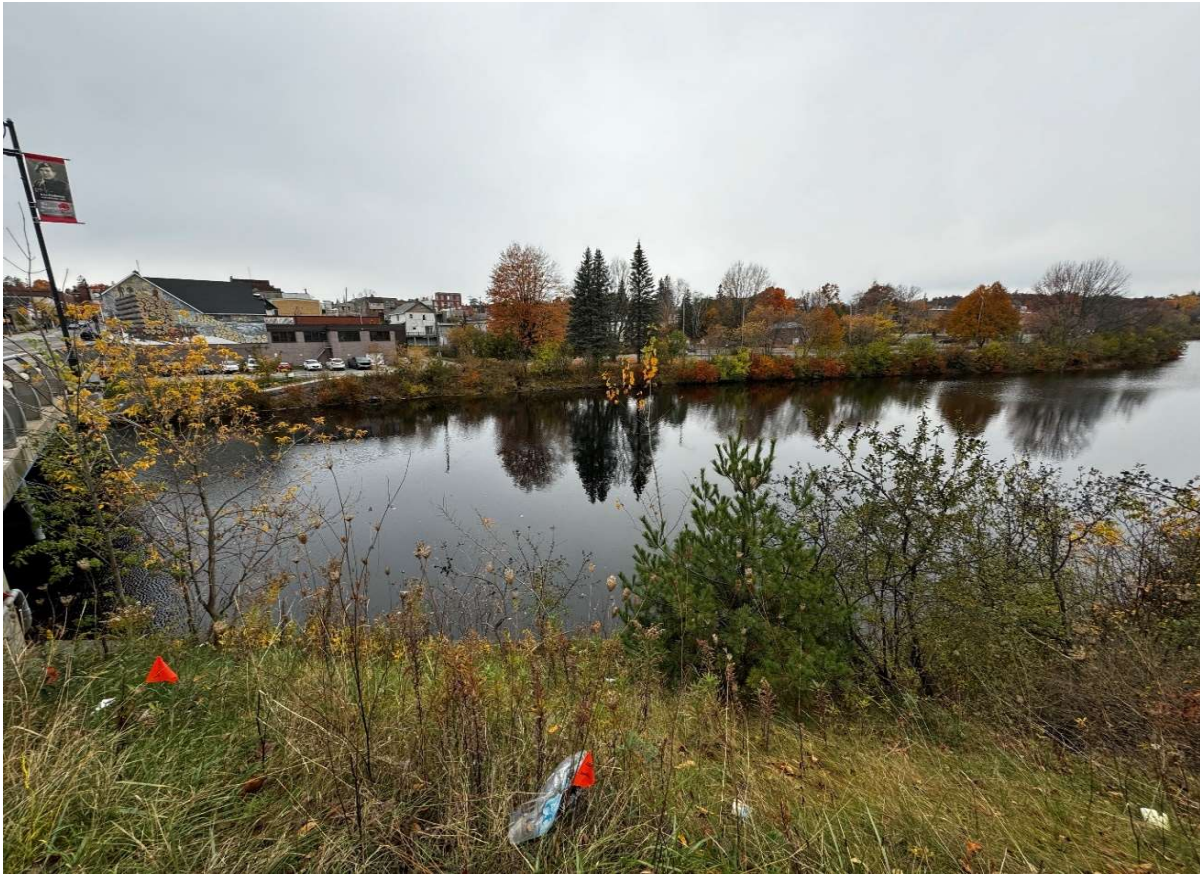
Comments: **No observed defects.**

Description of Photo: Waterway

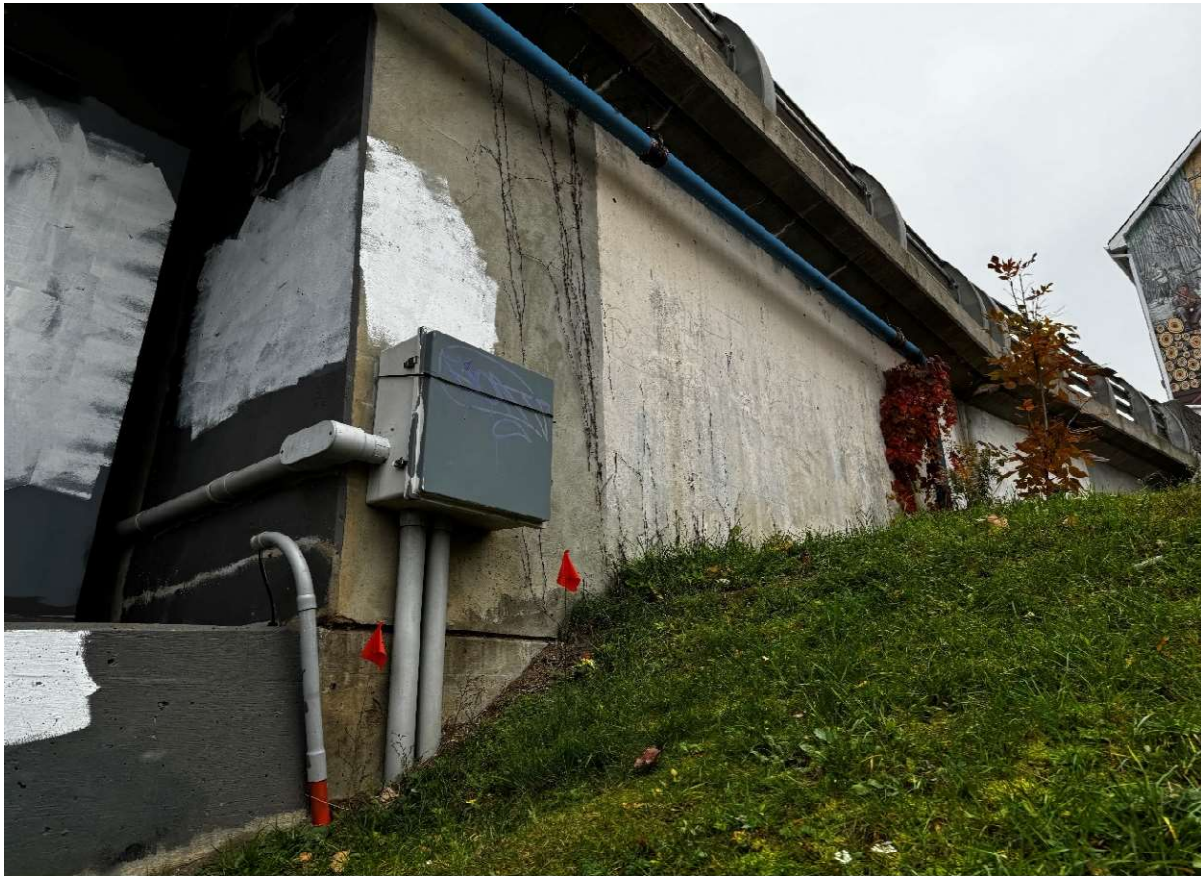
Element Data:						
Element Group:	Accessories		Length:			
Element Name:	Utilities		Width:			
Location:			Height:			
Material:			Count:	14		
Element Type:	Various		Total Quantity:	14		
Environment:			Inspected	Yes <input checked="" type="checkbox"/>	No <input type="checkbox"/>	limited <input type="checkbox"/>
Protection System:						Performance Deficiencies
Condition Data:	Units	Excellent	Good	Fair	Poor*	
	each		13	1		
Comments: There is gas line supported along the north face of the bridge, hangers have exhibited medium to severe corrosion. An insulated pipe (likely a watermain) under the north interior soffit, electrical and bell also appear to be supported under the north interior soffit. There are some punctures in the watermain insulation protective covering. Electrical lines are also supported along both ballast walls. 8-90mm diameter ducts are in each sidewalk. Electrical box at northwest quadrant has a damaged latch and can be opened.

Description of Photo: Utilities

Recommended Work:		Rehab: <input type="checkbox"/>	Replace: <input type="checkbox"/>	Maintenance Needs:		18 - Other Maintenance
Urgent: <input type="checkbox"/>		1-5 Years: <input type="checkbox"/>	6-10 Years: <input type="checkbox"/>	None: <input checked="" type="checkbox"/>	Urgent: <input type="checkbox"/>	1 Year: <input checked="" type="checkbox"/> 2 Year: <input type="checkbox"/>
				Replace latch and ensure electrical box can be closed and locked.

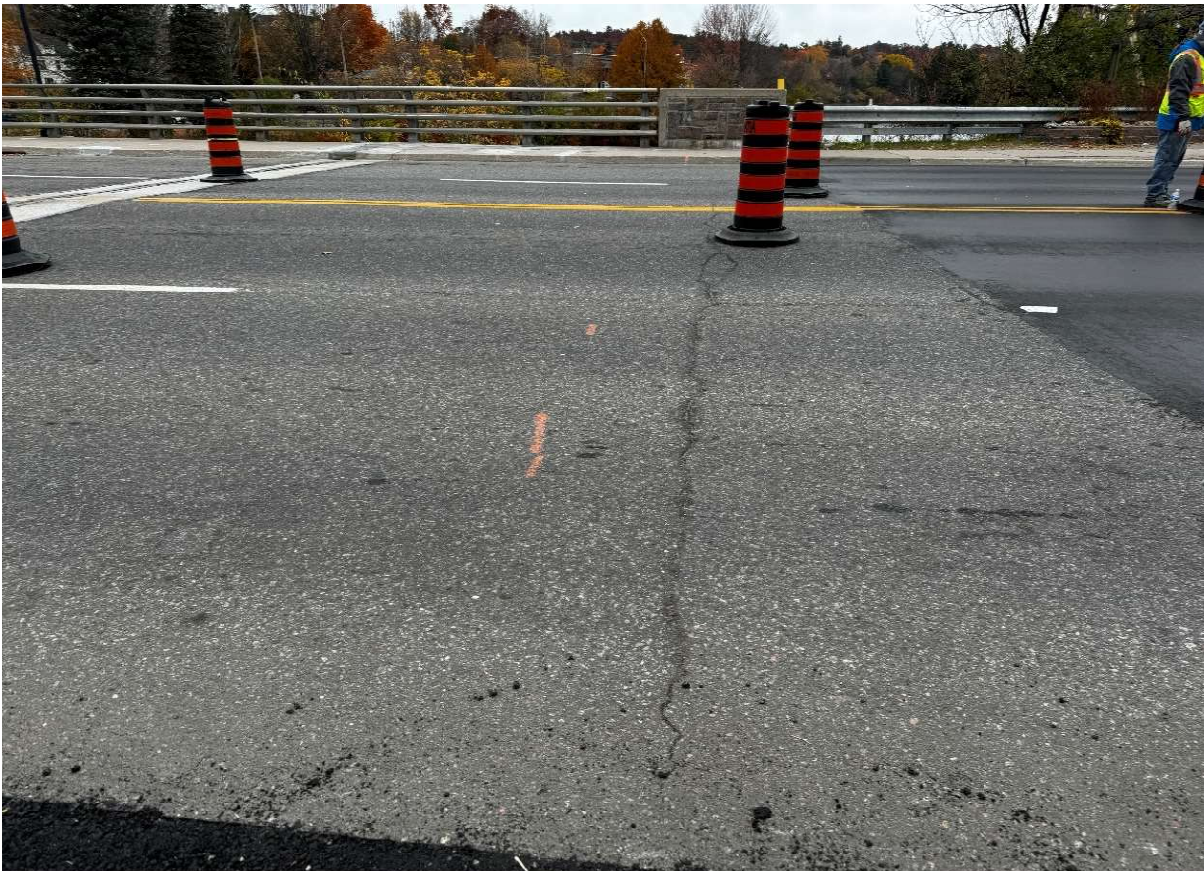
Comments: Light ravelling, typical. West lane has medium wheel rutting 6.0m x 500 x 8mm. Southeast 7m of medium transverse cracks. Medium loss of bond (300mm x 300mm).

Description of Photo: East approach

Description of Photo: West approach

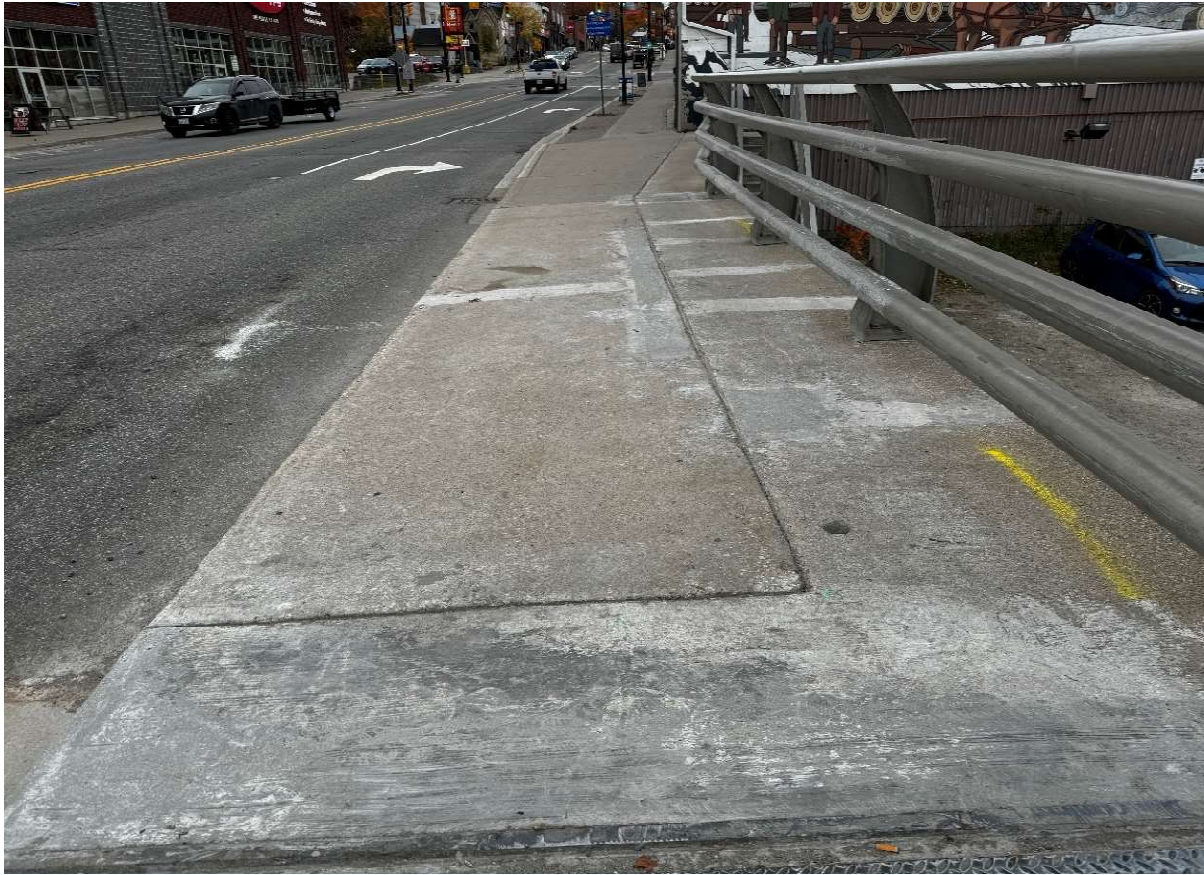
Comments: **Light scaling, typical.**

Description of Photo: Approach sidewalk
