Bridge Needs Study 2024

INSPECTION SUMMARY REPORT

Town of Parry Sound

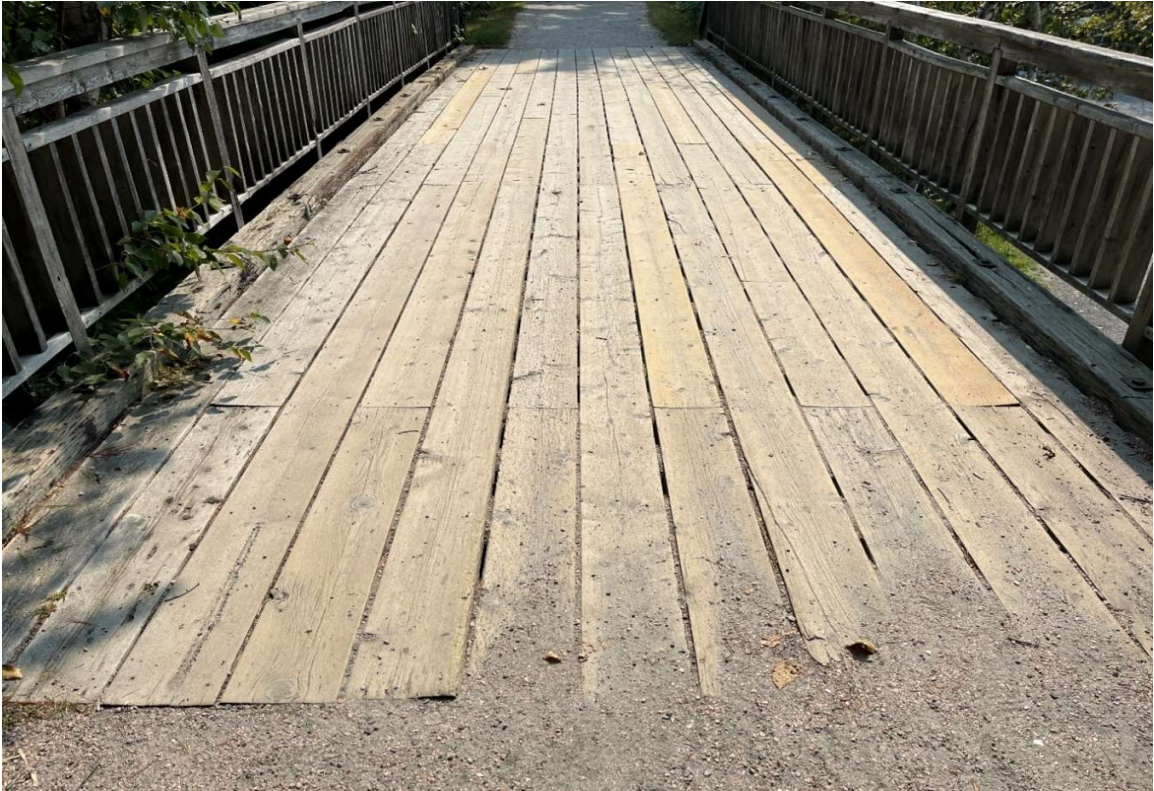
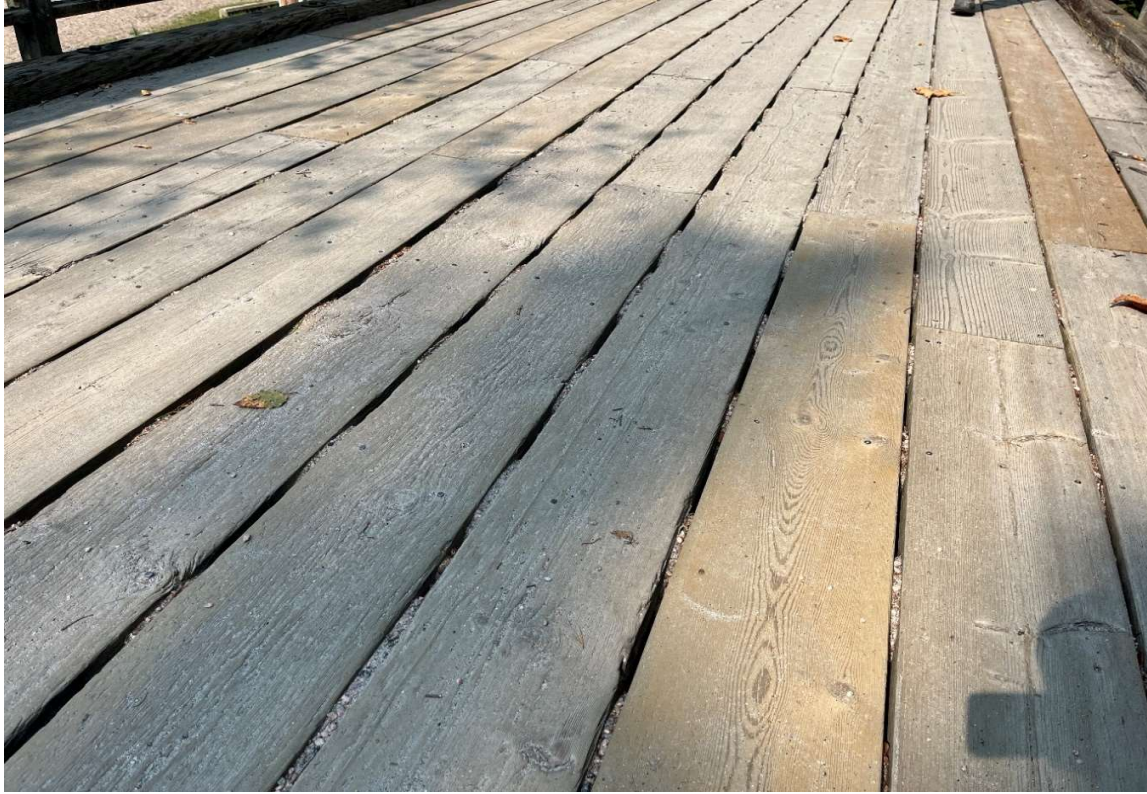
Description of Photo:		Deck top

Description of Photo: Deck top

Replace rottent planks						
Element Photo:

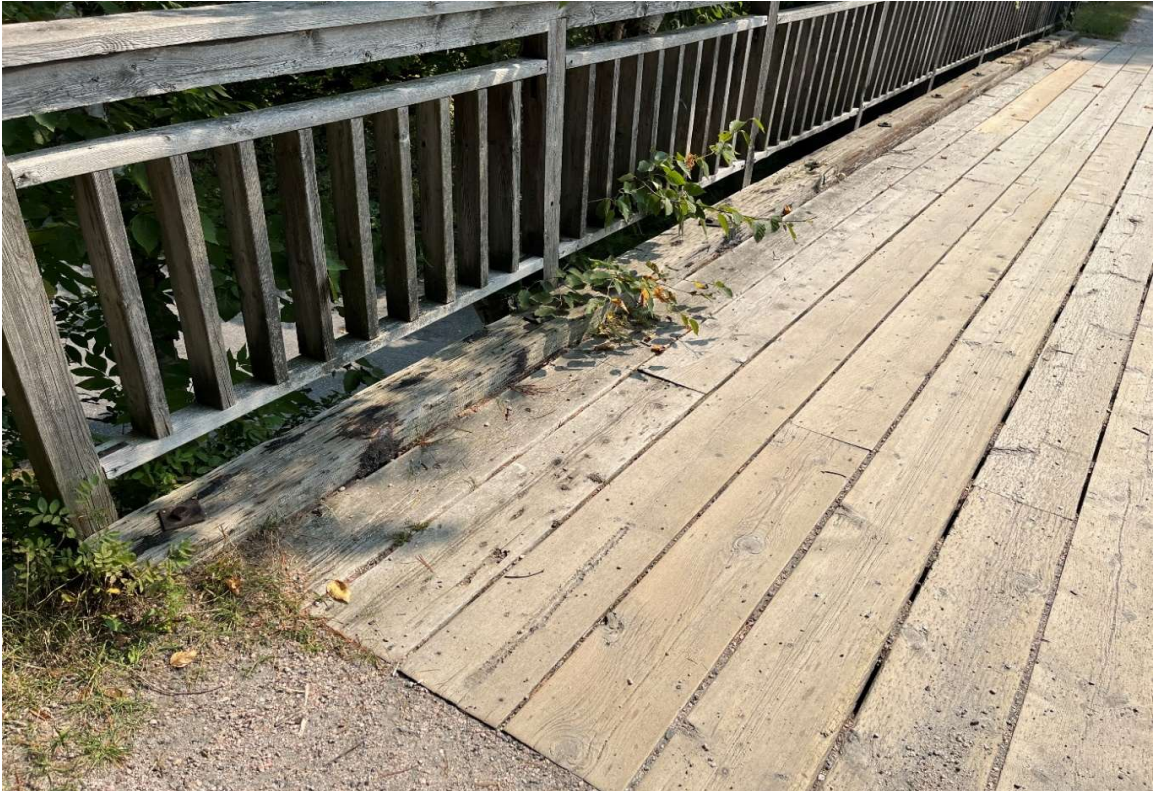
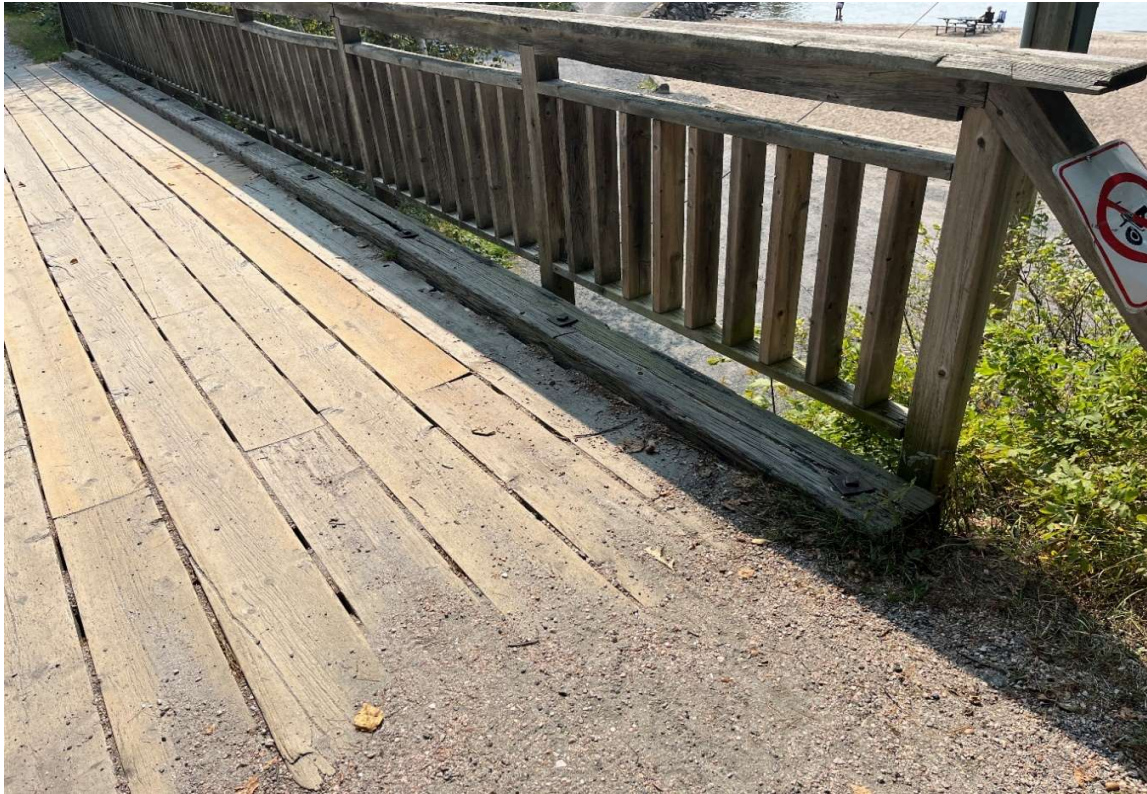
Description of Photo:		Curb

Description of Photo: Curb

Description of Photo: Rot on curb

Element Data:						
Element Group:	Sidewalk/Curb		Length:	12.8		
Element Name:	Curbs		Width:	0.2		
Location:			Height:	0.2		
Material:	Wood		Count:	2		
Element Type:			Total Quantity:	10.2		
Environment:	Benign		Inspected	Yes <input checked="" type="checkbox"/>	No <input type="checkbox"/>	limited <input type="checkbox"/>
Protection System:						Performance Deficiencies
Condition Data:	Units	Excellent	Good	Fair	Poor*	
	sq.m		3.7	3.3	3.3	
Comments: Light weathering, typ. Light to severe checks, typ. Isolated rot on multiple curb members.						
Recommended Work:		Rehab: <input checked="" type="checkbox"/>	Replace: <input type="checkbox"/>	Maintenance Needs:		
Urgent: <input type="checkbox"/>	1-5 Years: <input checked="" type="checkbox"/>	6-10 Years: <input type="checkbox"/>	None: <input type="checkbox"/>	Urgent: <input type="checkbox"/>	1 Year: <input type="checkbox"/>	2 Year: <input type="checkbox"/>
Replace rotten timbers

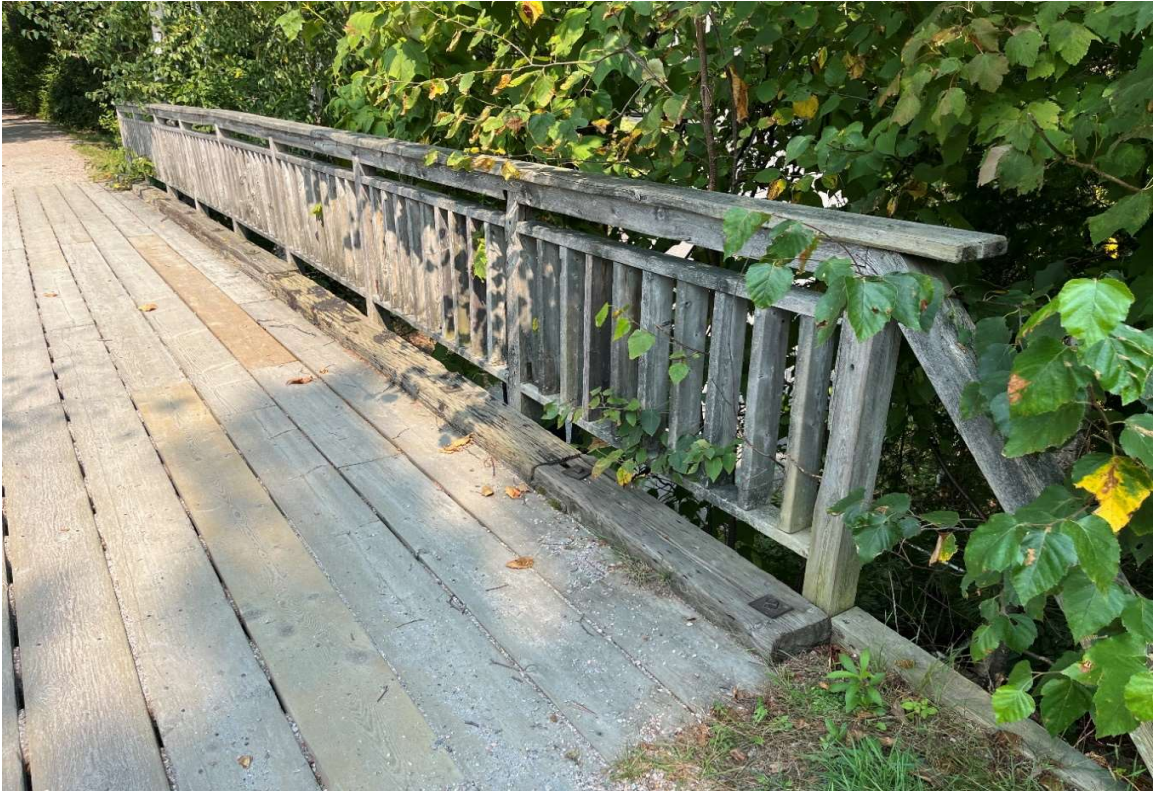
Description of Photo:		Barrier

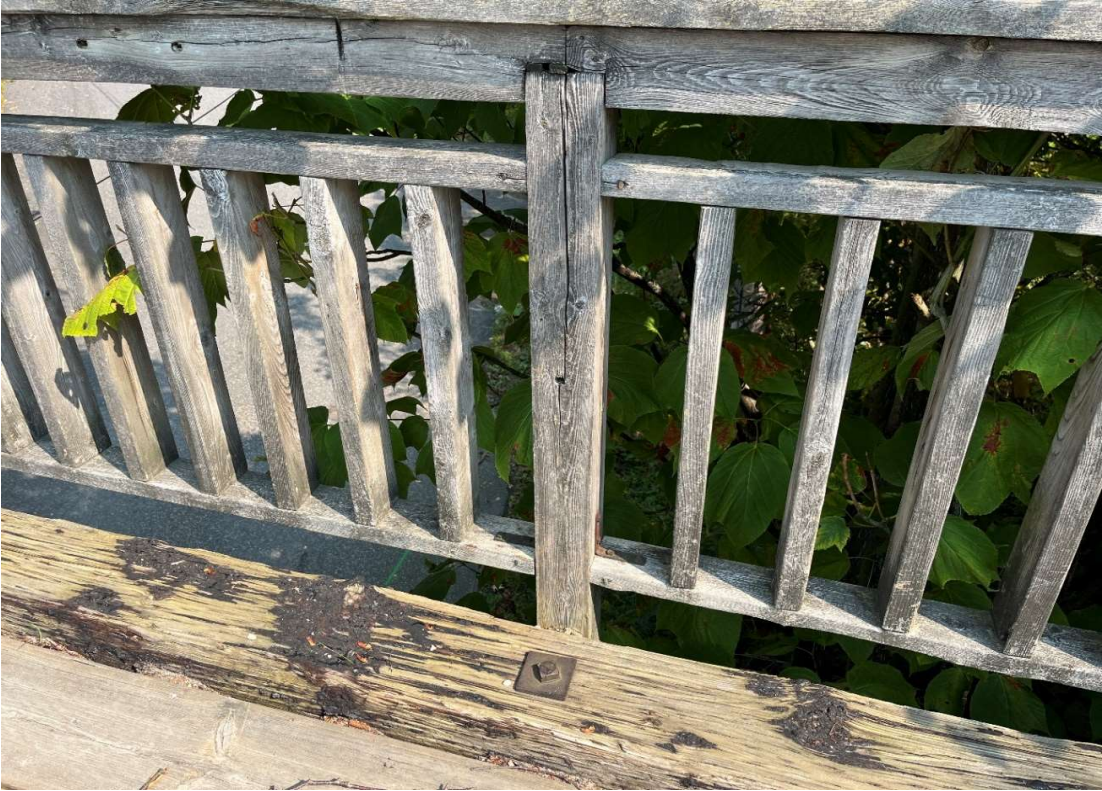
Description of Photo:		Railing Post

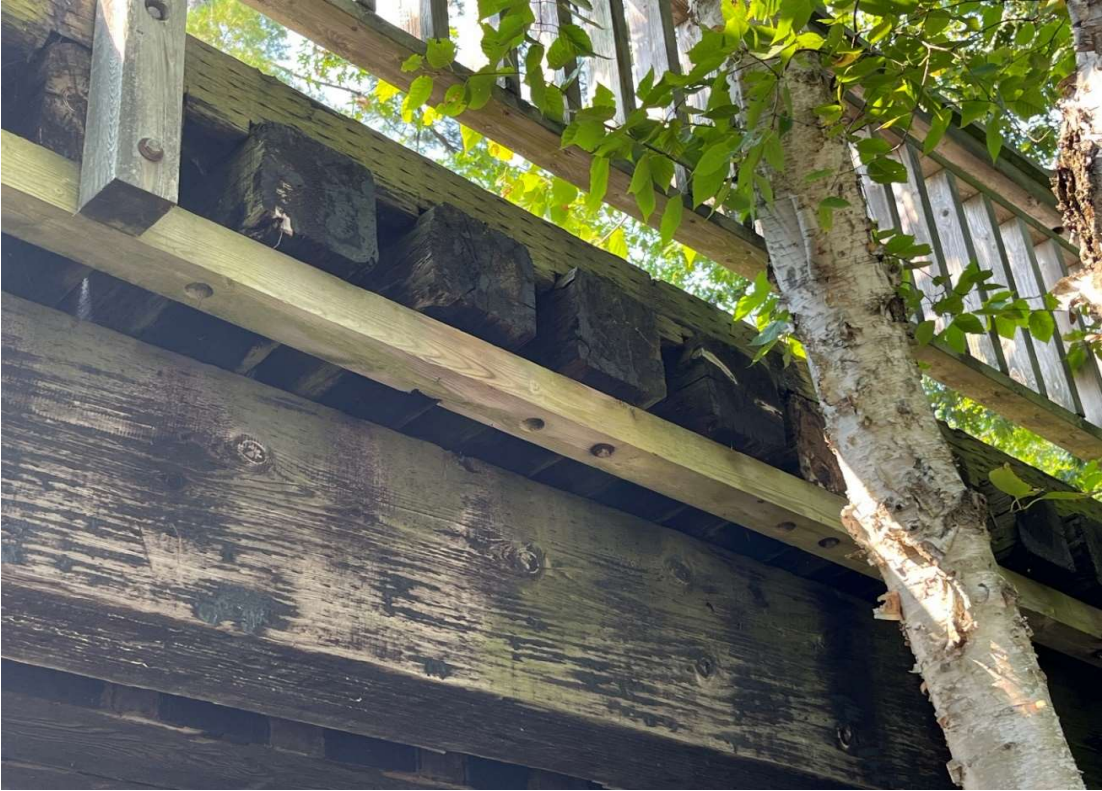
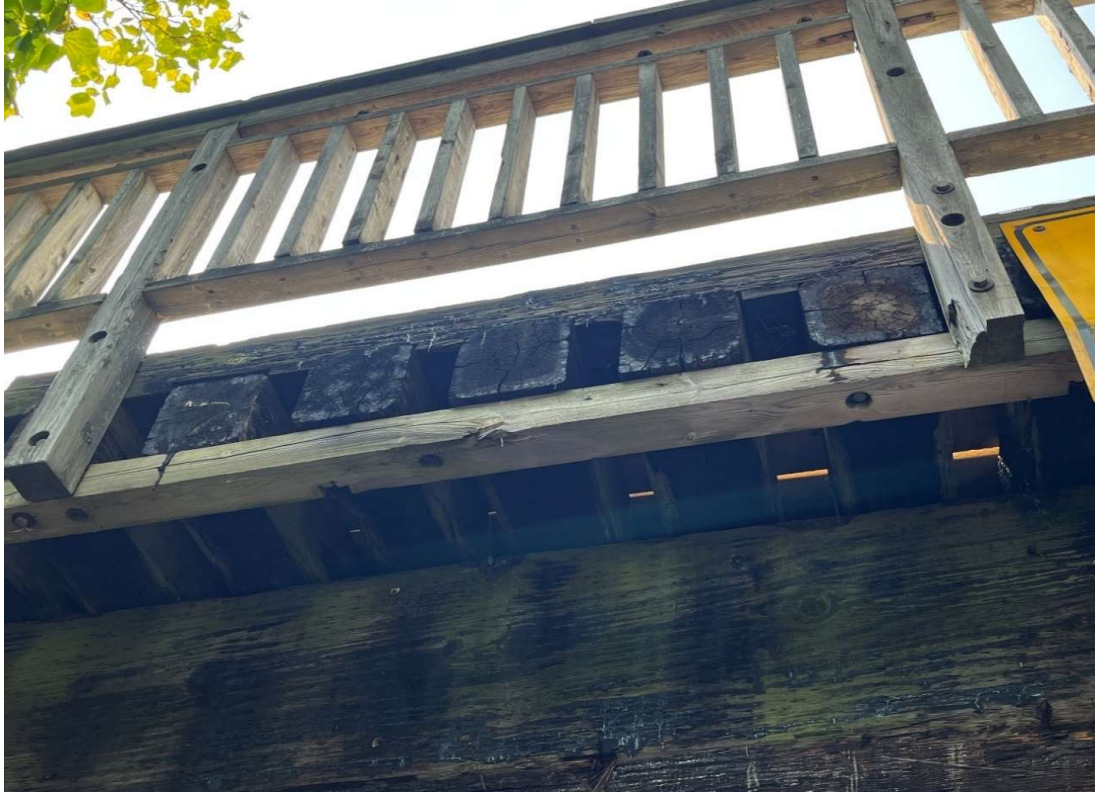
Description of Photo:		Crossties

Description of Photo: Crossies

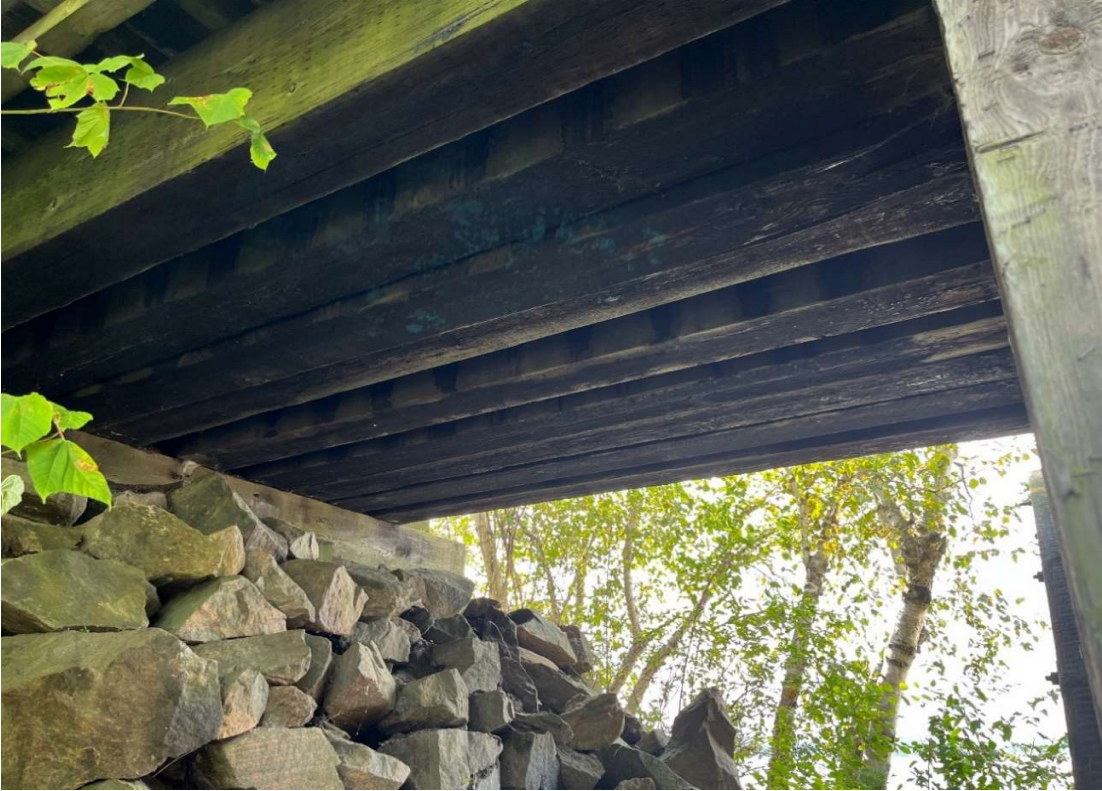
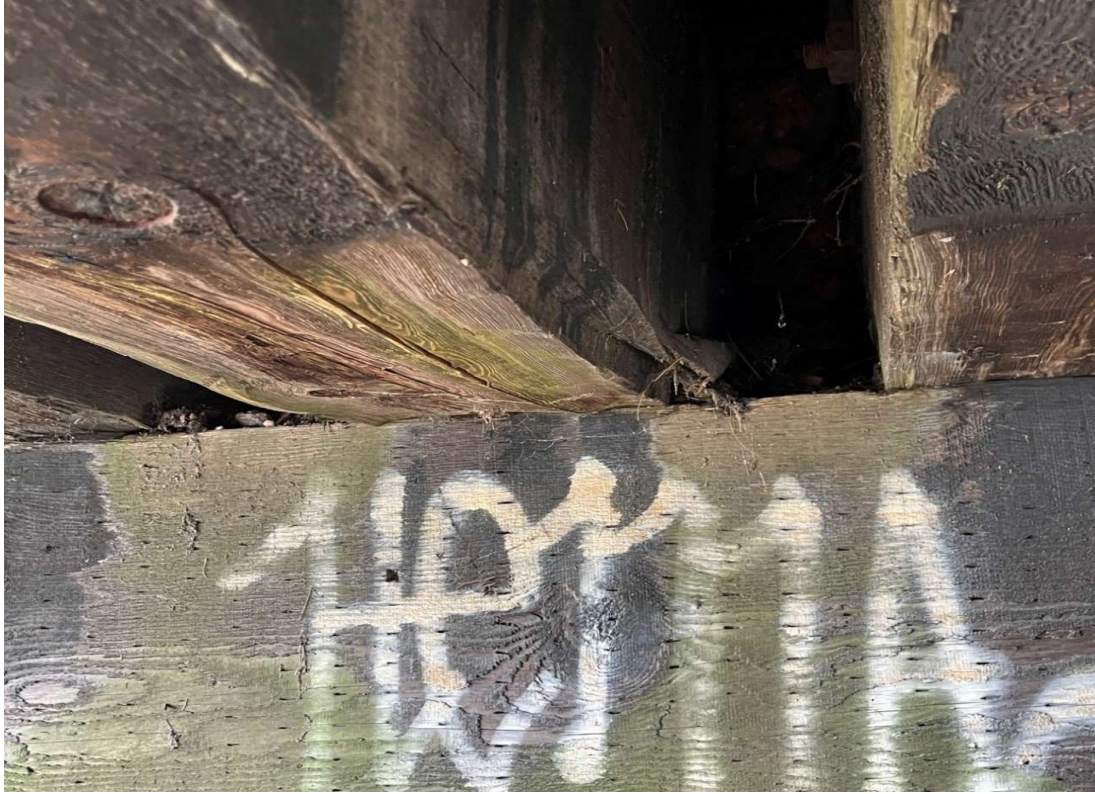
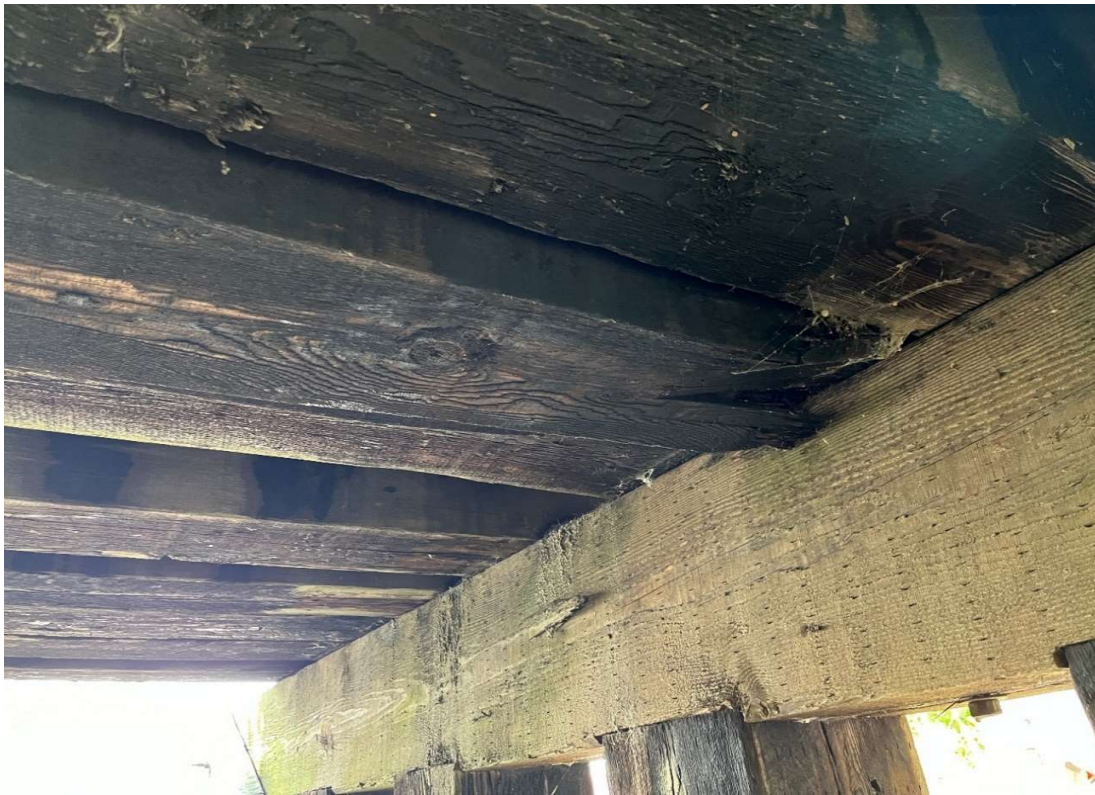
Element Data:						
Element Group:	Beams/Main Longitudinal Elements	Length:	3.73, 4.18, 3.53			
Element Name:	Stringers	Width:	0.25			
Location:		Height:	0.45			
Material:	Wood	Count:	18			
Element Type:	Rectangular Solid	Total Quantity:	288.3			
Environment:	Benign	Inspected	Yes <input checked="" type="checkbox"/>	No <input type="checkbox"/>	limited <input type="checkbox"/>	
Protection System:	Creosote					Performance Deficiencies
Condition Data:	Units	Excellent	Good	Fair	Poor*	
	sq.m		244.1	28.8	15.4	1 - Load carrying capacity
Comments: Light weathering typical. Isolated medium to severe checks and splits. Center span light splintering on the east and west exterior stringers, likely from vehicle impact. North span center stringer 2.0m of rot from abutment with severe bulging, 2nd girder from west 2.0m of rot from abutment, 6th stringer has 1.0m of rot from abutment with severe bulging and 8th stringer has 1.0m of rot from abutment. South span at pier 3rd and 7th stringer has 1.0m of rot from pier, 7th stringer has 1.0 of rot from abutment. Center span at south pier 9th stringer has 1.0m of rot from pier and 8th stringer has 1.0m of rot from north pier.

Description of Photo: South span 7th stringer rot

Description of Photo: North span 5th stringer rot and bulging

Description of Photo: Centre span stringer rot

Recommended Work:		Rehab: <input checked="" type="checkbox"/>	Replace: <input type="checkbox"/>	Maintenance Needs:		
Urgent: <input type="checkbox"/>	1-5 Years: <input checked="" type="checkbox"/>	6-10 Years: <input type="checkbox"/>	None: <input type="checkbox"/>	Urgent: <input type="checkbox"/>	1 Year: <input type="checkbox"/>	2 Year: <input type="checkbox"/>
Replace 8 rotten stringers						
Element Photo:

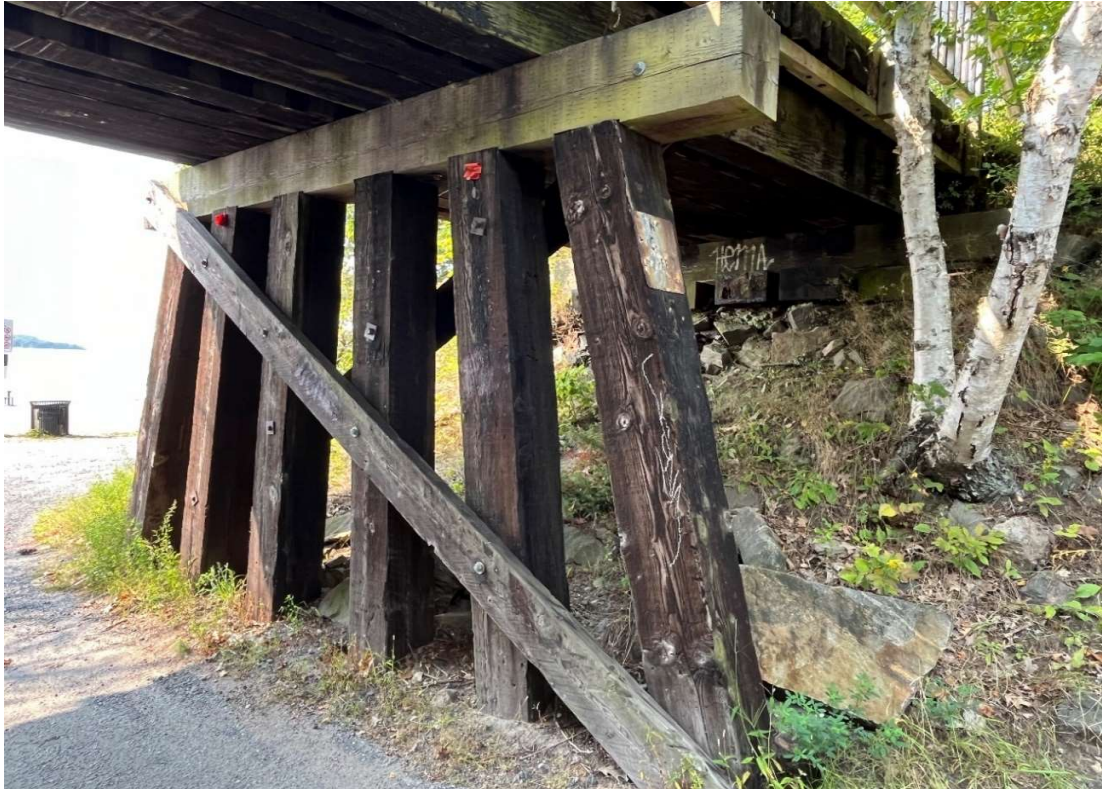
Description of Photo:		Bracing

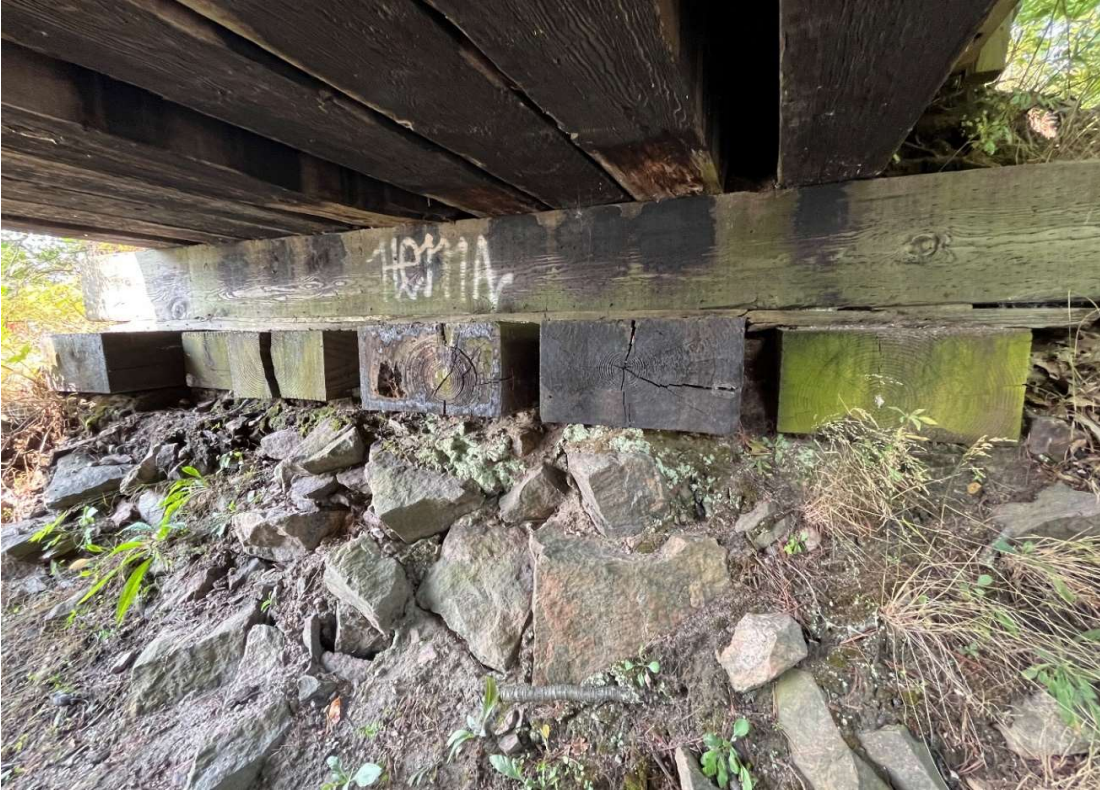
Description of Photo: Sill

Replace deteriorated timber sills						
<p>Element Photo:</p>

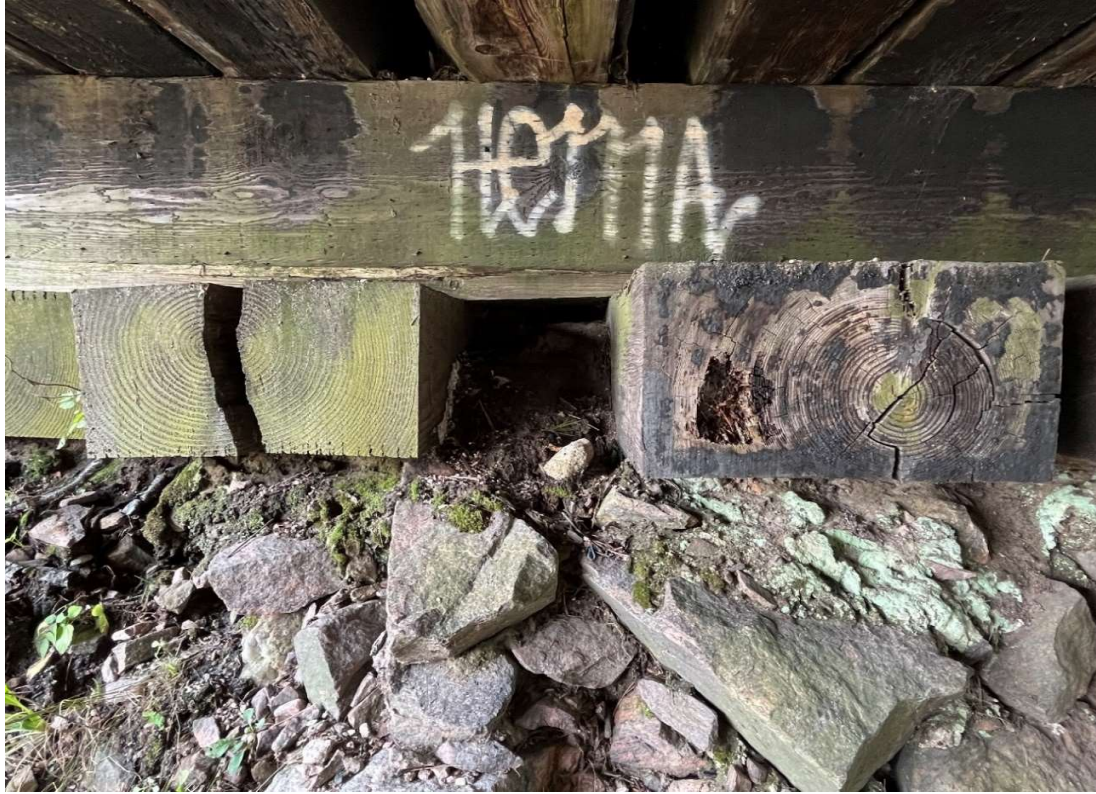
Description of Photo: Sill rot

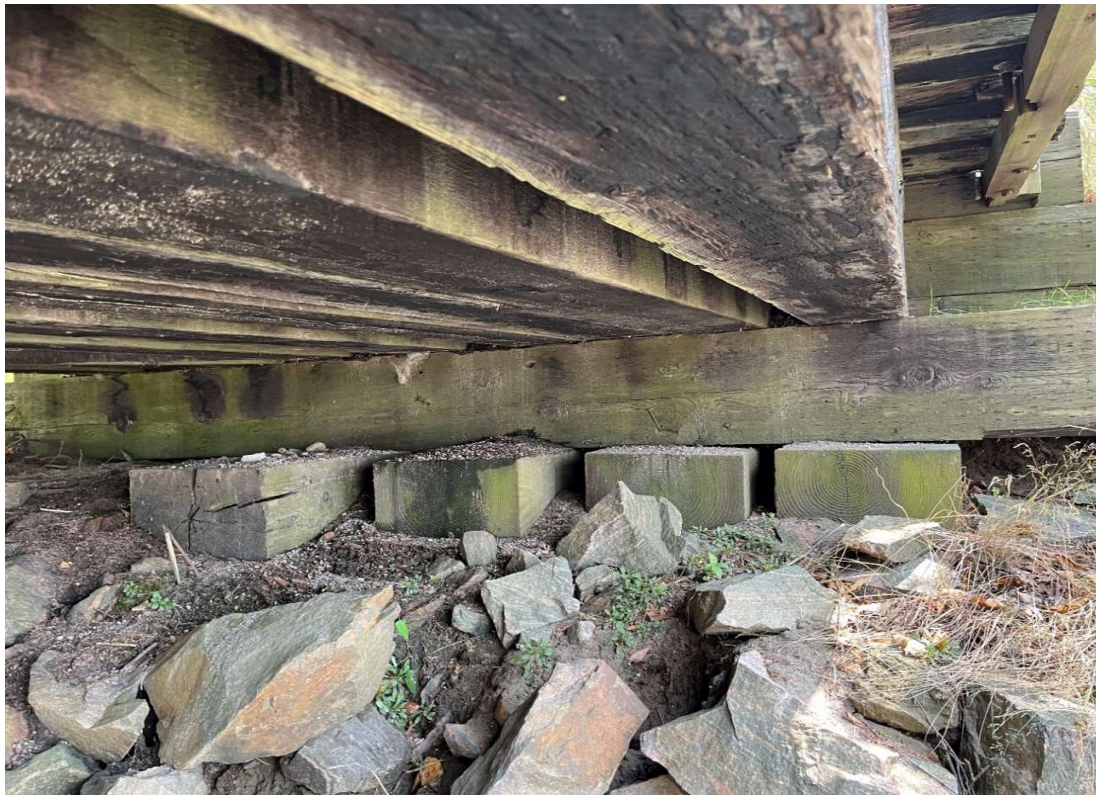
Description of Photo: Sill

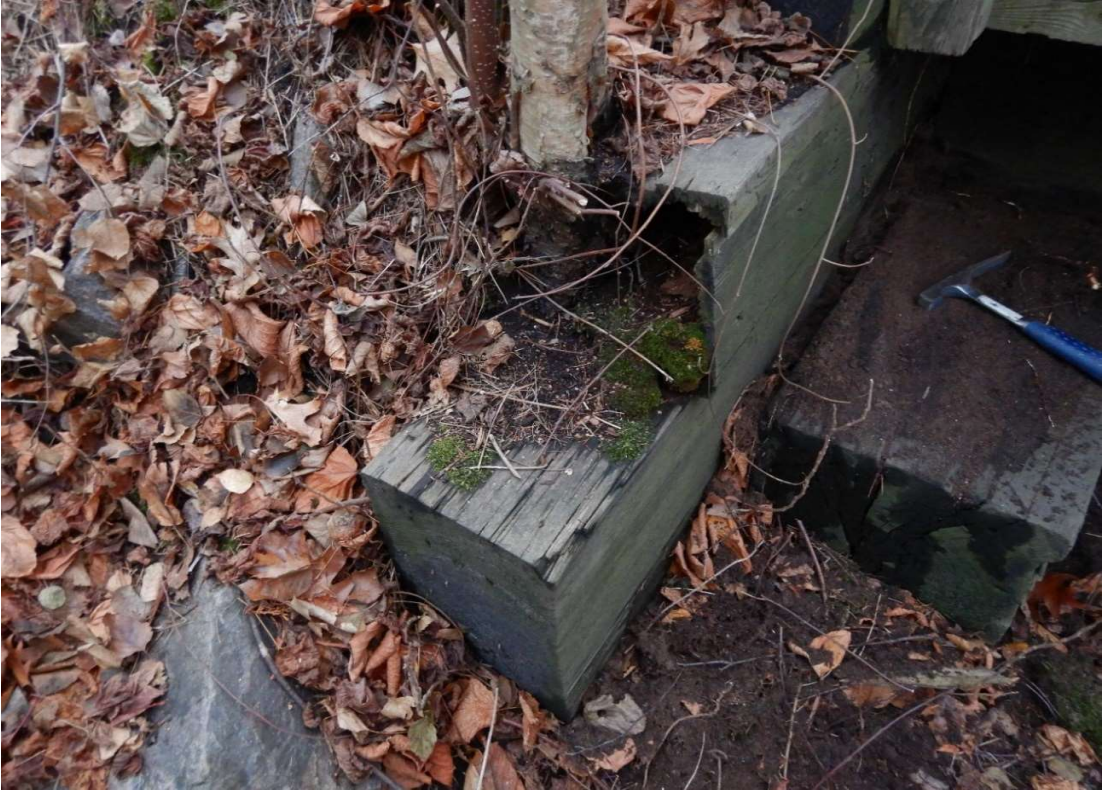
Description of Photo: South Ballast Wall, Rot

Replace south ballast wall						
Element Photo:

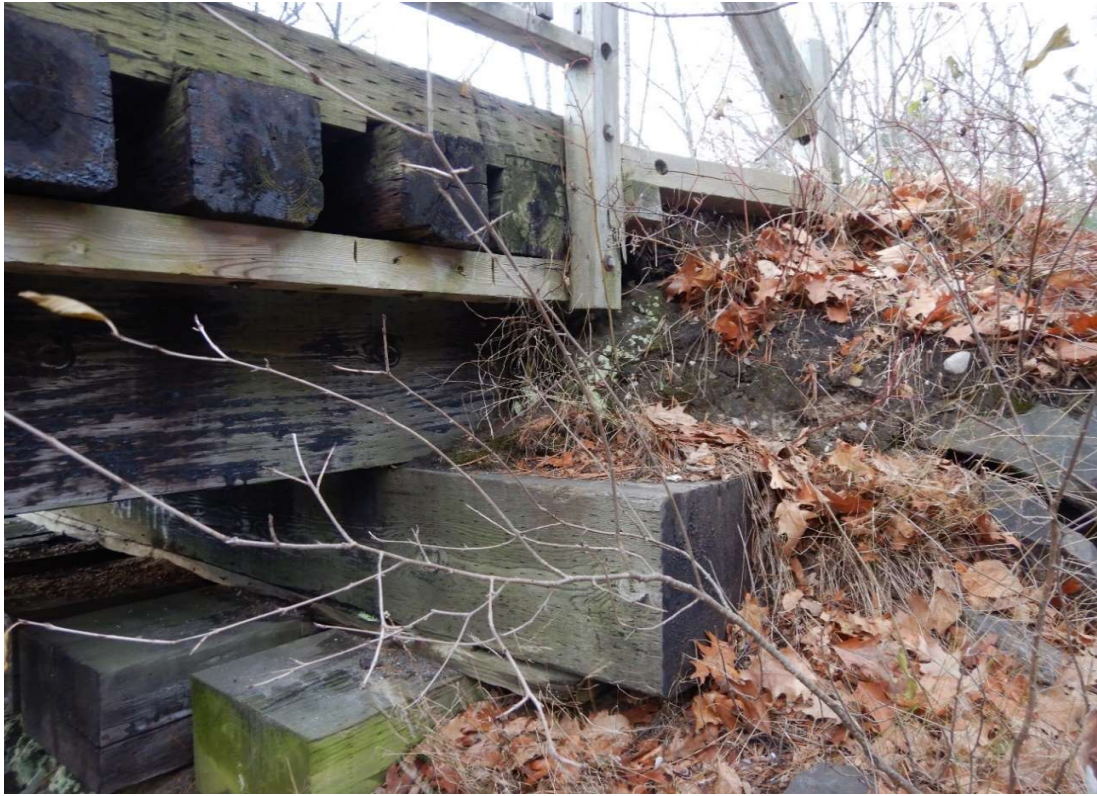
Description of Photo: Ballast wall

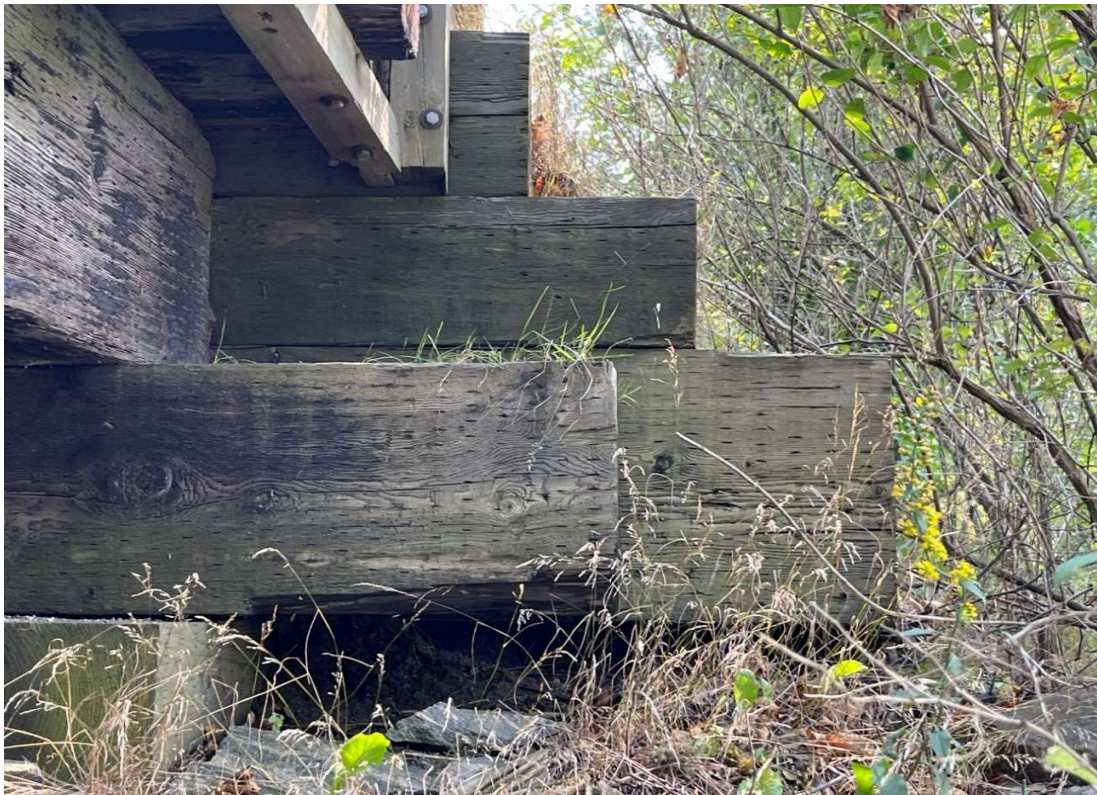
Description of Photo: Ballast wall

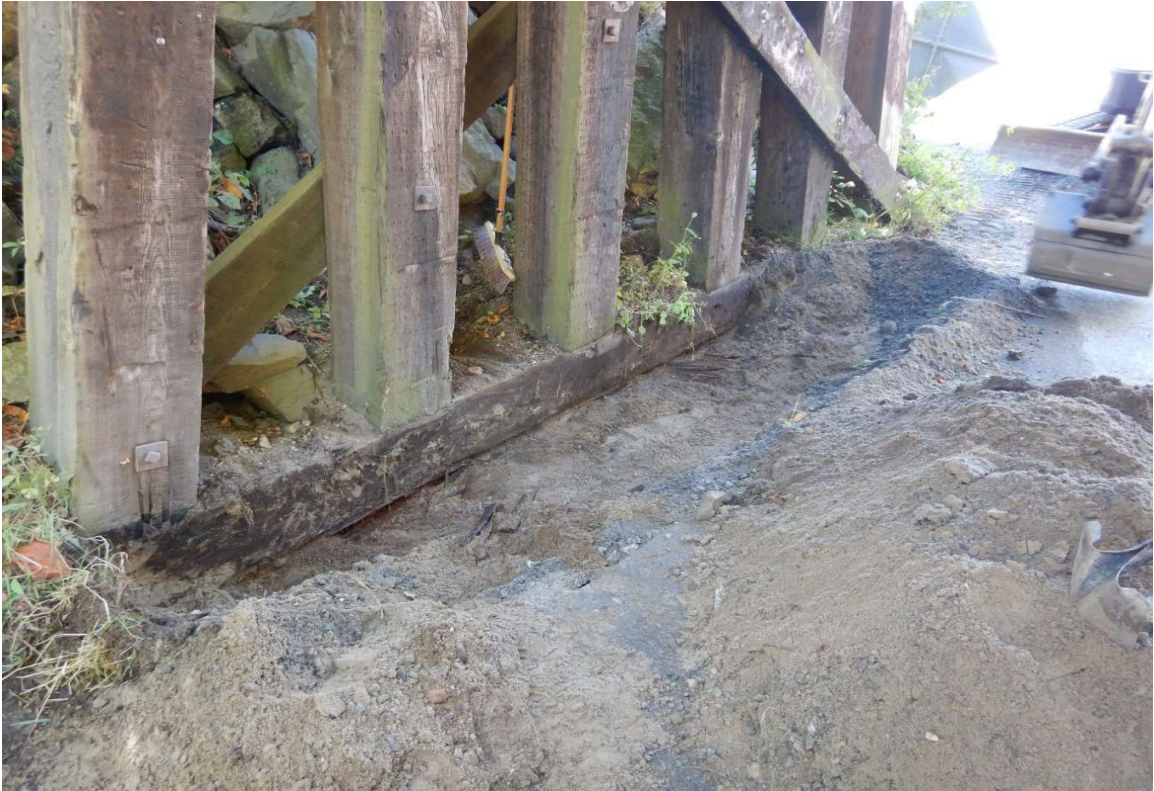
Description of Photo: South timber sill

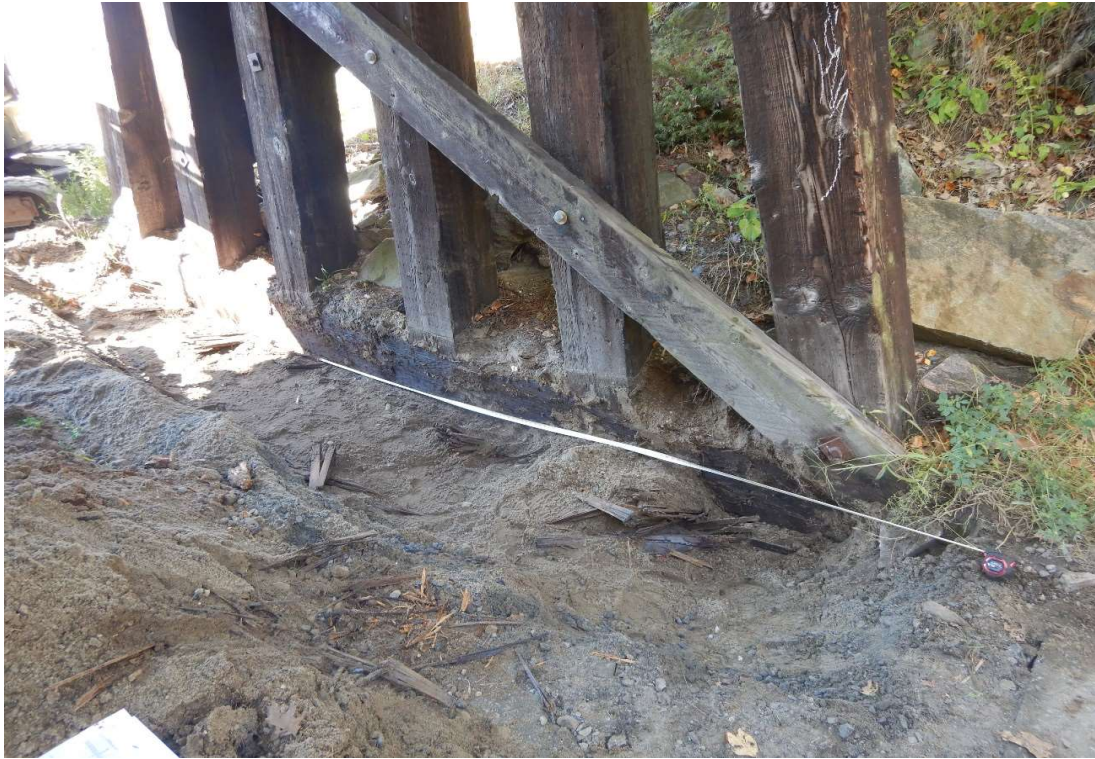
Description of Photo: North timber sill

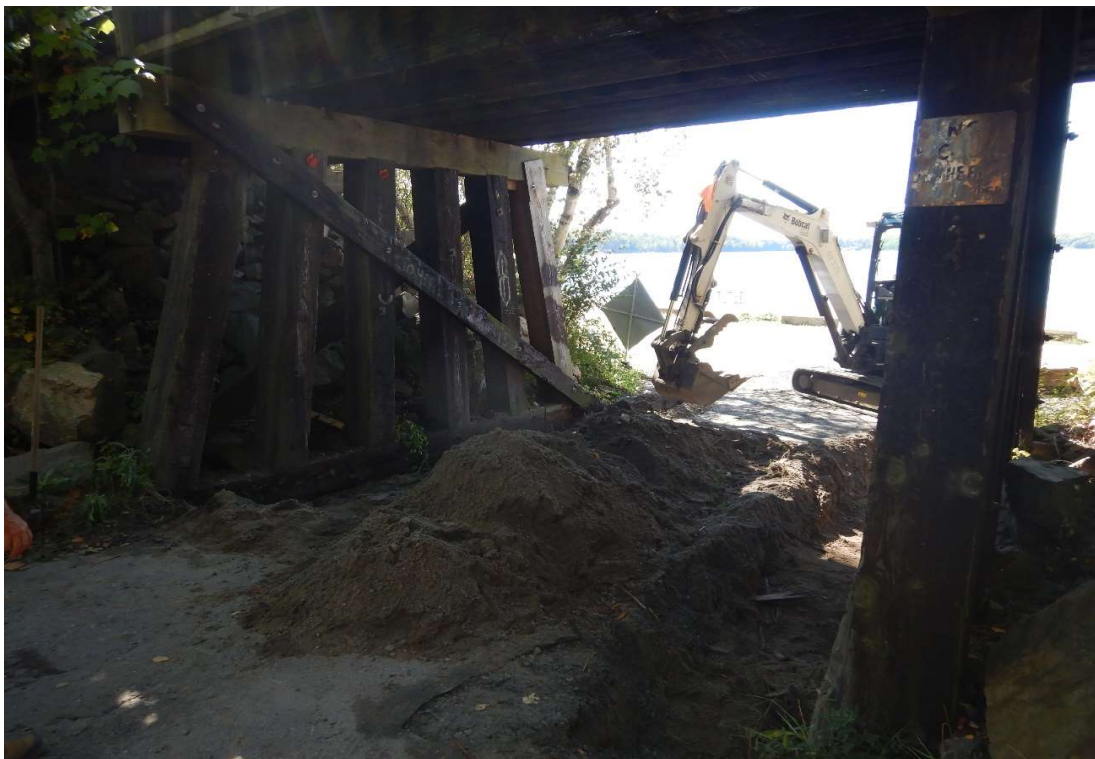
Description of Photo: Isolated rot along timber sill

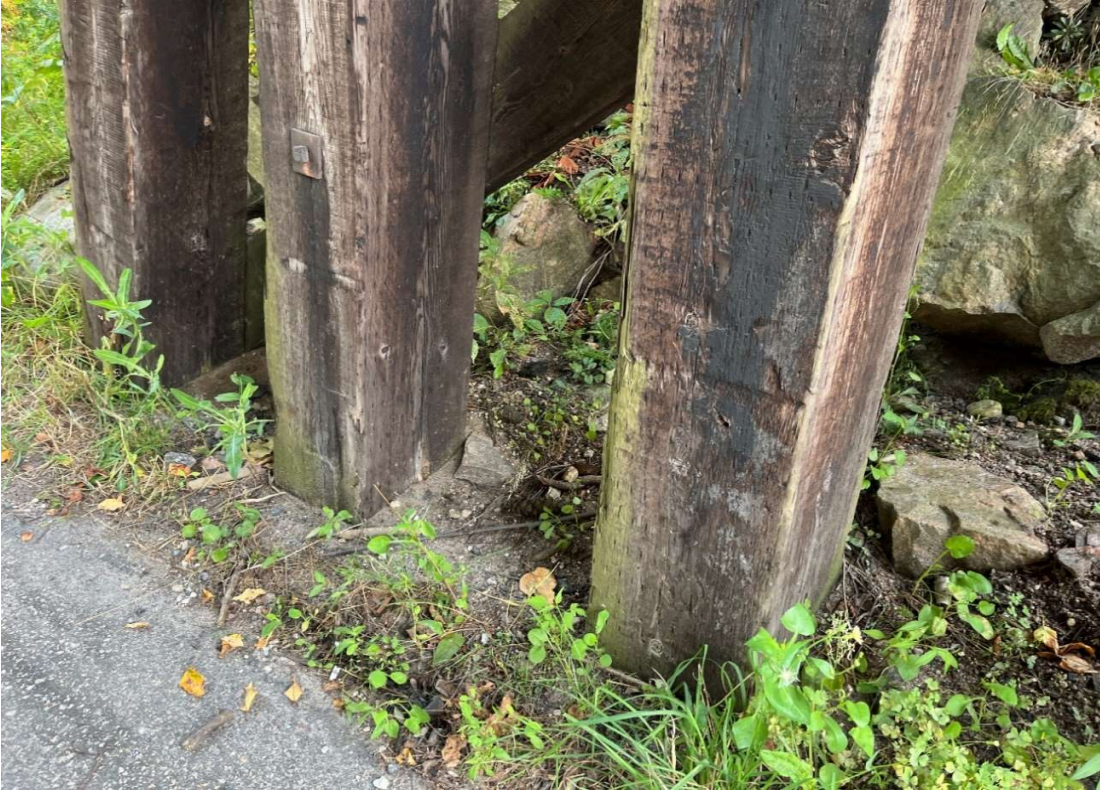
Description of Photo:		Pier

Urgent: <input type="checkbox"/>	1-5 Years: <input checked="" type="checkbox"/>	6-10 Years: <input type="checkbox"/>	None: <input type="checkbox"/>	Urgent: <input type="checkbox"/>	1 Year: <input type="checkbox"/>	2 Year: <input type="checkbox"/>
Replace 5 timber columns						
Element Photo:

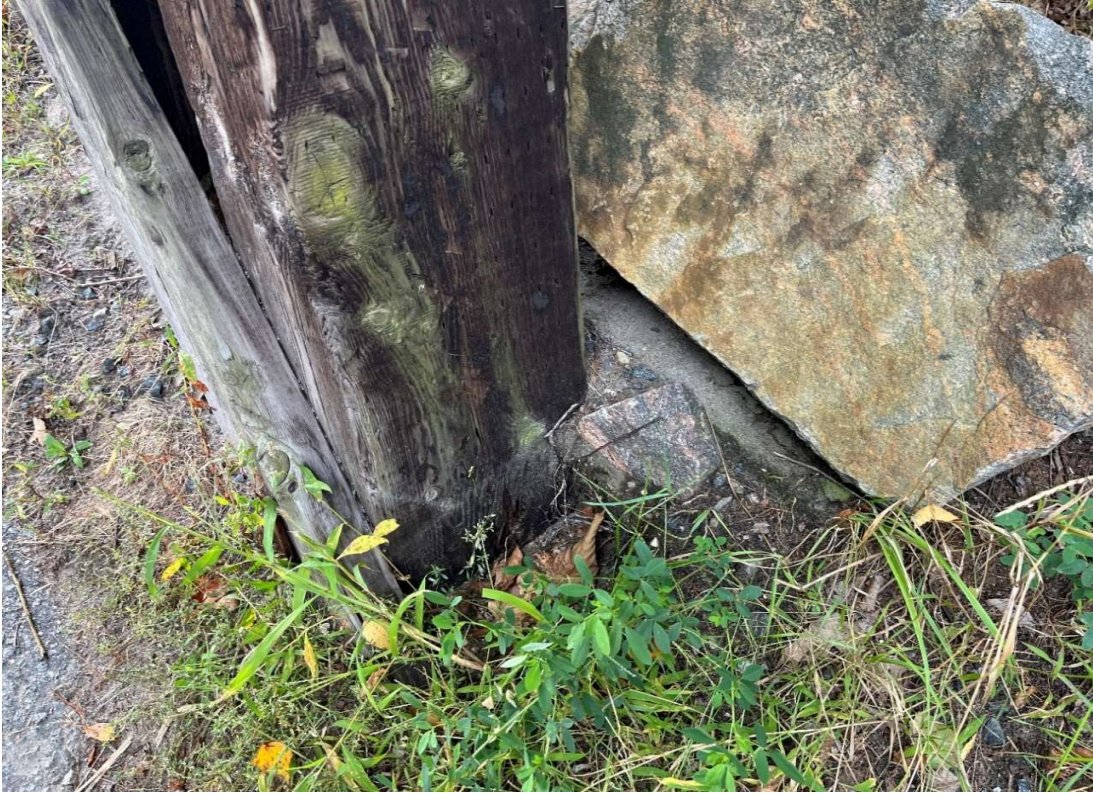
Description of Photo: Pier rot

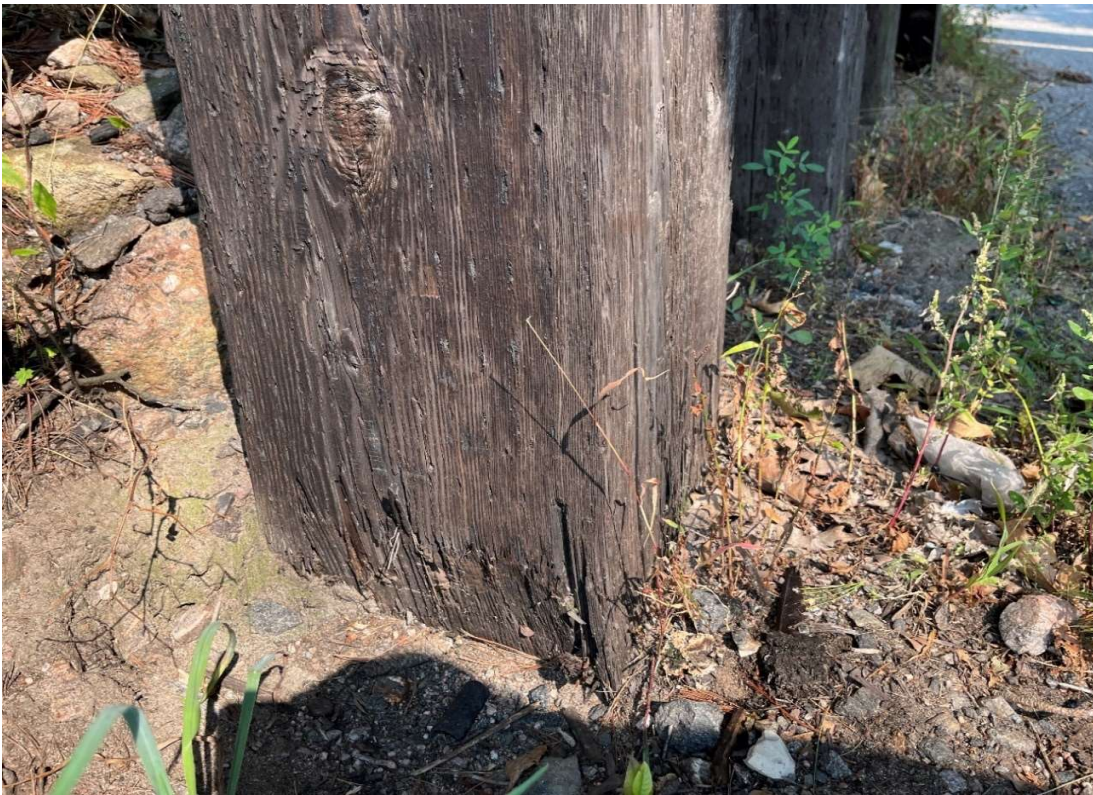
Description of Photo: Pier rot

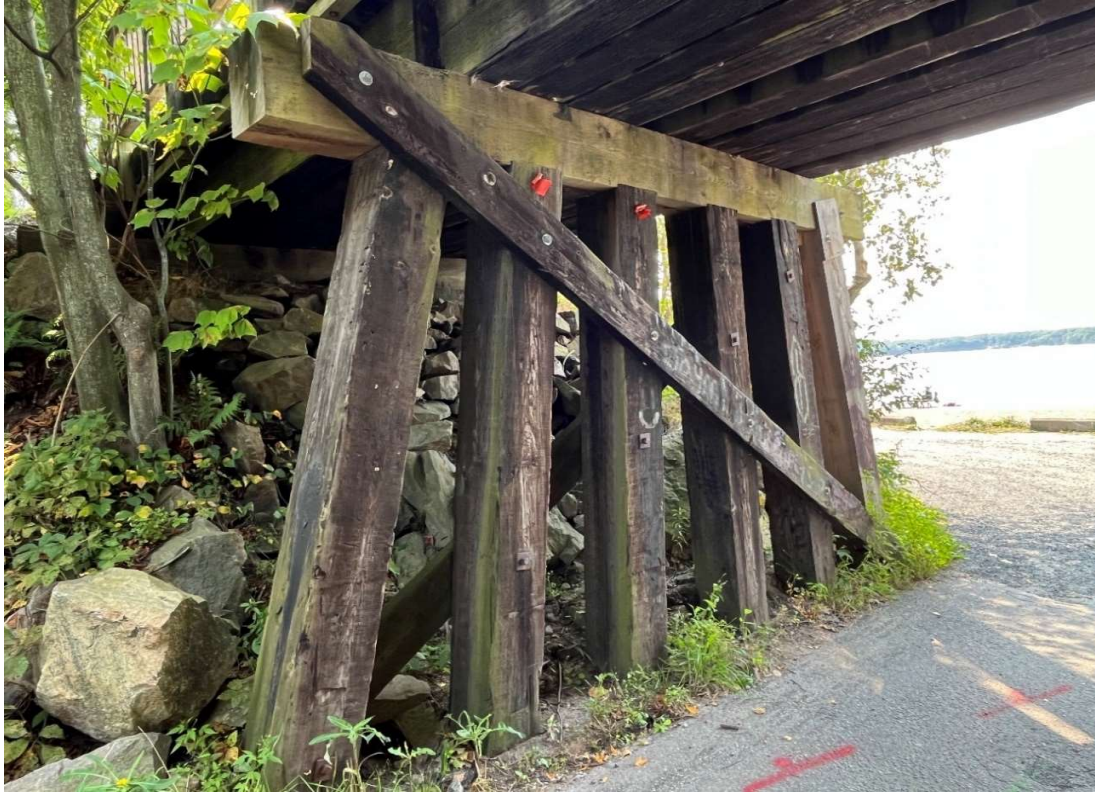
Description of Photo: South Pier
