Bridge Needs Study 2024

INSPECTION SUMMARY REPORT

Town of Parry Sound

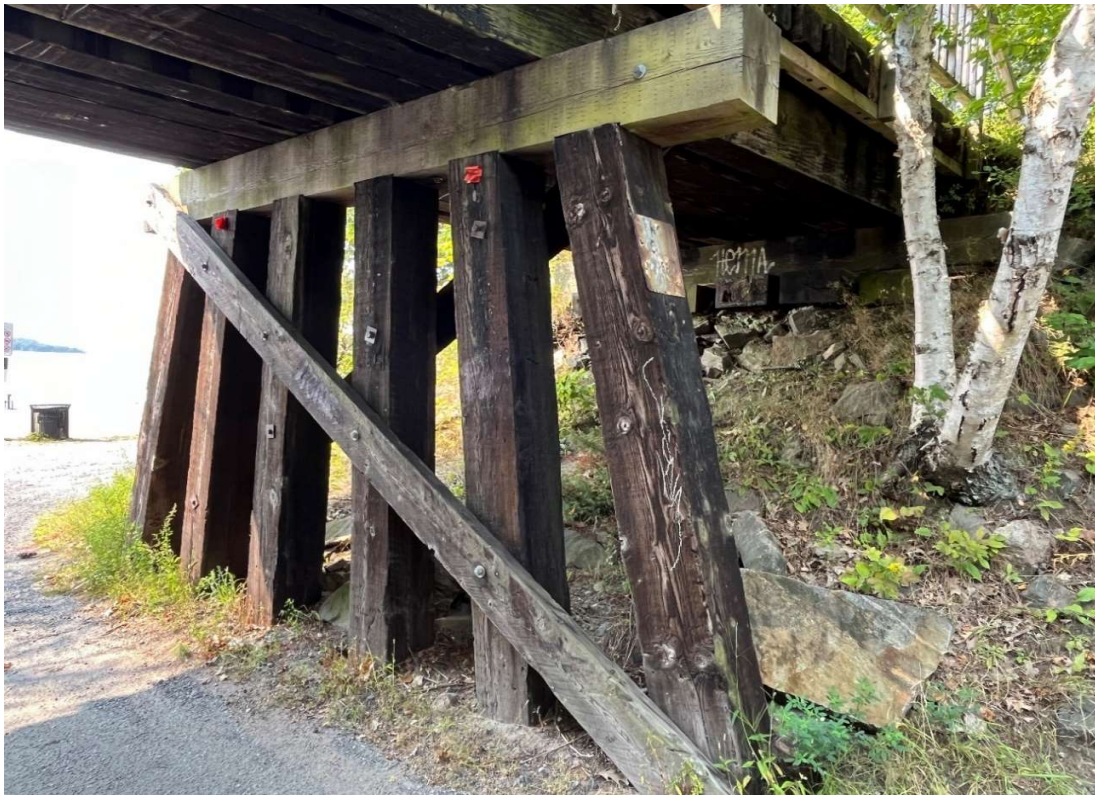
Description of Photo: North Pier

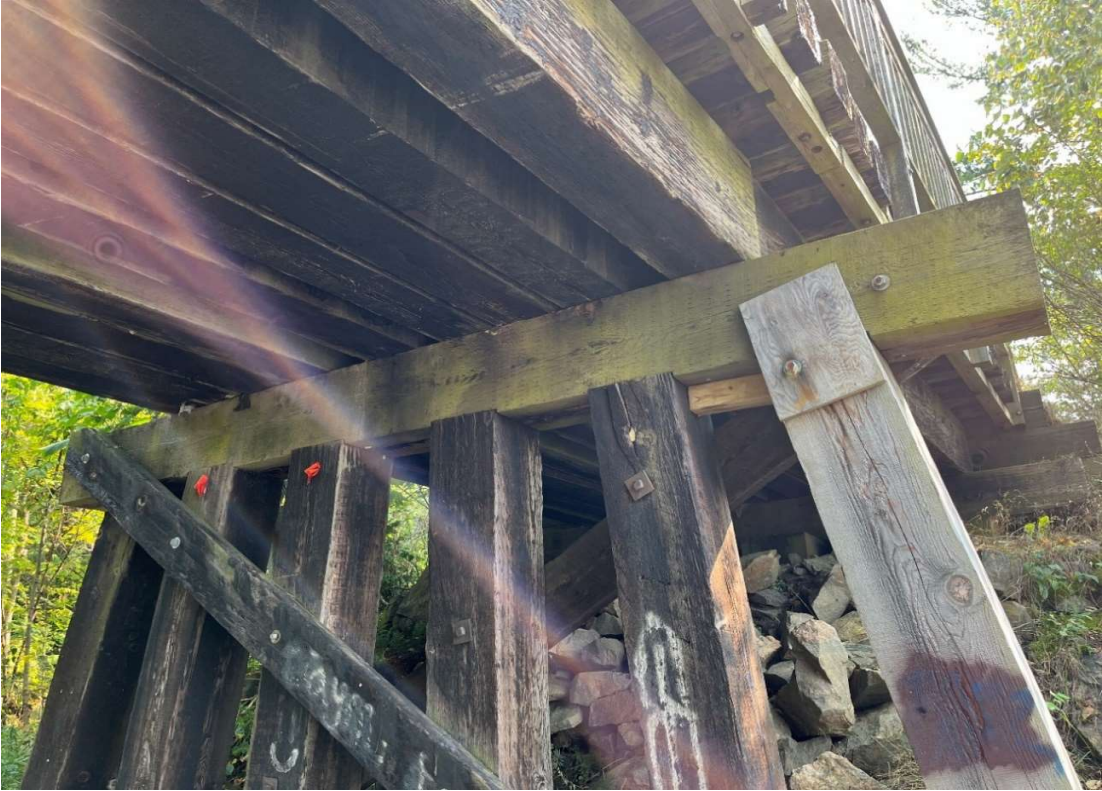
Description of Photo:	Pier Cap

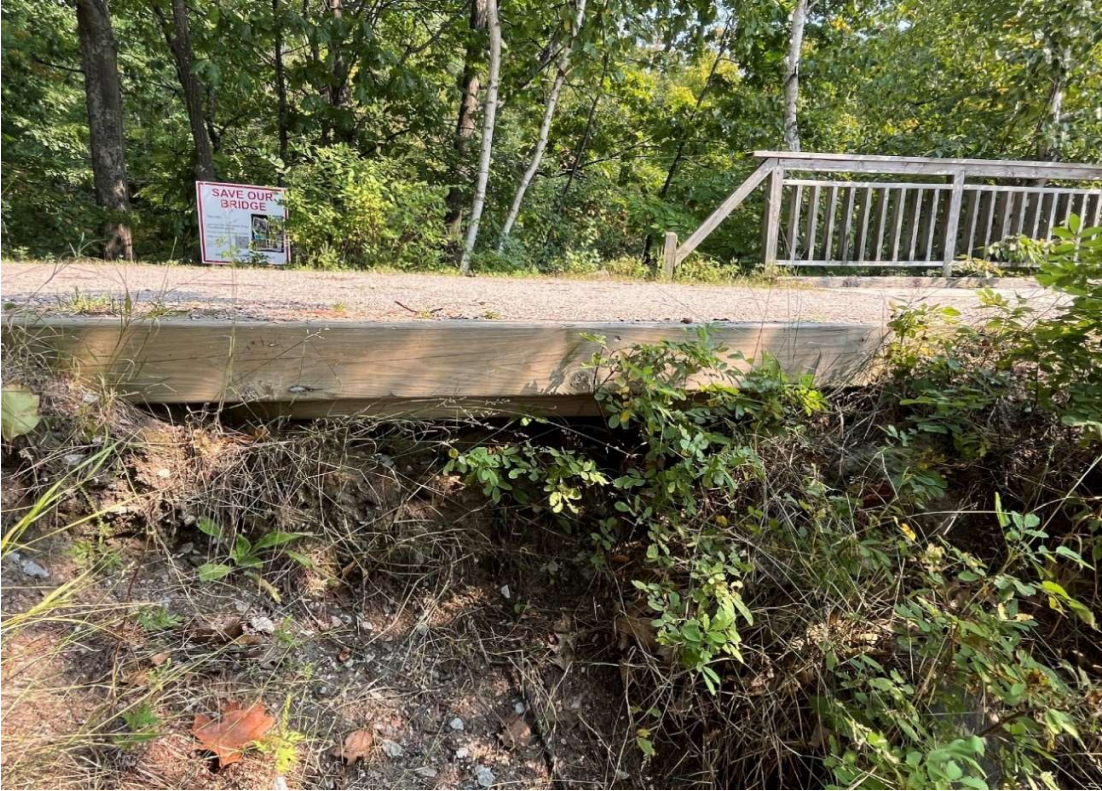
Description of Photo:		Northwest Embankment erosion

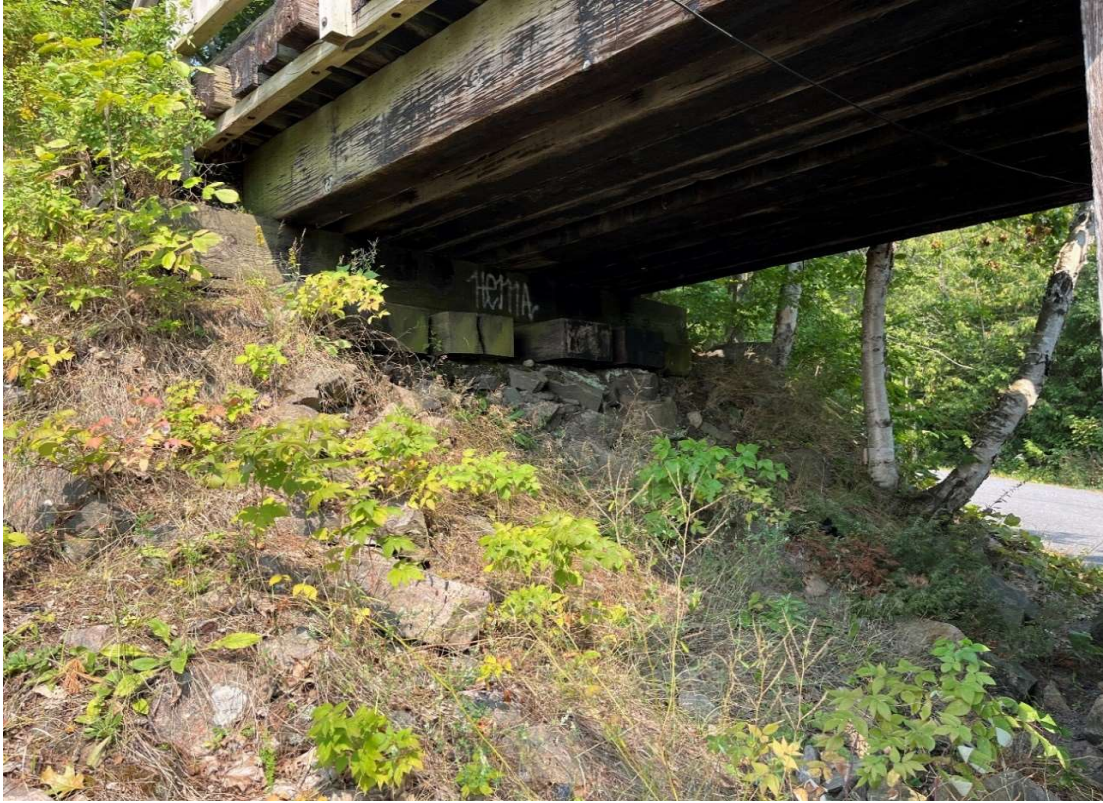
Description of Photo: Southwest Embankment

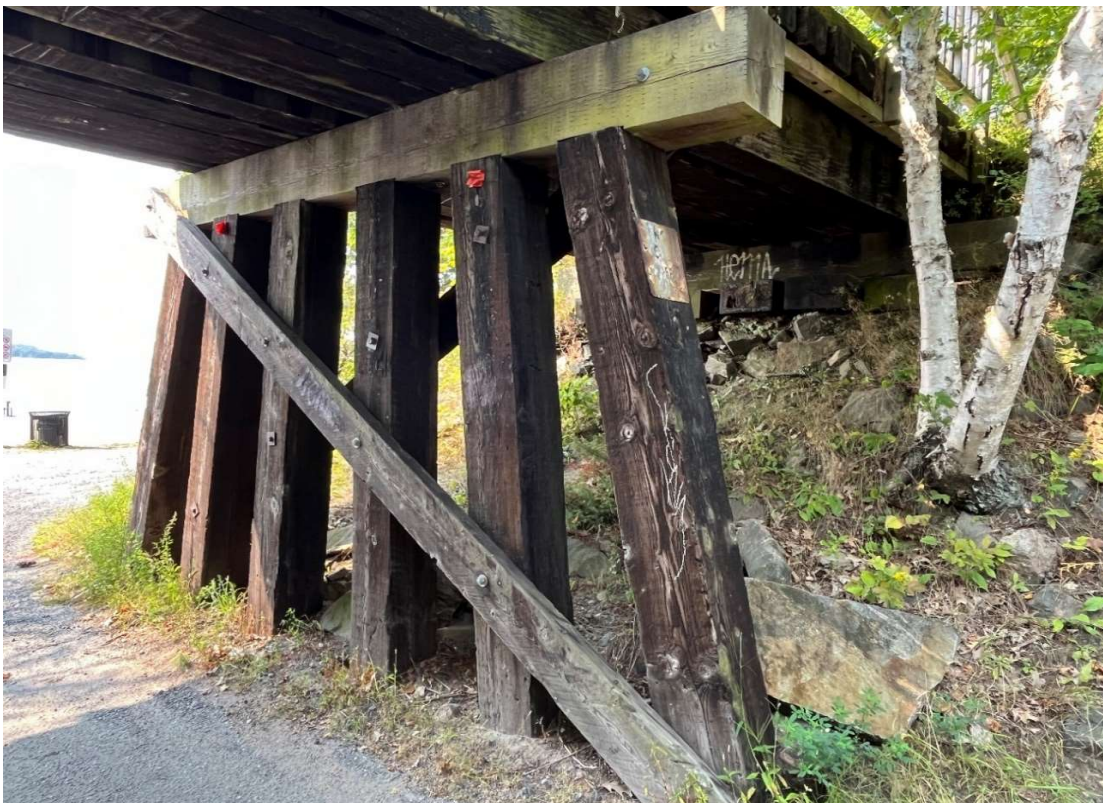
Description of Photo: Northeast Embankment

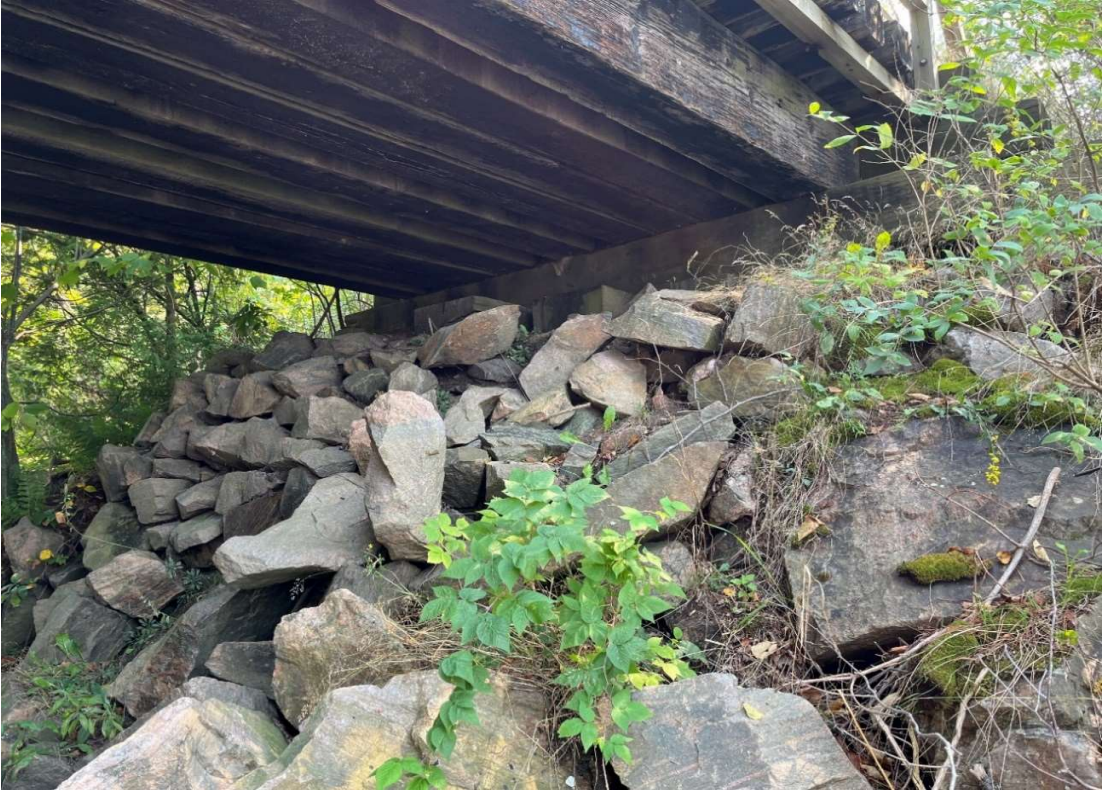
Description of Photo:		Slope protection

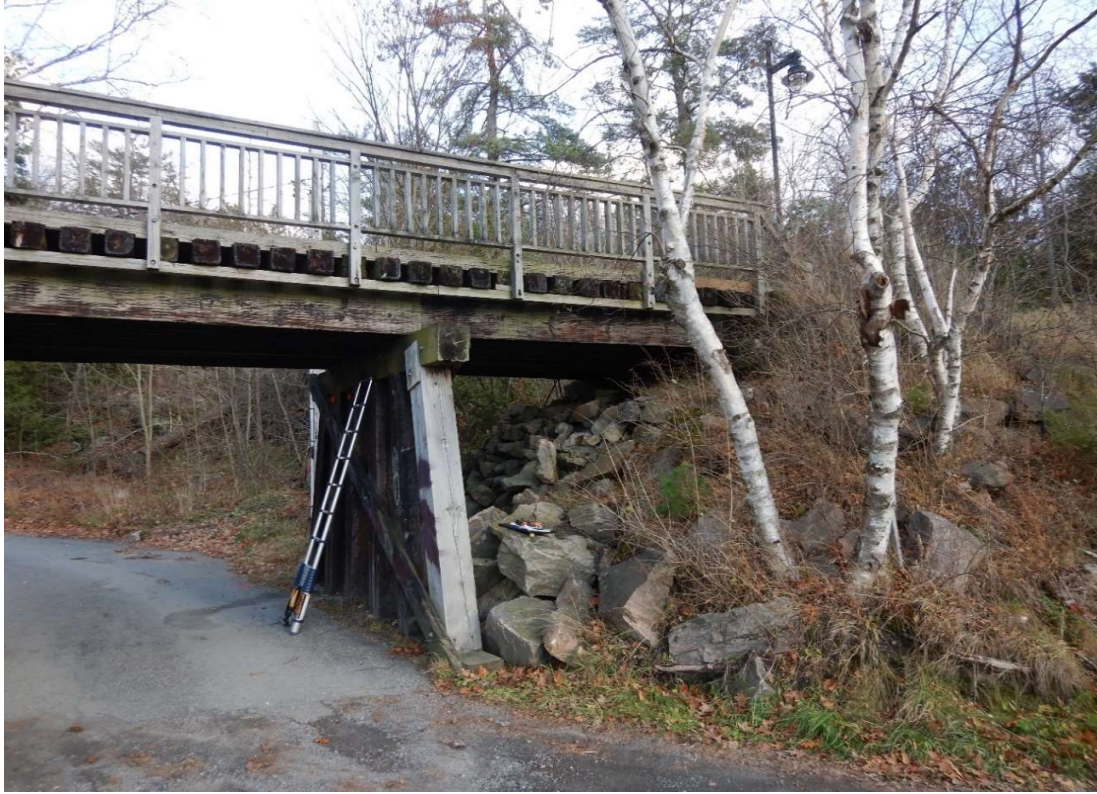
Description of Photo: North slope protection

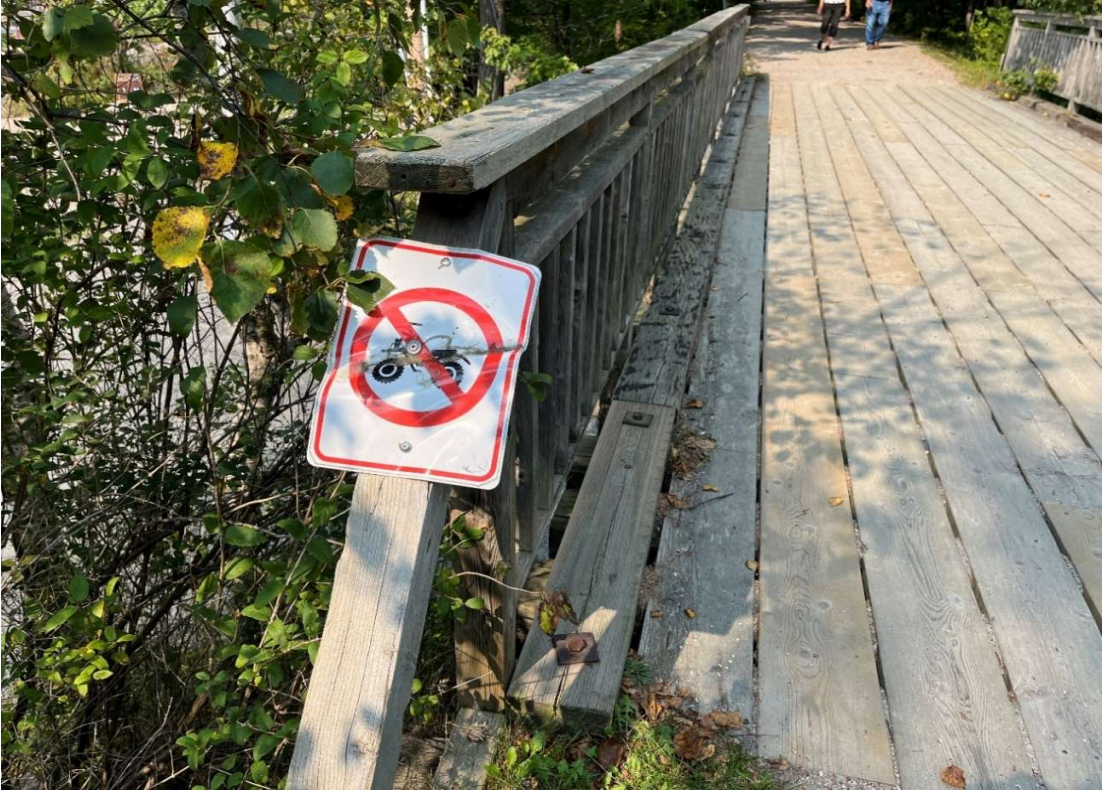
Description of Photo:		No motorized vehicles sign

Relocate no motorized vehicles to be easily visible.			
Element Photo:

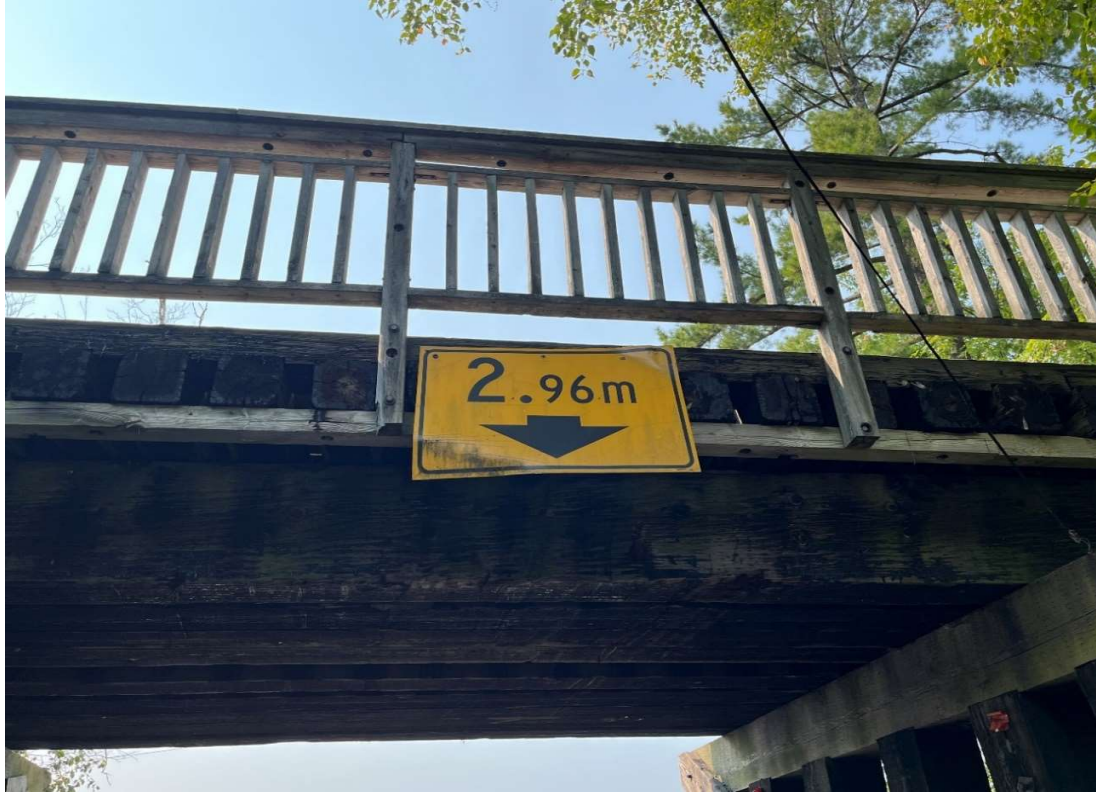
Description of Photo: Clearance sign

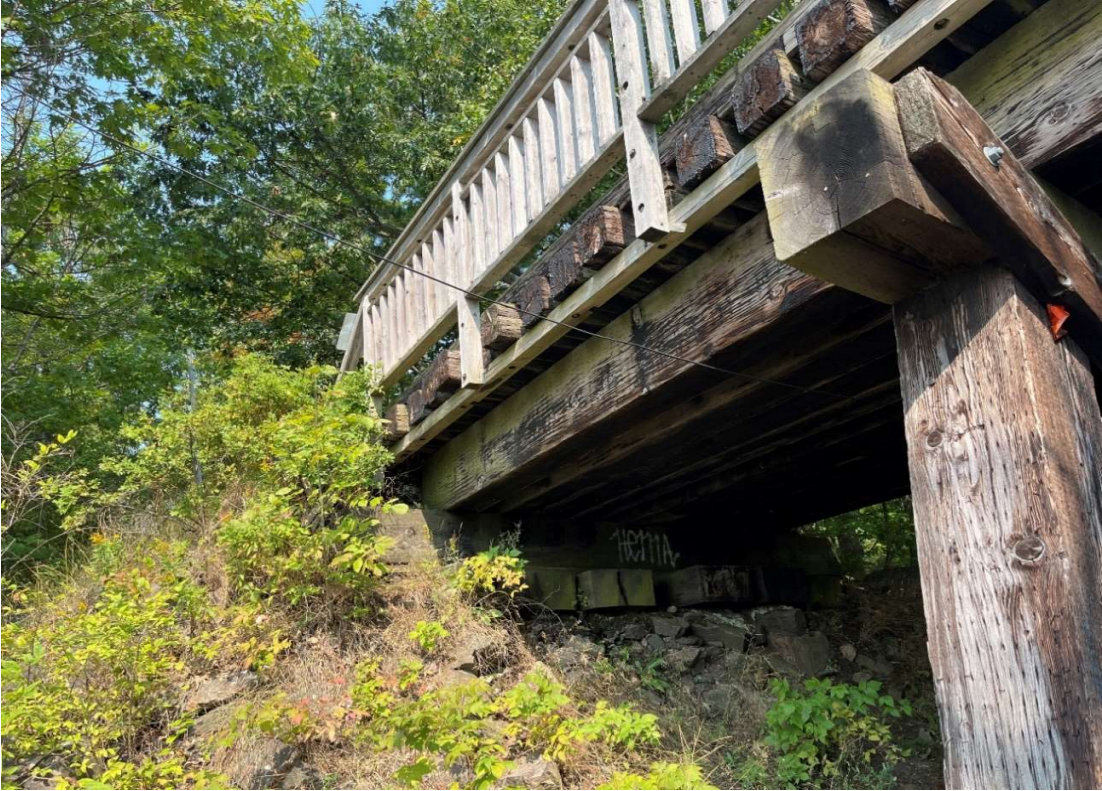
Description of Photo:		Utility

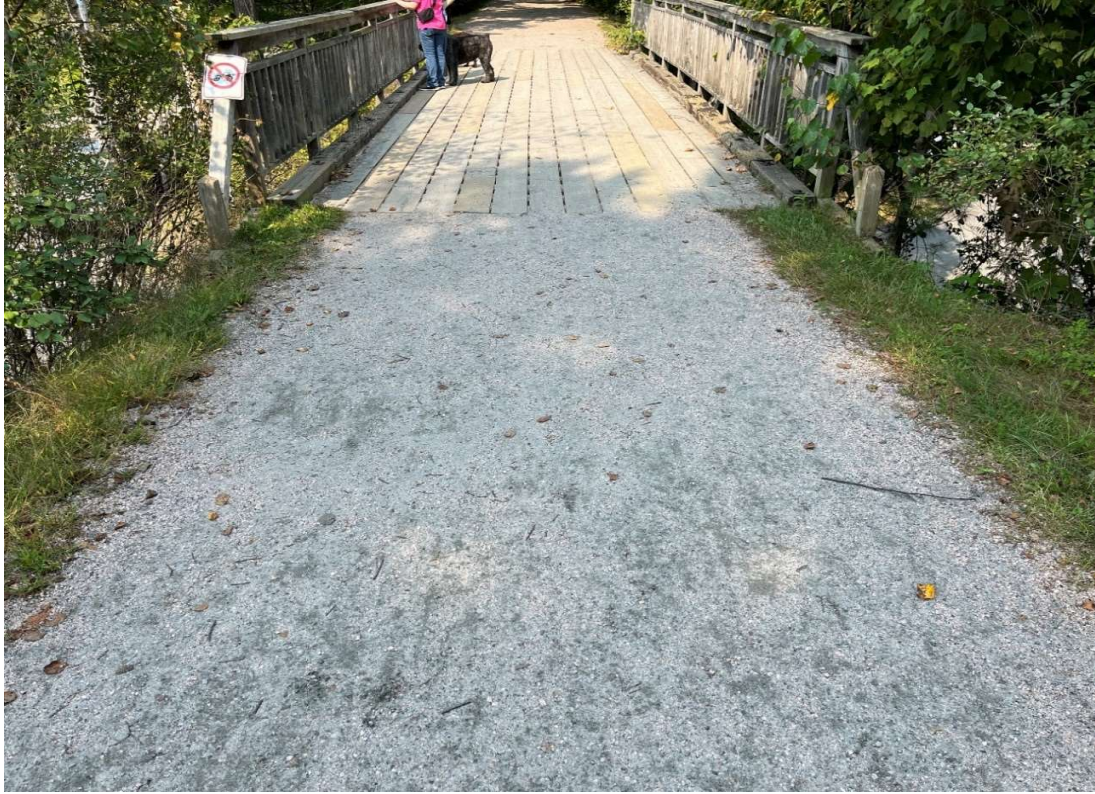
Description of Photo: Approach looking north
