# Bridge Inspections

**TOWN OF PARRY SOUND**

Inspection Summary Report

January  
12, 2023

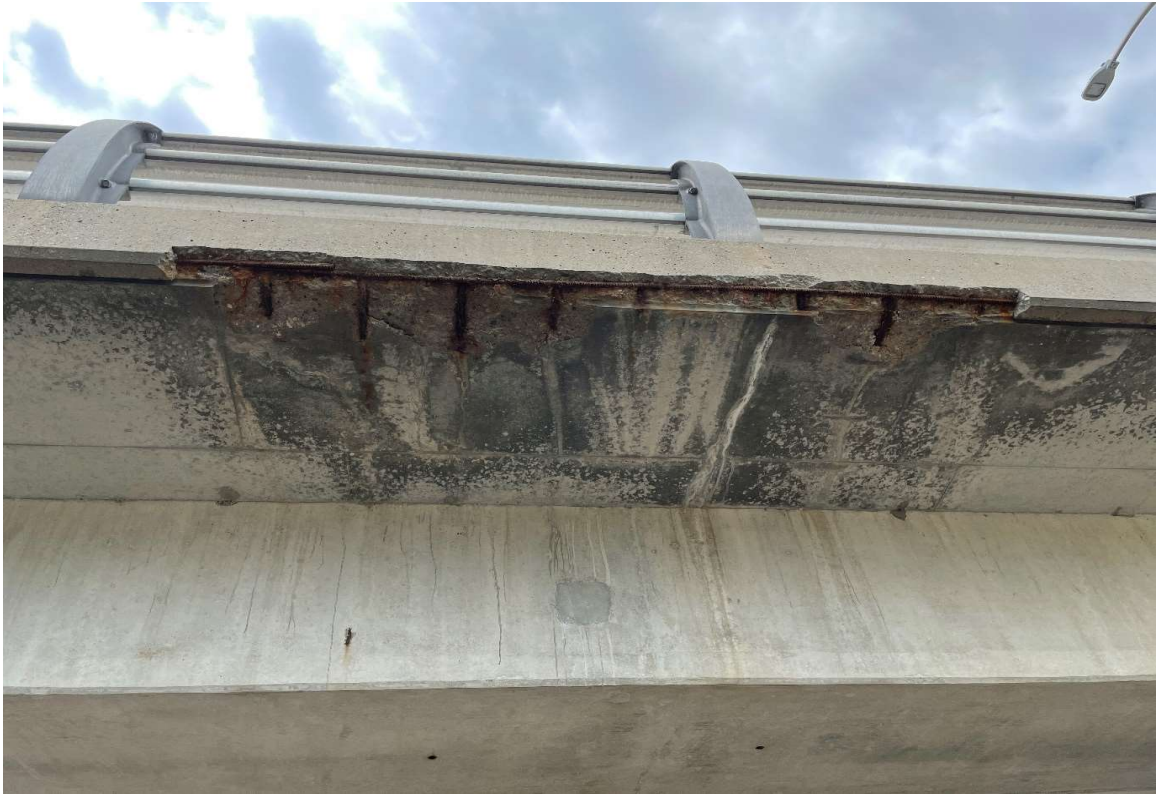
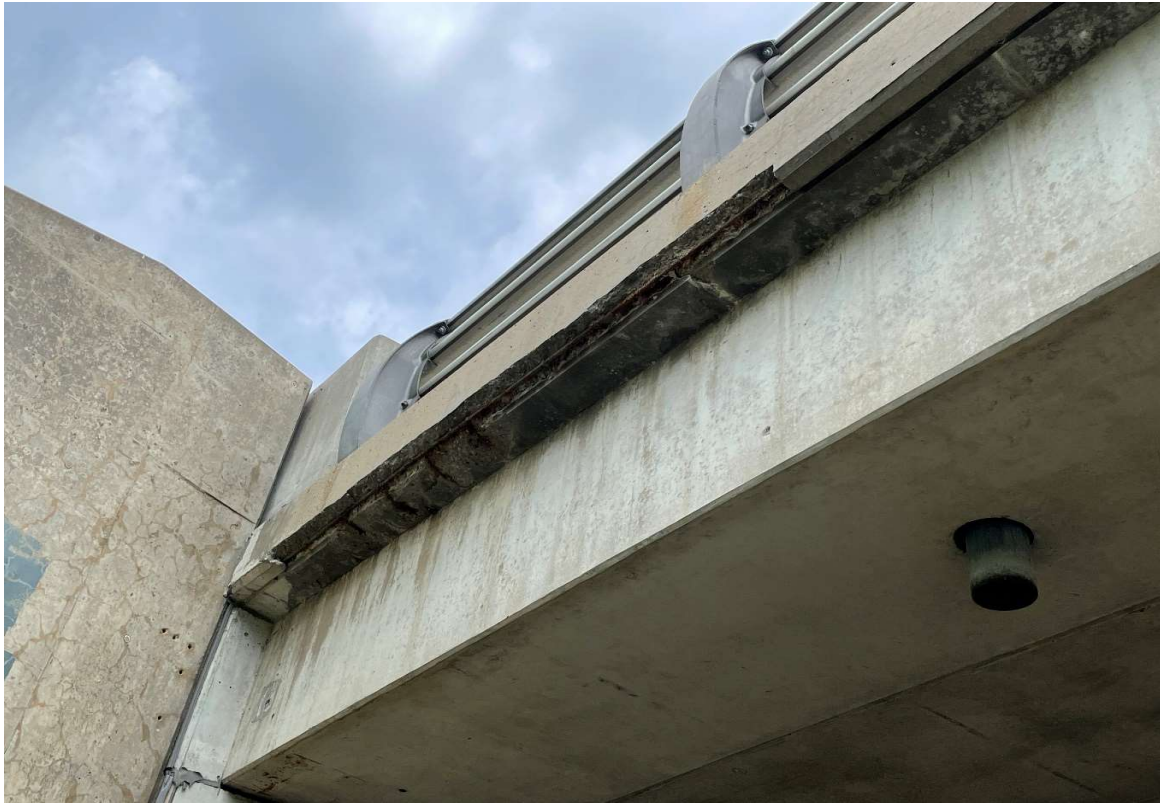
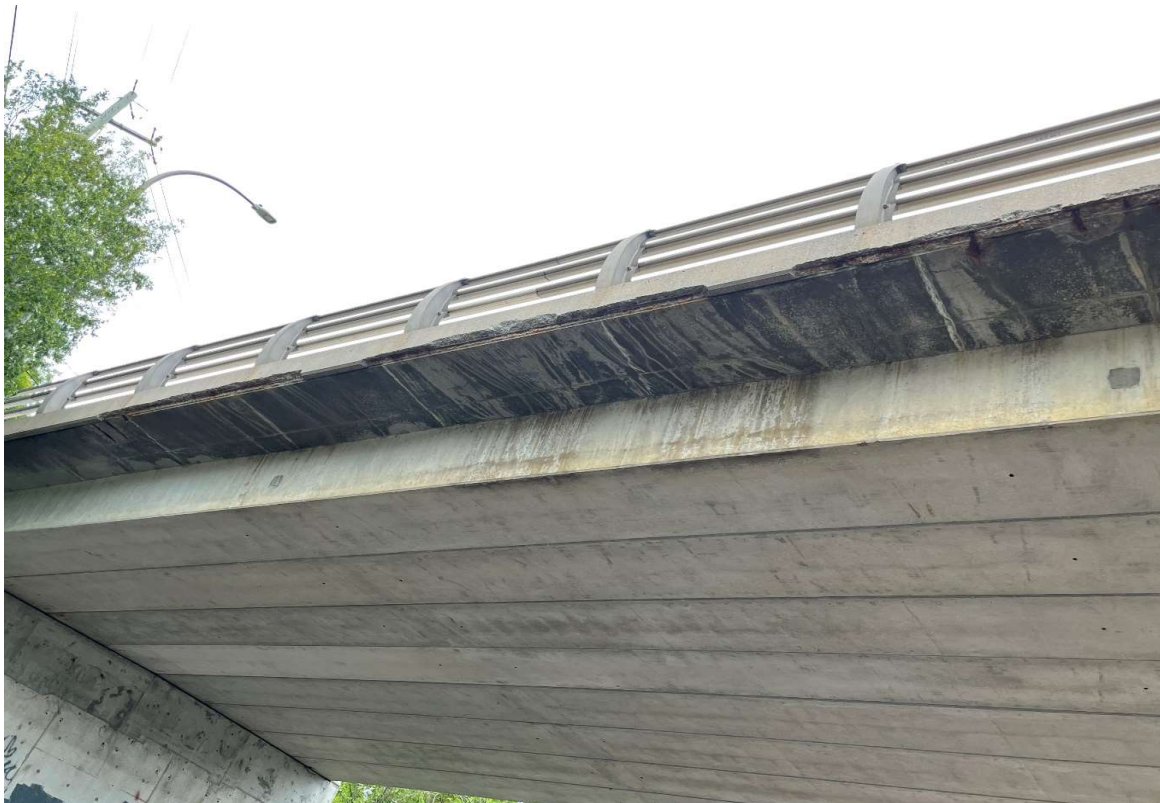
Element Data:						
Element Group:	Decks		Length:	52.9		
Element Name:	Soffit - Thin Slab		Width:	11.2		
Location:			Height:	N/A		
Material:	Concrete and Precast Concrete		Count:			
Element Type:	Cast-in-place ext. soffits, Precast Girders		Total Quantity:	592.5		
Environment:	Benign		Inspected	Yes <input type="checkbox"/>	No <input type="checkbox"/>	limited <input checked="" type="checkbox"/>
Protection System:						Performance Deficiencies
Condition Data:	Units	Excellent	Good	Fair	Poor*	
	sq.m		567.5	10.0	15.0	
Comments: Limited inspection due to height. Light scaling, typical. Northeast fascia has 13 x 1.0m medium cracks with efflorescence, 4 areas of severe delamination with exposed rebar (8.0m x 500mm total) and 3 area of severe delamination (3 x 300 x 300mm). Northwest fascia has 14 x 1.0m medium cracks with efflorescence and 1 severe delamination with exposed rebar (3.0m x 300mm). Southwest fascia has 11 x 1.0m light cracks with efflorescence. Southeast fascia has 3 areas of severe delamination with exposed rebar (14.0m x 500mm total), 9 areas of 1.0m light to medium cracking with efflorescence and staining typical.

<b>Description of Photo:</b>		Soffit Exposed Rebar and Cracks with Efflorescence, Typical

**Description of Photo:** Soffit Exposed Rebar and Cracks with Efflorescence, Typical

Recommended Work:		Rehab: <input checked="" type="checkbox"/>	Replace: <input type="checkbox"/>	Maintenance Needs:		
Urgent: <input type="checkbox"/>	1-5 Years: <input checked="" type="checkbox"/>	6-10 Years: <input type="checkbox"/>	None: <input type="checkbox"/>	Urgent: <input type="checkbox"/>	1 Year: <input type="checkbox"/>	2 Year: <input type="checkbox"/>
Concrete repairs for the exterior soffit cast-in-place concrete						
<b>Element Photo:</b>

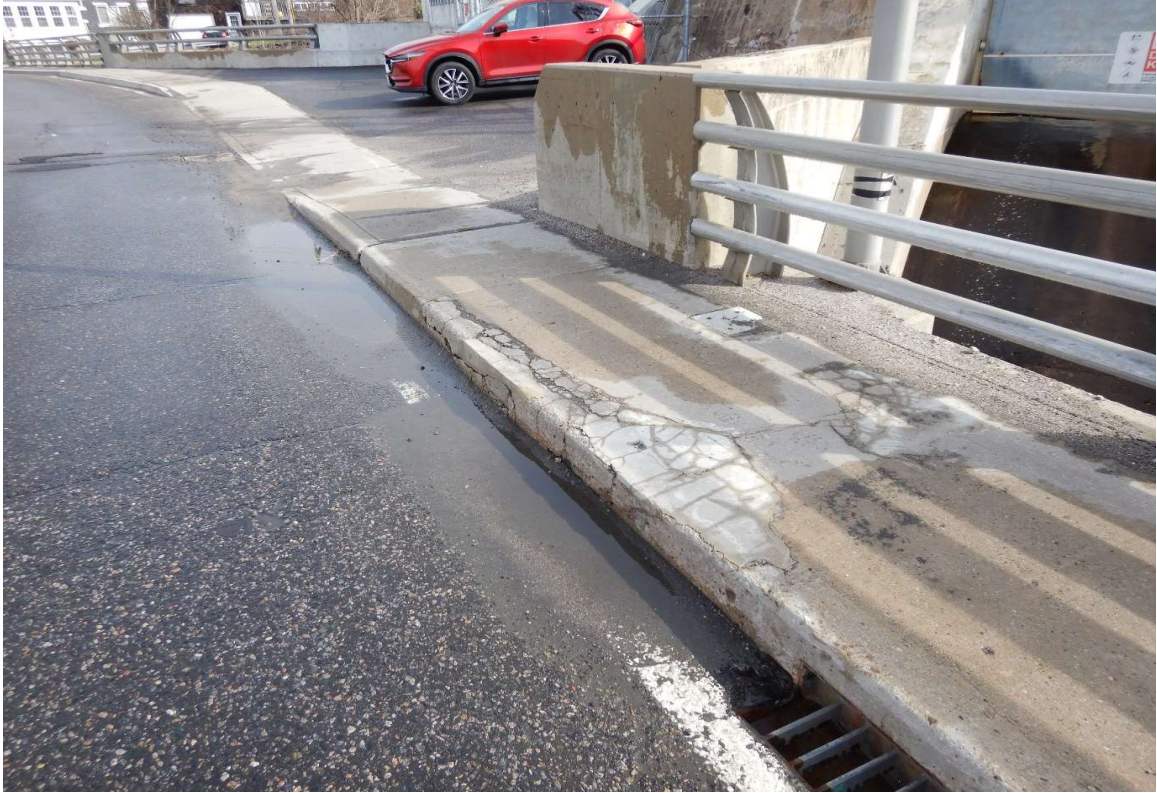
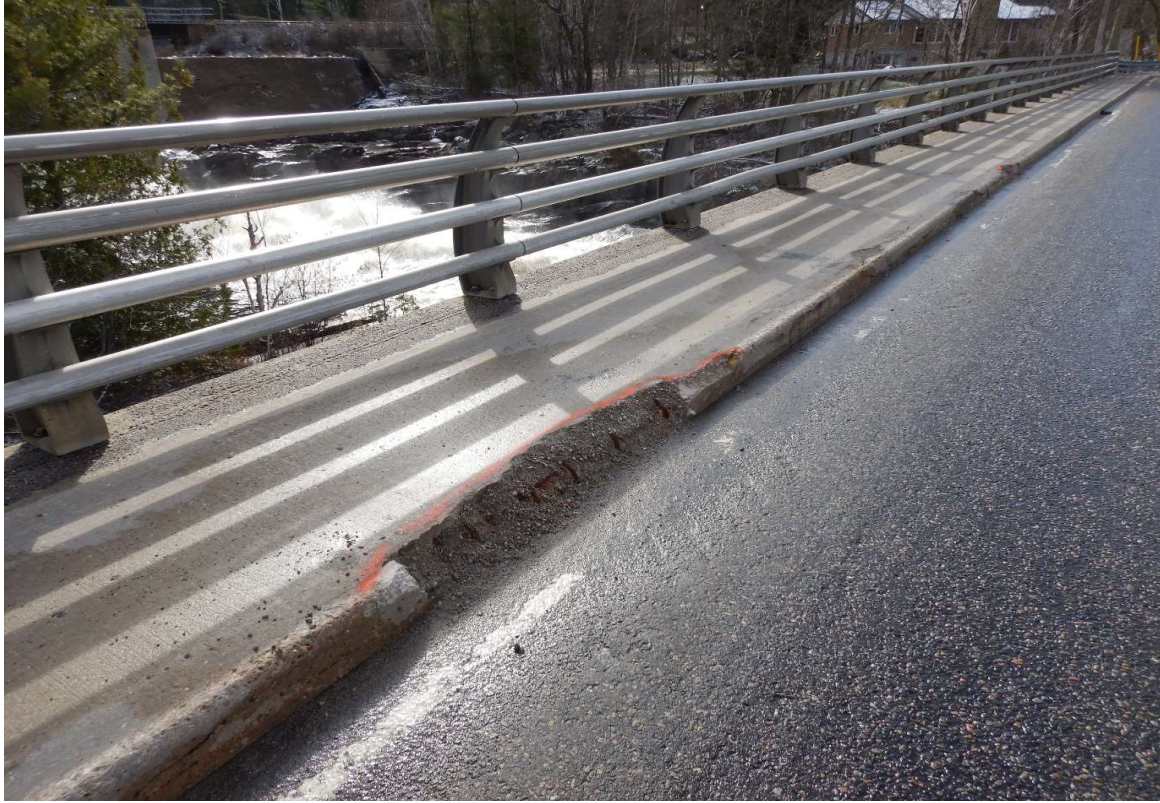
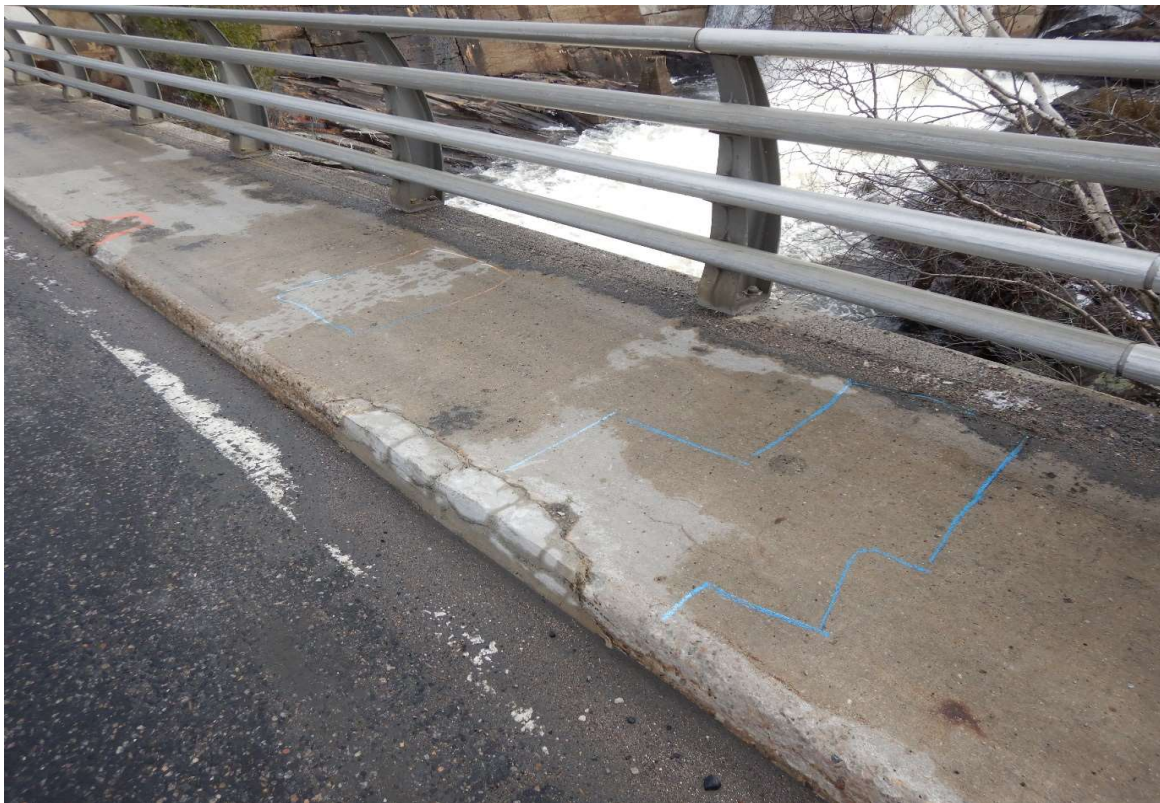
Element Data:						
Element Group:	Sidewalk/Curb	Length:	52.8			
Element Name:	Sidewalks and Medians	Width:	1.8			
Location:	East and West Sides	Height:	0.15			
Material:	Concrete	Count:	1			
Element Type:	Cast-in-place	Total Quantity:	103.0			
Environment:	Severe	Inspected	Yes	<input checked="" type="checkbox"/>	No	<input type="checkbox"/> limited <input type="checkbox"/>
Protection System:						Performance Deficiencies
Condition Data:	Units	Excellent	Good	Fair	Poor*	
	sq.m		91.0	2.0	10.0	
Comments: Light scaling, typical. Three general areas of severe delamination. 4 medium to severe spalls along edge of sidewalk.						
Recommended Work:	Rehab:	<input checked="" type="checkbox"/>	Replace:	<input type="checkbox"/>	Maintenance Needs:	
Urgent:	<input type="checkbox"/>	1-5 Years:	<input checked="" type="checkbox"/>	6-10 Years:	<input type="checkbox"/>	None:
					<input type="checkbox"/>	Urgent:
						1 Year:

Description of Photo: Sidewalk

2 Year:
Repair concrete						
Element Photo:

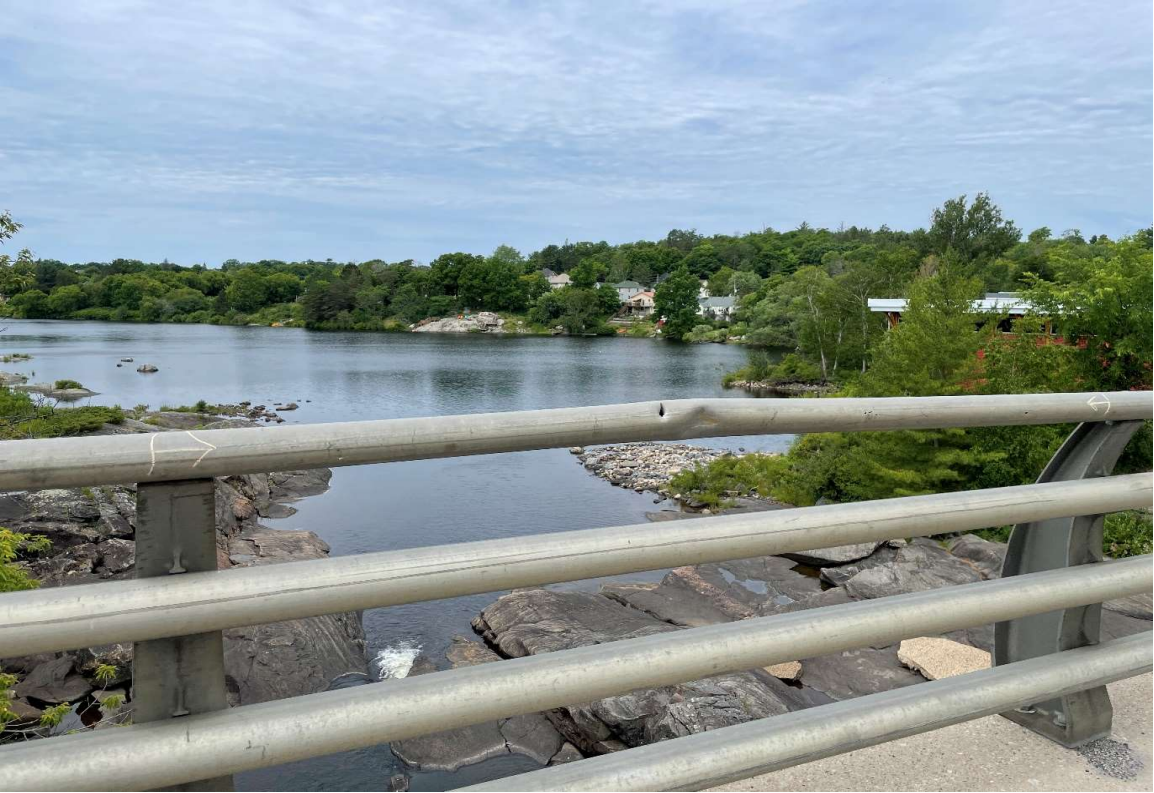
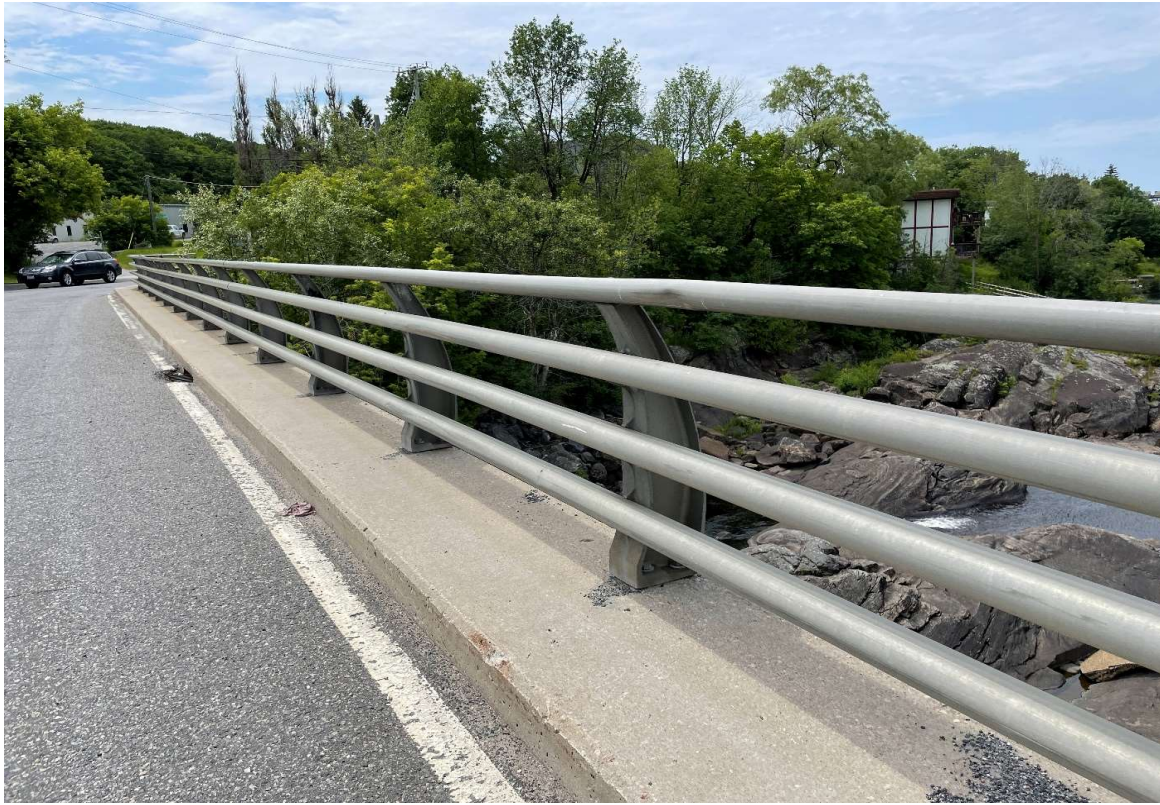
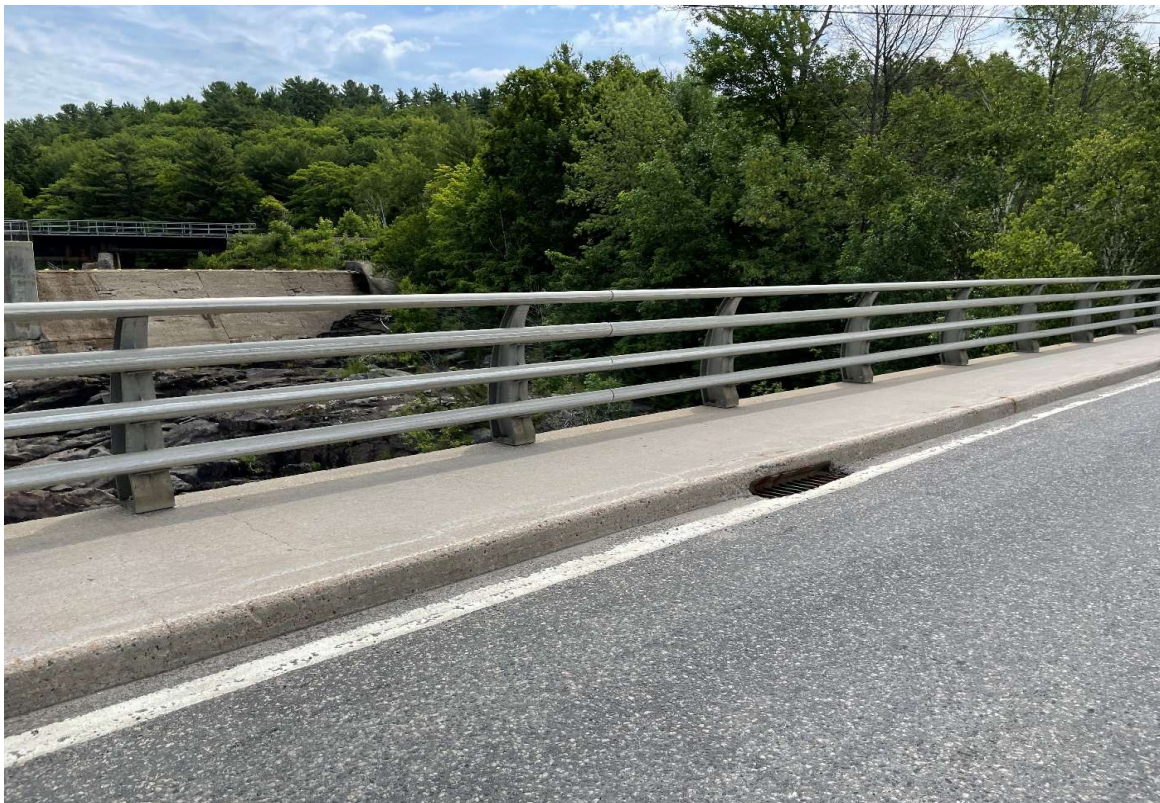
Element Data:						
Element Group:	Barriers		Length:	2.4		
Element Name:	Railing Systems		Width:			
Location:	East and West Side		Height:	1.12		
Material:	Aluminum		Count:	50		
Element Type:	4 Rail Metal Railing - Aluminum		Total Quantity:	120.0		
Environment:	Severe		Inspected	Yes <input type="checkbox"/>	No <input type="checkbox"/>	limited <input type="checkbox"/>
Protection System:						Performance Deficiencies
Condition Data:	Units	Excellent	Good	Fair	Poor*	
	m		115.6	2.4	2.0	
Comments: West rail has 1 x 2.0m and 1 x 400mm of deformed section and 1 puncture. East rail has isolated areas of medium abrasions and 3 deformations (1 x 100 x 100mm and 2 x 100 x 300mm)						
Recommended Work:		Rehab: <input type="checkbox"/>	Replace: <input type="checkbox"/>	Maintenance Needs:		3 - Railing System Repair
Urgent: <input type="checkbox"/>	1-5 Years: <input type="checkbox"/>	6-10 Years: <input type="checkbox"/>	None: <input checked="" type="checkbox"/>	Urgent: <input type="checkbox"/>	1 Year: <input type="checkbox"/>	2 Year: <input checked="" type="checkbox"/>

<b>Description of Photo:</b>		East railing system

**Description of Photo:** West railing system

Repair railing		
<b>Element Photo:</b>

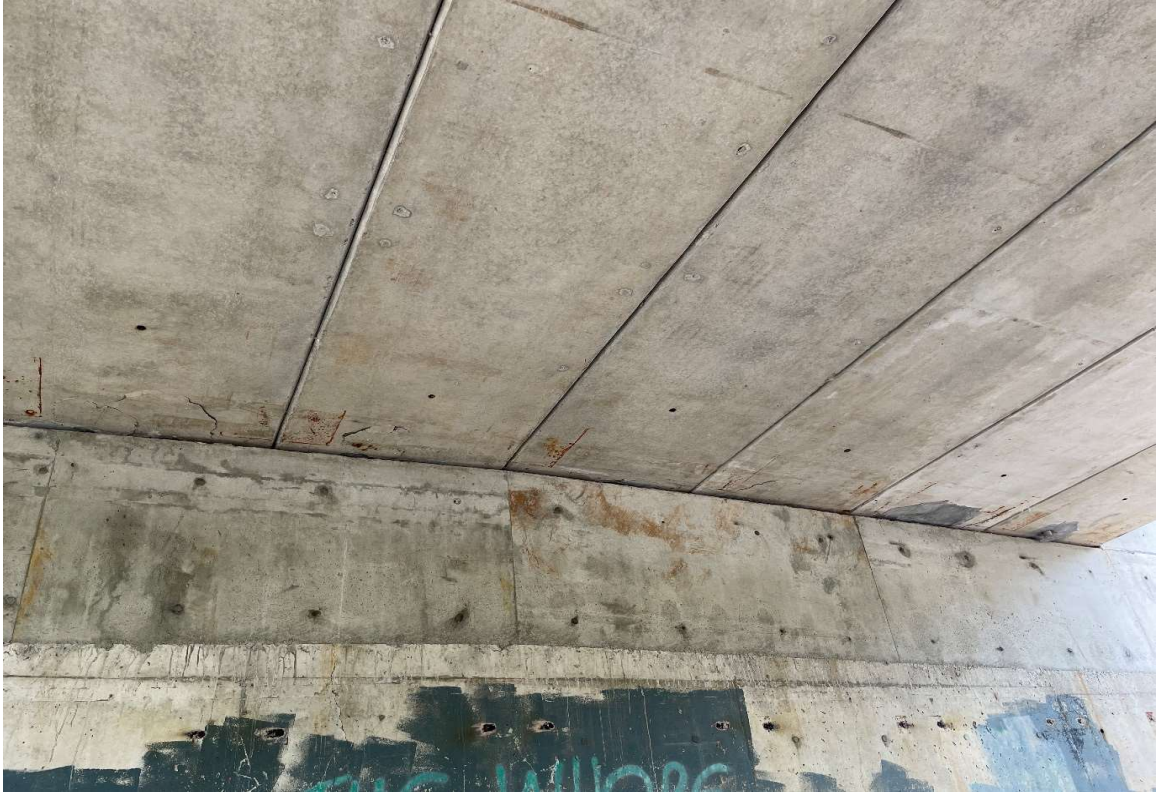
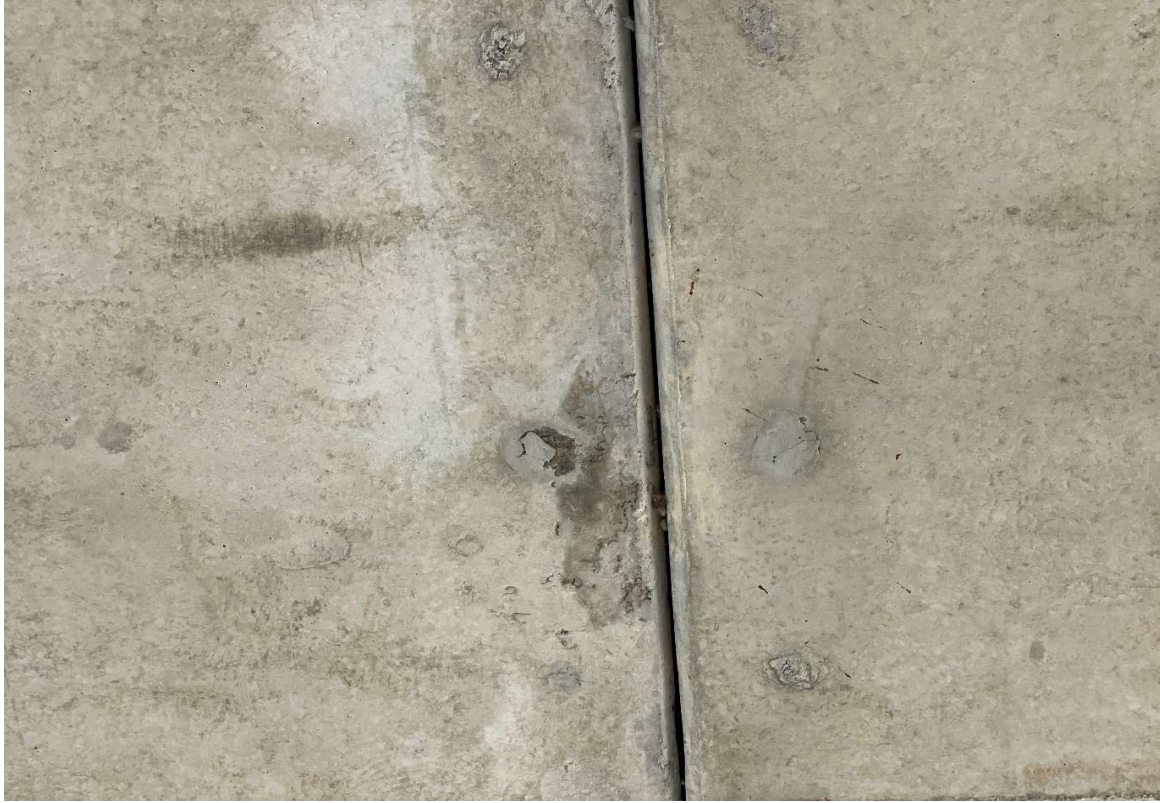
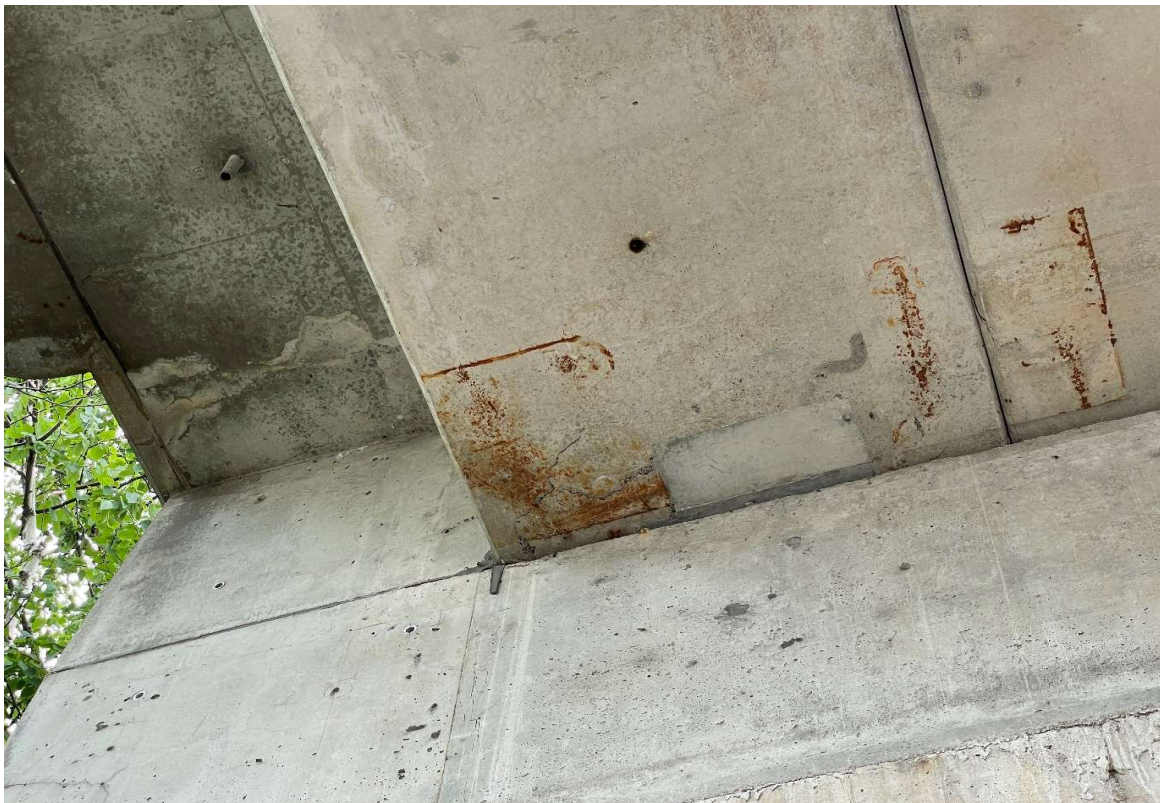
Element Data:						
Element Group:	Beams/Main Longitudinal Elements	Length:	26.45			
Element Name:	Girders	Width:	1.20			
Location:	Below Deck	Height:	0.84			
Material:	Precast Concrete	Count:	16			
Element Type:	Box Girder	Total Quantity:	298.3			
Environment:	Benign	Inspected	Yes <input type="checkbox"/>	No <input type="checkbox"/>	limited <input checked="" type="checkbox"/>	
Protection System:						Performance Deficiencies
Condition Data:	Units	Excellent	Good	Fair	Poor*	
	sq.m		298.3	4.0	2.0	
Comments: Light scaling, typical North end of girder at abutment has 5 areas of 500 x 500mm severe delamination. Center span has several areas of 100 x 100mm delaminations. South end of girder at abutment has 2 areas of 300 x 300mm severe delaminations. Light rebar staining at girder ends typical.						
Recommended Work:		Rehab: <input type="checkbox"/>	Replace: <input type="checkbox"/>	Maintenance Needs:		
Urgent: <input type="checkbox"/>	1-5 Years: <input checked="" type="checkbox"/>	6-10 Years: <input type="checkbox"/>	None: <input type="checkbox"/>	Urgent: <input type="checkbox"/>	1 Year: <input type="checkbox"/>	2 Year: <input type="checkbox"/>

Description of Photo:		Girder Soffit

Description of Photo: Girder Soffit

Repair concrete						
<b>Element Photo:</b>

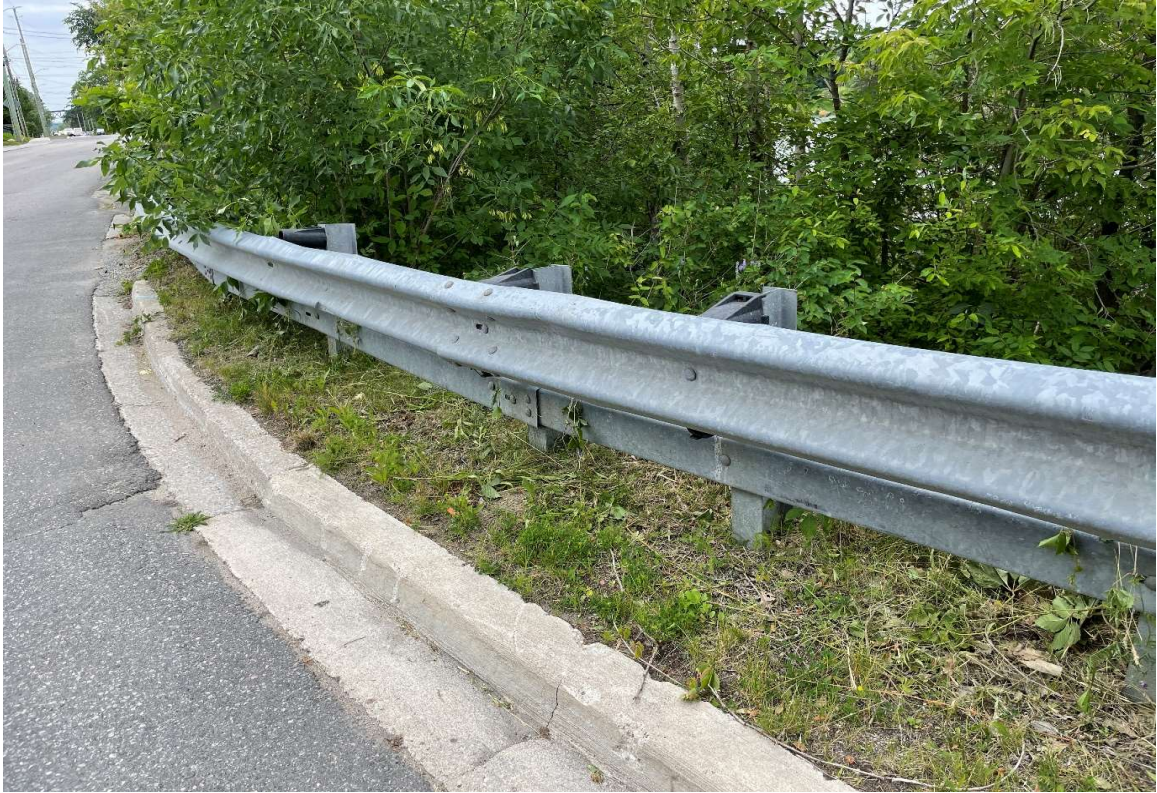
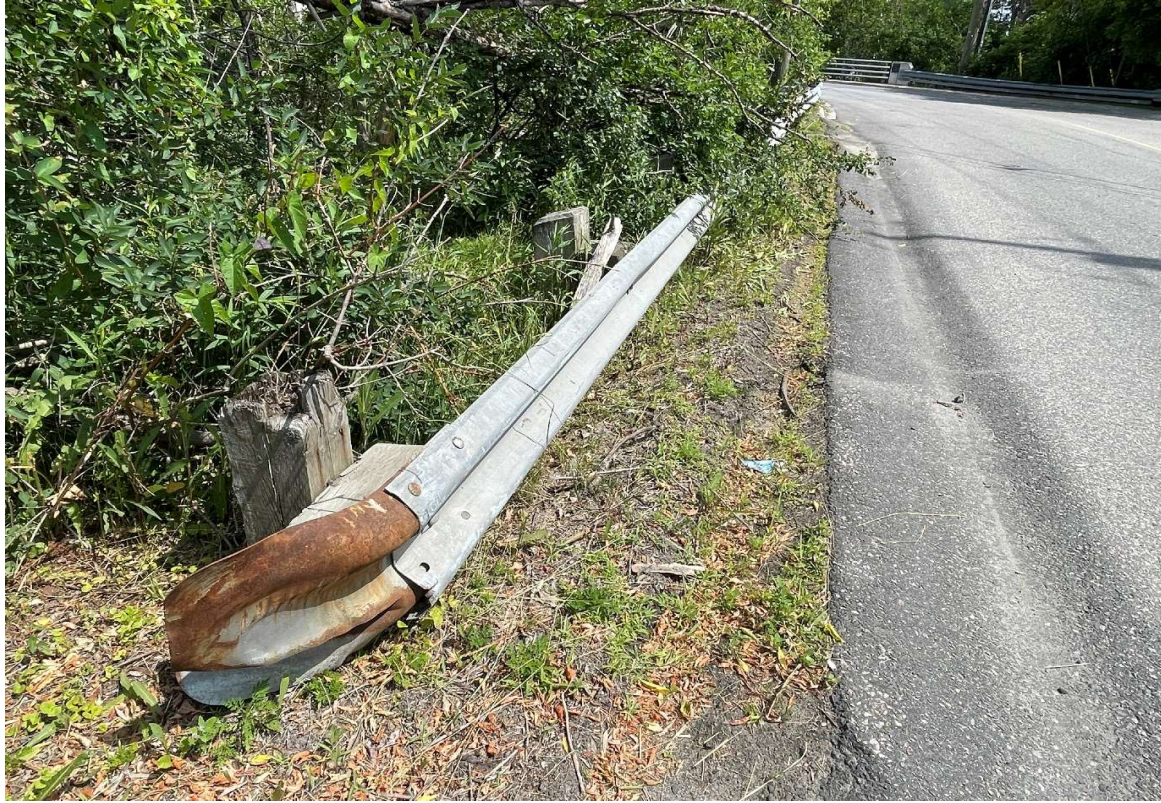
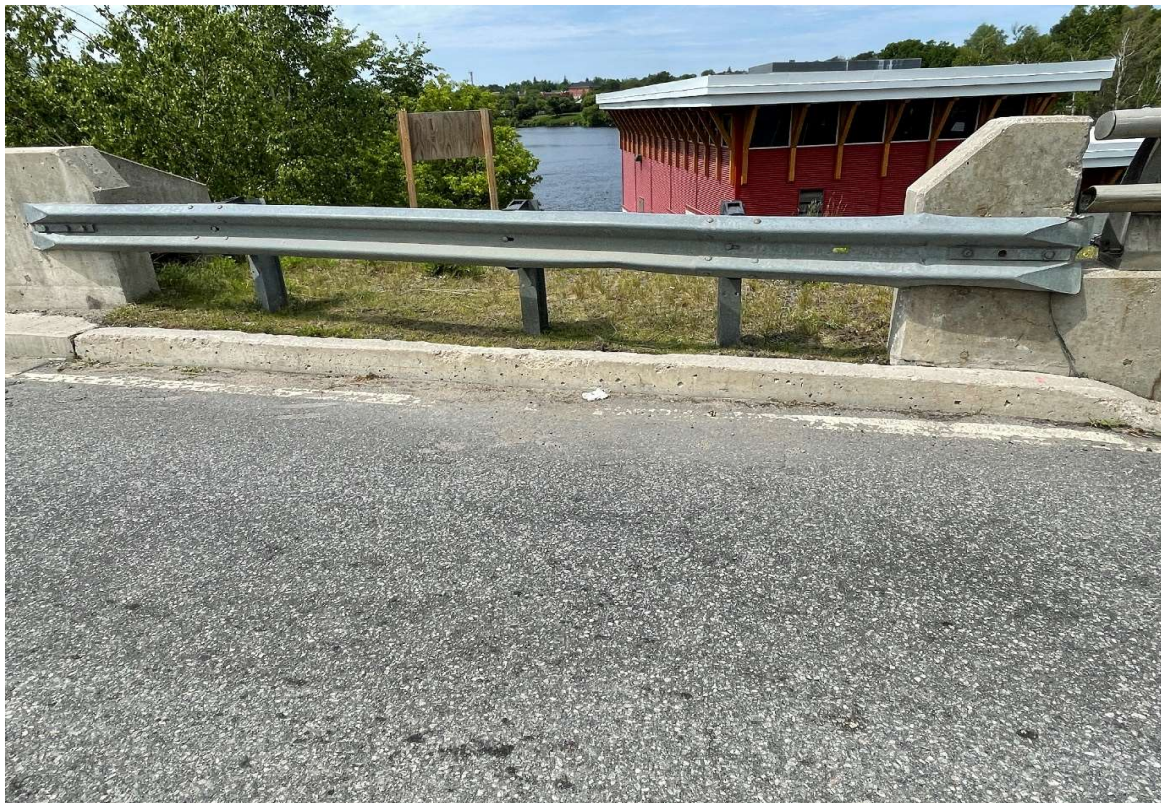
Element Data:						
Element Group:	Approaches	Length:	46.0			
Element Name:	Barrier	Width:				
Location:	NW, SE and SW Quadrants	Height:				
Material:	Steel	Count:	1			
Element Type:	Steel beam Guide Rail on Steel Posts	Total Quantity:	46.0			
Environment:	Severe	Inspected	Yes <input checked="" type="checkbox"/>	No <input type="checkbox"/>	limited <input type="checkbox"/>	
Protection System:	Galvanized					Performance Deficiencies
Condition Data:	Units	Excellent	Good	Fair	Poor*	8 - Pedestrian / vehicular hazard
	m	8.0	22.0	12.0	4.0	
Comments: Northwest is in excellent condition. Remaining rails have localized light corrosion typical. No guide rail northeast approach. Southwest end termination has medium corrosion, full length deformations and 4 rotten wood posts. Southwest W-beam has 2.5m of deformations and two 300x300mm deformations. The end terminal has deficient height and end block is rotated sideways. Southeast has abrasion deformations and it's bridge connection has deficient height.

<b>Description of Photo:</b> Approach Barrier

**Description of Photo:** Approach Barrier

Recommended Work:	Rehab: <input type="checkbox"/>	Replace: <input type="checkbox"/>	Maintenance Needs:	3 - Railing System Repair		
Urgent: <input type="checkbox"/>	1-5 Years: <input type="checkbox"/>	6-10 Years: <input type="checkbox"/>	None: <input checked="" type="checkbox"/>	Urgent: <input type="checkbox"/>	1 Year: <input type="checkbox"/>	2 Year: <input checked="" type="checkbox"/>
				Replaced damaged rail sections, rotten wood post and install end treatments at the south approach.		
<b>Element Photo:</b>

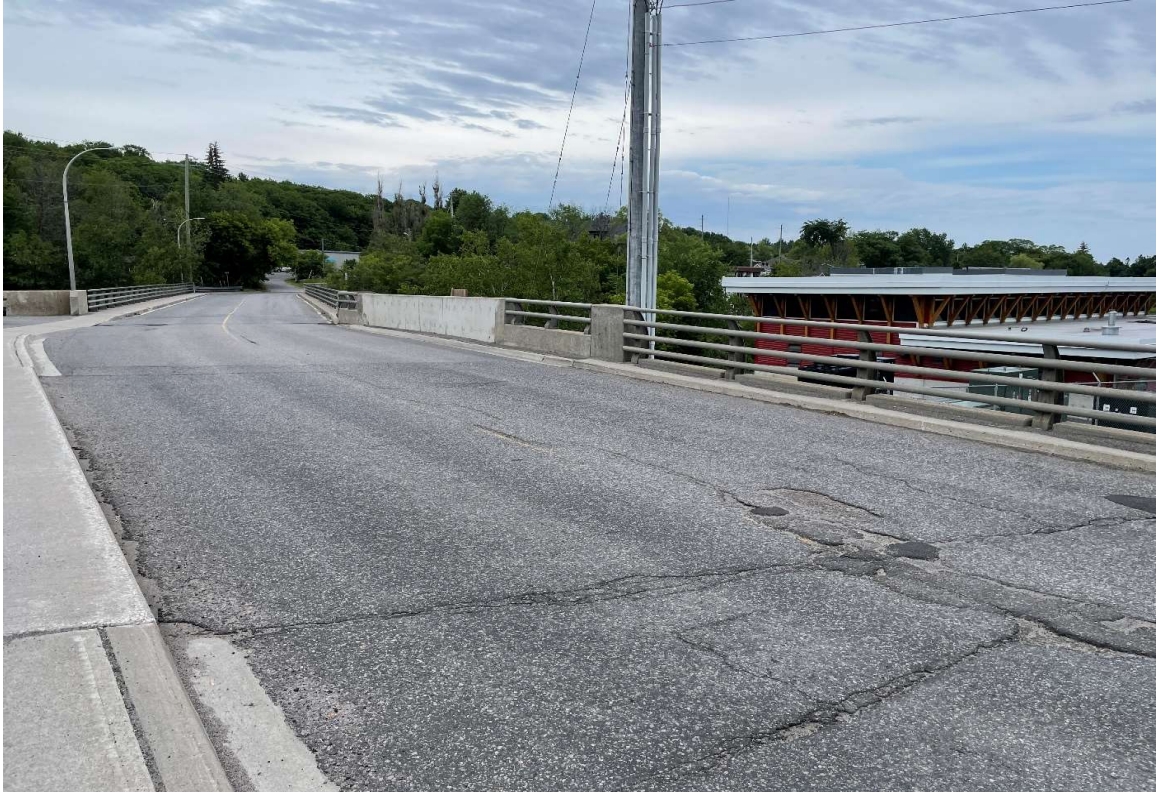
Description of Photo:		Deck wearing surface

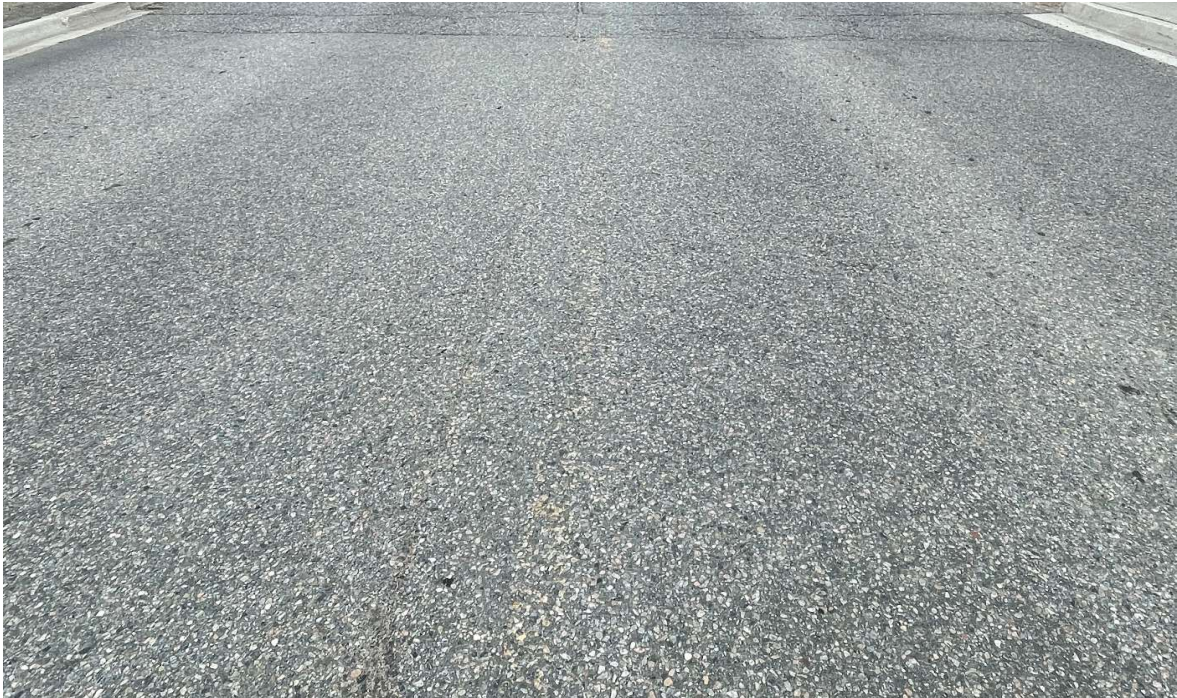
Description of Photo:		Deck top

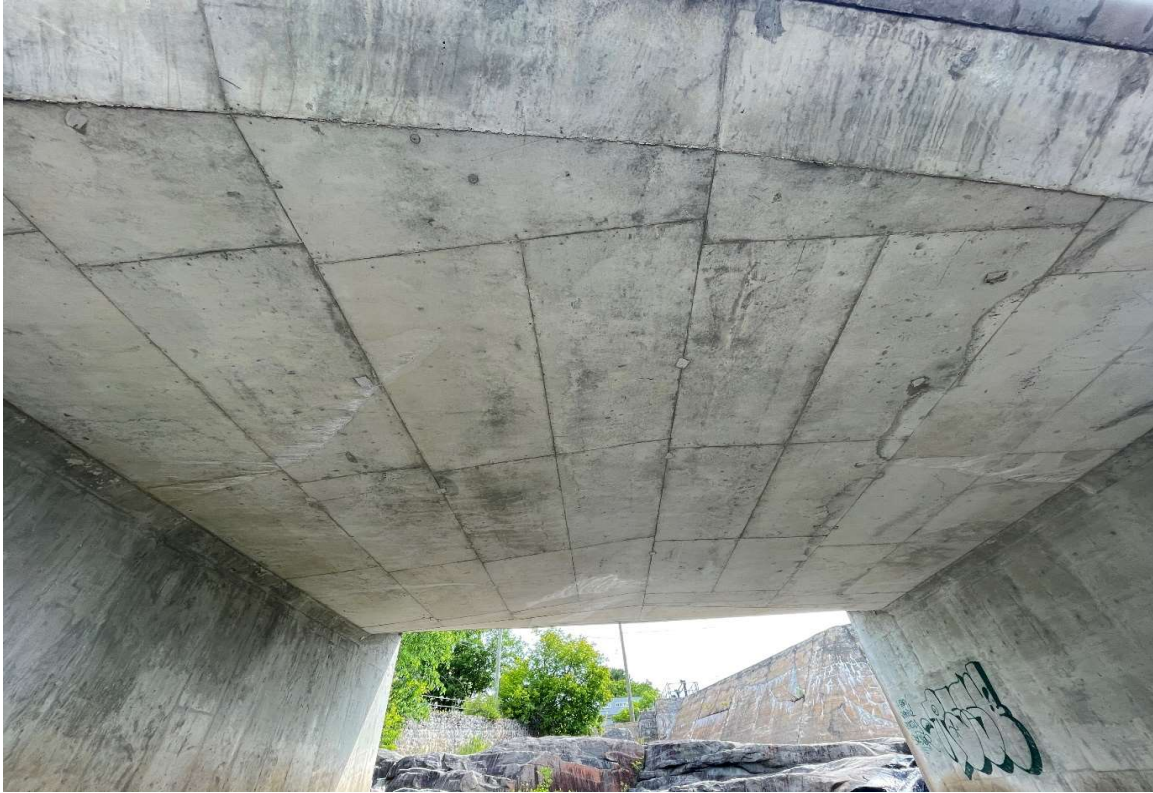
<b>Description of Photo:</b> Soffit typical

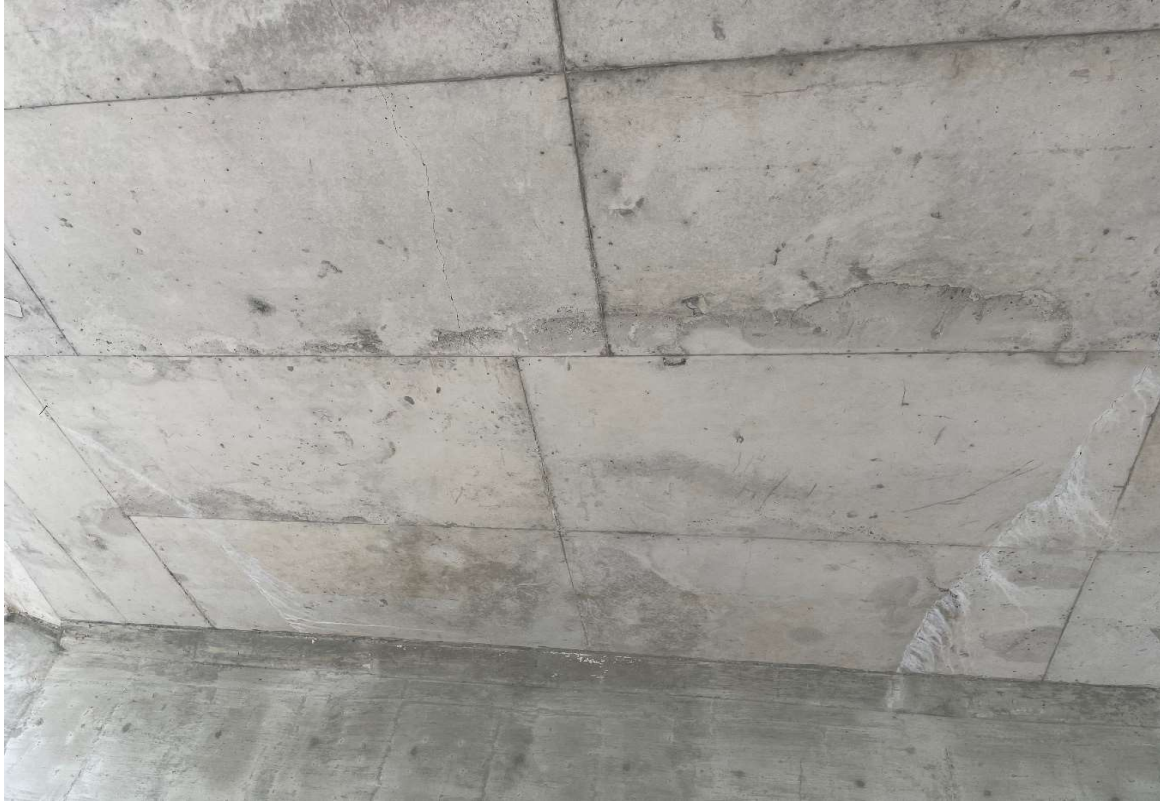
**Description of Photo:** Cracks with Efflorescence

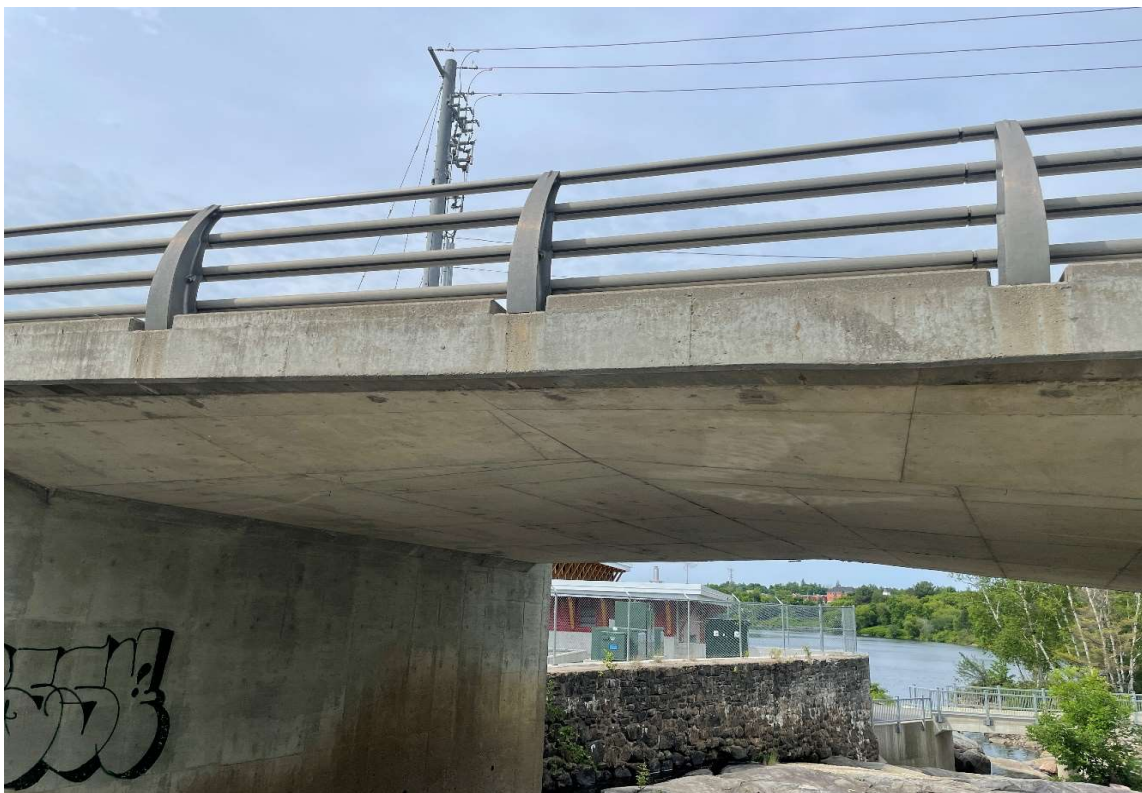
**Description of Photo:** Soffit fascia

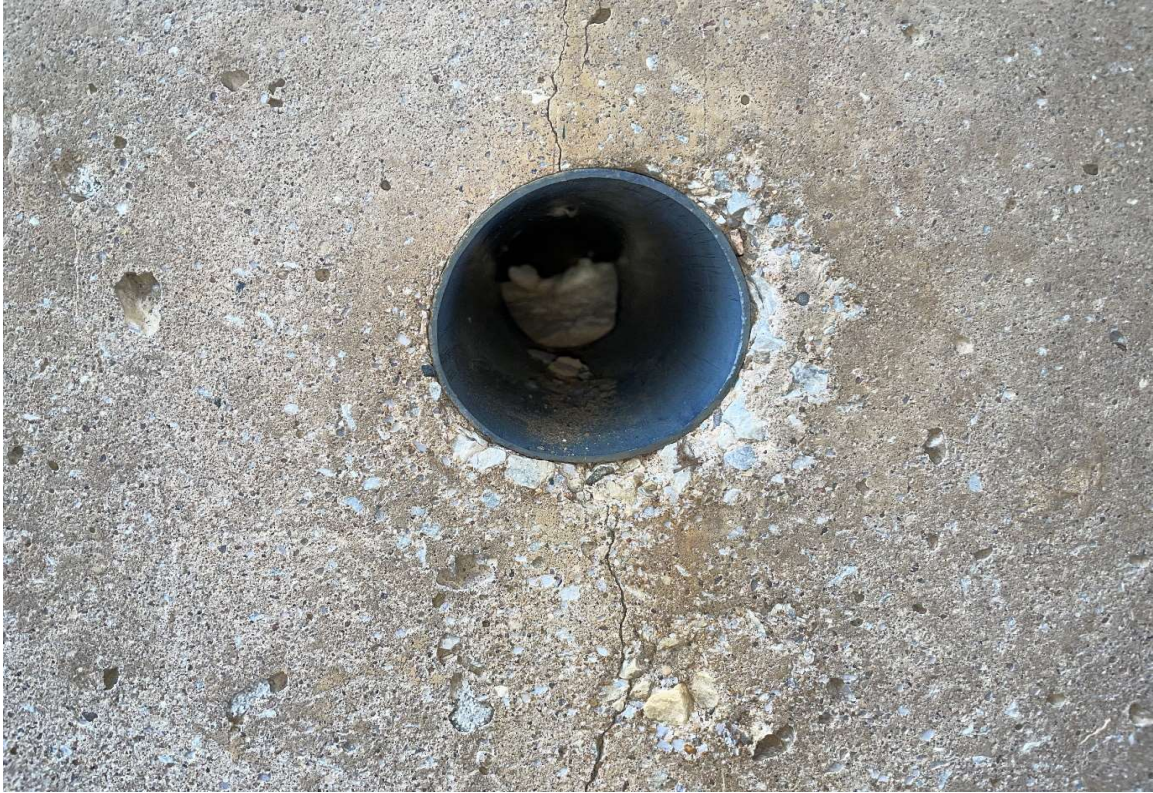
Description of Photo: Abutment Wall Drain Pipe, Typical

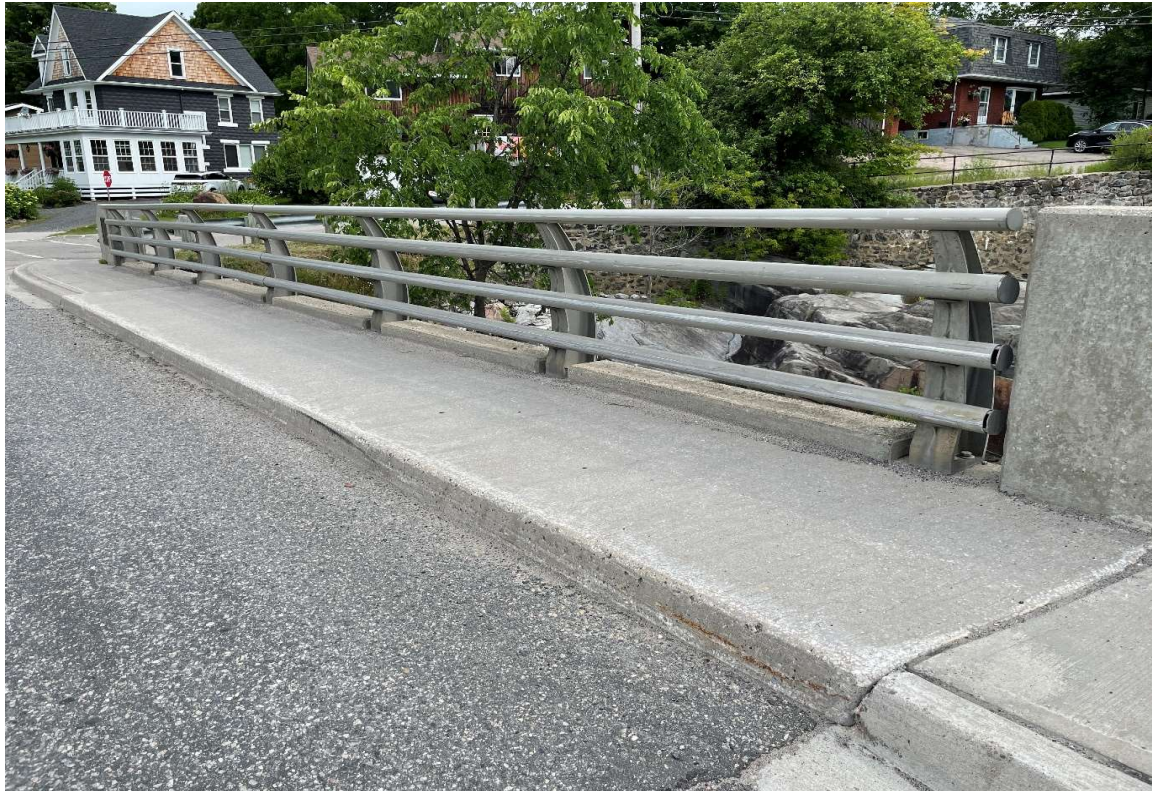
**Description of Photo:** East sidewalk

Urgent: <input type="checkbox"/>	1-5 Years: <input type="checkbox"/>	6-10 Years: <input type="checkbox"/>	None: <input checked="" type="checkbox"/>	Urgent: <input type="checkbox"/>	1 Year: <input checked="" type="checkbox"/>	2 Year: <input type="checkbox"/>
				Remove debris build-up
