# Bridge Inspections

**TOWN OF PARRY SOUND**

Inspection Summary Report

January  
12, 2023

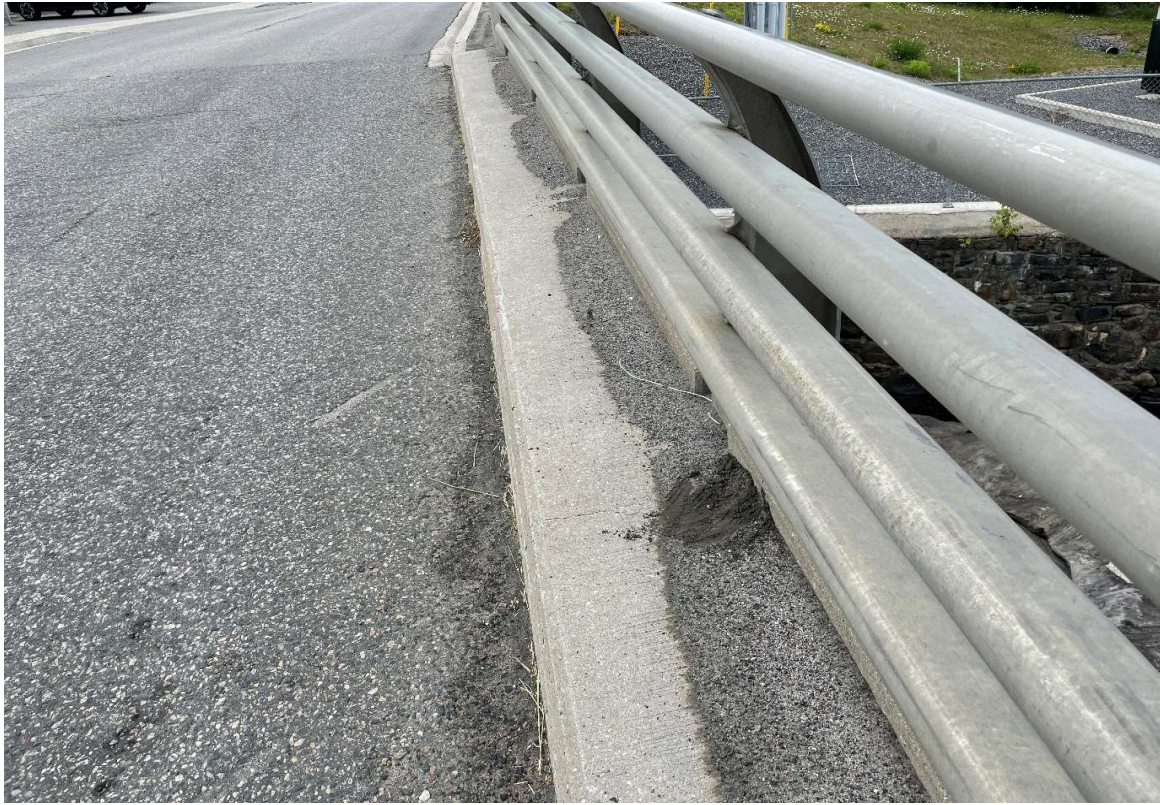
**Description of Photo:** West sidewalk

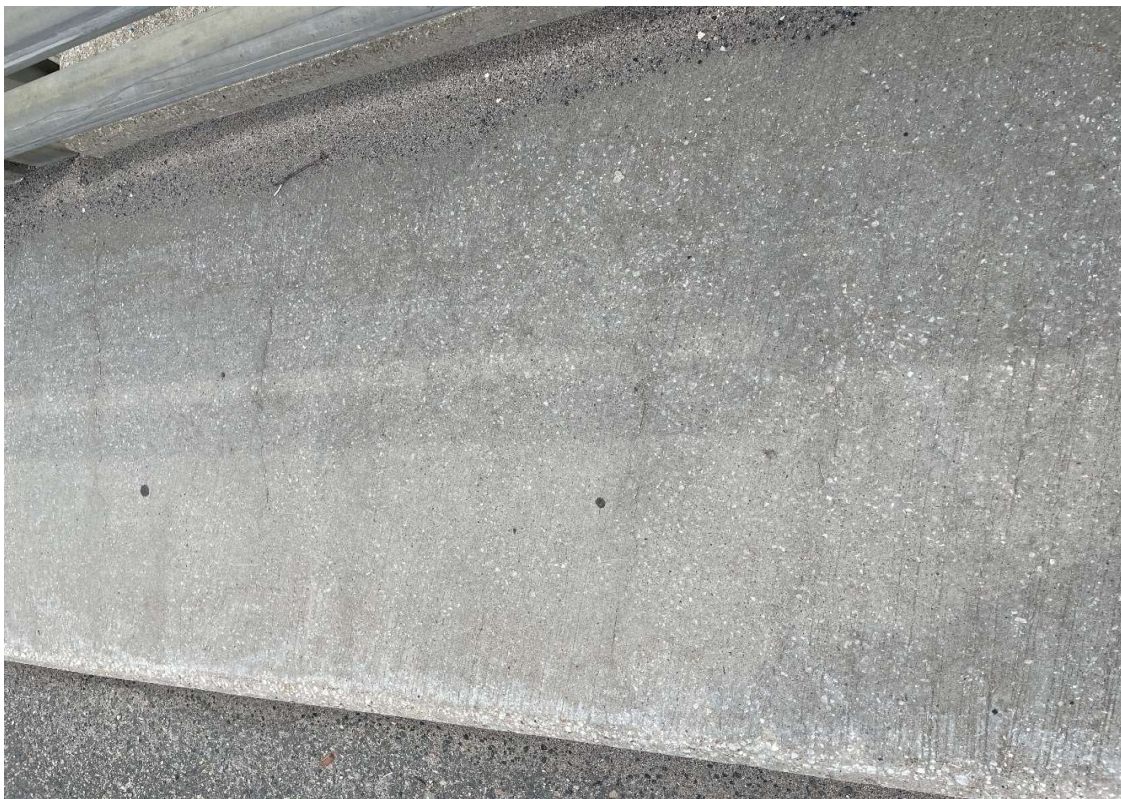
**Description of Photo:** East sidewalk light cracks

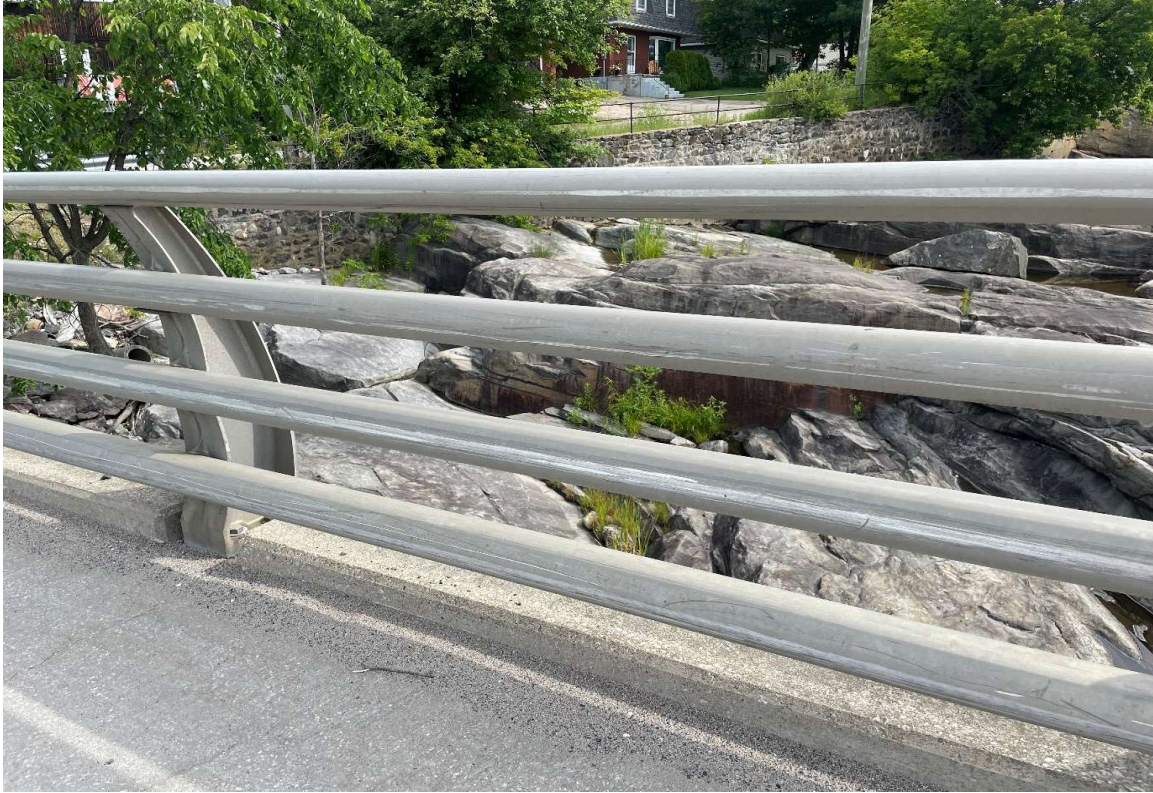
<b>Description of Photo:</b>		Railing System, Abrasions, Typical

Urgent: <input type="checkbox"/>	1-5 Years: <input type="checkbox"/>	6-10 Years: <input type="checkbox"/>	None: <input checked="" type="checkbox"/>	Urgent: <input type="checkbox"/>	1 Year: <input type="checkbox"/>	2 Year: <input checked="" type="checkbox"/>
				Replace missing end caps.		
<b>Element Photo:</b>

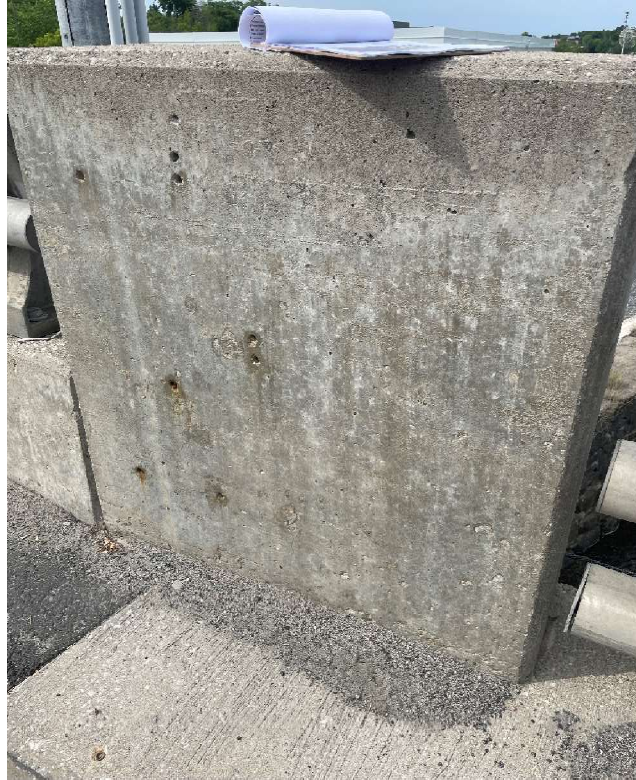
**Description of Photo:** Concrete End Wall, Typical

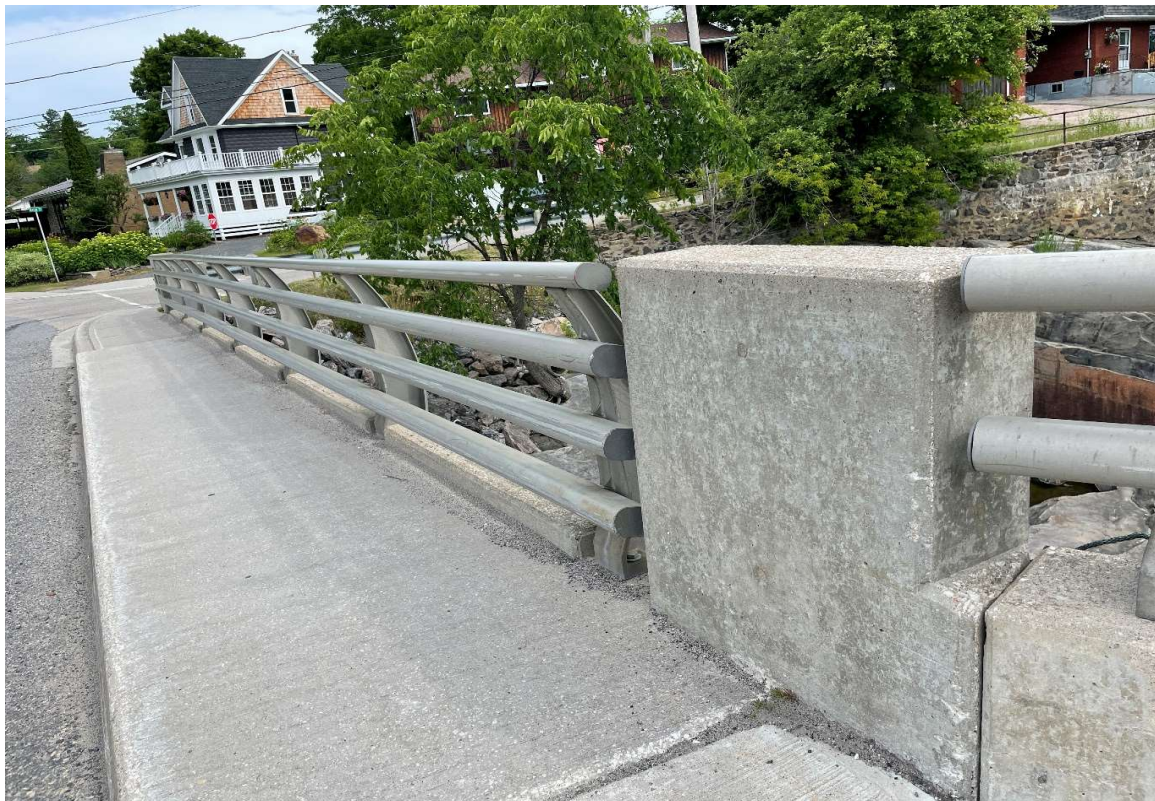
**Description of Photo:** East Railing System

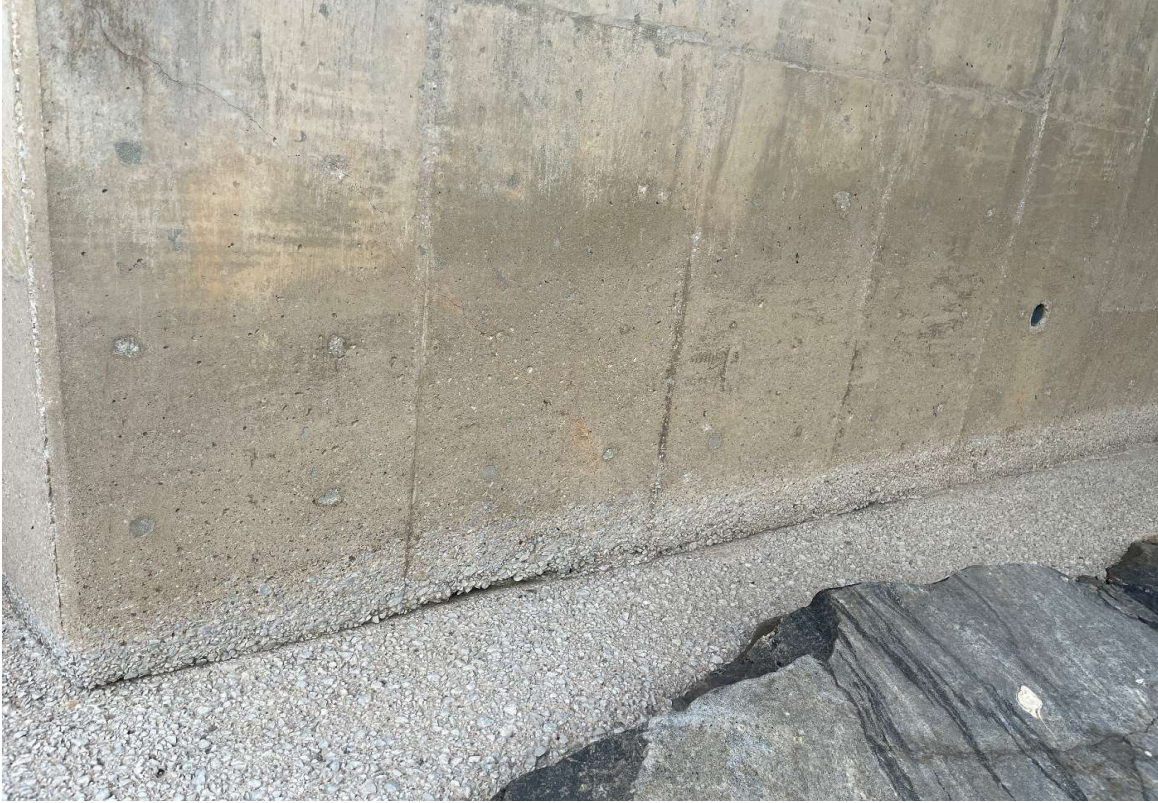
**Description of Photo:** Northwest Corner

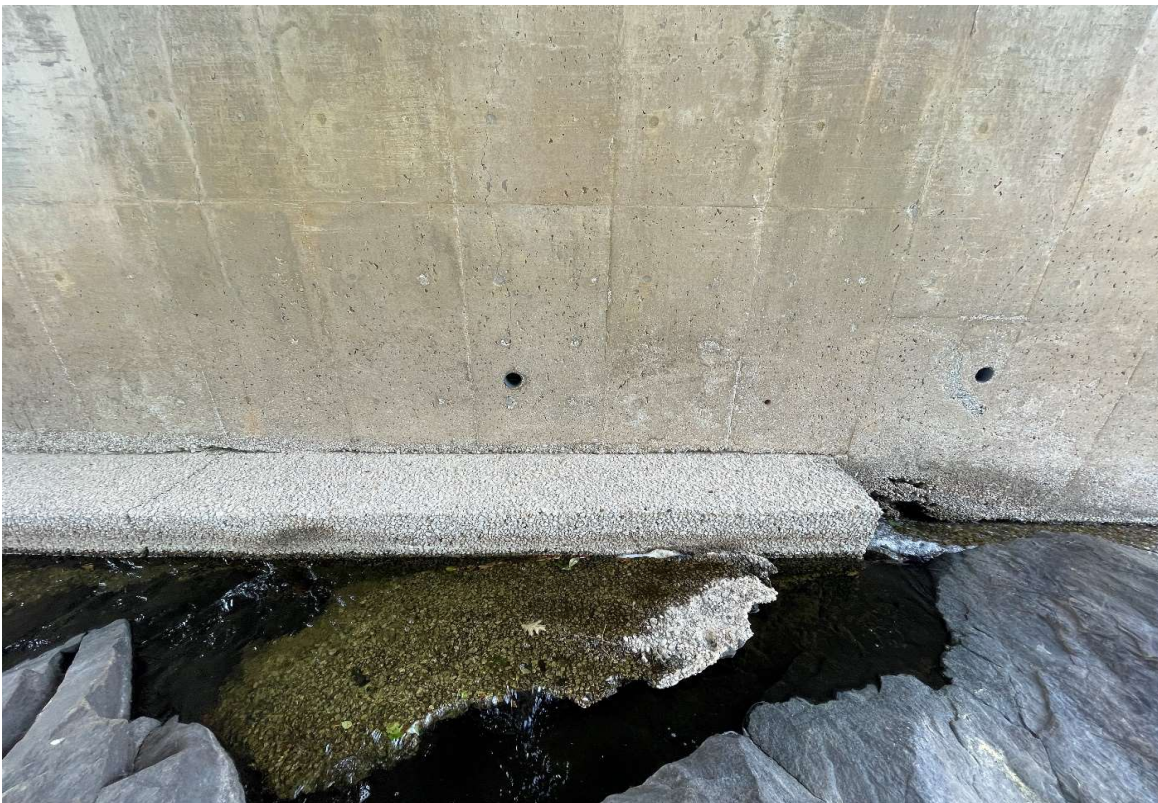
Element Data:						
Element Group:	Abutments		Length:			
Element Name:	Abutment Walls		Width:	11.3		
Location:	North and South		Height:	5.1		
Material:	Concrete		Count:	2		
Element Type:	Cast-in-place		Total Quantity:	115.6		
Environment:	Benign		Inspected	Yes <input checked="" type="checkbox"/>	No <input type="checkbox"/>	limited <input type="checkbox"/>
Protection System:						Performance Deficiencies
Condition Data:	Units	Excellent	Good	Fair	Poor*	
	sq.m		106.7	5.0	5.0	
Comments: Light scaling, typical. Light erosion at both ends of the footings. 4.0m of light cracking. 15.0m of medium cracking. 800mm of severe cracking at center of footing. Bottom of south wall has localized area of very severe scouring with a 500mm x 300mm x 100mm deep void with water churning within the void. 300mm x 100mm light scouring @ northwest corner. Severe scaling 200mm from bottom of wall for the full length on bridge on both sides. 400mm x 200mm spall at south footing.

**Description of Photo:** South Abutment, Note Void at End of Footing

Recommended Work:	Rehab: <input type="checkbox"/> Replace: <input type="checkbox"/>		Maintenance Needs:	8 - Concrete Repair		
Urgent: <input type="checkbox"/>	1-5 Years: <input type="checkbox"/>	6-10 Years: <input type="checkbox"/>	None: <input checked="" type="checkbox"/>	Urgent: <input type="checkbox"/>	1 Year: <input type="checkbox"/>	2 Year: <input checked="" type="checkbox"/>
				Repair concrete void.

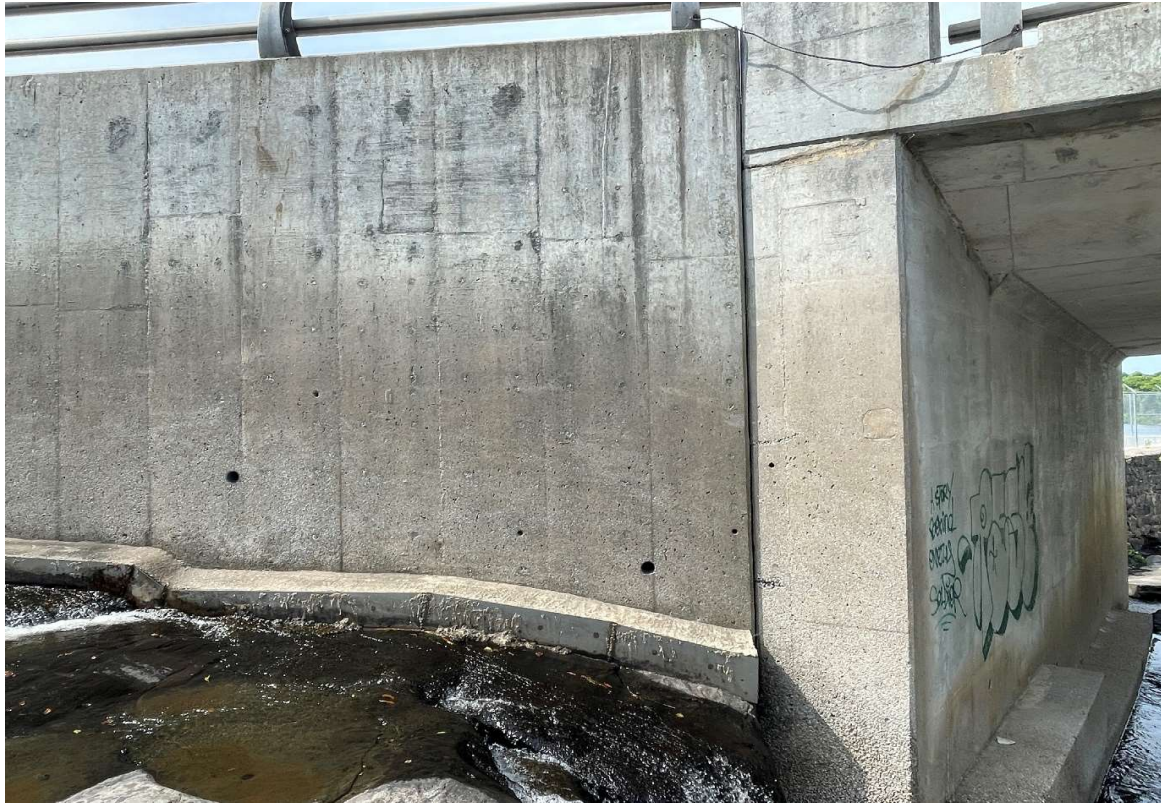
Description of Photo: Wingwall

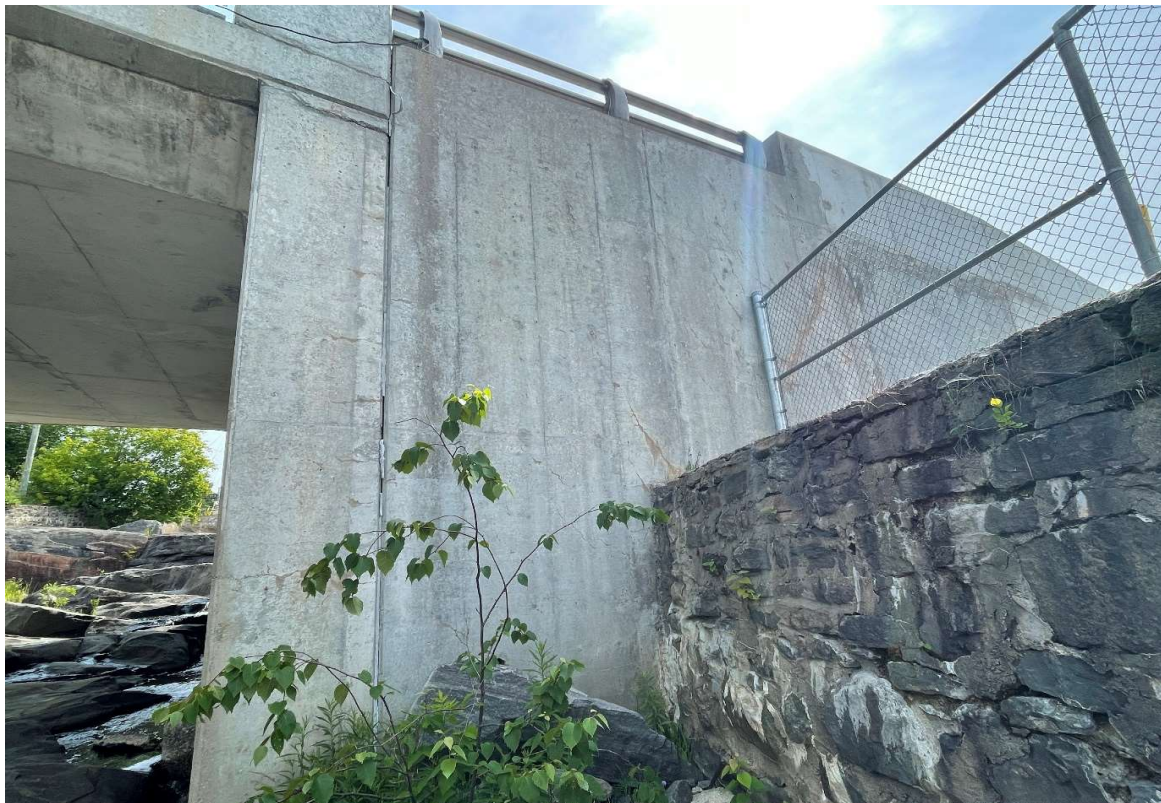
Description of Photo: Northeast wingwall

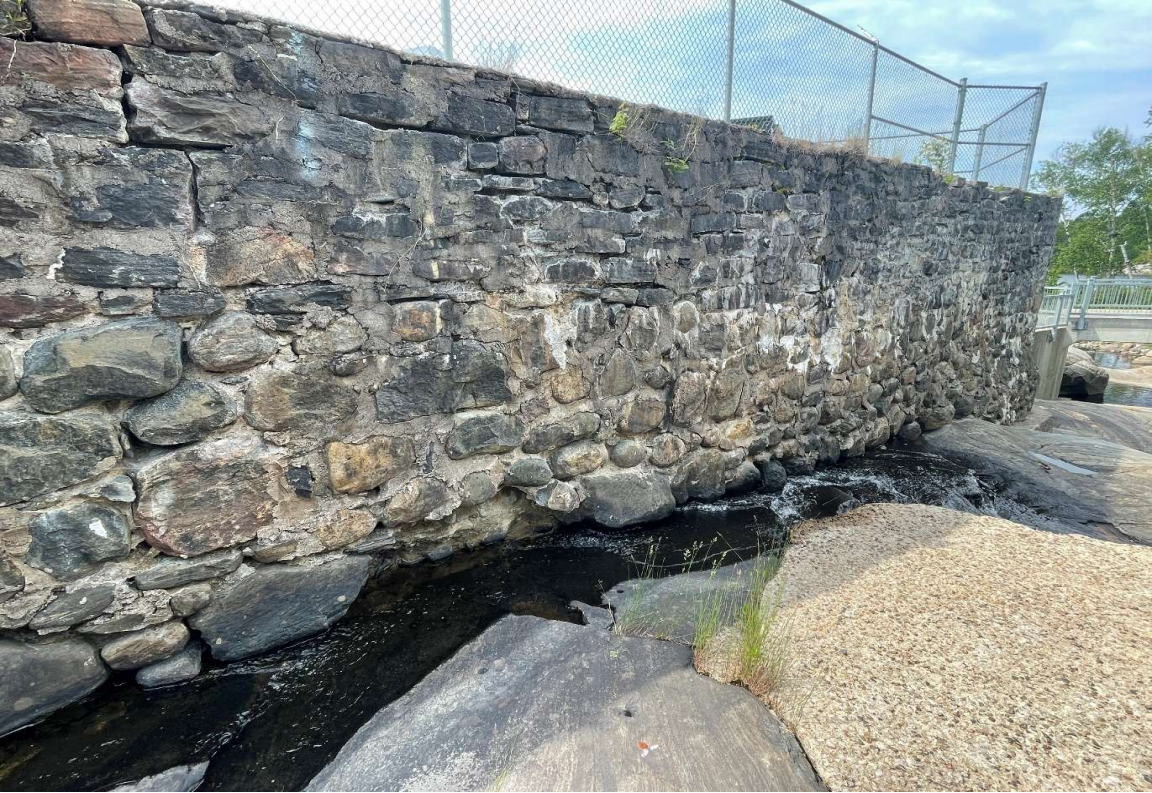
Description of Photo:		Retaining wall

Urgent: <input type="checkbox"/>		1-5 Years: <input type="checkbox"/>	6-10 Years: <input type="checkbox"/>	None: <input checked="" type="checkbox"/>	Urgent: <input type="checkbox"/>	1 Year: <input type="checkbox"/> 2 Year: <input checked="" type="checkbox"/>
				Repair scouring at bottom of retaining wall. Confirm if this element belongs to the generation facility prior to undertaking repairs.		
<b>Element Photo:</b>

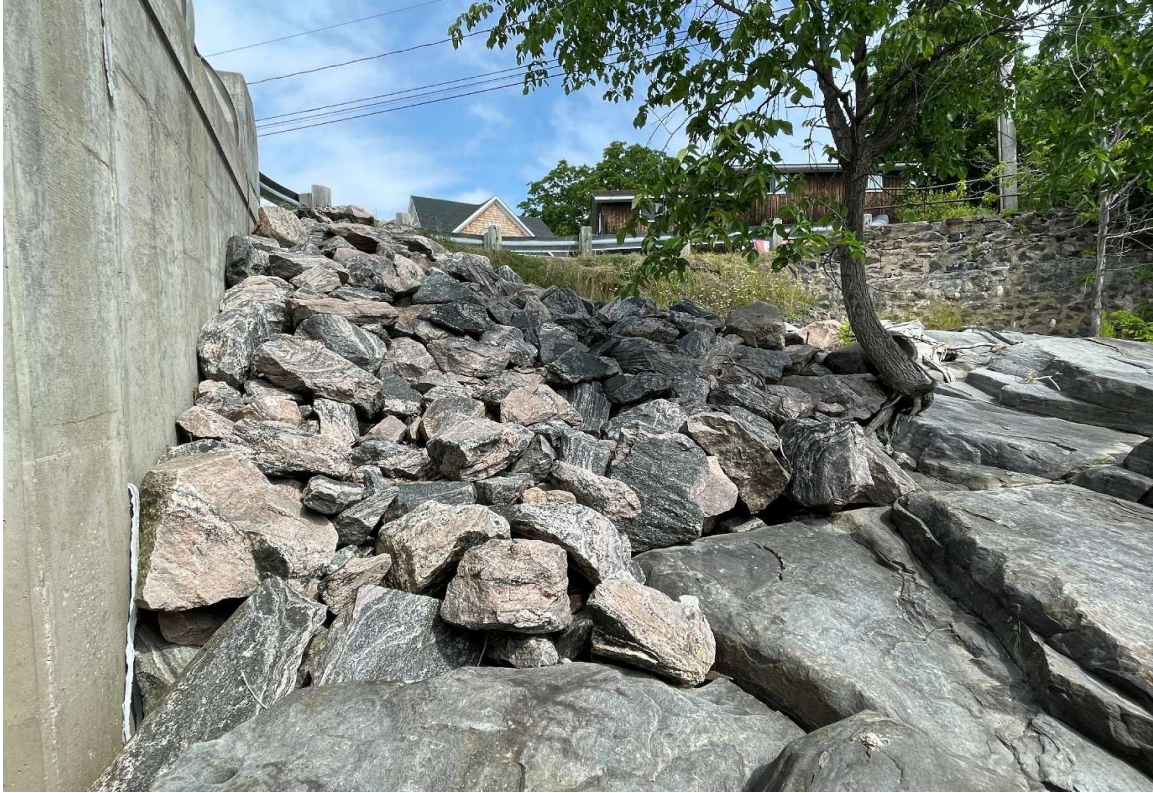
Description of Photo:		Northeast embankment

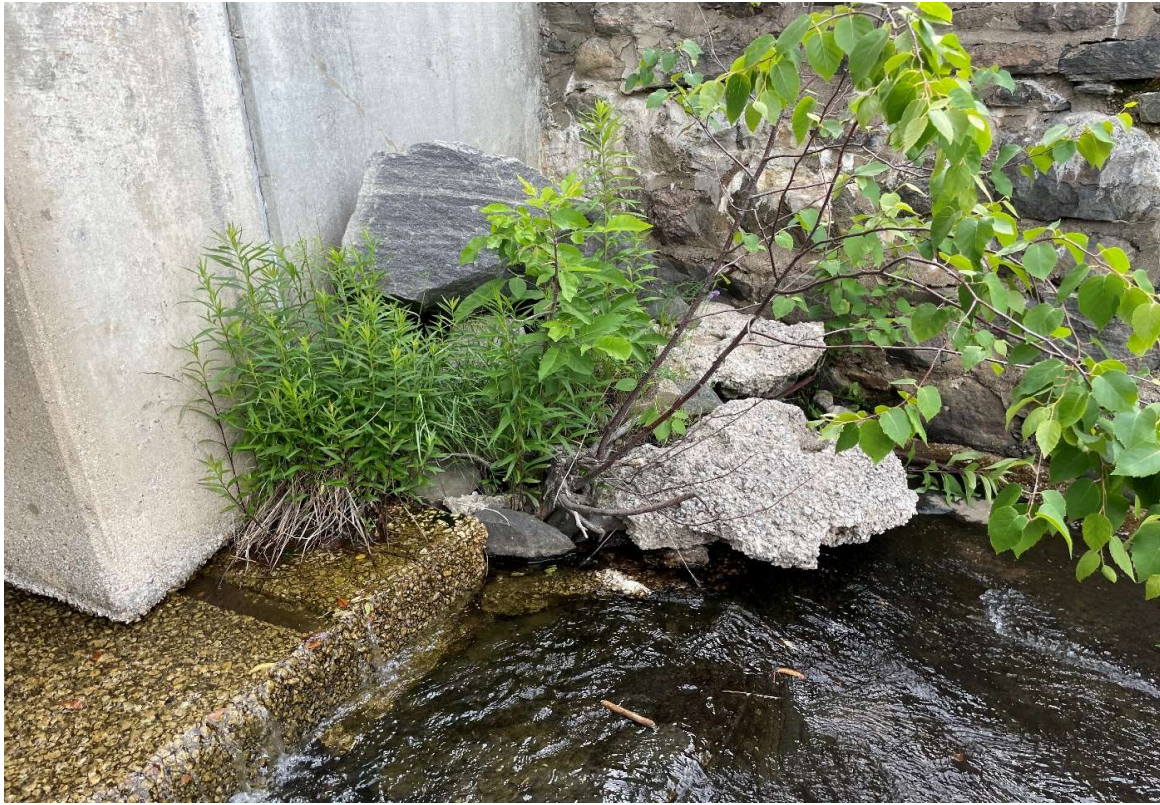
Description of Photo: Southwest embankment

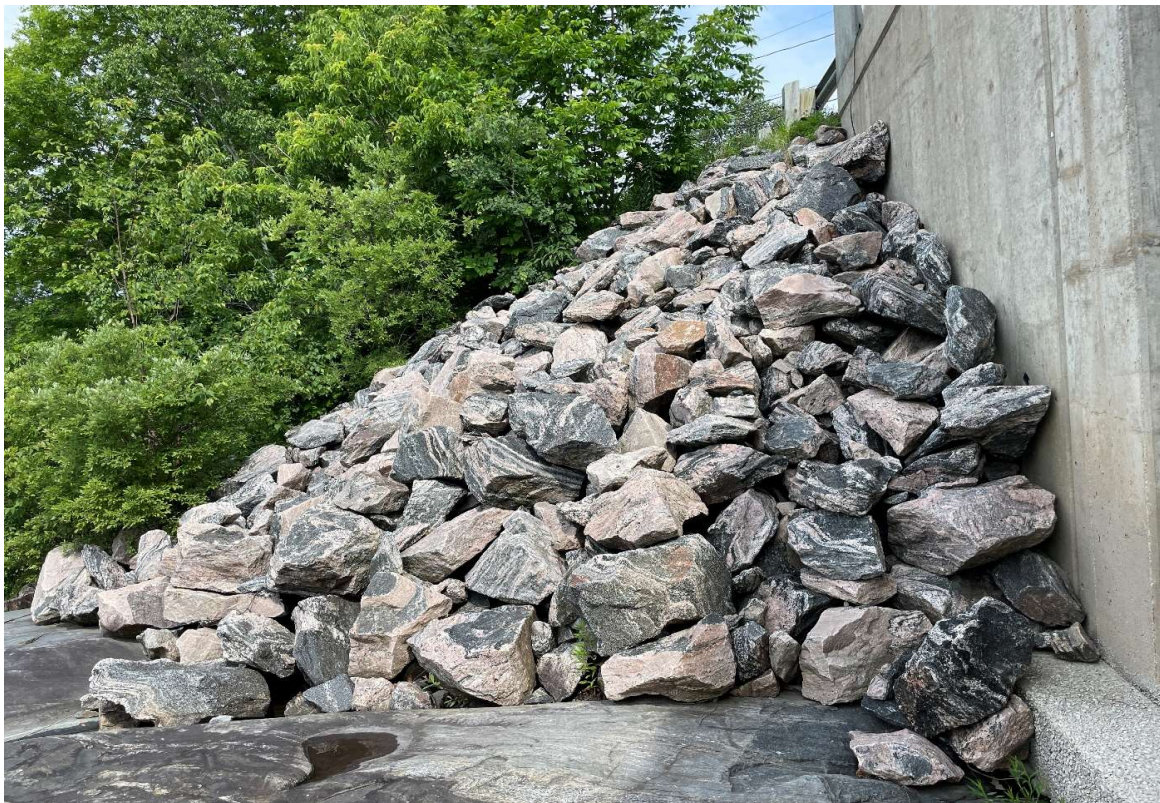
Description of Photo: Northwest embankment

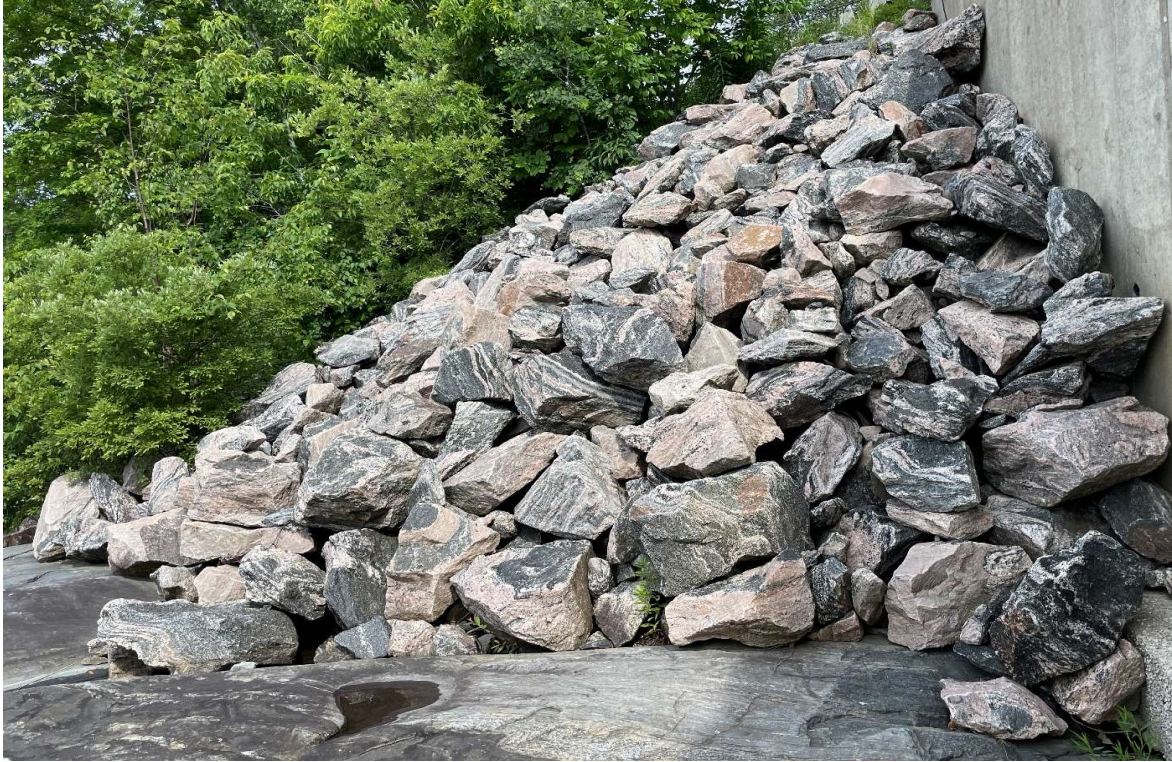
<b>Description of Photo:</b>		Slope Protection

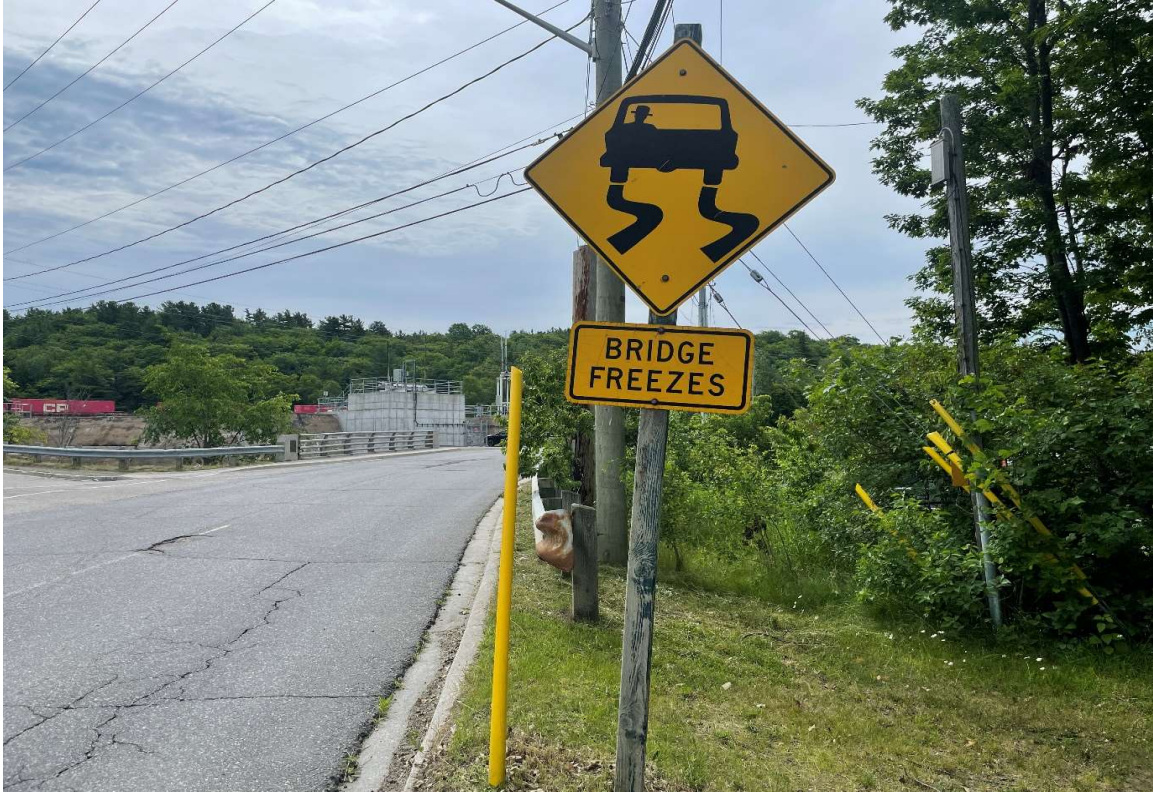
Description of Photo:		Sign

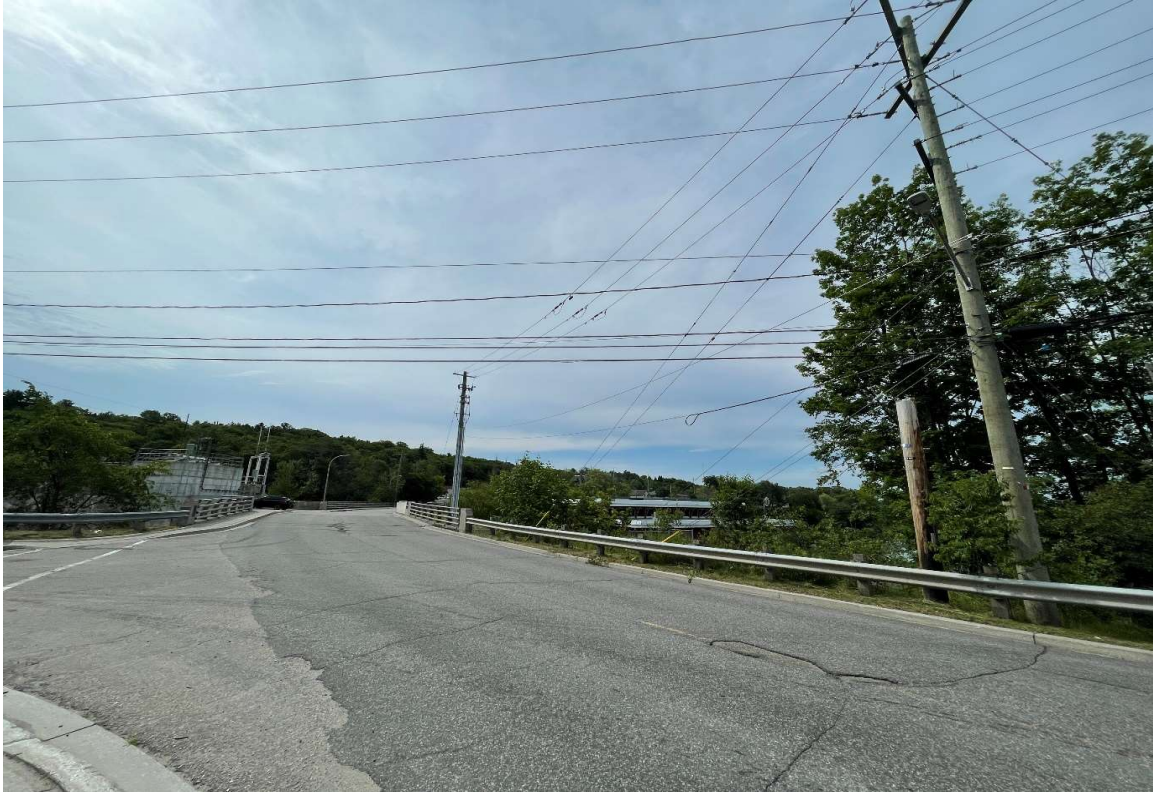
Description of Photo:		Utilities

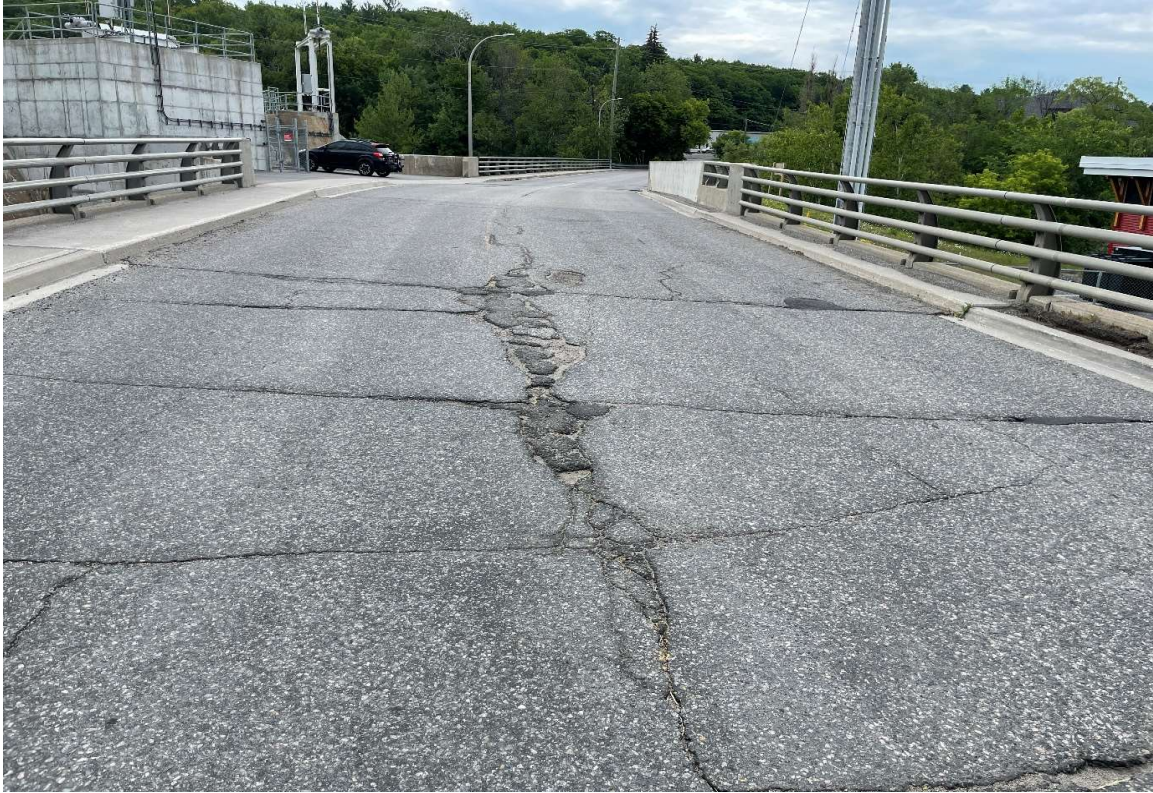
Description of Photo: North Approach

Repair asphalt		
Element Photo:

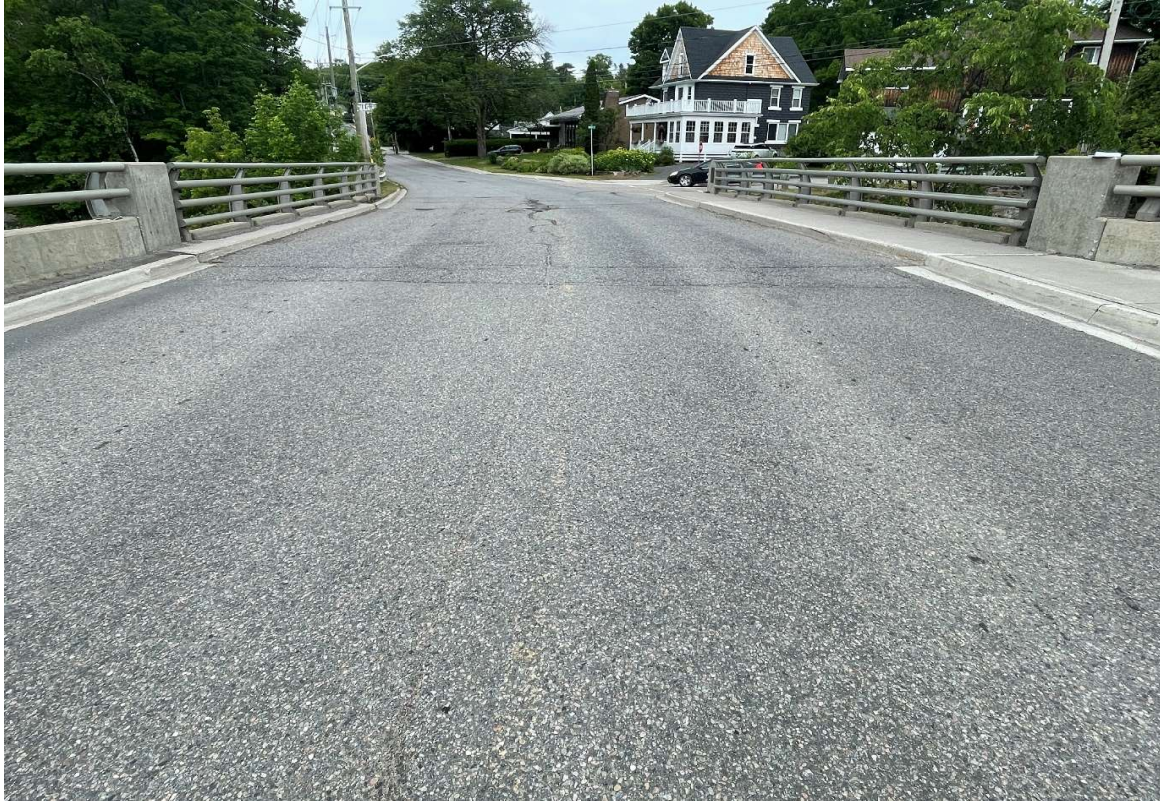
**Description of Photo:** South Approach

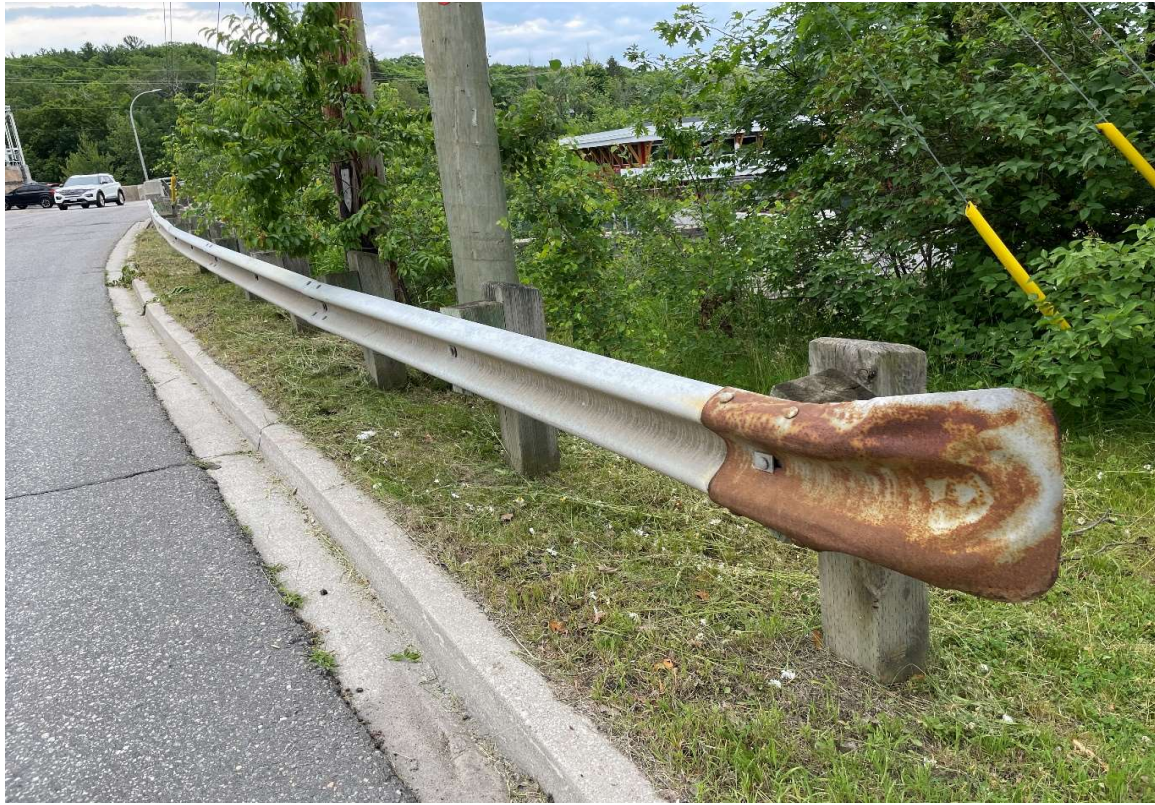
**Description of Photo:** Northwest approach barrier

Recommended Work:	Rehab: <input type="checkbox"/>	Replace: <input type="checkbox"/>	Maintenance Needs:	3 - Railing System Repair		
Urgent: <input type="checkbox"/>	1-5 Years: <input type="checkbox"/>	6-10 Years: <input type="checkbox"/>	None: <input checked="" type="checkbox"/>	Urgent: <input type="checkbox"/>	1 Year: <input type="checkbox"/>	2 Year: <input checked="" type="checkbox"/>
				Upgrade NE and NW barrier to bridge connection

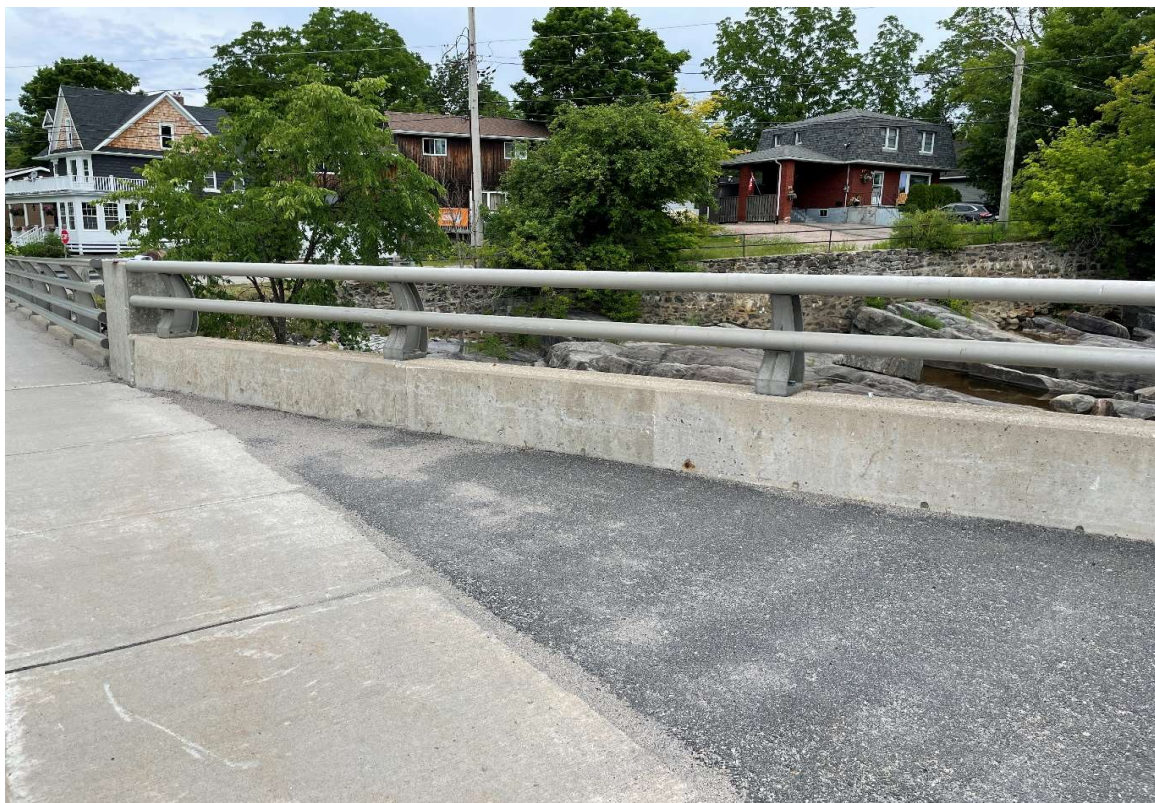
**Description of Photo:** Southeast approach barrier

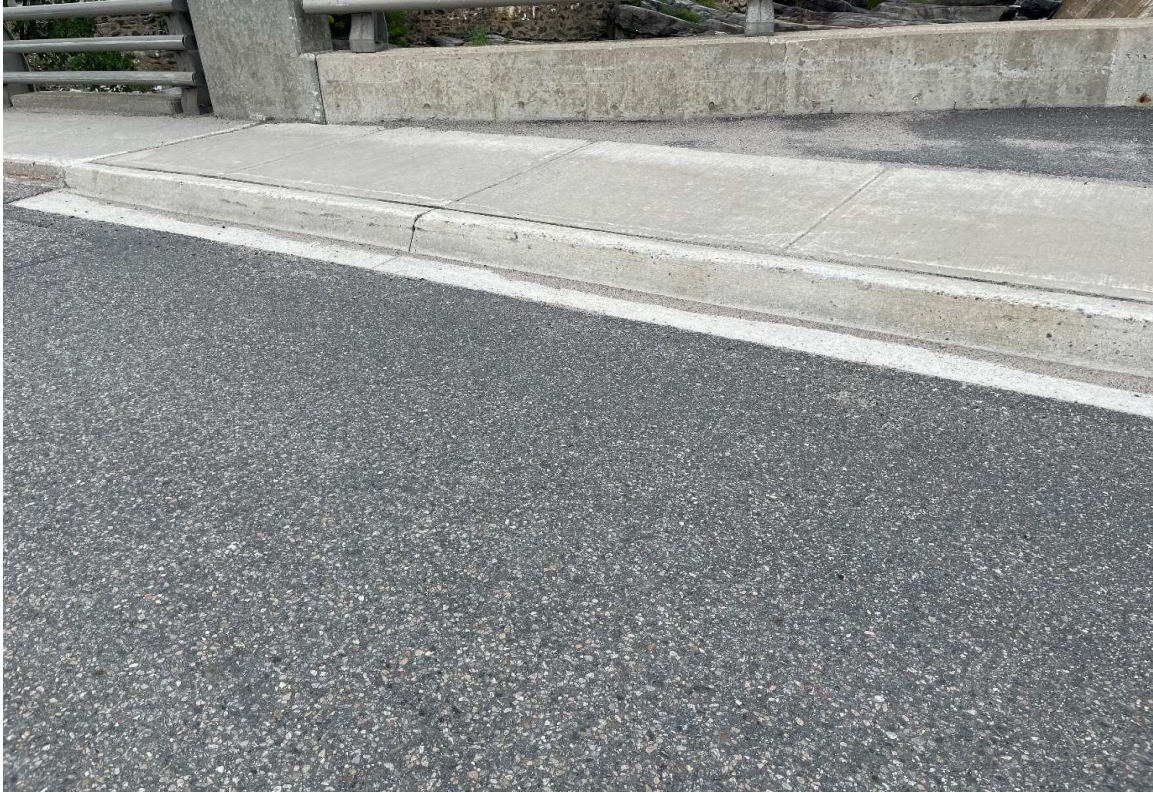
<b>Description of Photo:</b> Approach curb

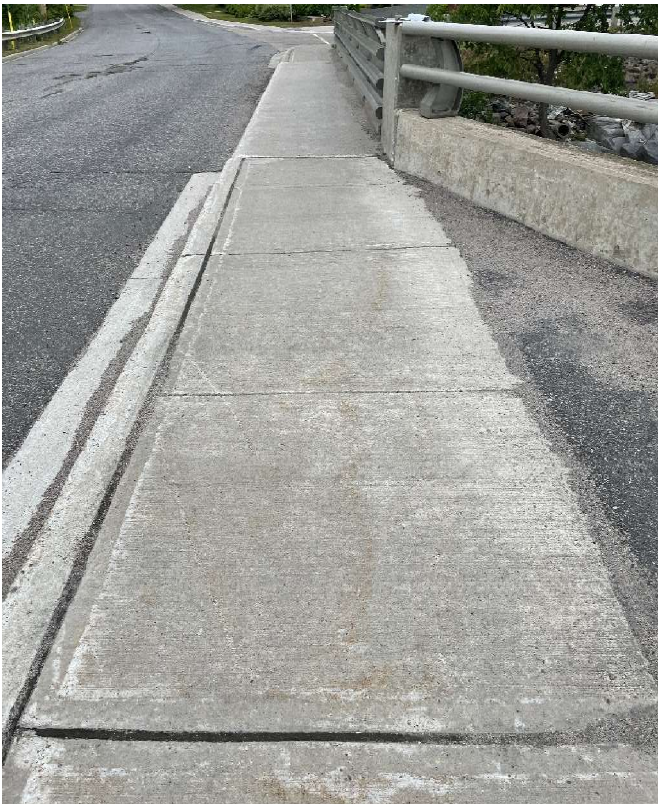
<b>Description of Photo:</b> Approach sidewalk

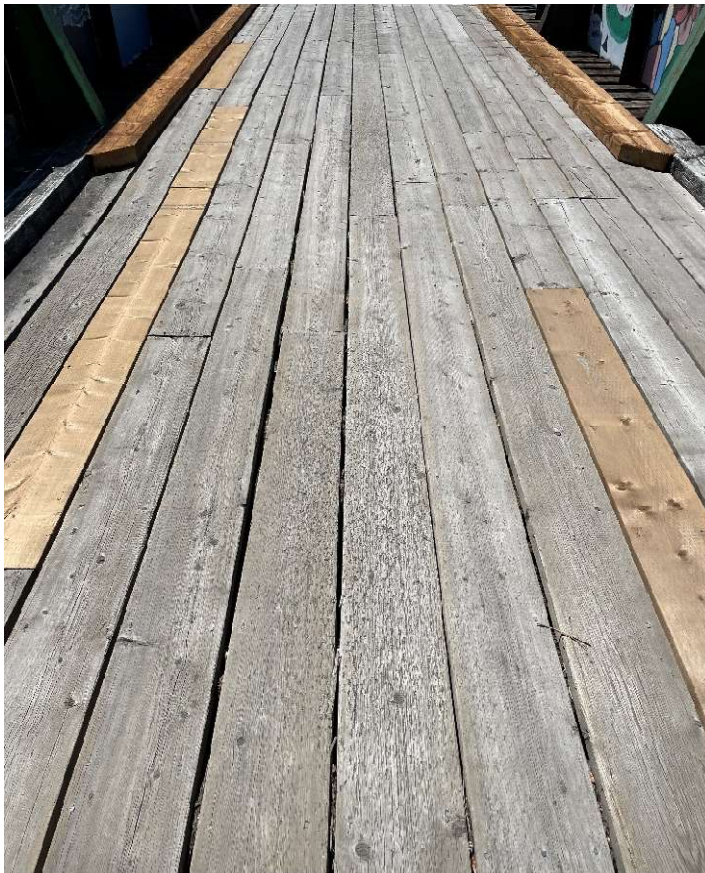
Comments: Boards along center of path have light wear. Light to medium checks typical. Severe split board at west end.

**Description of Photo:** Deck Wearing Surface

Recommended Work:	Rehab: <input type="checkbox"/>	Replace: <input type="checkbox"/>	Maintenance Needs:	12 - Bridge Surface Repair		
Urgent: <input type="checkbox"/>	1-5 Years: <input type="checkbox"/>	6-10 Years: <input type="checkbox"/>	None: <input checked="" type="checkbox"/>	Urgent: <input type="checkbox"/>	1 Year: <input type="checkbox"/>	2 Year: <input checked="" type="checkbox"/>
				Replace 1 split board

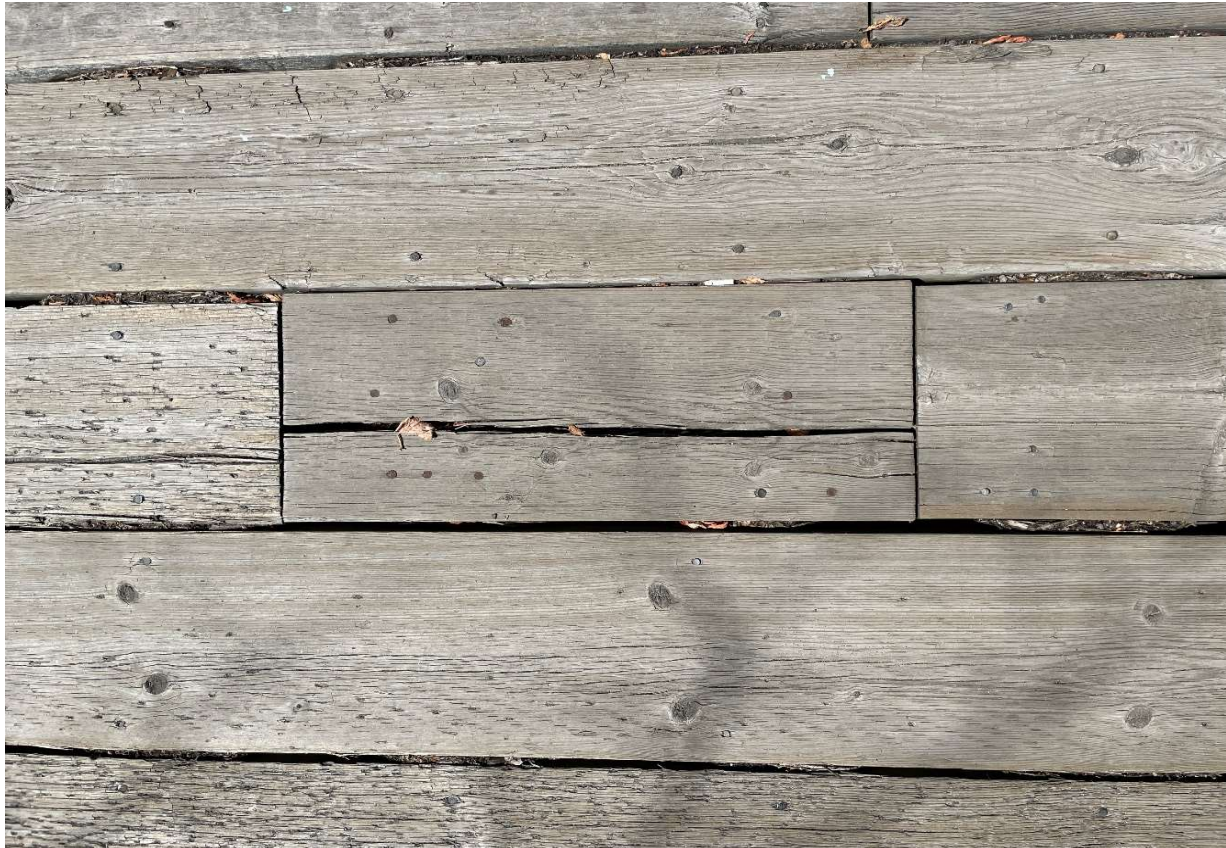
**Description of Photo:** Deck Wearing Surface
