# Bridge Inspections

**TOWN OF PARRY SOUND**

Inspection Summary Report

January  
12, 2023

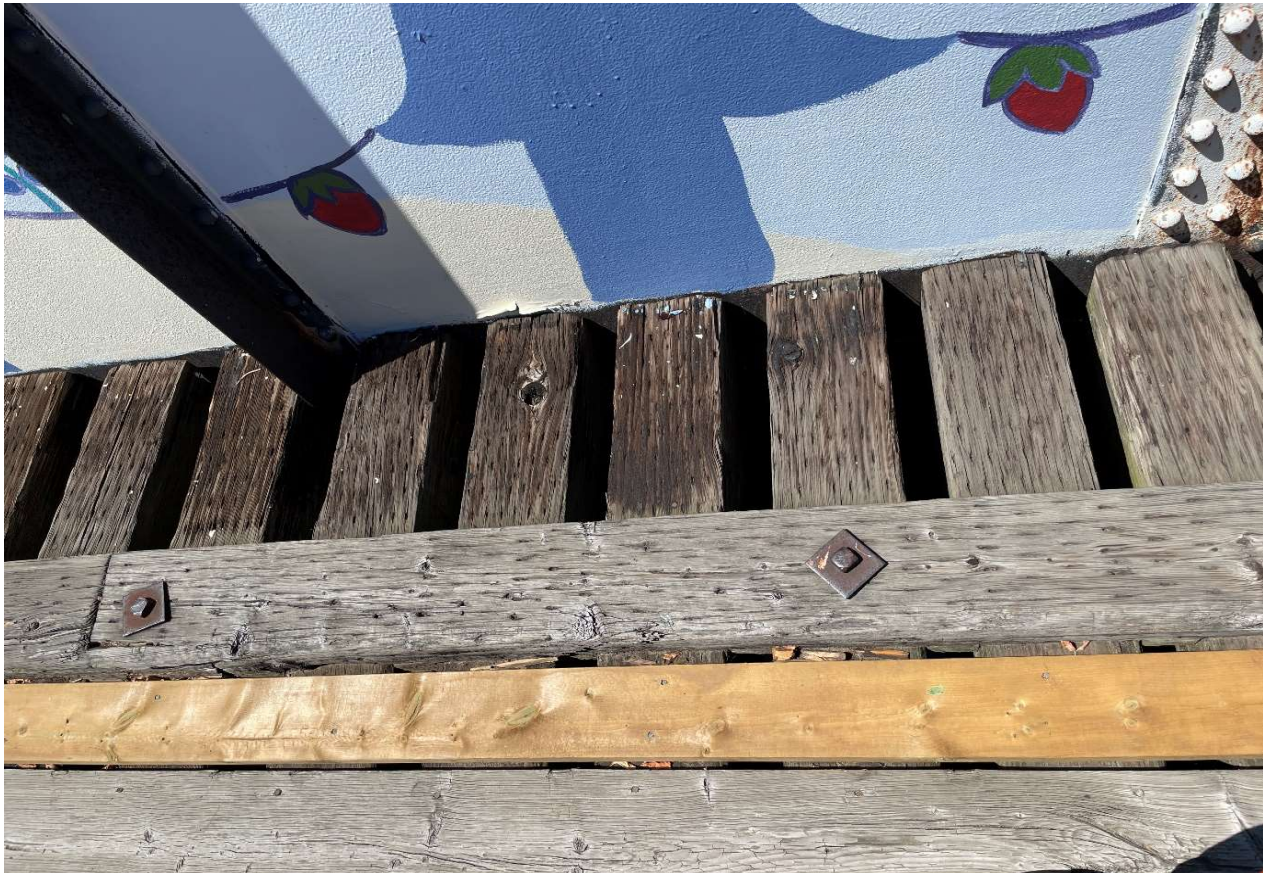
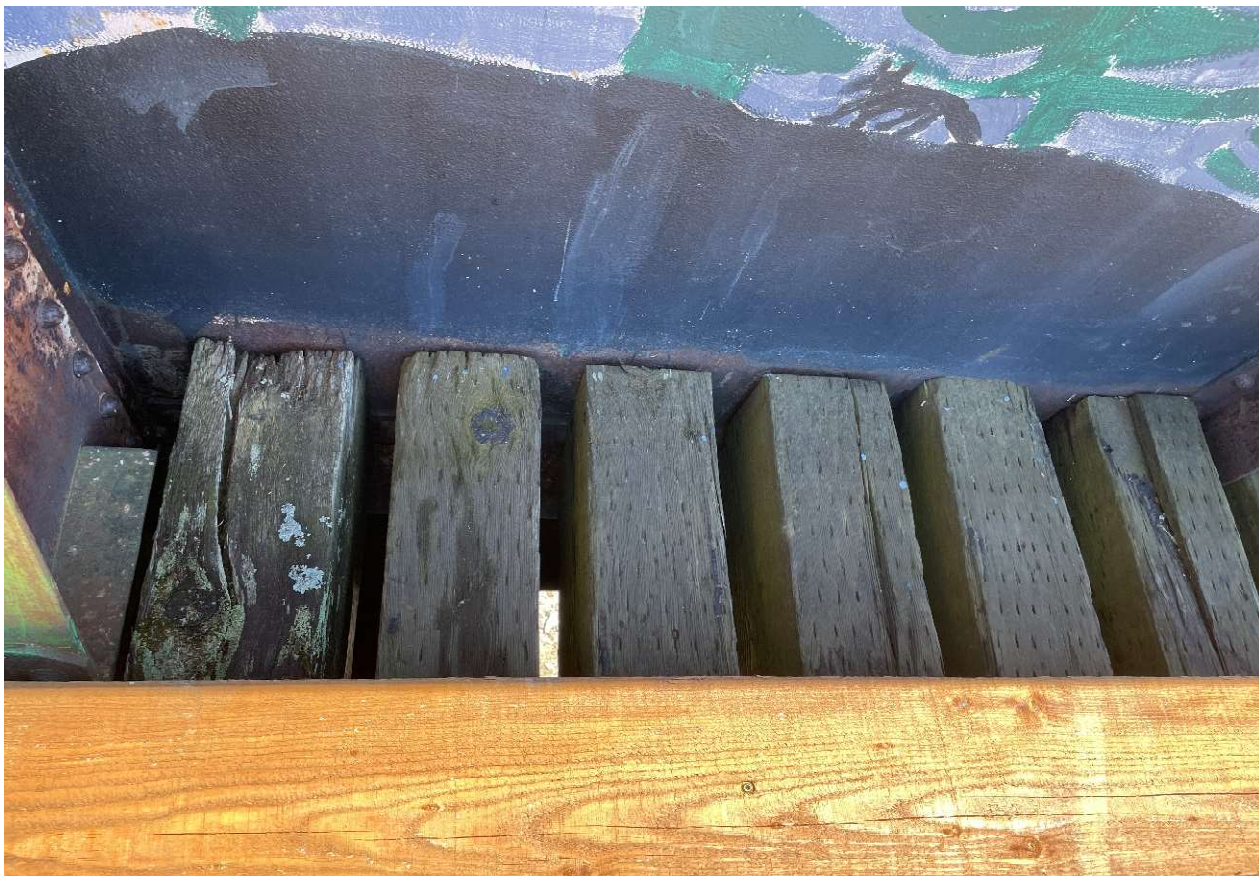
**Description of Photo:** Deck Top

Description of Photo: Deck Top

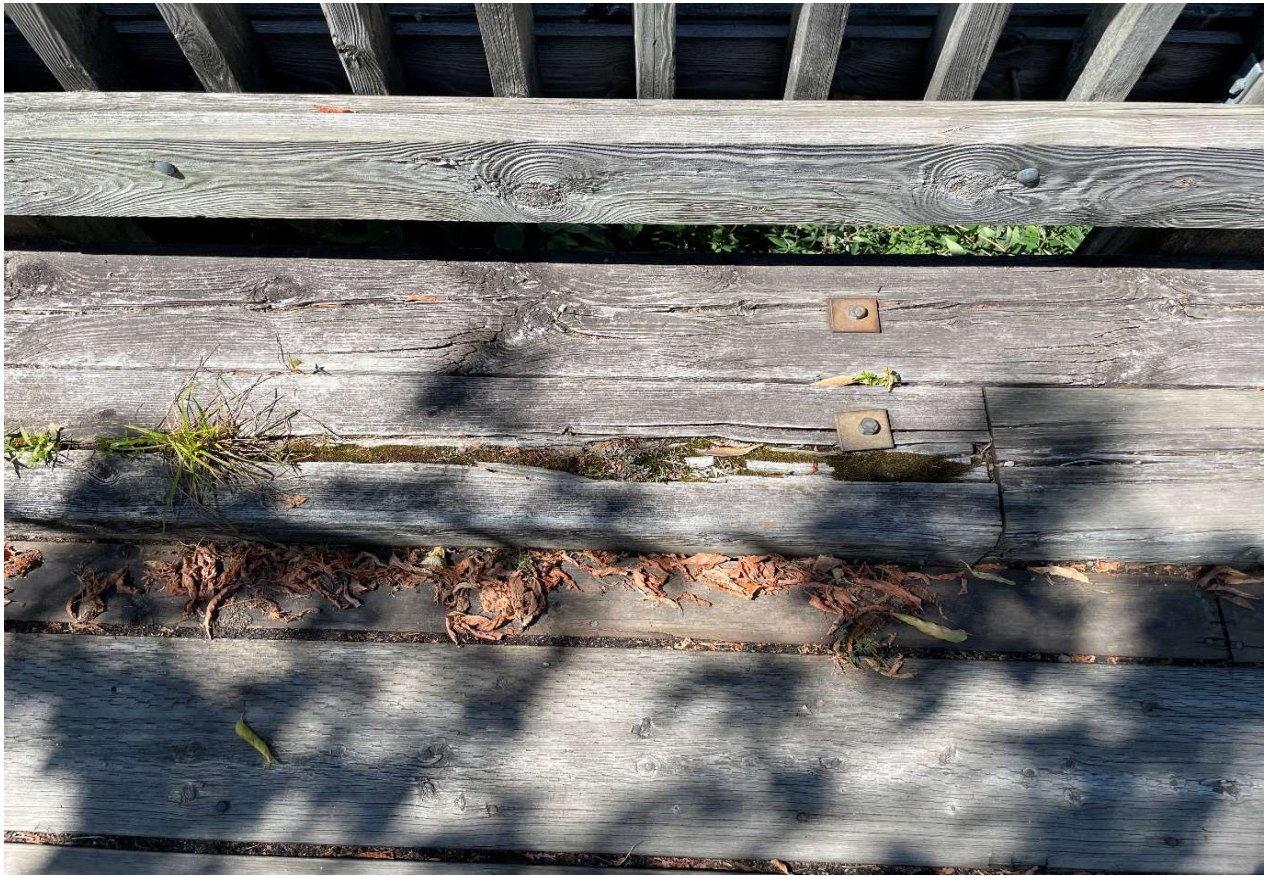
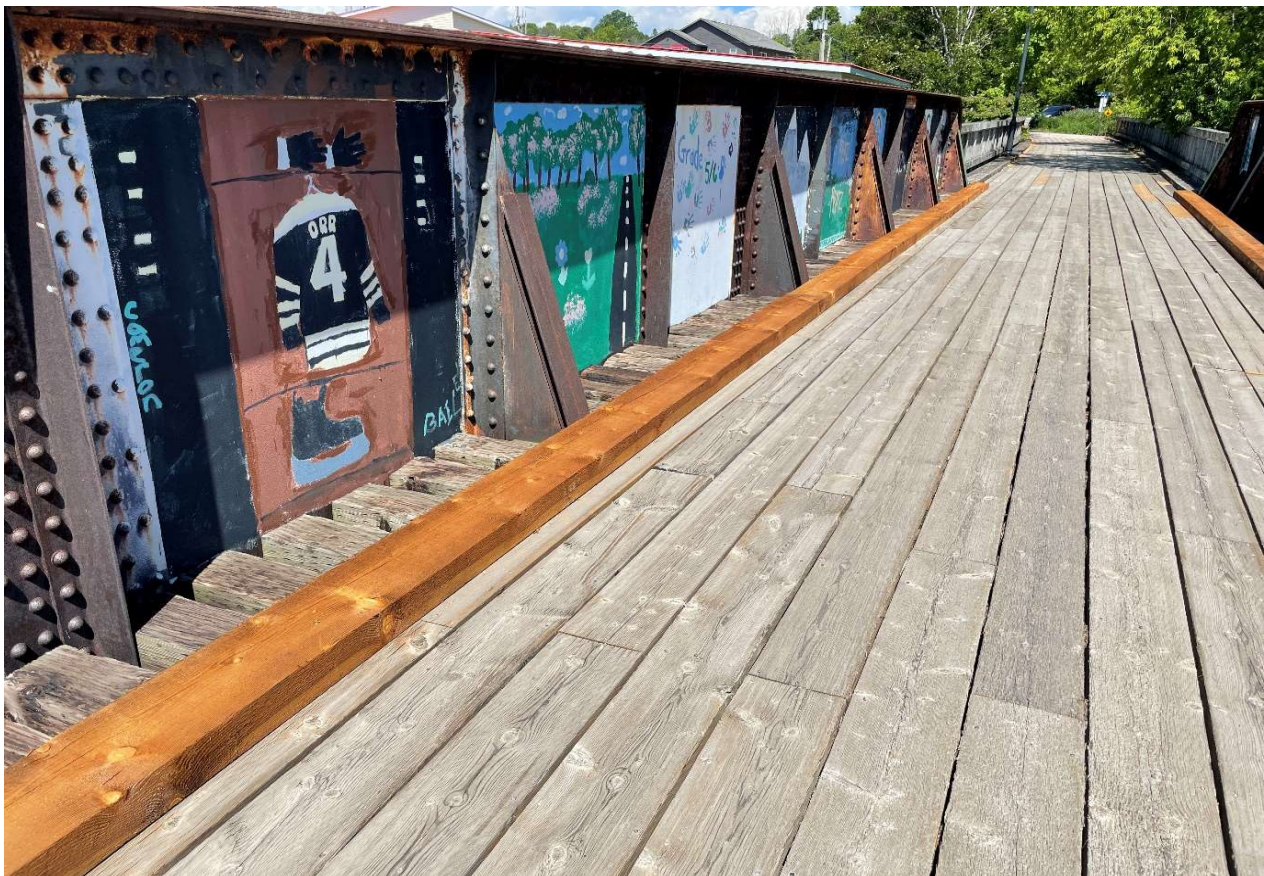
**Description of Photo:** Curb

Description of Photo: Curb

Replace rotten timbers

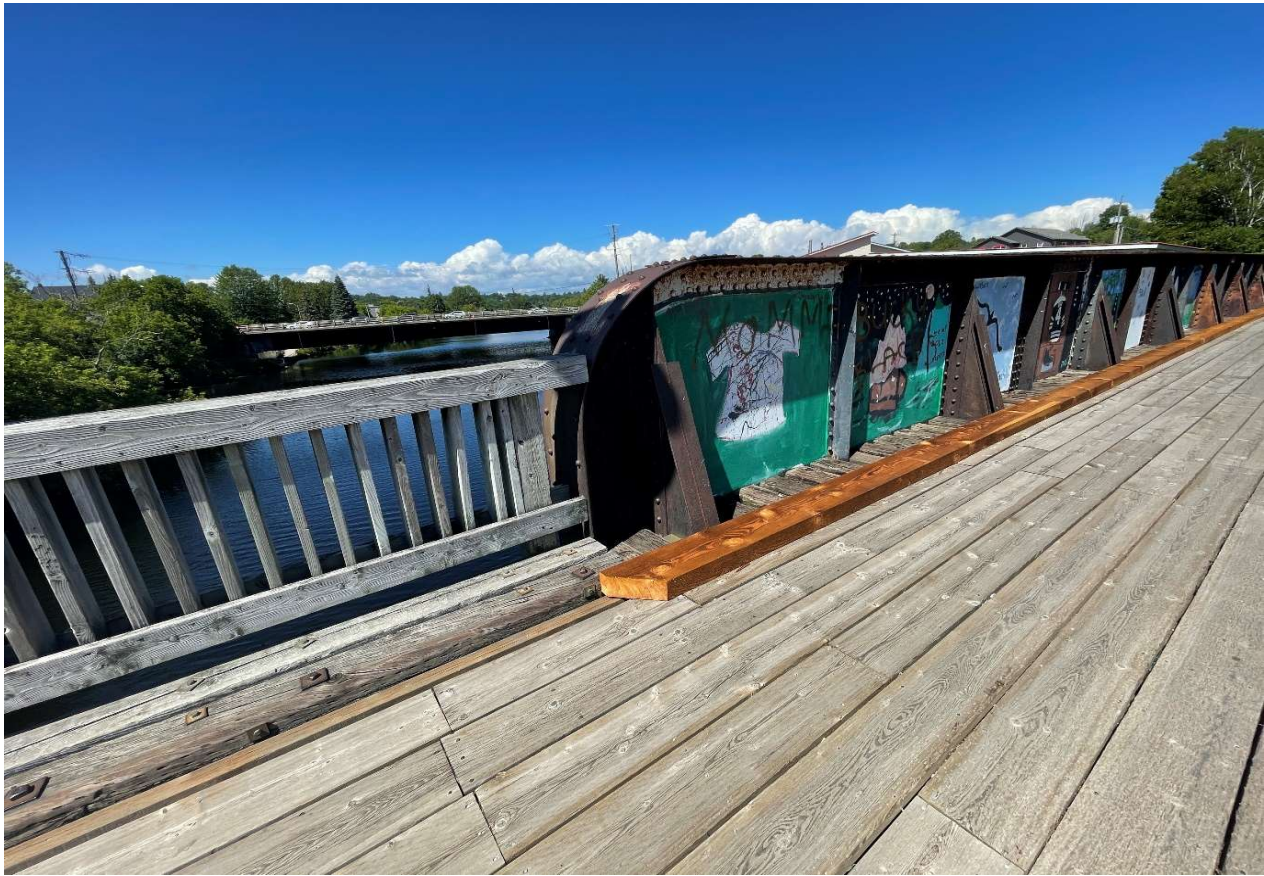
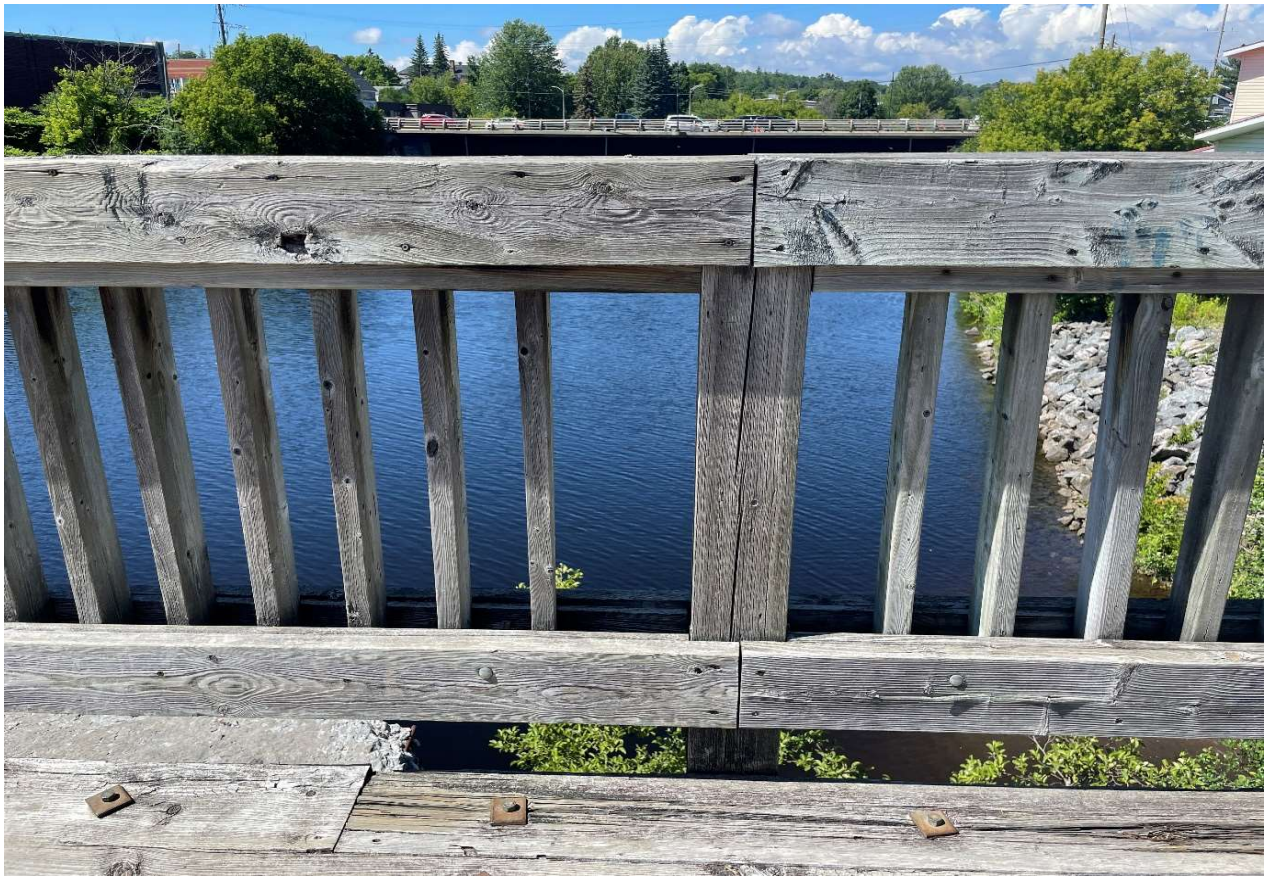
Comments: Timber railing system is in generally good condition. 1 missing timber post at northeast and 1 split timber post at southeast. Isolated areas of light splintering at bolt hole locations. Steel through girder span girders acts as railing system and is in generally good condition with light corrosion, typical. Consider increasing timber barrier height to 1.37 m to meet current code requirements for cyclists, however 1.2m can be used based on owner approval.

**Description of Photo:** Railing System

Description of Photo: Railing System

Recommended Work:	Rehab: <input type="checkbox"/>	Replace: <input type="checkbox"/>	Maintenance Needs:	3 - Railing System Repair		
Urgent: <input type="checkbox"/>	1-5 Years: <input type="checkbox"/>	6-10 Years: <input type="checkbox"/>	None: <input checked="" type="checkbox"/>	Urgent: <input type="checkbox"/>	1 Year: <input checked="" type="checkbox"/>	2 Year: <input type="checkbox"/>
				Replace 2 timber posts.

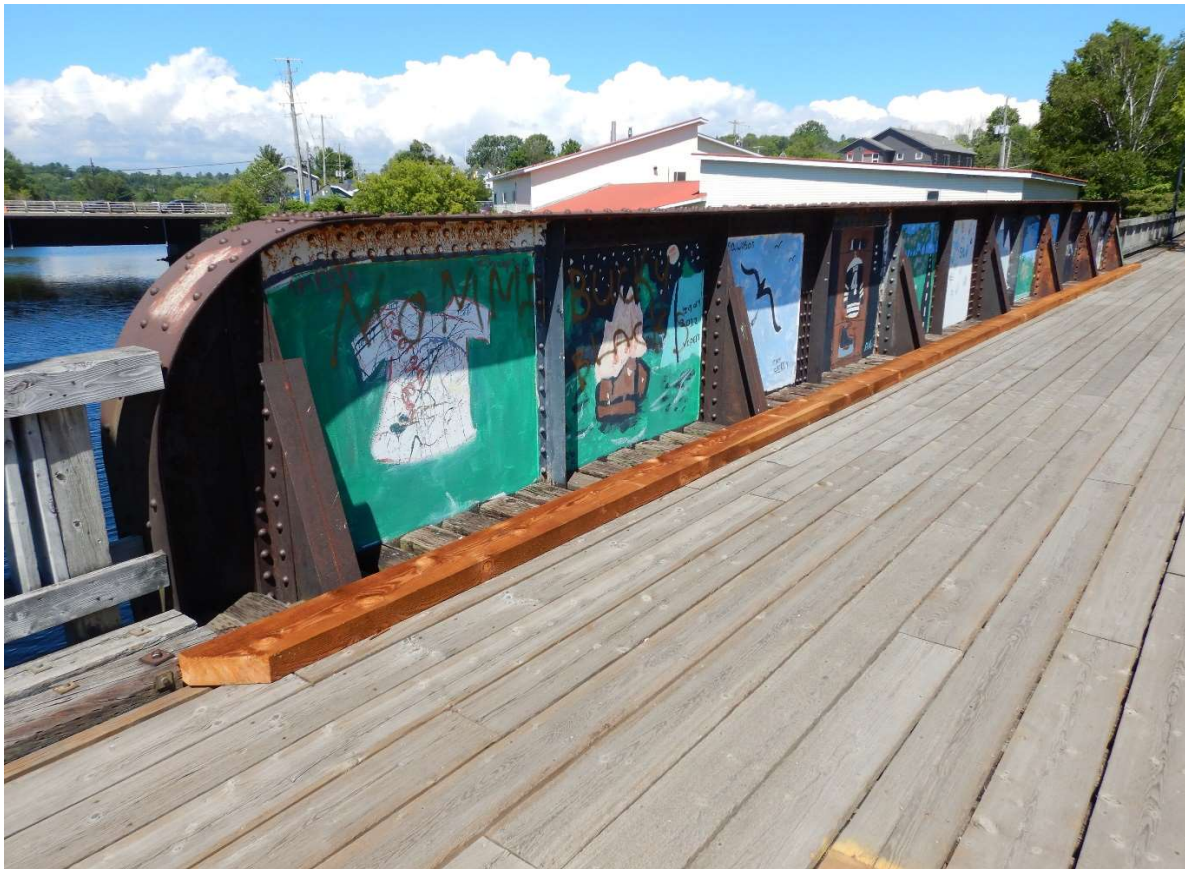
Comments: Light corrosion, typical. Assumed medium corrosion along bottom components, and isolated locations of severe corrosion based on Span 12 steel through plate girder observations.

**Description of Photo:** Inside Face of Girder

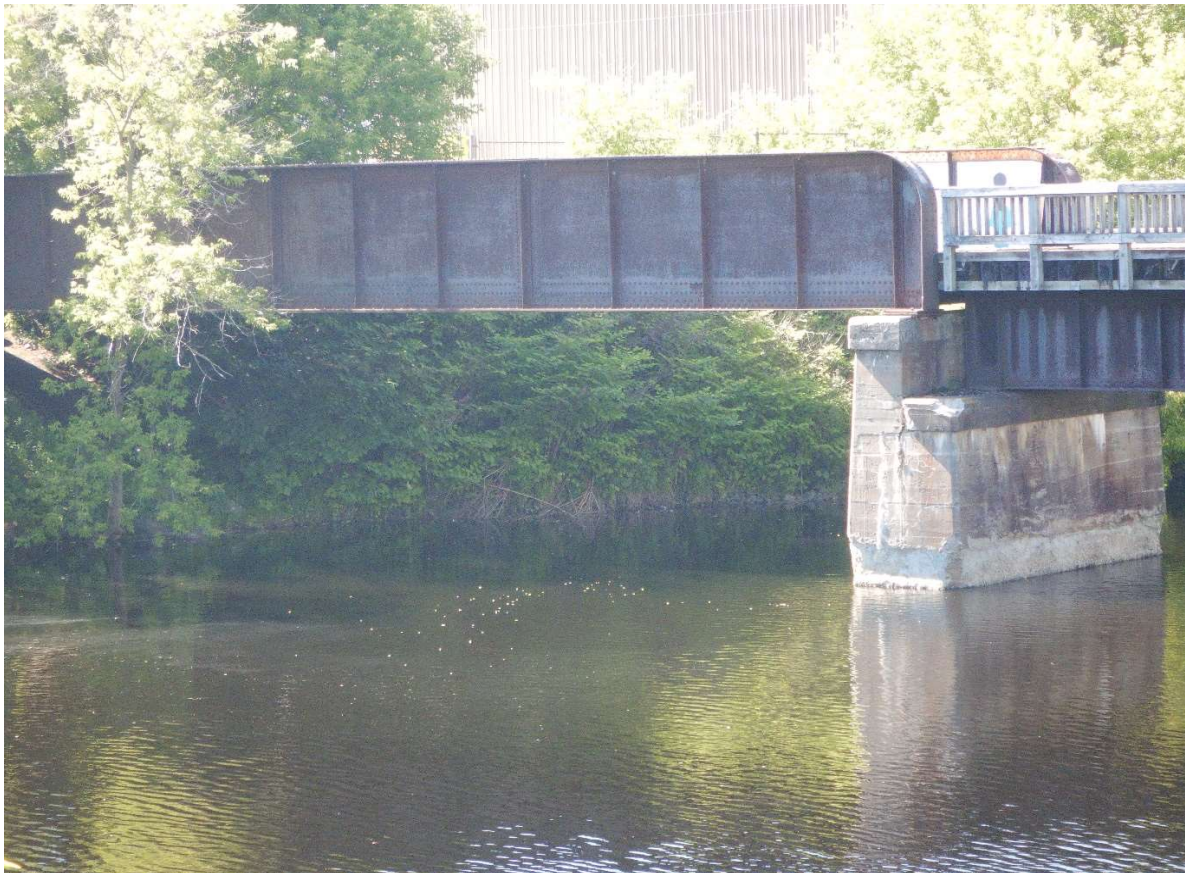
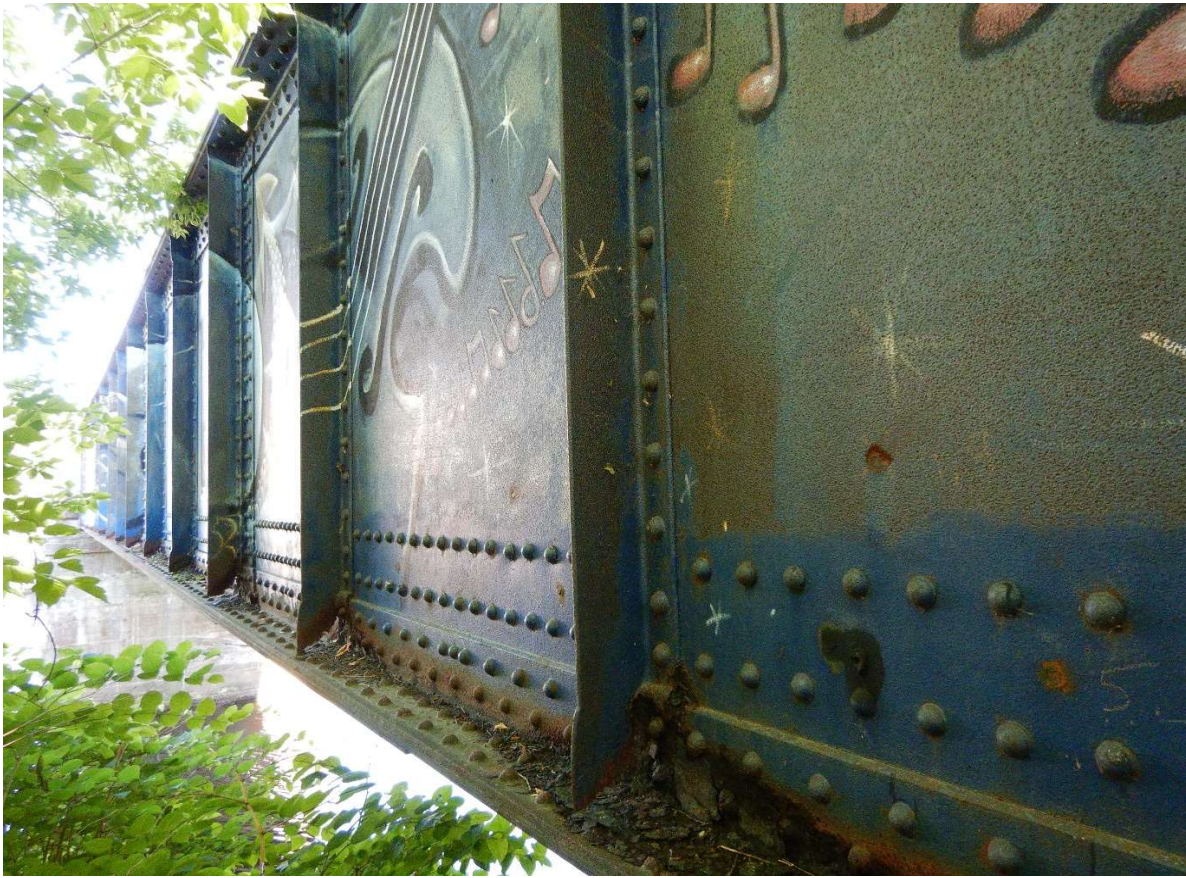
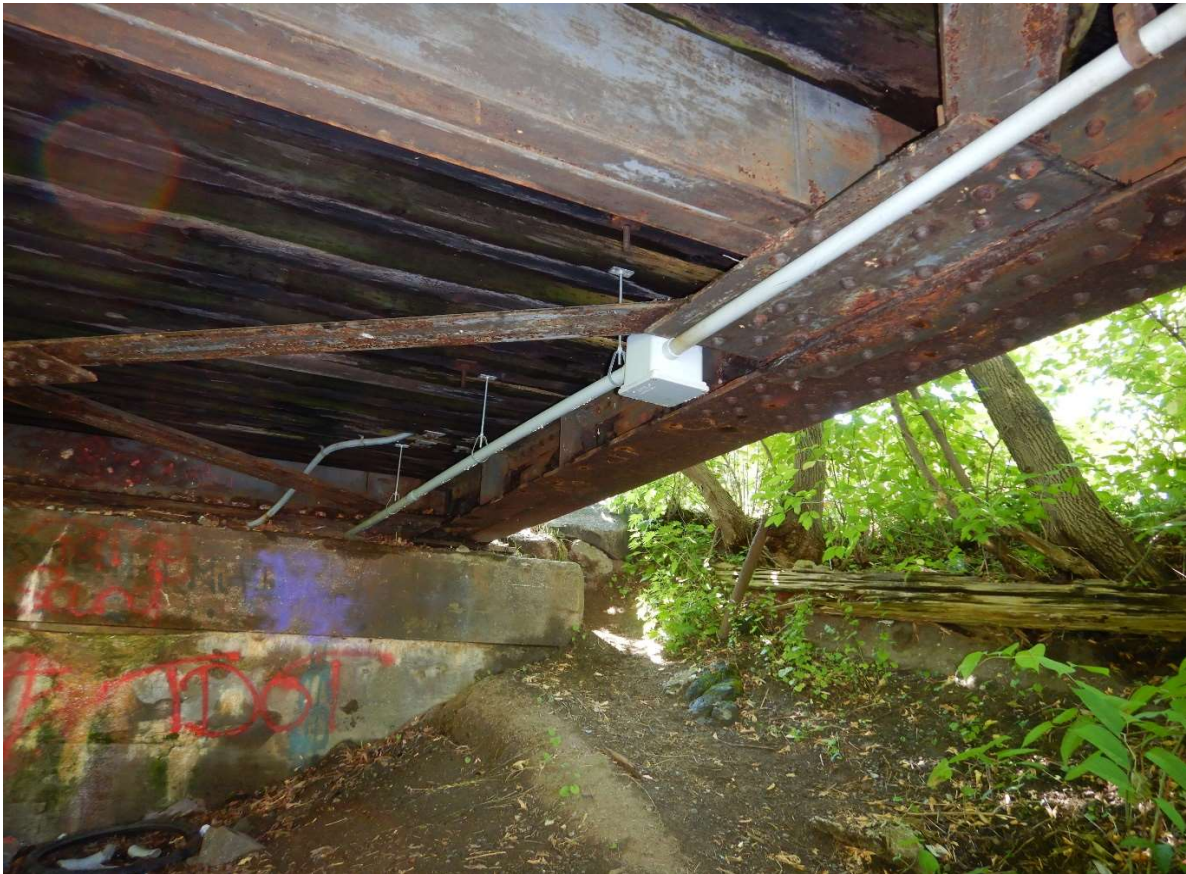
Comments: **Light corrosion typical. Significant areas of the bottoms of stiffeners have medium to very severe corrosion with up to approximately 50% section loss. Several bottoms of stiffeners have very severe corrosion with up to 100% section loss, particularly along the north side.**

Description of Photo: Exterior Face, Note Corrosion at Bottom of Stiffeners

Description of Photo: View Towards Abutment

Recommended Work:	Rehab: <input checked="" type="checkbox"/>	Replace: <input type="checkbox"/>	Maintenance Needs:			
Urgent: <input type="checkbox"/>	1-5 Years: <input type="checkbox"/>	6-10 Years: <input checked="" type="checkbox"/>	None: <input type="checkbox"/>	Urgent: <input type="checkbox"/>	1 Year: <input type="checkbox"/>	2 Year: <input type="checkbox"/>
Select repairs to structural steel

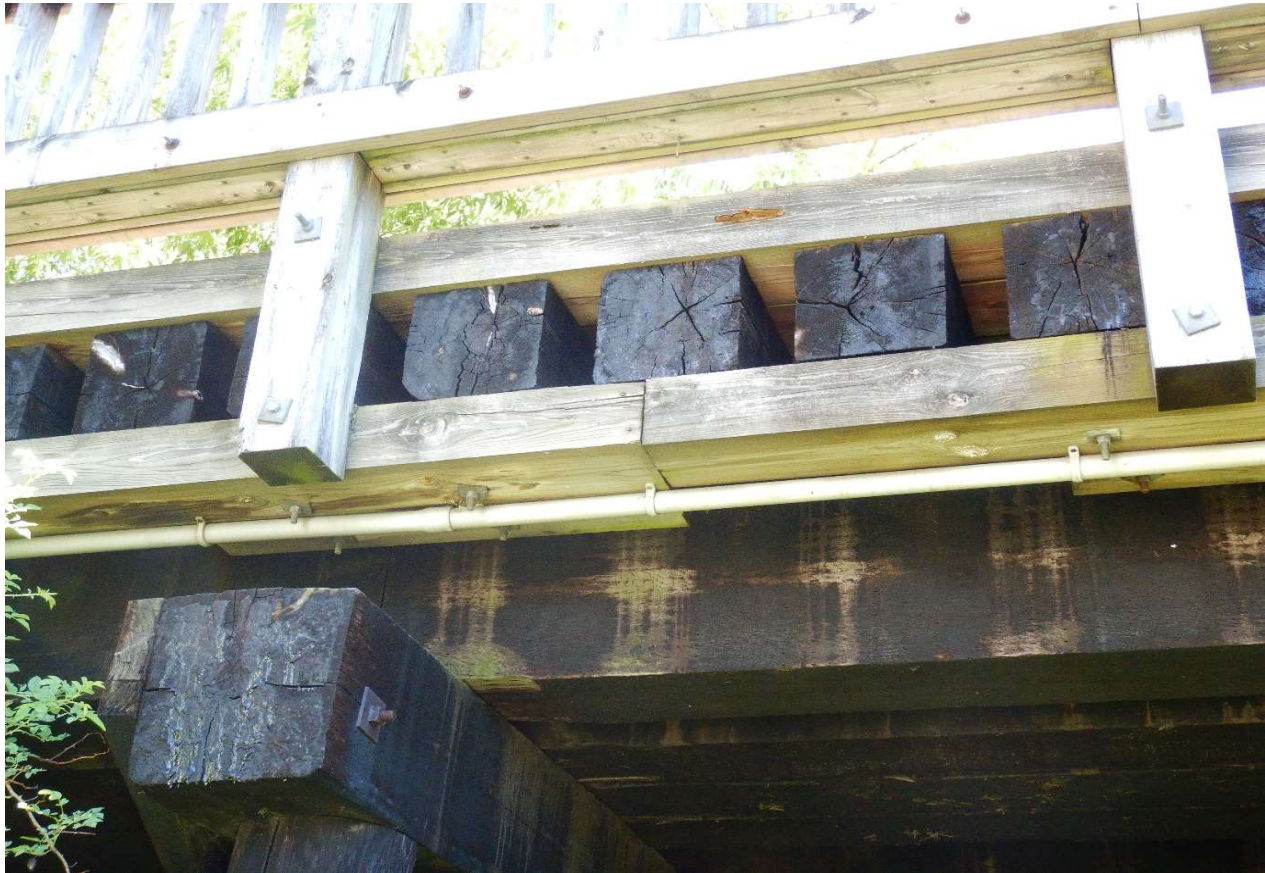
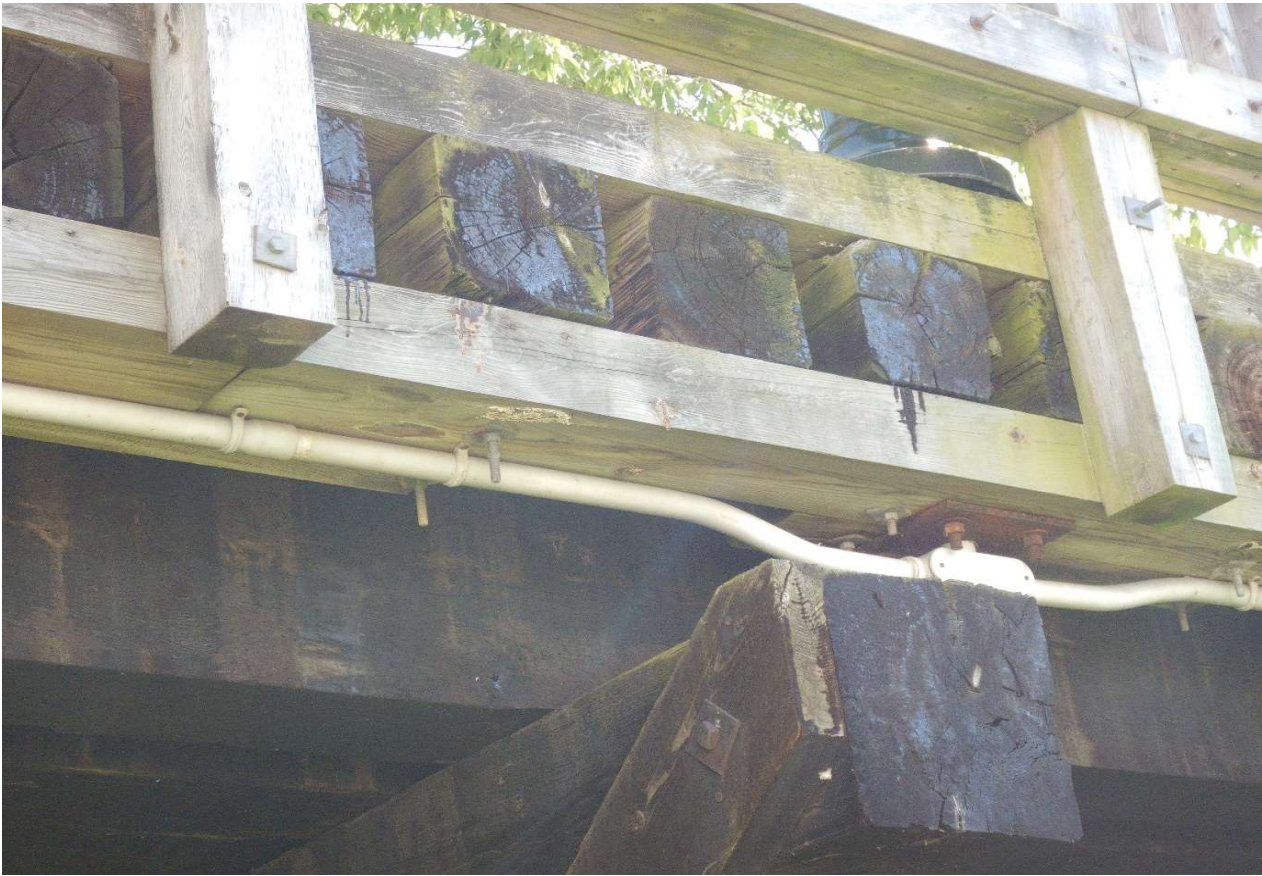
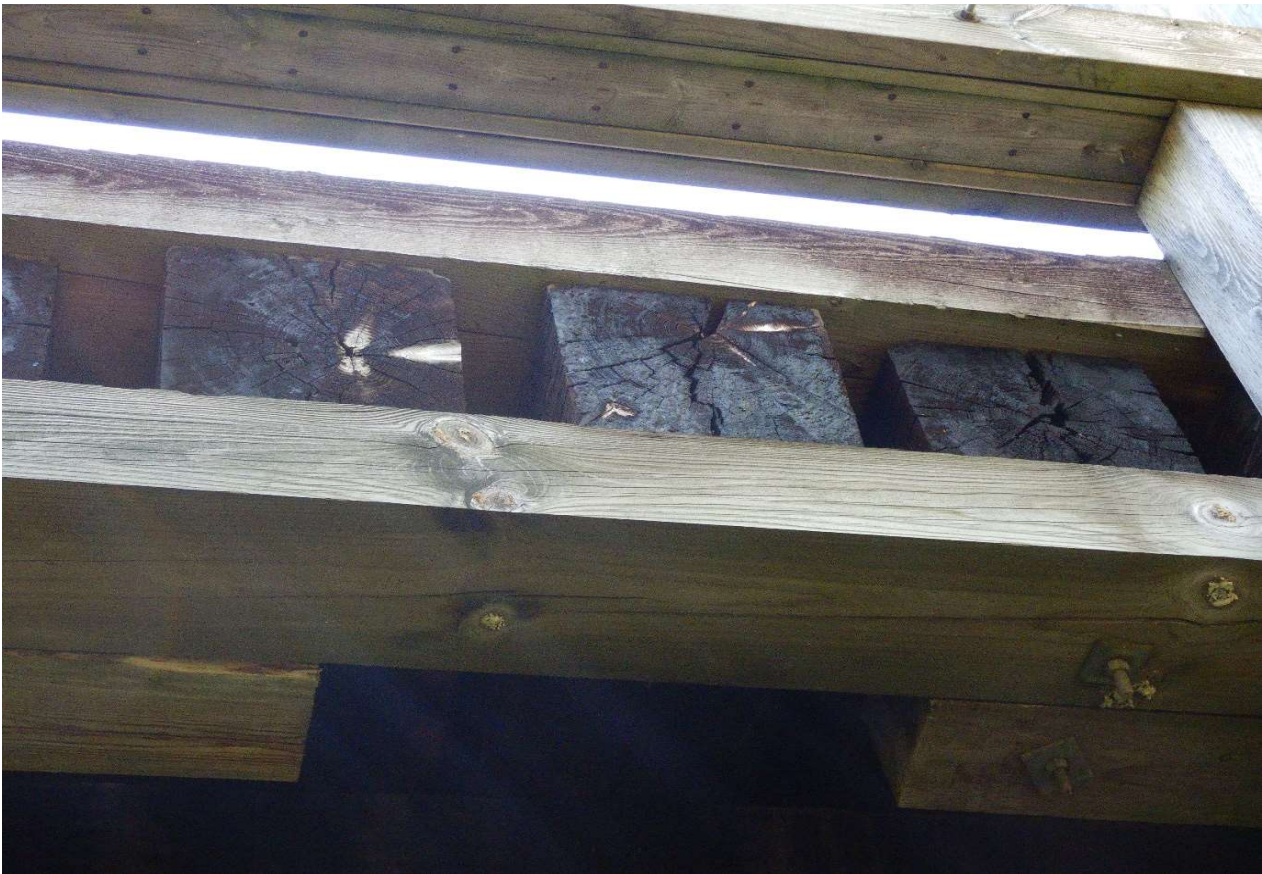
**Description of Photo:** Crossties

Description of Photo: Cross-ties

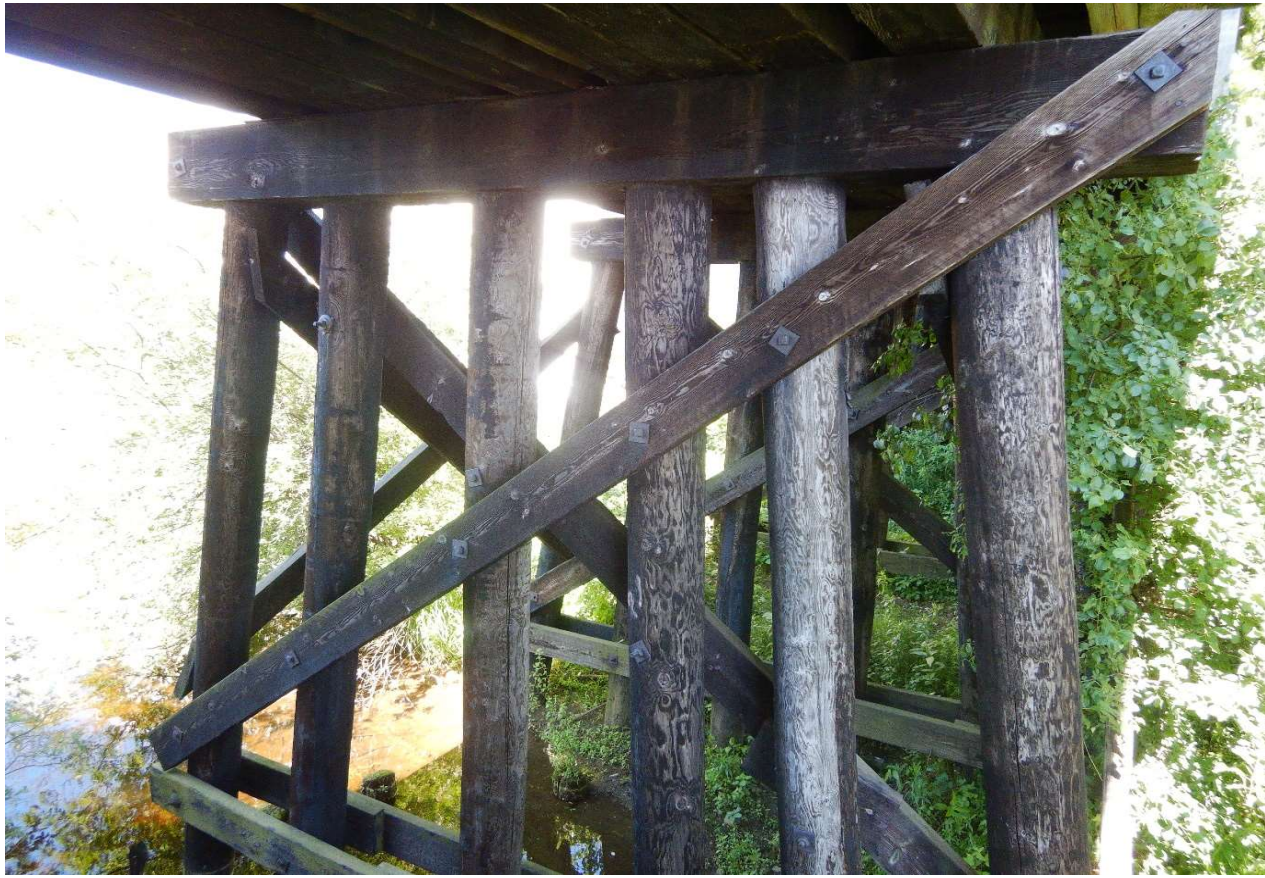
Comments: Localized light to severe checks and splits, typical. One brace near first east pier has severe rot at the end of the member.

Description of Photo: Bracing

Recommended Work:	Rehab: <input type="checkbox"/>	Replace: <input type="checkbox"/>	Maintenance Needs:	9 - Timber Repair
Urgent: <input type="checkbox"/>	1-5 Years: <input type="checkbox"/>	6-10 Years: <input type="checkbox"/>	None: <input checked="" type="checkbox"/>	Urgent: <input type="checkbox"/> 1 Year: <input type="checkbox"/> 2 Year: <input checked="" type="checkbox"/>
				Replace damaged brace

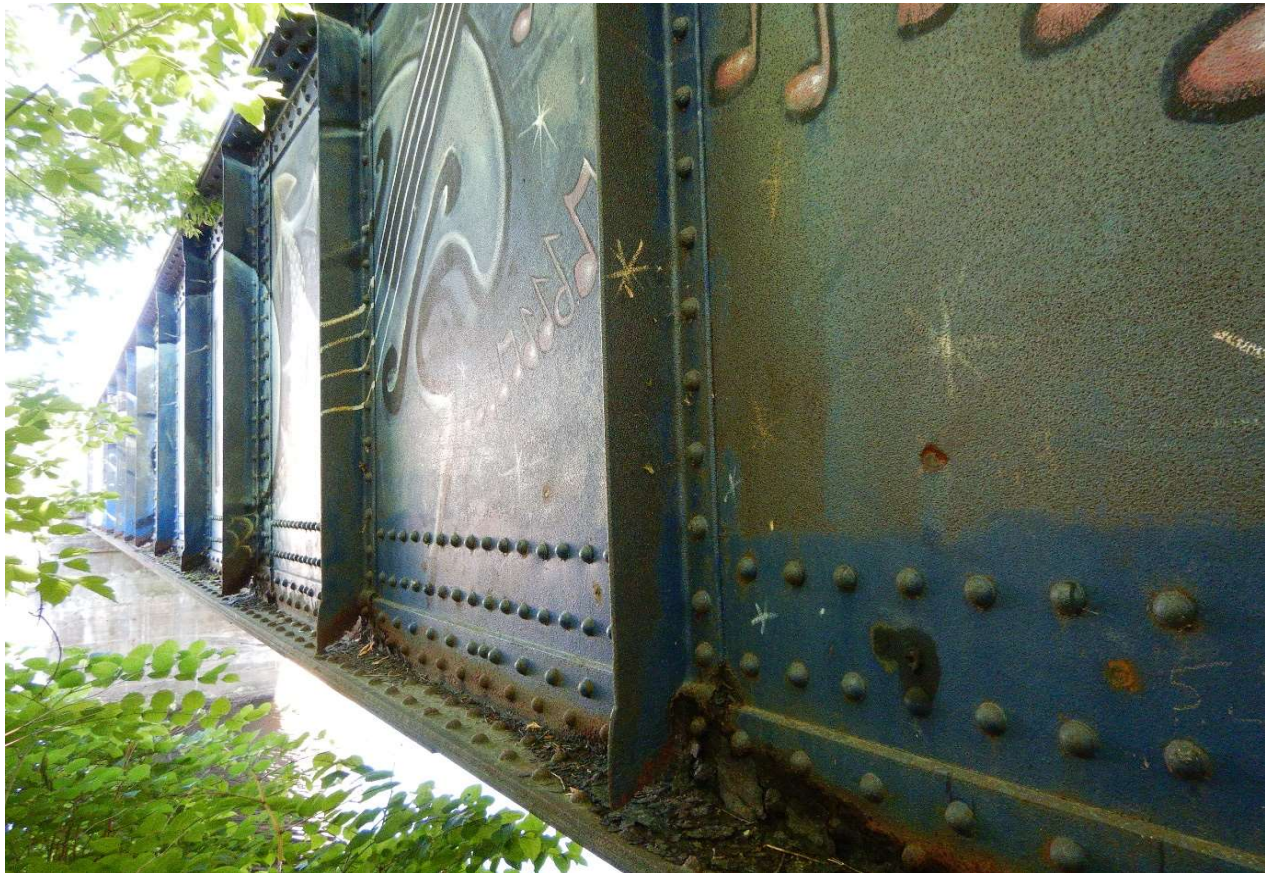
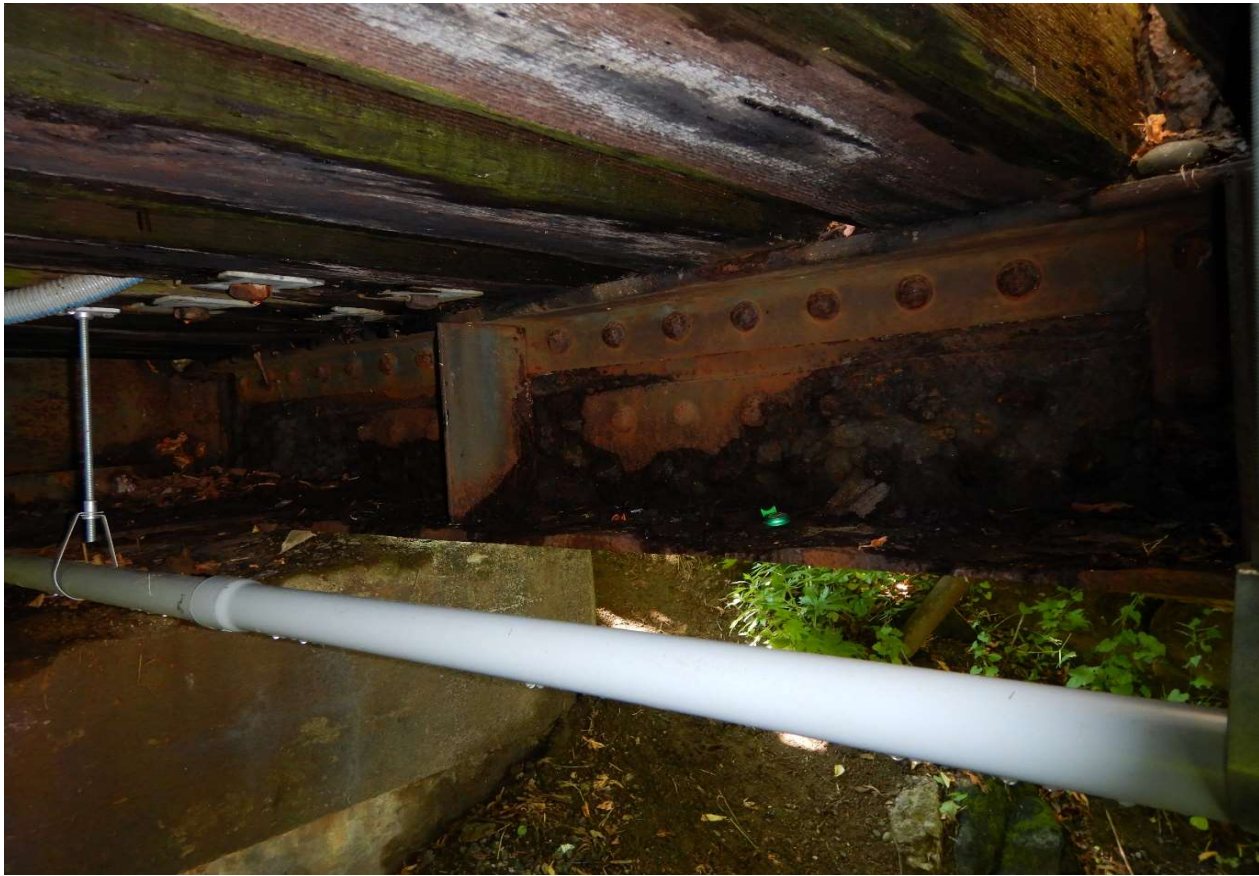
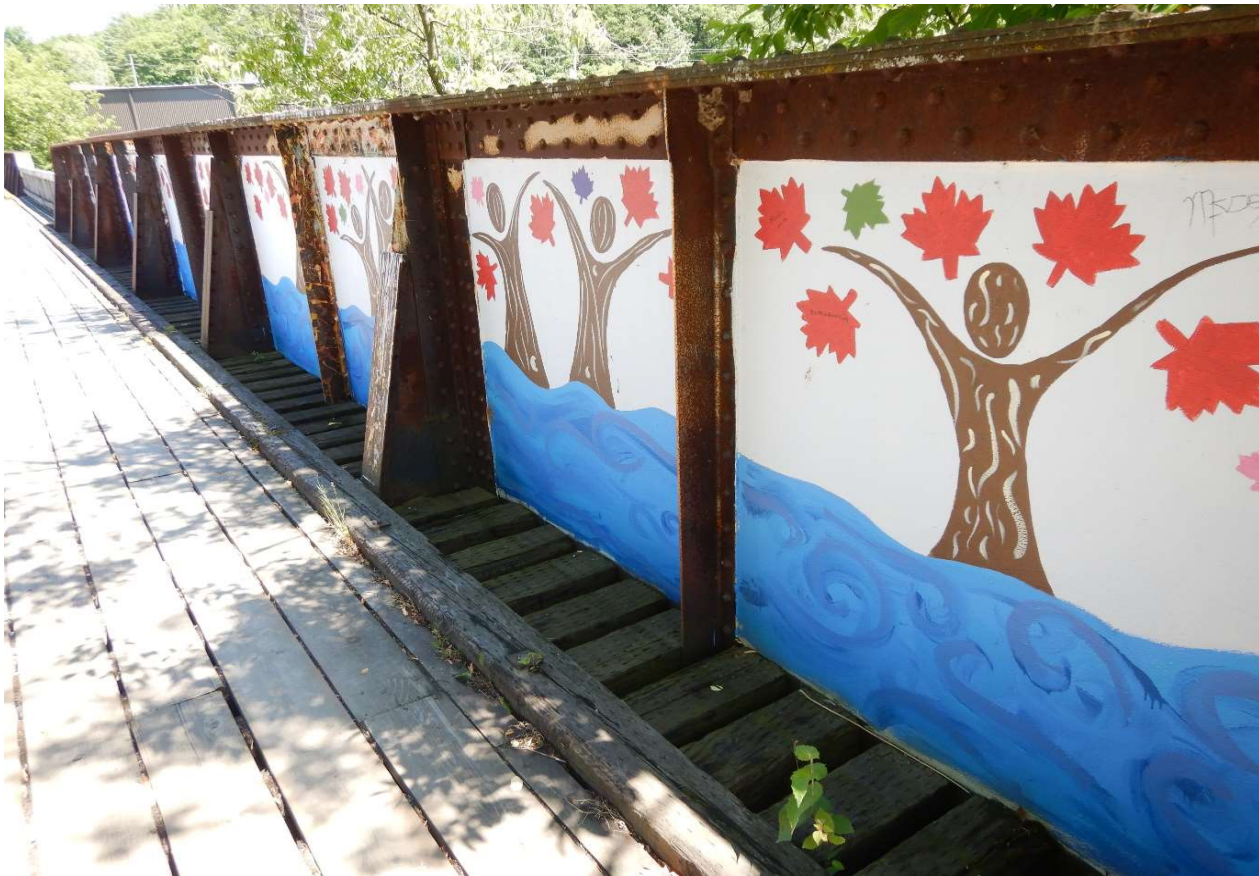
Comments: The two Through Plate Girder spans, interior faces, were painted by the Rotary Club in 2005 and the paint is in generally good condition. The remaining coatings are generally in poor condition with some fair, in combination with Category 2 and 3 rust conditions, and isolated Category 4 rust conditions.

Description of Photo: Coating

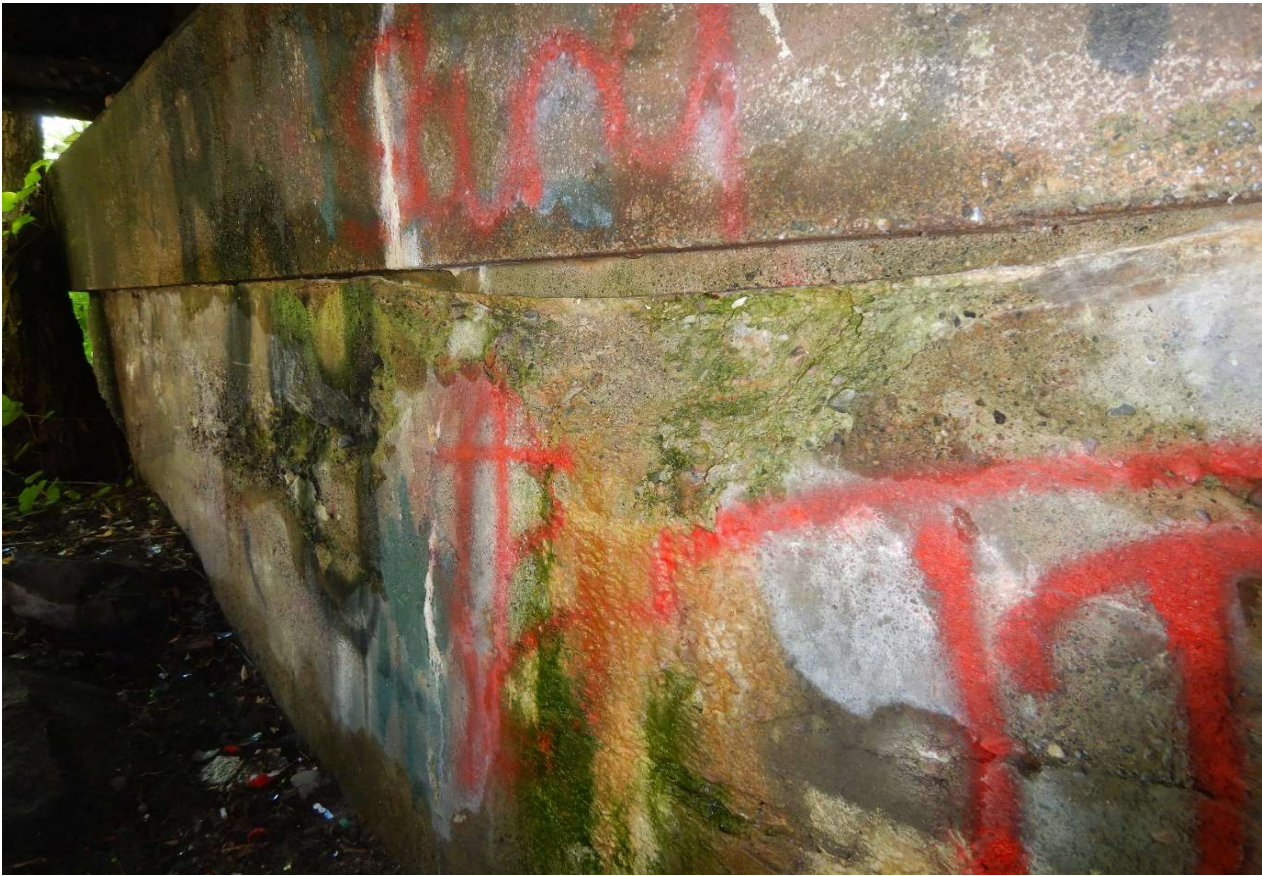
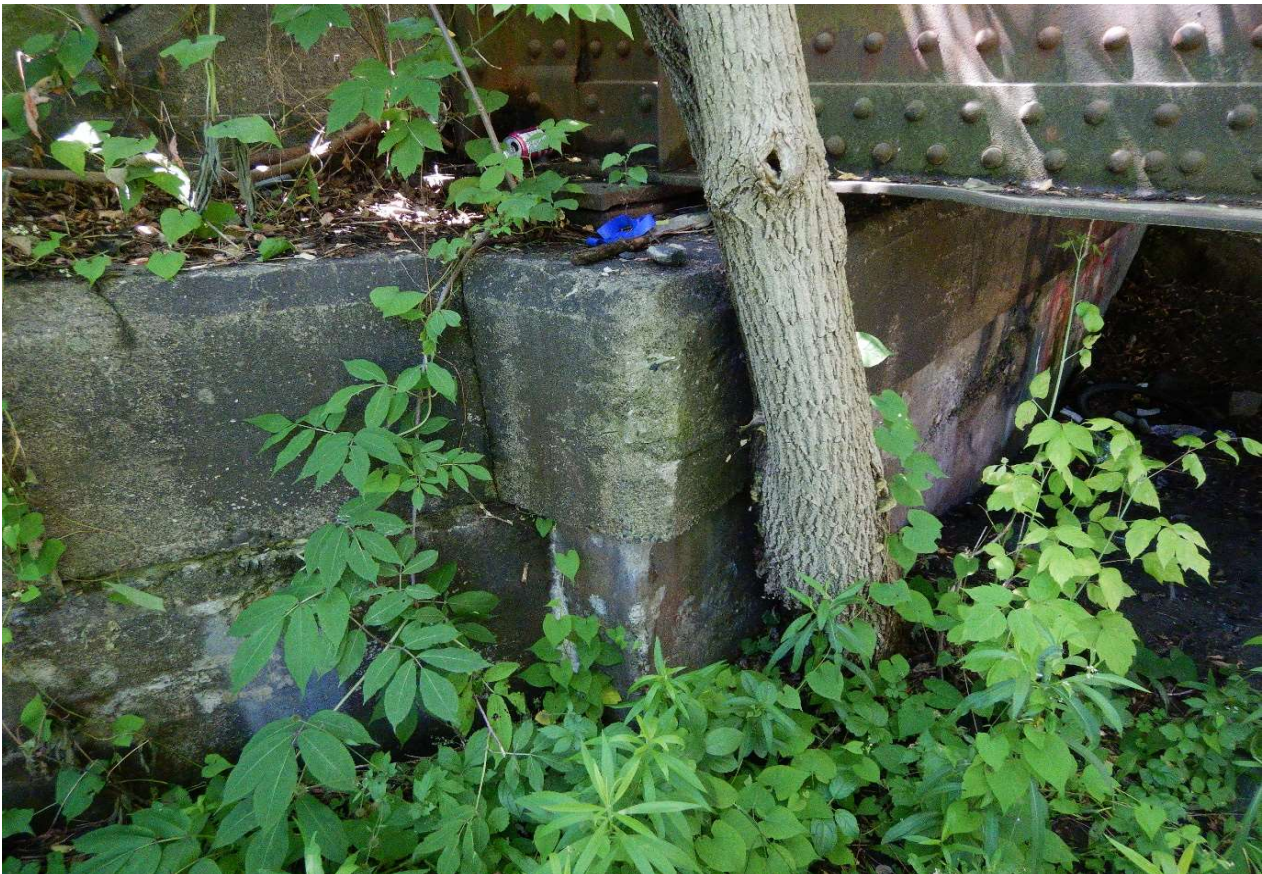
Comments: Light scaling, typical. Evidence of wet areas with efflorescence and localized light to severe disintegration around edges. Some spalls have wet areas and efflorescence. Very severe 1,000x250x75 mm disintegration. Severe 1,500x600x25 deep scaling and disintegration. Two very severe 1,500x50x25 mm deep spalls. Medium 200x250x25 mm spall. Ballast wall behind end diaphragm not inspected.

Description of Photo: West Abutment

Repair concrete
