# Bridge Inspections

**TOWN OF PARRY SOUND**

Inspection Summary Report

January  
12, 2023

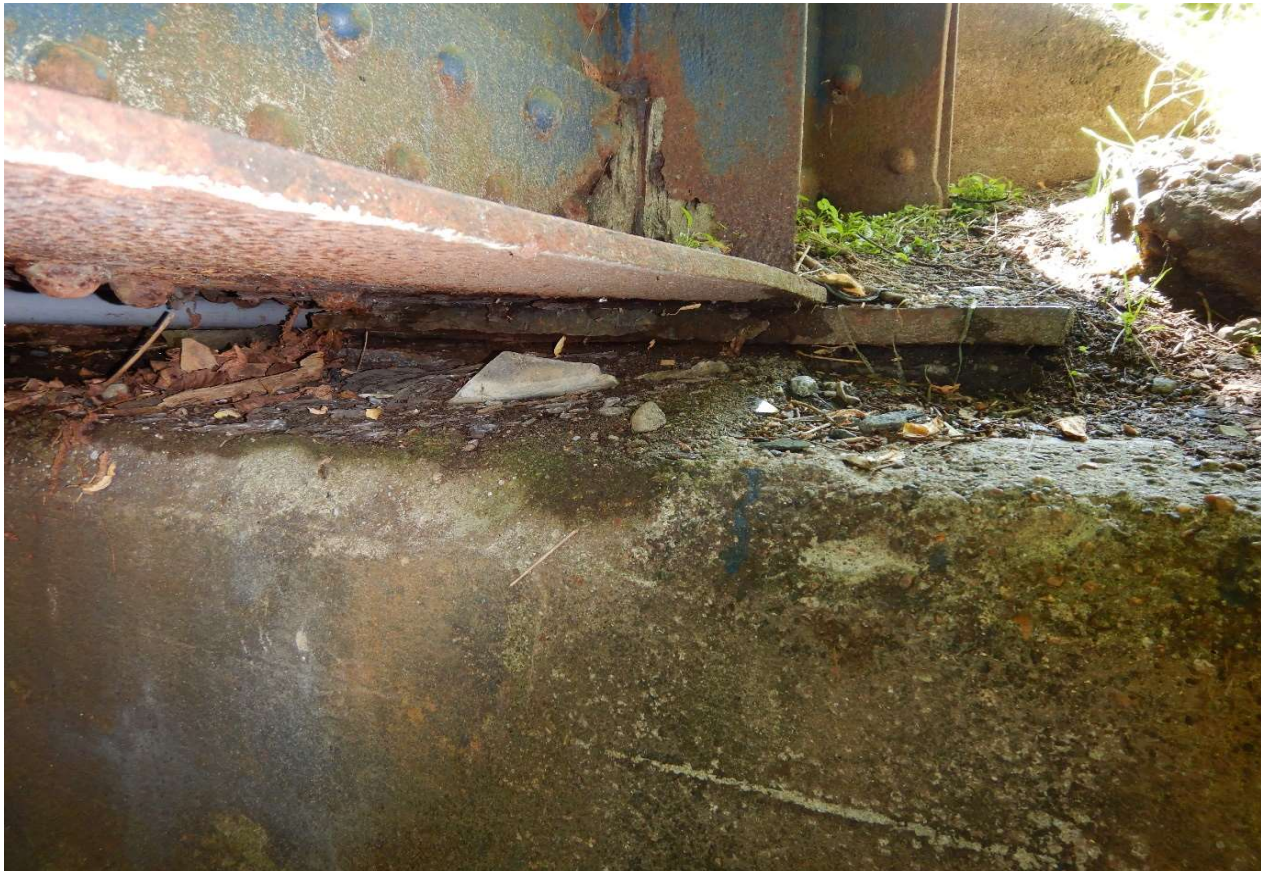
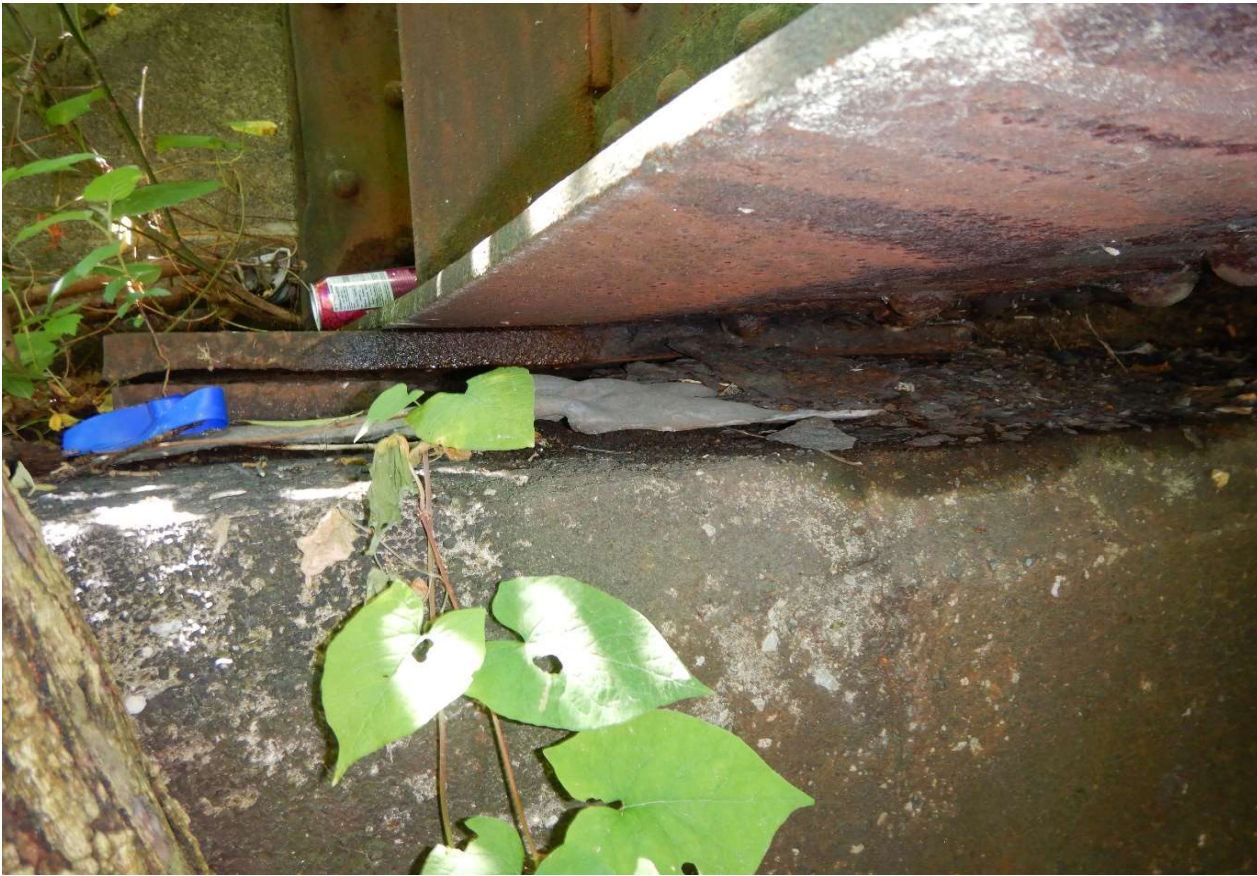
Comments: Bearings have medium corrosion with debris accumulating around the bearings.

Description of Photo: Bearings

Description of Photo:      Bearings

Recommended Work:	Rehab: <input type="checkbox"/>	Replace: <input type="checkbox"/>	Maintenance Needs:	2 - Bridge Cleaning		
Urgent: <input type="checkbox"/>	1-5 Years: <input type="checkbox"/>	6-10 Years: <input type="checkbox"/>	None: <input checked="" type="checkbox"/>	Urgent: <input type="checkbox"/>	1 Year: <input checked="" type="checkbox"/>	2 Year: <input type="checkbox"/>
				Clean debris from bearing seat.

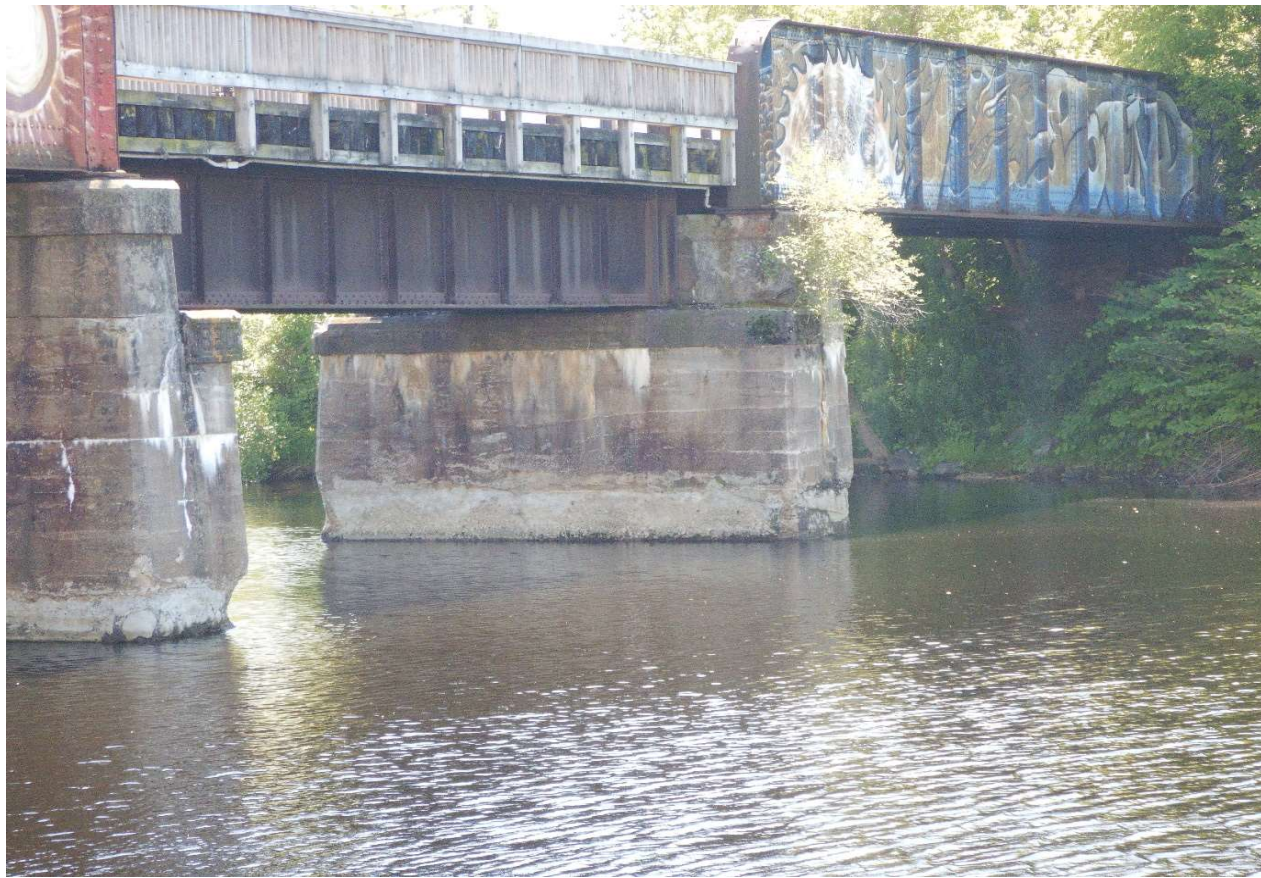
Urgent: <input type="checkbox"/>	1-5 Years: <input type="checkbox"/>	6-10 Years: <input checked="" type="checkbox"/>	None: <input type="checkbox"/>	Urgent: <input type="checkbox"/>	1 Year: <input type="checkbox"/>	2 Year: <input type="checkbox"/>
Abutments originally designed for railway loading - deterioration not anticipated to impact load carrying capacity at this time. Future repairs should be planned for.

Description of Photo: West Pier East Face

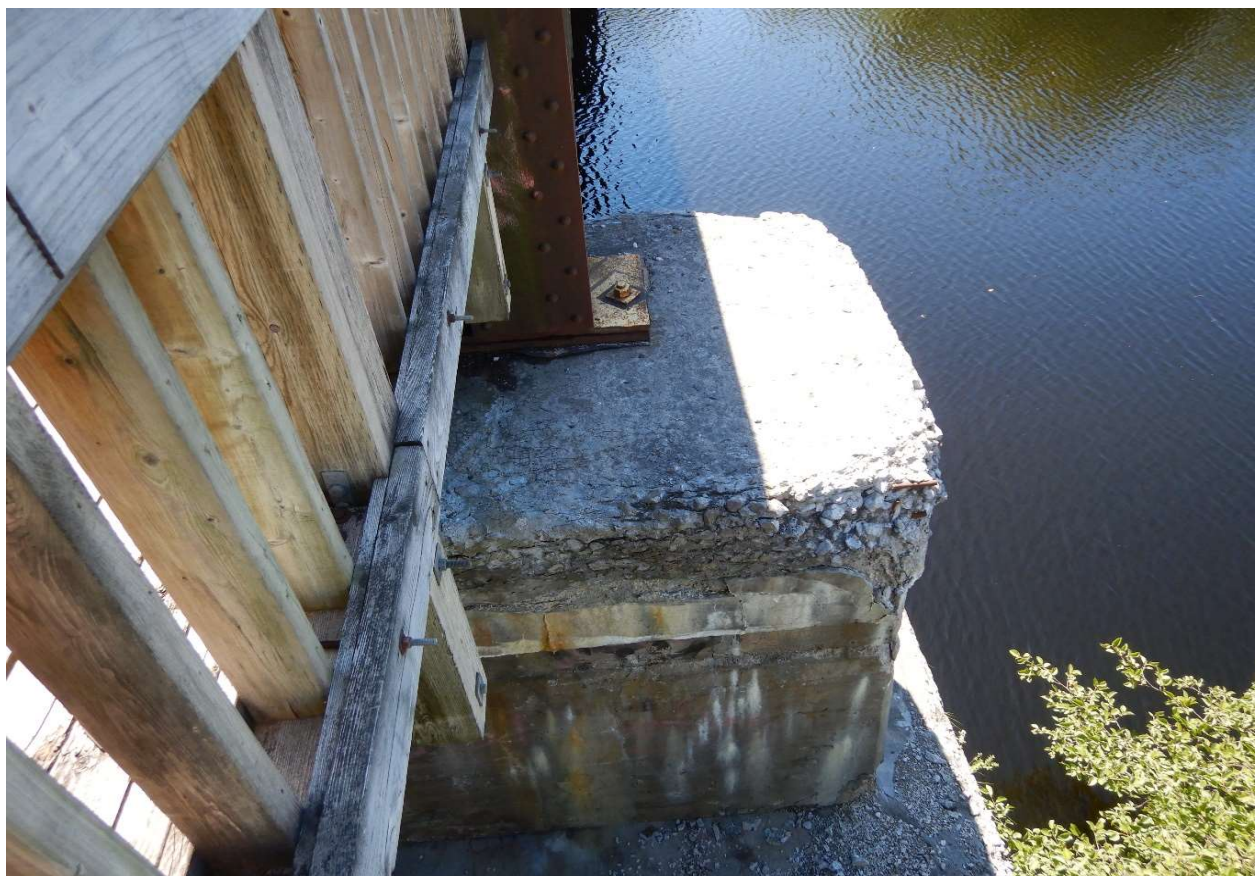
**Description of Photo:** Pier Bearings

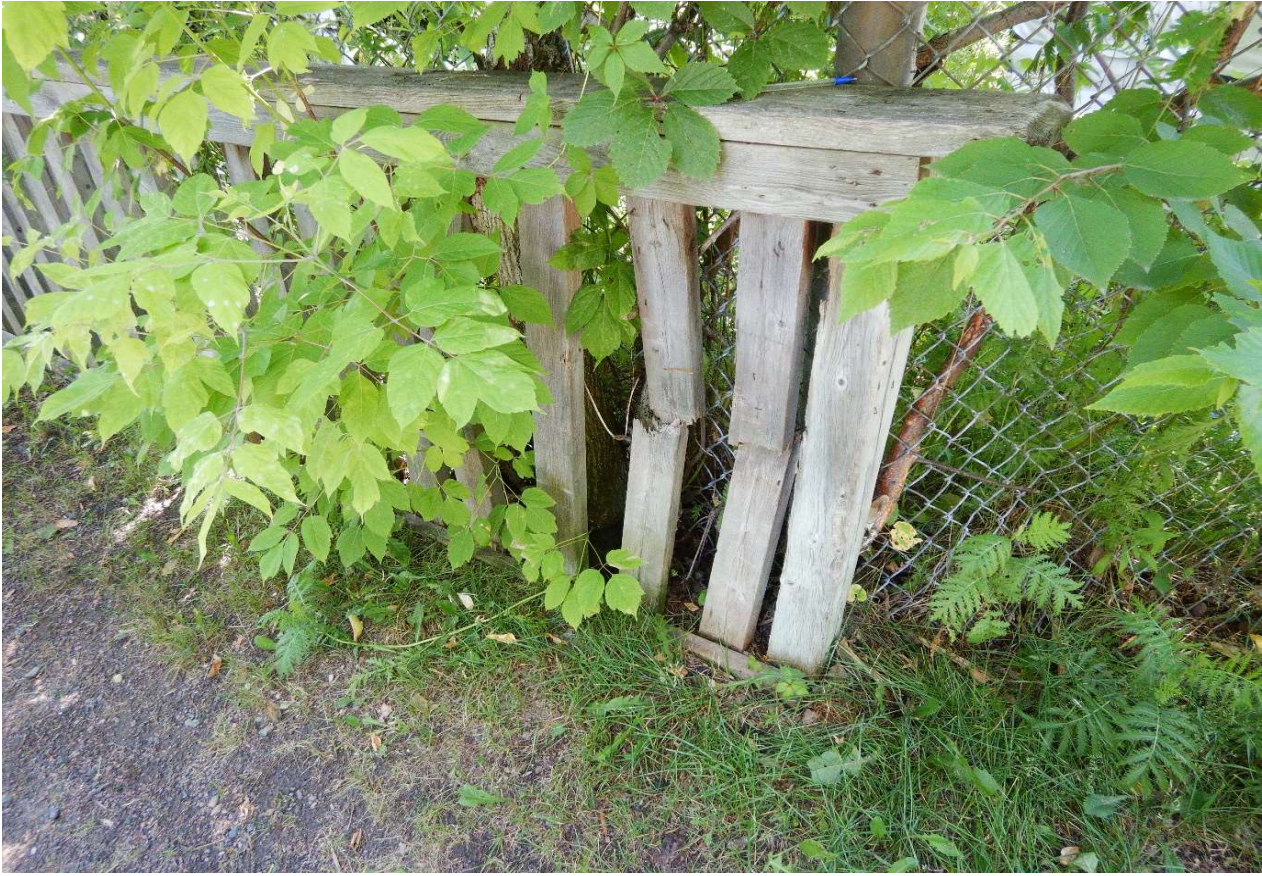
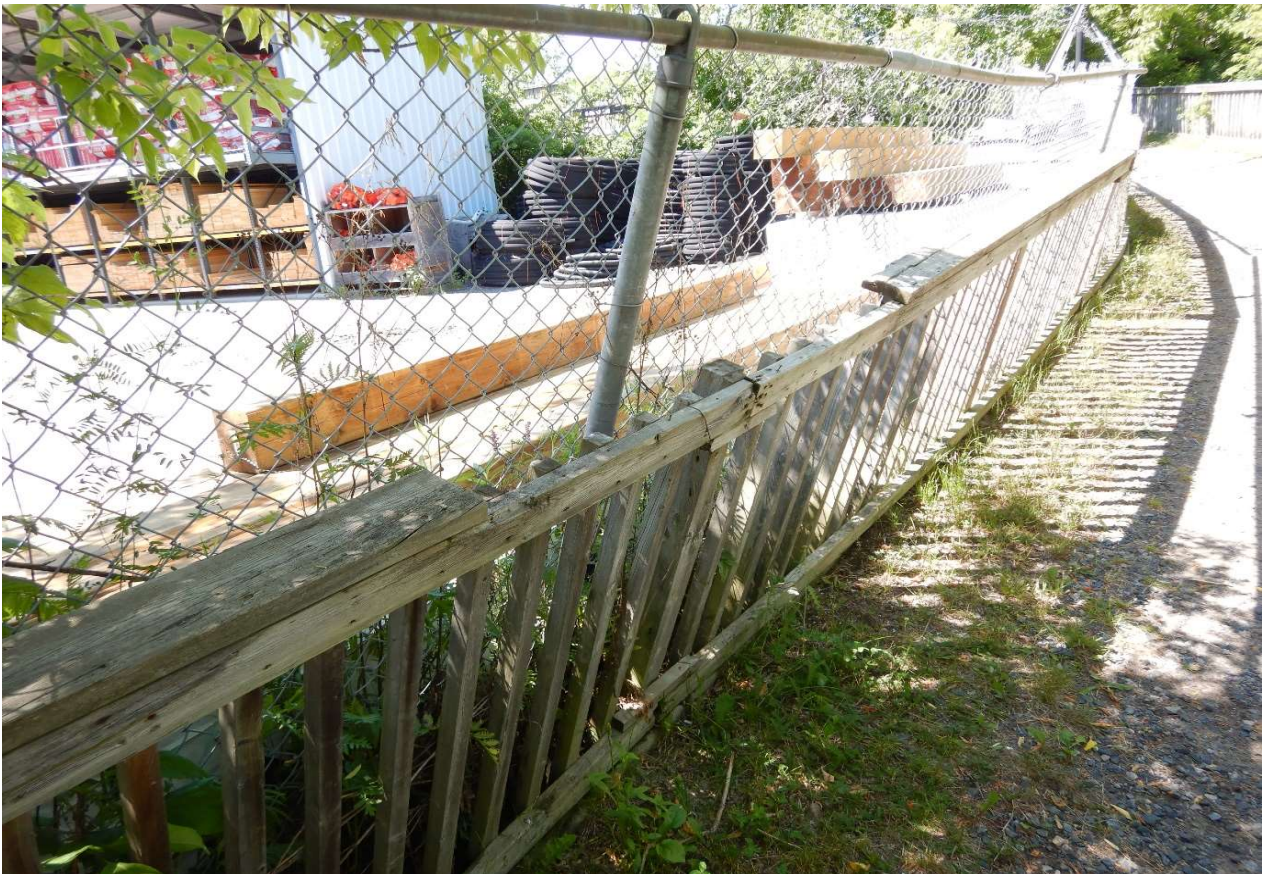
Comments: Light weathering, typical. 18 broken post or missing posts. 3.0m of top rail is missing. Several post anchors have become unattached.

**Description of Photo:** Railing System

Recommended Work:	Rehab: <input type="checkbox"/>	Replace: <input type="checkbox"/>	Maintenance Needs:	3 - Railing System Repair		
Urgent: <input type="checkbox"/>	1-5 Years: <input type="checkbox"/>	6-10 Years: <input type="checkbox"/>	None: <input checked="" type="checkbox"/>	Urgent: <input type="checkbox"/>	1 Year: <input type="checkbox"/>	2 Year: <input checked="" type="checkbox"/>
				Replace missing and broken pickets, anchors and top rail.

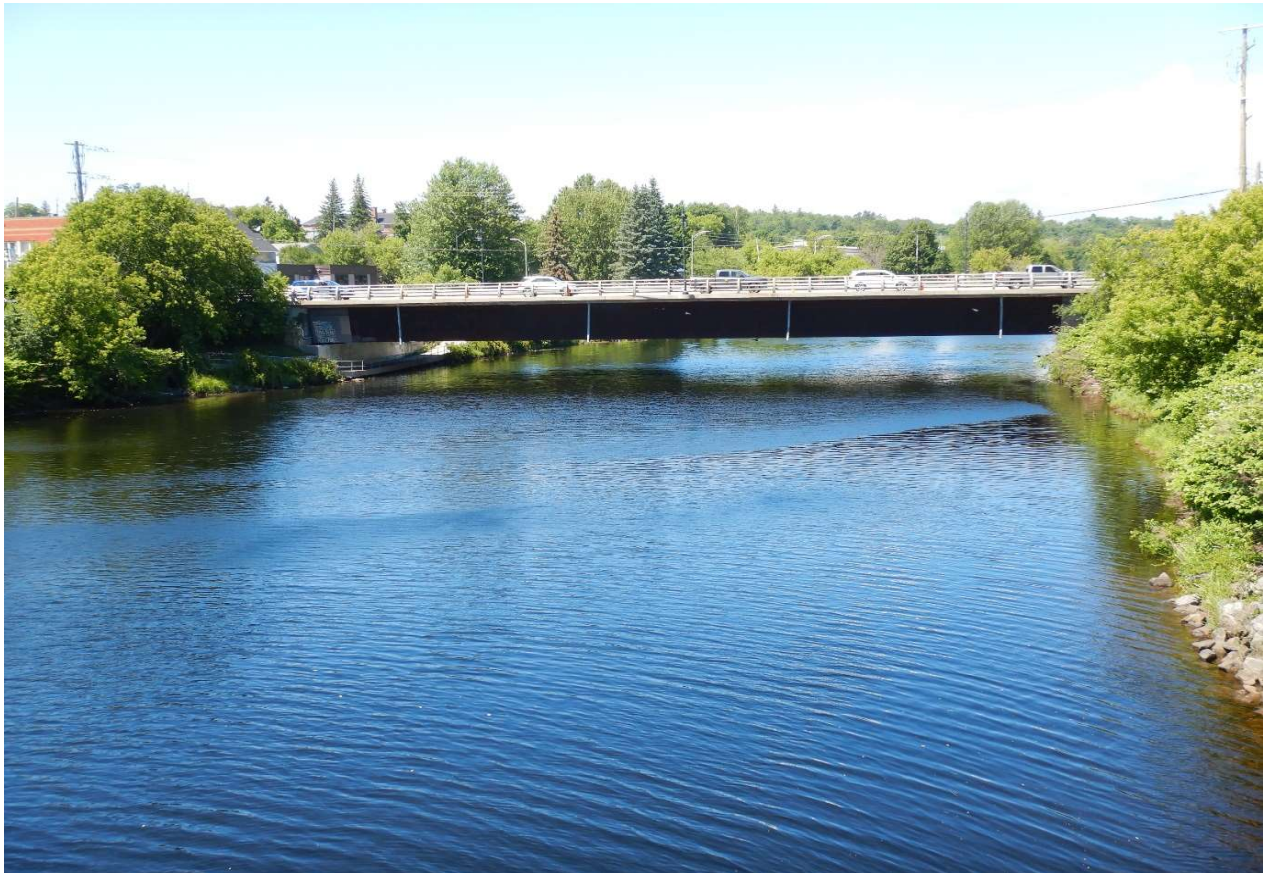
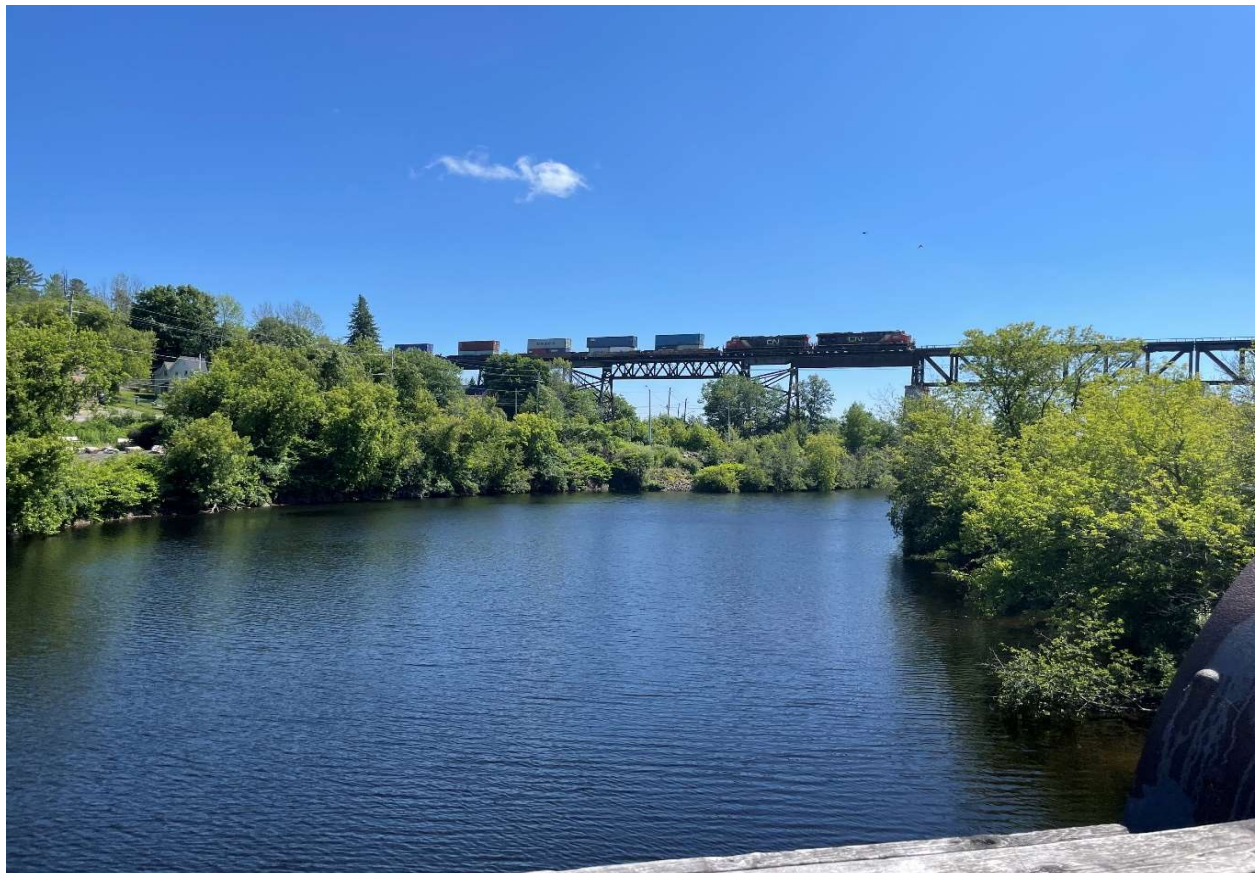
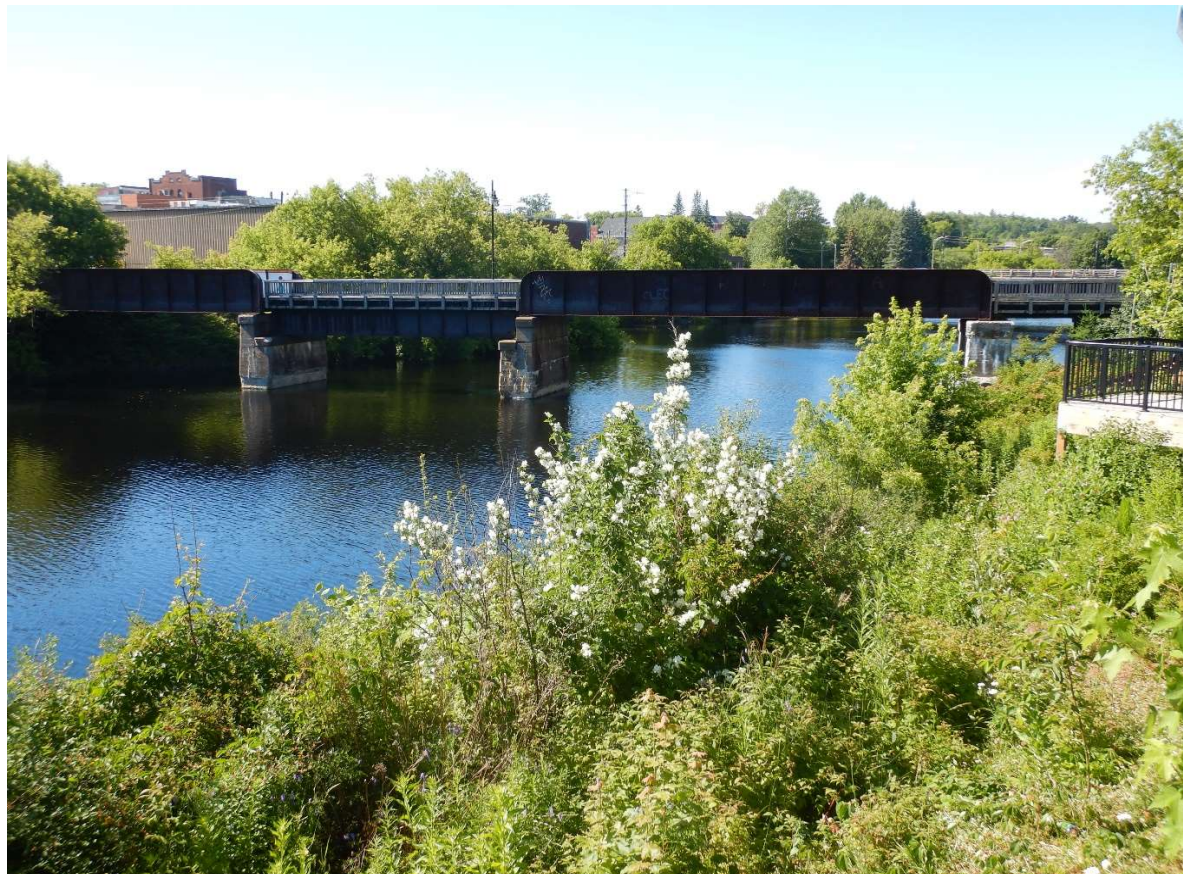
Comments: **Armour around east end barriers. Waterway is free flowing. No observed defects.**

**Description of Photo:** Waterway Looking Upstream

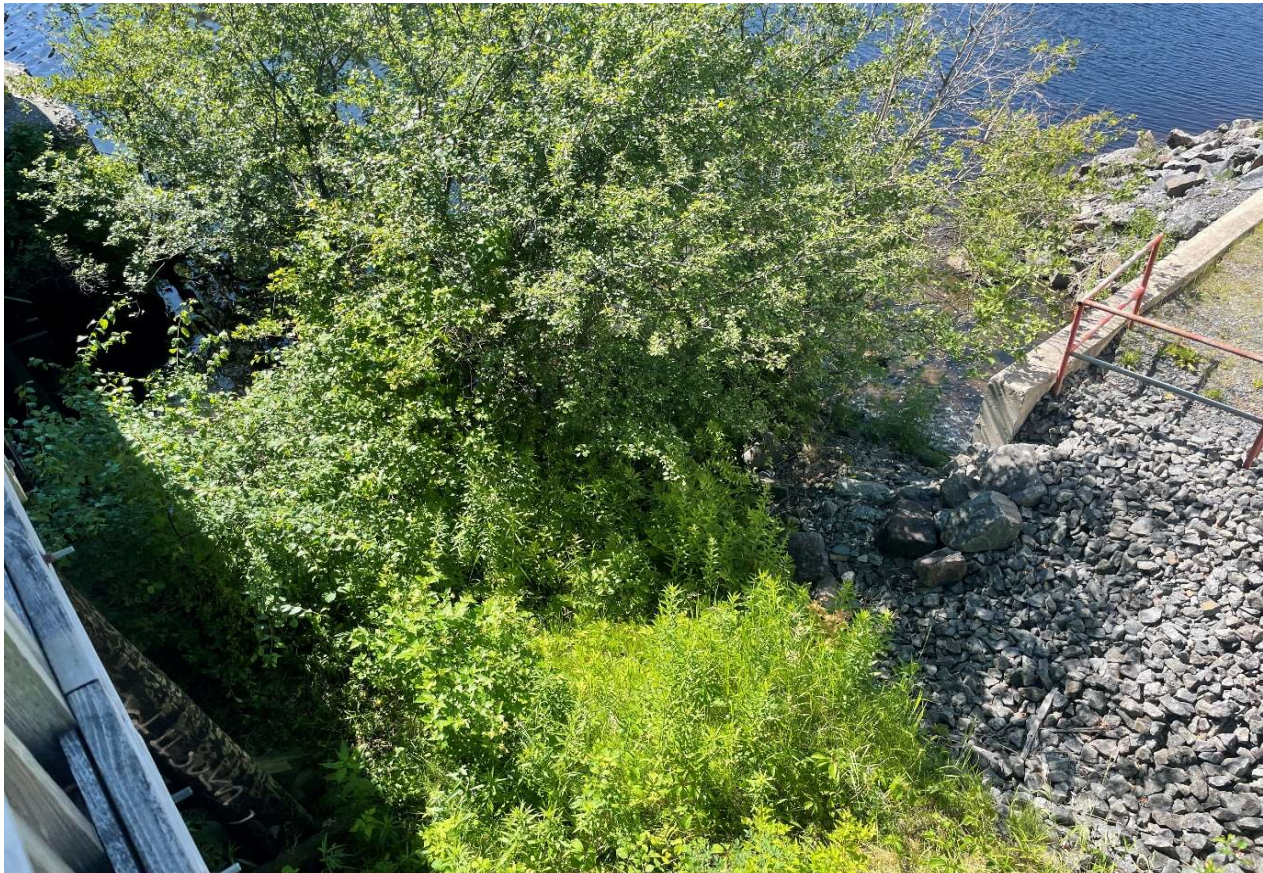
Comments: **No observed defects. Embankments are vegetated and appear stable.**

**Description of Photo:** Embankment

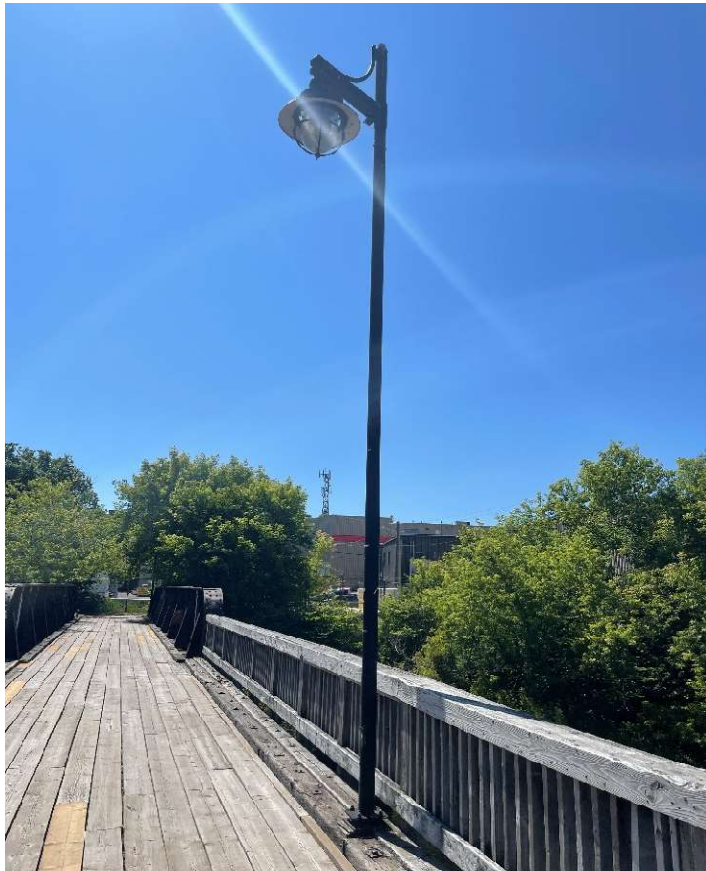
Comments: Posts are in good condition. One light stand missing bottom housing.

**Description of Photo:** Light Utility

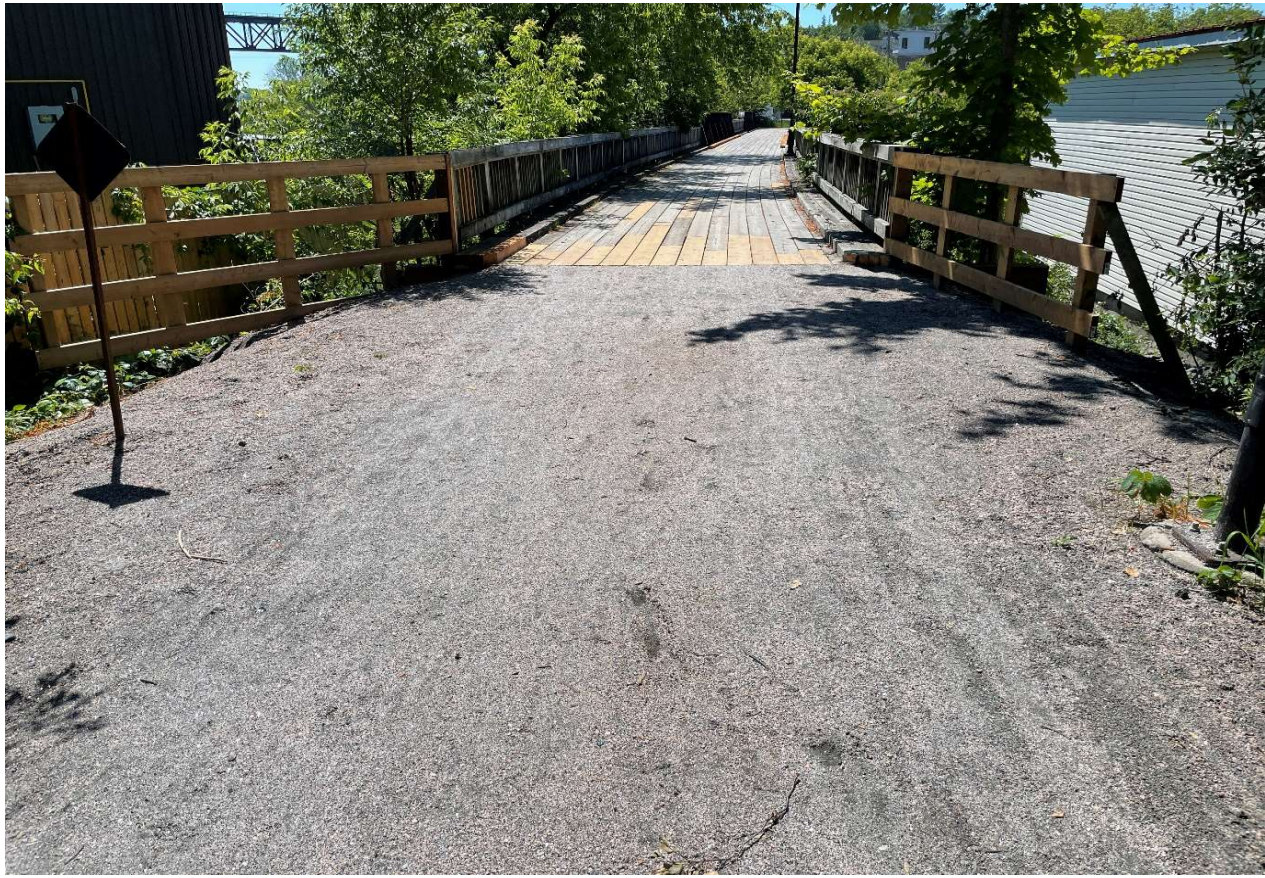
Comments: **Light wear typical. No other observed defects.**

**Description of Photo:** Approach Surface

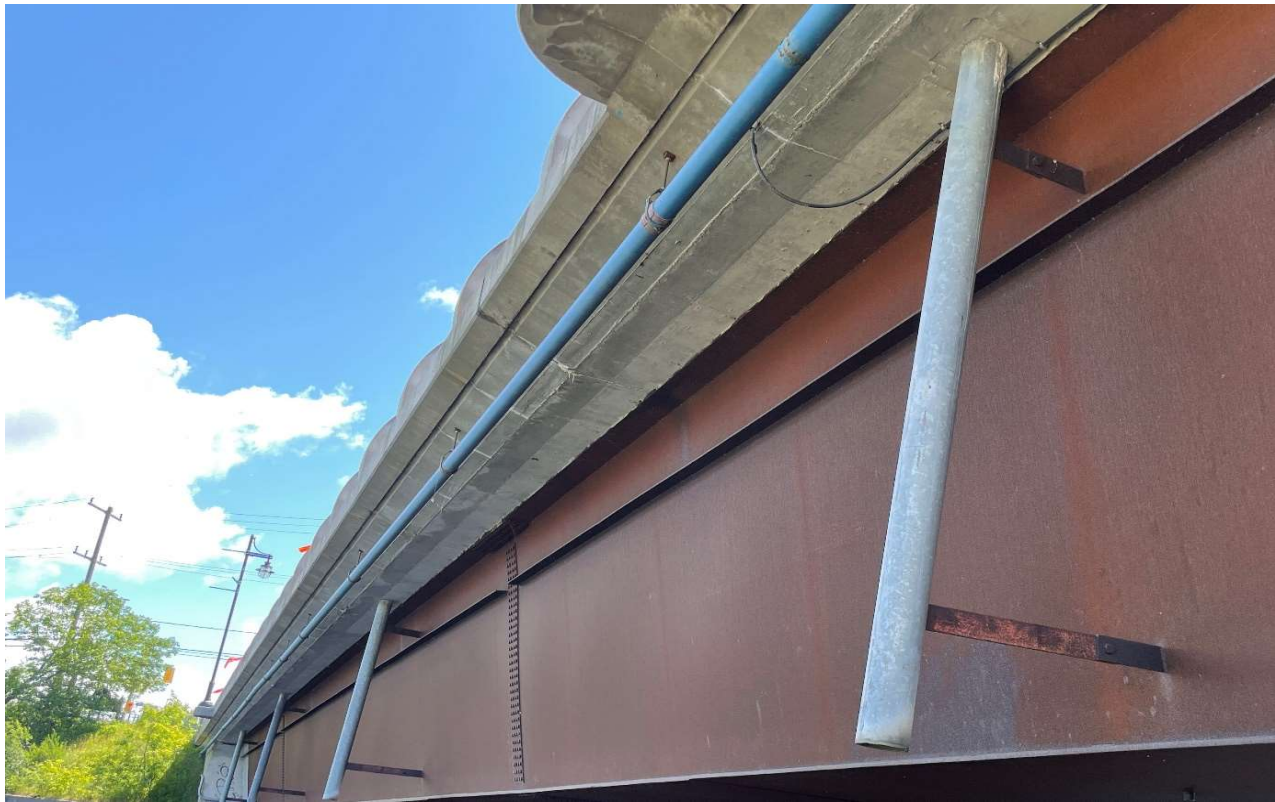
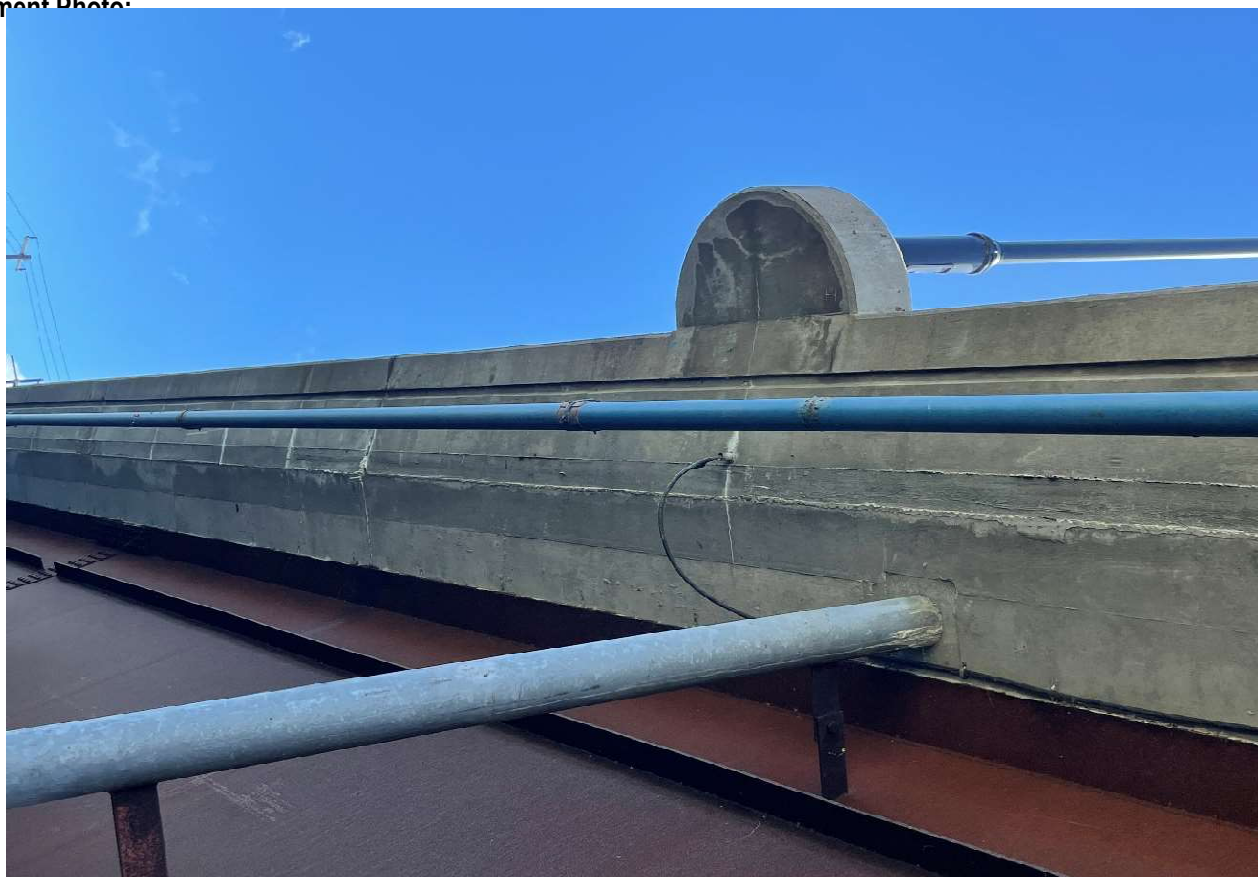
Comments: Light scaling typical. Narrow to medium cracks with some water staining along overhang soffit at regular intervals (+/- 2.0m c/c avg.). Several cracks with wet areas and leachate deposits.

**Description of Photo:** Exterior Soffit

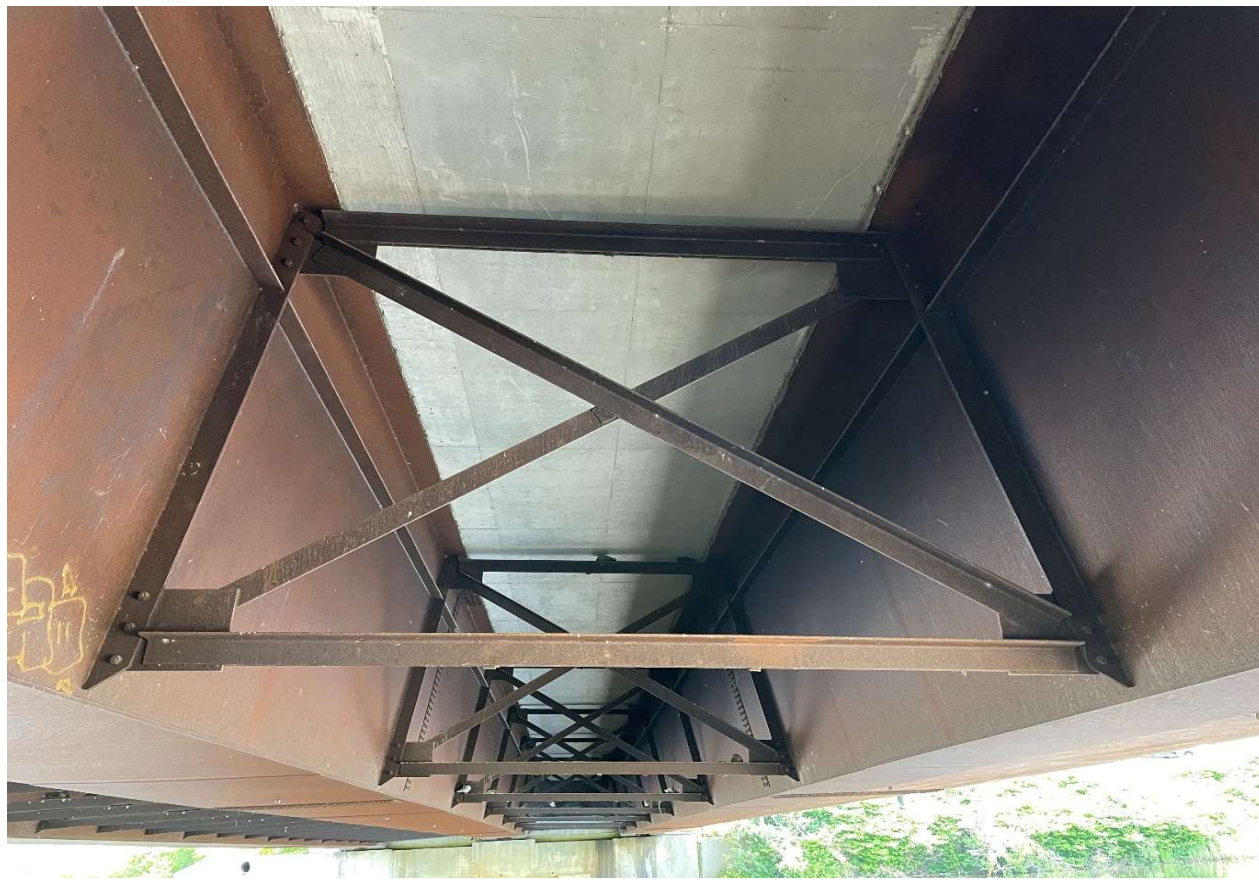
Description of Photo: Interior Soffit

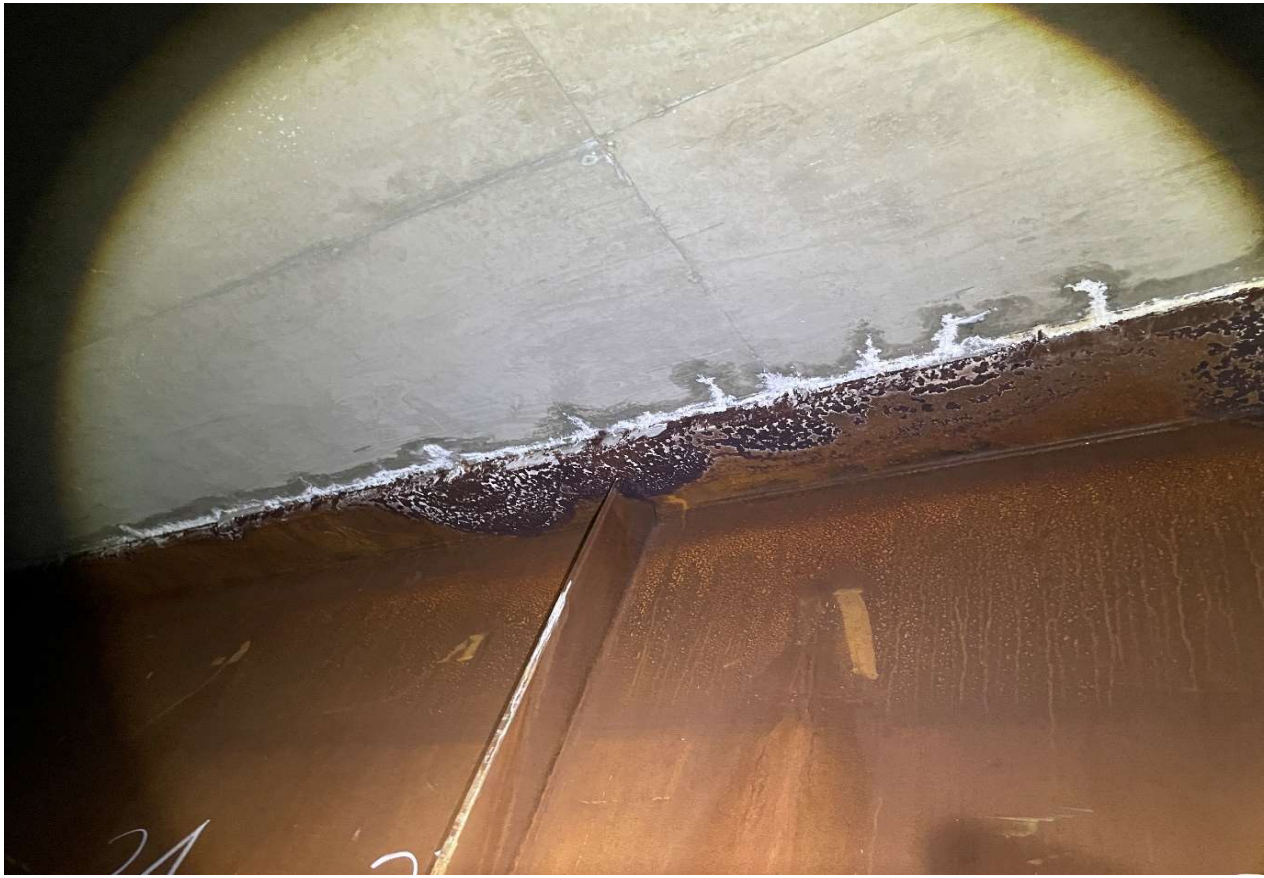
Comments: Light scaling, typical. North girder soffit has 4.0 m of narrow to medium cracks with efflorescence. South girder soffit has isolated areas of efflorescence built up at slab and girder top flange interface, and one 0.5 m crack with efflorescence. Remainder of soffit areas have several narrow to medium transverse cracks.

Description of Photo: South Girder Interior Soffit

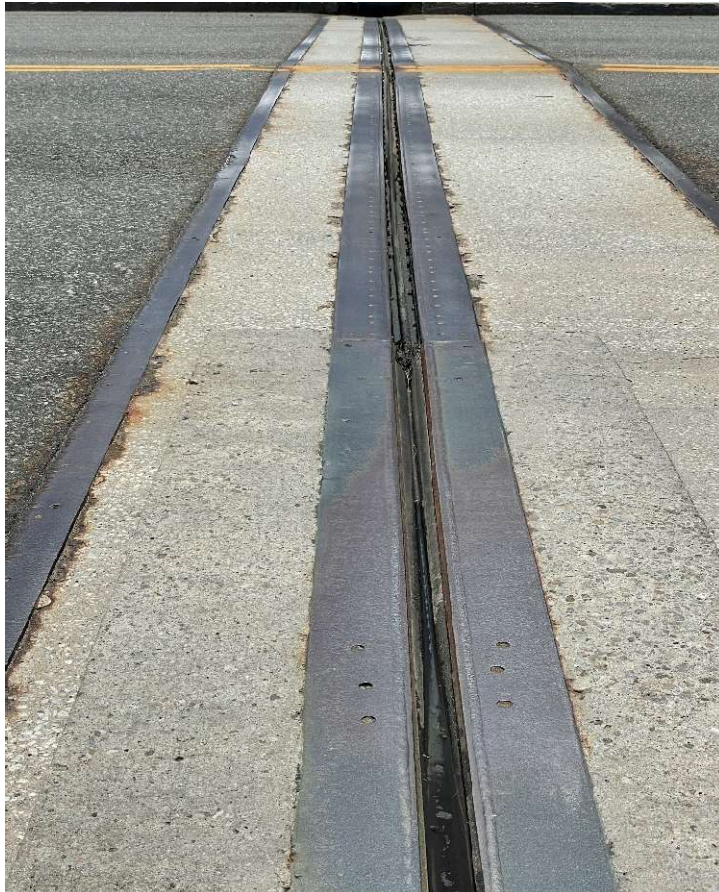
Comments: Seals are in generally good condition. No evidence of leakage or other performance deficiencies.

**Description of Photo:** Joint Seals

Recommended Work:	Rehab: <input type="checkbox"/>	Replace: <input type="checkbox"/>	Maintenance Needs:	2 - Bridge Cleaning		
Urgent: <input type="checkbox"/>	1-5 Years: <input type="checkbox"/>	6-10 Years: <input type="checkbox"/>	None: <input checked="" type="checkbox"/>	Urgent: <input type="checkbox"/>	1 Year: <input checked="" type="checkbox"/>	2 Year: <input type="checkbox"/>
				Clean joint gap and seals yearly.

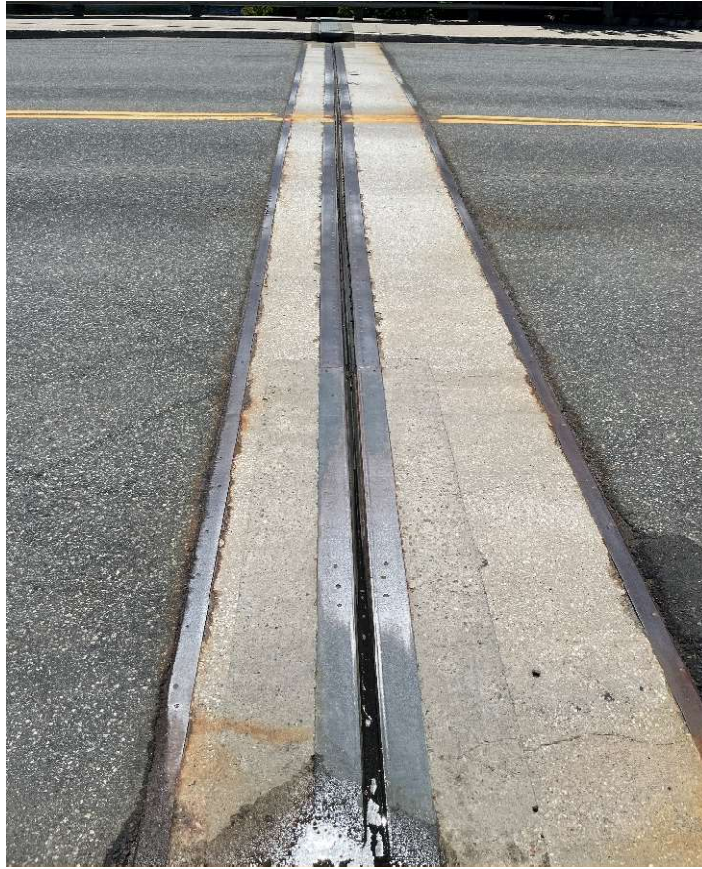
Comments: Light scaling and abrasions typical. Light 300 x100 x15mm spall on east side and 2 light 300x100x15mm spall on west side. Approximately 1.0m of light cracks.

**Description of Photo:** Joint Concrete End Dam

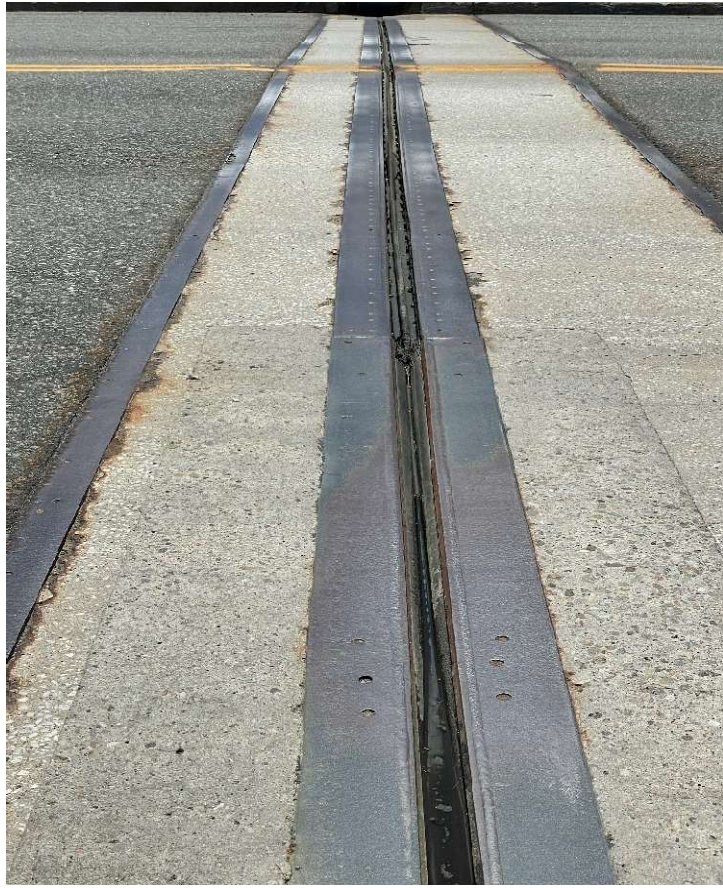
Comments: **Light corrosion typical. Isolated deformations within wheel lines, typical.**

**Description of Photo:** Joint Armour

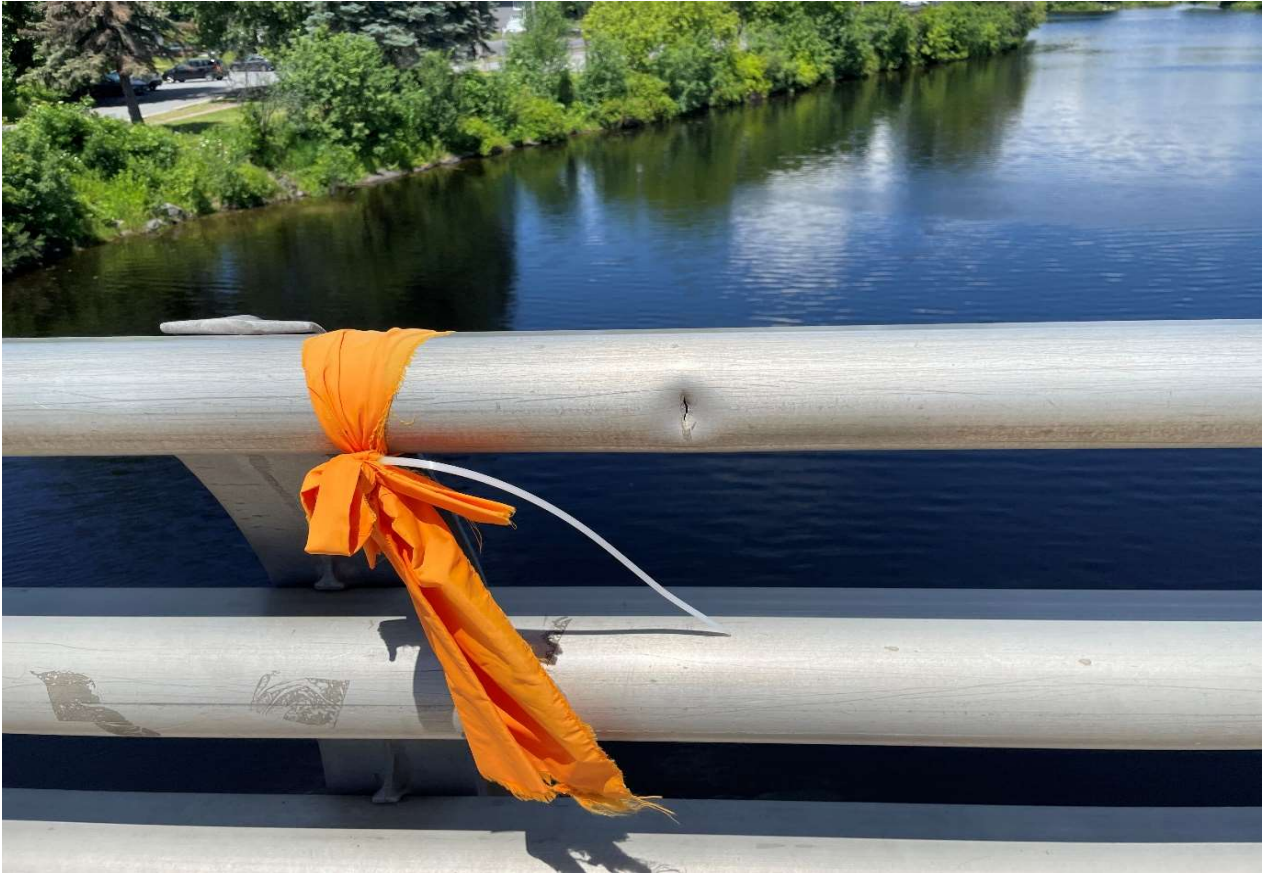
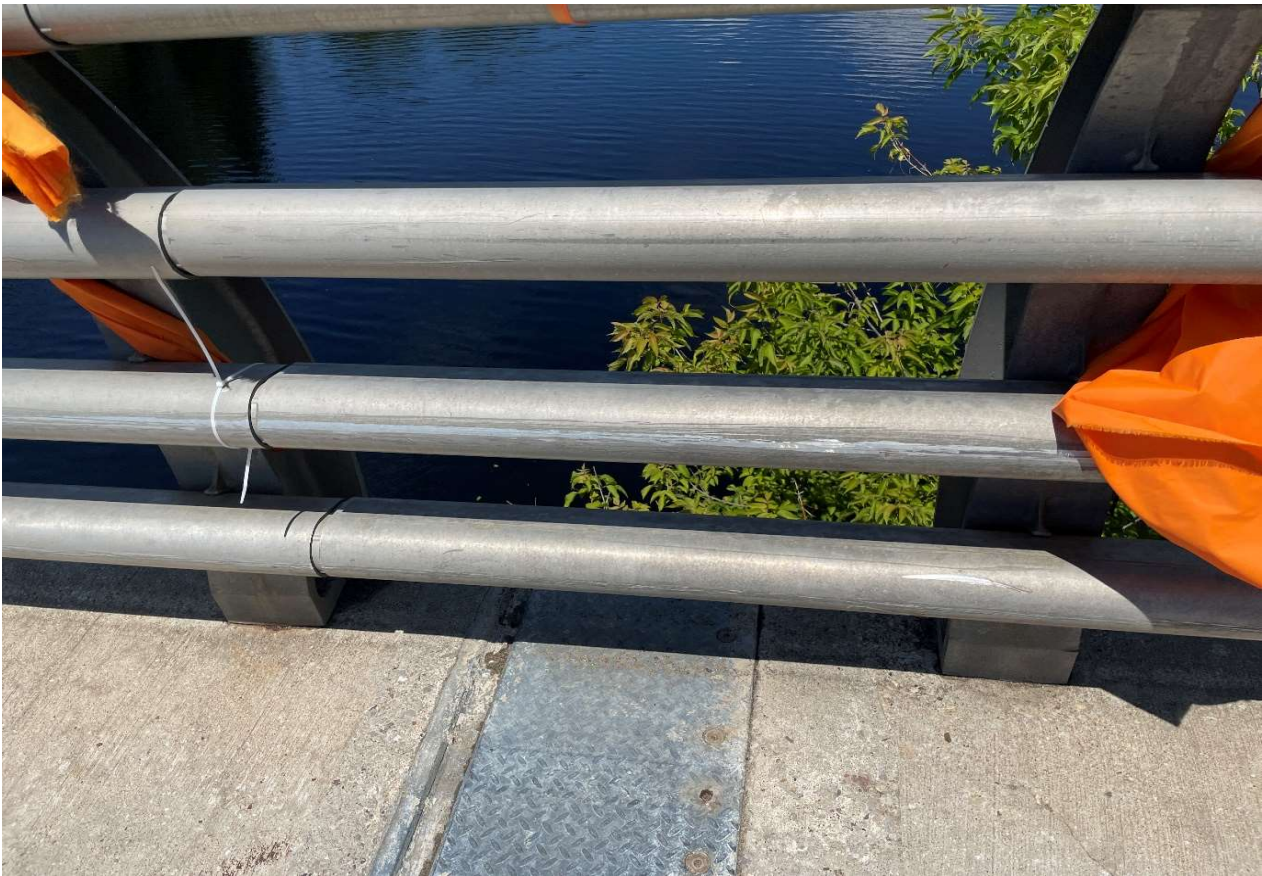
Comments: Two 100x100mm deformations with perforations on north rail. Localized abrasions throughout with some wear of aluminum surface.

**Description of Photo:** Railing System
