# Bridge Inspections

**TOWN OF PARRY SOUND**

Inspection Summary Report

January  
12, 2023

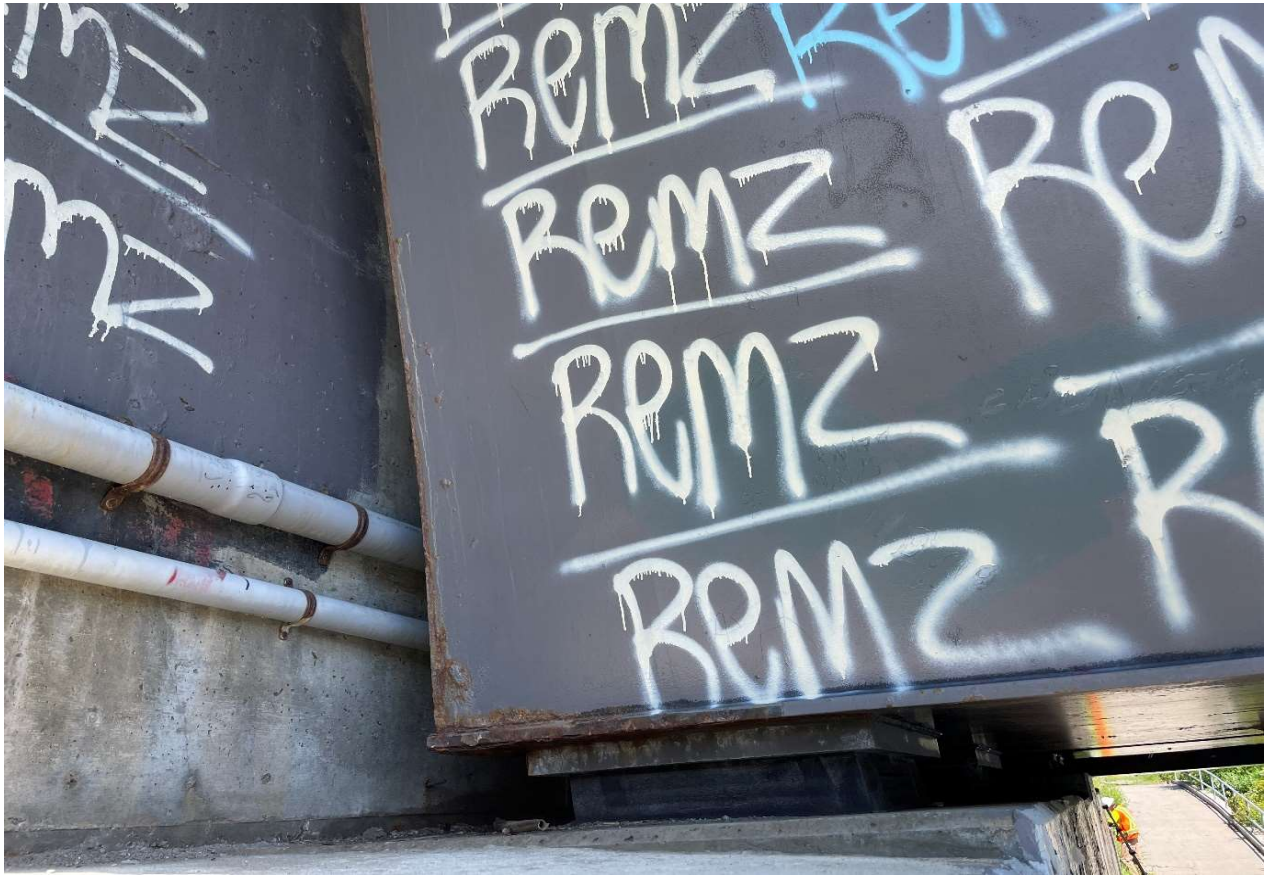
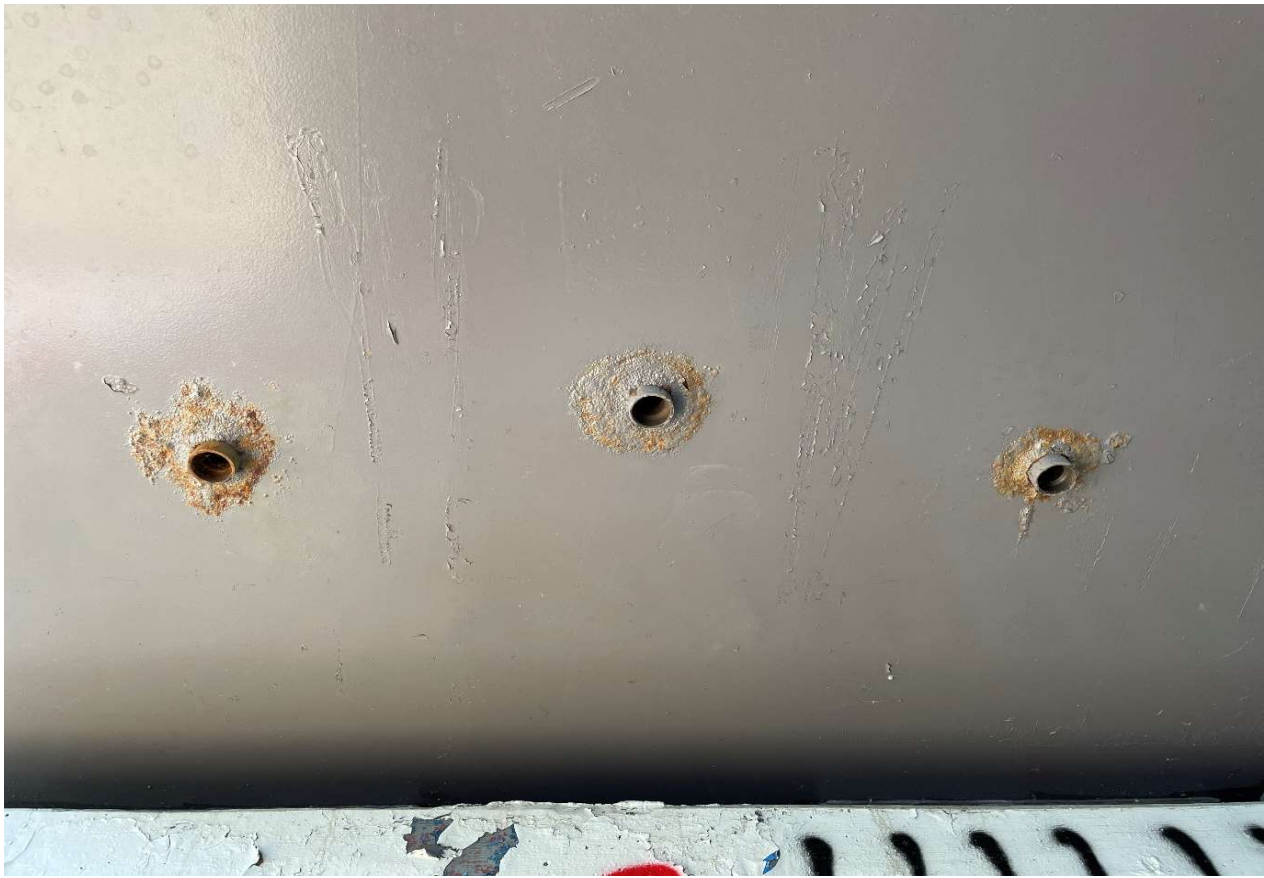
Comments: Five 200x200mm areas of medium corrosion at the bottom flange at drain holes. Light corrosion at top of southwest girder.

**Description of Photo:** Girder - Exterior End

Recommended Work:	Rehab: <input checked="" type="checkbox"/>	Replace: <input type="checkbox"/>	Maintenance Needs:	
Urgent: <input type="checkbox"/>	1-5 Years: <input type="checkbox"/>	6-10 Years: <input checked="" type="checkbox"/>	None: <input type="checkbox"/>	Urgent: <input type="checkbox"/> 1 Year: <input type="checkbox"/> 2 Year: <input type="checkbox"/>
Clean and recoat in conjunction with interior cleaning. Refer to Beams - Inside Boxes regarding cleaning.

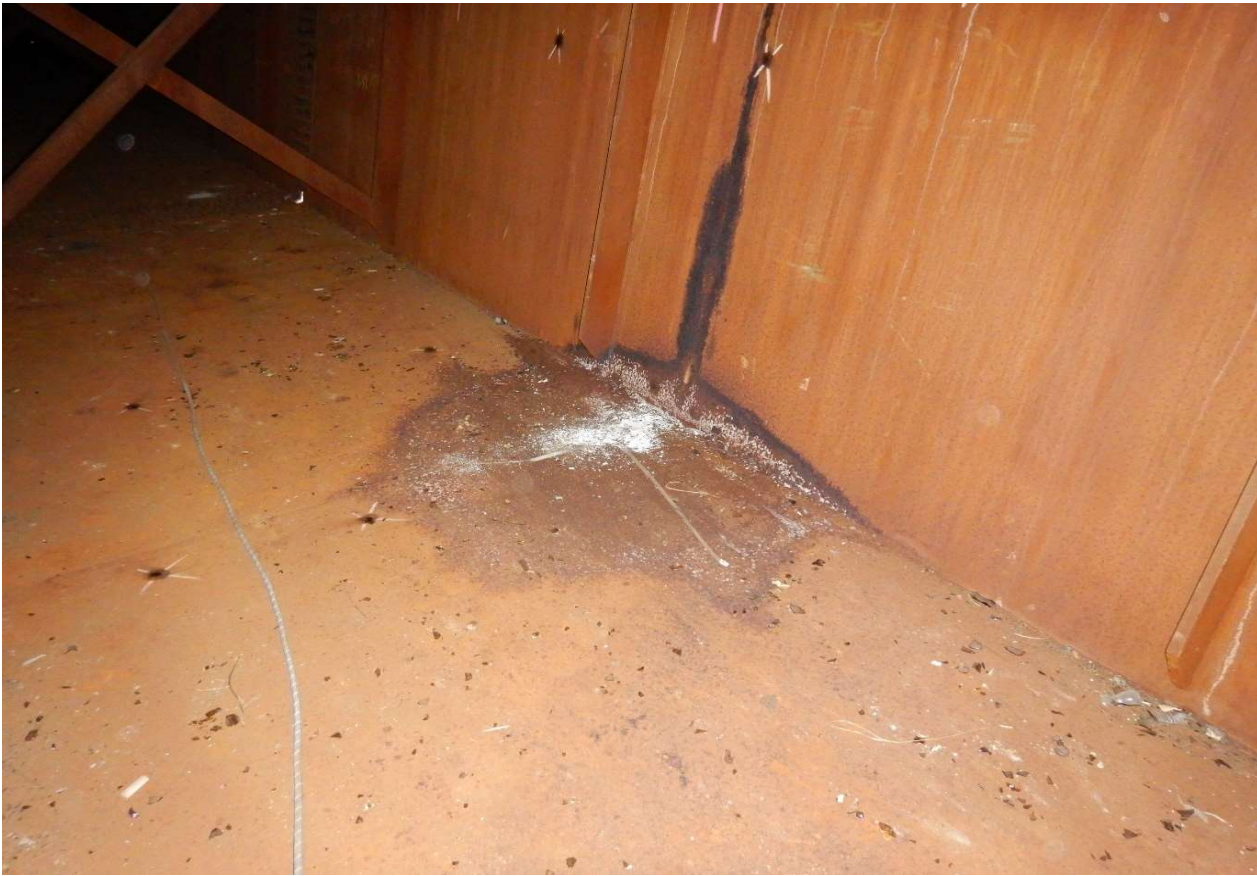
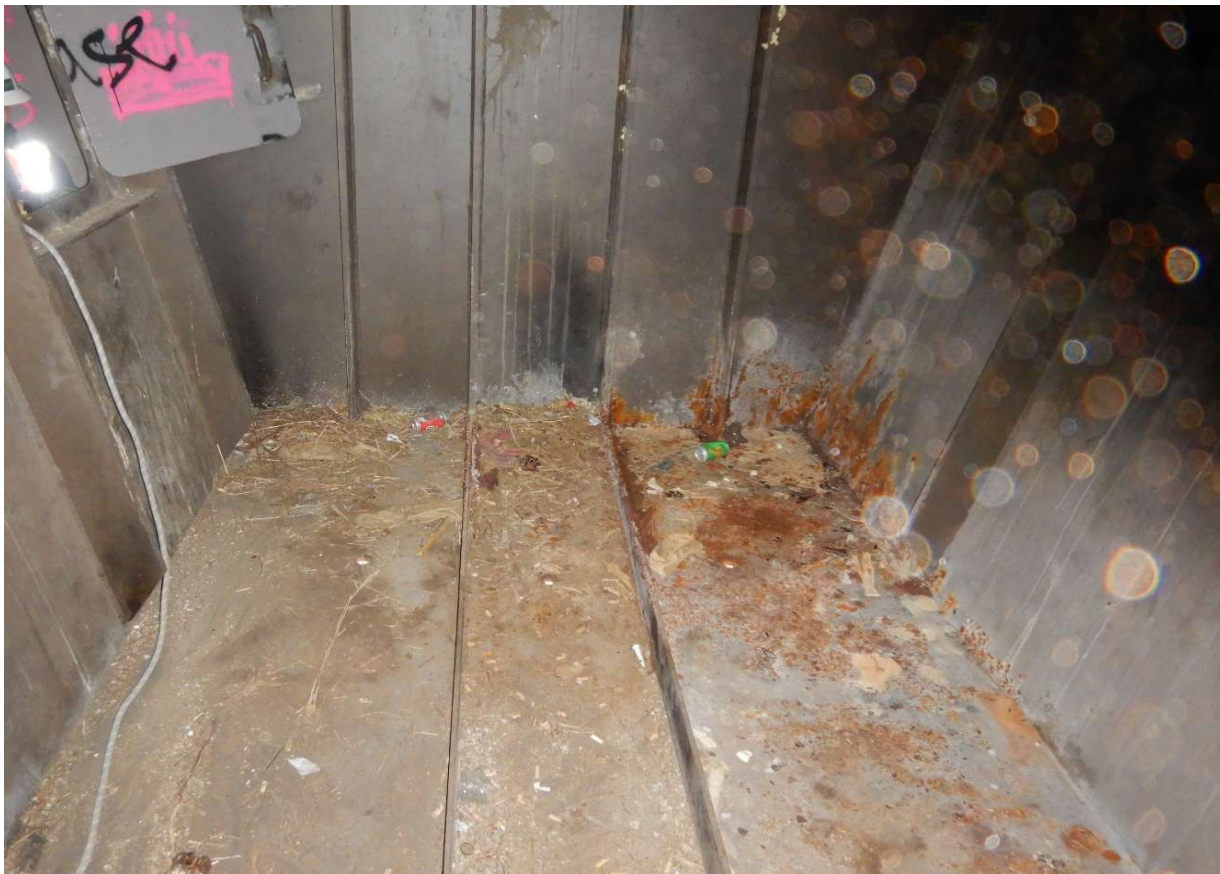
Comments: Medium corrosion along bottom, 8.0mx200mm at west and east end of girder. The coating along the bottom flange and stiffeners has failed exhibiting Category 2 to 4 surface rust at west end. 1 sq.m of white deposits on bottom. Steel stiffeners have areas of localized severe corrosion with section loss at ends of girder. 20m from west end 4.0m of efflorescence deposits at top flange and deck interface. Both ends have significant build-up of debris.

**Description of Photo:** East Girder End

Recommended Work:	Rehab: <input checked="" type="checkbox"/>	Replace: <input type="checkbox"/>	Maintenance Needs:	
Urgent: <input type="checkbox"/>	1-5 Years: <input checked="" type="checkbox"/>	6-10 Years: <input type="checkbox"/>	None: <input type="checkbox"/>	Urgent: <input type="checkbox"/> 1 Year: <input type="checkbox"/> 2 Year: <input type="checkbox"/>
Clean debris from girder ends, recoat the girder ends.

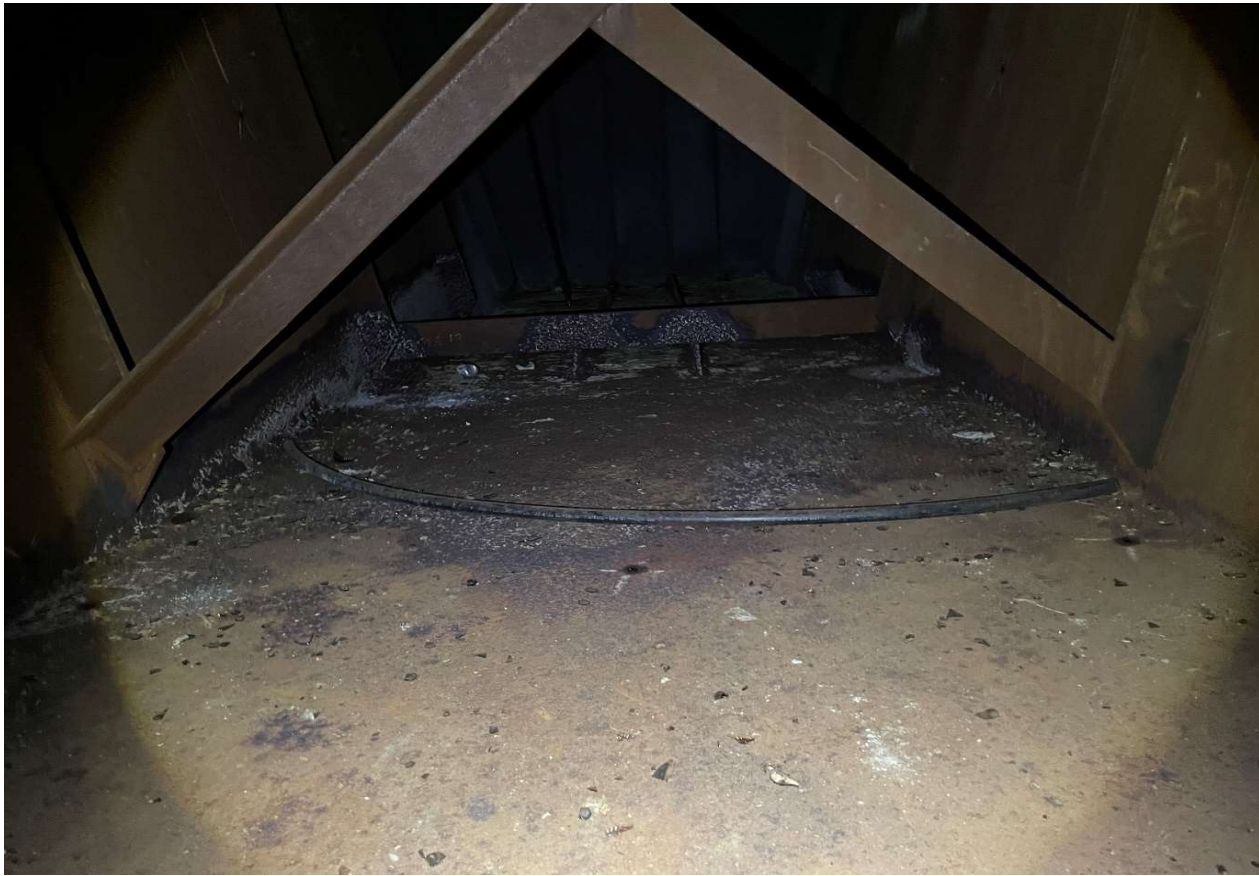
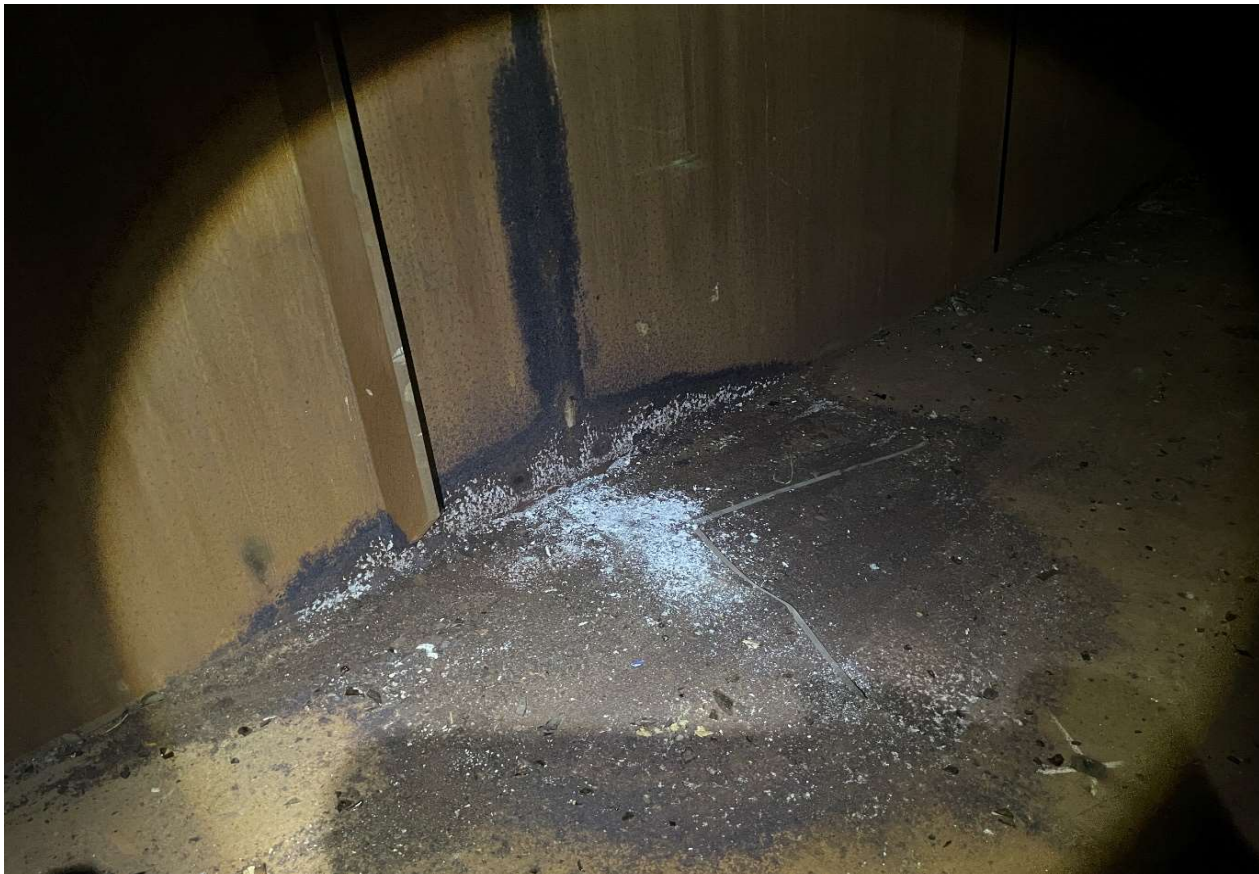
Comments: 8.0mx100mm of light corrosion along bottom flange at east end of girder. One area of white deposits on the bottom flange. Both ends have some build-up of debris.

Description of Photo: Center Girder East End

Recommended Work:	Rehab: <input checked="" type="checkbox"/>	Replace: <input type="checkbox"/>	Maintenance Needs:	
Urgent: <input type="checkbox"/>	1-5 Years: <input checked="" type="checkbox"/>	6-10 Years: <input type="checkbox"/>	None: <input type="checkbox"/>	Urgent: <input type="checkbox"/> 1 Year: <input type="checkbox"/> 2 Year: <input type="checkbox"/>
Clean debris from girder ends, recoat the girder ends.

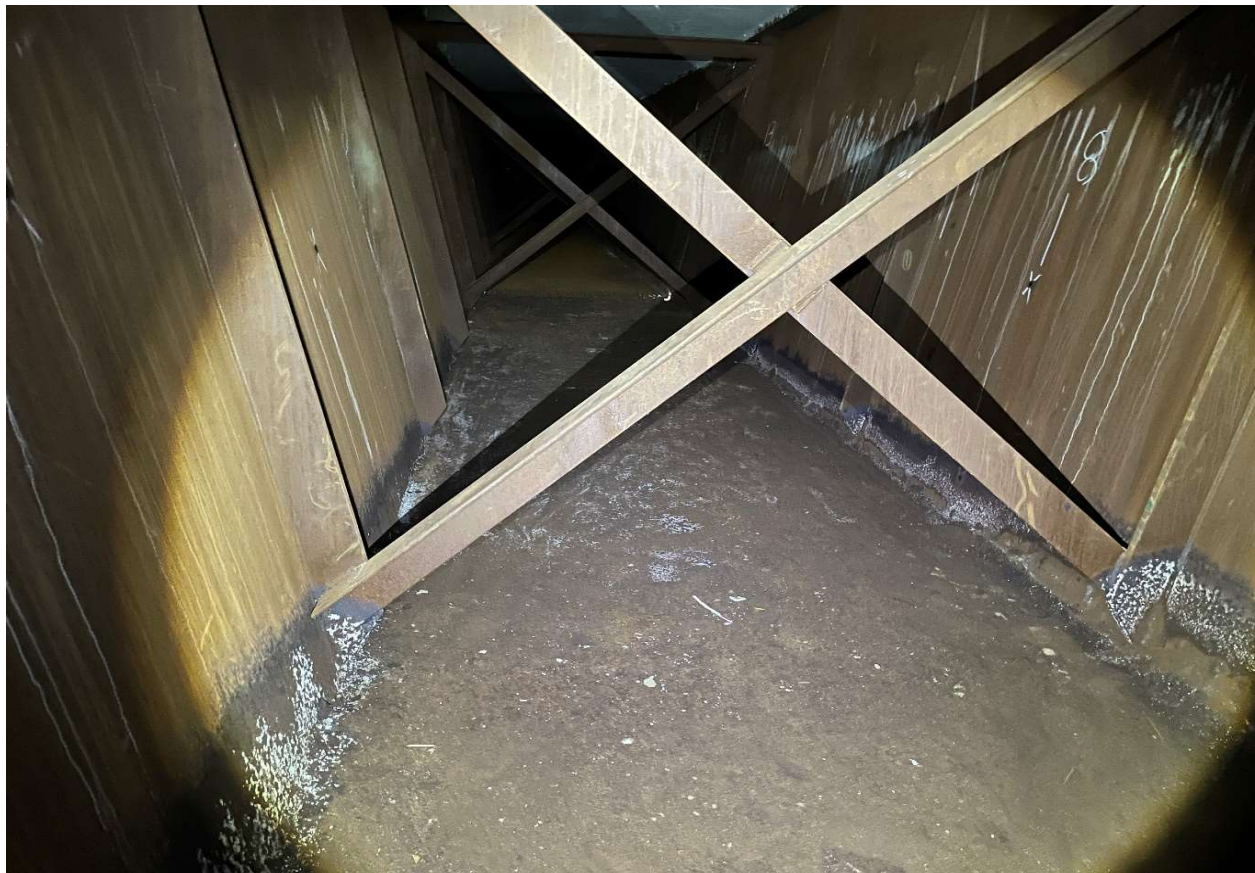
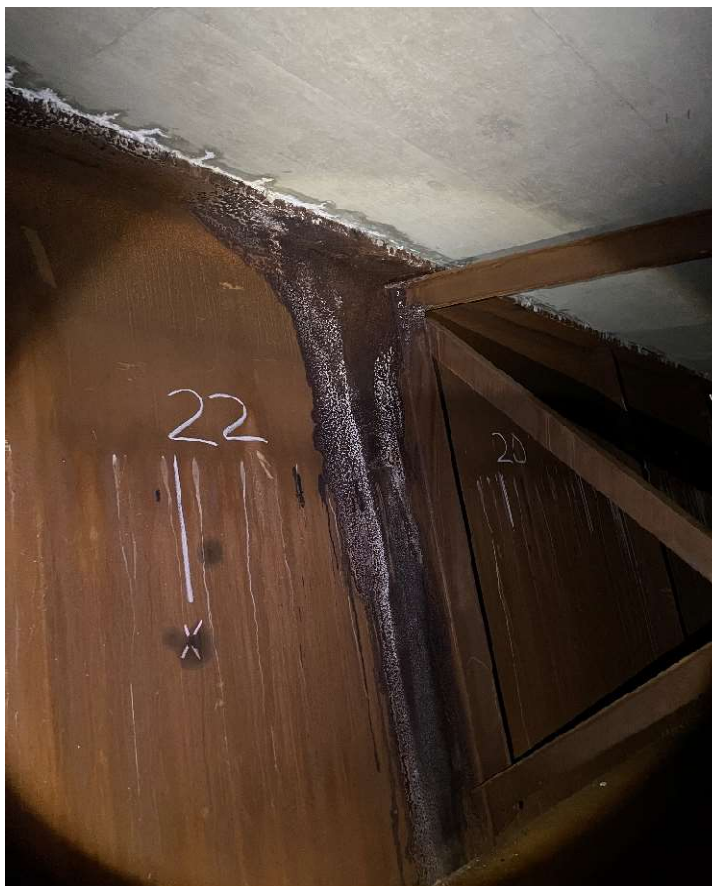
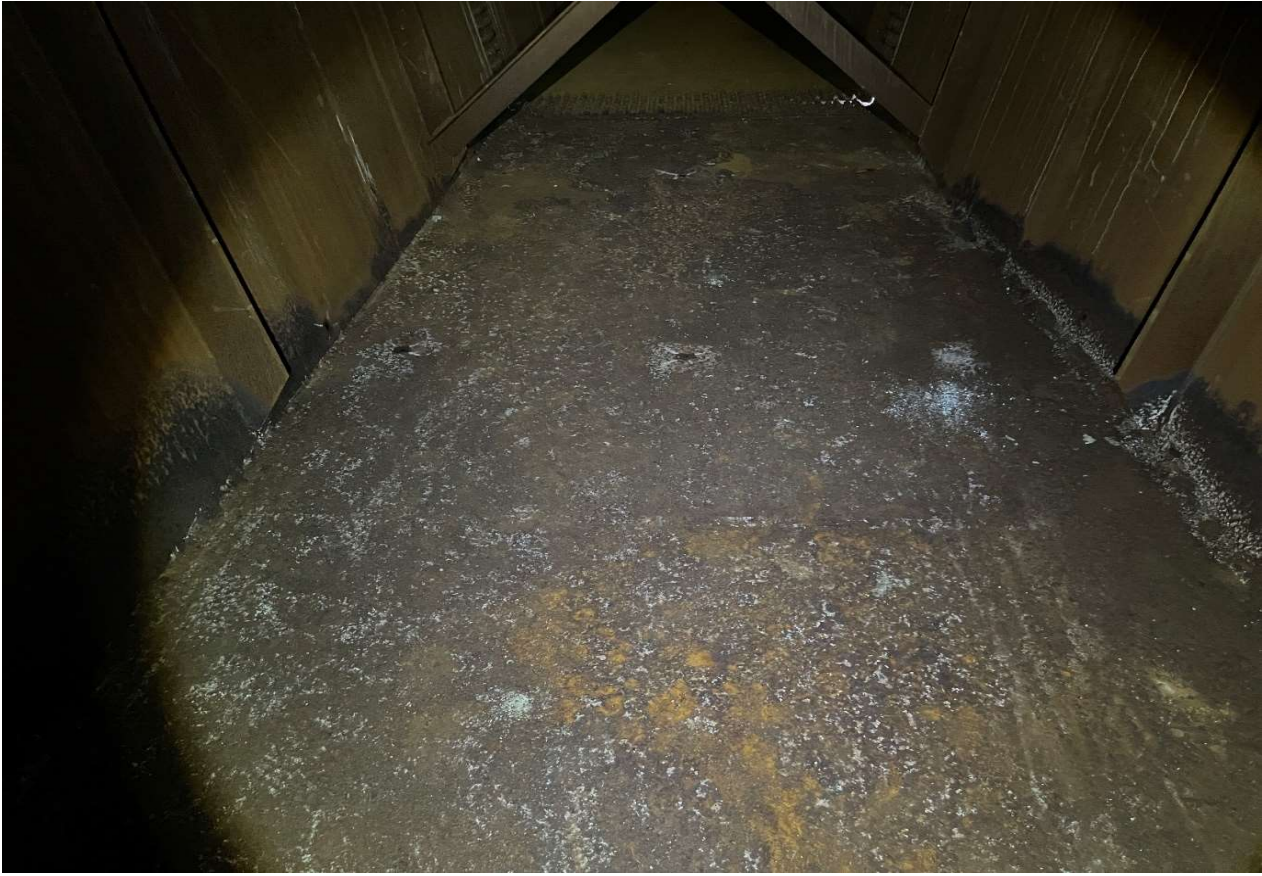
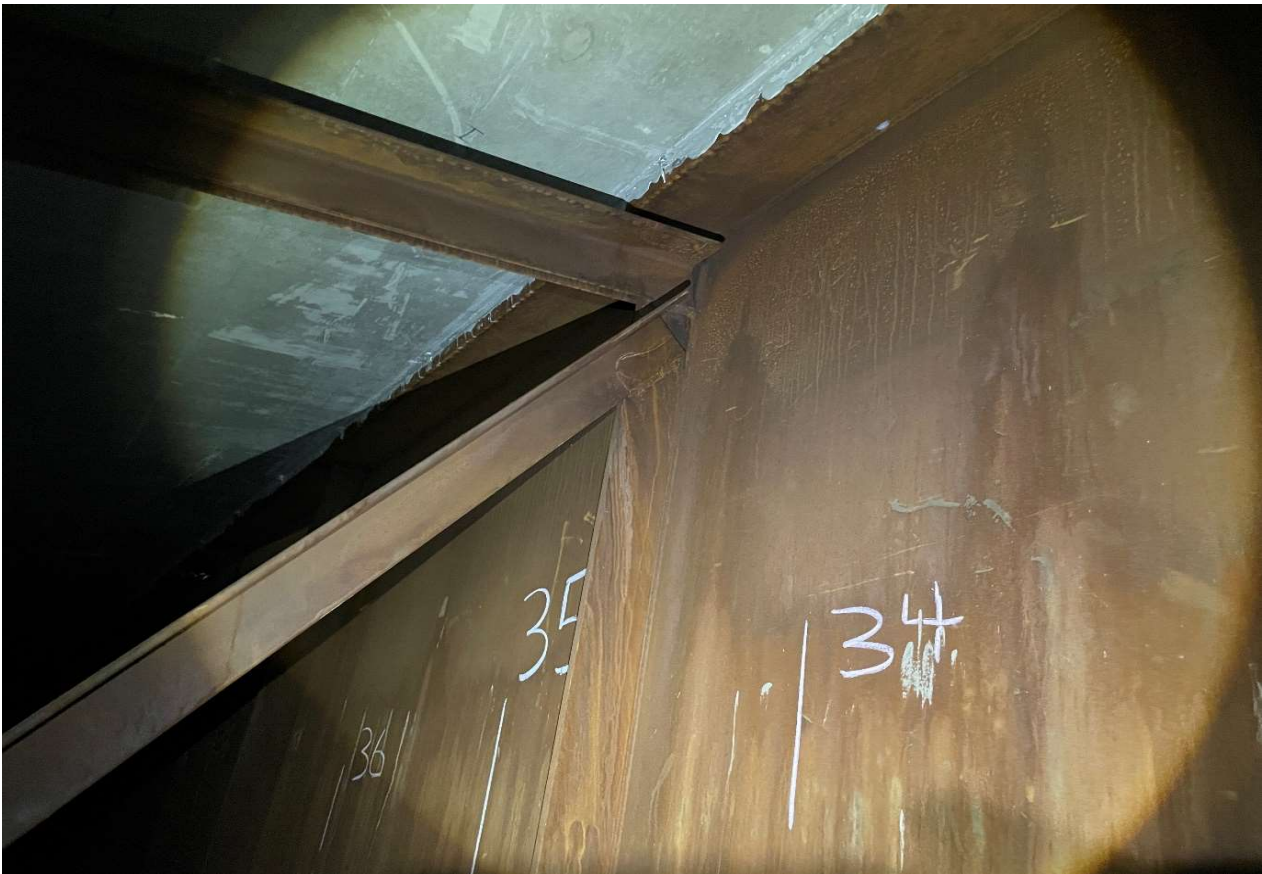
Comments: Light to medium corrosion along bottom, 15.0mx200mm at west and 6.0mx100mm at east end of girder. The coating along the bottom flange and stiffeners has failed exhibiting Category 2 to 4 surface rust at west end. One section of girder has light corrosion (4.0x2.2m) on bottom. Steel stiffeners have areas of localized severe corrosion with section loss at ends of girder. 20m from west end 4.0m of efflorescence at top flange and deck interface. Isolated areas of efflorescence deposits with corrosion on webs and top flange. Both ends have significant build-up of debris.

**Description of Photo:** Girder West End

Clean debris from girder ends, recoat the girder ends.

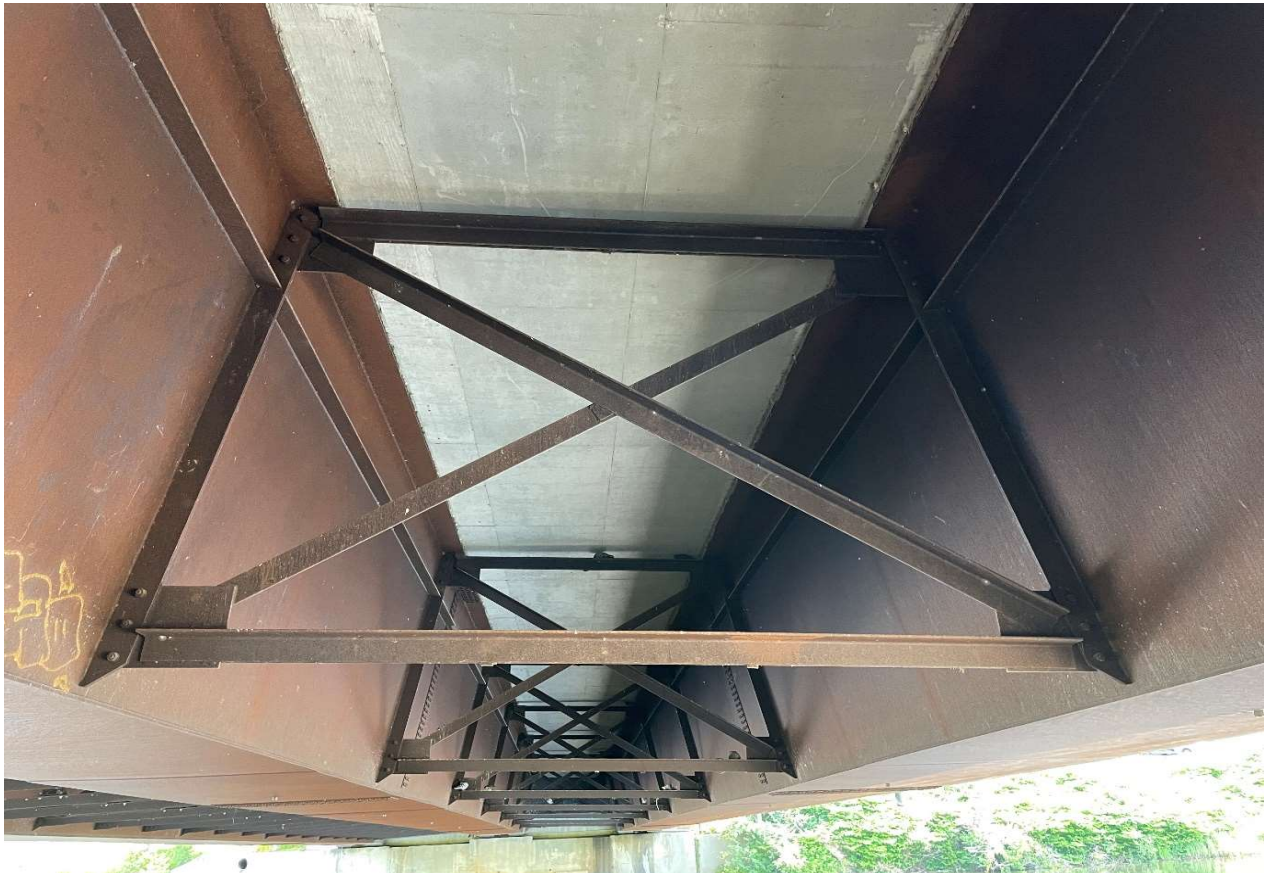
Comments: **No observed defects, patina is formed and uniform.**

**Description of Photo:** Diaphragms

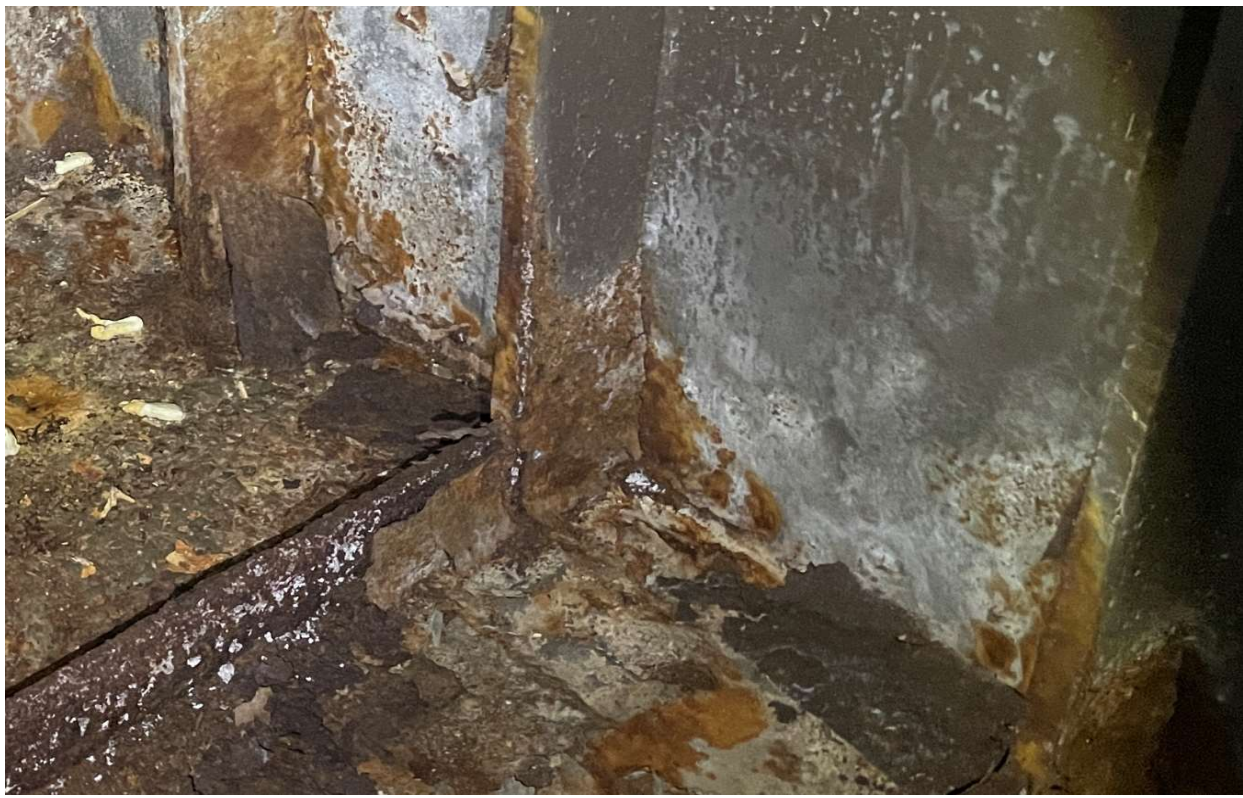
Comments: Interior coating at ends of north and south girder have failed along the bottom flange and stiffener plates exhibiting Category 3 and 4 rusting. Category 2 to 3 rusting around the drain holes in the bottom flange. Remaining coating exhibiting chalking and Category 2 rusting, typical.

**Description of Photo:** Coating

Recommended Work:	Rehab: <input checked="" type="checkbox"/>	Replace: <input type="checkbox"/>	Maintenance Needs:	
Urgent: <input type="checkbox"/>	1-5 Years: <input checked="" type="checkbox"/>	6-10 Years: <input type="checkbox"/>	None: <input checked="" type="checkbox"/>	Urgent: <input type="checkbox"/> 1 Year: <input type="checkbox"/> 2 Year: <input type="checkbox"/>
Clean debris from girder ends, recoat the girder ends.

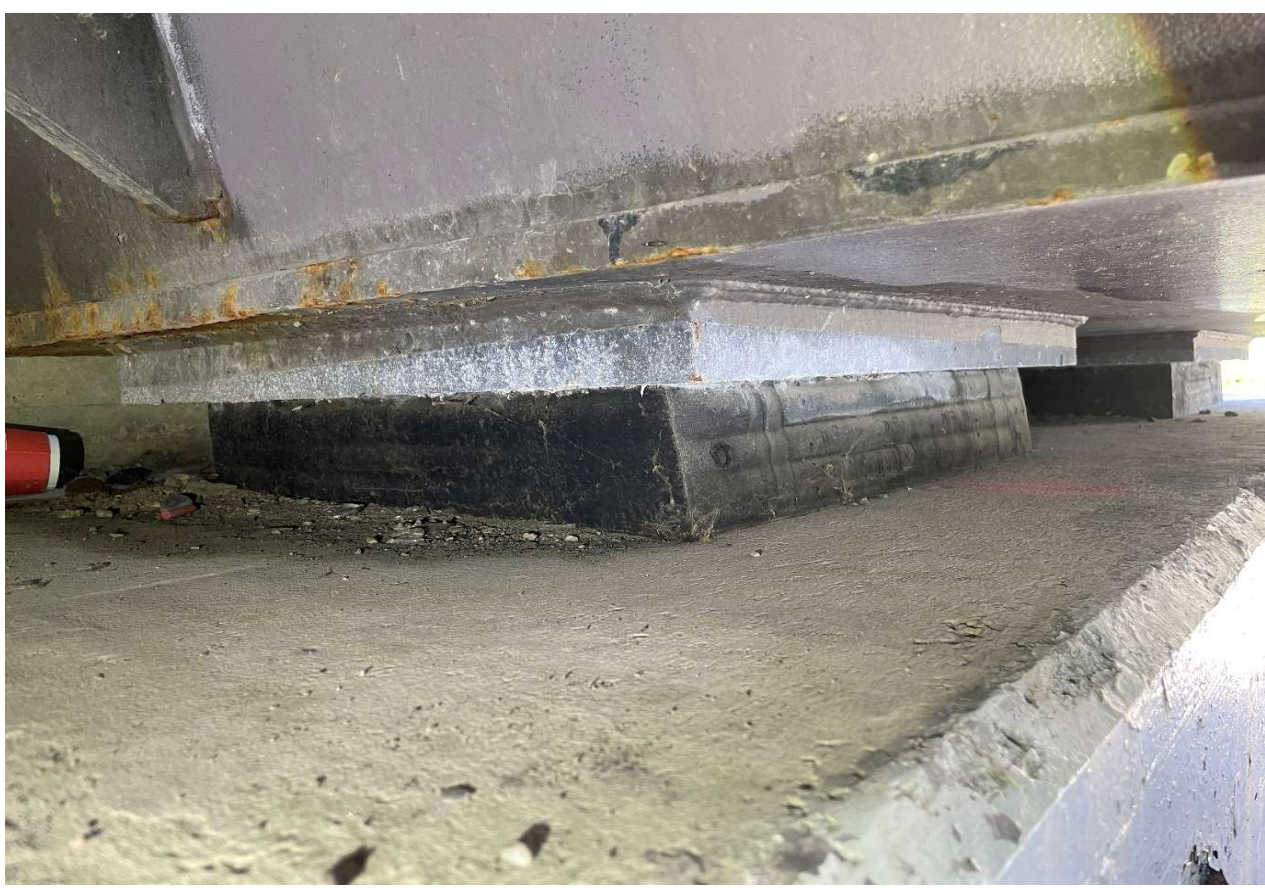
Comments: **East end bearing pads were not accessible and were not inspected. Bearings on west end are in good condition.**

**Description of Photo:** Bearings

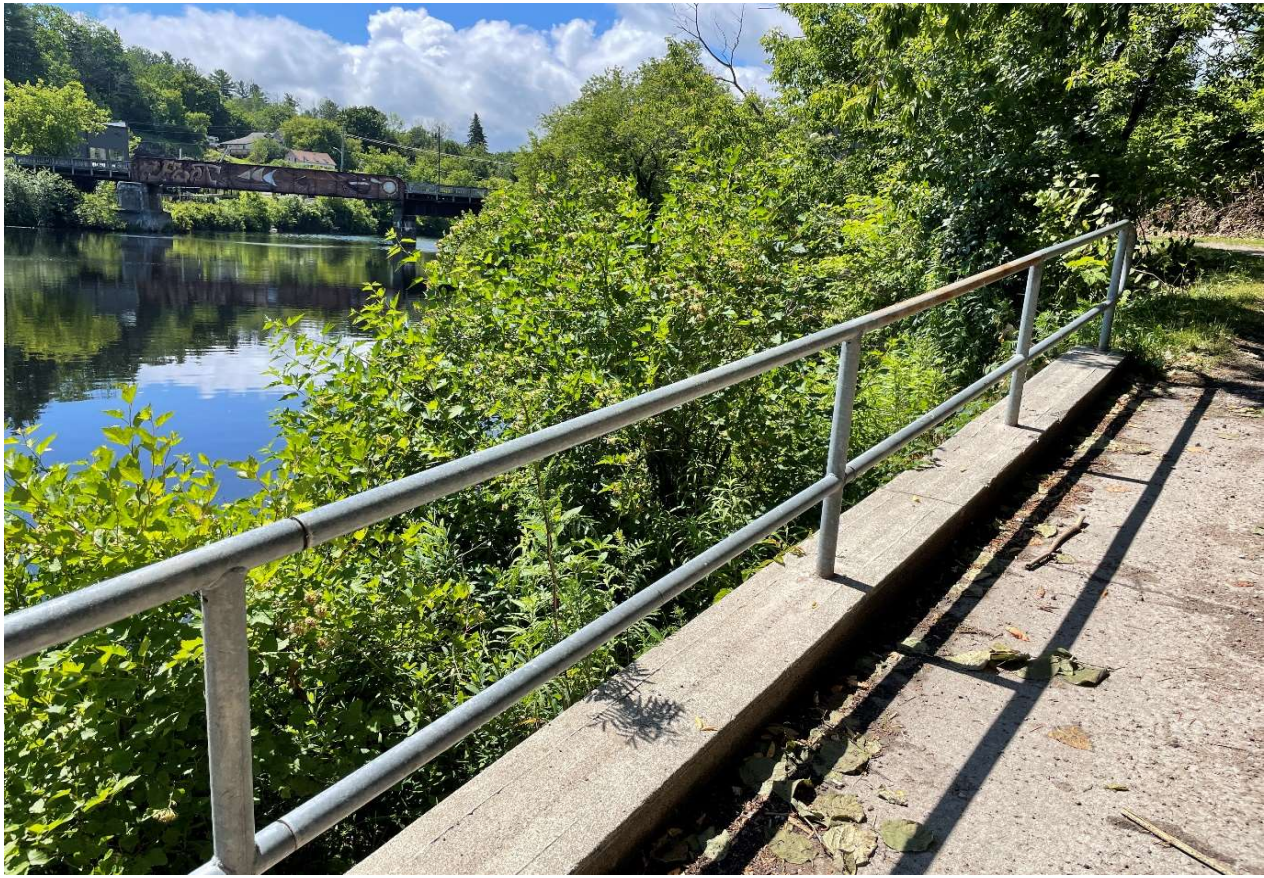
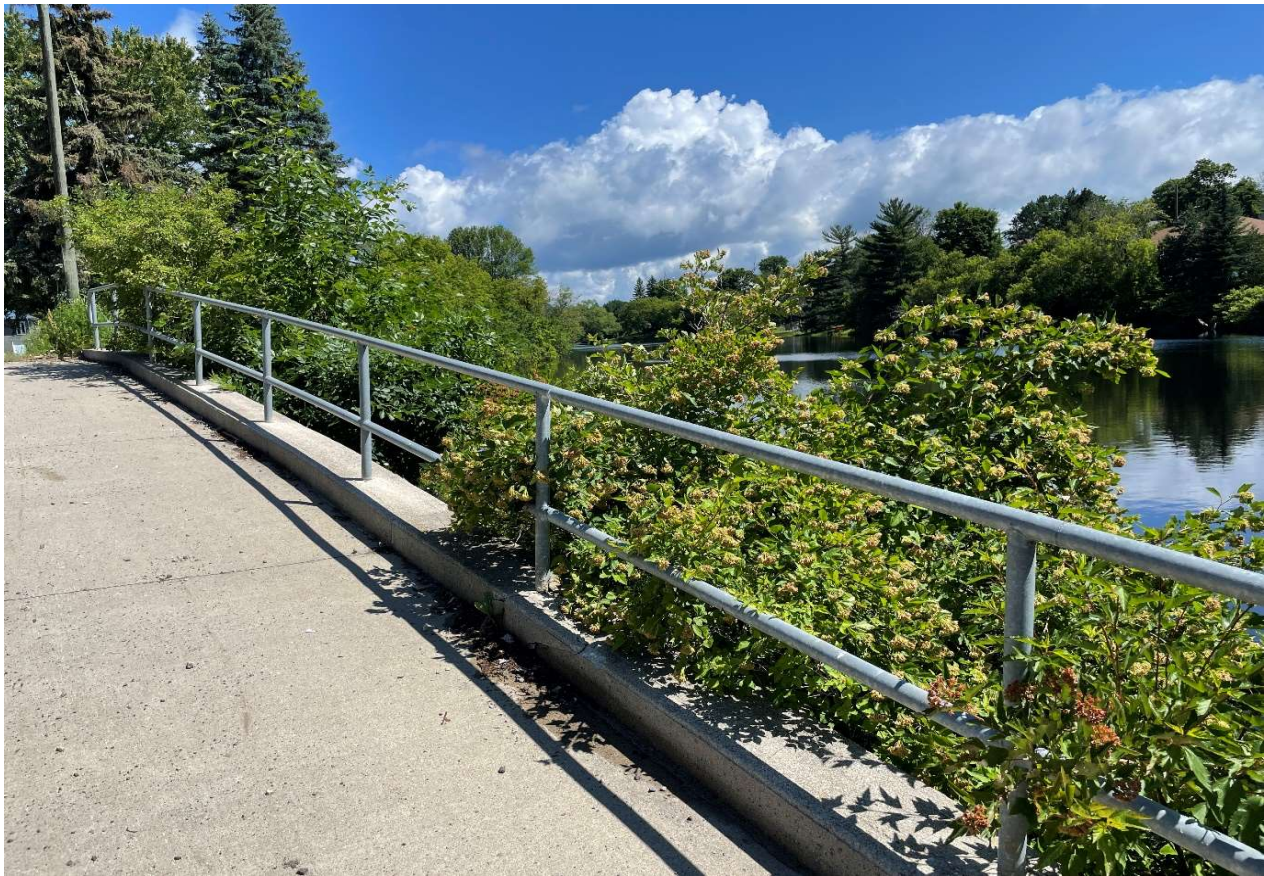
Comments: Pedestrian handrail along path under the west end of the bridge. Localized light corrosion and abrasion throughout. 0.5 mm narrow crack in the concrete base of a post.

**Description of Photo:** Retaining Wall Railing

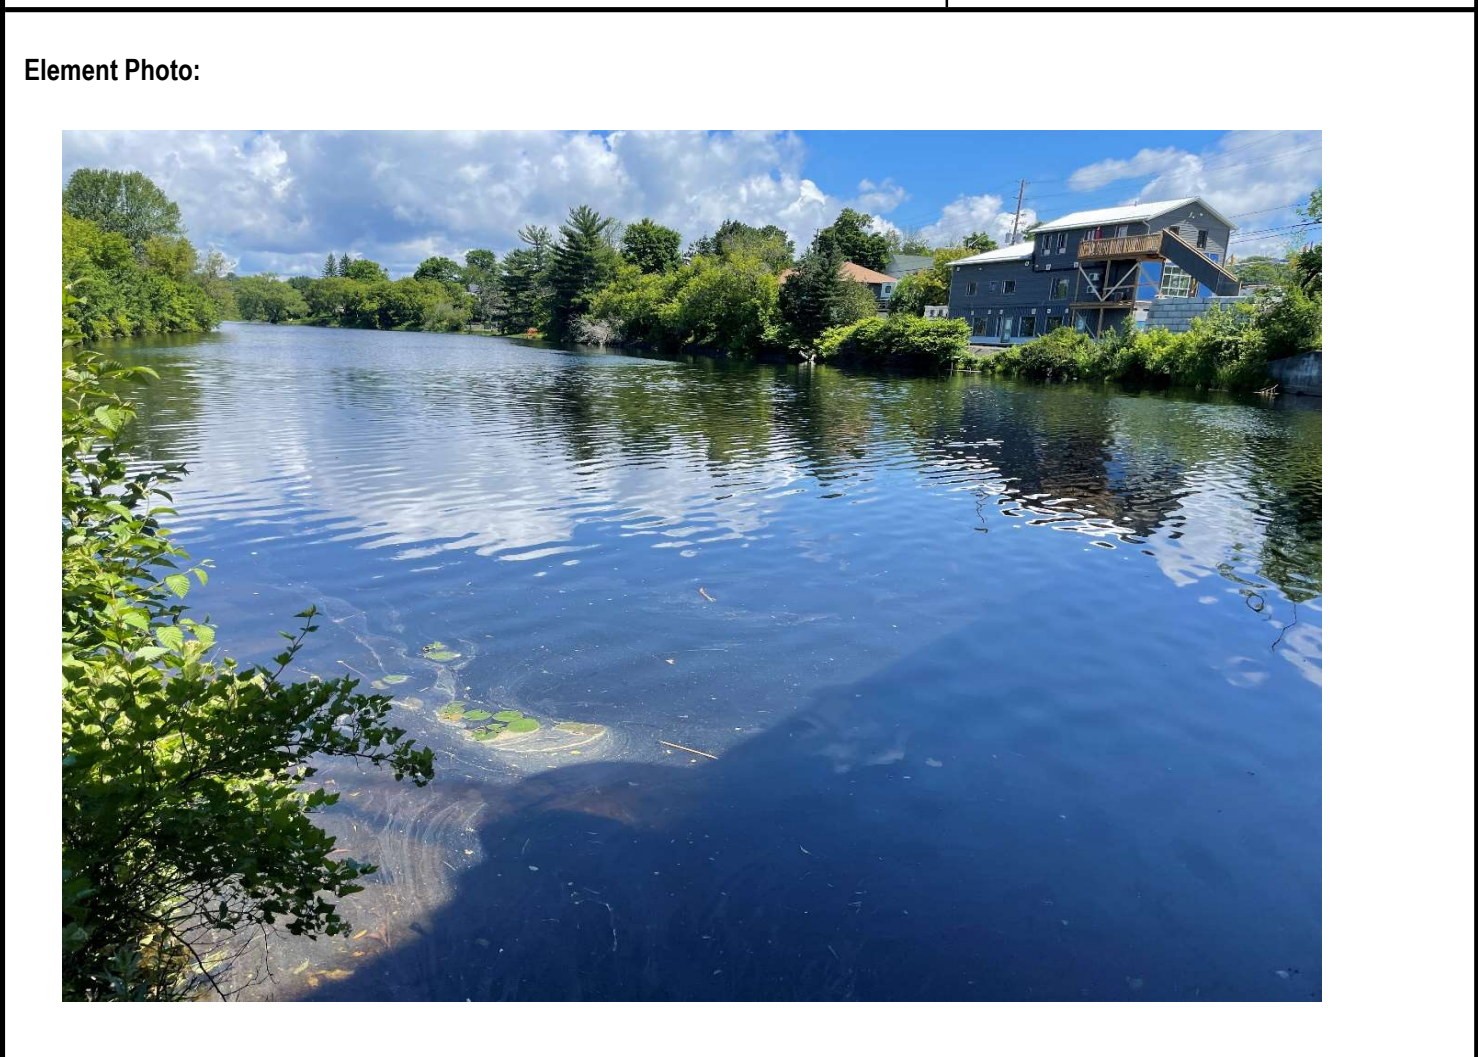
Comments: **No observed defects.**

**Description of Photo:** Waterway

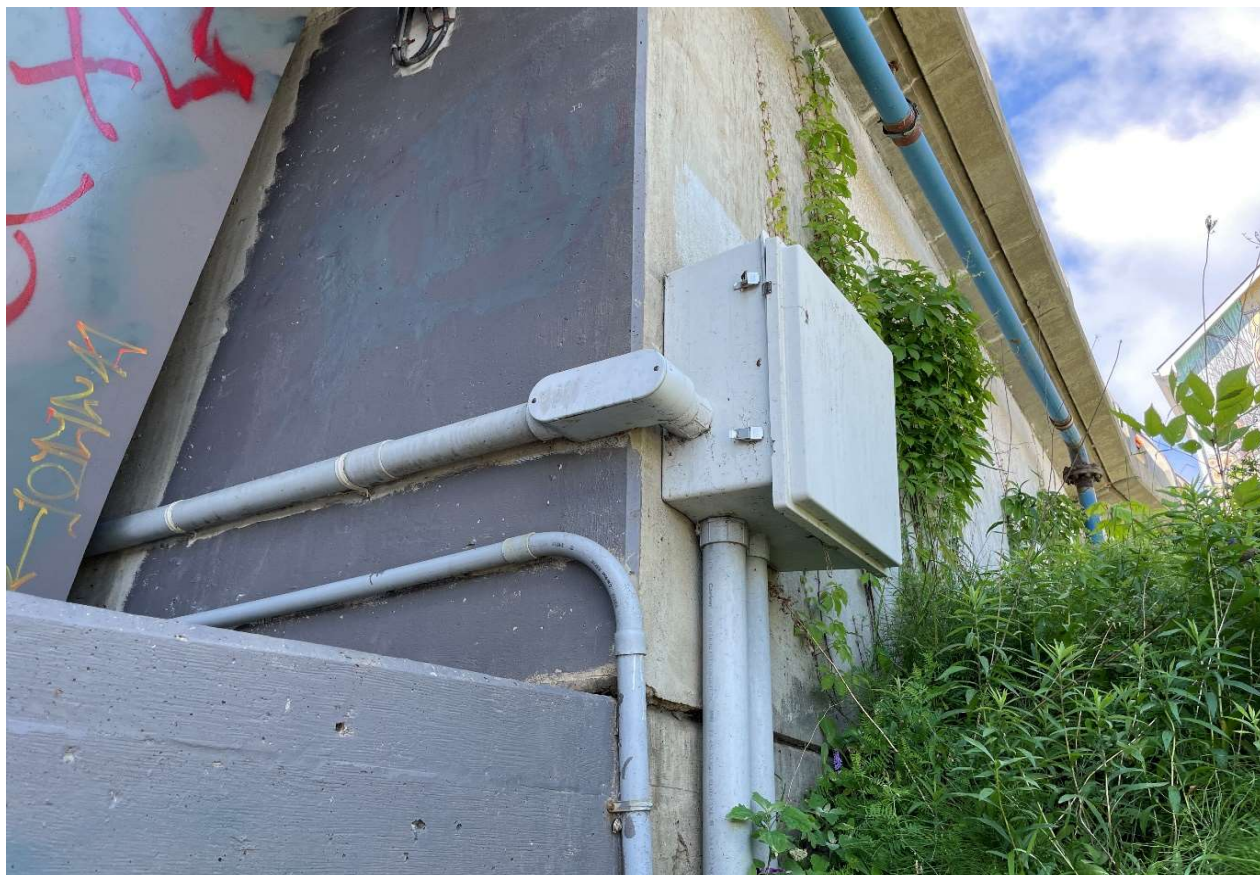
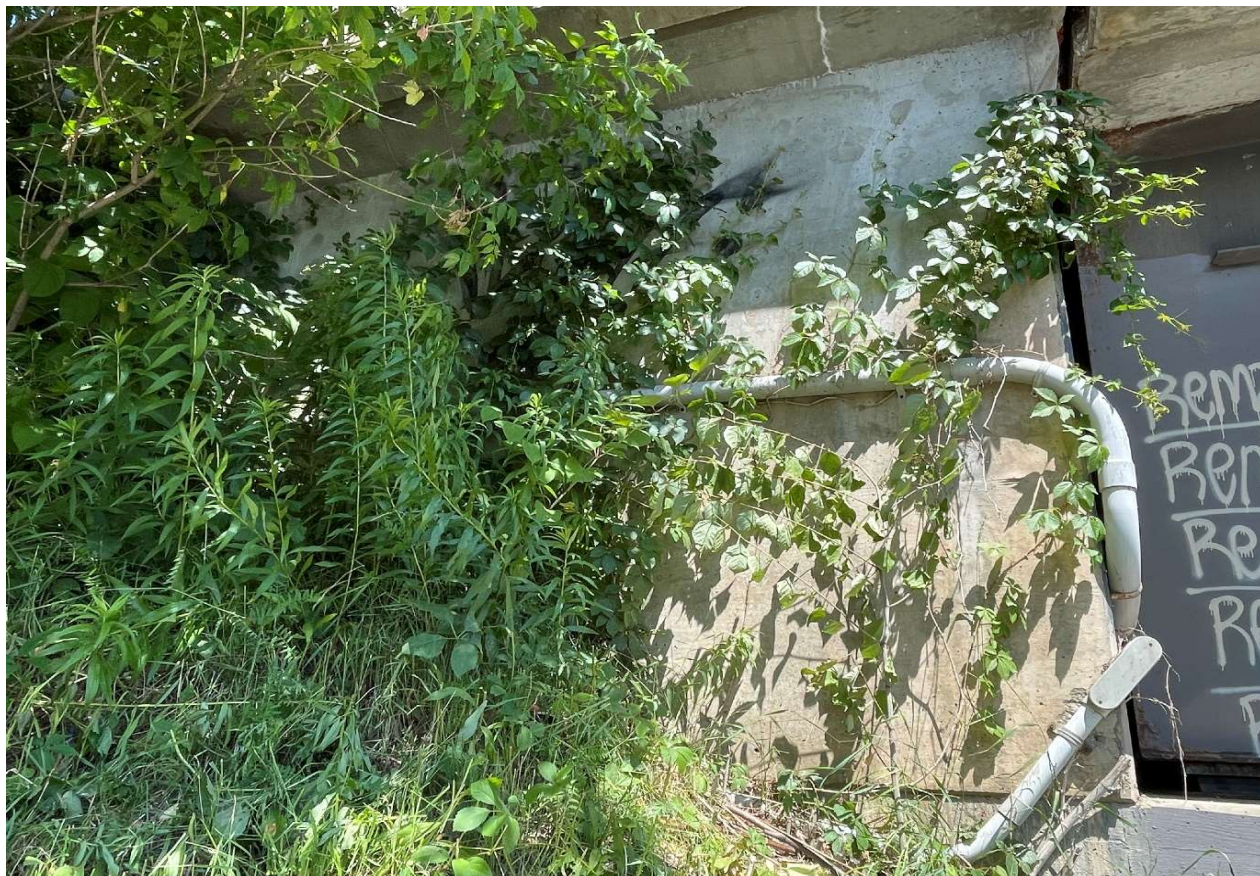
<b>Element Data:</b>						
Element Group:	Accessories		Length:			
Element Name:	Utilities		Width:			
Location:			Height:			
Material:			Count:	6		
Element Type:	Various		Total Quantity:	6		
Environment:			Inspected	Yes <input type="checkbox"/>	No <input type="checkbox"/>	limited <input checked="" type="checkbox"/>
Protection System:						Performance Deficiencies
Condition Data:	Units	Excellent	Good	Fair	Poor*	
	each		6			
Comments: Limited inspection due to access. There is gas line supported along the north face of the bridge, insulated pipe (likely a watermain) under the north interior soffit, electrical and bell also appear to be supported under the north interior soffit. There are some punctures in the watermain insulation protective covering. Electrical lines are also supported along both ballast walls. The drawings indicate that there could also be hydro ducts within the sidewalks. Electrical box at northwest quadrant has a damaged latch and can be opened.

**Description of Photo:** Utilities

Recommended Work:		Rehab: <input type="checkbox"/>	Replace: <input type="checkbox"/>	Maintenance Needs:		18 - Other Maintenance
Urgent: <input type="checkbox"/>	1-5 Years: <input type="checkbox"/>	6-10 Years: <input type="checkbox"/>	None: <input checked="" type="checkbox"/>	Urgent: <input type="checkbox"/>	1 Year: <input checked="" type="checkbox"/>	2 Year: <input type="checkbox"/>
				Replace latch and ensure electrical box can be closed and locked.
