# Bridge Inspections

**TOWN OF PARRY SOUND**

Inspection Summary Report

January  
12, 2023

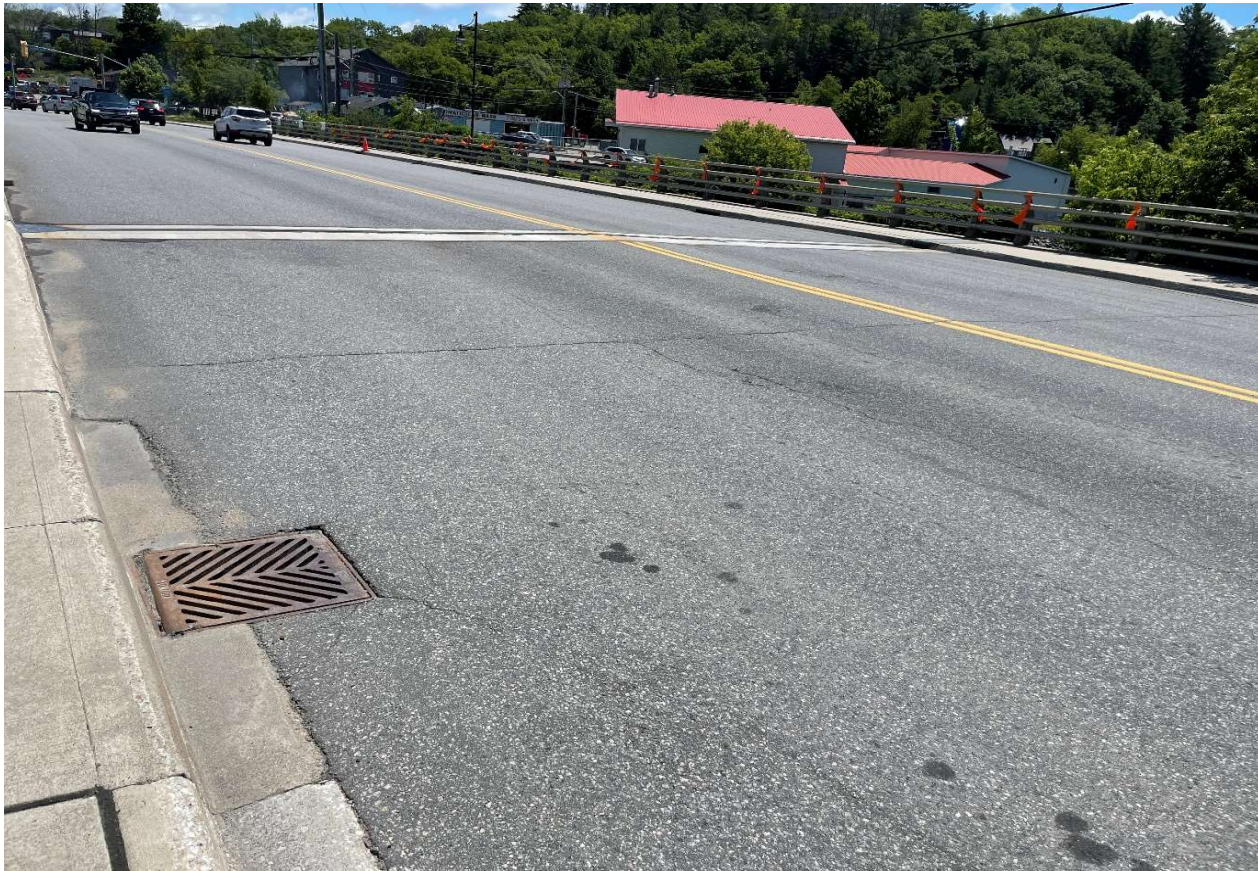
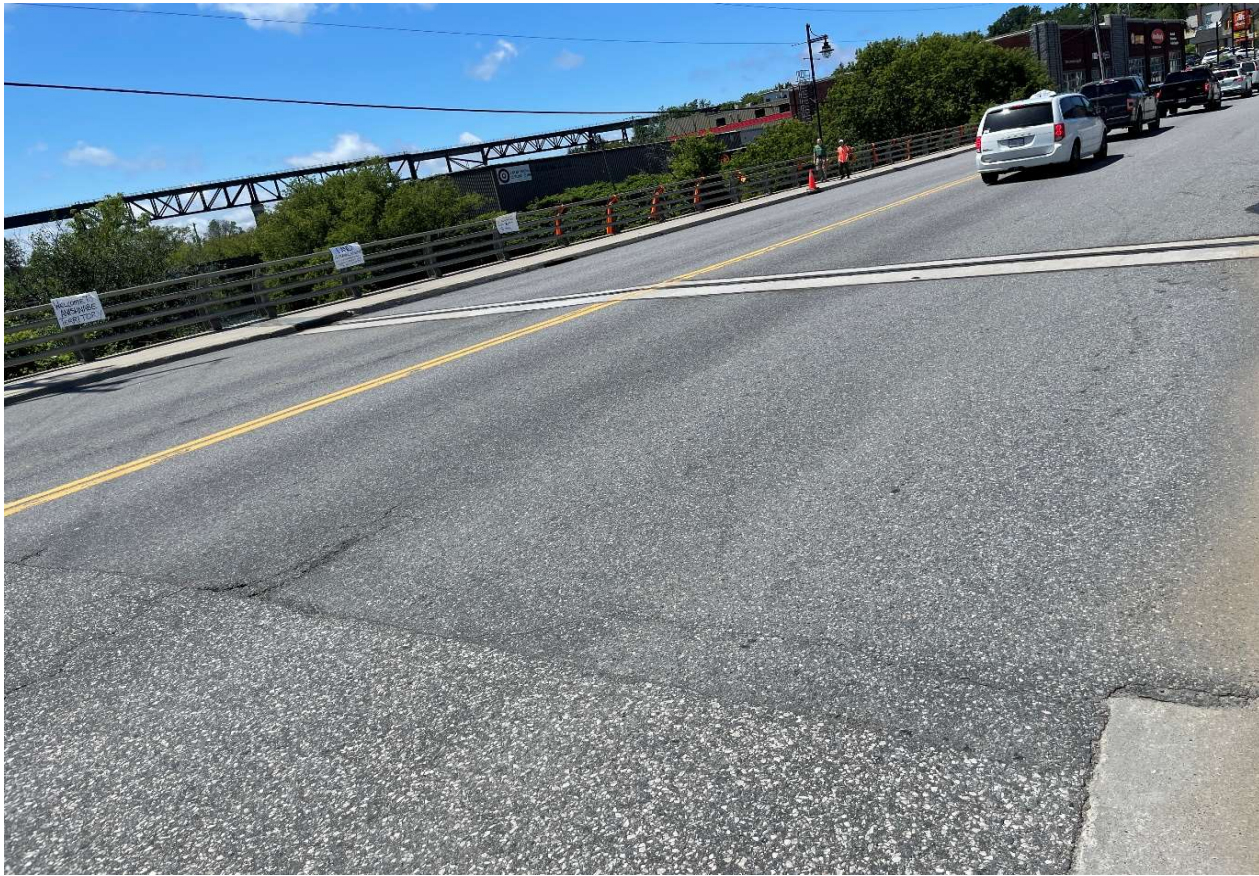
Comments: Light ravelling, typical. West lane has medium wheel rutting 6.0m x 500 x 8mm. Southeast 7m of medium transverse cracks. Medium loss of bond (300mm x 300mm).

**Description of Photo:** West Approach

**Description of Photo:** East Approach

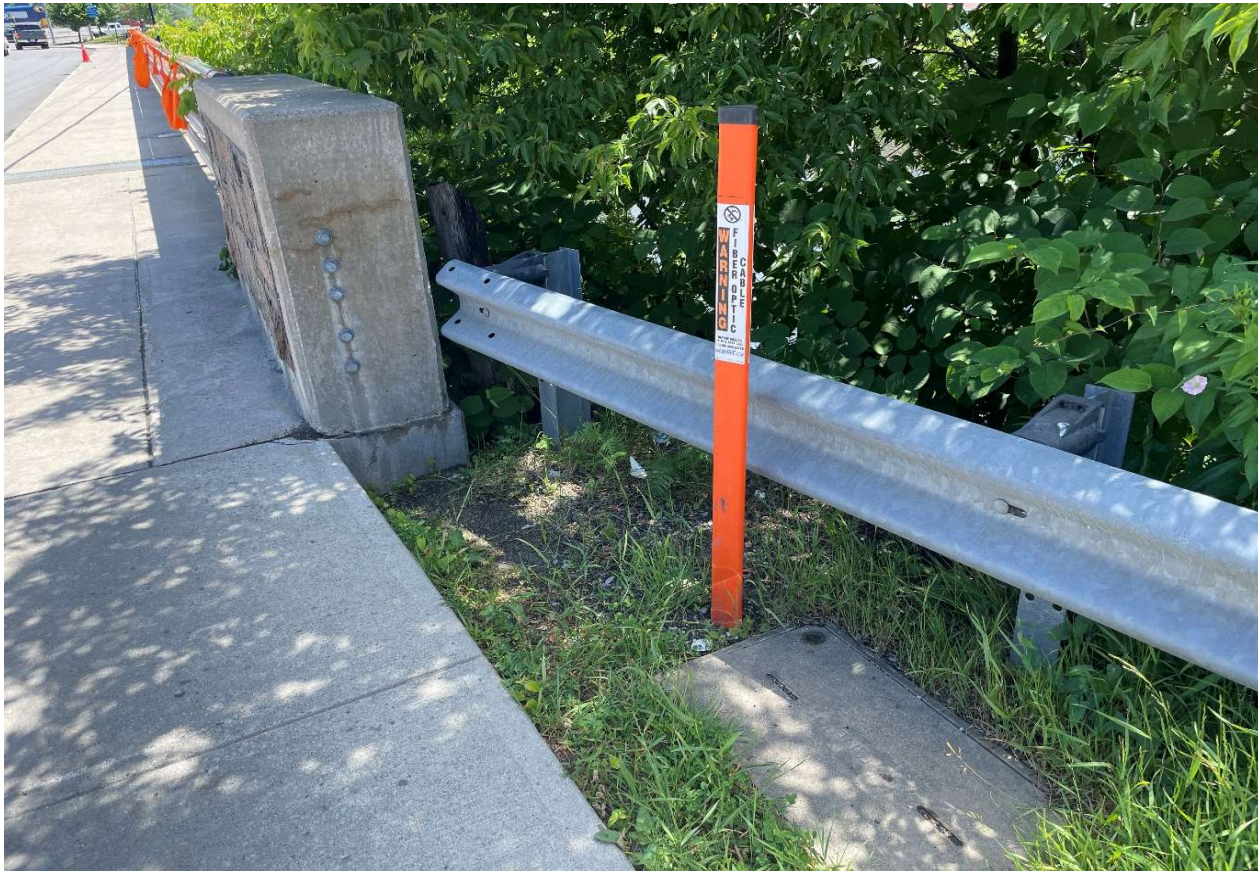
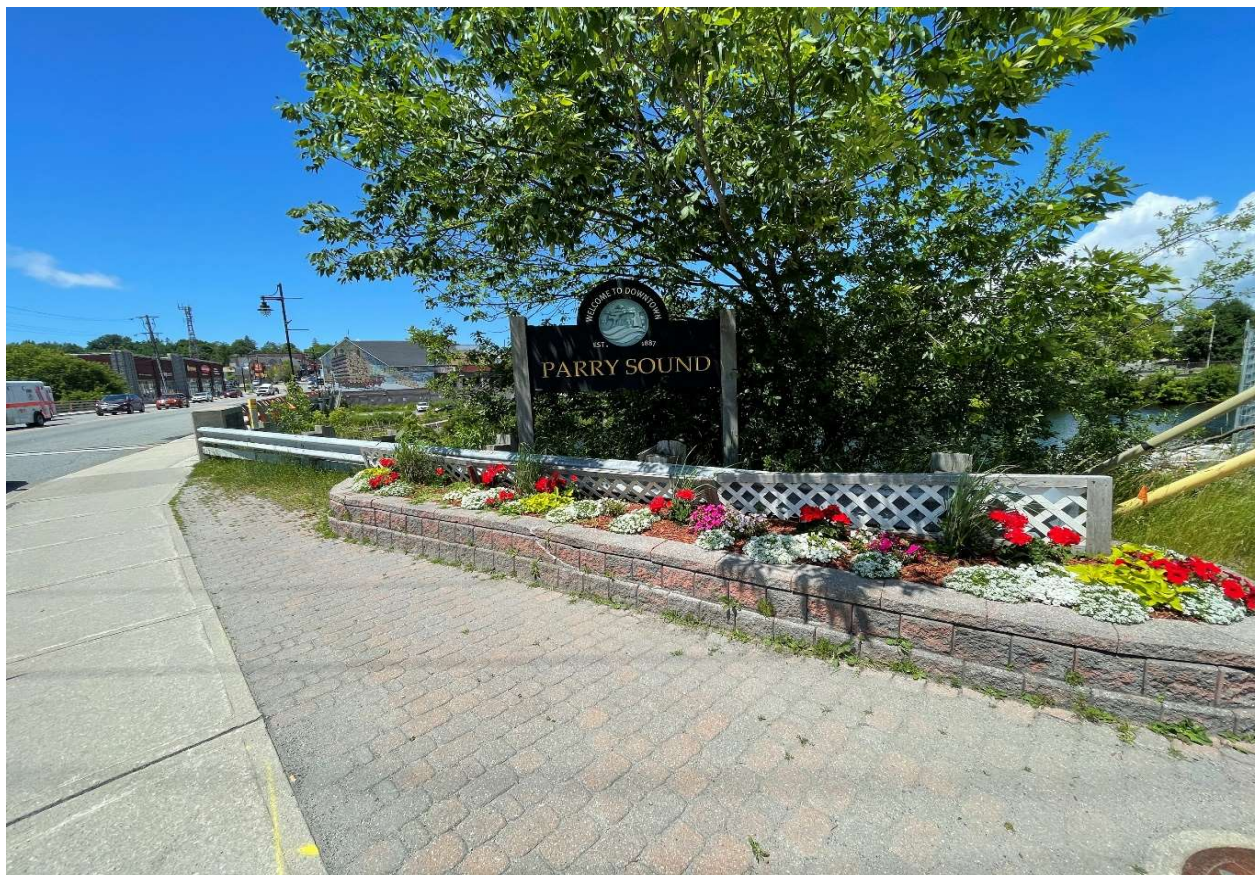
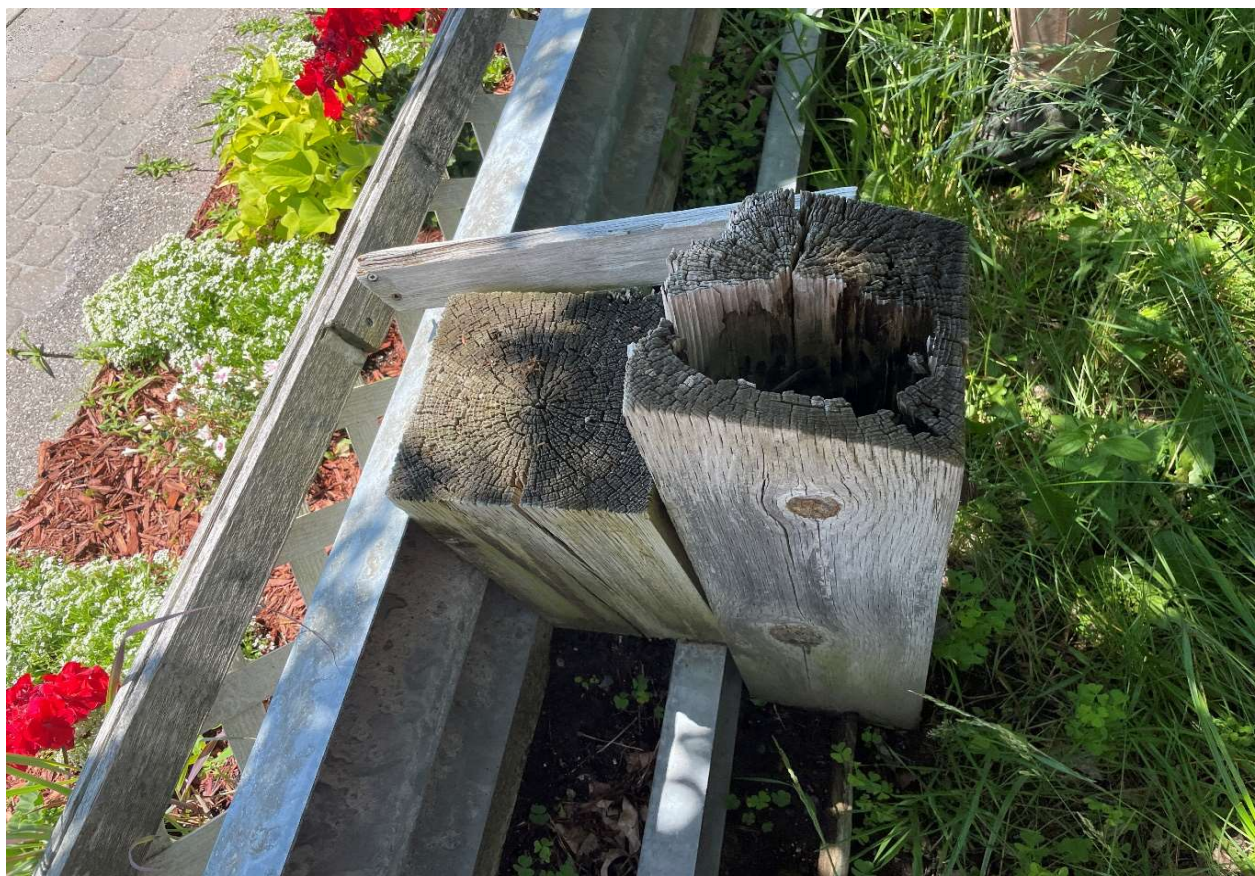
**Description of Photo:** Southwest Barrier

Urgent: <input type="checkbox"/>	1-5 Years: <input checked="" type="checkbox"/>	6-10 Years: <input type="checkbox"/>	None: <input type="checkbox"/>	Urgent: <input type="checkbox"/>	1 Year: <input type="checkbox"/>	2 Year: <input type="checkbox"/>
Replace substandard connections approach barrier to bridge connections

Justification:
Interior girder ends recommended to be cleaned and re-coated to mitigate continued corrosion. The approach guide rail connections to the bridge should be replaced with standard connections. The sidewalk concrete should be repaired to prevent tripping hazard to pedestrians and to maintain its safe use.

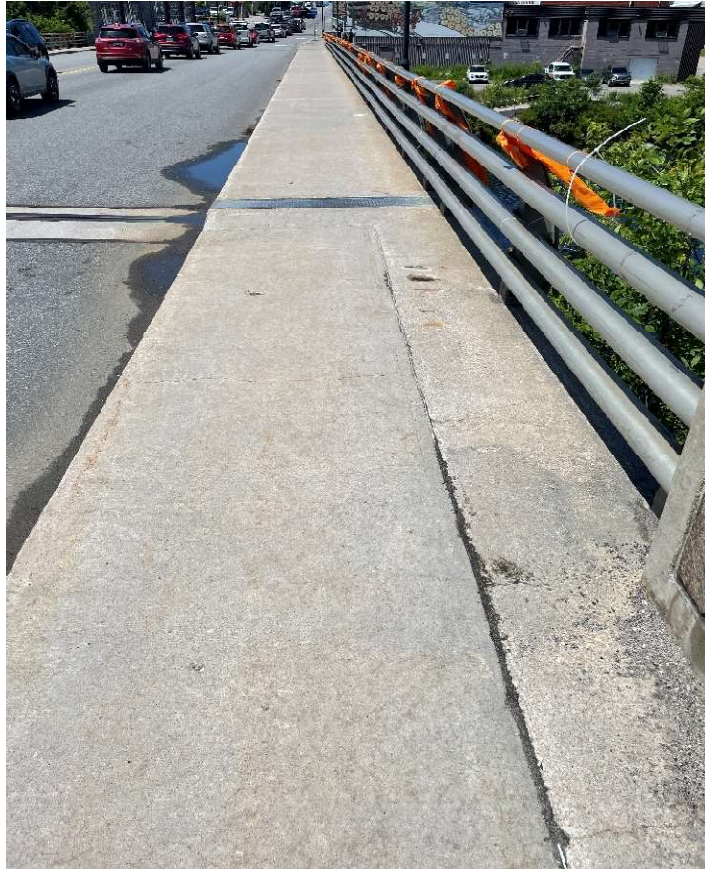
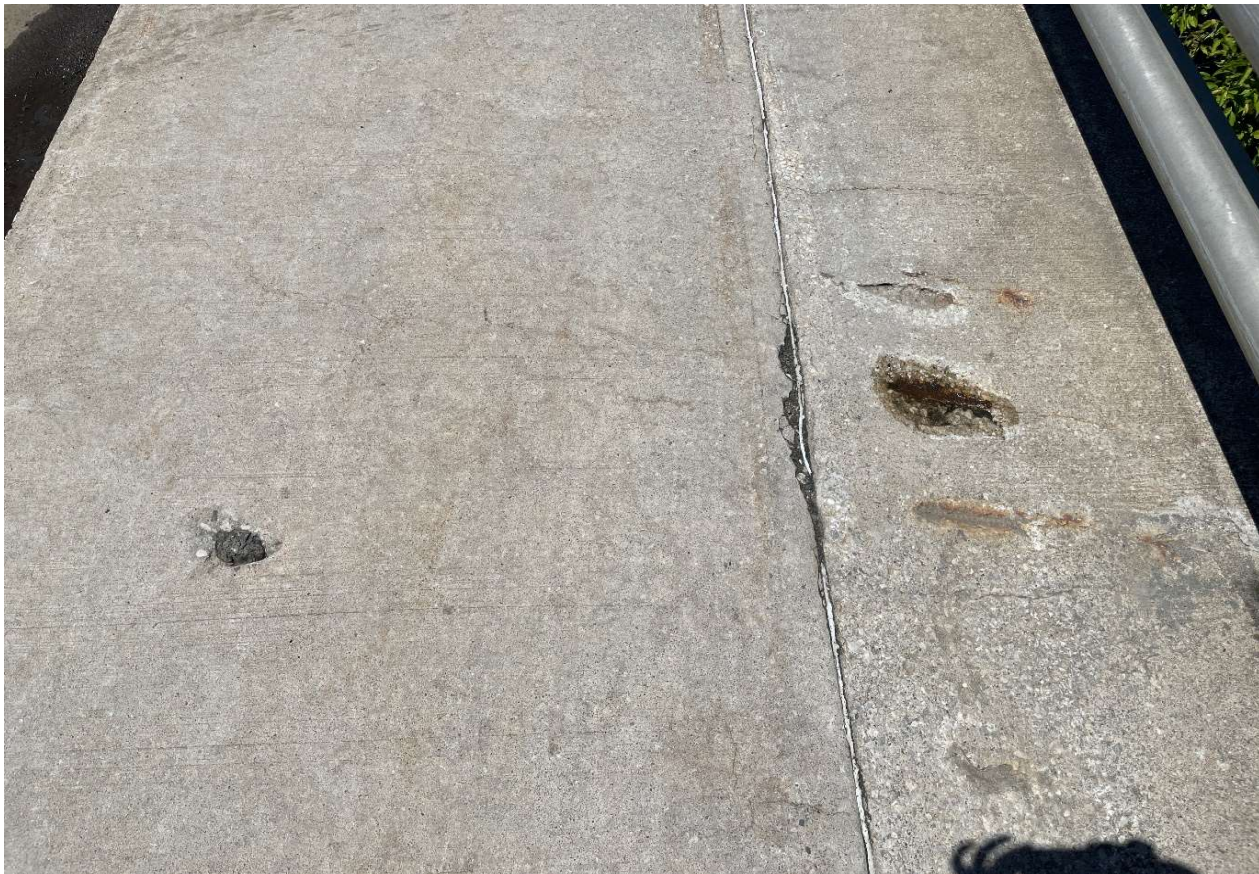
Comments: Light scaling, typical. 4 medium 200x200x 25mm spalls on northeast approach. 200x200x25mm medium spall, 4.5m of medium cracks and 2 - 400 x 400mm spalls on southeast approach. 7.5 of medium cracks on southwest approach. 3.0m of medium cracks and 2.0x 50mm medium spall on northwest approach. 300mm of narrow cracking at the edge of wingwalls.

**Description of Photo:** Approach Sidewalk

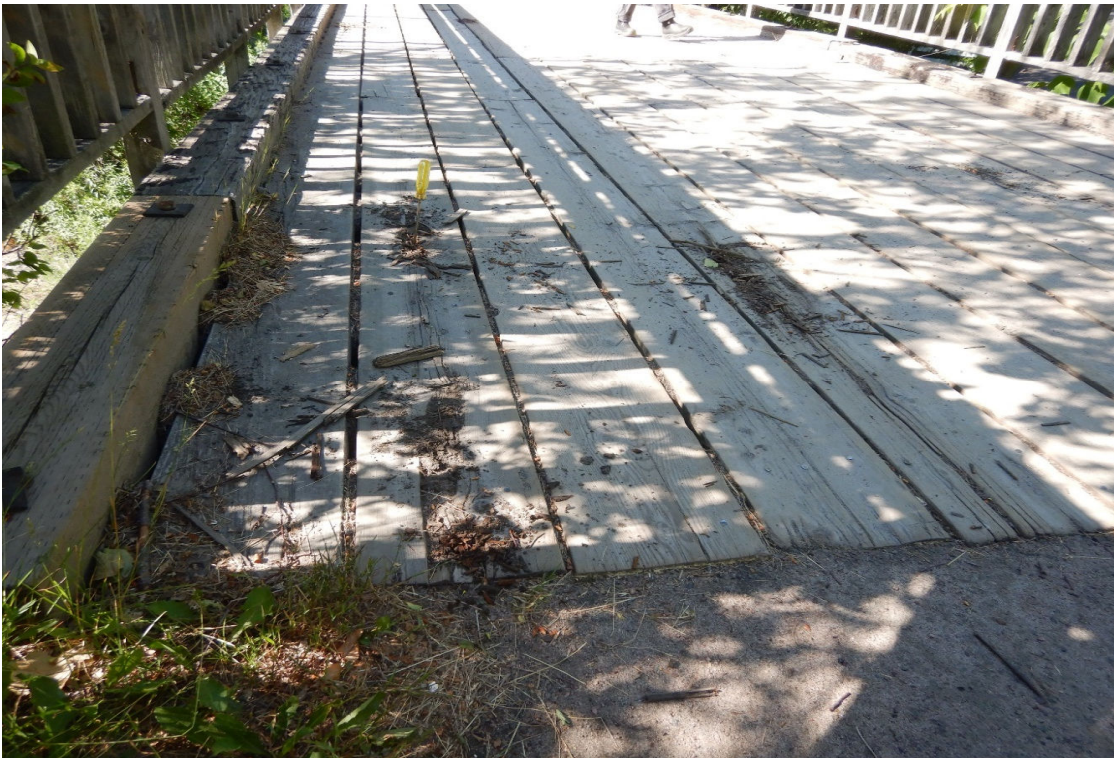
Description of Photo: Deck Top rot

Replace rottent planks				Fasten loose planks			
Element Photo:

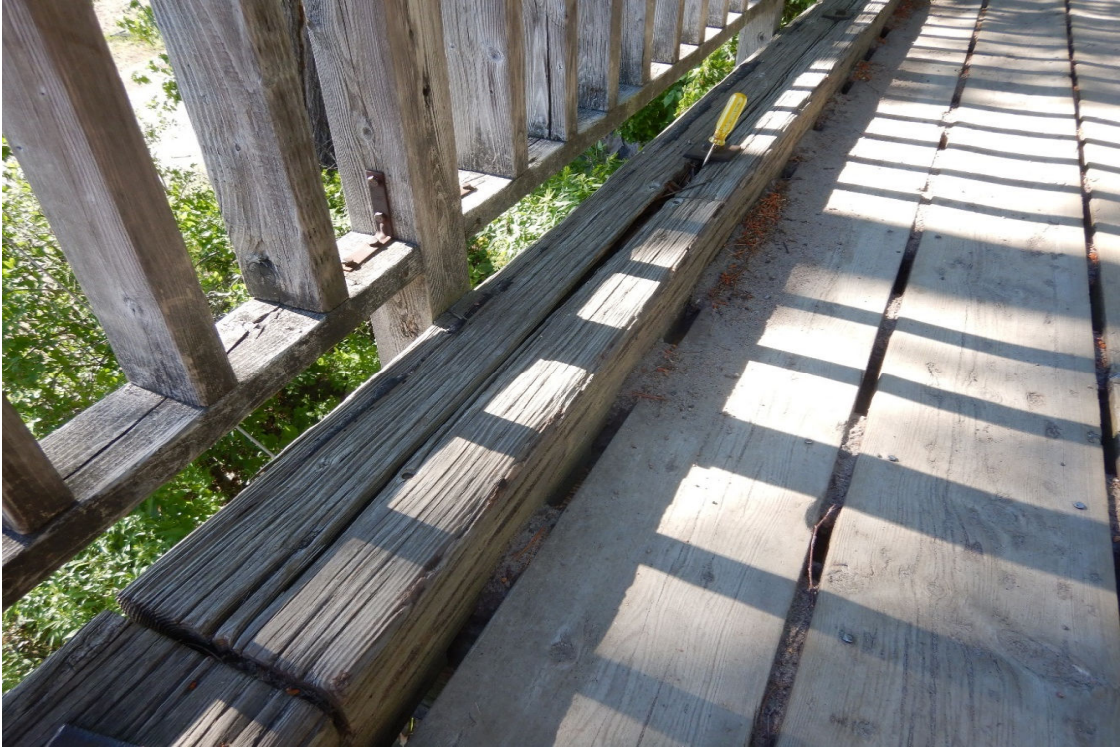
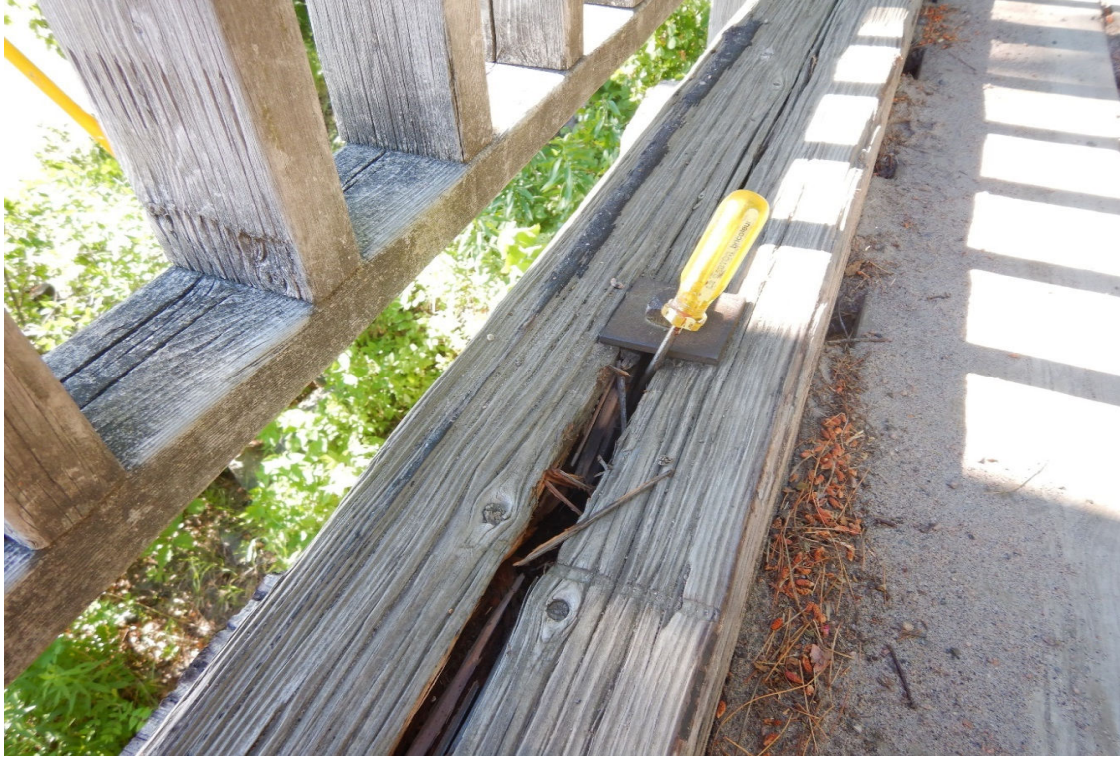
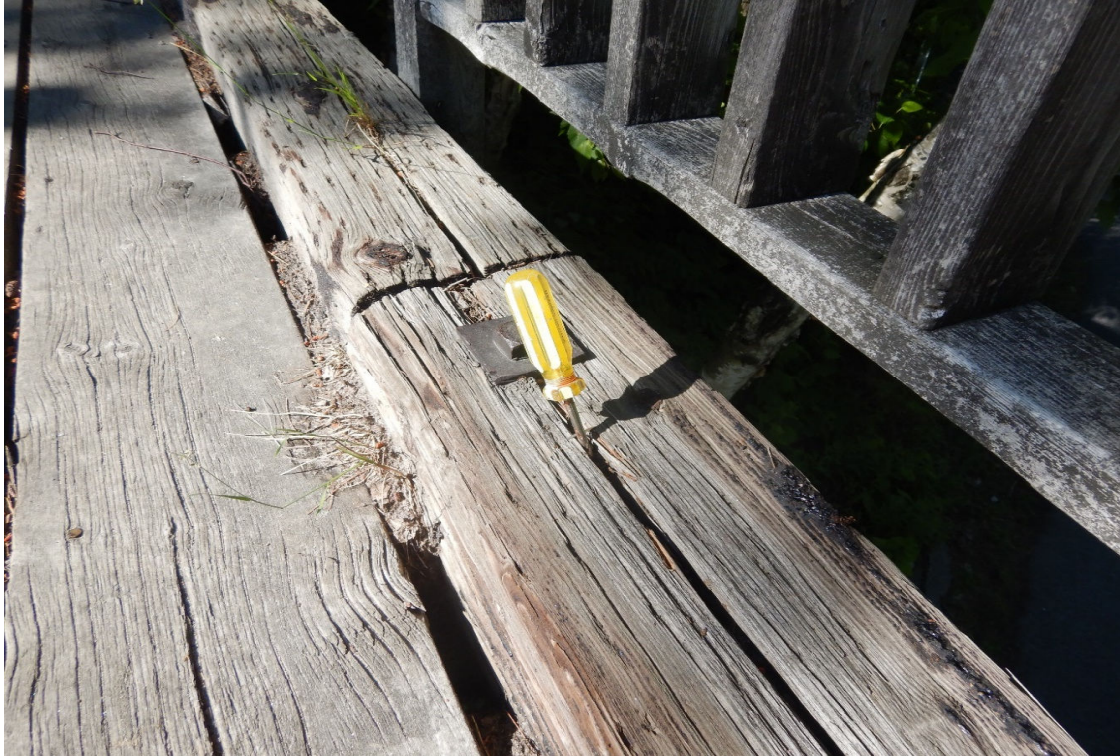
Description of Photo:		Curb

Replace rotten timbers							
Element Photo:

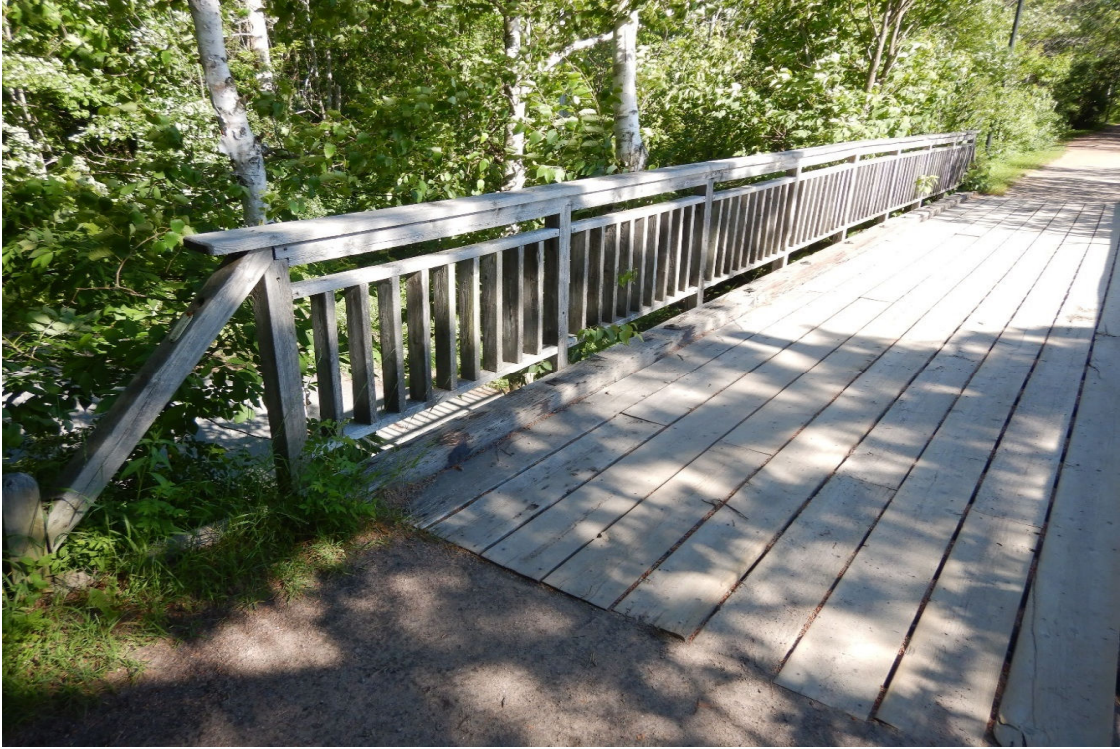
Description of Photo:		Railing

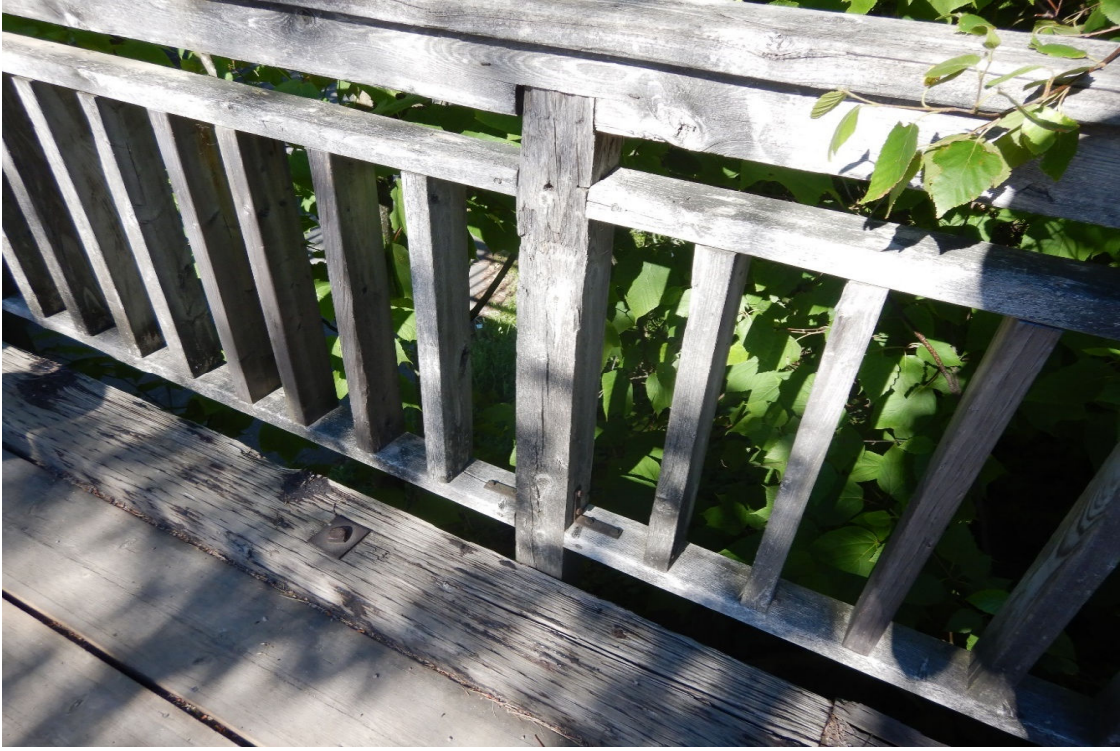
Description of Photo:		Railing Post

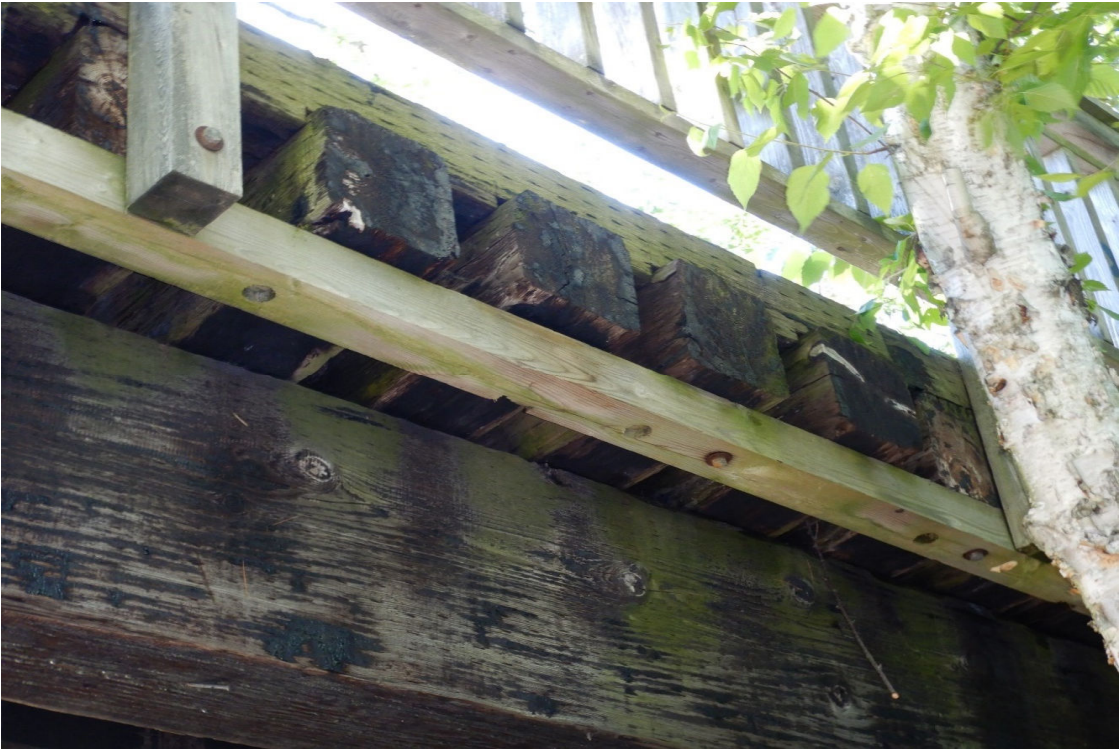
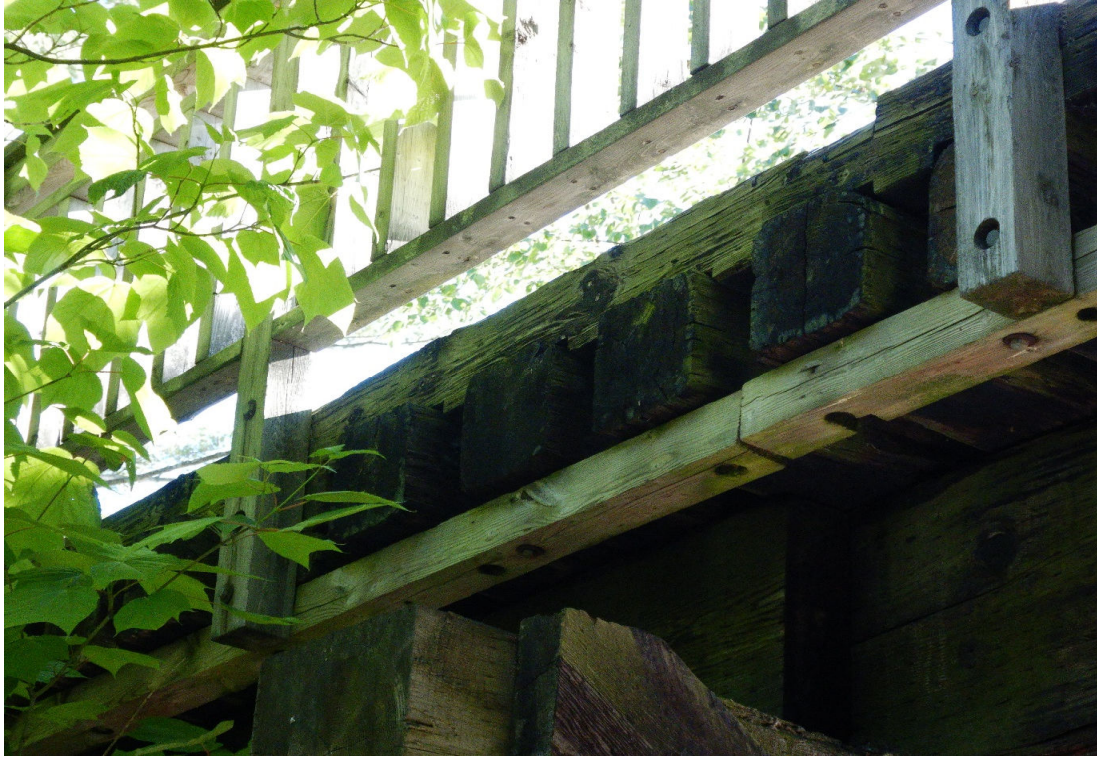
Description of Photo:		Crossties

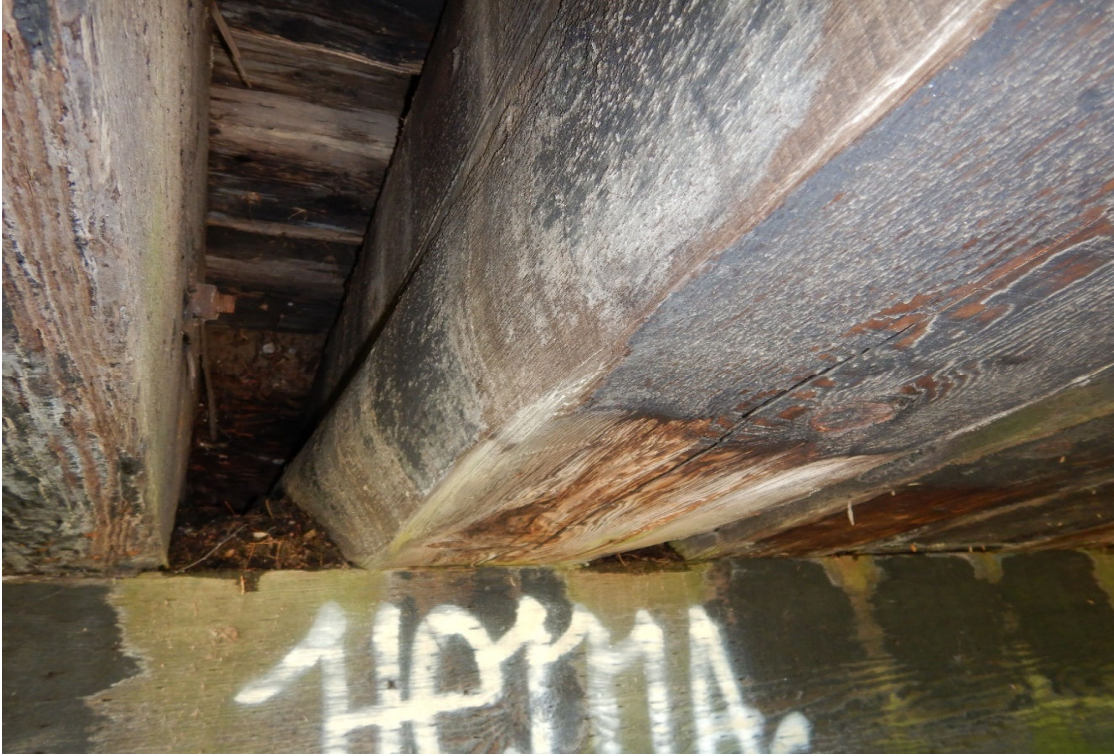
Element Data:							
Element Group:	Beams/Main Longitudinal Elements		Length:	3.73, 4.18, 3.53			
Element Name:	Stringers		Width:	0.25			
Location:			Height:	0.45			
Material:	Wood		Count:	18			
Element Type:	Rectangular Solid		Total Quantity:	288.3			
Environment:	Benign		Inspected	Yes <input checked="" type="checkbox"/>	No <input type="checkbox"/>	limited <input type="checkbox"/>	
Protection System:	Creosote						Performance Deficiencies
Condition Data:	Units	Excellent	Good	Fair	Poor*		
	sq.m		244.1	28.8	15.4	1 - Load carrying capacity	
Comments: Light weathering typical. Isolated medium to severe checks and splits. Center span light splintering on the east and west exterior stringers, likely from vehicle impact. North span center stringer 2.0m of rot from abutment with severe bulging, 2nd girder from west 2.0m of rot from abutment, 6th stringer has 1.0m of rot from abutment with severe bulging and 8th stringer has 1.0m of rot from abutment. South span at pier 3rd and 7th stringer has 1.0m of rot from pier, 7th stringer has 1.0 of rot from abutment. Center span at south pier 9th stringer has 1.0m of rot from pier and 8th stringer has 1.0m of rot from north pier.

Description of Photo: North span 5th stringer rot and bulging

Recommended Work:		Rehab: <input checked="" type="checkbox"/>	Replace: <input type="checkbox"/>	Maintenance Needs:			
Urgent: <input type="checkbox"/>	1-5 Years: <input checked="" type="checkbox"/>	6-10 Years: <input type="checkbox"/>	None: <input type="checkbox"/>	Urgent: <input type="checkbox"/>	1 Year: <input type="checkbox"/>	2 Year: <input type="checkbox"/>	
Replace 8 rotten stringers							
Element Photo:

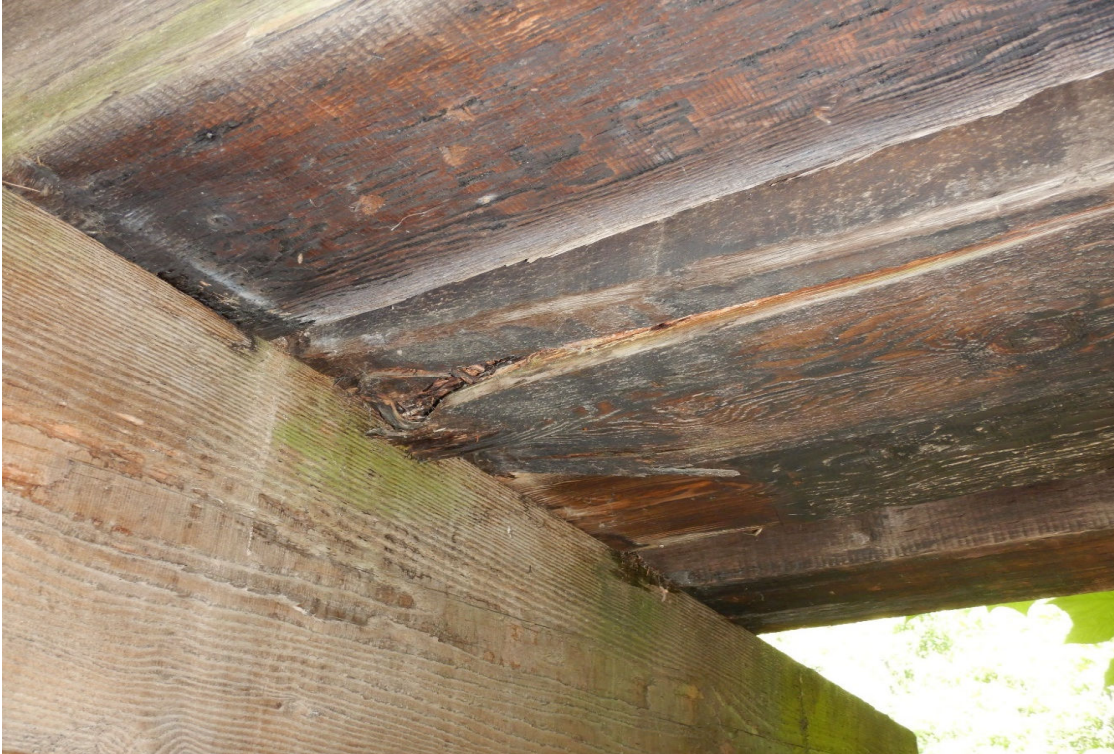
Description of Photo: South span 7th stringer rot

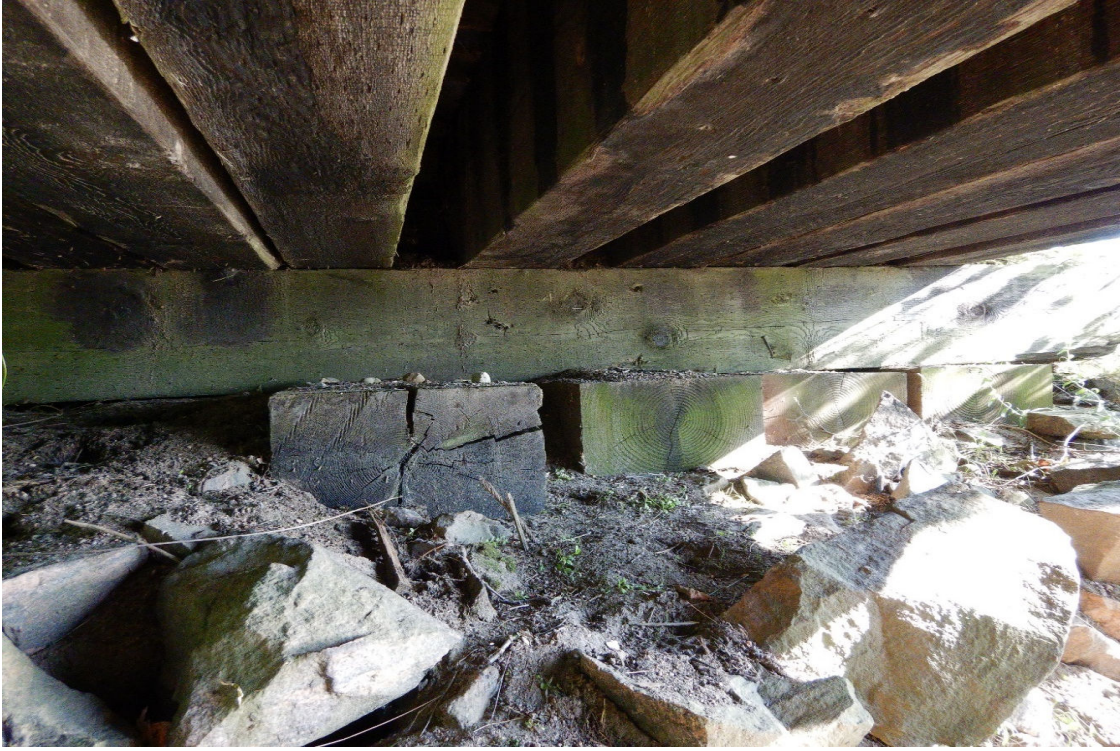
Description of Photo:		Sill

Replace poor timber sills							
Element Photo:

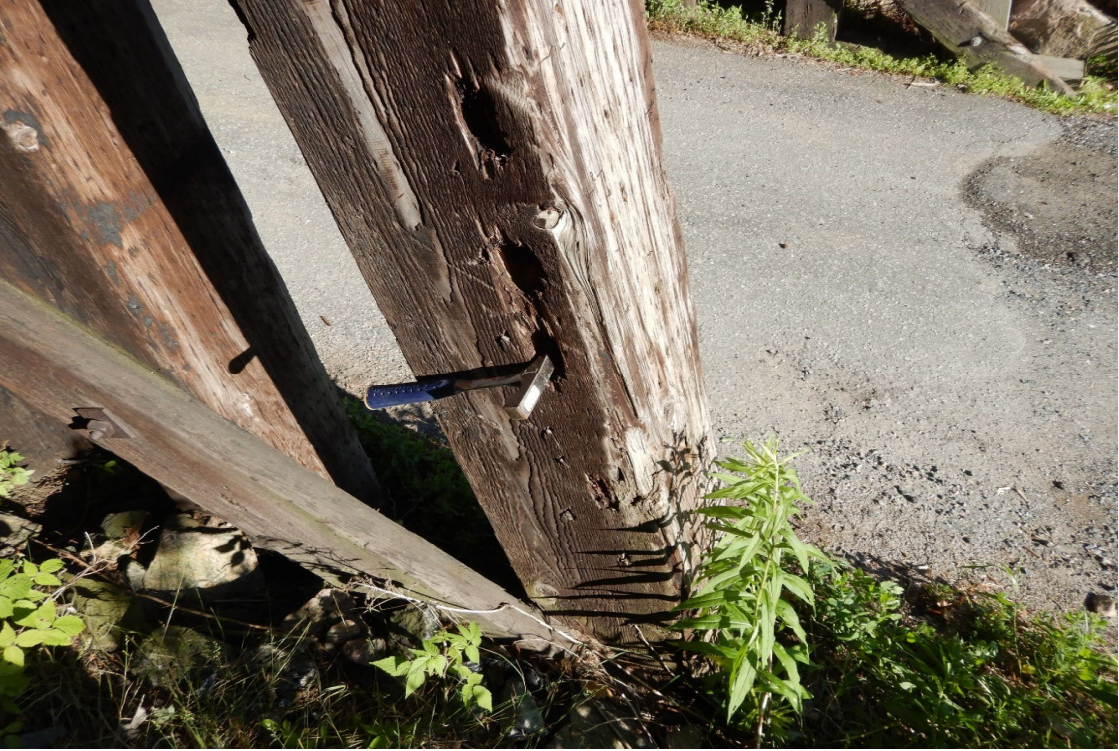
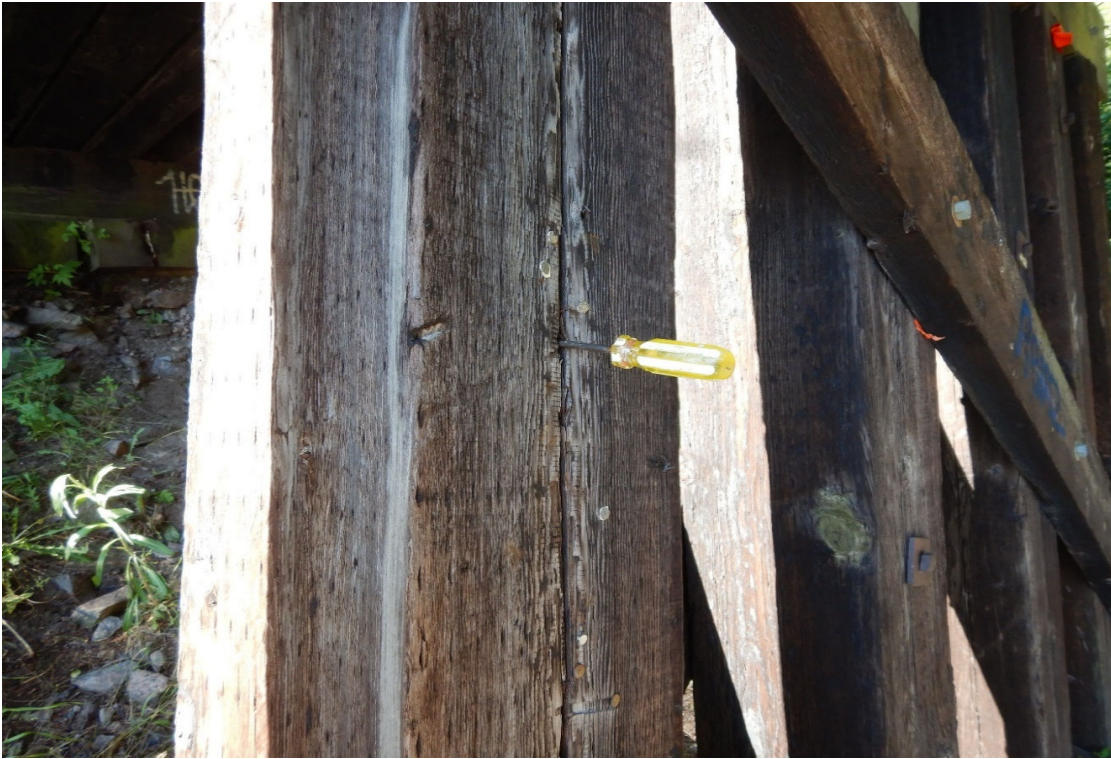
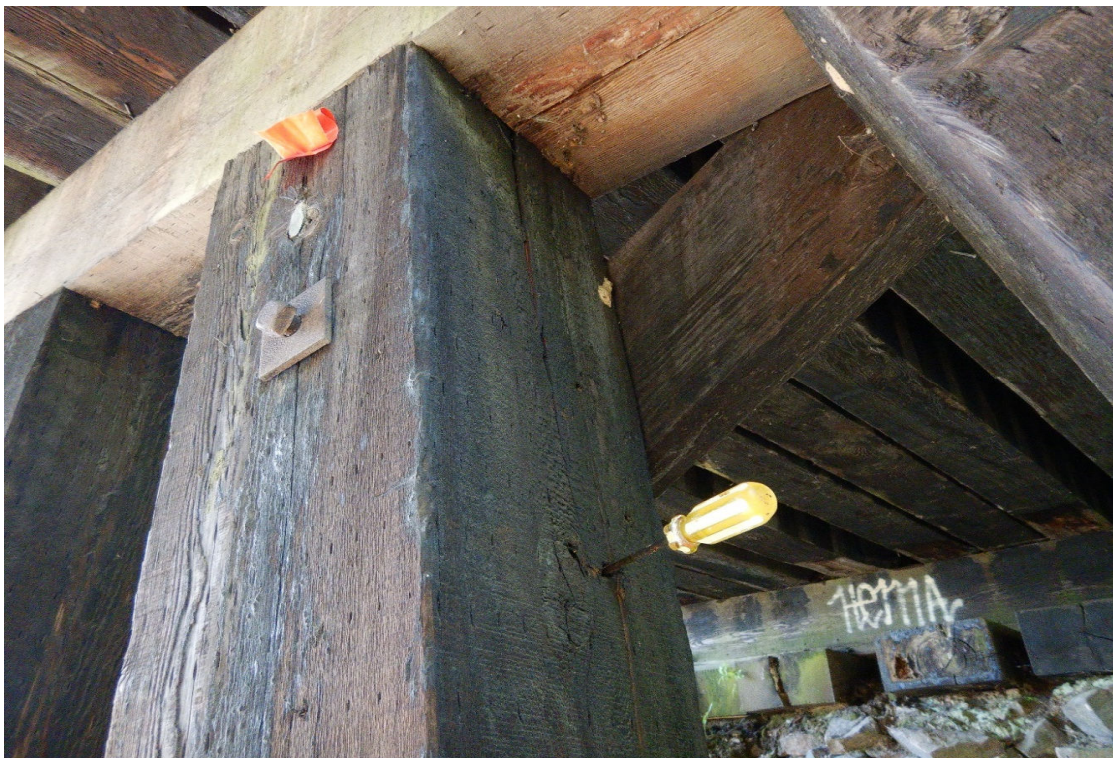
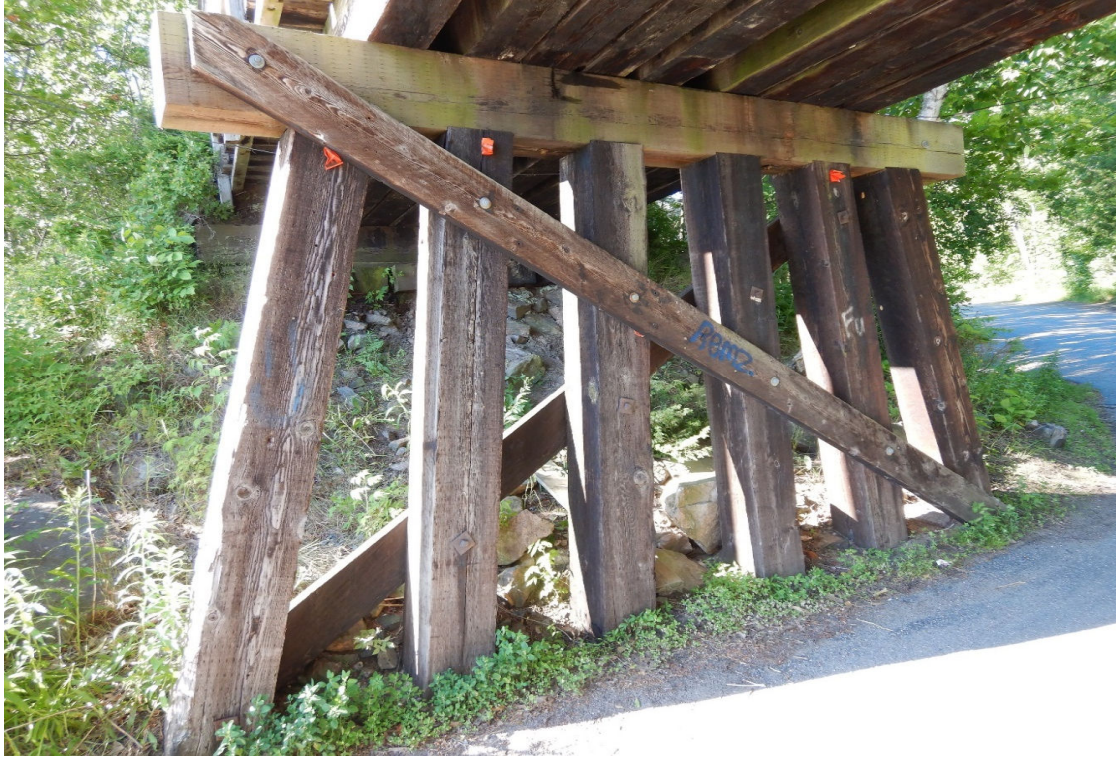
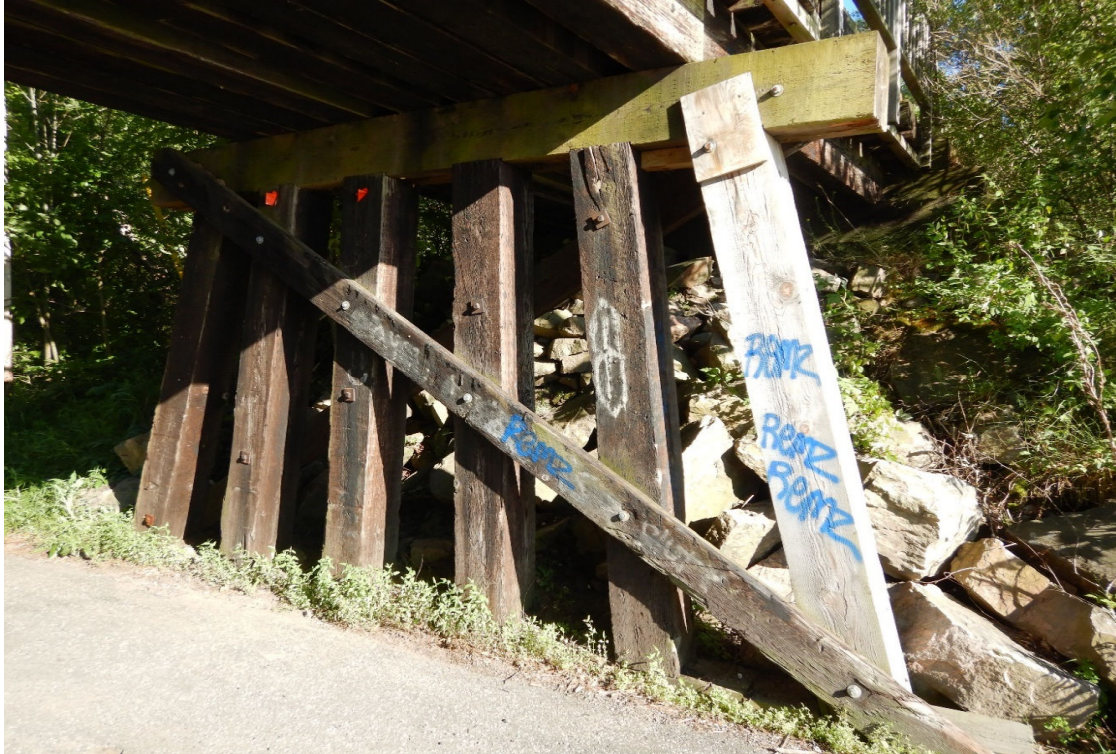
Description of Photo:		North Pier, Column 1

Description of Photo: North Pier, Column 2

Description of Photo: North Pier, Column 5

Description of Photo: North Pier

Description of Photo: South Pier

Urgent: <input type="checkbox"/>	1-5 Years: <input checked="" type="checkbox"/>	6-10 Years: <input type="checkbox"/>	None: <input type="checkbox"/>	Urgent: <input type="checkbox"/>	1 Year: <input type="checkbox"/>	2 Year: <input type="checkbox"/>	
Replace 5 timber columns							
Element Photo:

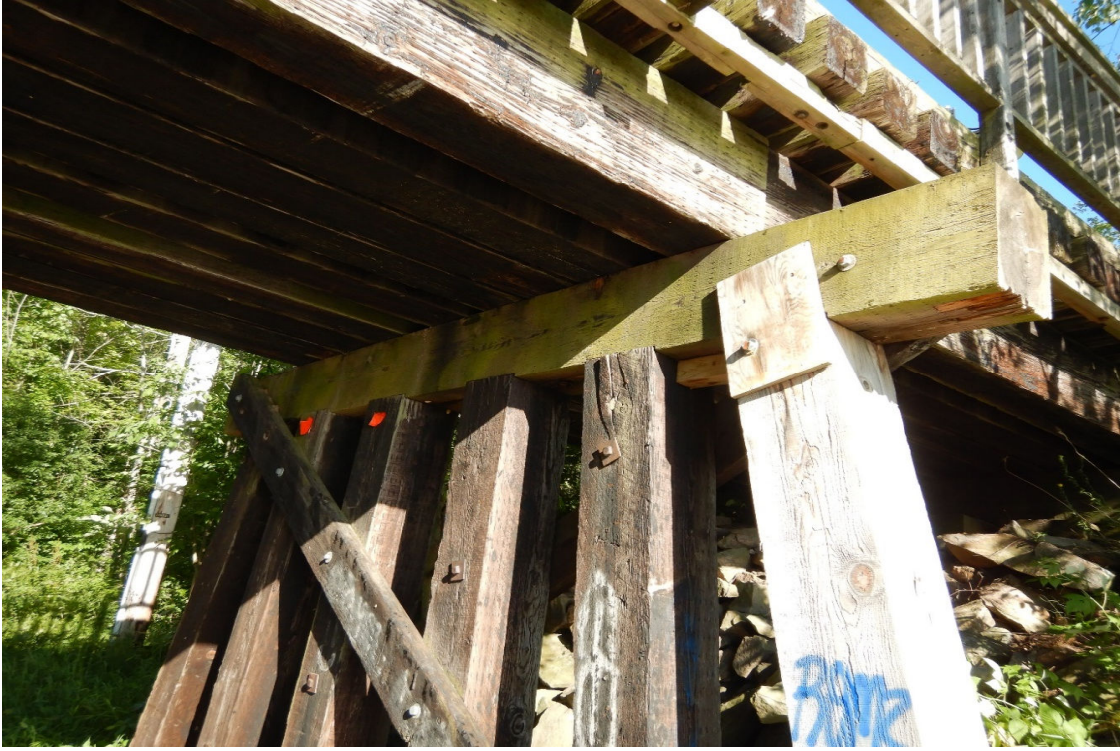
Description of Photo:		Pier Cap
