# Bridge Inspections

**TOWN OF PARRY SOUND**

Inspection Summary Report

January  
12, 2023

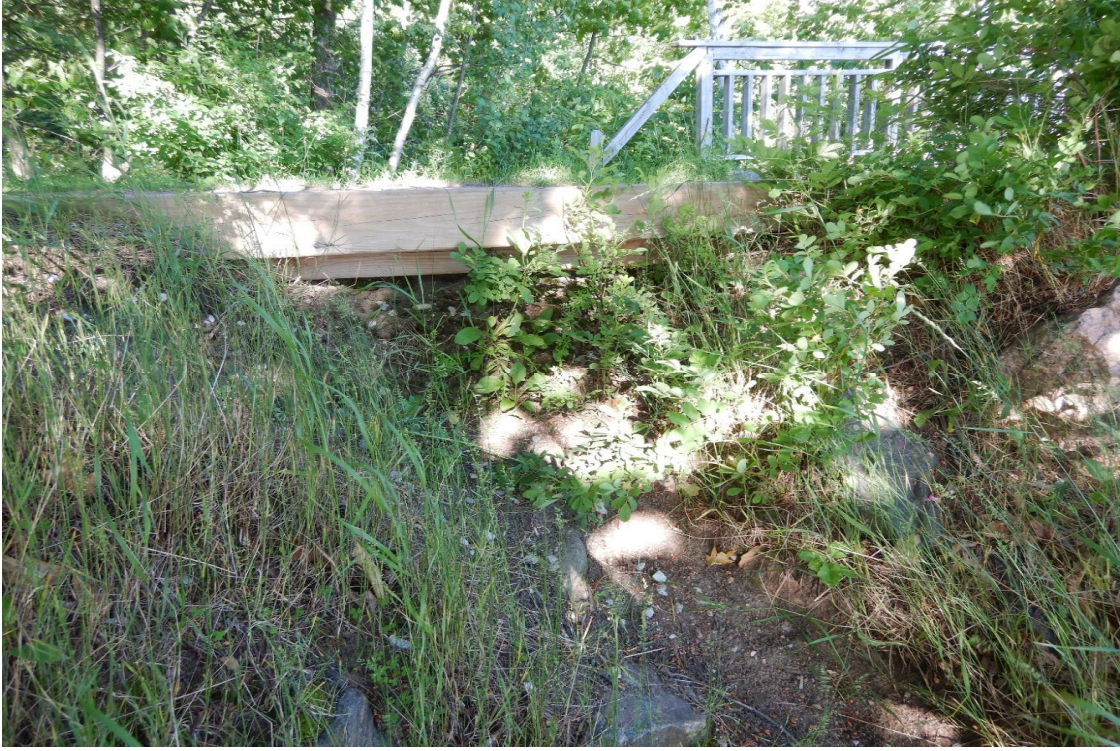
Description of Photo:		Northwest Embankment

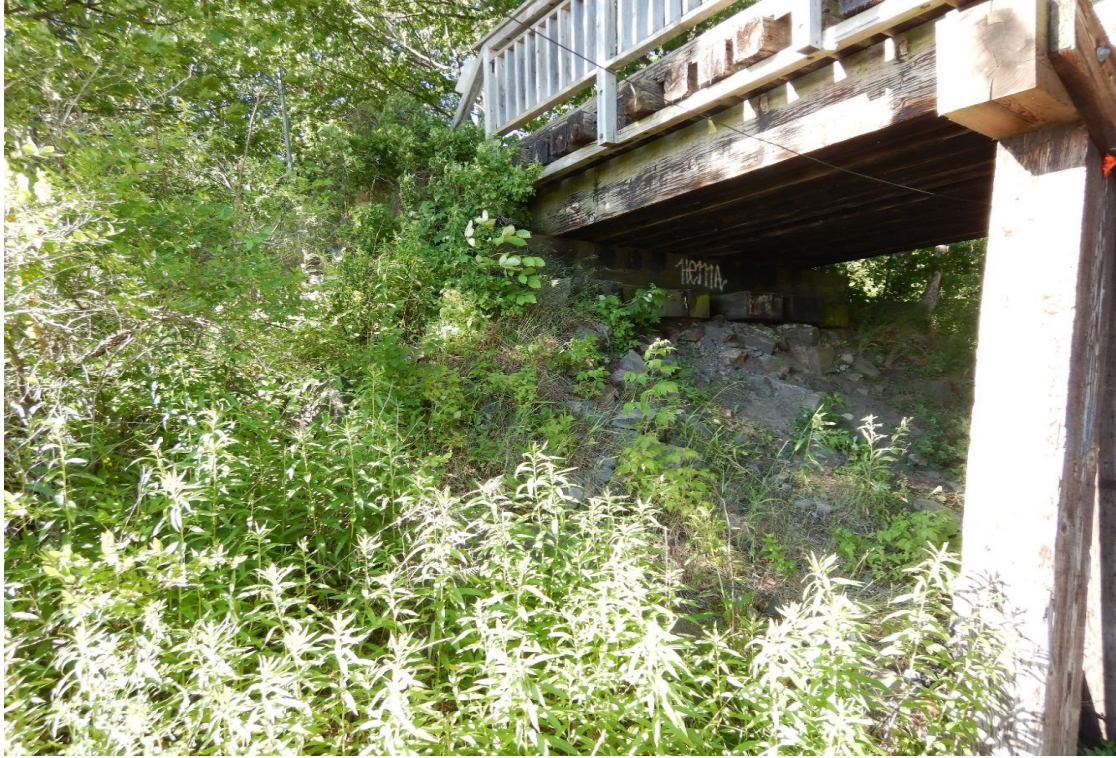
Description of Photo: Southwest Embankment

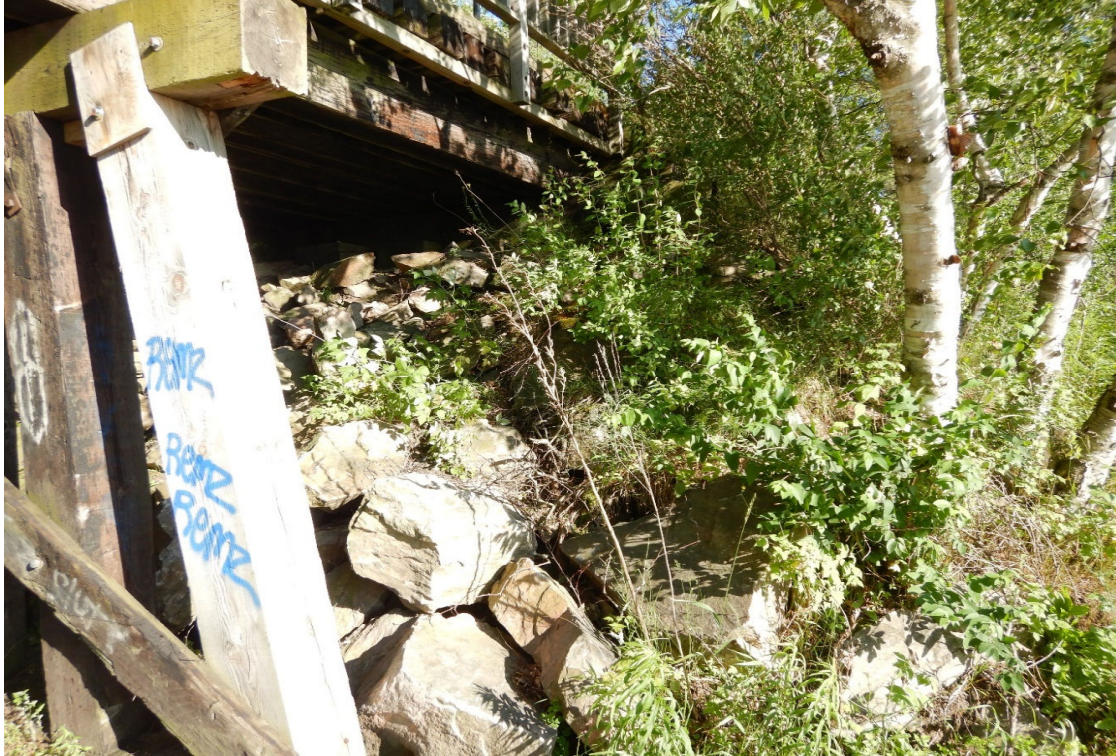
Description of Photo: Northeast Embankment

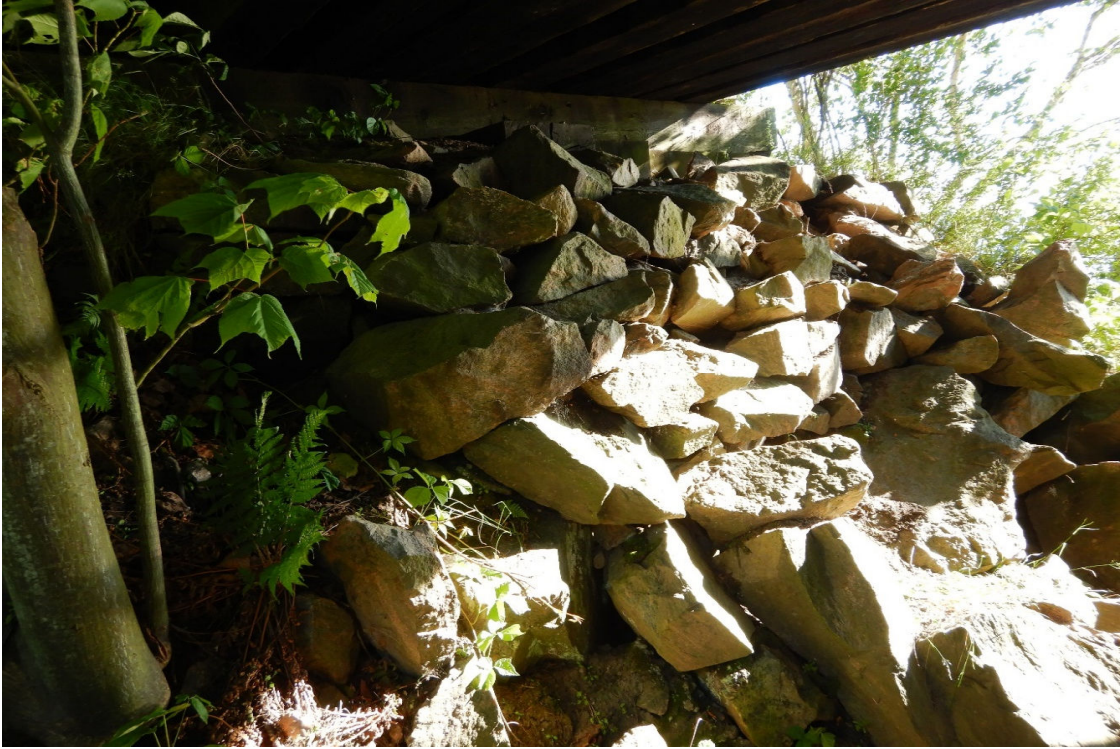
Description of Photo:		South slope protection

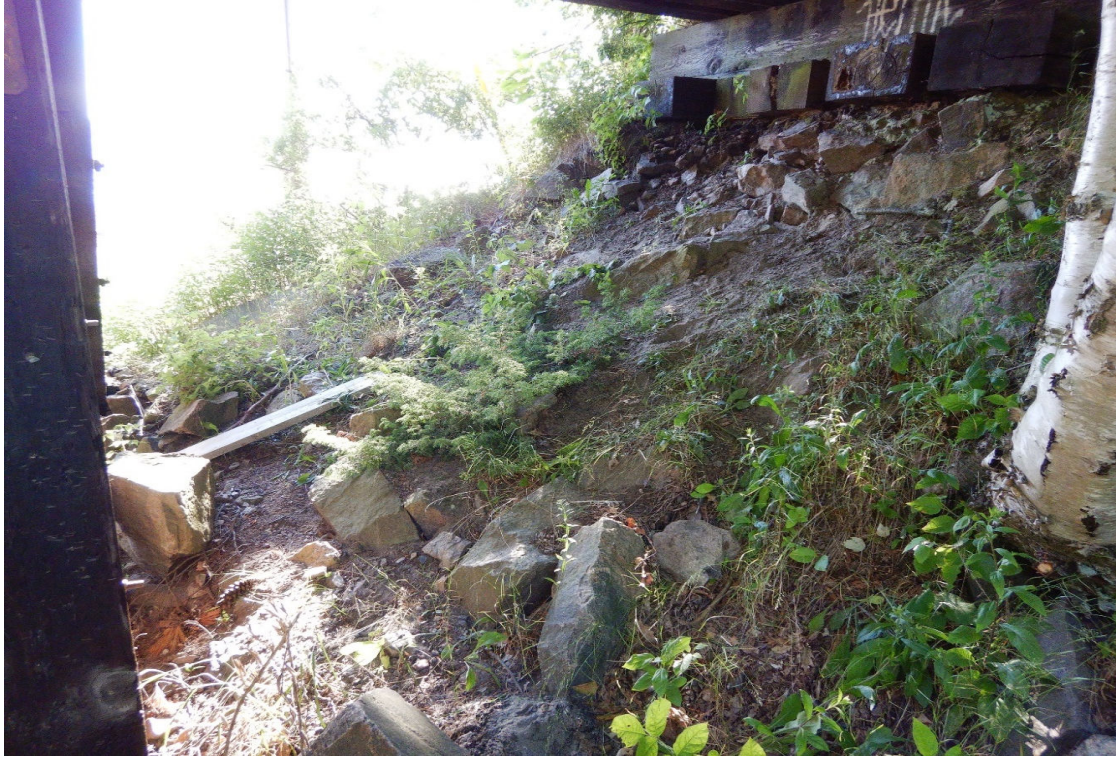
Description of Photo: North slope protection

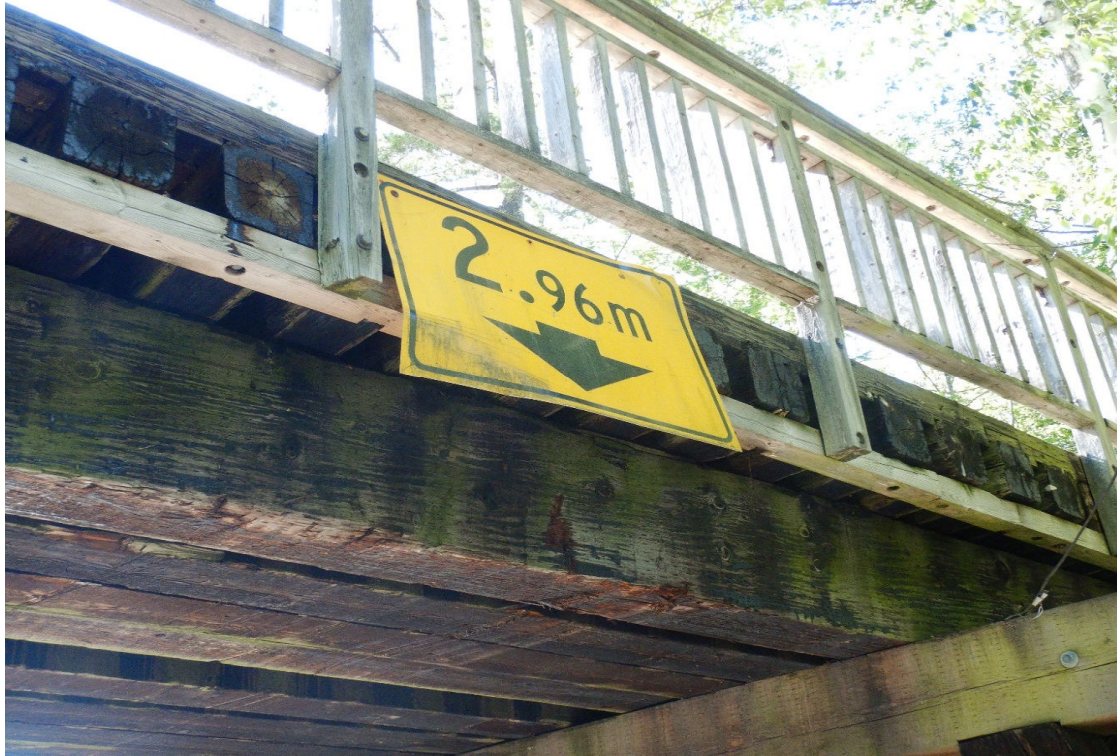
Description of Photo: Clearance sign

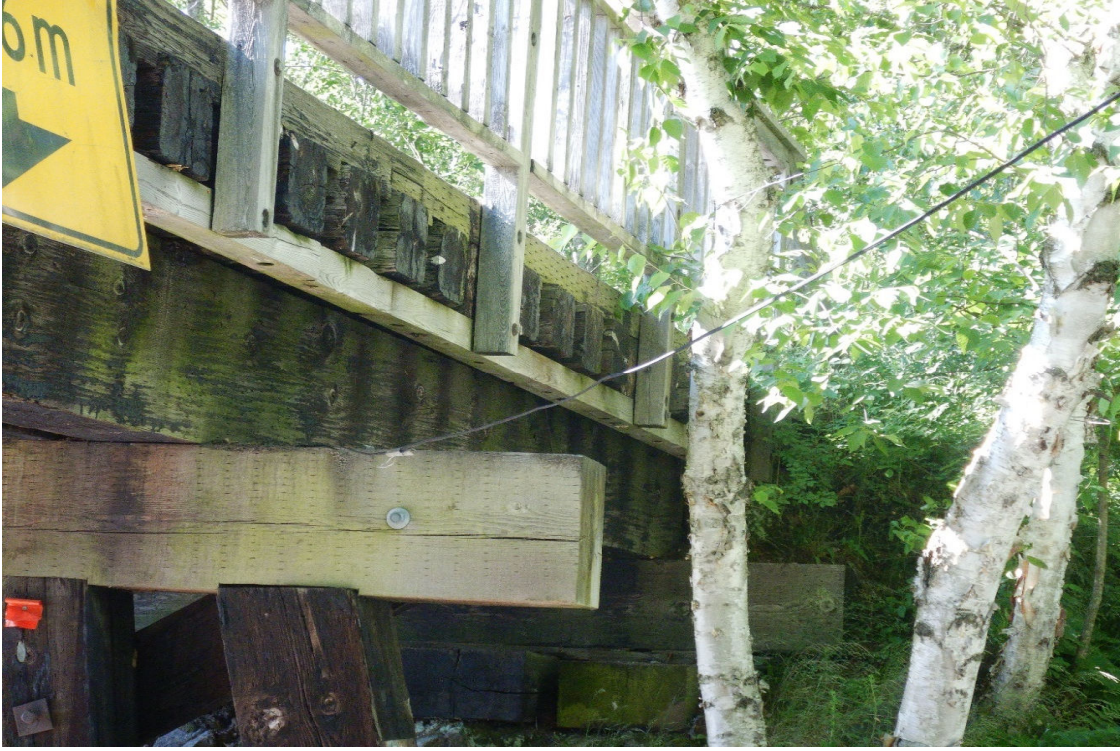
Description of Photo:		Utility

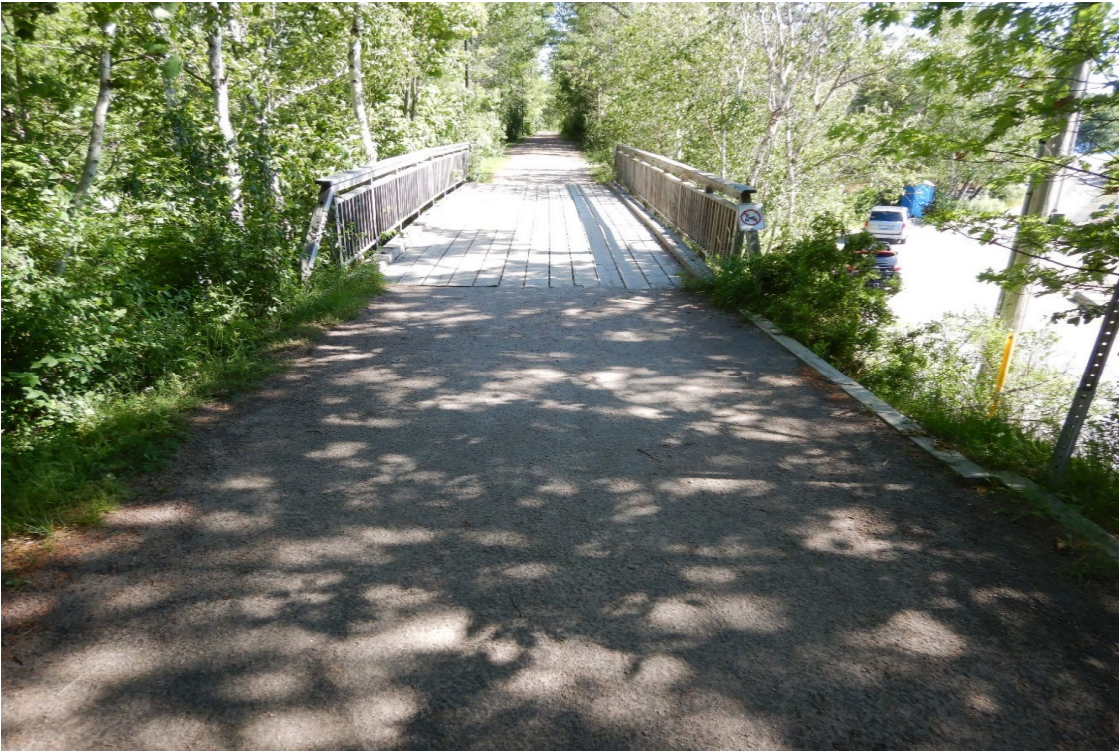
Description of Photo:		Approach looking south

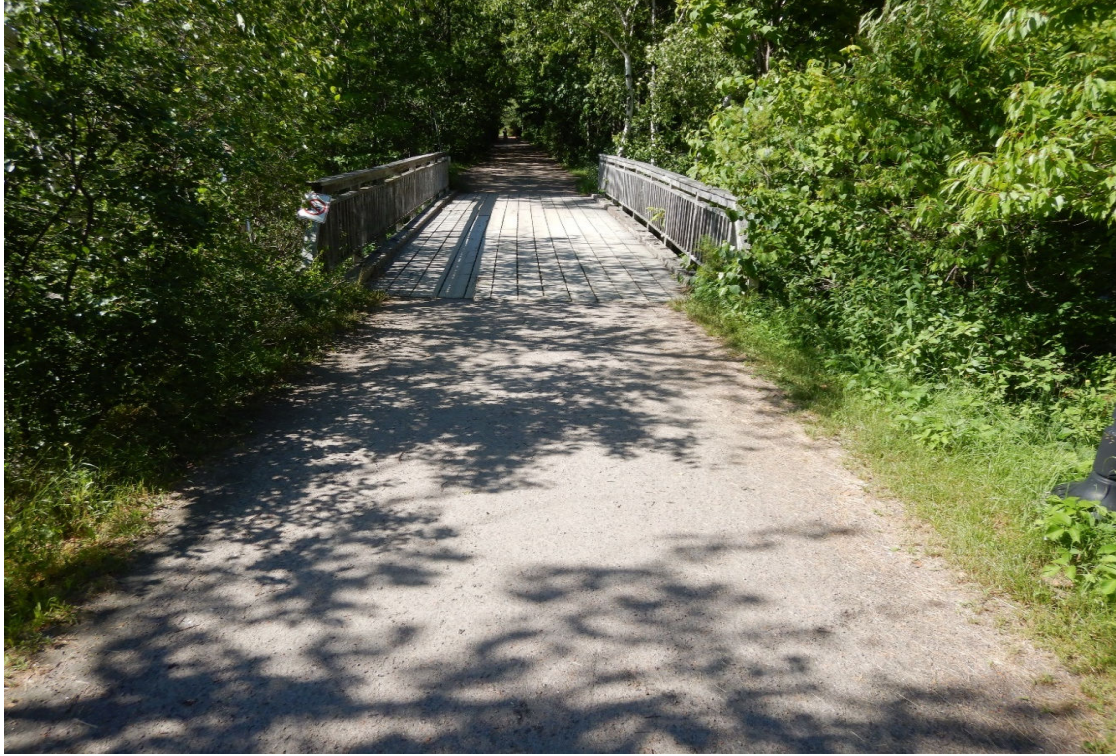
**Description of Photo:** Approach looking north
