Parry Sound Harbour, Ontario

Bay St. Wharf (#401)
Condition Assessment Report

Small Craft Harbours, Fisheries and Oceans Canada

March 2024

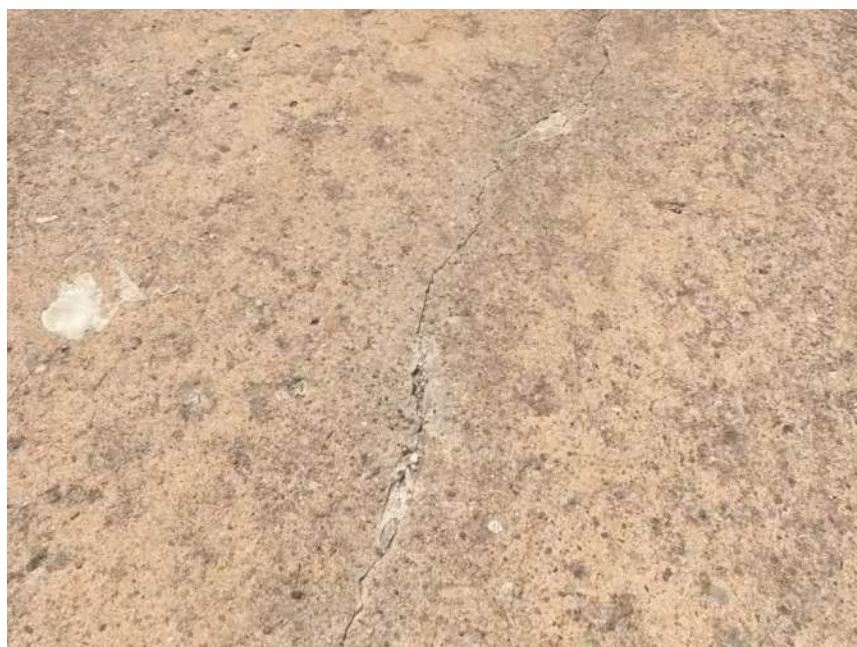
PHOTO # 8

Crack at 0+013 on the west side

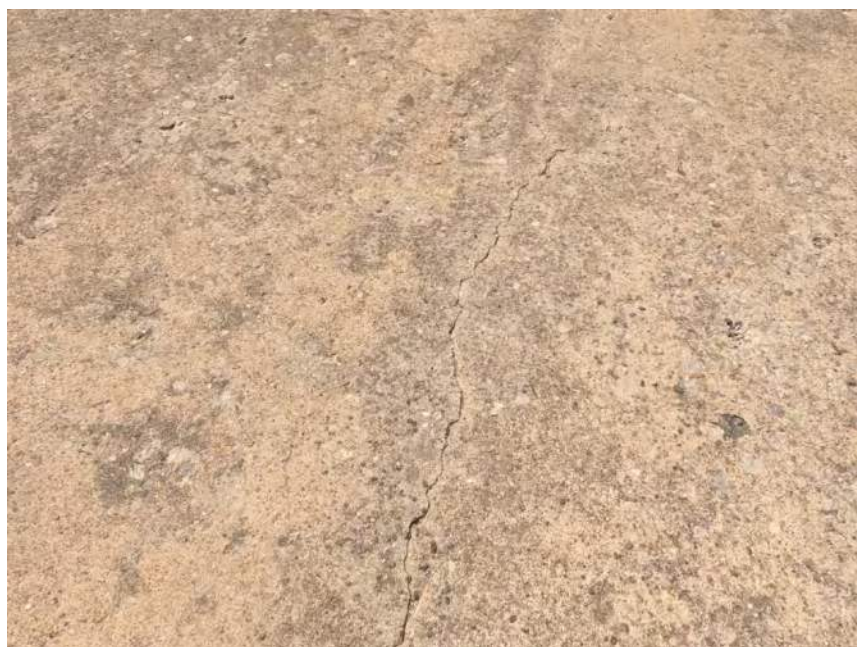
PHOTO # 9

Crack at 0+013 on the west side

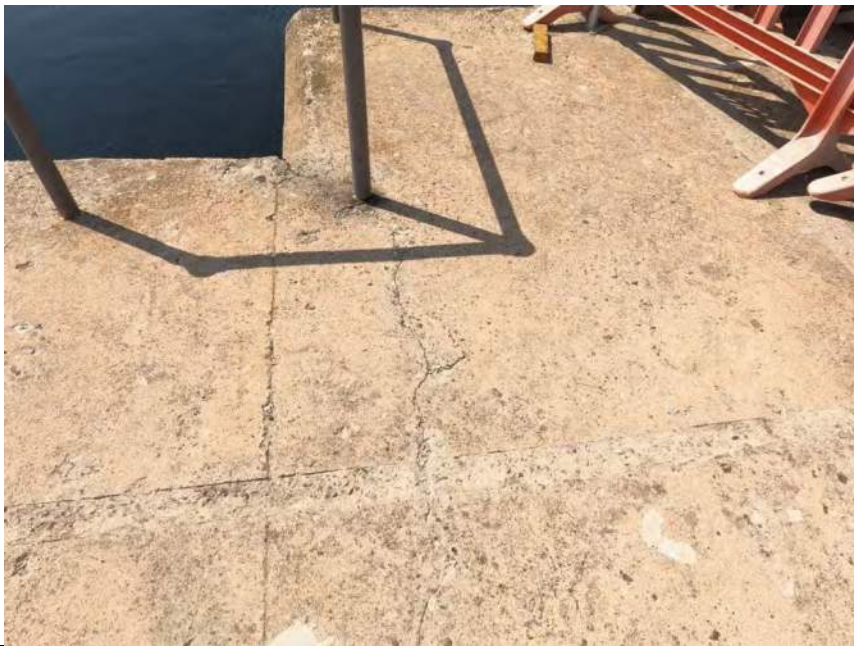
PHOTO # 10

Crack at 0+019 on the west side

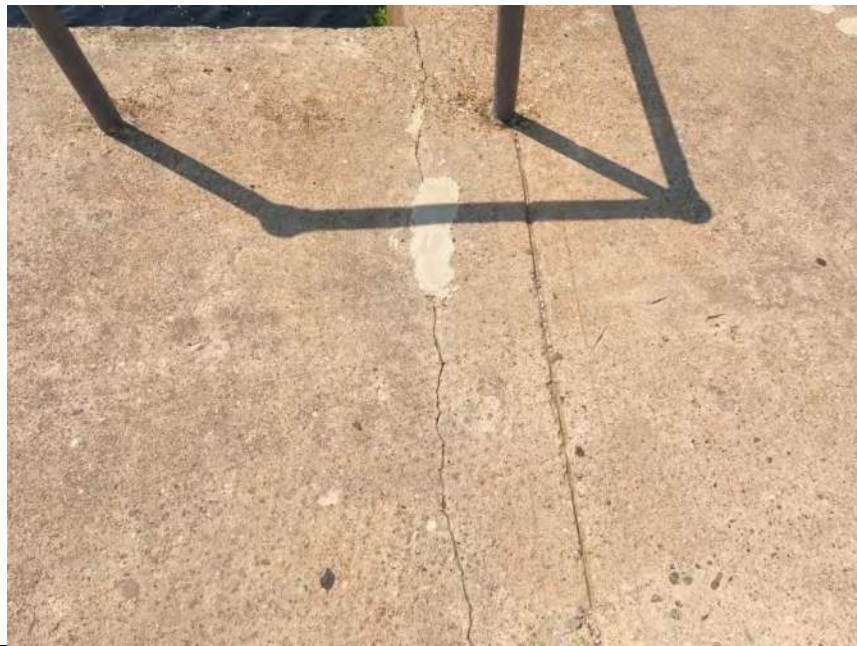
PHOTO # 16

Crack at 0+052 on the west side

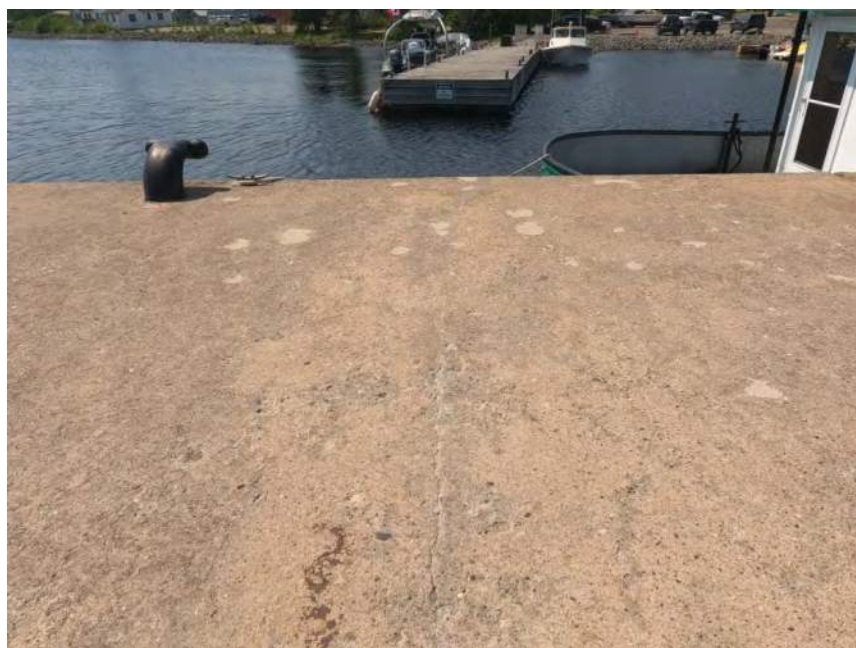
PHOTO # 22

Crack at 0+074 on the west side

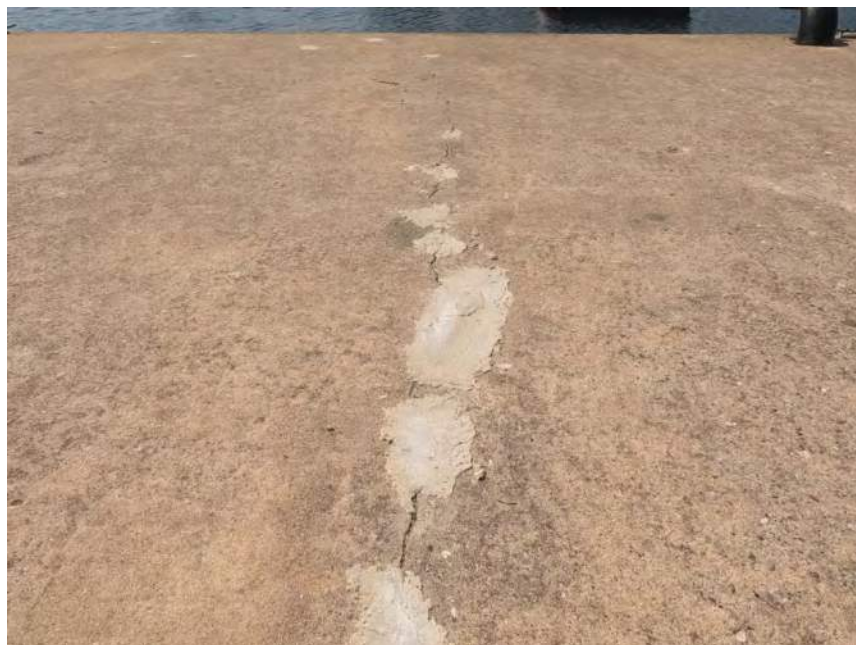
PHOTO # 24

Crack at 0+077 on the west side

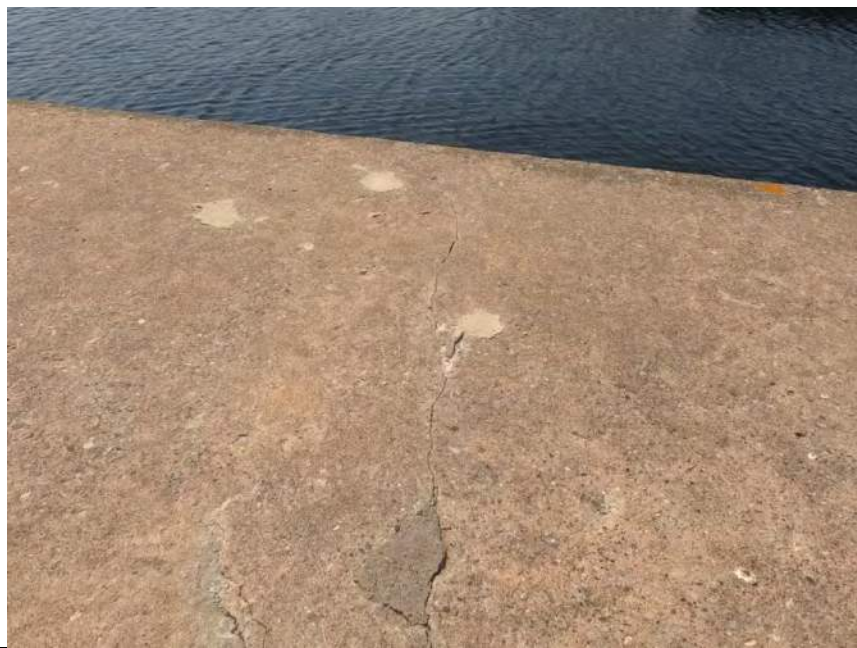
PHOTO # 25

Crack at 0+077 on the west side

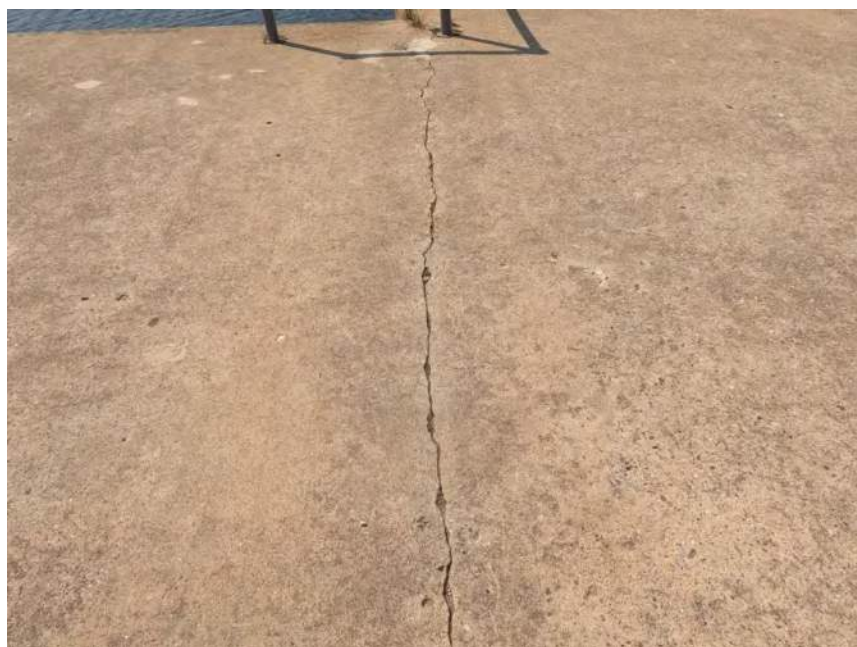
PHOTO # 27

Crack at 0+082 on the west side

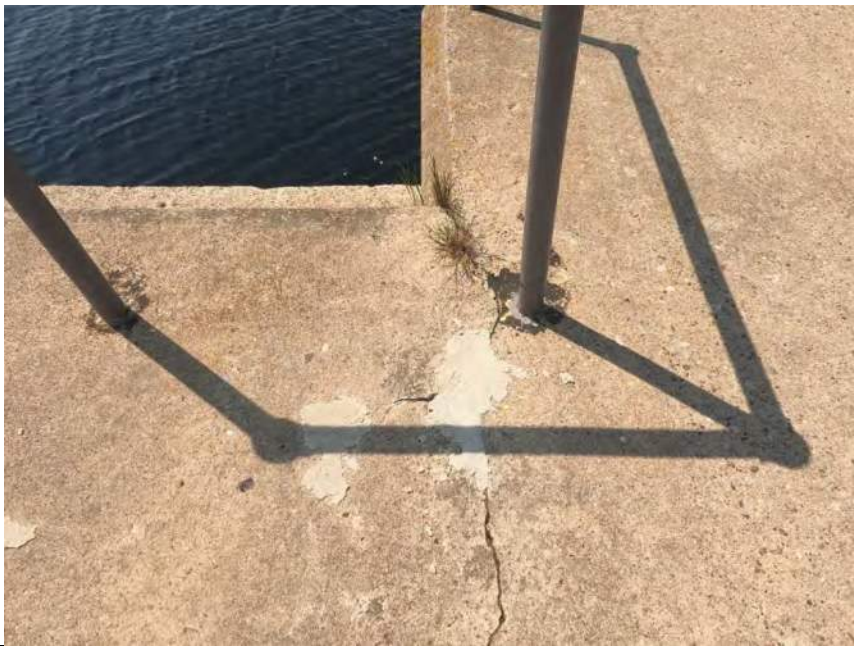
PHOTO # 28

Crack at 0+082 on the west side

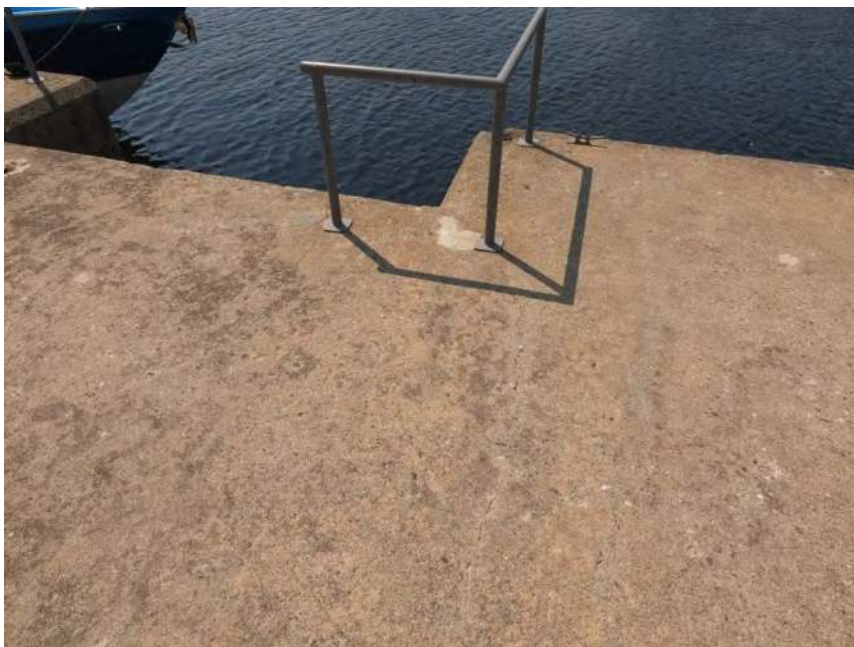
PHOTO # 29

Crack at 0+098 on the west side

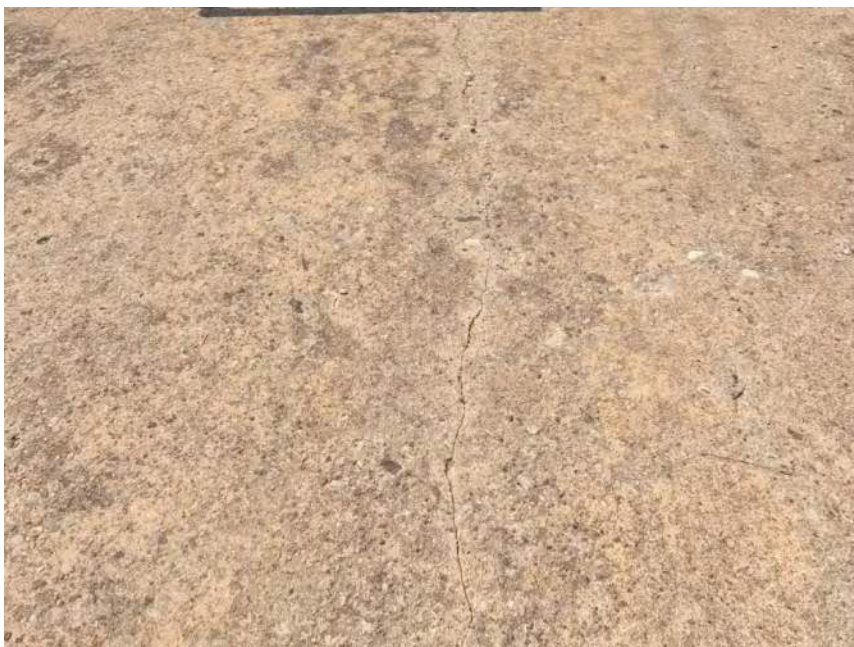
PHOTO # 30

Crack at 0+098 on the west side

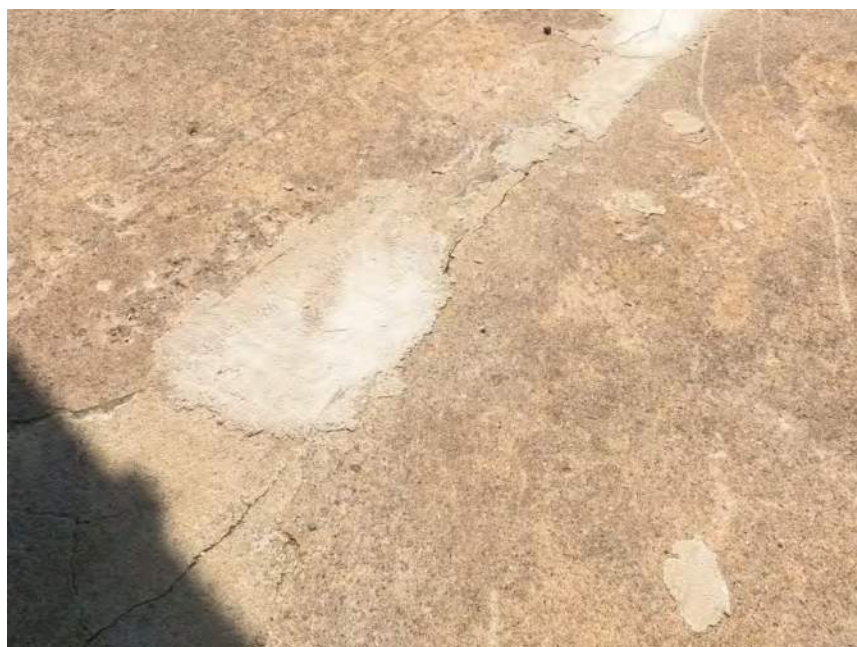
PHOTO # 38

Crack at 0+123 on the west side

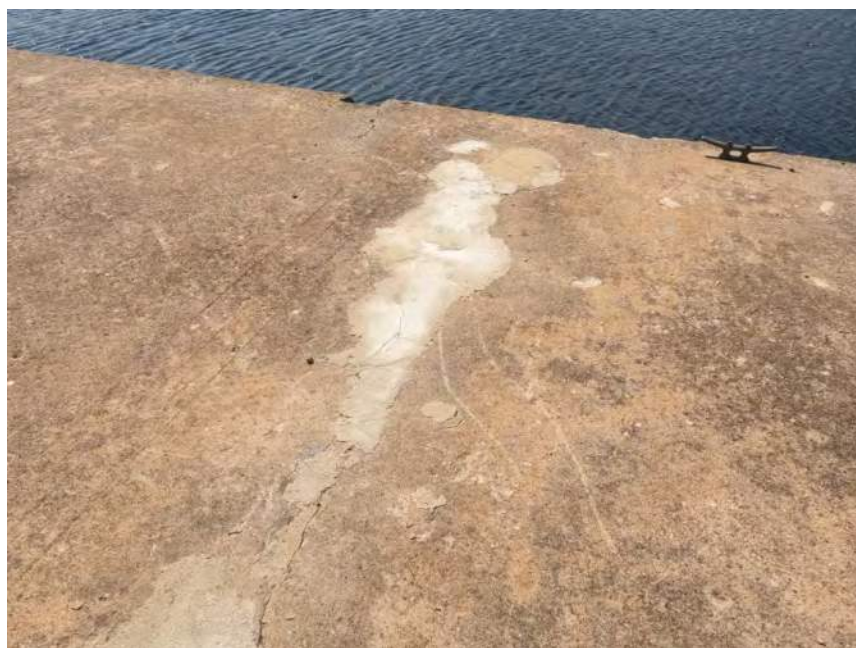
PHOTO # 39

Patch at 0+124 on the west side

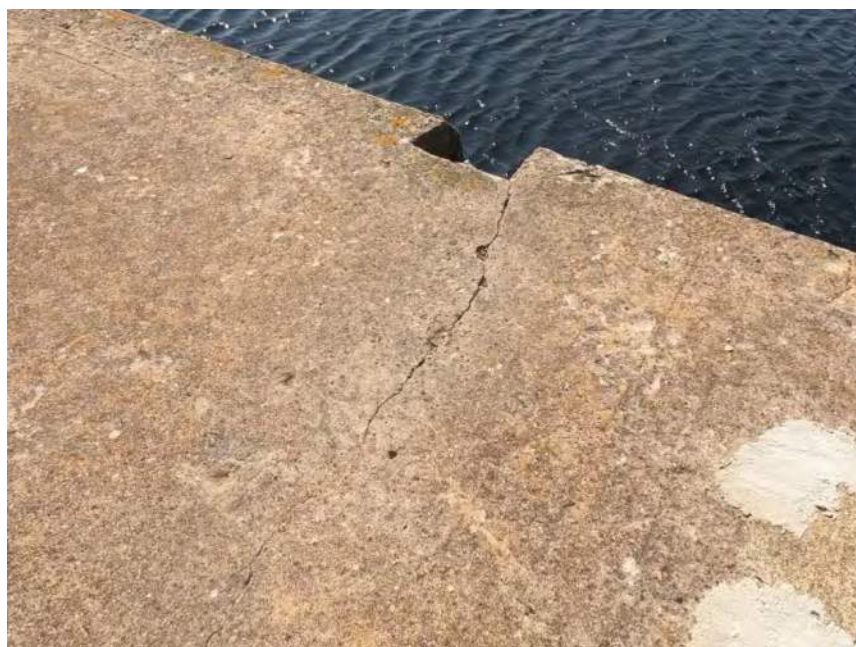
PHOTO # 40

Patch at 0+124 on the west side

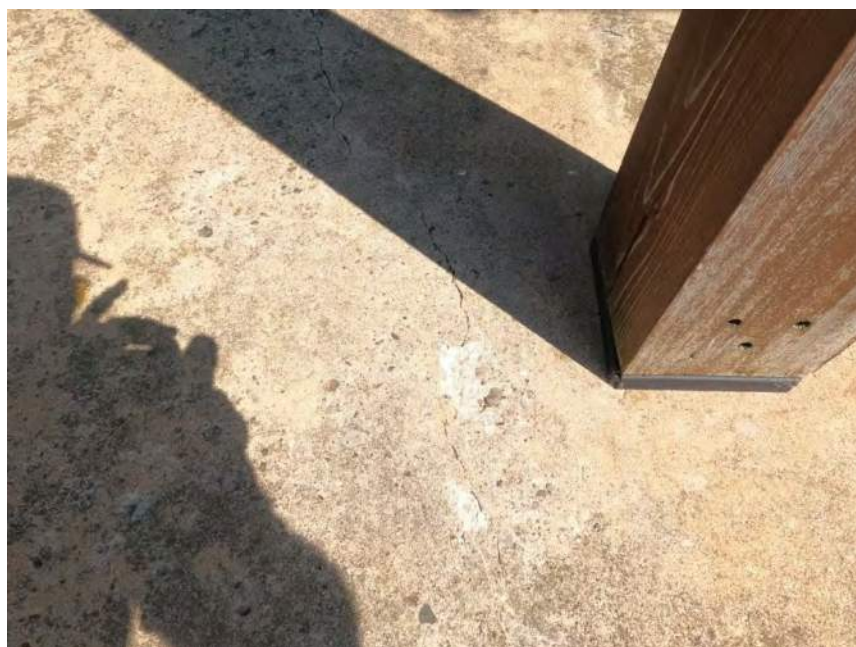
PHOTO # 41

Crack at 0+127 on the west side

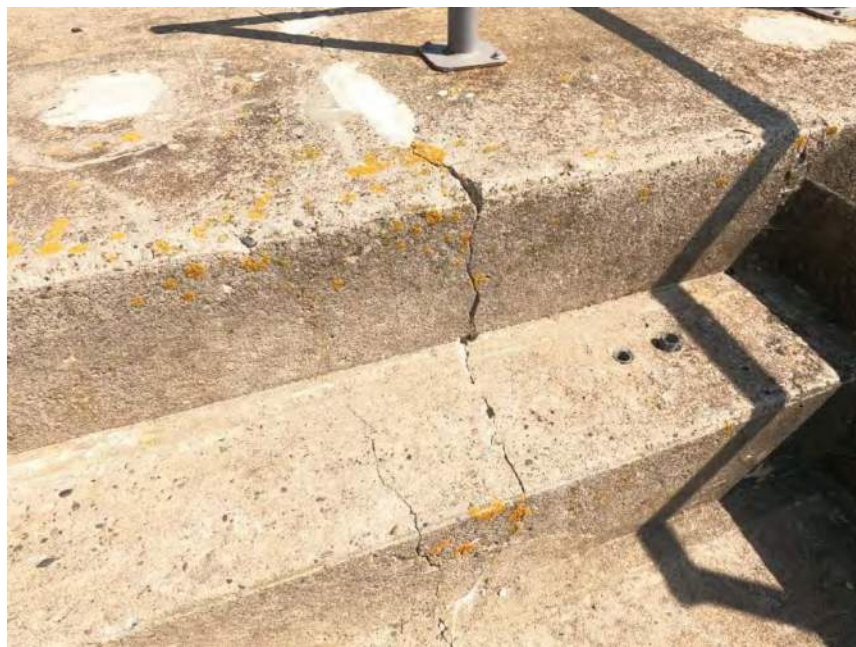
PHOTO # 43

Crack on stairs at 0+131
on the west side

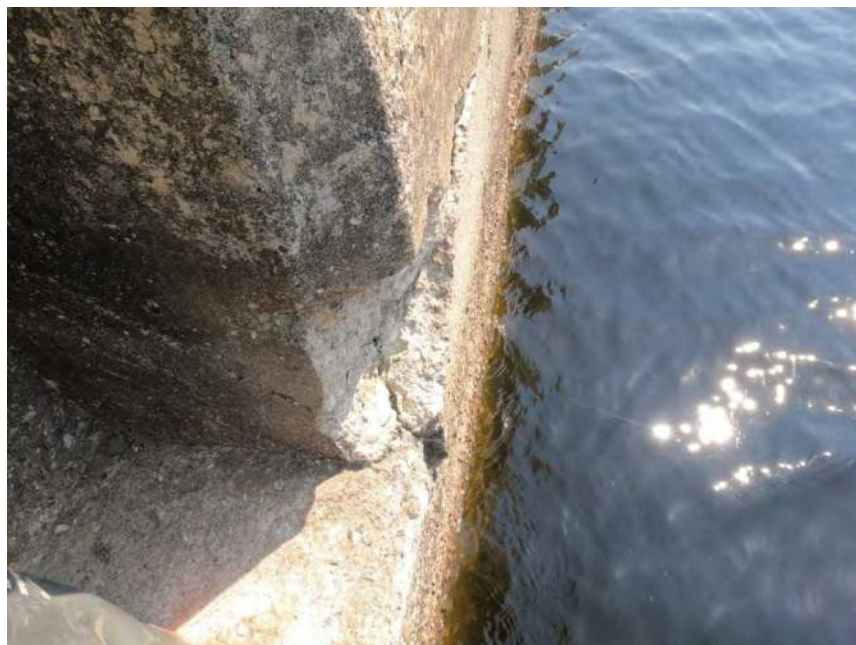
PHOTO # 44

Crack on stairs at 0+131
on the west side

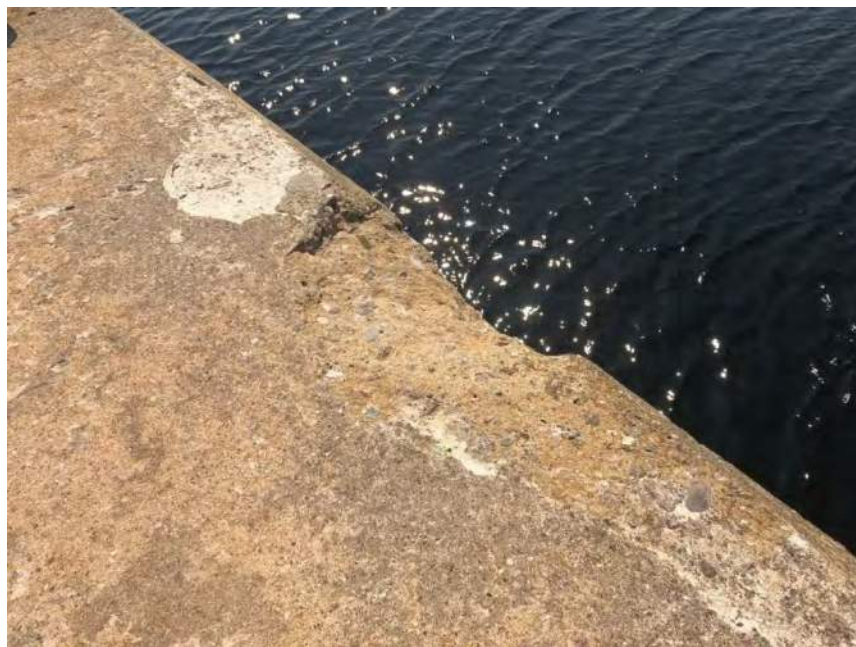
PHOTO # 46

Spalling at 0+136 on the west side

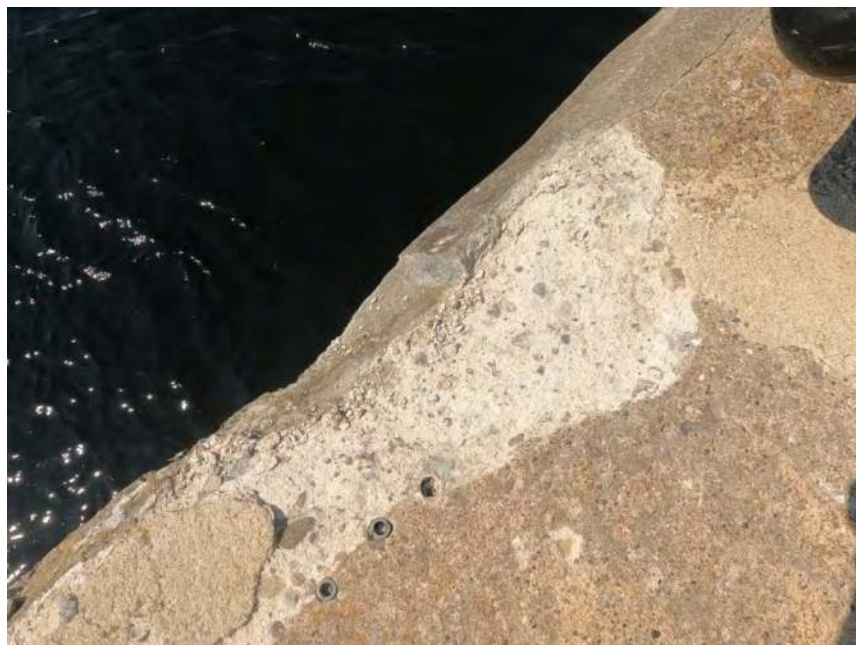
PHOTO # 47

Spalling at 0+136 on the west side

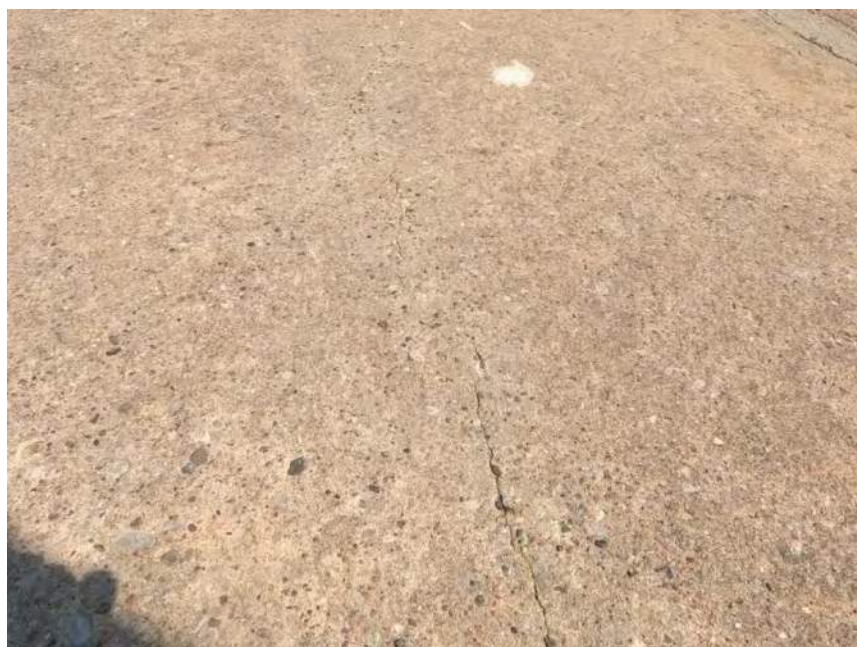
PHOTO # 50

Patch at 0+141 on the west side

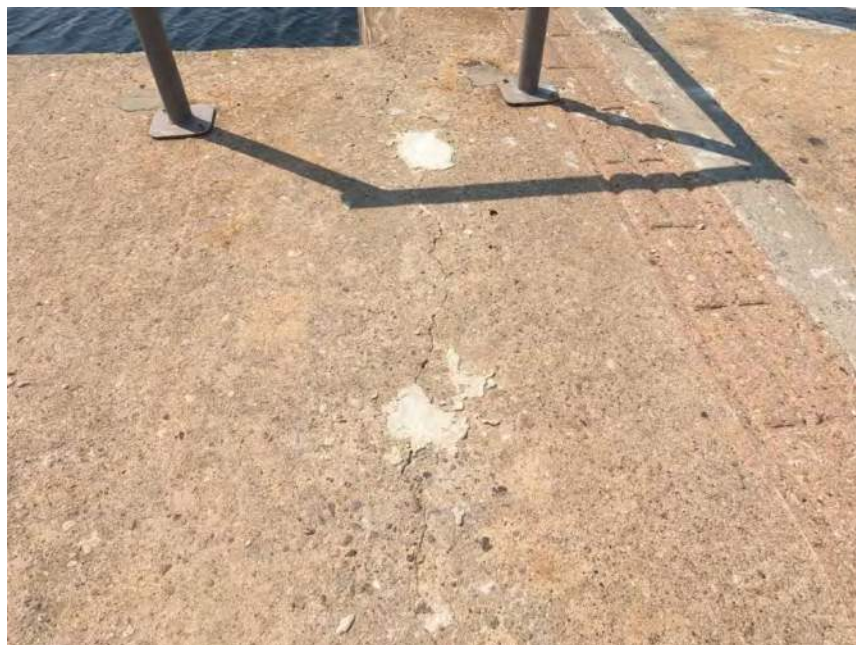
PHOTO # 53

Calcite and cracking
0+144

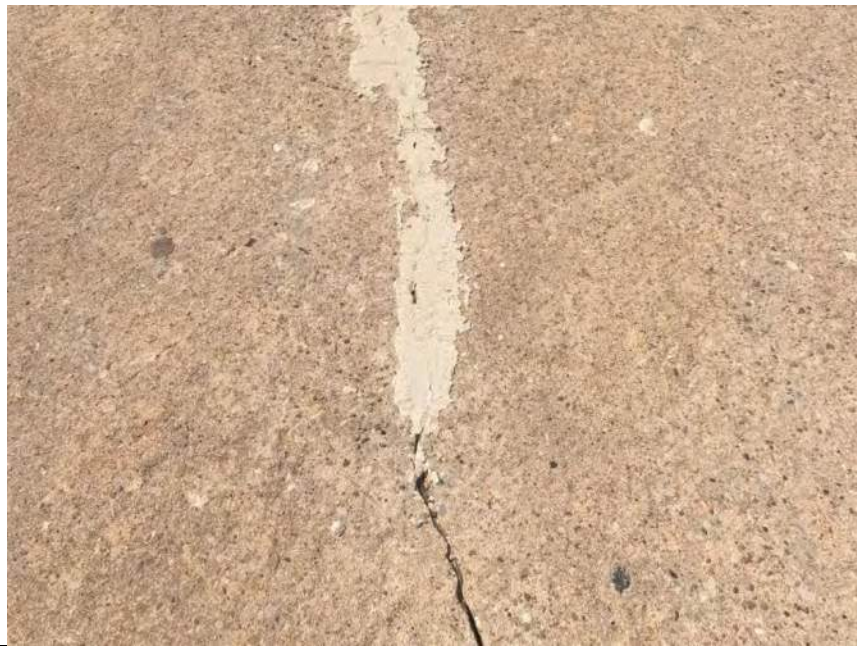
PHOTO # 54

Crack at 0+144 on the
west side

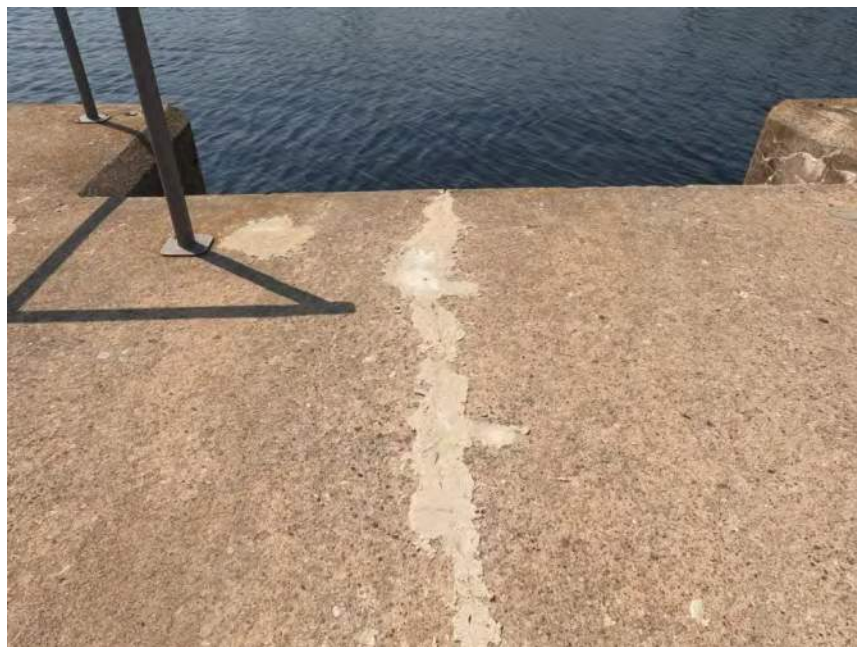
PHOTO # 55

Crack at 0+146 on the west side

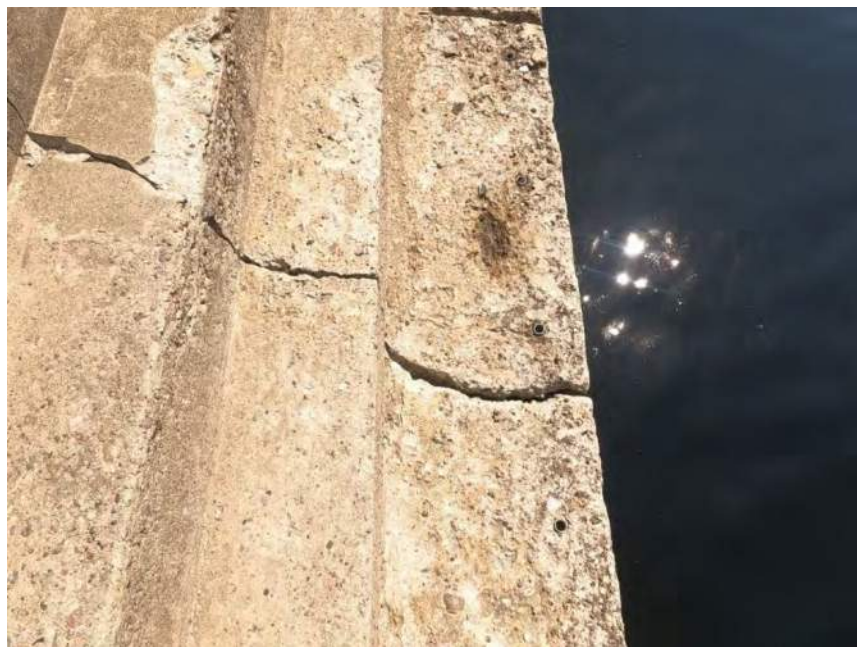
PHOTO # 56

Crack at 0+146 on the west side

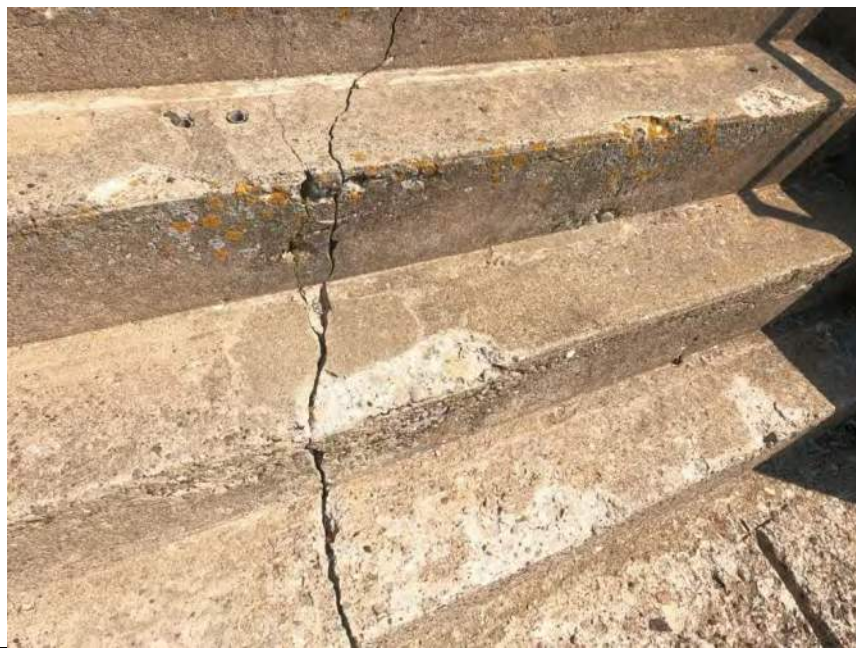
PHOTO # 57

Crack at 0+146 on the west side

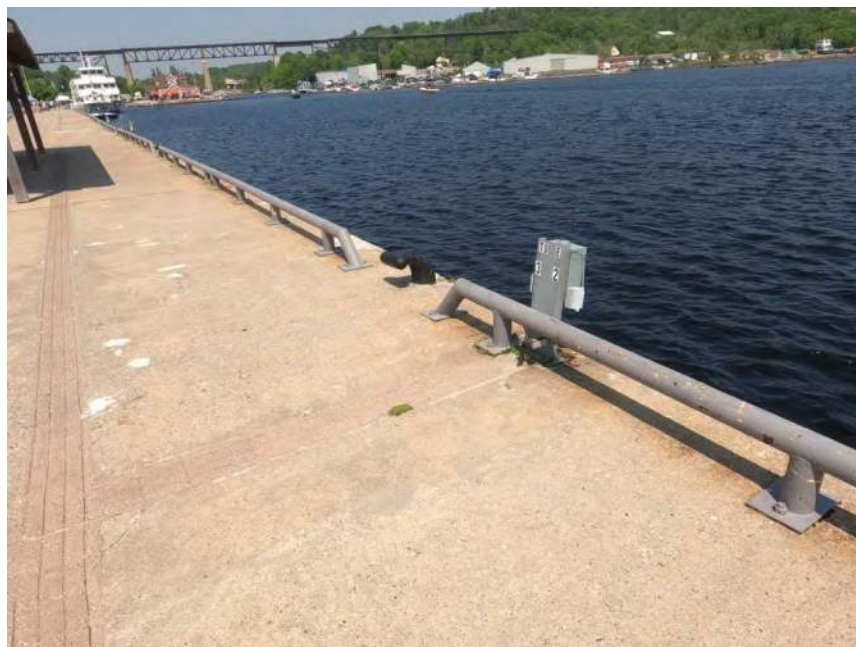
PHOTO # 61

Crack on deck at 0+0145
on the east side

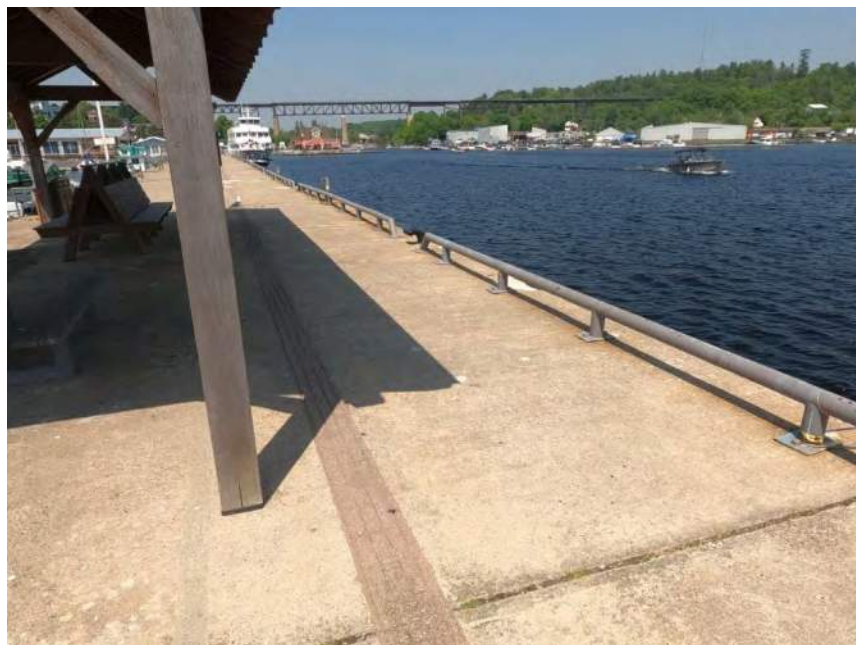
PHOTO # 62

Bollard at 0+142 on the
east side

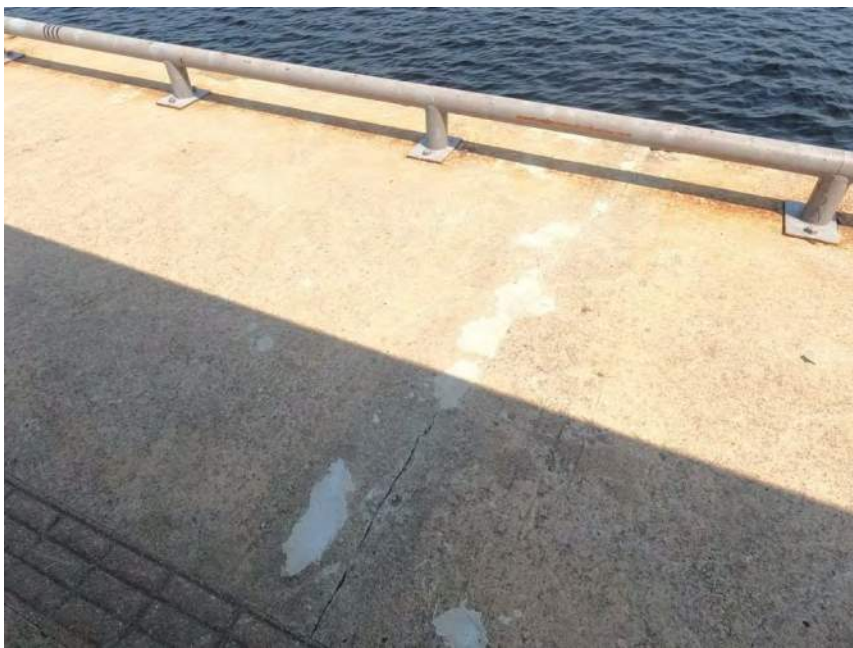
PHOTO # 65

Crack and bollard at 0+127 on the east side

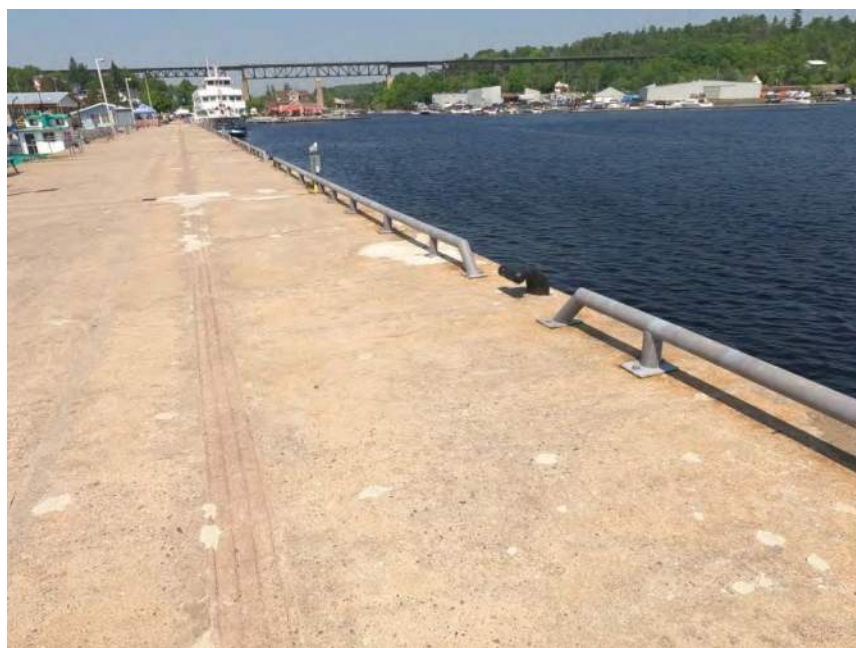
PHOTO # 66

Crack at 0+124 on the east side

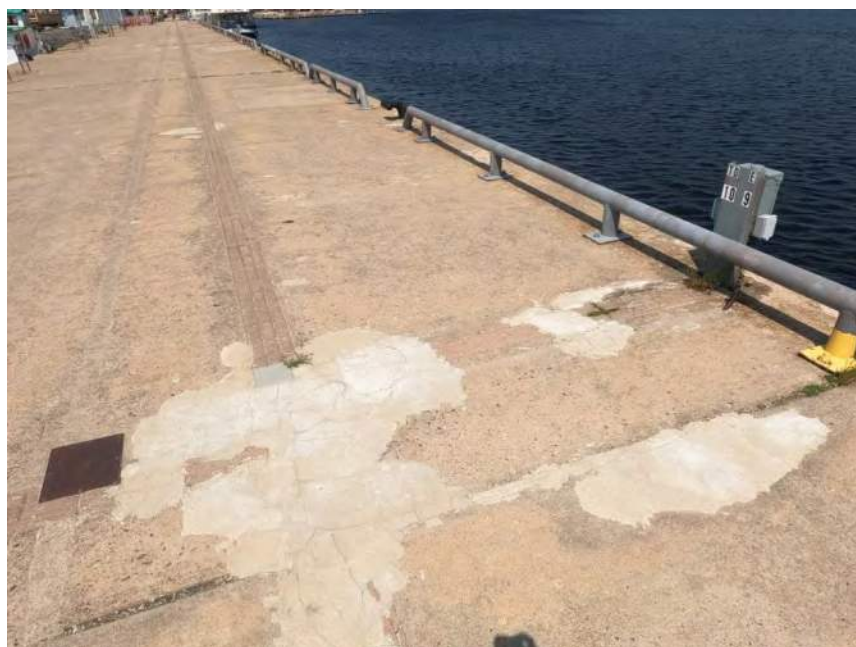
PHOTO # 68

Crack and patch 0+110 on the east side

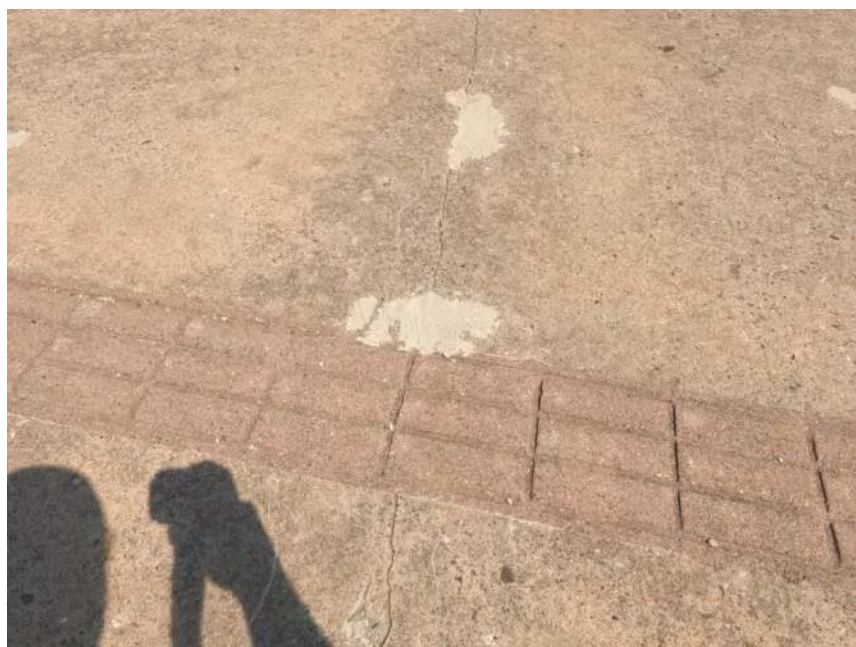
PHOTO # 71

Crack at 0+097 on the east side

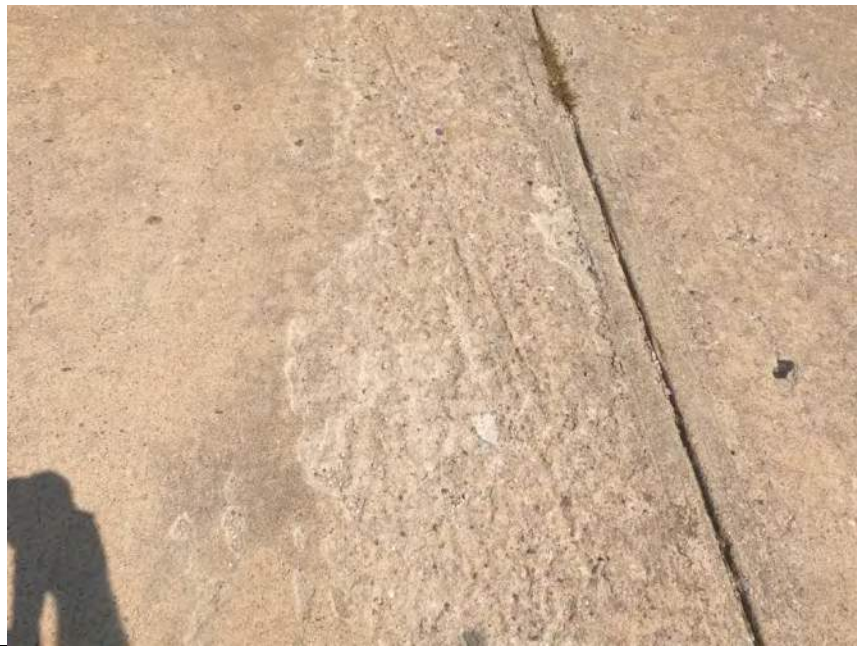
PHOTO # 72

Crack at 0+097 on the east side

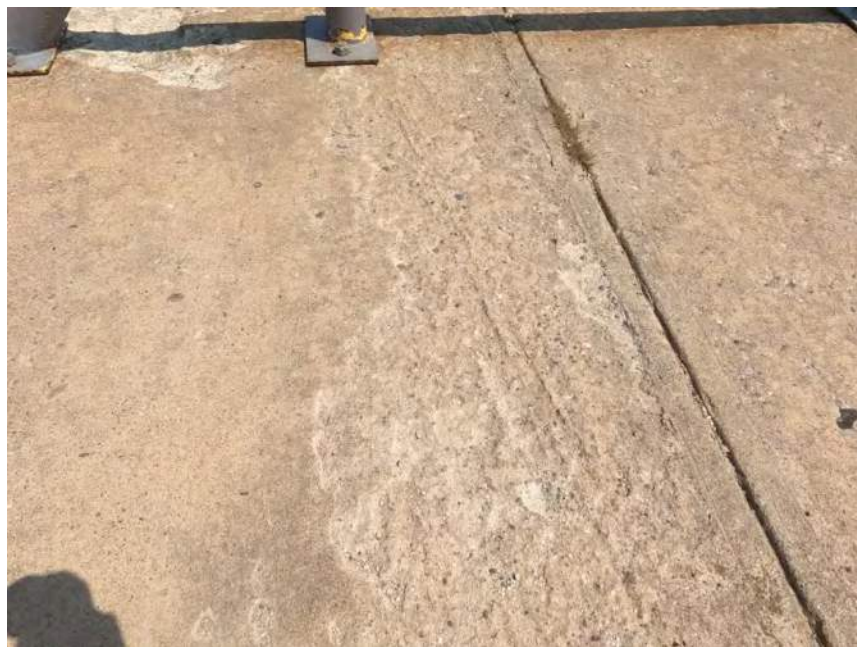
PHOTO # 73

Spalling at 0+065 on the east side

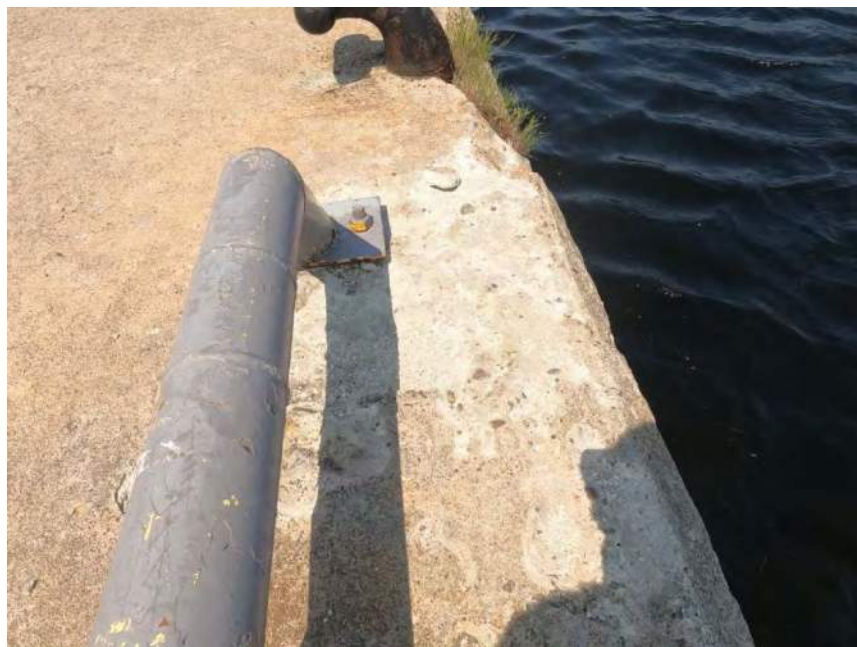
PHOTO # 74

Spalling at 0+065 on the east side

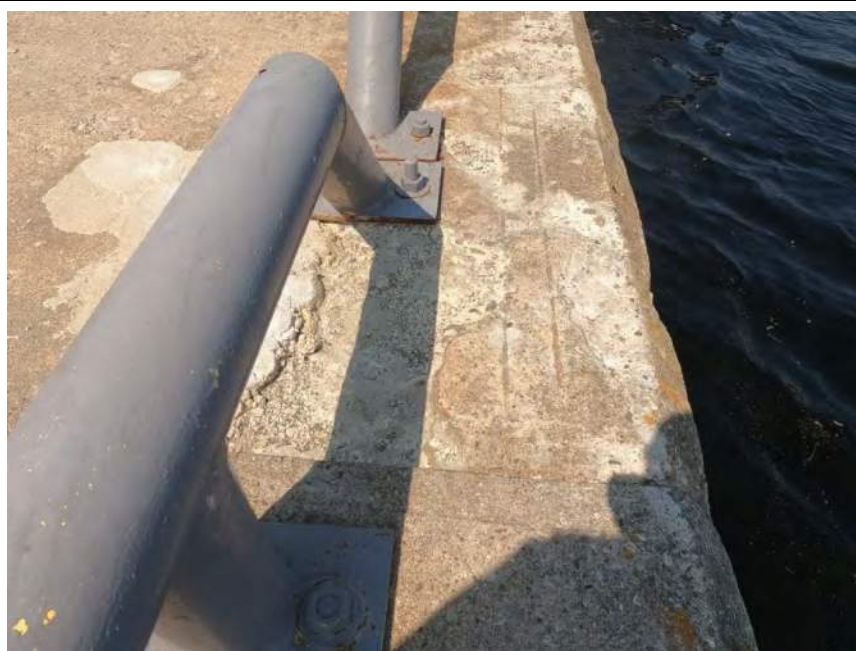
PHOTO # 76

Patch at 0+042 on the east side

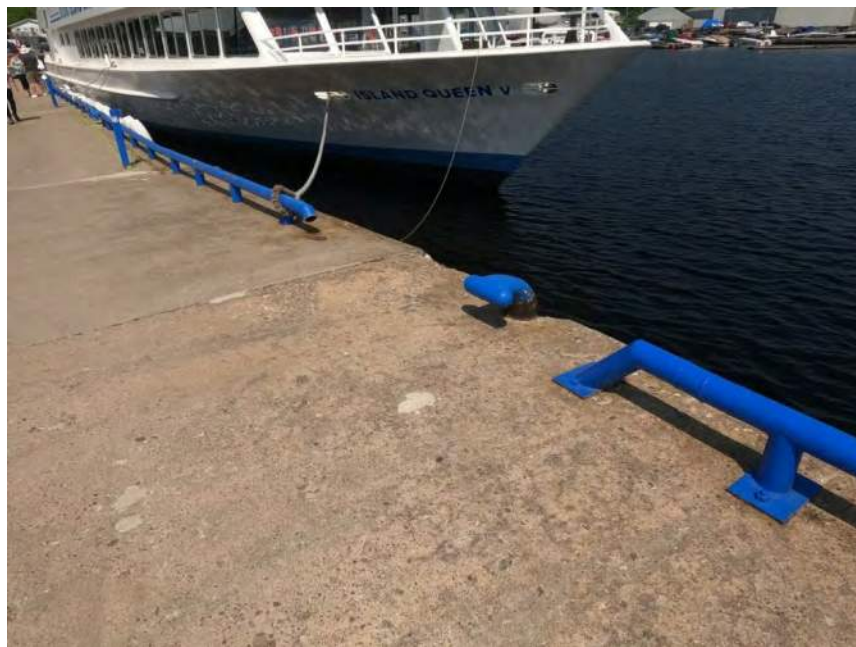
PHOTO # 79

0+018 on the east side

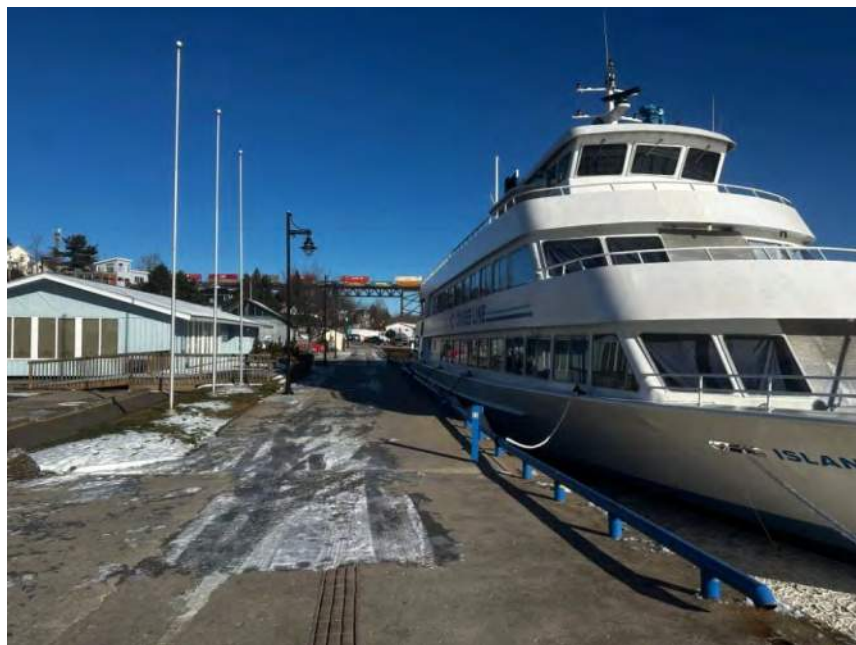
PHOTO # 80

Bollard at 0+001 on the east side

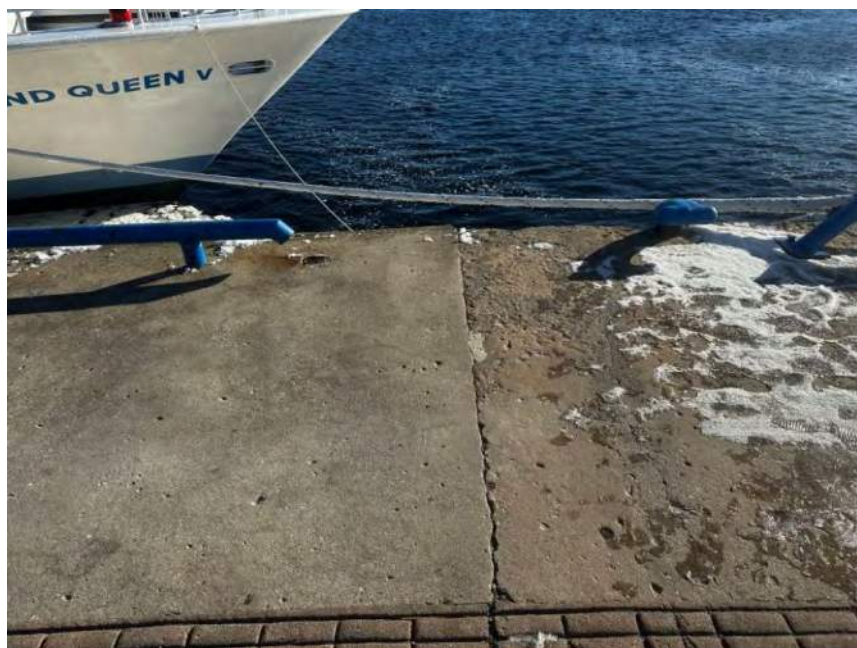
PHOTO # 81

Overview of the dock from the south looking north

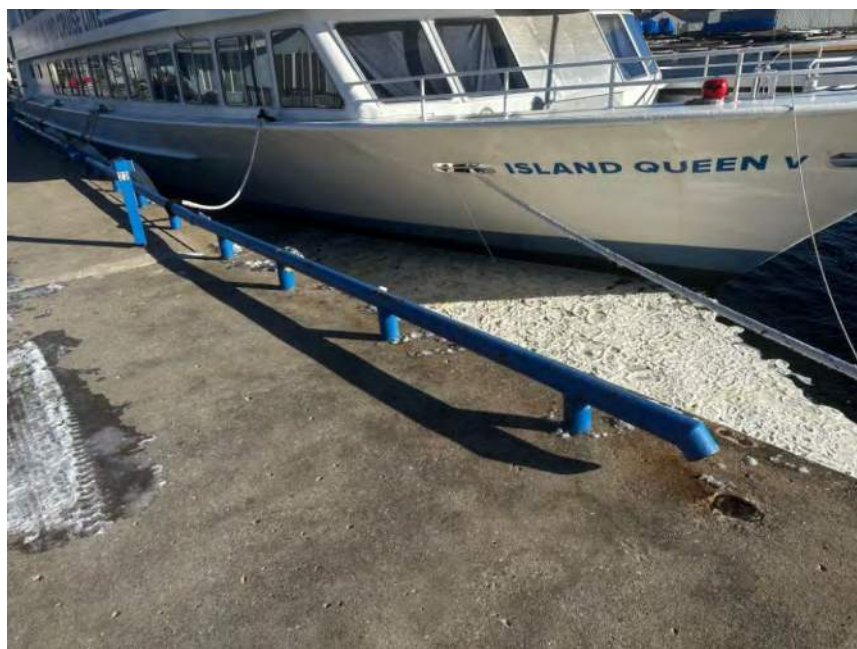
PHOTO # 82

Joint at 0+000

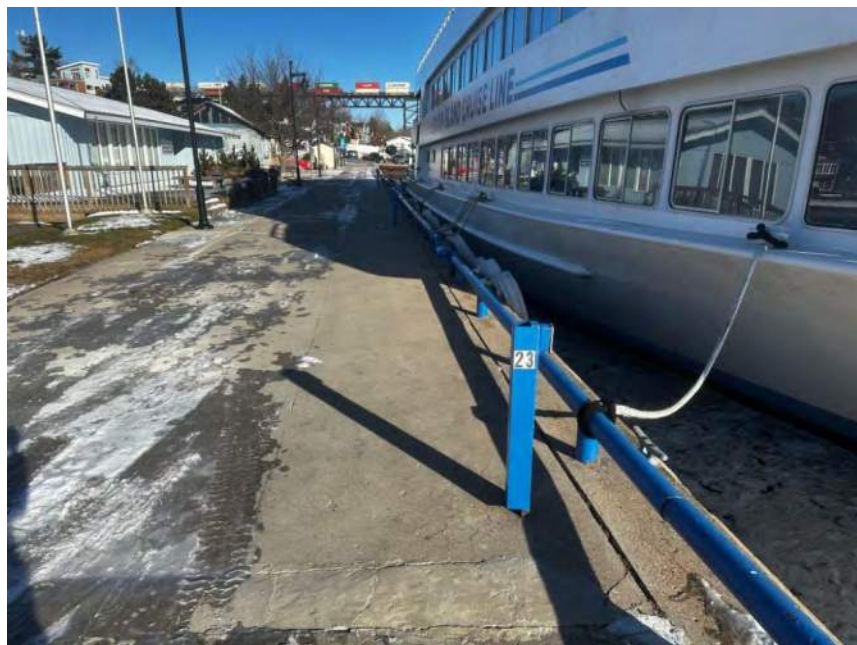
PHOTO # 83

Start of railing

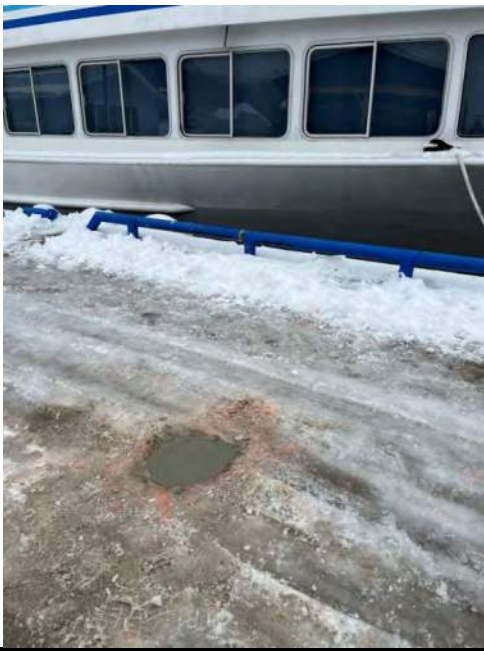
PHOTO # 84

Hydro station #23 at
-0+007 looking north

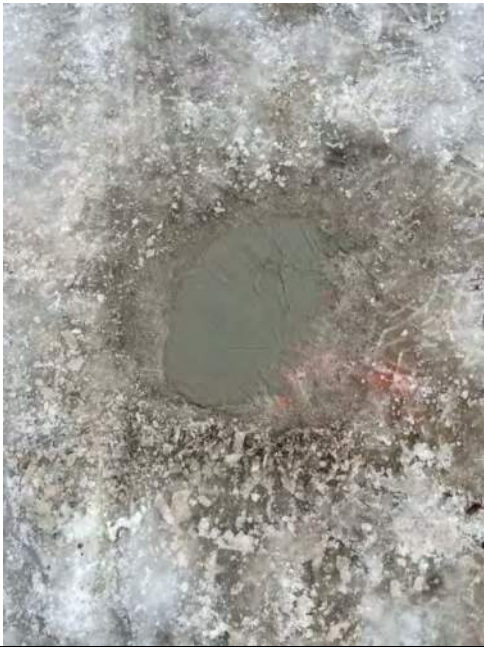
PHOTO # 85

Typical core hole after patching
