Parry Sound Harbour, Ontario

Bay St. Wharf (#401)
Condition Assessment Report

Small Craft Harbours, Fisheries and Oceans Canada

March 2024

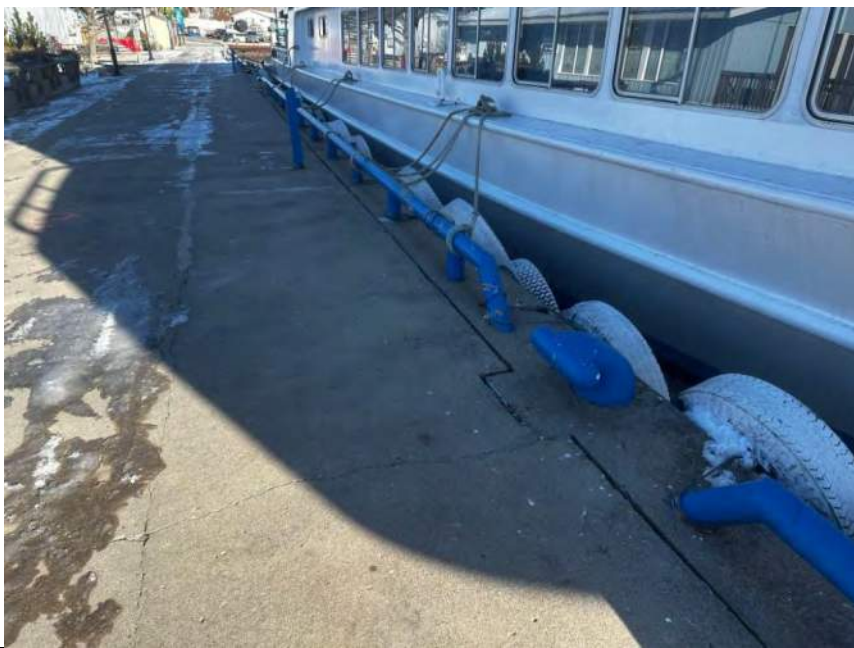
PHOTO # 86

Typical core hole after patching

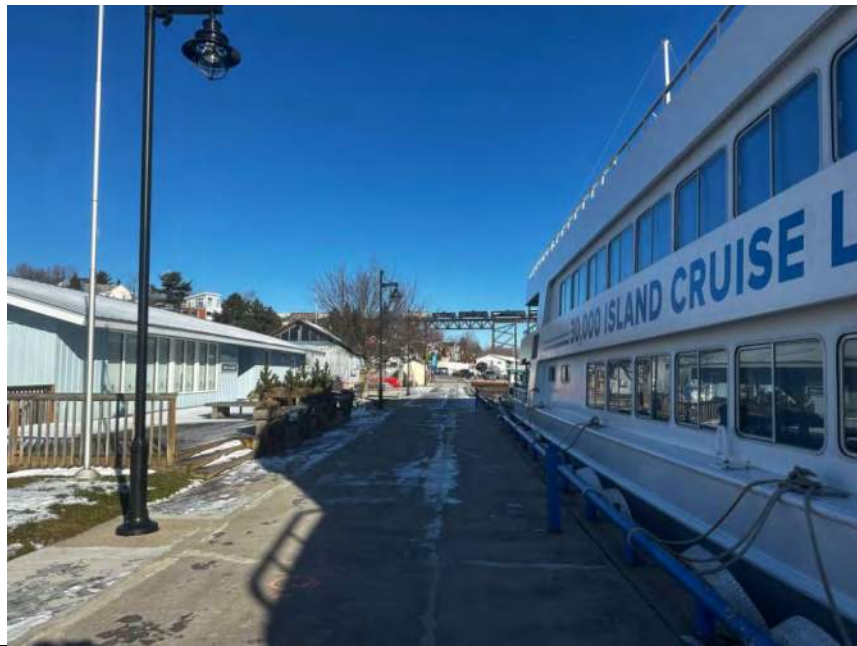
PHOTO # 87

Bollard at -0+014

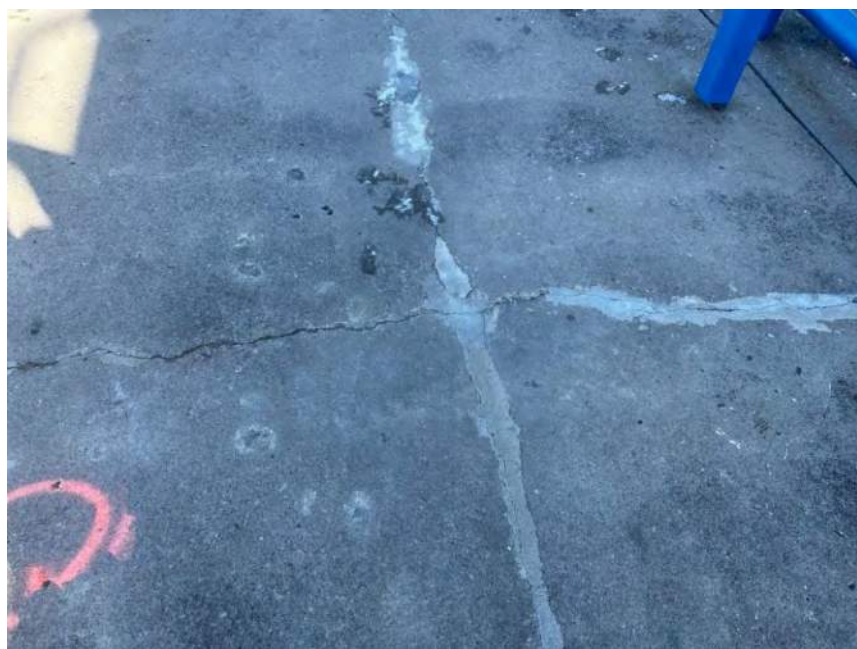
PHOTO # 88

Overview looking north
from -0+014

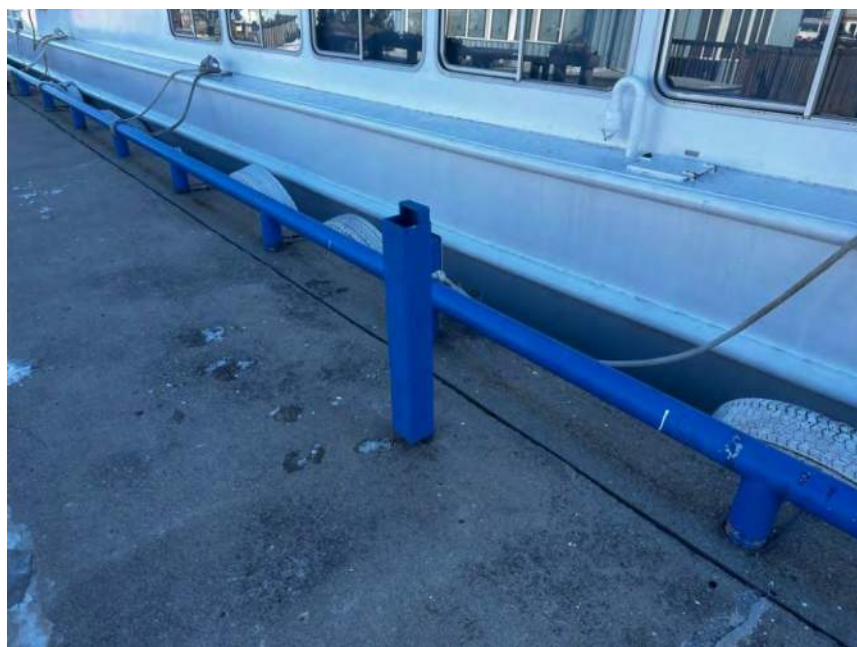
PHOTO # 89

Cracking in concrete at -
0+018

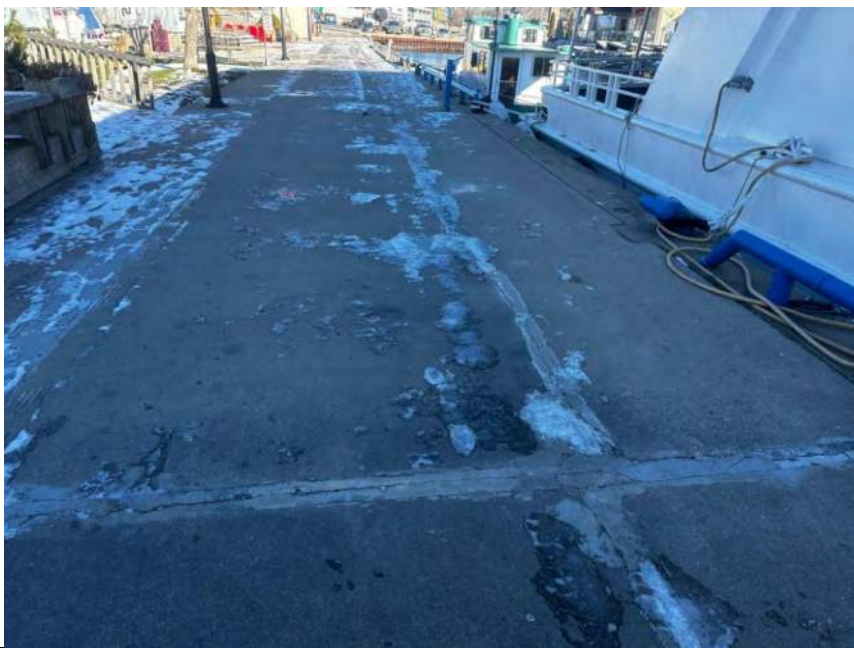
PHOTO # 90

Hydro station #23 at
-0+019

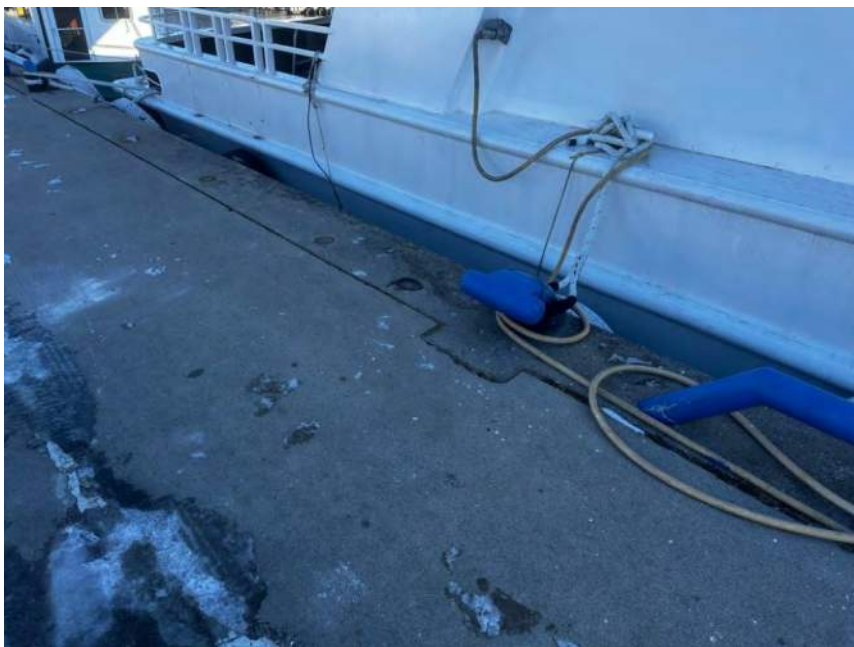
PHOTO # 91

Concrete cracking at
-0+029

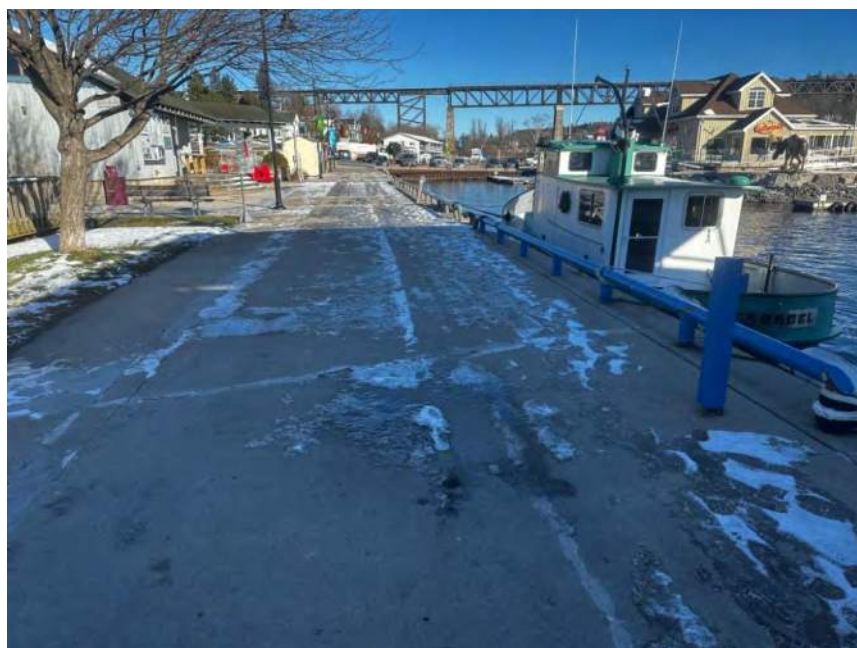
PHOTO # 93

Overview looking south at
-0+032

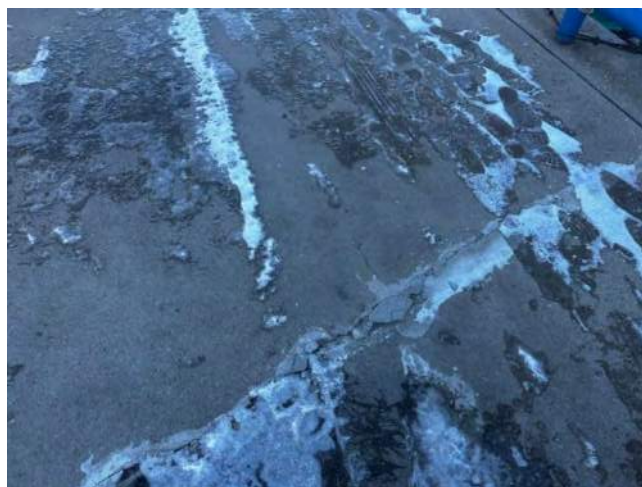
PHOTO # 94

Hydro station #23 at
-0+040

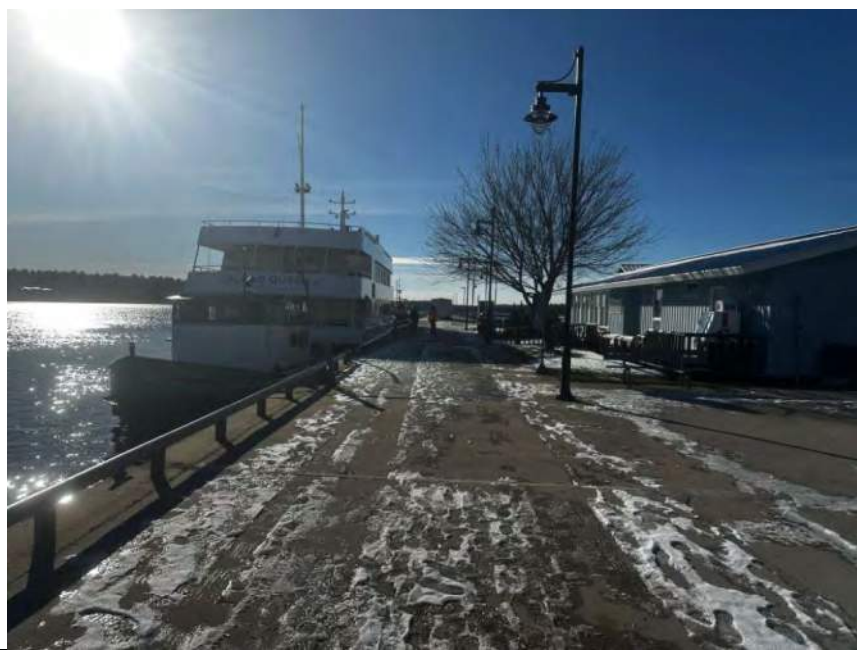
PHOTO # 99

Bollard at -0+069

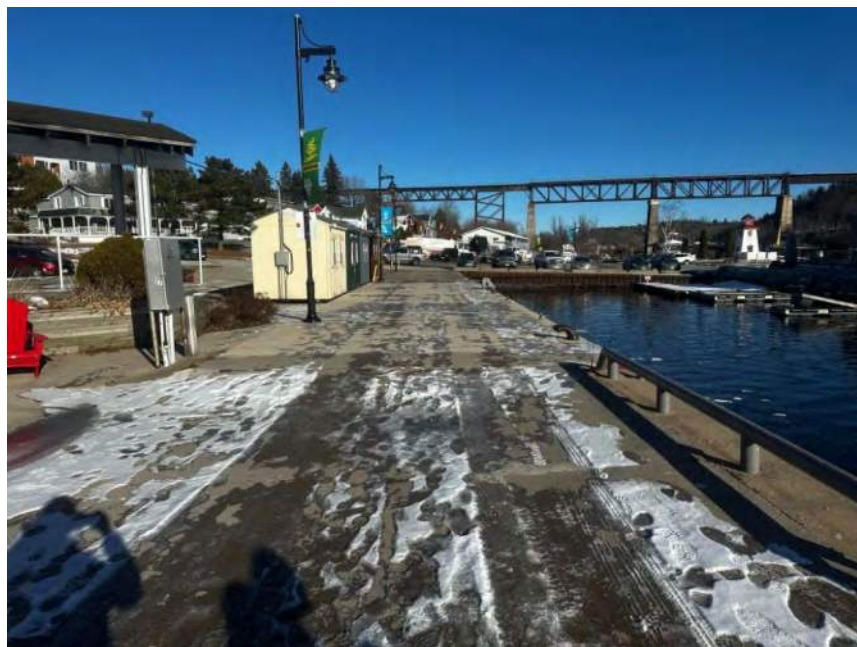
PHOTO # 100

Overview looking south
from -0+069

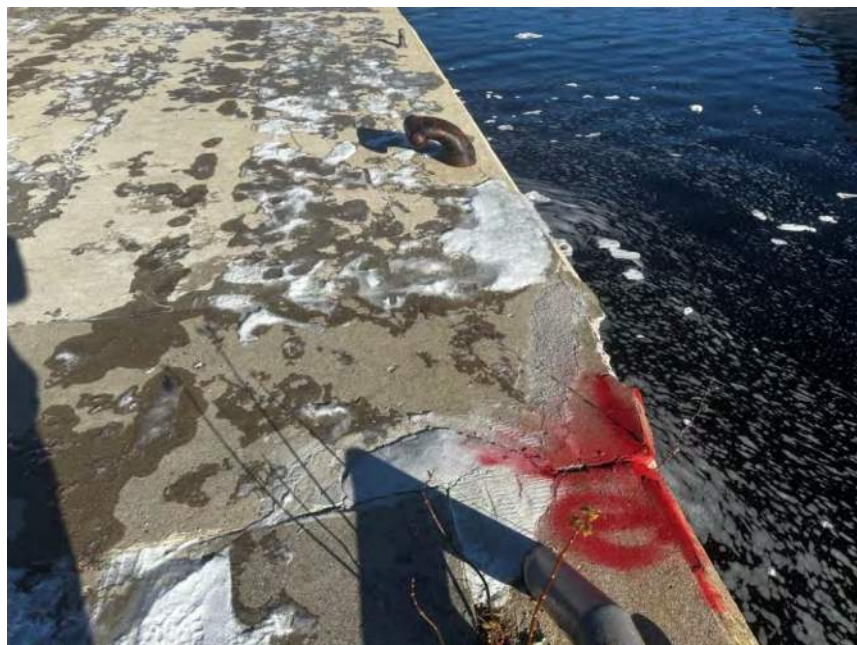
PHOTO # 101

Overview looking north
from -0+069

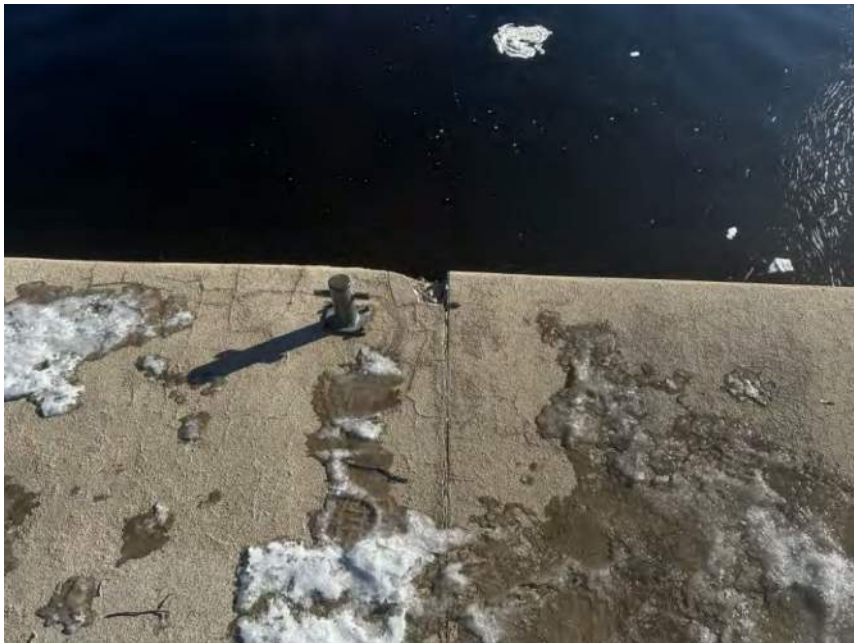
PHOTO # 103

Bollard at -0+078

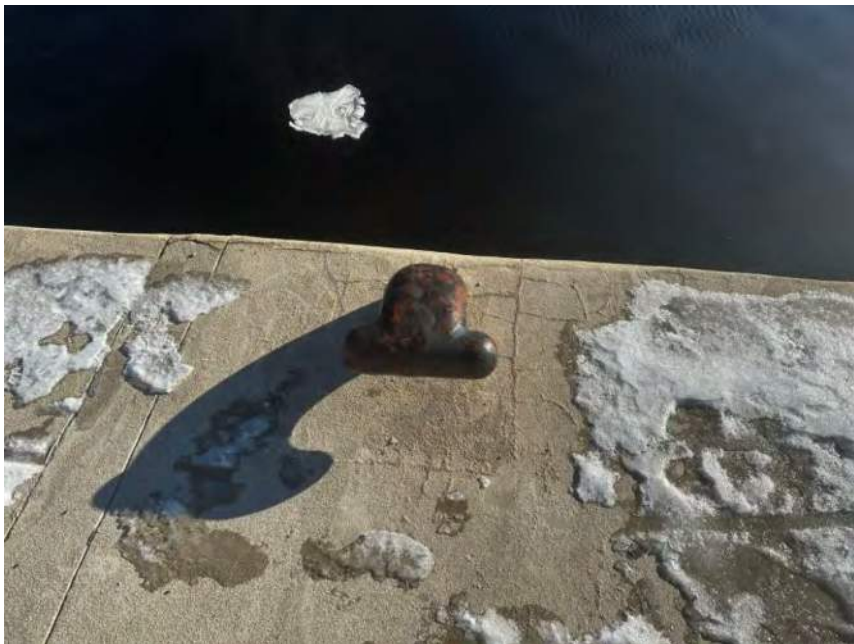
PHOTO # 104

Spalling at -0+081

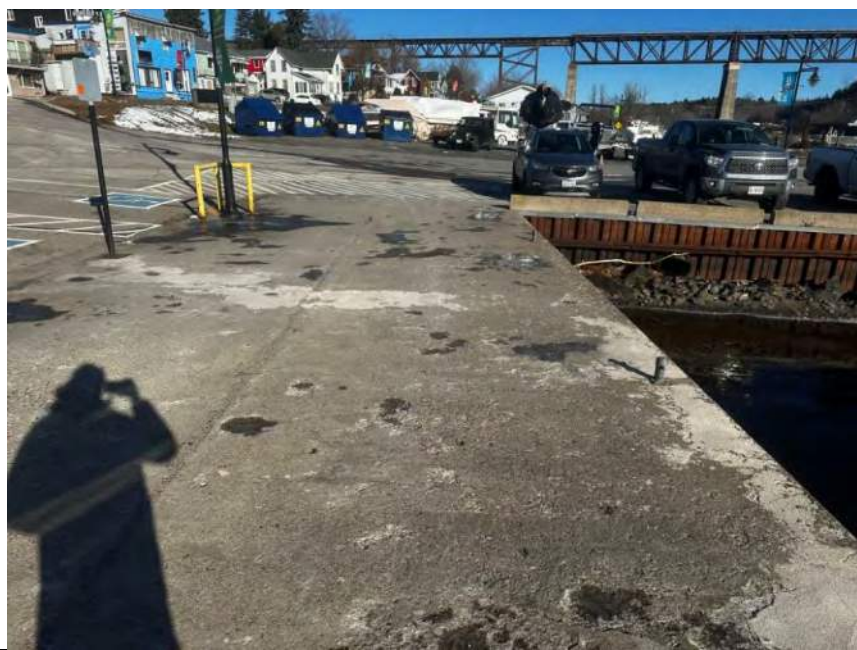
PHOTO # 105

Bollard at -0+091

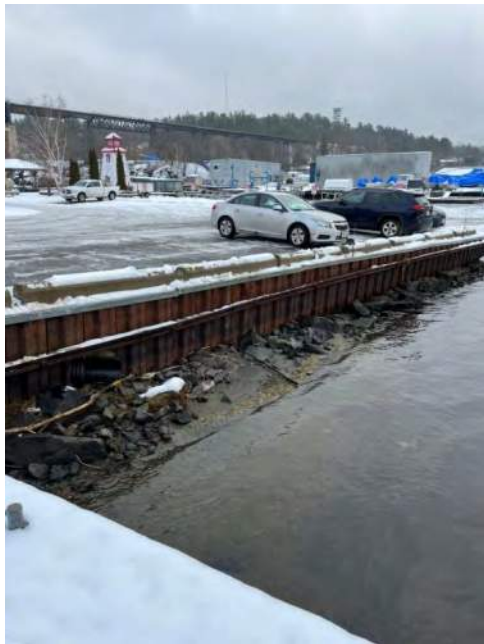
PHOTO # 106

Overview looking north at end of dock

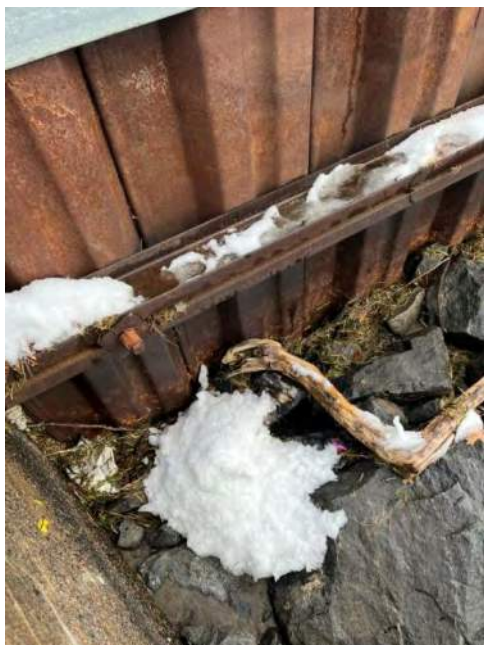
PHOTO # 107

Northeast face of the sheet pile wall

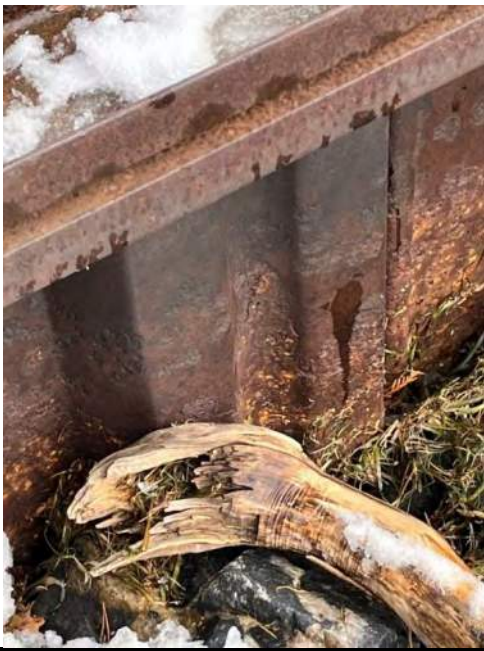
PHOTO # 108

Typical condition of sheet pile wall

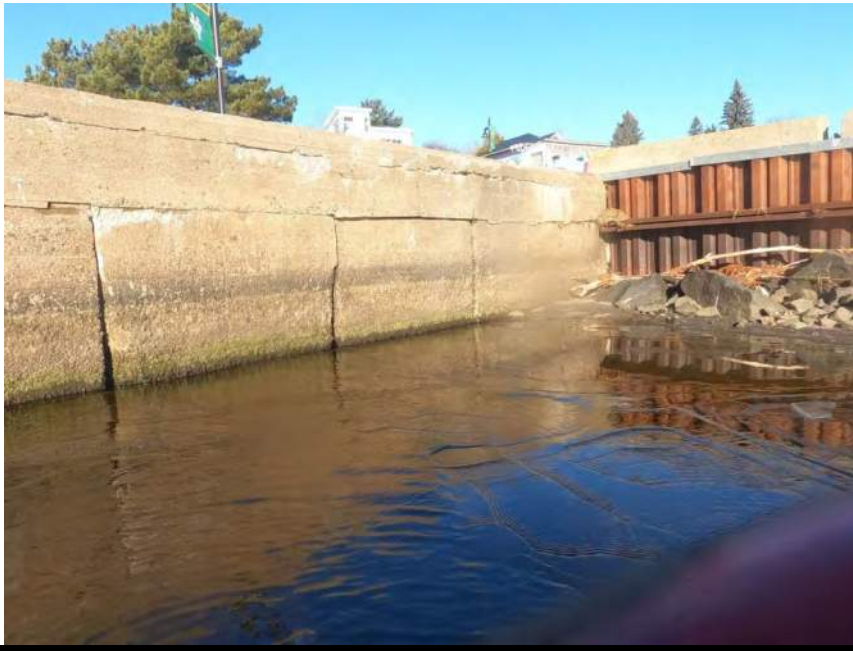
PHOTO # 109

Close up view of sheet pile wall

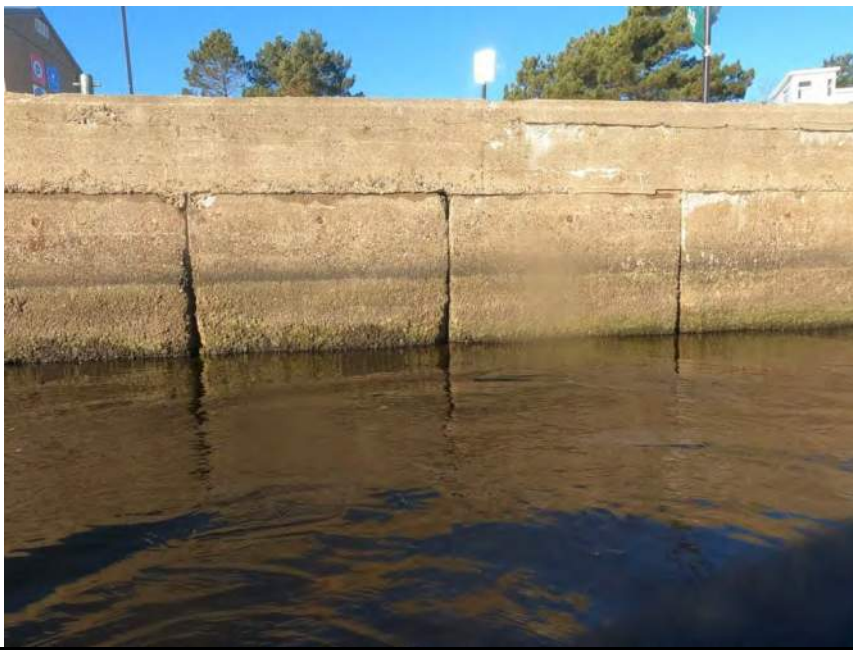
PHOTO # 110

North end of the dock from the east side

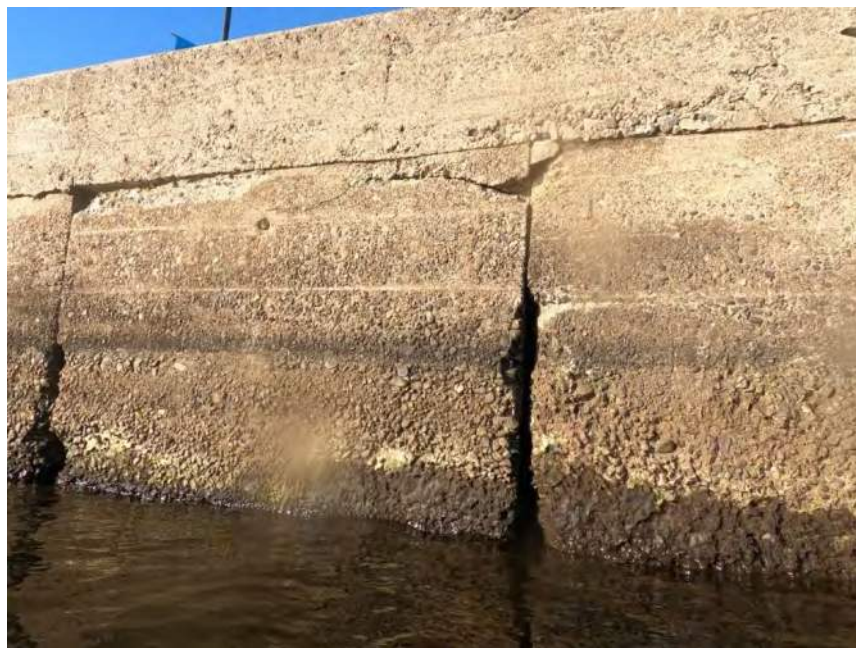
PHOTO # 113

Spalling at -0+109

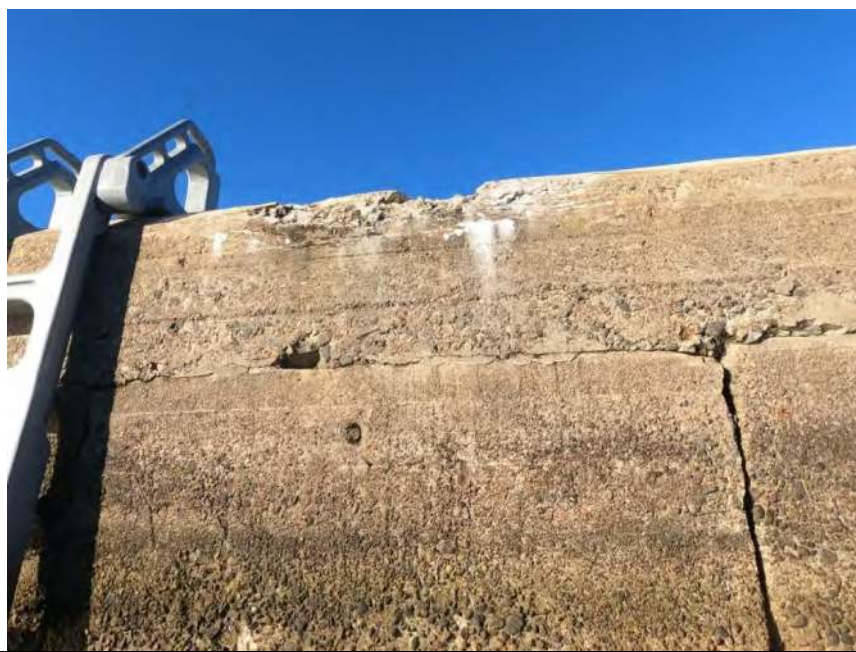
PHOTO # 118

Typical concrete condition
at -0+098

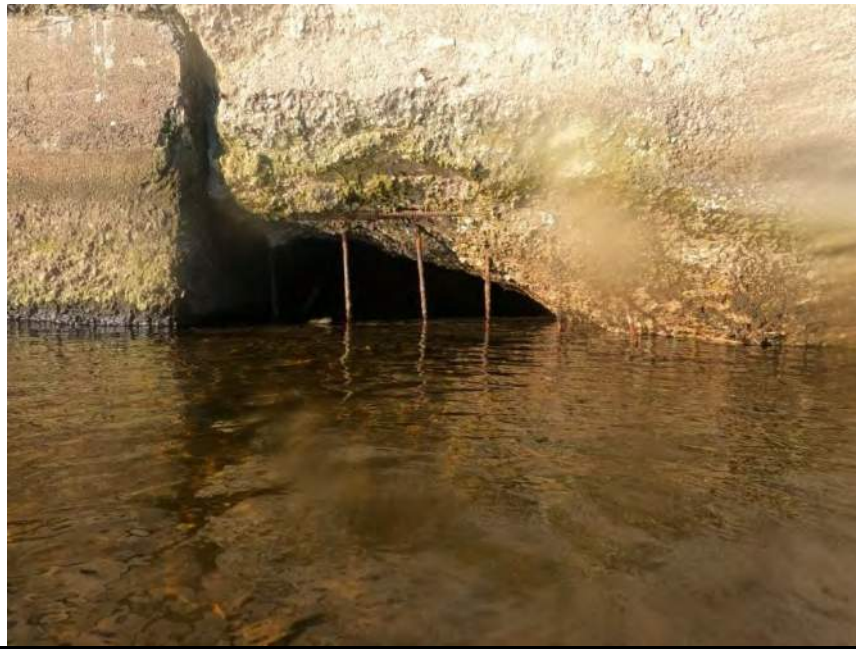
PHOTO # 124

Typical concrete condition
at -0+087

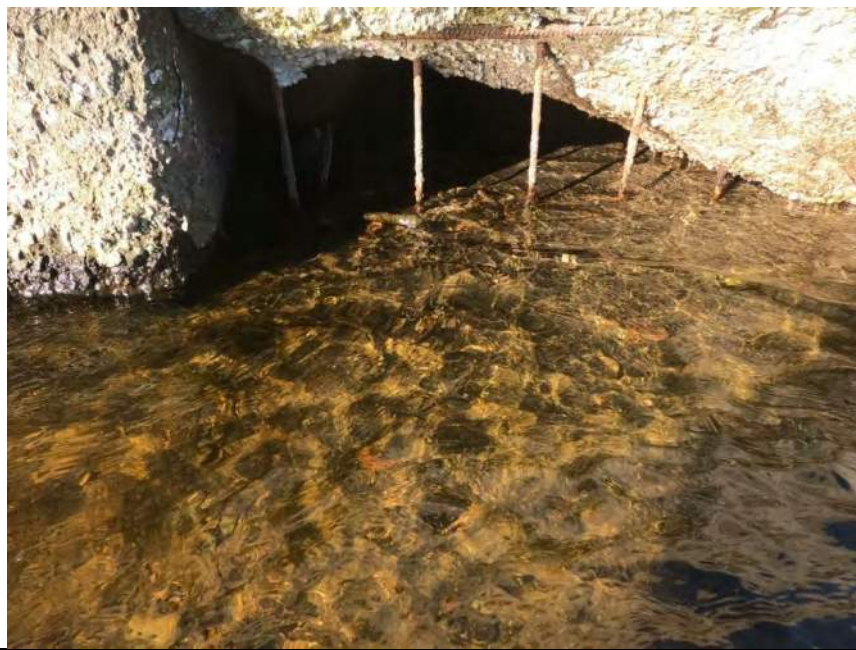
PHOTO # 125

Outfall at -0+083

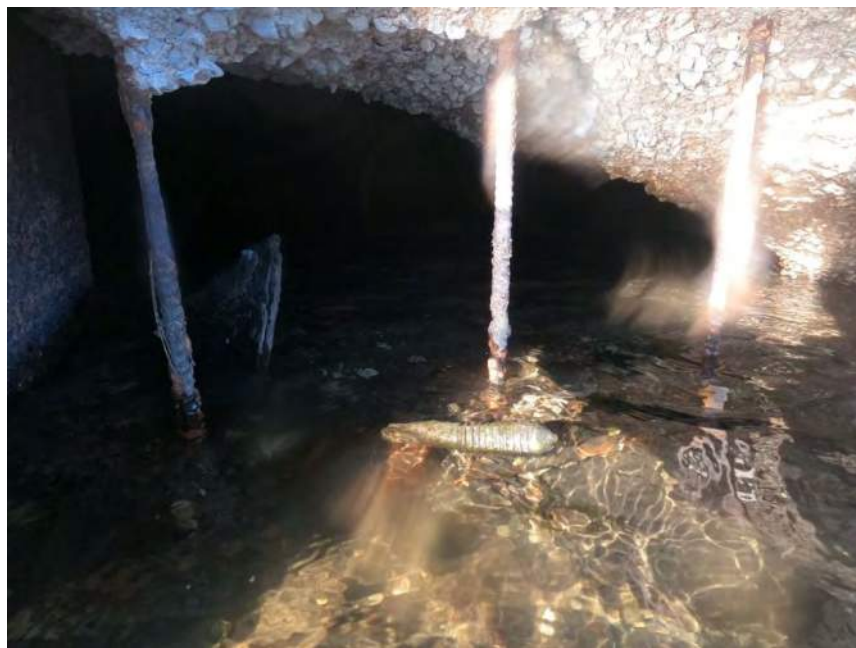
PHOTO # 126

Outfall at -0+083

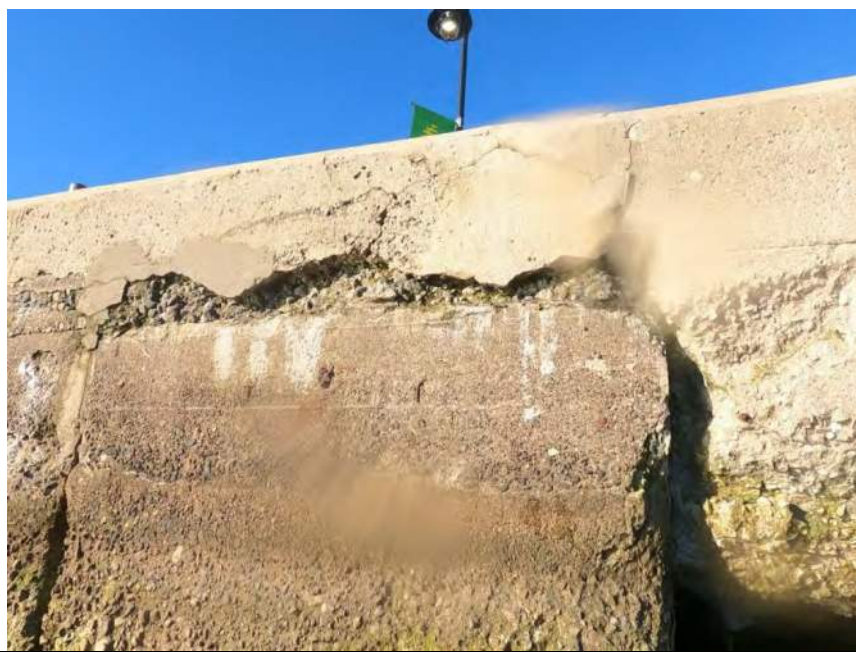
PHOTO # 127

Close up of outfall at
-0+083

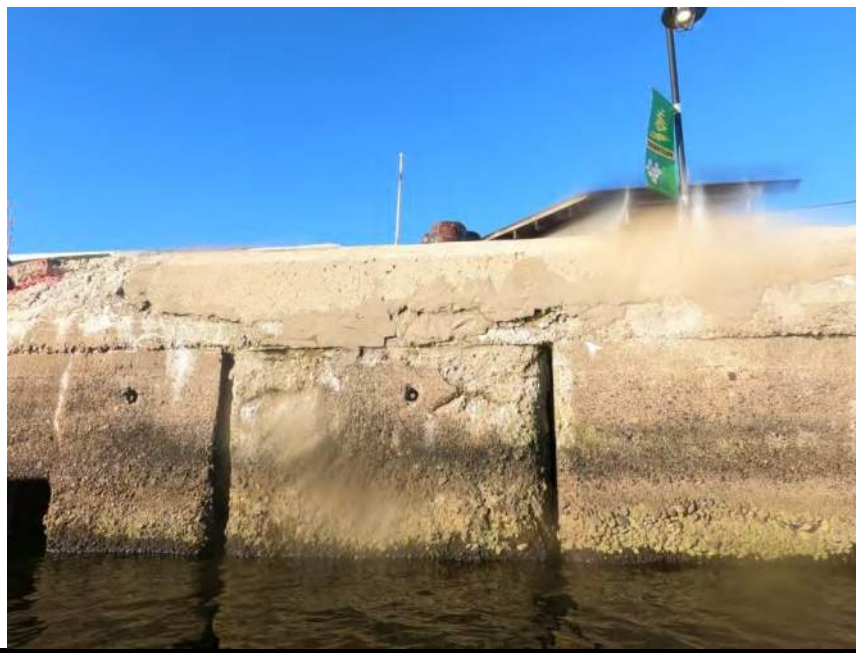
PHOTO # 129

Typical condition of
concrete at -0+079

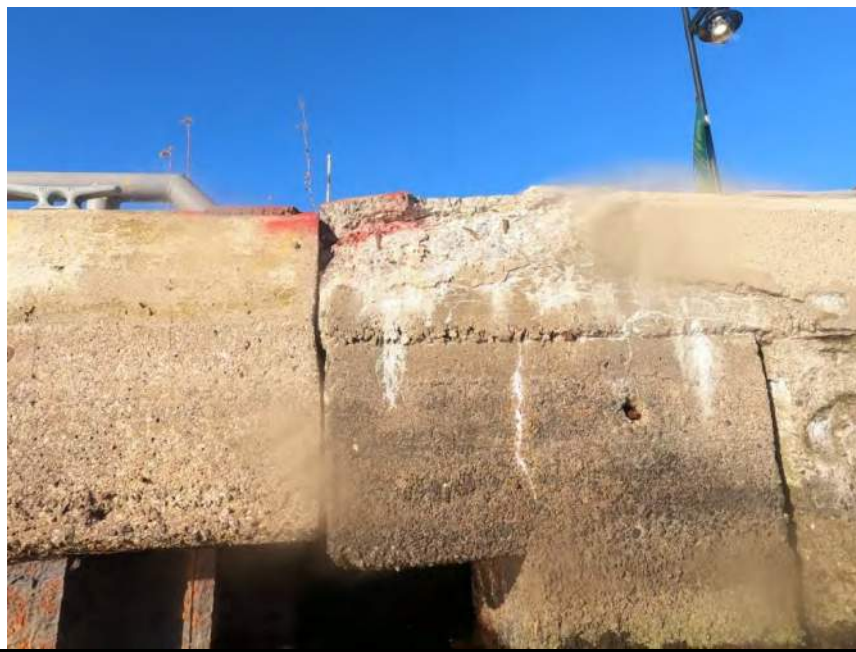
PHOTO # 130

Typical condition of concrete underneath bollard at -0+078

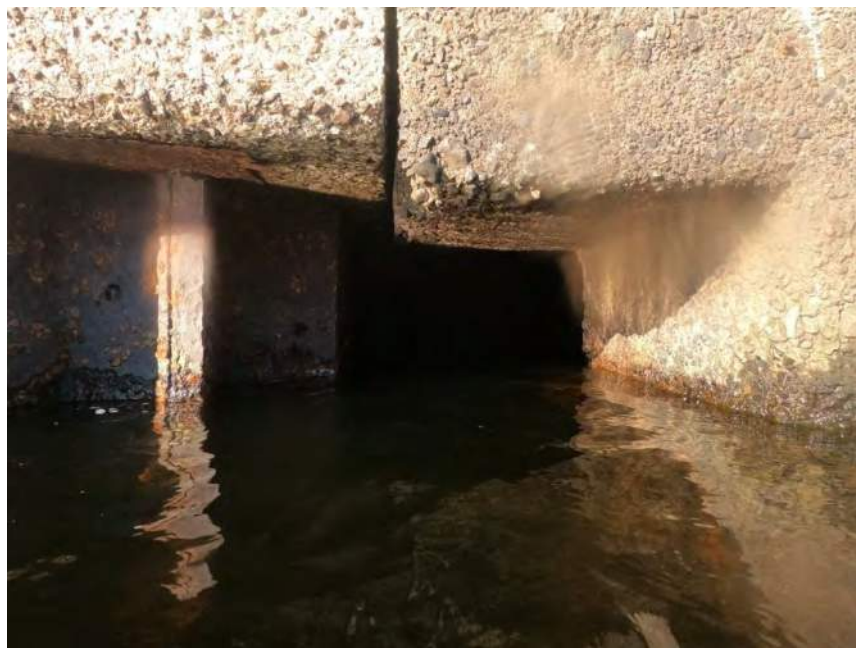
PHOTO # 131

Spalling at -0+076

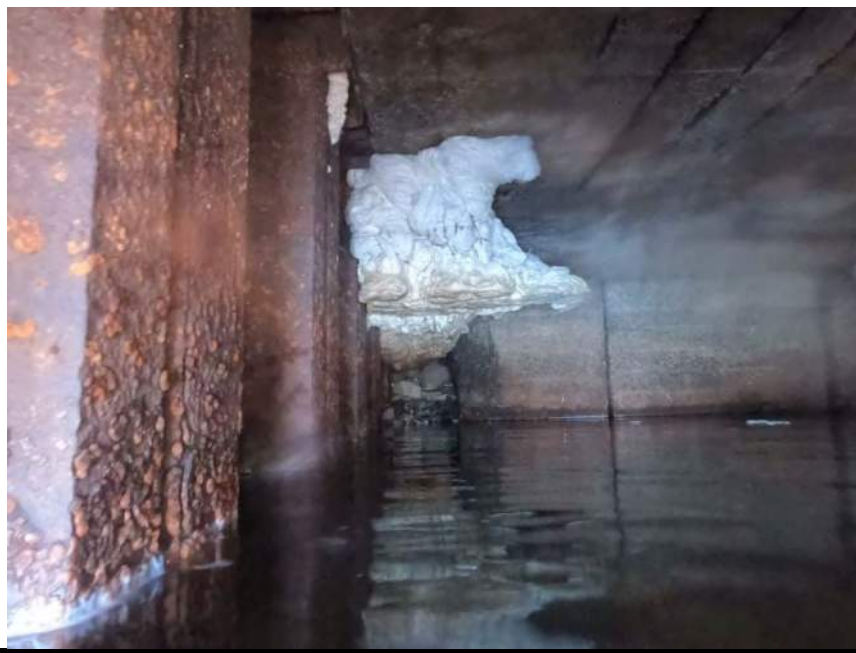
PHOTO # 132

Opening in concrete at -0+076

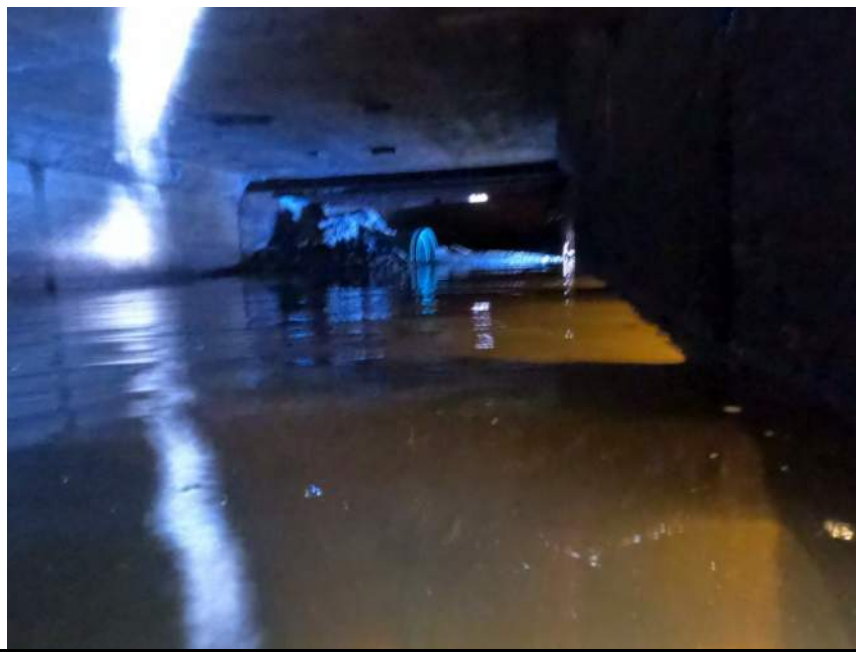
PHOTO # 133

Looking inside opening at
-0+076

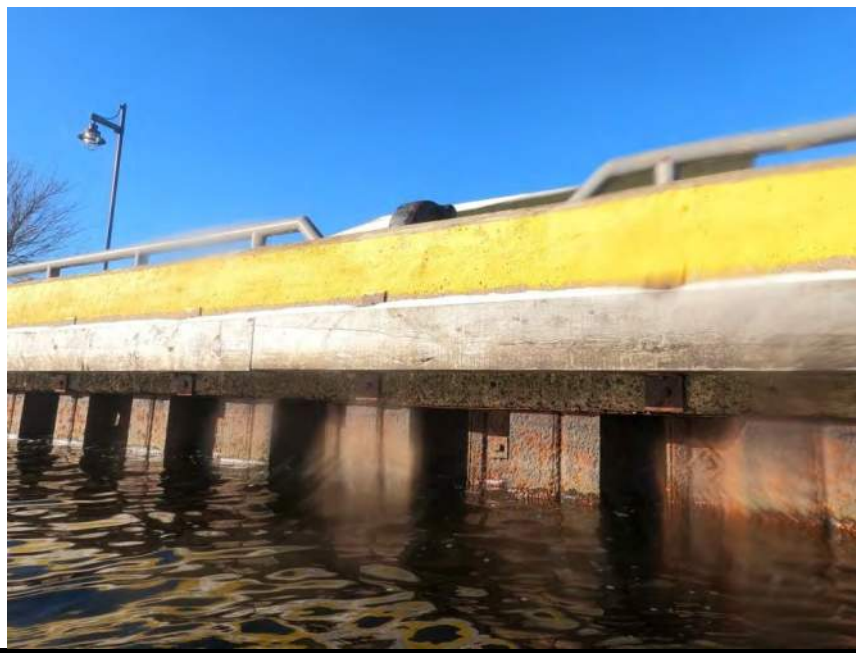
PHOTO # 135

Typical condition of sheet
pile at -0+073

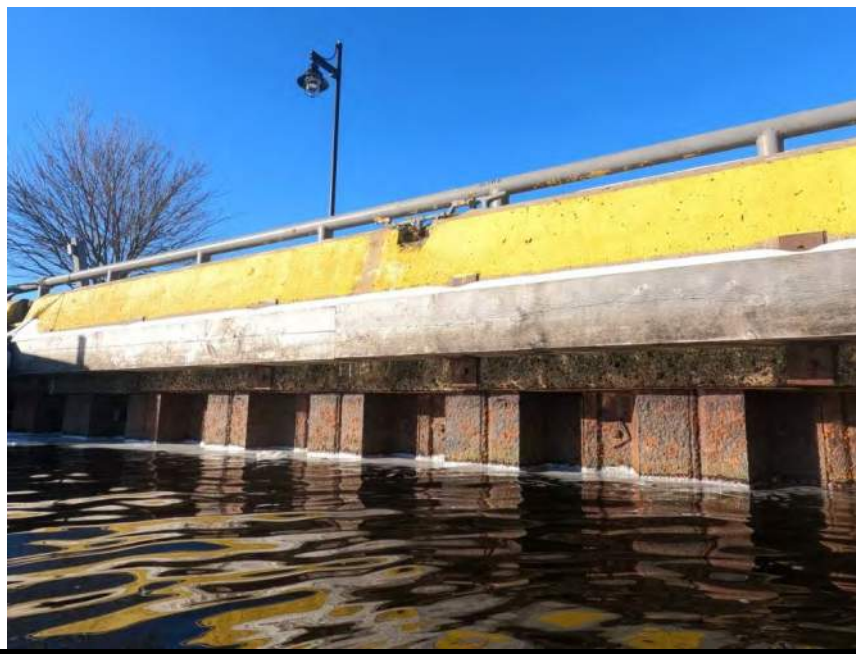
PHOTO # 136

Typical condition of sheet pile at -0+069

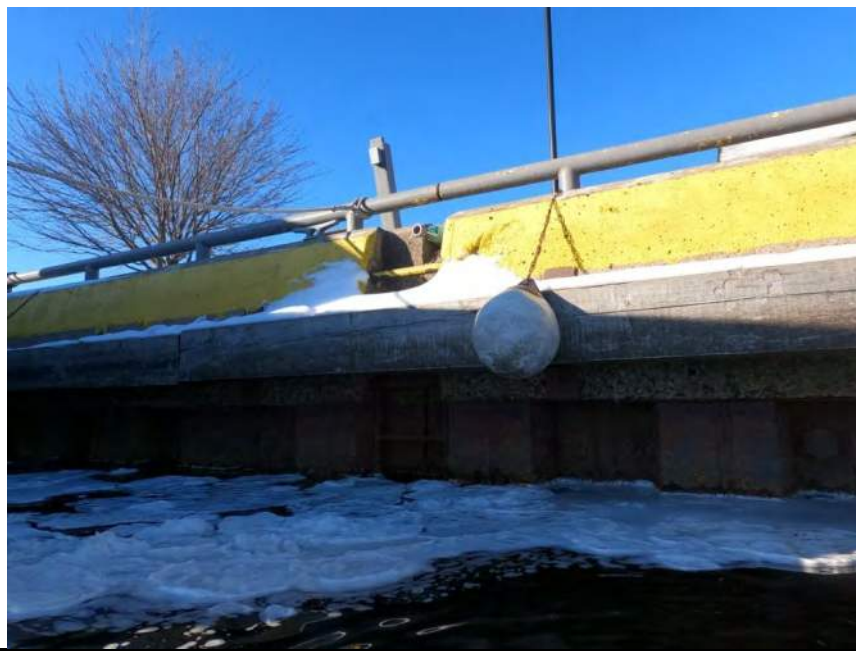
PHOTO # 138

Typical condition of sheet pile at -0+063

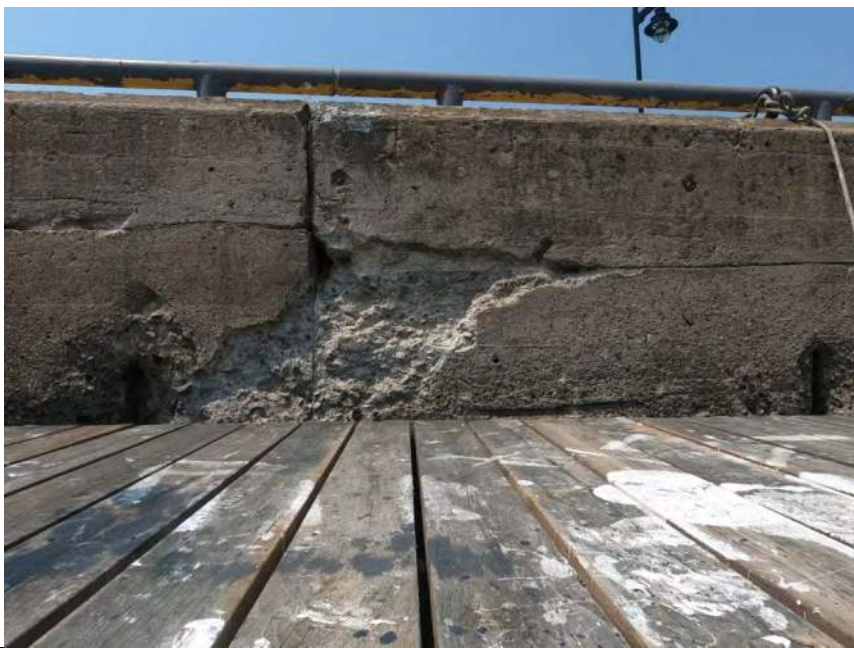
PHOTO # 141

Cracking and spalling at
0+000 on the east face

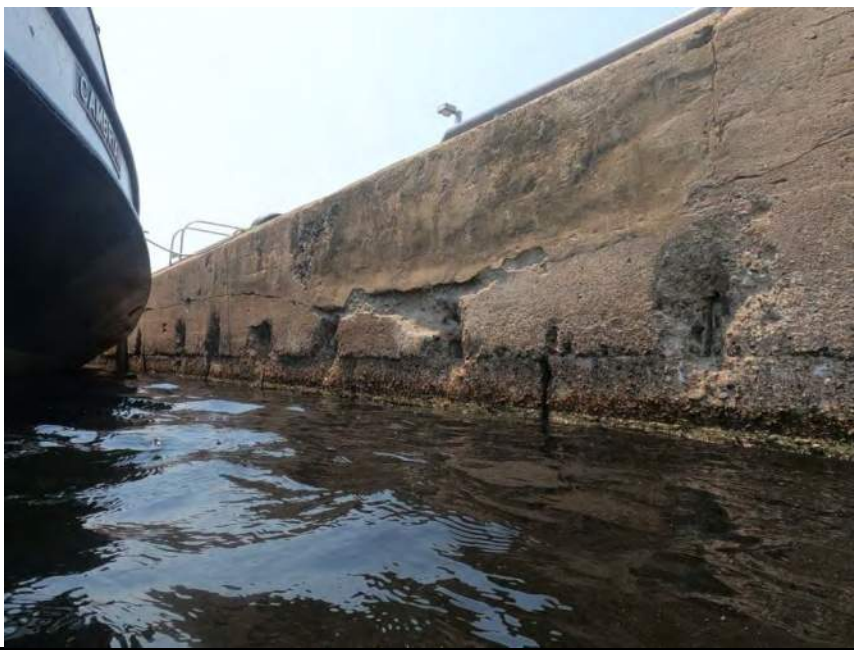
PHOTO # 142

Cracking and spalling at 0+010 on the east face

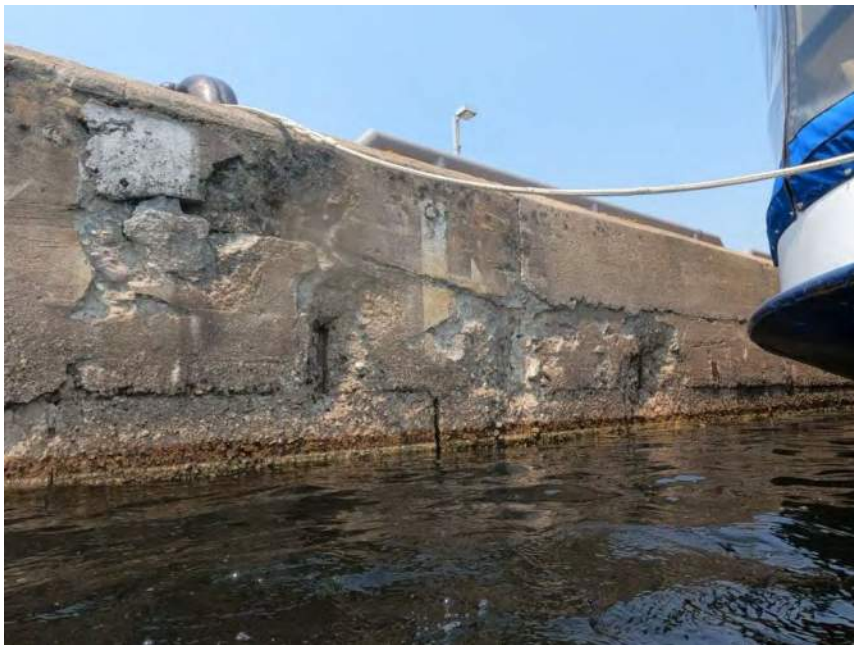
PHOTO # 143

Cracking and spalling at 0+014 on the east face

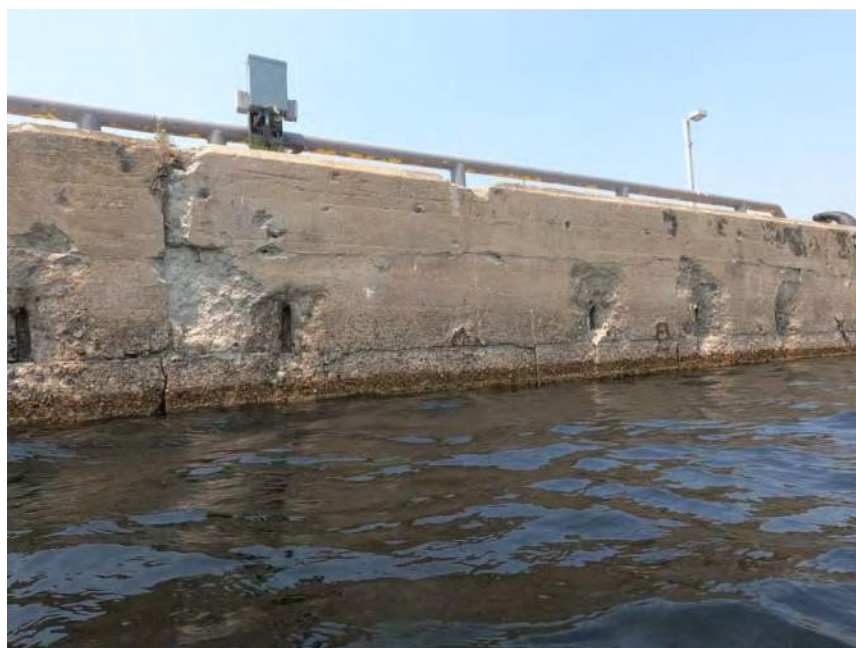
PHOTO # 144

Spalling at 0+036 on the east face

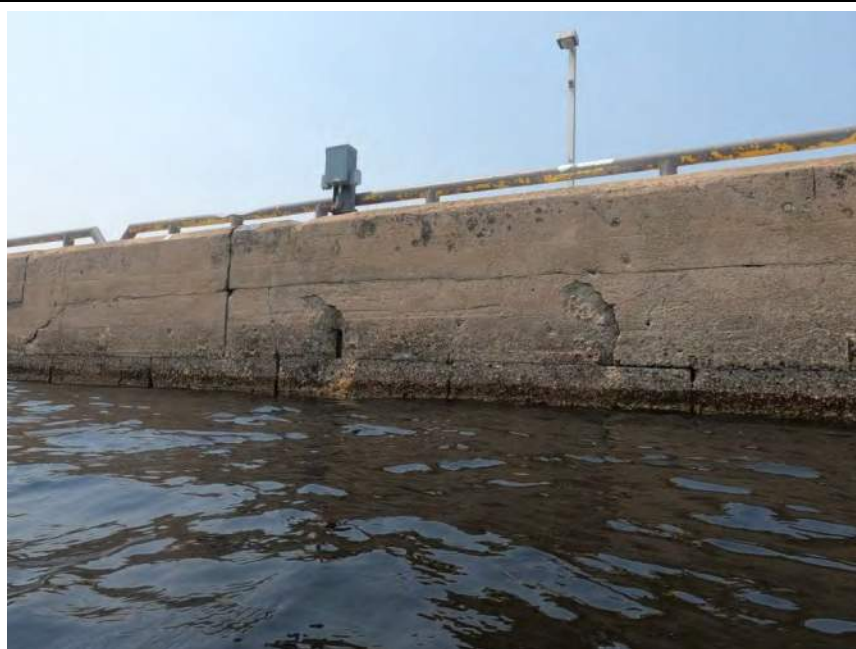
PHOTO # 146

Spalling at 0+049 on the east face

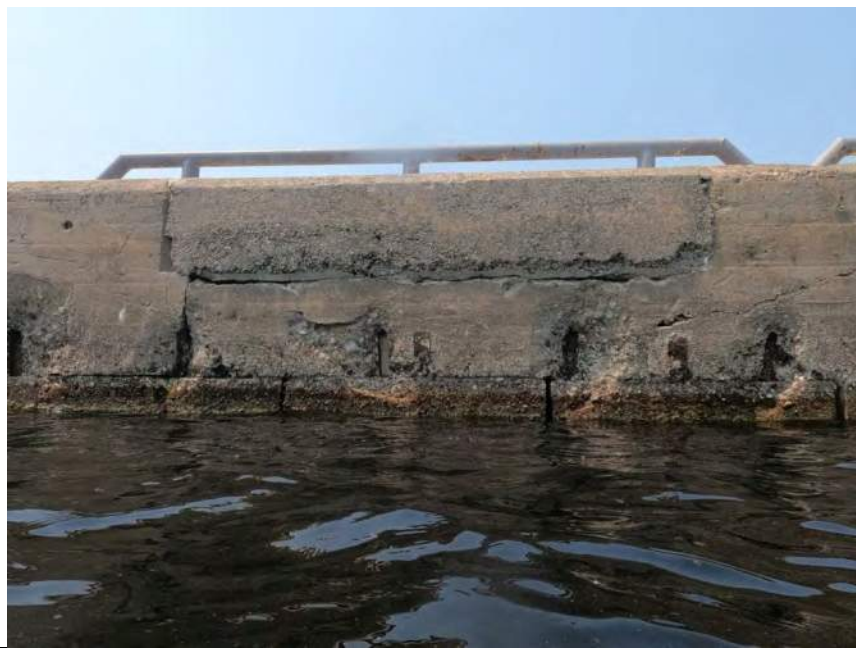
PHOTO # 150

Cracking and spalling at 0+072 on the east face

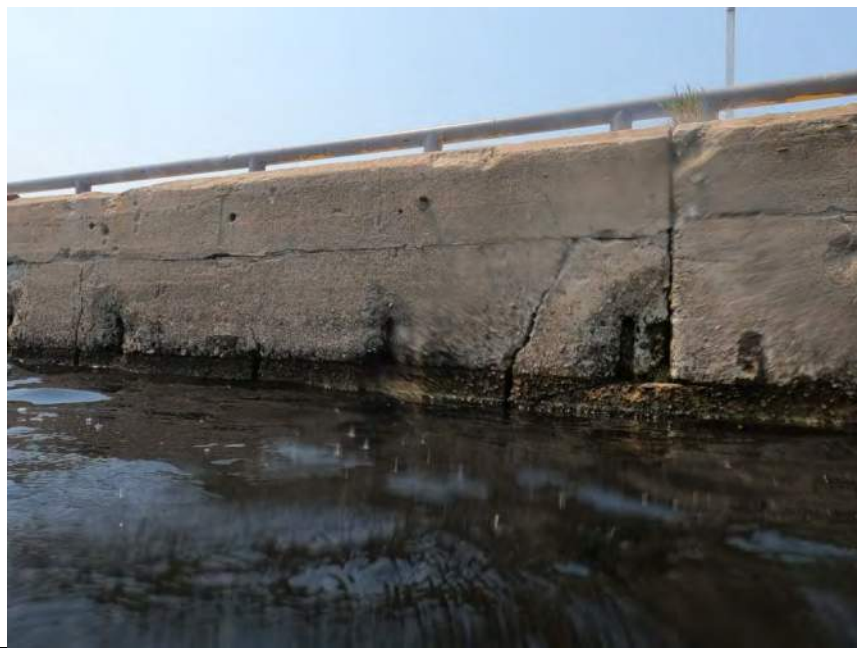
PHOTO # 156

Cracking and spalling at
0+099 on the east face

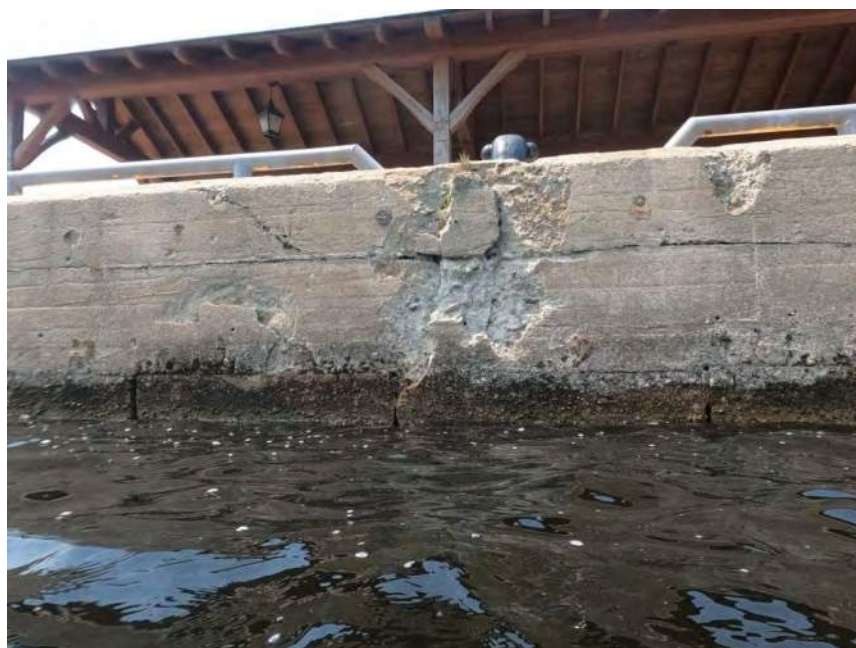
PHOTO # 159

Cracking and spalling at
0+118 on the east face

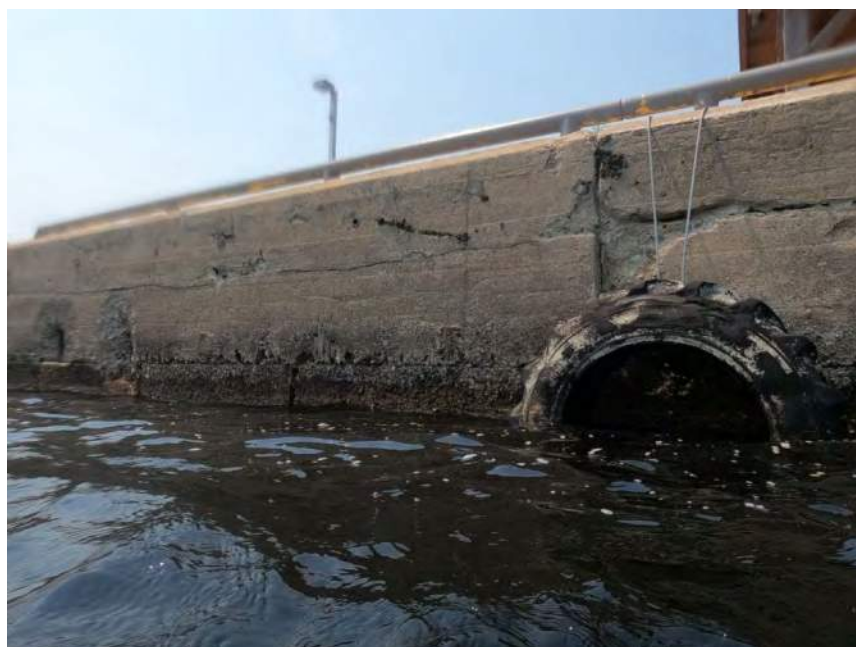
PHOTO # 161

Cracking and spalling at
0+127 on the east face
