Parry Sound Harbour, Ontario

Bay St. Wharf (#401)
Condition Assessment Report

Small Craft Harbours, Fisheries and Oceans Canada

March 2024

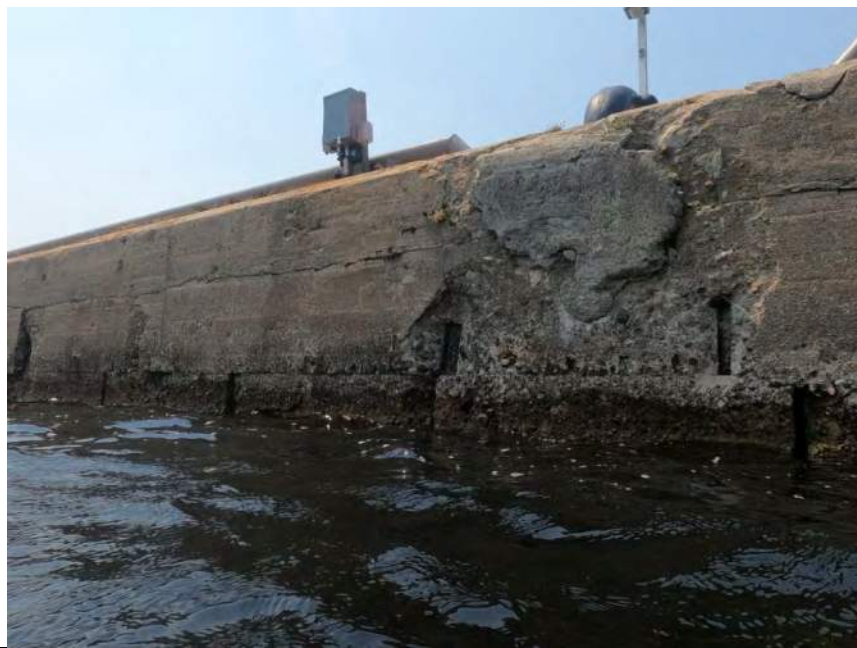
PHOTO # 162

Cracking and spalling at
0+135 on the east face

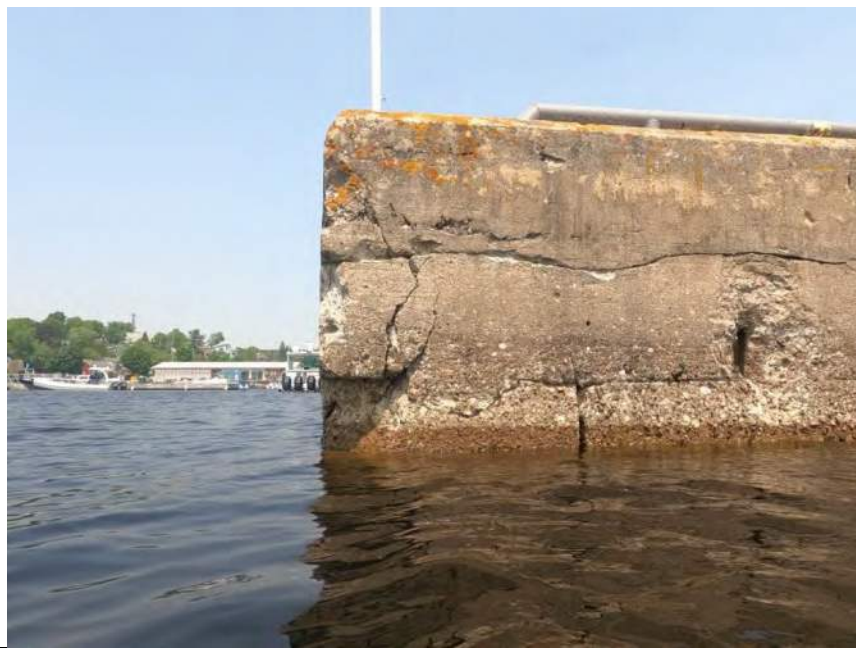
PHOTO # 168

Cracking and spalling on the south face

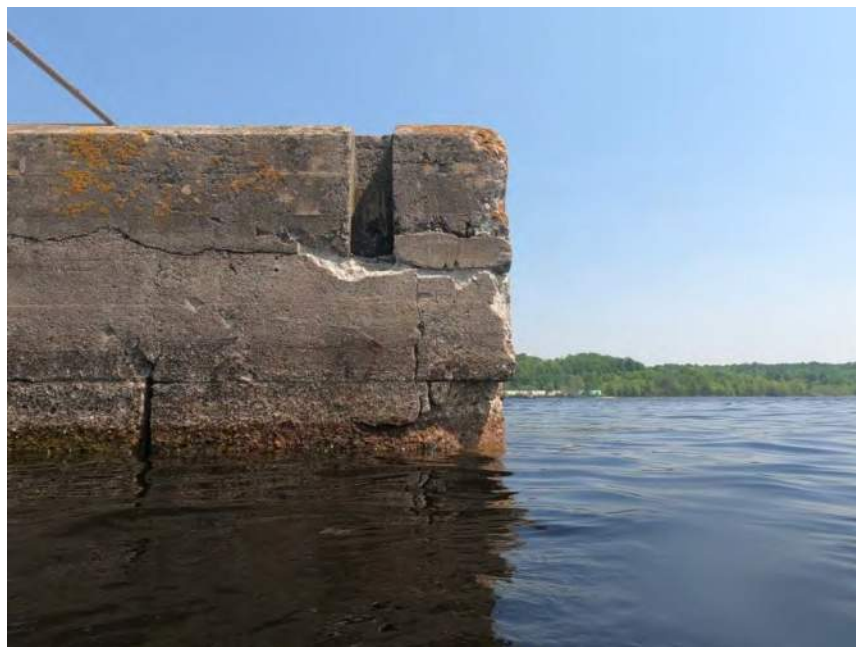
PHOTO # 170

Cracking and spalling at 0+150 on the southwest corner

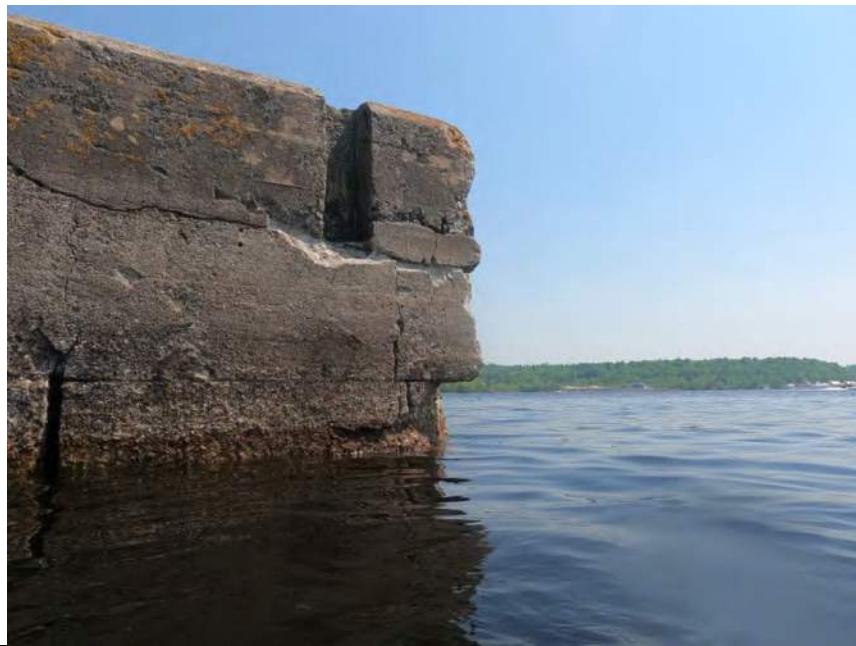
PHOTO # 171

Cracking at 0+150 on the southwest corner

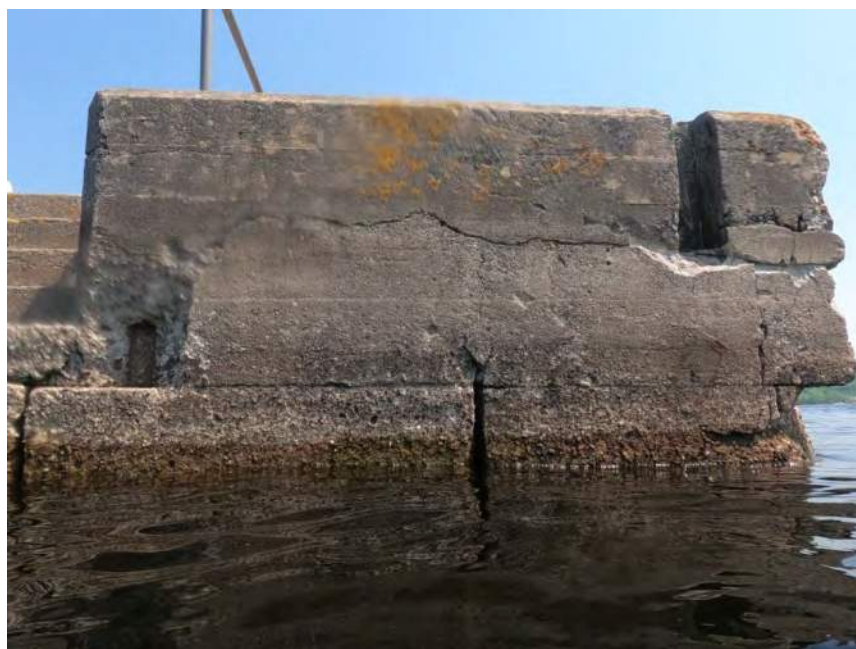
PHOTO # 172

Cracking at 0+150 on the southwest corner

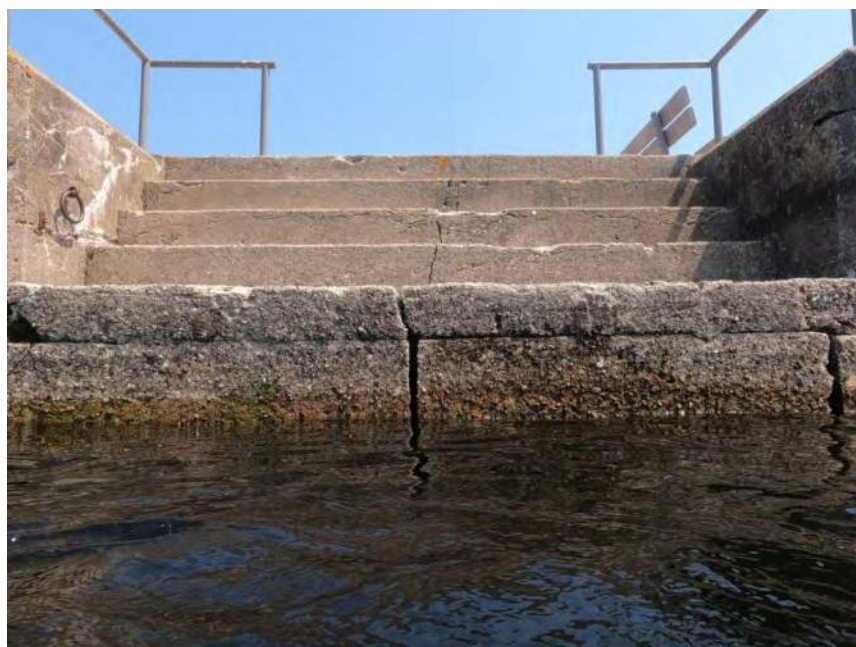
PHOTO # 173

Significant cracks and spalls are also noted at the stairwells on the west side of the wharf (see Photographs 173, 175, 179-180, 183-185, 188-189, 191, 194-195, 198, and 204 in the above water photographs). The stair treads are generally in better condition and have been patched where required.

Cracking at 0+149 on the west face

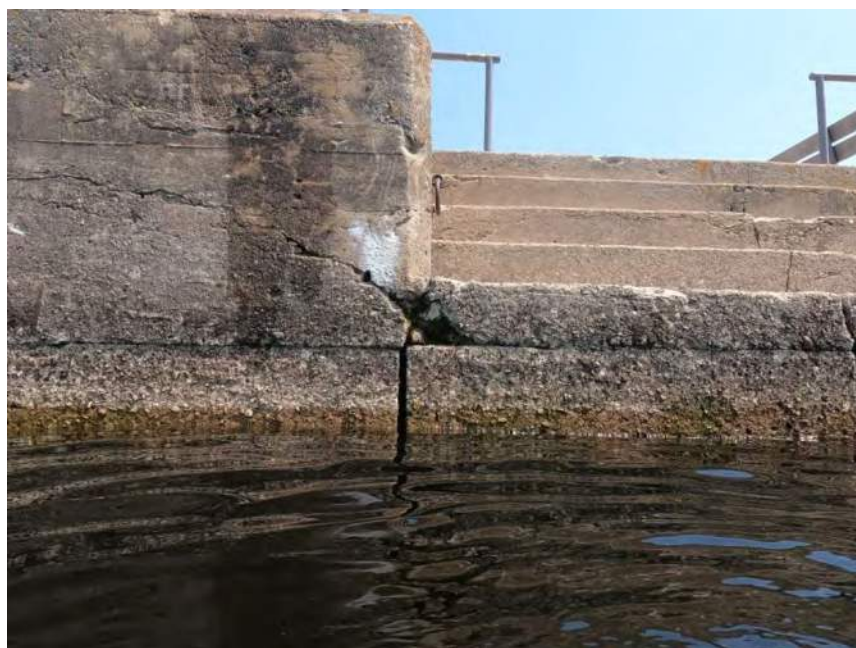
PHOTO # 174

Cracking on the west face at the stairs at 0+145

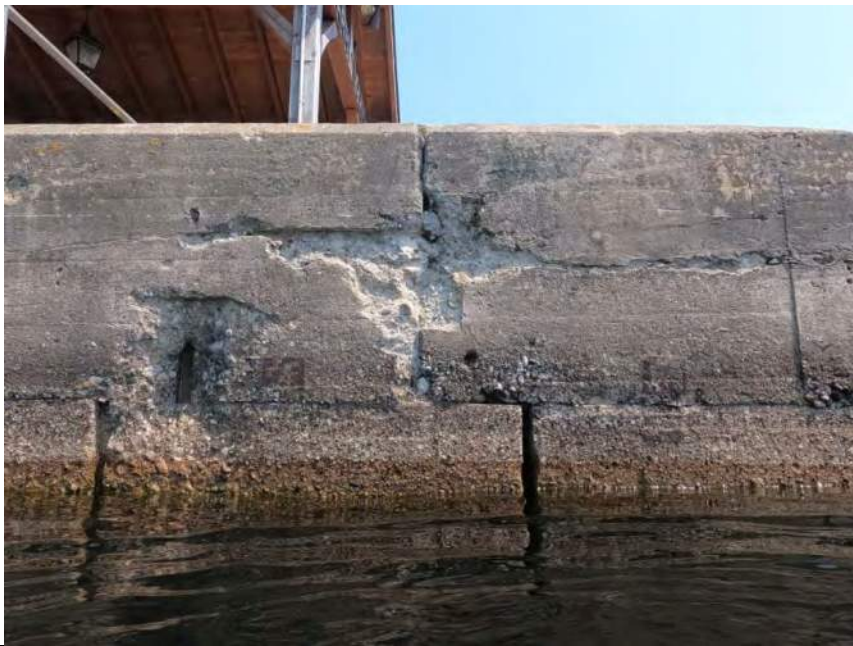
PHOTO # 177

Cracking and spalling at 0+138 on the west face

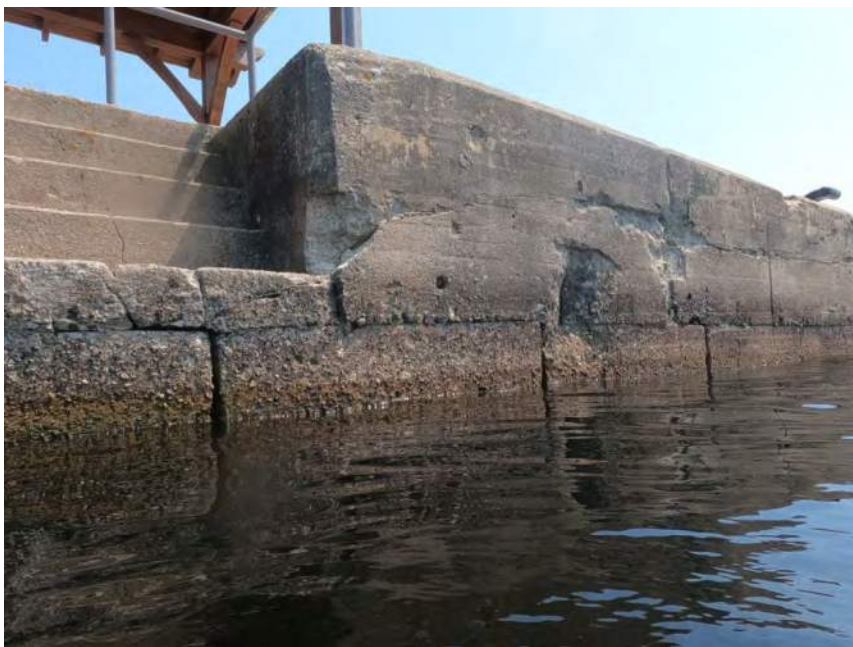
PHOTO # 178

Cracking and spalling at 0+135 on the west face

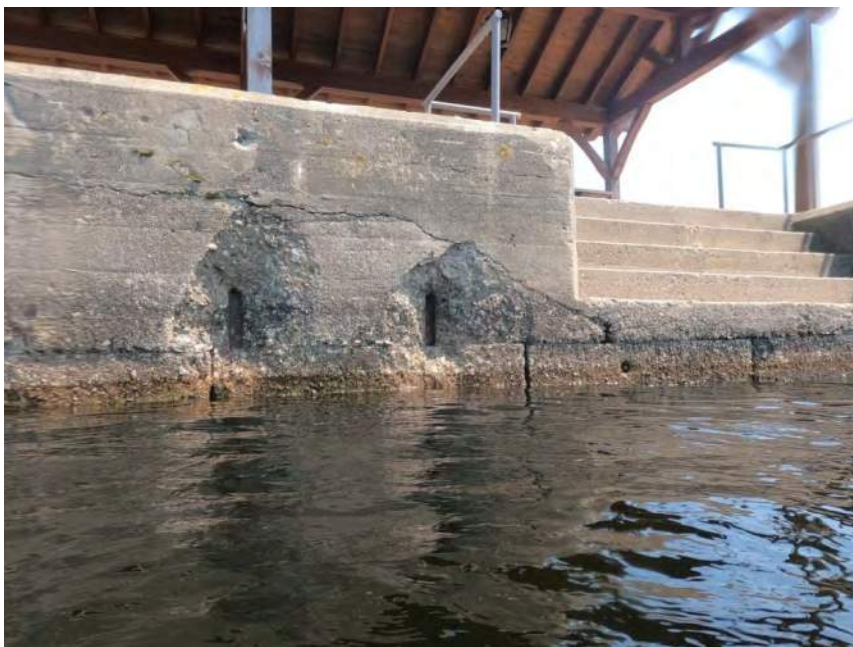
PHOTO # 179

Cracking and spalling at 0+132 on the west face

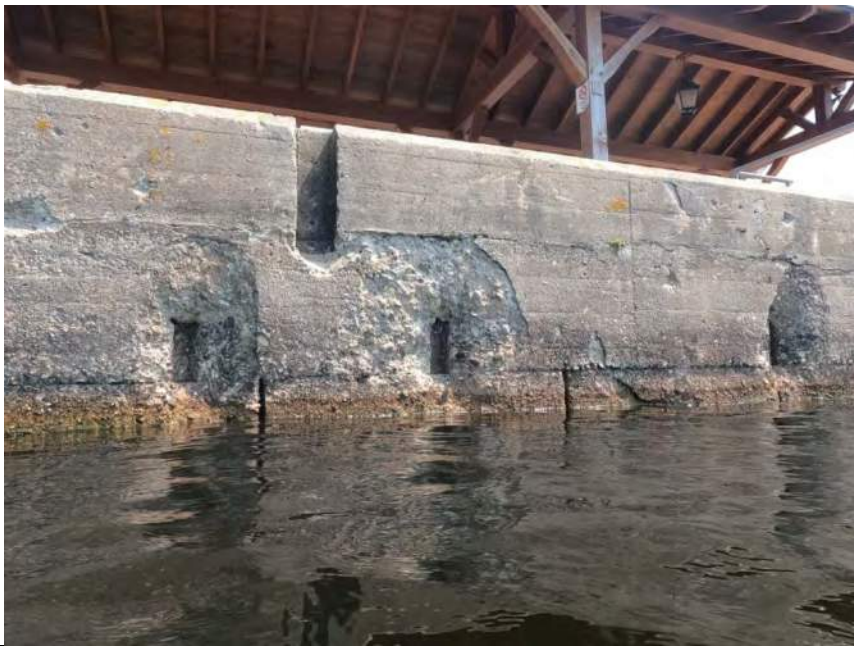
PHOTO # 180

Cracking and spalling at 0+128 on the west face

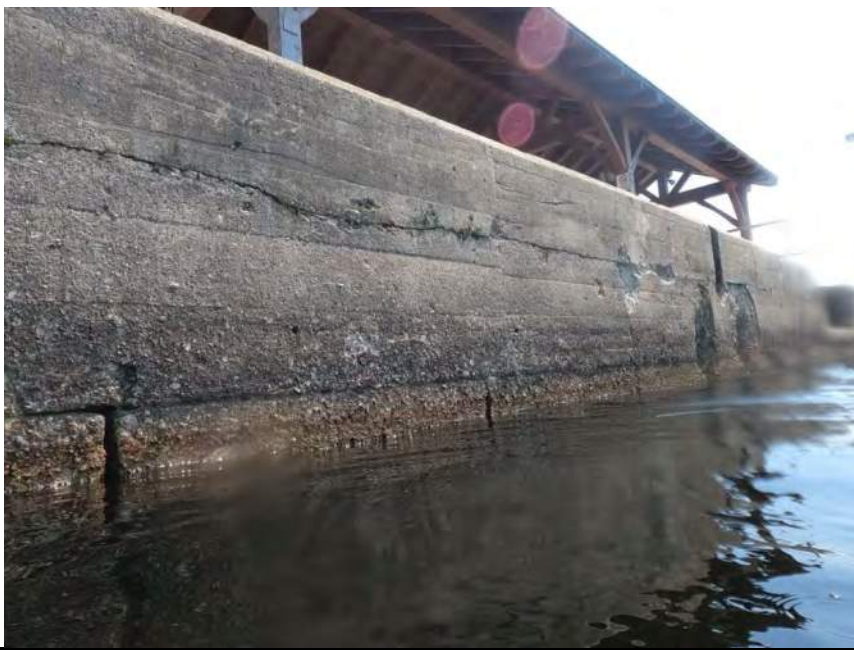
PHOTO # 181

Cracking and spalling at 0+123 on the west face

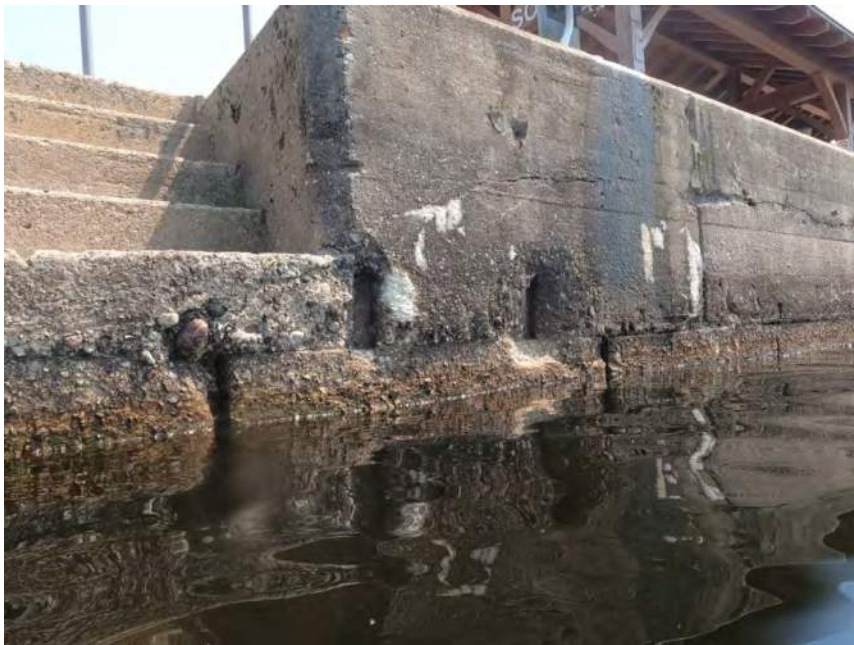
PHOTO # 182

Cracking at 0+118 on the west face

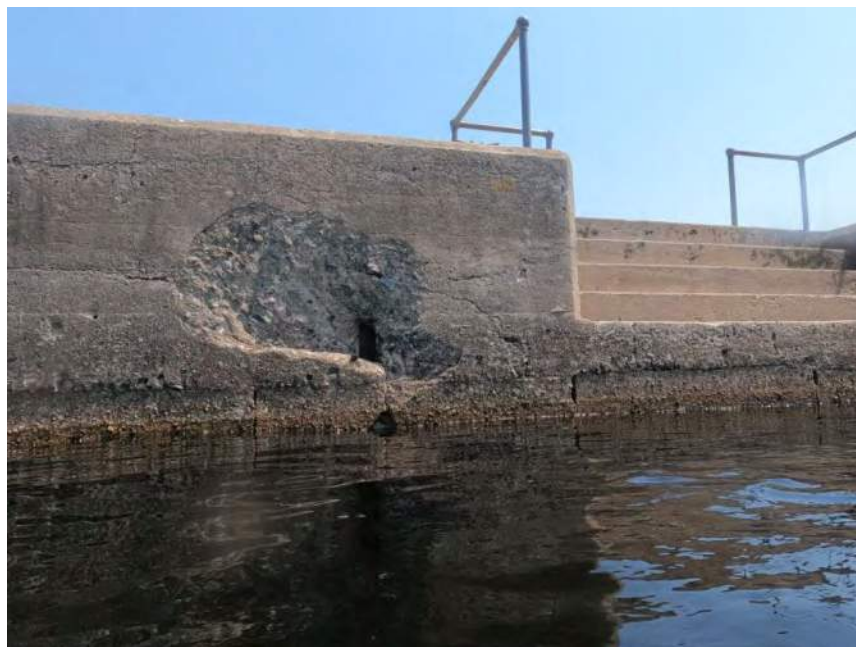
PHOTO # 188

Cracking and spalling at
0+086 on the west face

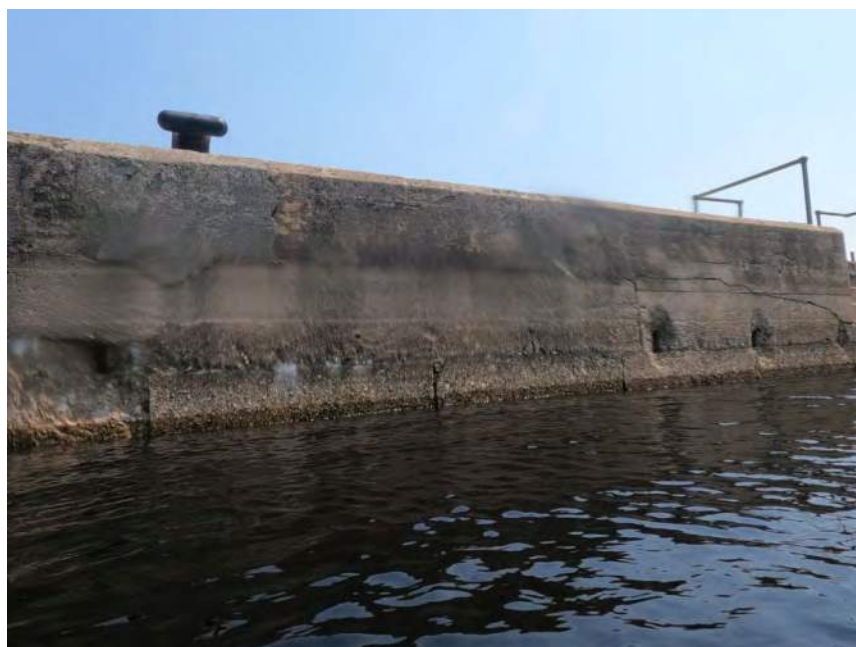
PHOTO # 191

Cracking and spalling at 0+052 on the west face

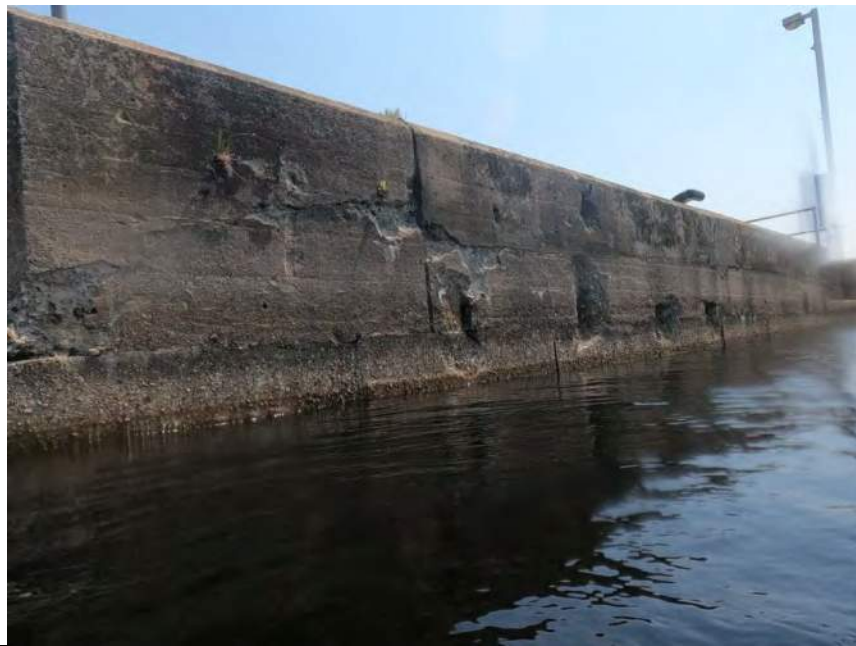
PHOTO # 192

Cracking and spalling at 0+047 on the west face

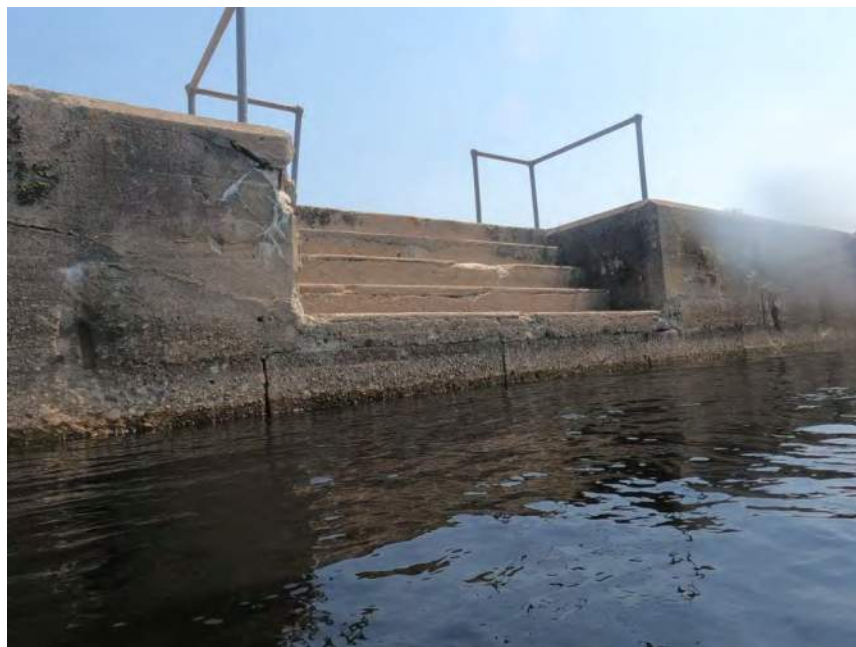
PHOTO # 194

Cracking and spalling at 0+037 on the west face

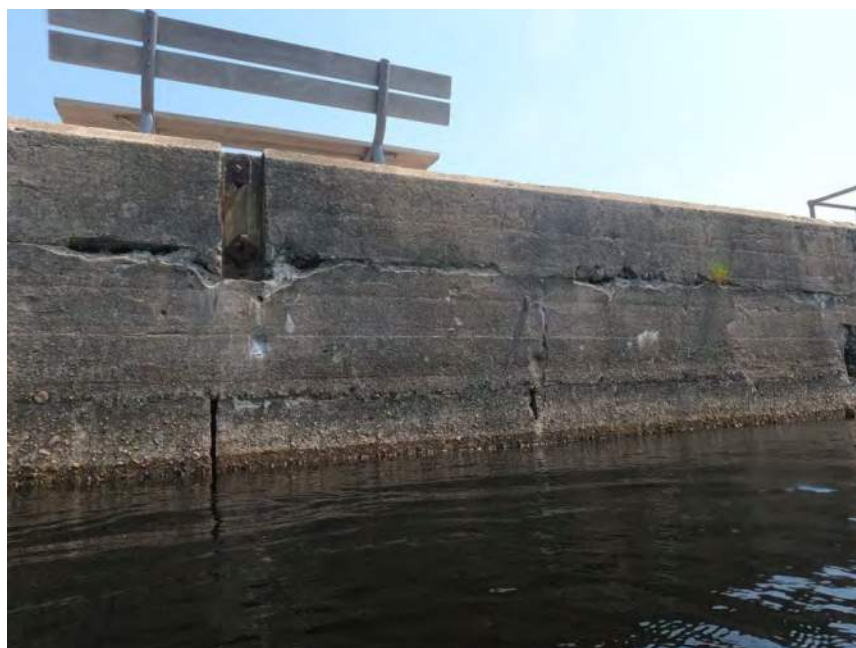
PHOTO # 195

Cracking and spalling at 0+035 on the west face

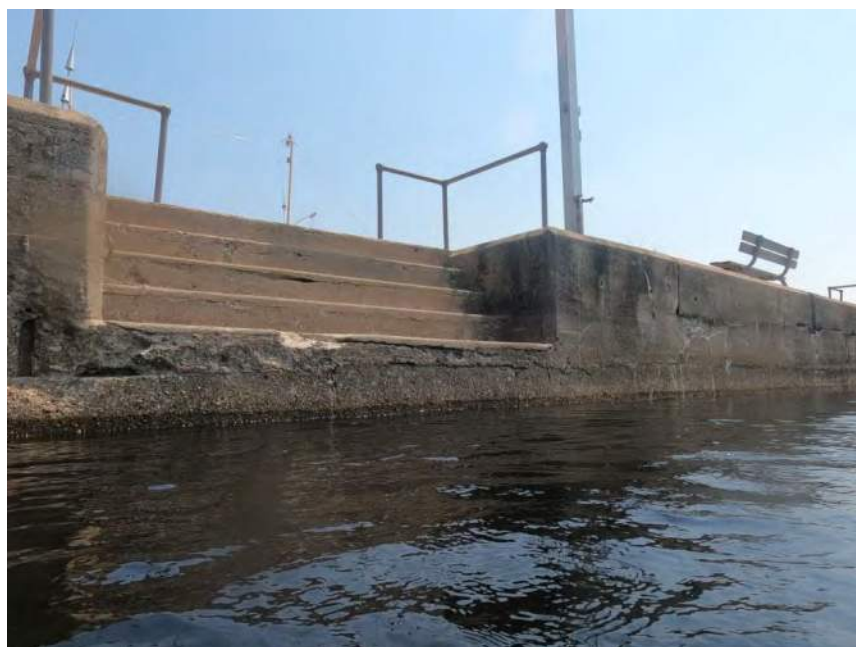
PHOTO # 197

Cracking and spalling at 0+026 on the west face

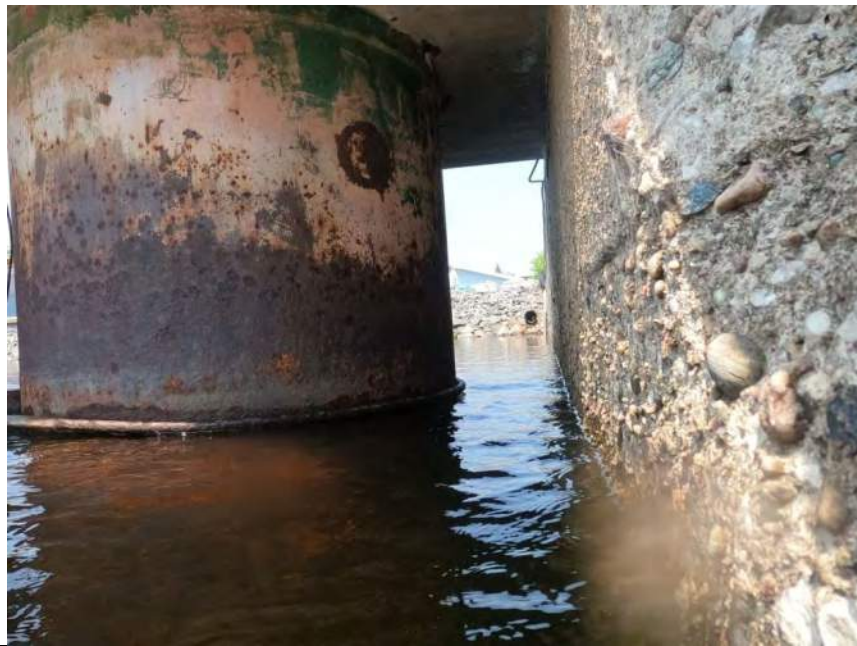
PHOTO # 198

Cracking and spalling at 0+018 on the west face

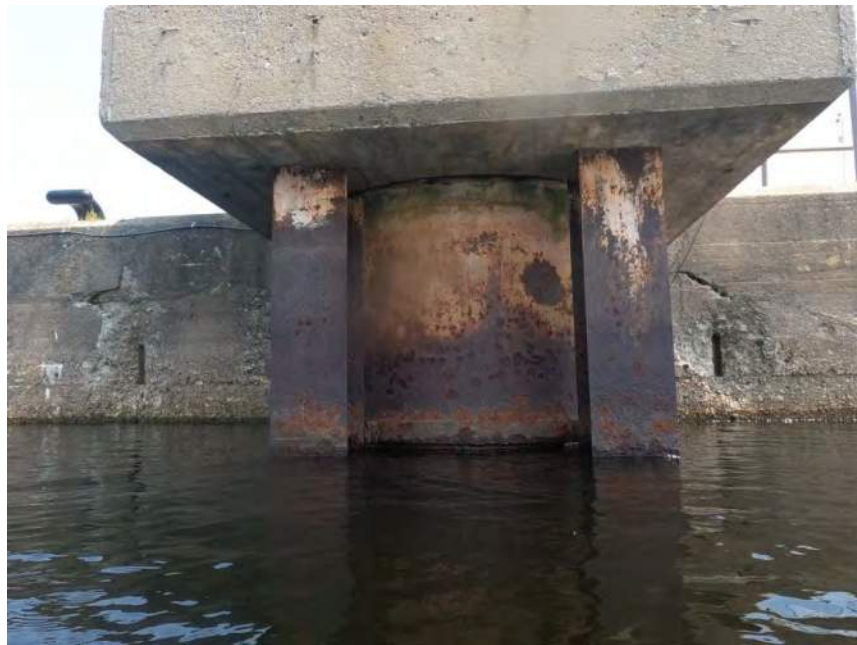
PHOTO # 200

Cracking and spalling at 0+017 on the west face

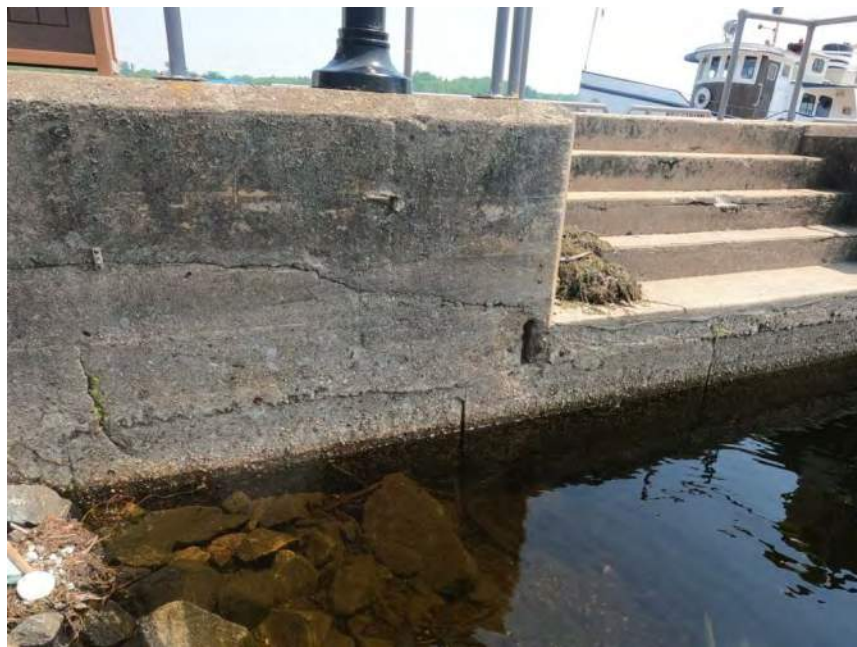
PHOTO # 203

Cracking and spalling at 0+007 on the west face

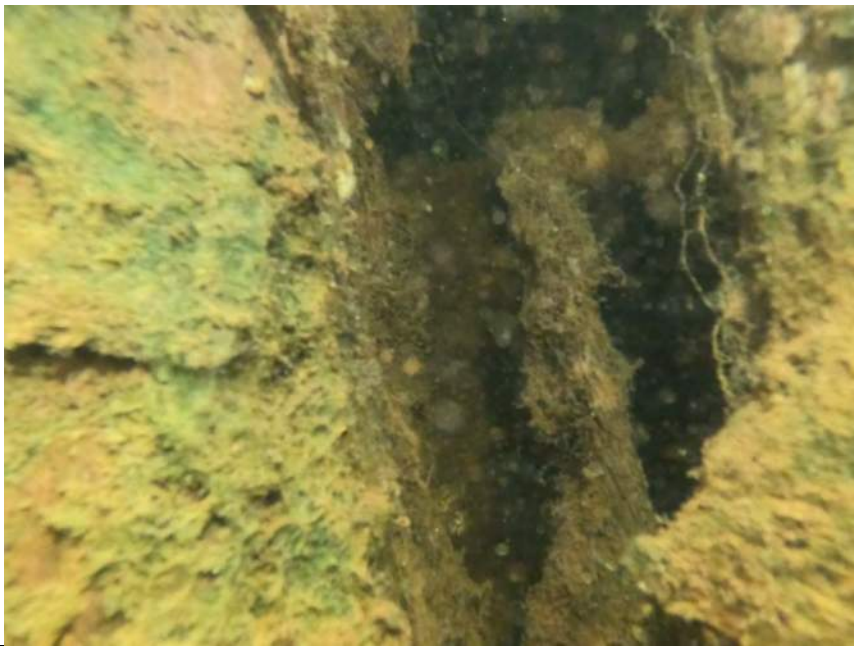
PHOTO # 7

Deteriorated timber at
0+035 (west face)

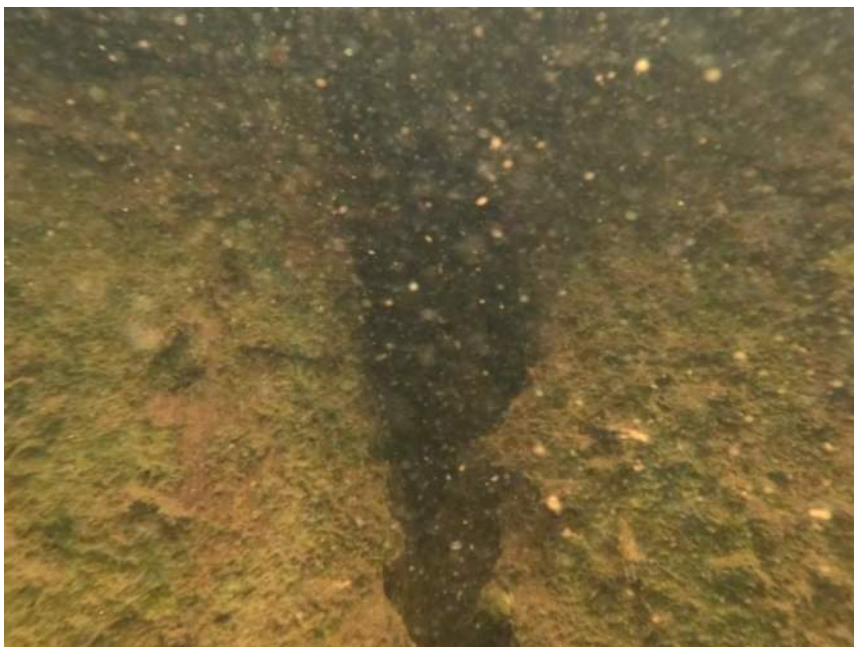
PHOTO # 8

Deteriorated timber at
0+035 (west face)

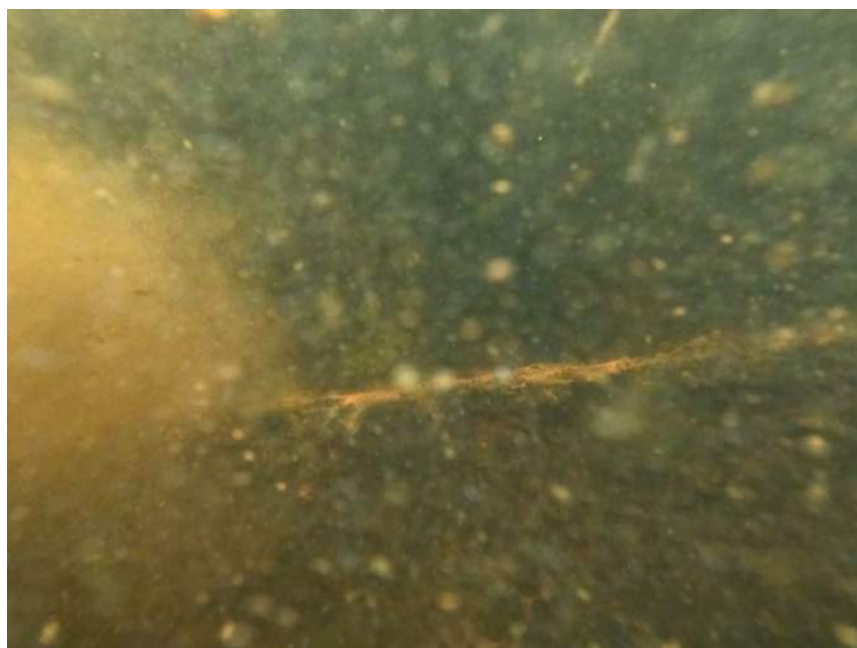
PHOTO # 13

Tie back bolt at 0+069
(west face)

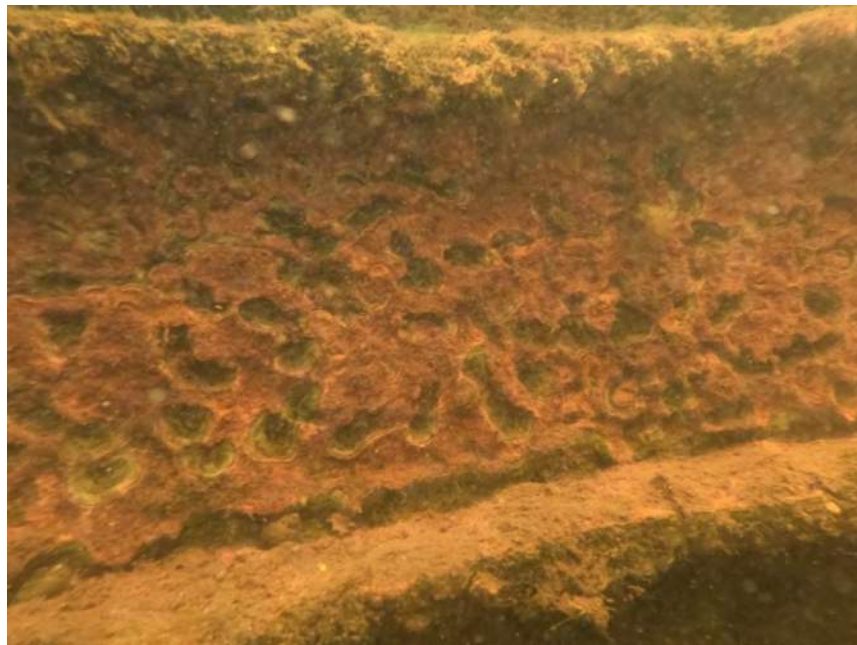
PHOTO # 26

"C" channel at 0+085
(west face)

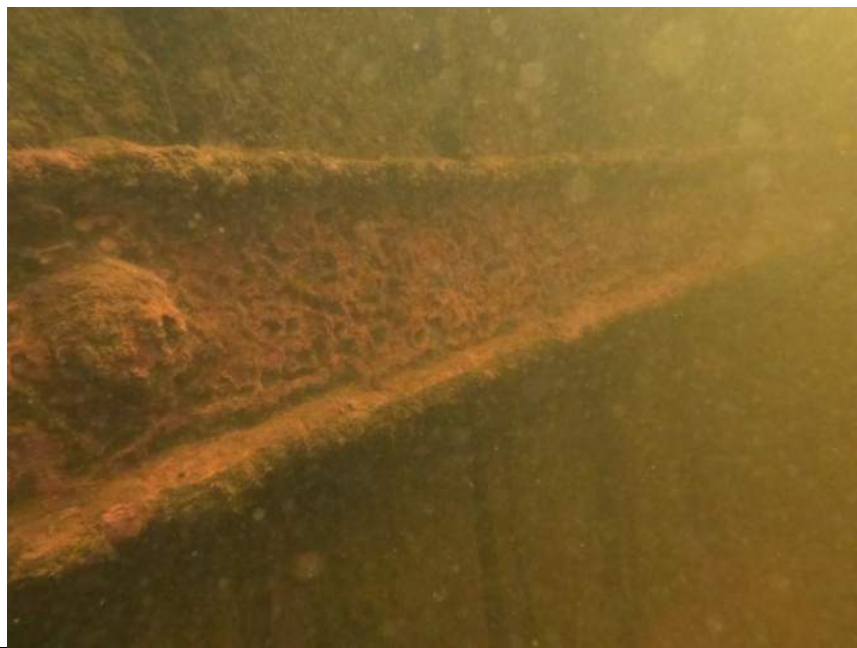
PHOTO # 27

"C" channel at 0+086
(west face)

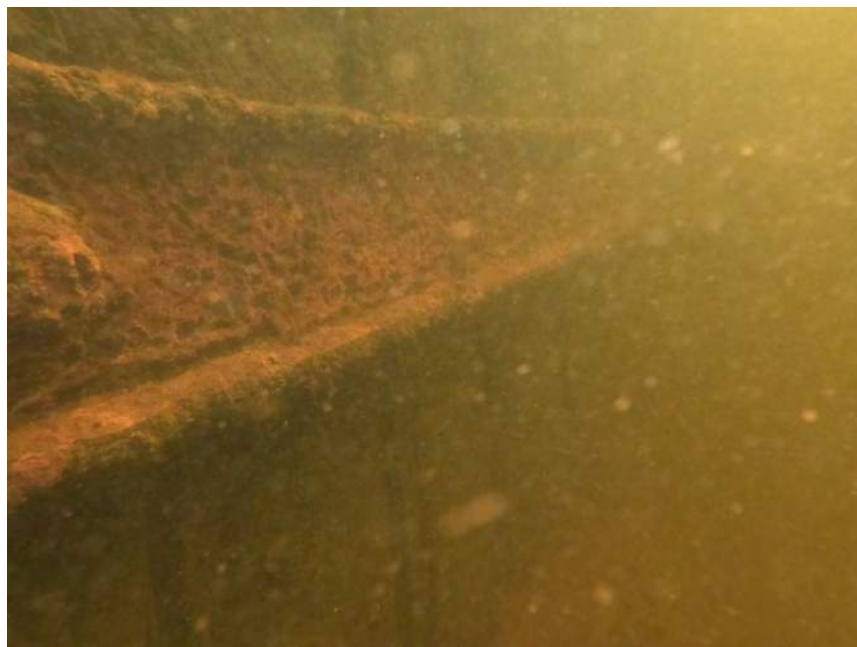
PHOTO # 28

"C" channel at 0+088
(west face)

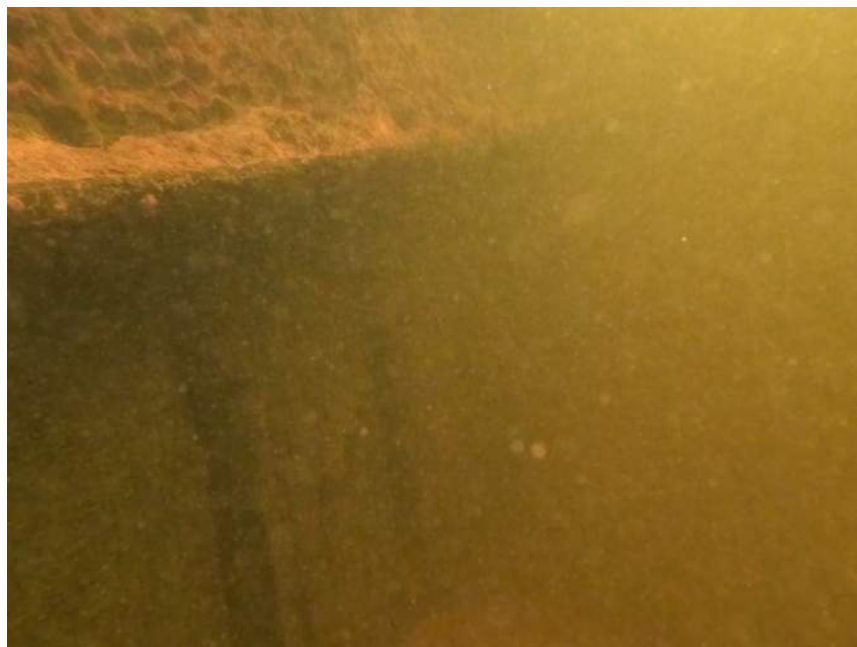
PHOTO # 29

"C" channel at 0+090
(west face)

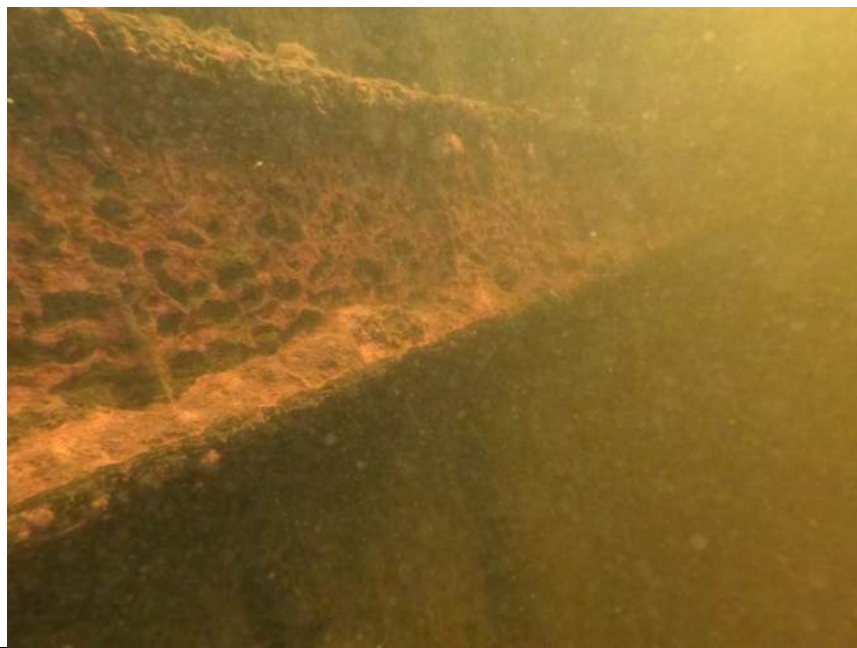
PHOTO # 30

Piles at bottom at 0+091
(west face)

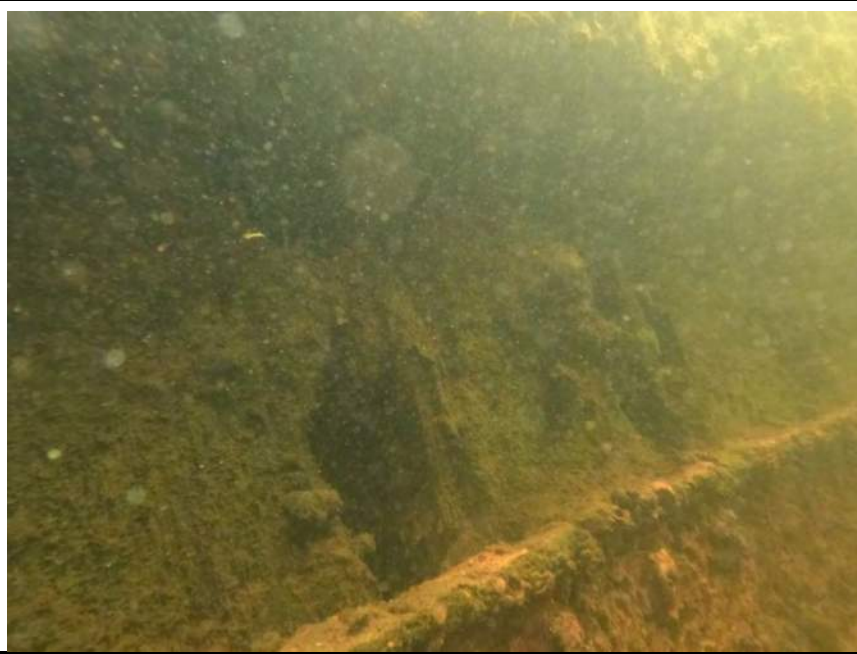
PHOTO # 31

"C" Channel at 0+092
(west face)

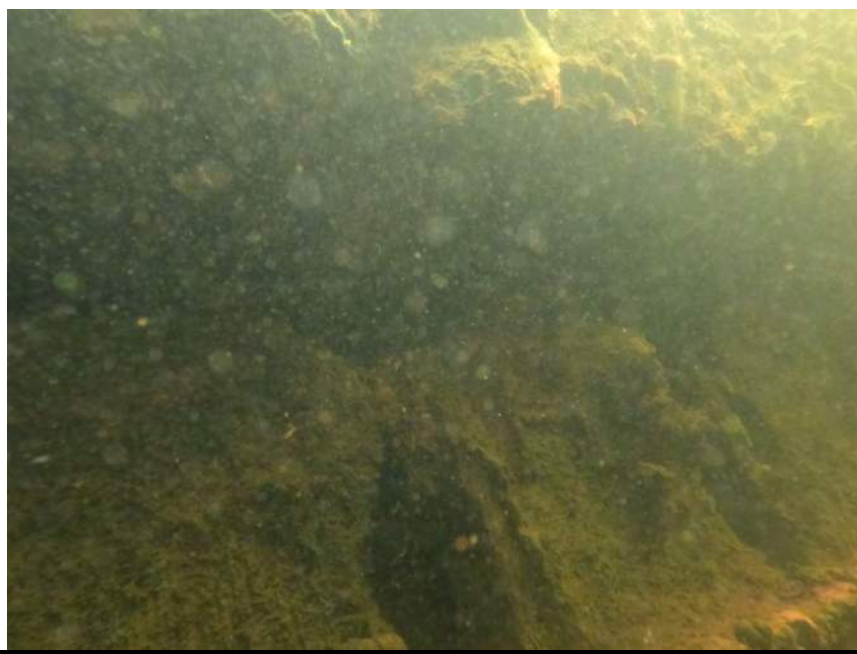
PHOTO # 32

Top of "C" channel 0+093
(west face)

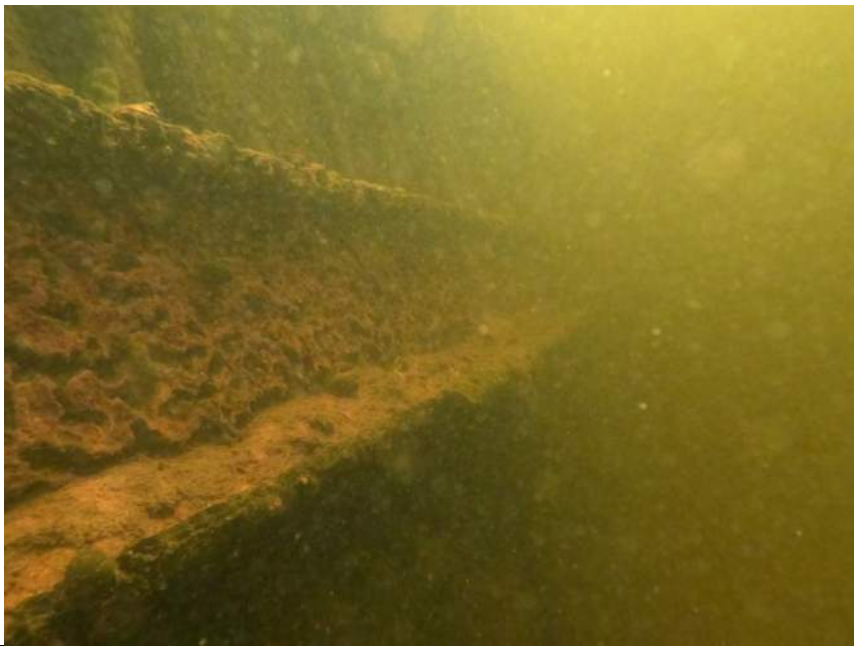
PHOTO # 33

Typical timber condition at
0+095 (west face)

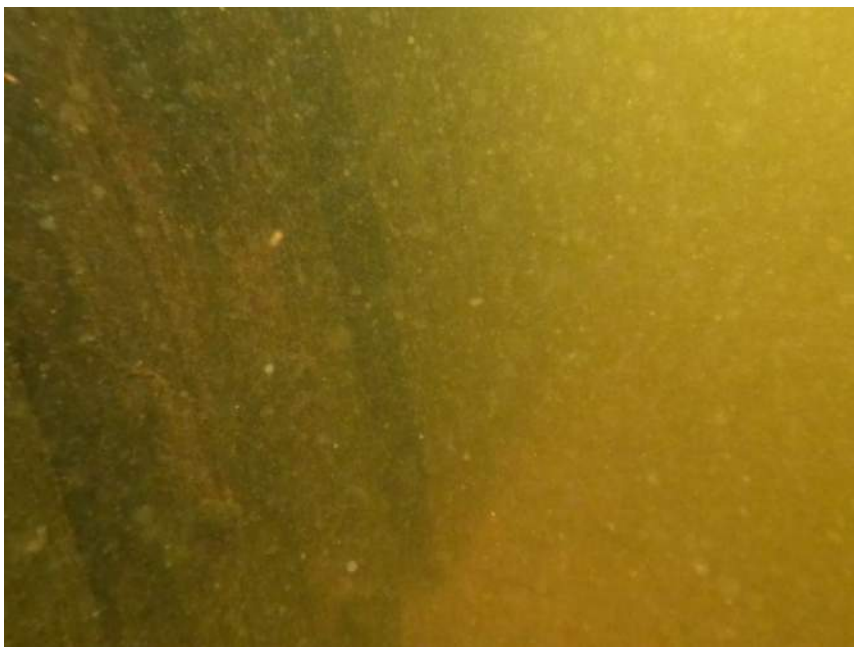
PHOTO # 34

"C" channel at 0+095
(west face)

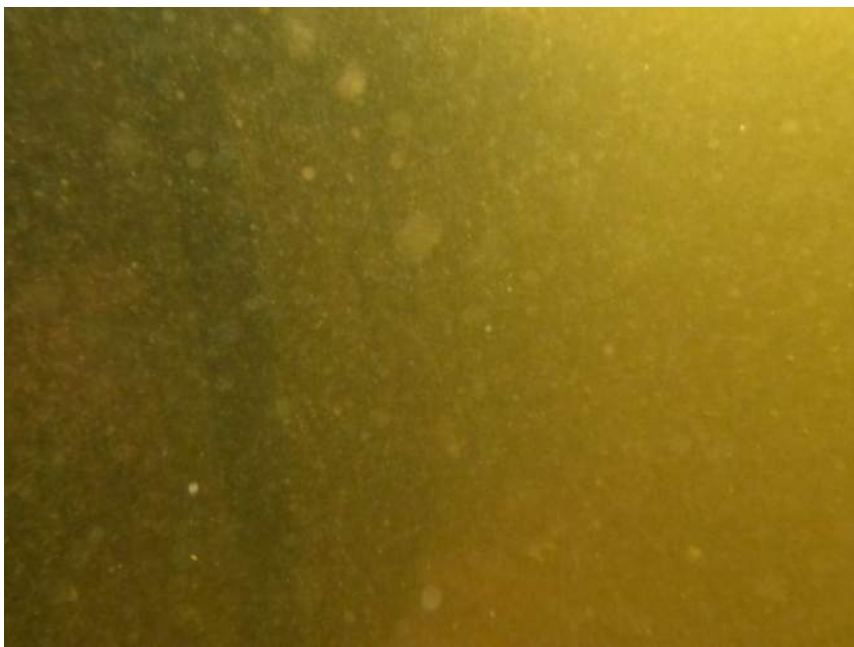
PHOTO # 35

Piles at bottom at 0+100
(west face)

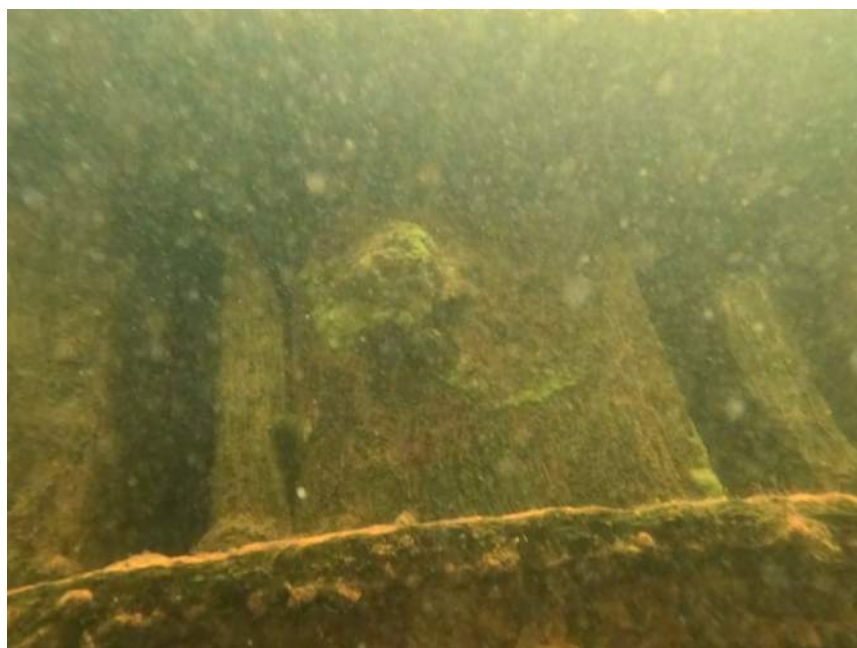
PHOTO # 36

Piles at bottom at 0+105
(west face)

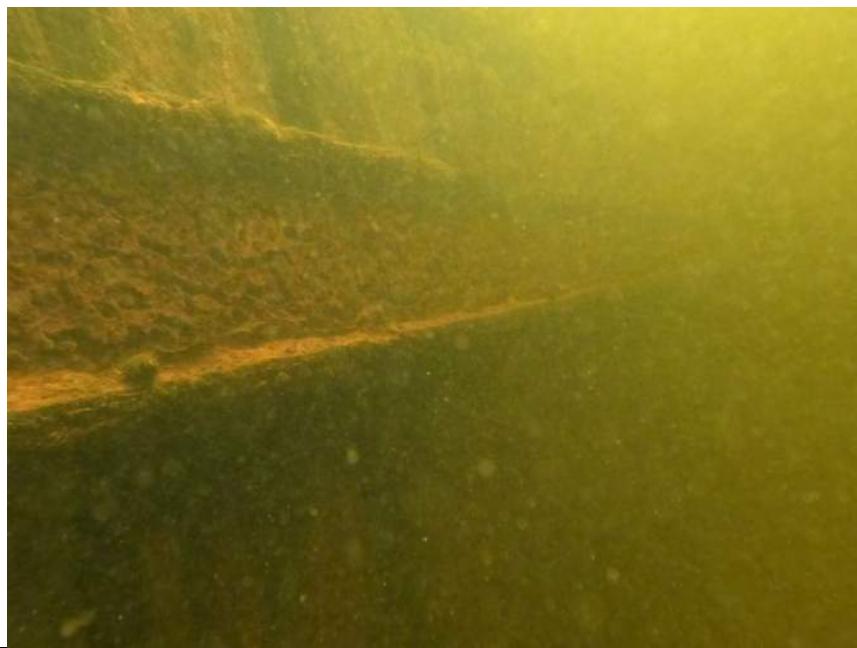
PHOTO # 39

"C" channel at 0+110
(west face)

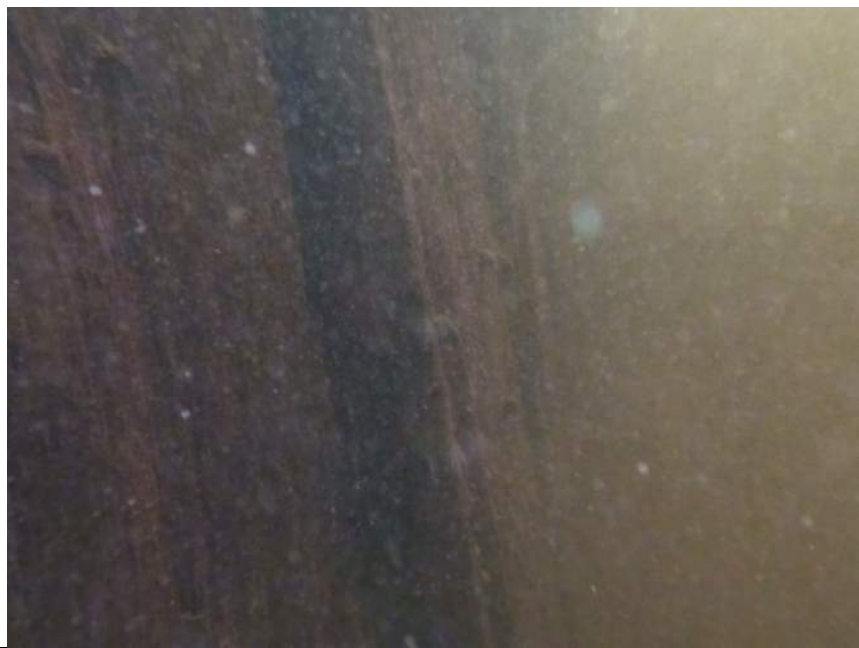
PHOTO # 42

Close up of typical condition of "C" channel at 0+118 (west face)

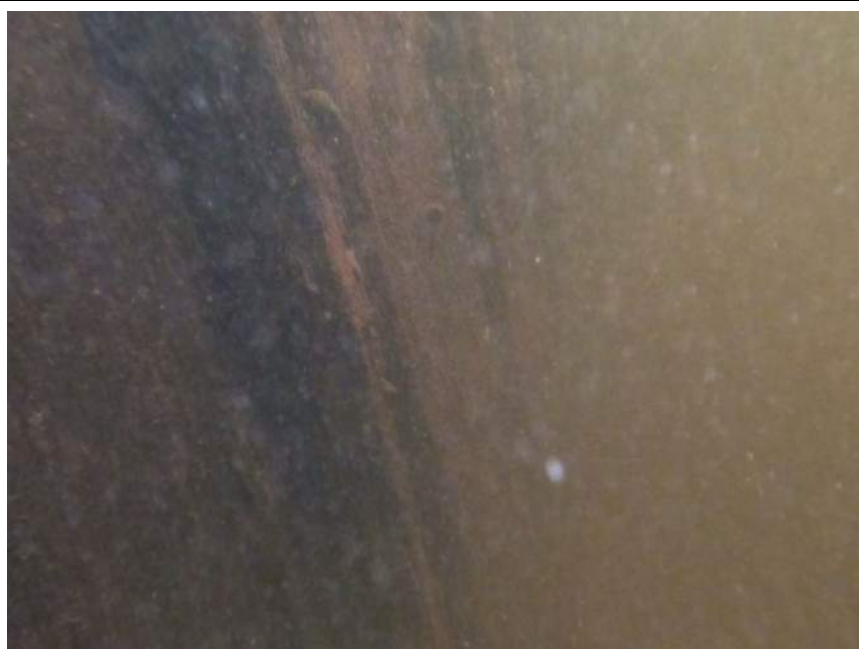
PHOTO # 43

Piles at bottom at 0+119
(west face)

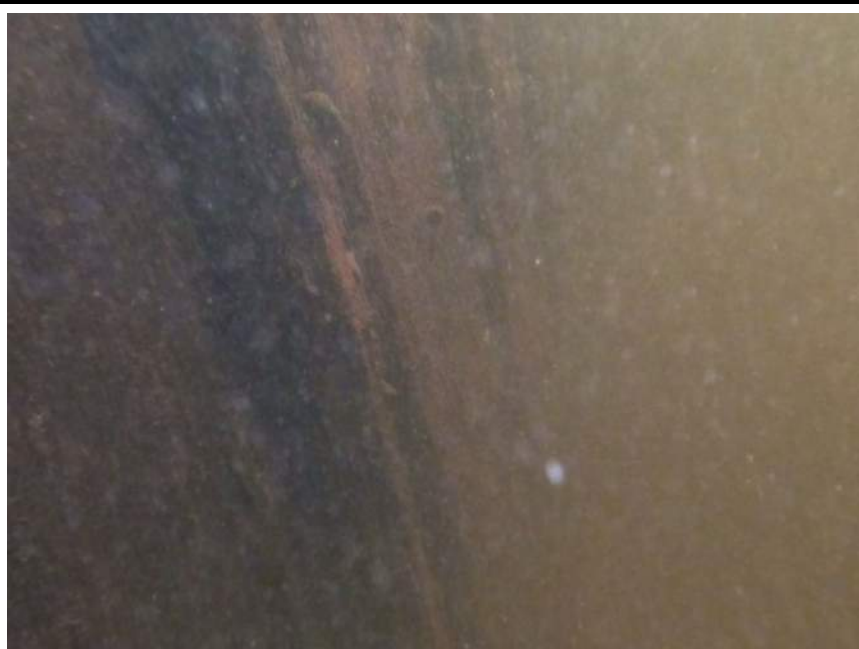
PHOTO # 44

Piles at bottom at 0+120
(west face)
