Parry Sound Harbour, Ontario

Bay St. Wharf (#401)
Condition Assessment Report

Small Craft Harbours, Fisheries and Oceans Canada

March 2024

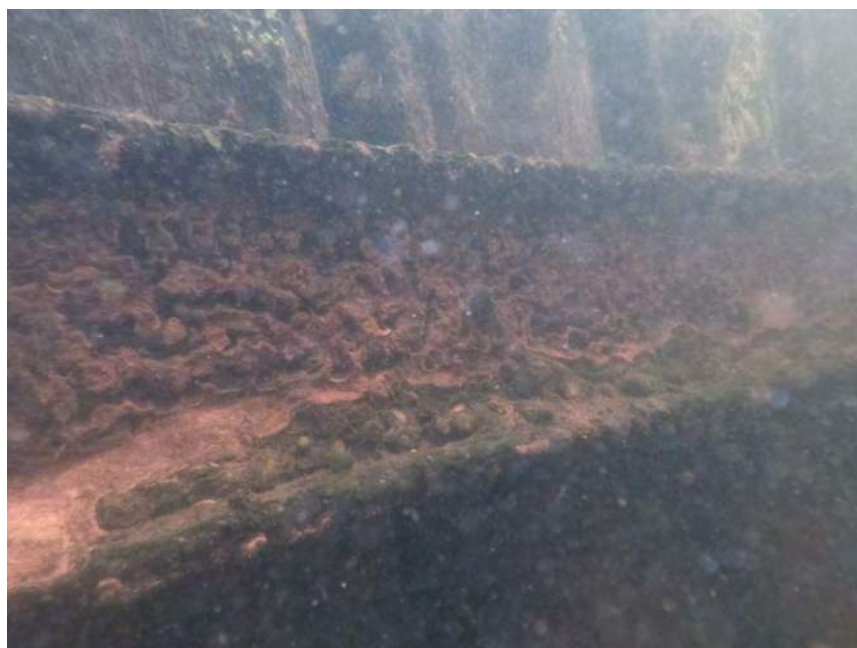
PHOTO # 45

Piles at bottom at 0+124
(west face)

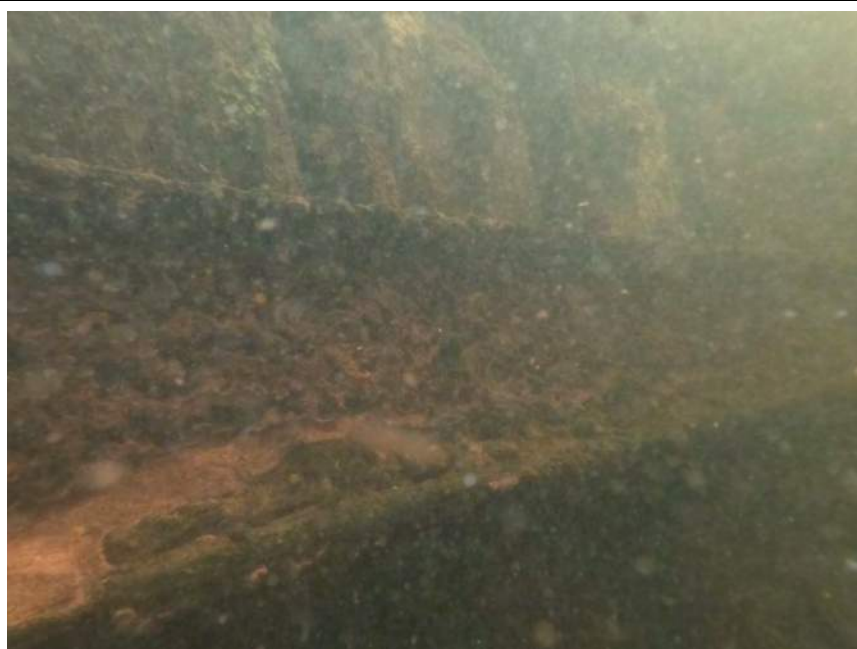
PHOTO # 46

"C" channel at 0+135
(west face)

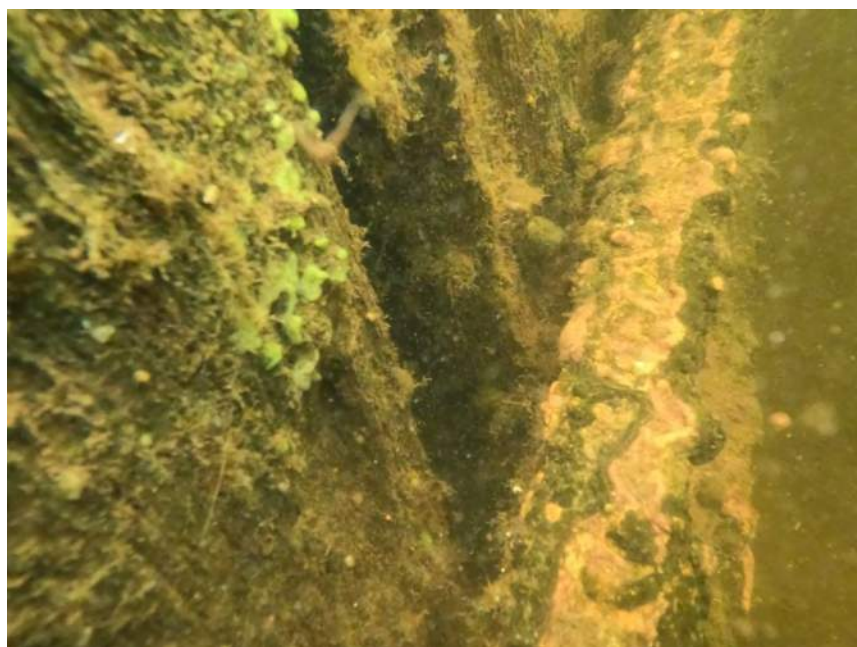
PHOTO # 47

"C" channel at 0+135
(west face)

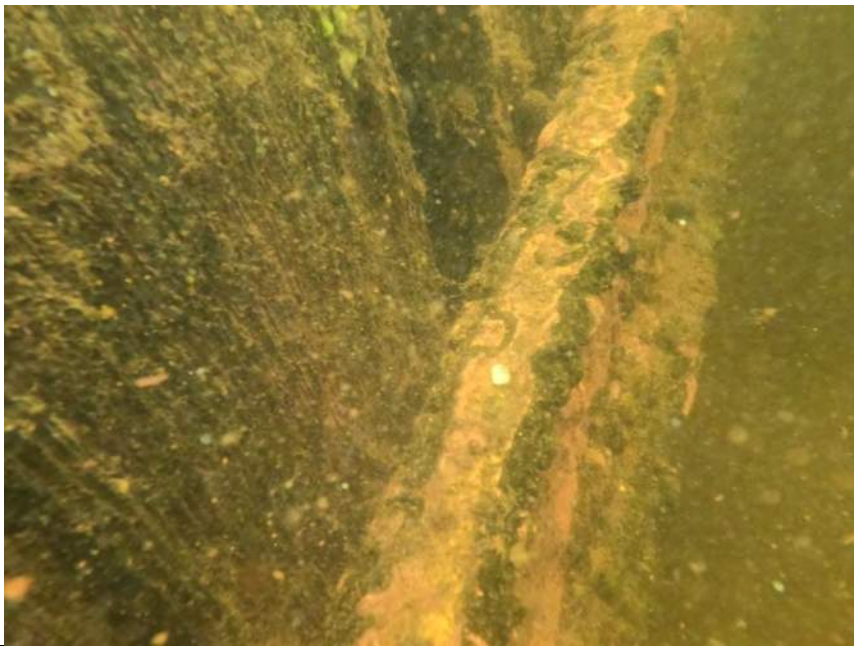
PHOTO # 48

"C" channel at 0+140
(west face)

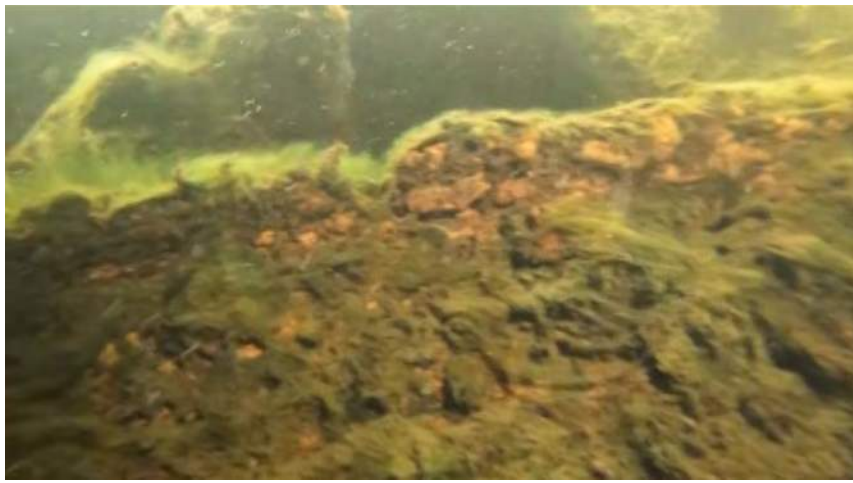
PHOTO # 54

Piles at bottom at 0+133 (east face)

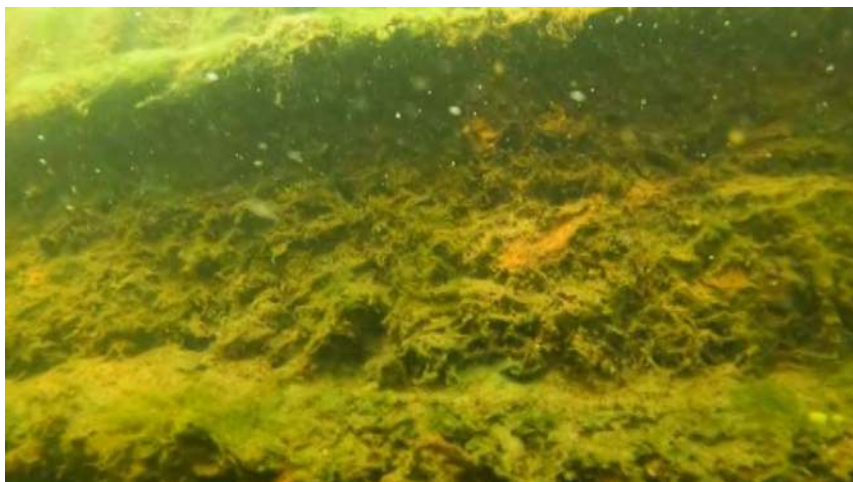
PHOTO # 56

Close up of typical condition of "C" channel at 0+128 (east face)

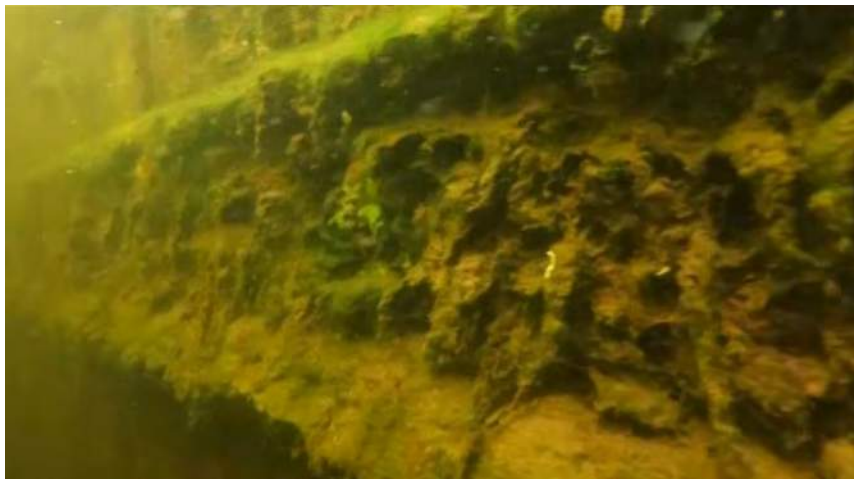
PHOTO # 58

Piles at bottom at 0+123
(east face)

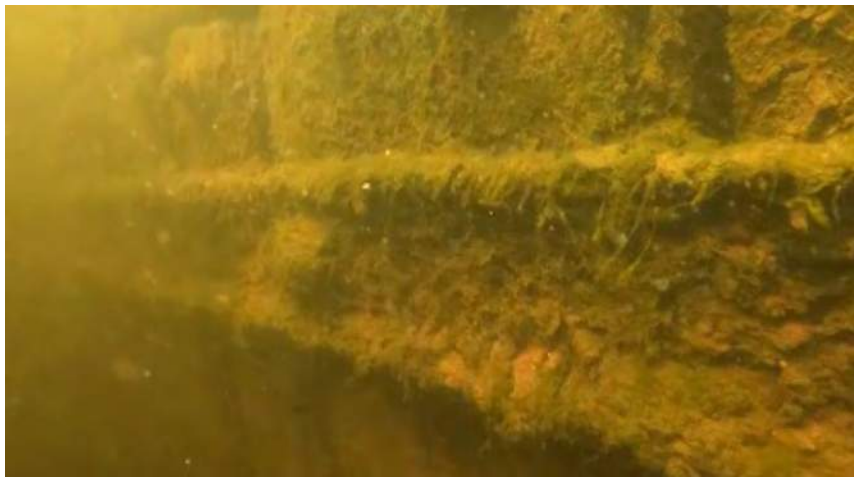
PHOTO # 61

Piles at bottom at 0+113
(east face)

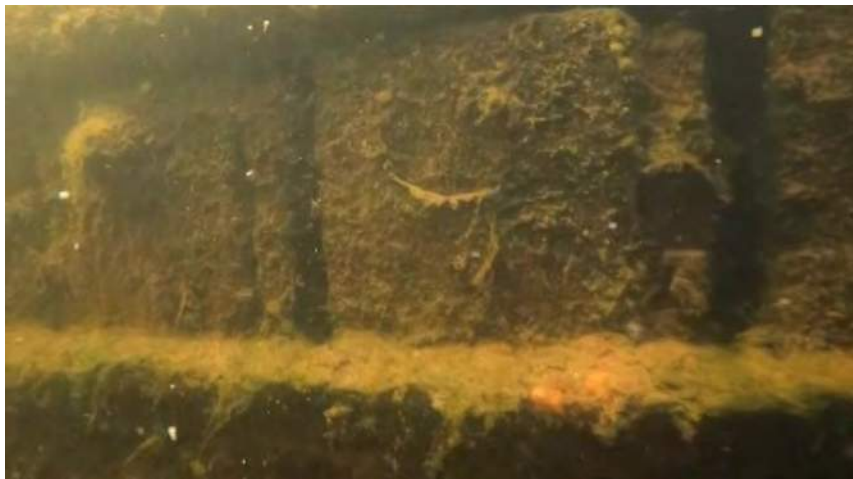
PHOTO # 64

Piles at bottom at 0+106
(east face)

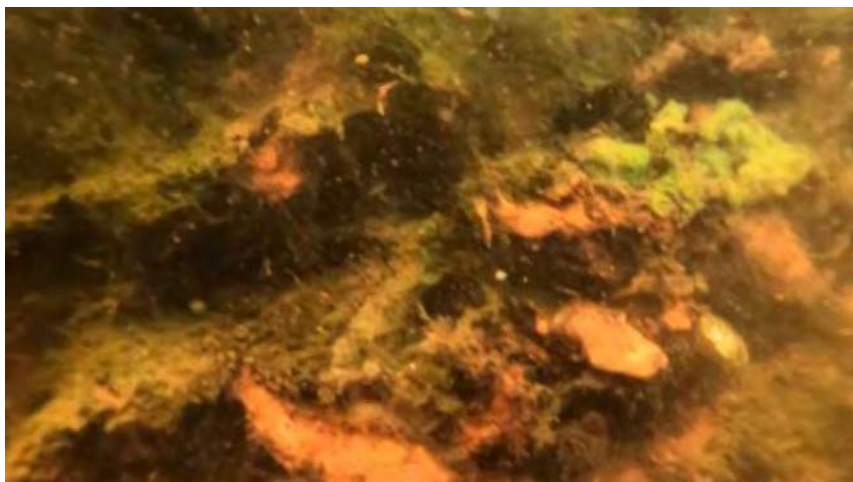
PHOTO # 65

Top of "C" channel 0+103
(east face)

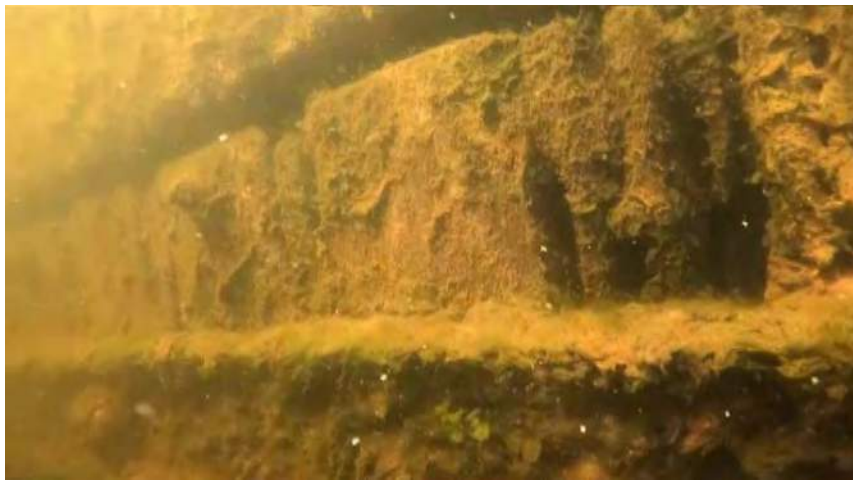
PHOTO # 66

Close up of typical
condition of "C" channel at
0+100 (east face)

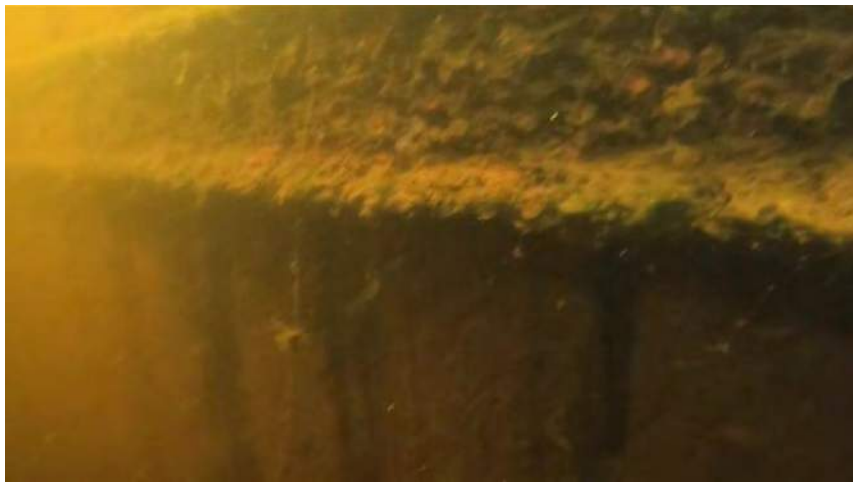
PHOTO # 67

Top of "C" channel 0+100
(east face)

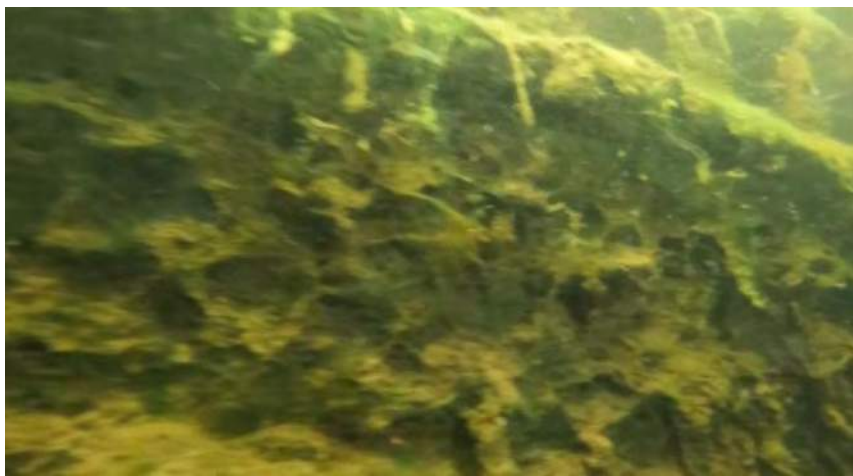
PHOTO # 68

"C" channel at 0+096 (east
side)

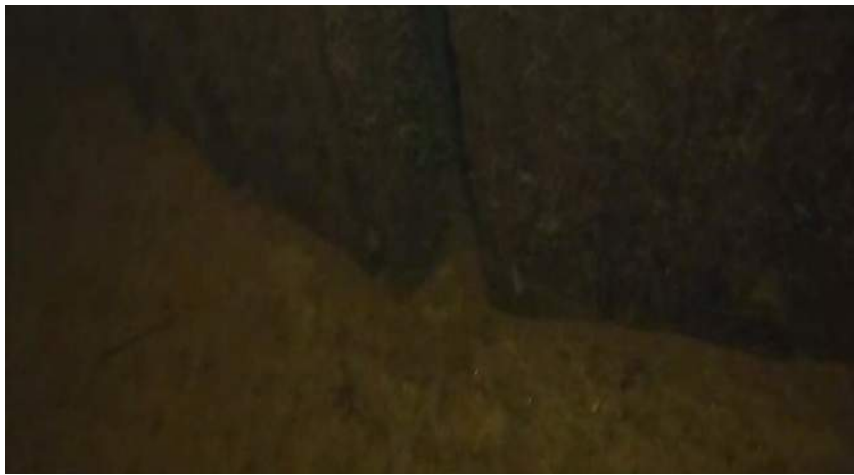
PHOTO # 69

Close up of typical
condition of "C" channel at
0+094 (east face)

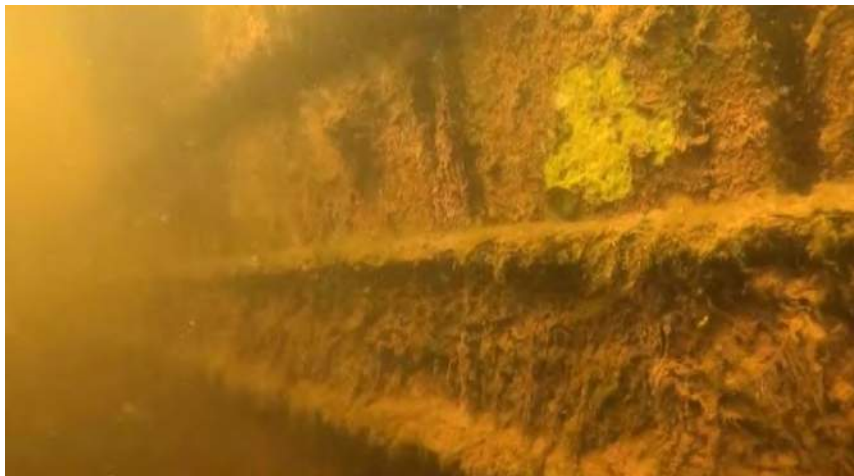
PHOTO # 71

Piles at bottom at 0+088
(east face)

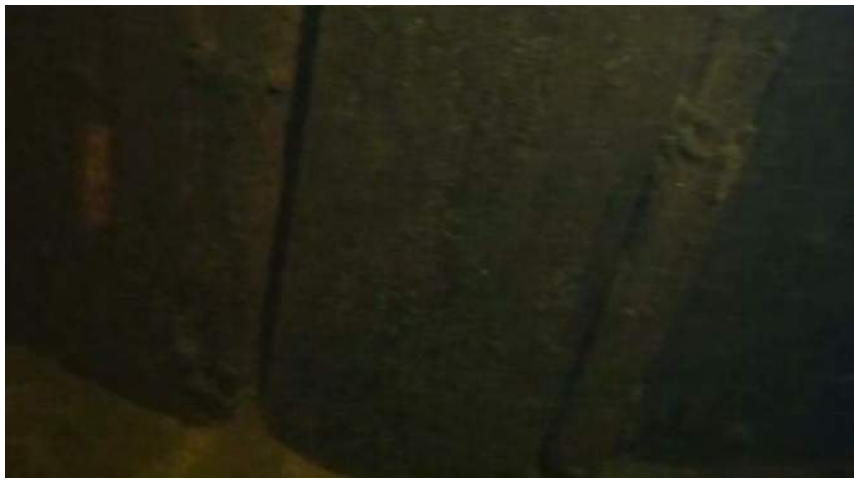
PHOTO # 72

"C" channel at 0+084 (east
side)

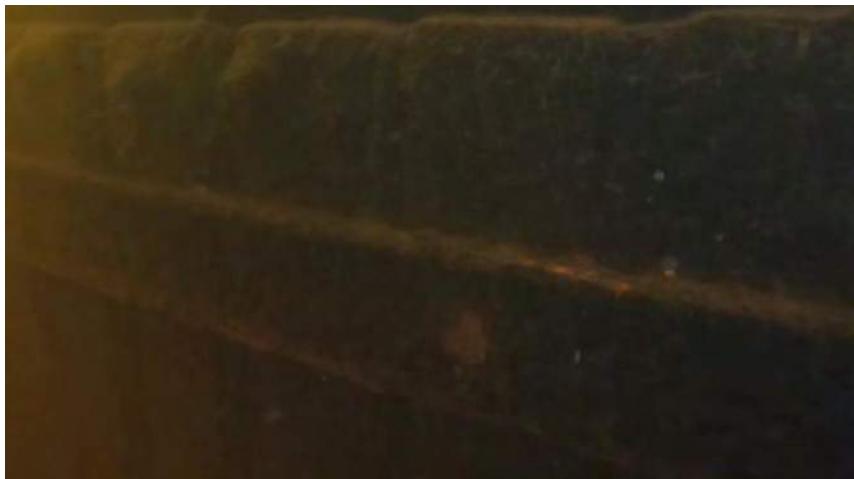
PHOTO # 73

Piles at bottom at 0+084
(east face)

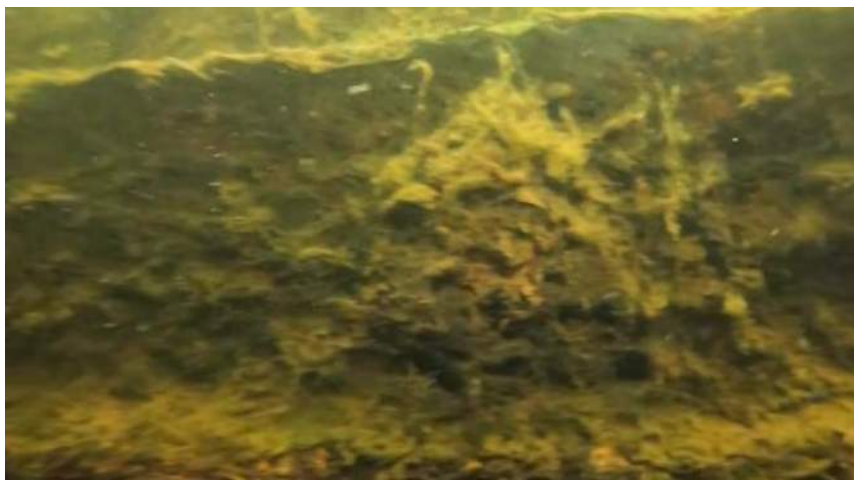
PHOTO # 74

Top of "C" channel 0+082
(east face)

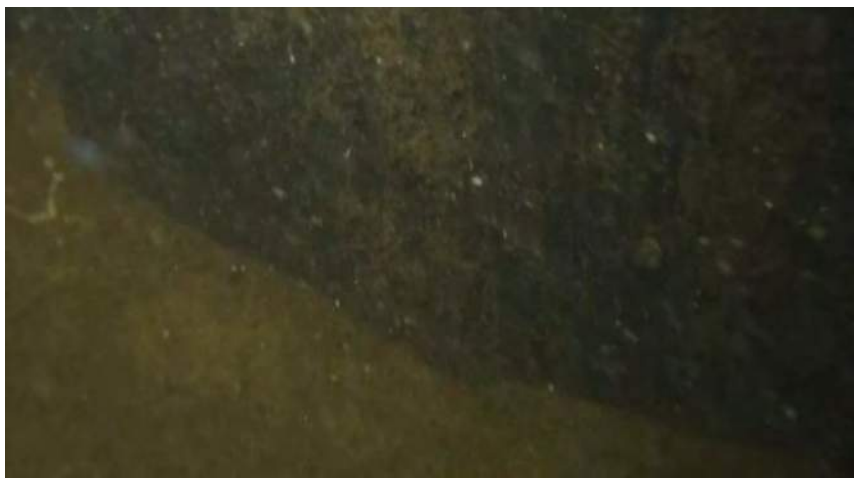
PHOTO # 77

Close up of typical
condition of "C" channel at
0+075 (east face)

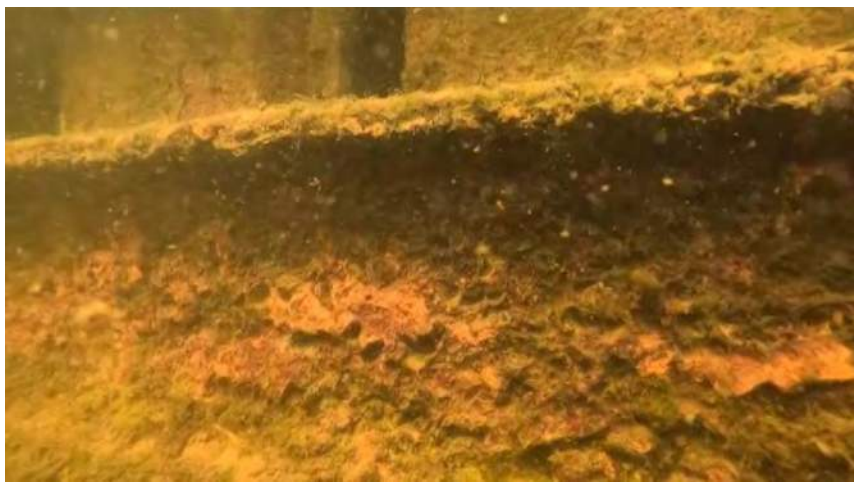
PHOTO # 80

Piles at bottom at 0+065 (east face)

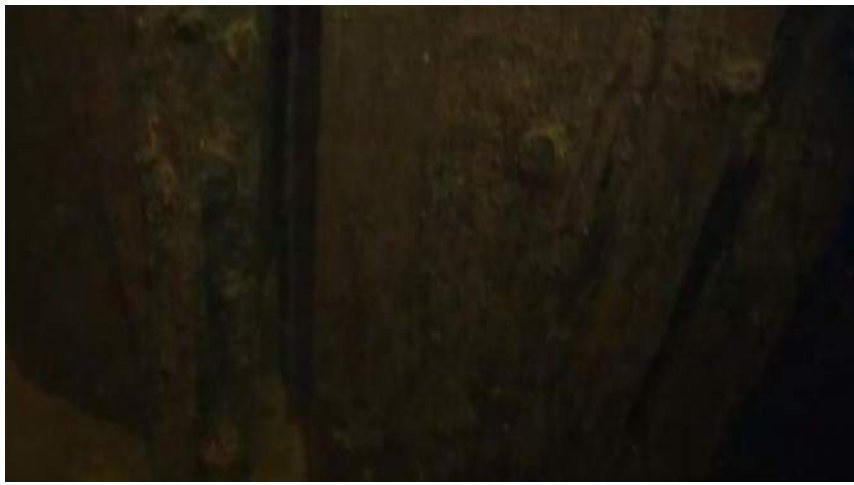
PHOTO # 81

"C" channel at 0+060 (east side)

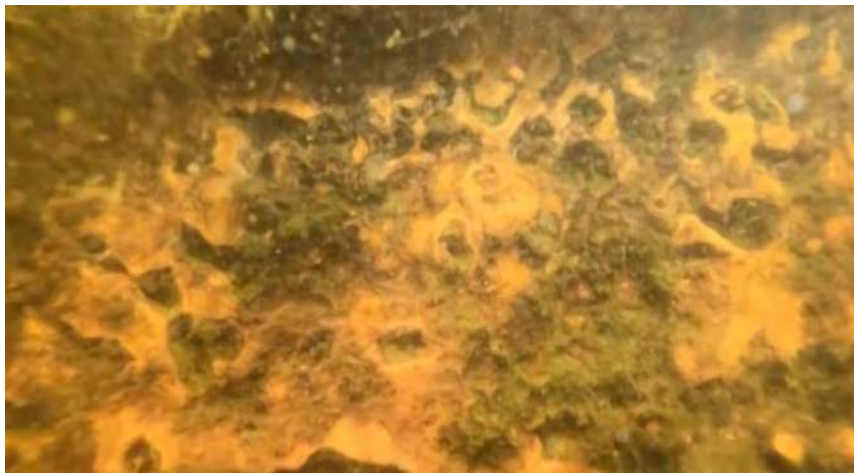
PHOTO # 82

Piles at bottom at 0+054
(east face)

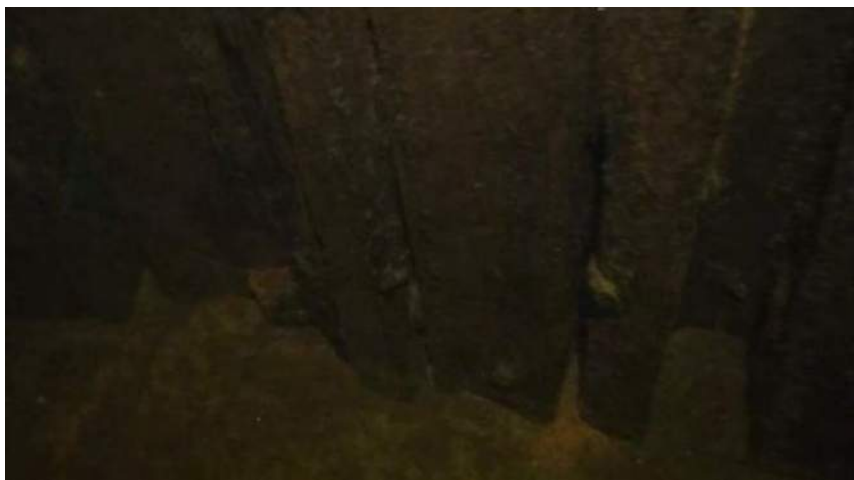
PHOTO # 83

Close up of typical
condition of "C" channel at
0+052 (east face)

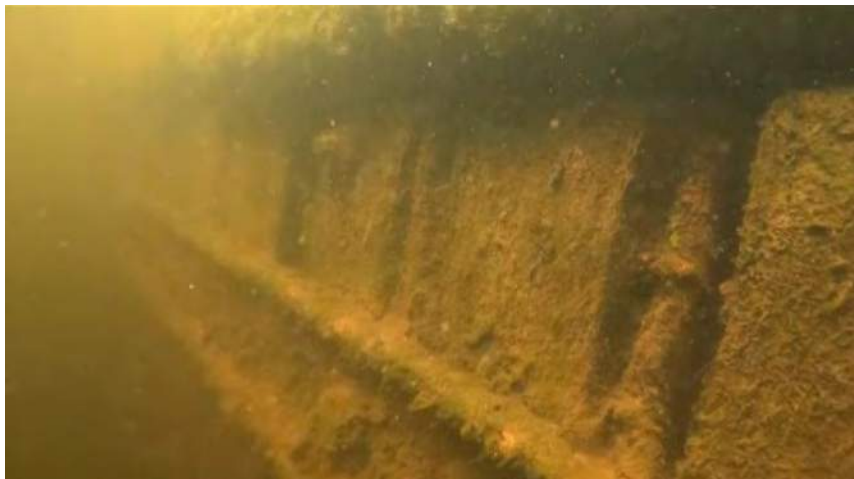
PHOTO # 85

Piles at bottom at 0+040
(east face)

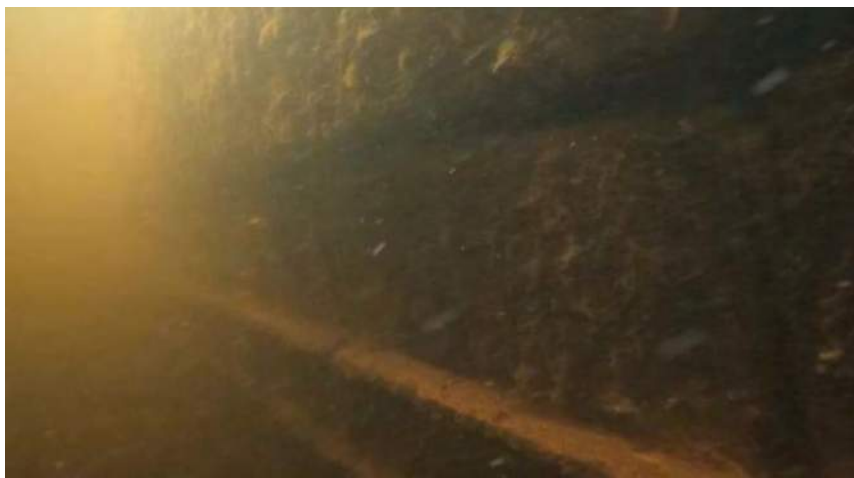
PHOTO # 86

Top of "C" channel 0+040
(east face)

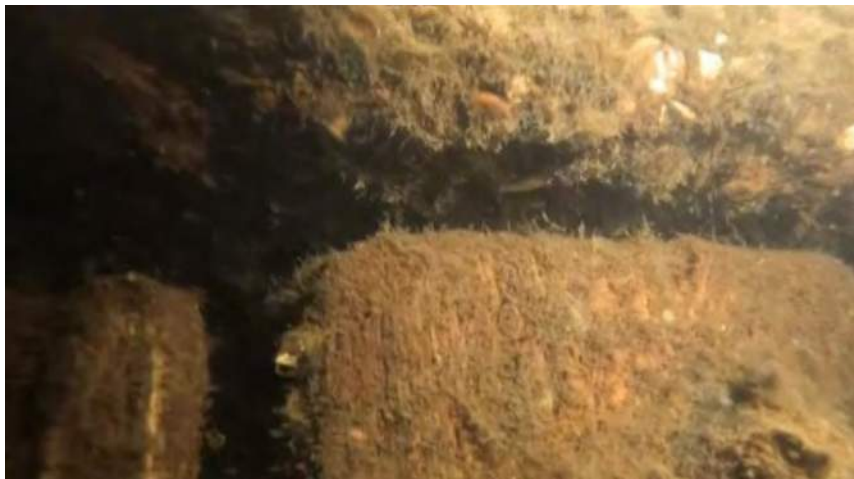
PHOTO # 88

Piles at bottom at 0+024
(east face)

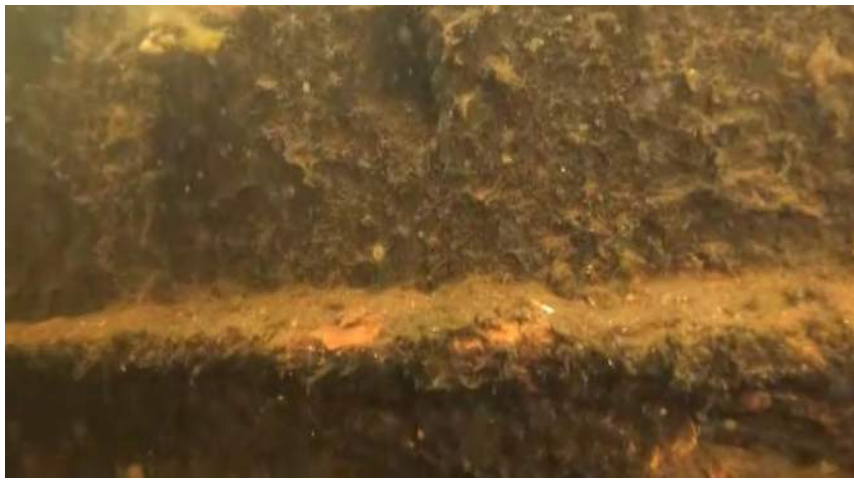
PHOTO # 89

Top of pile at 0+023 (east
side)

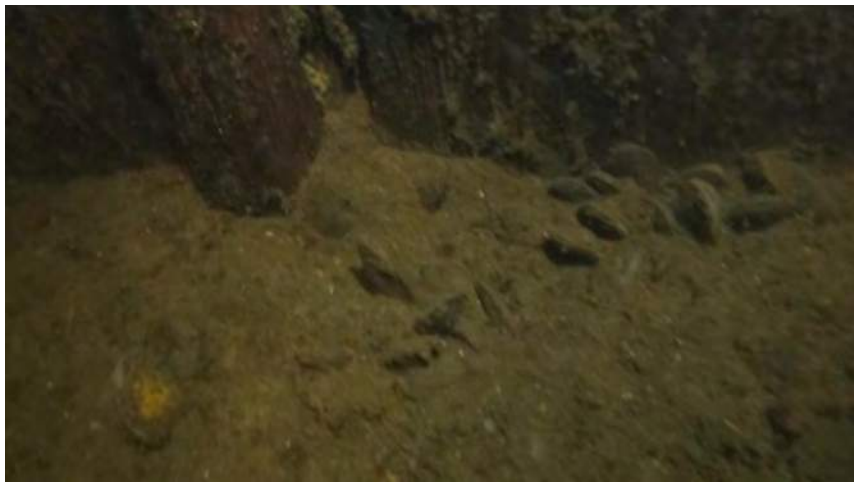
PHOTO # 90

Top of "C" channel 0+016
(east face)

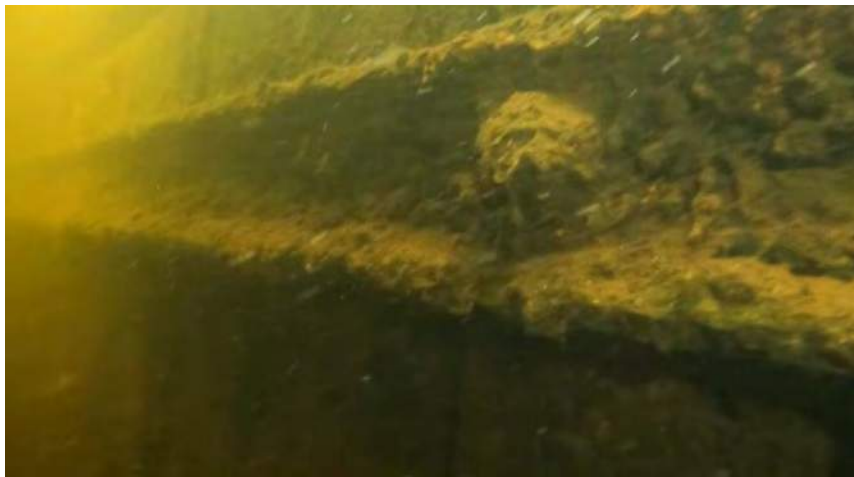
PHOTO # 91

Piles at bottom at 0+010
(east face)

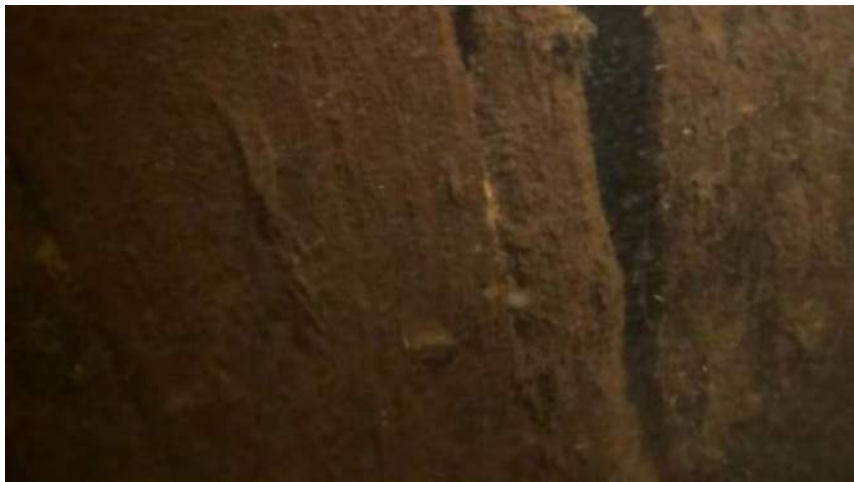
PHOTO # 92

"C" channel at 0+010 (east
side)

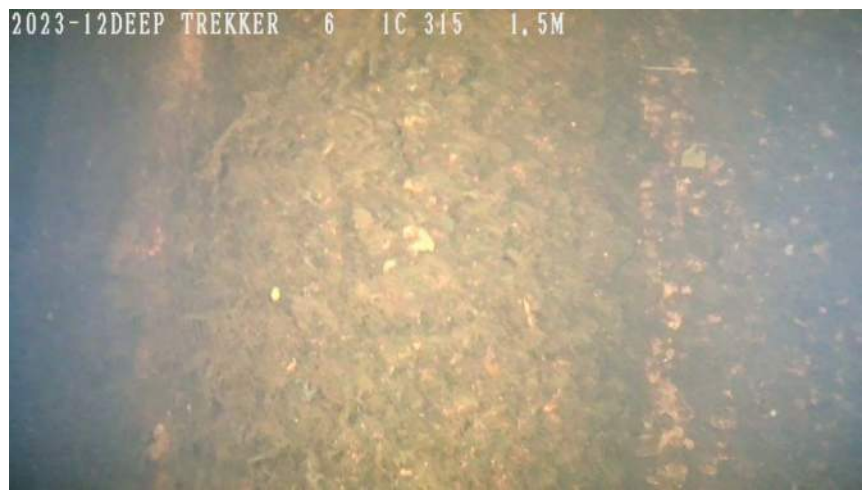
PHOTO # 93

Piles at 0+004 (east side)

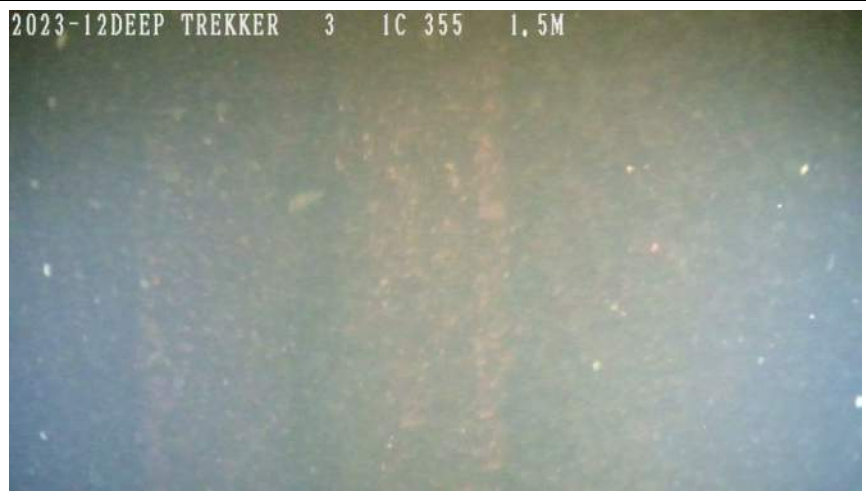
PHOTO # 94

Typical steel sheet pile
condition at 0+000

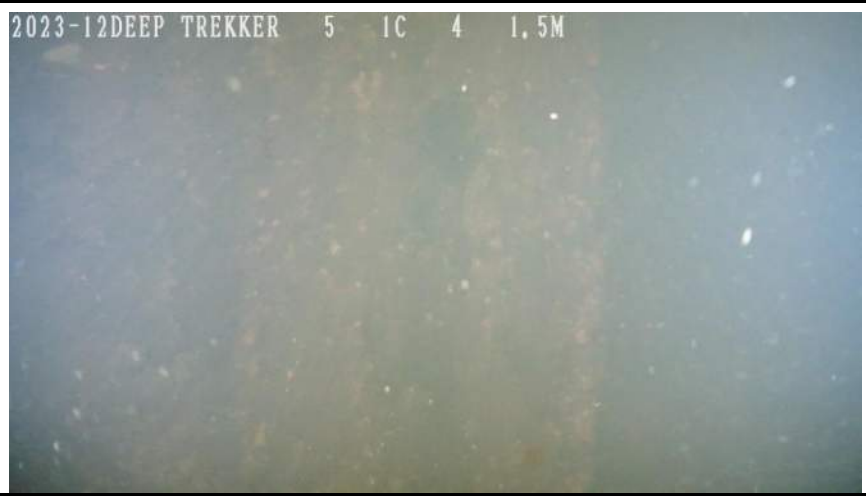
PHOTO # 95

Typical steel sheet pile
condition at -0+002

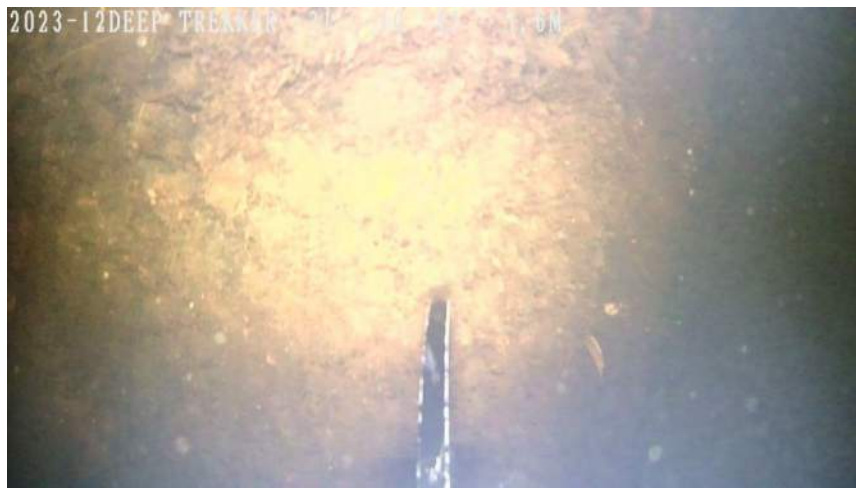
PHOTO # 97

Typical steel sheet pile
condition at -0+005

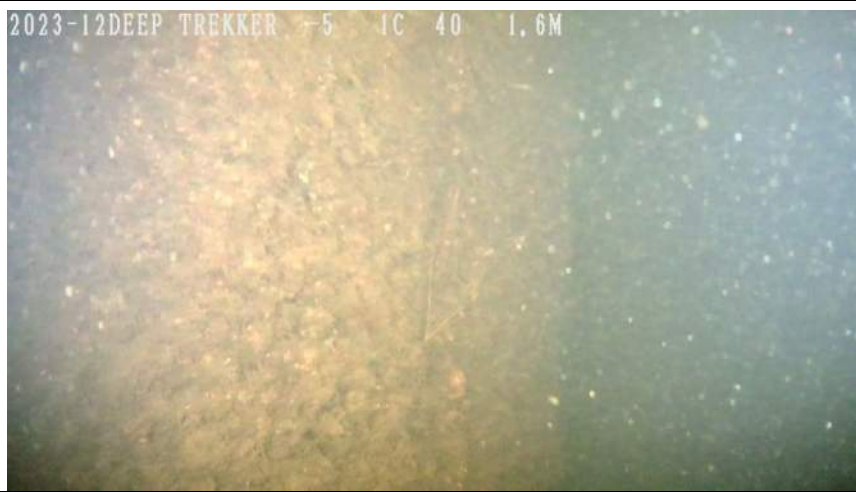
PHOTO # 98

Typical steel sheet pile
condition at -0+007

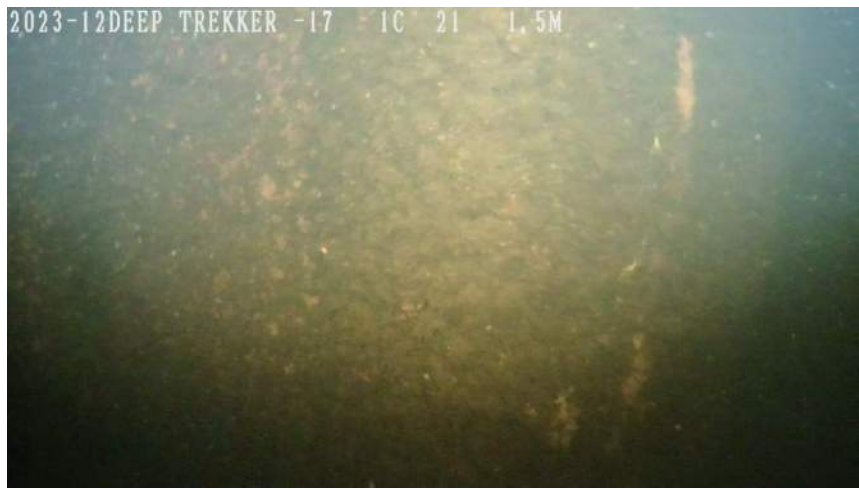
PHOTO # 100

Typical steel sheet pile condition at -0+010

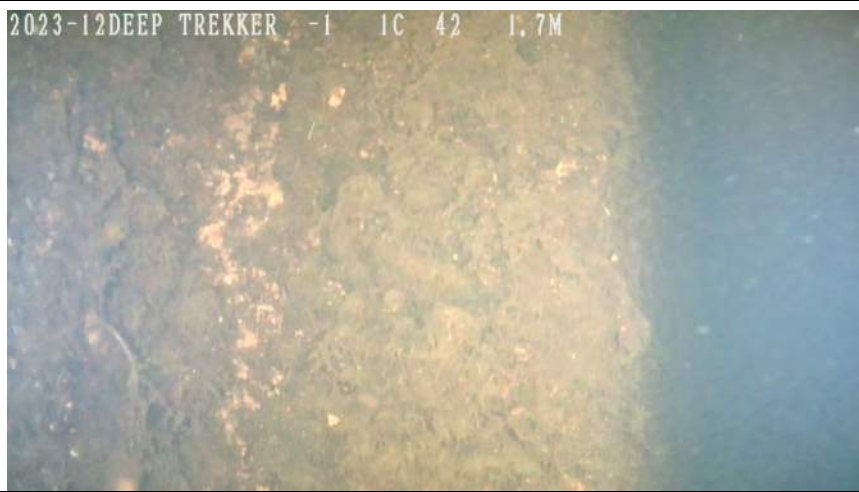
PHOTO # 101

Typical steel sheet pile condition at -0+012

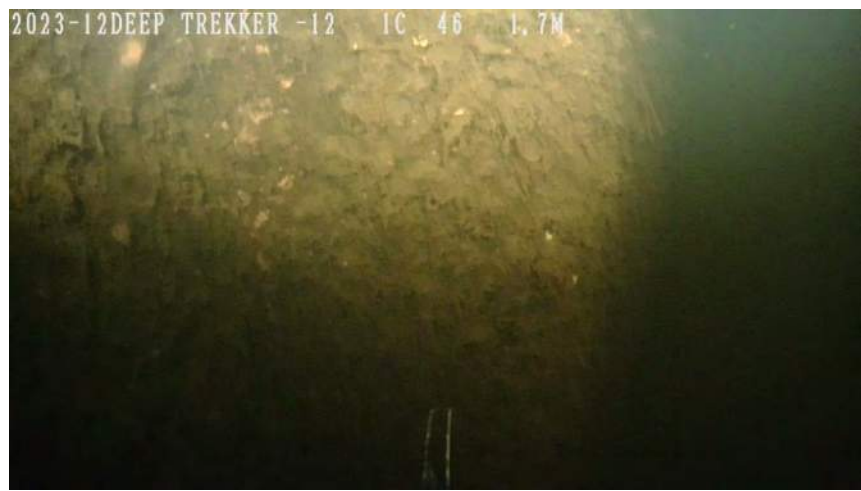
PHOTO # 102

Typical steel sheet pile condition at -0+015

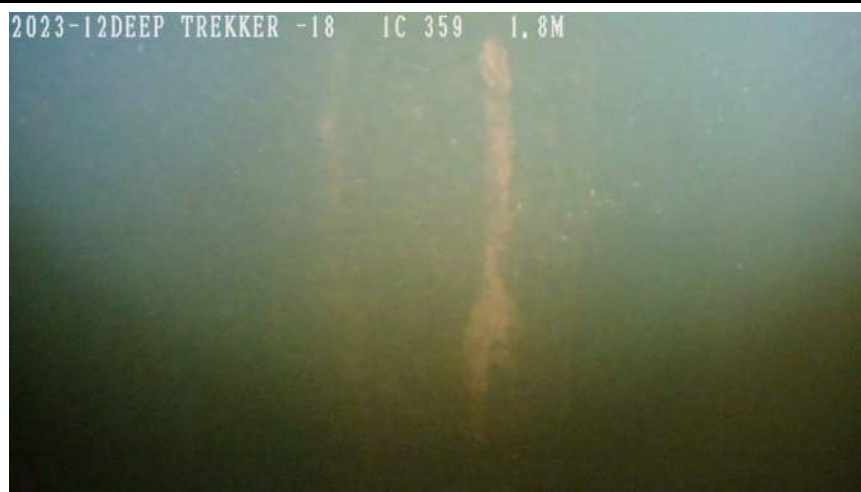
PHOTO # 104

Typical steel sheet pile condition at -0+018

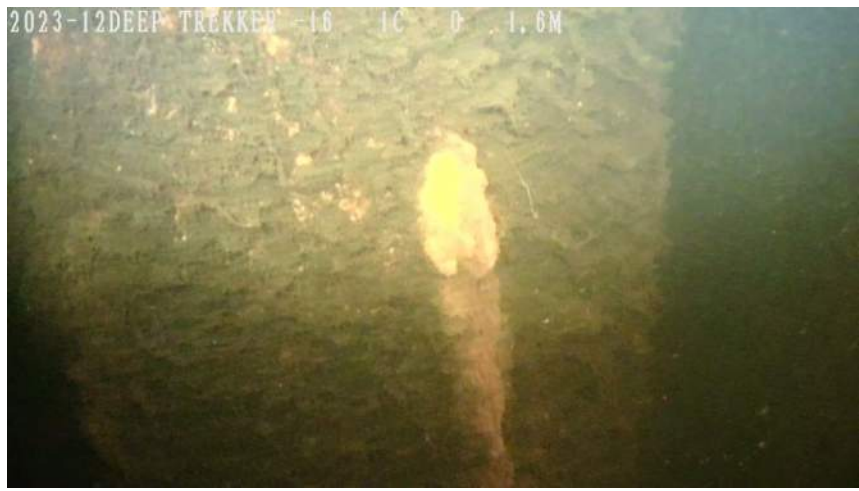
PHOTO # 105

Typical steel sheet pile condition at -0+020

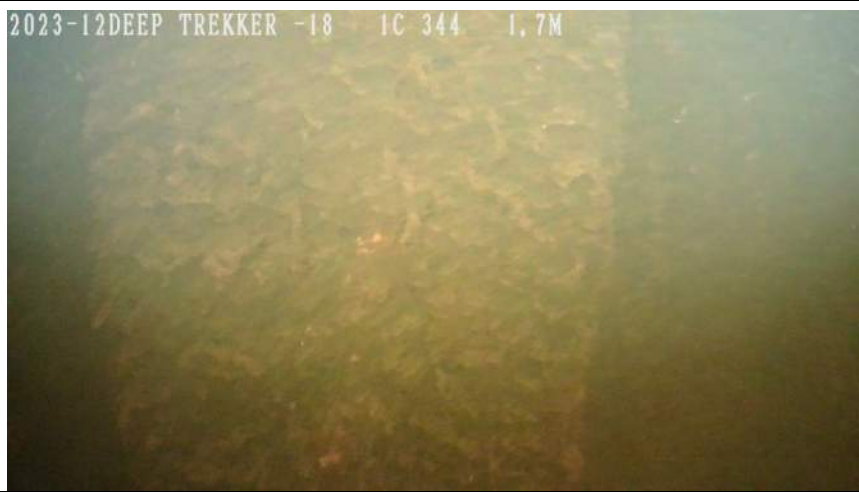
PHOTO # 107

Typical steel sheet pile
condition at -0+027

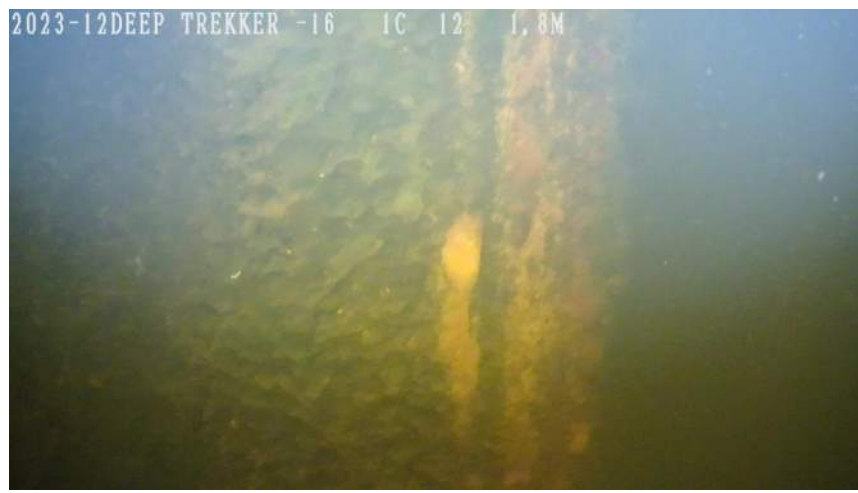
PHOTO # 108

Typical steel sheet pile
condition at -0+029

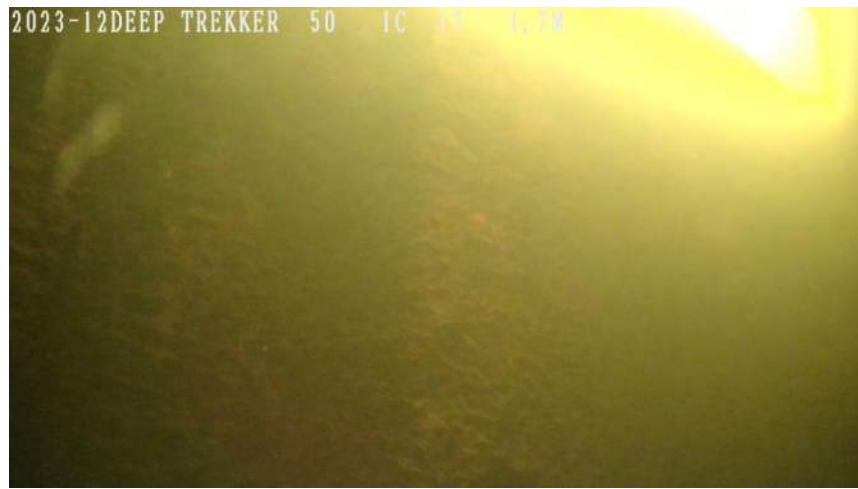
PHOTO # 109

Typical steel sheet pile condition at -0+031

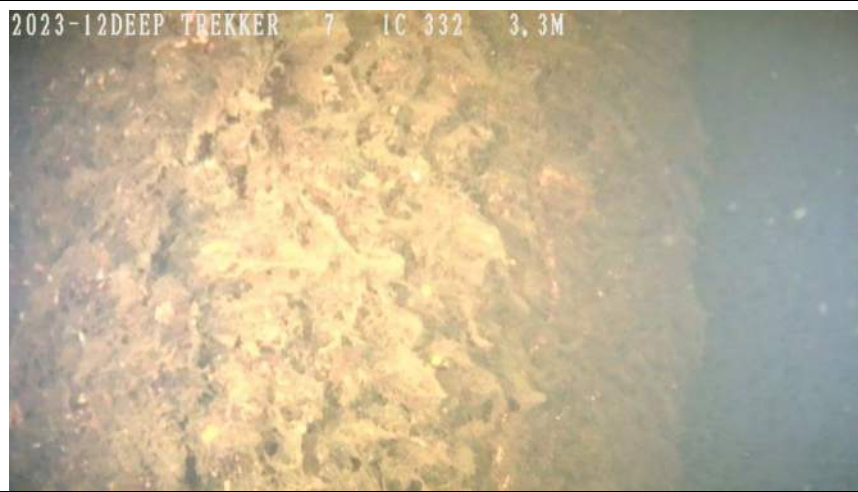
PHOTO # 110

Typical steel sheet pile condition at -0+034

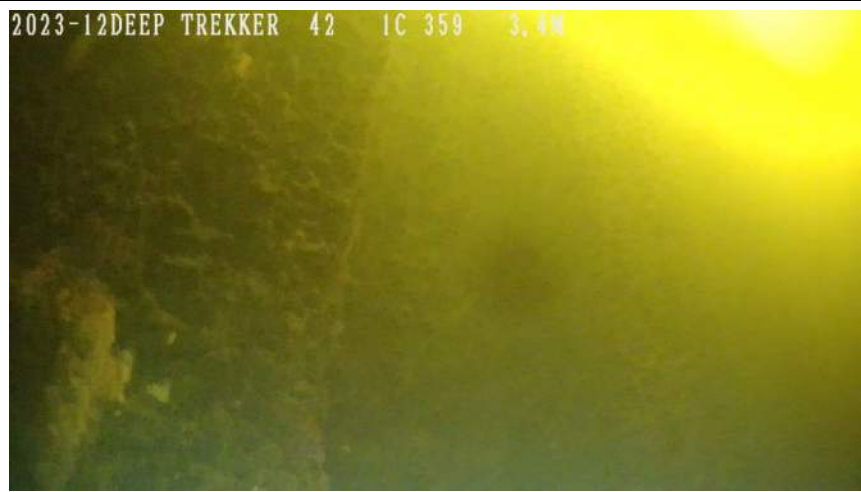
PHOTO # 112

Typical steel sheet pile
condition at -0+038

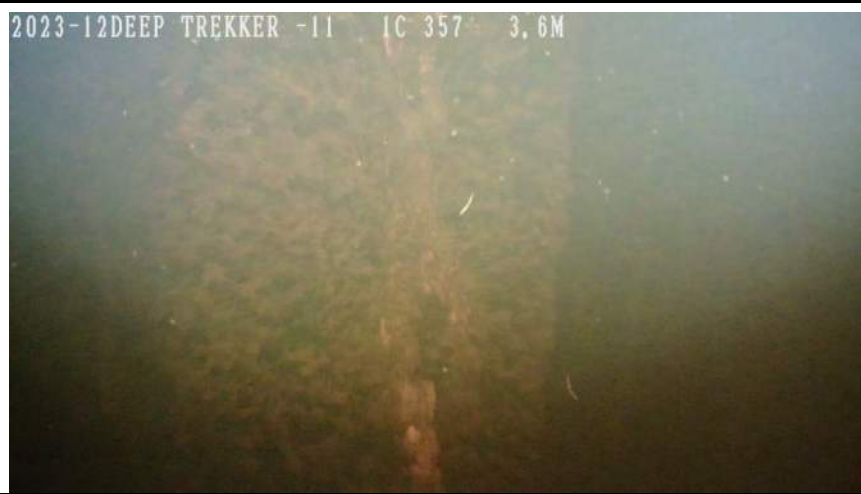
PHOTO # 113

Typical steel sheet pile
condition at -0+041

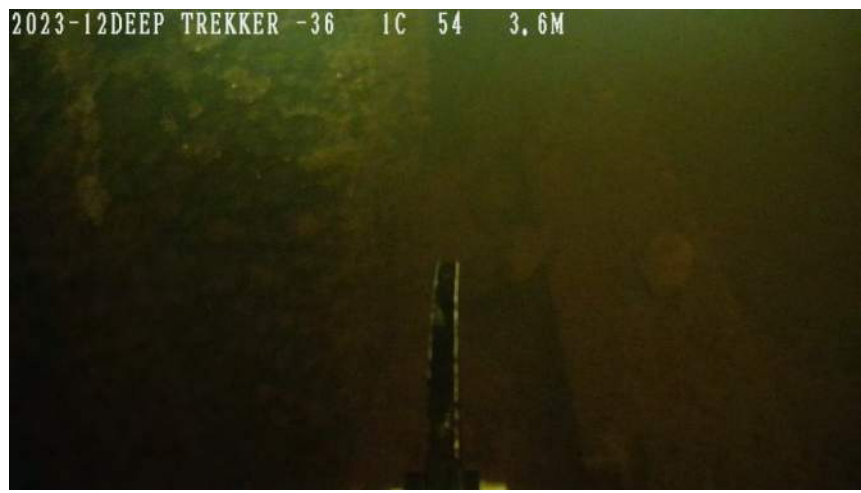
PHOTO # 114

Typical steel sheet pile
condition at -0+043

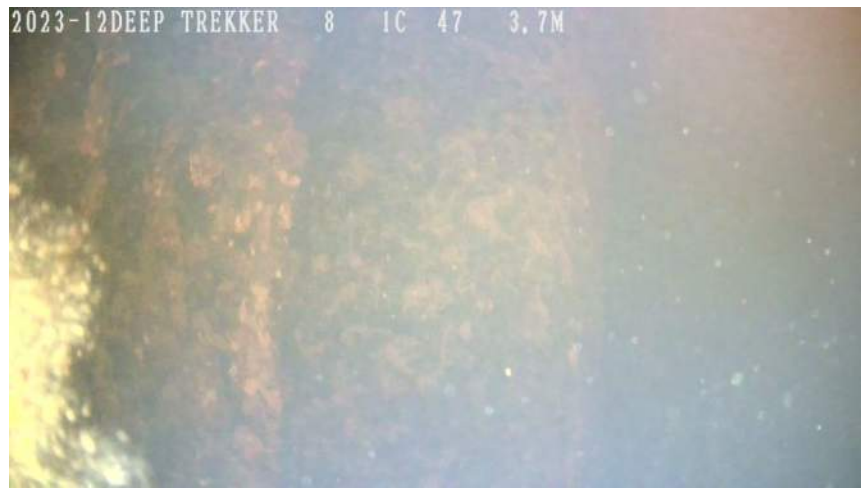
PHOTO # 115

Typical steel sheet pile condition at -0+045

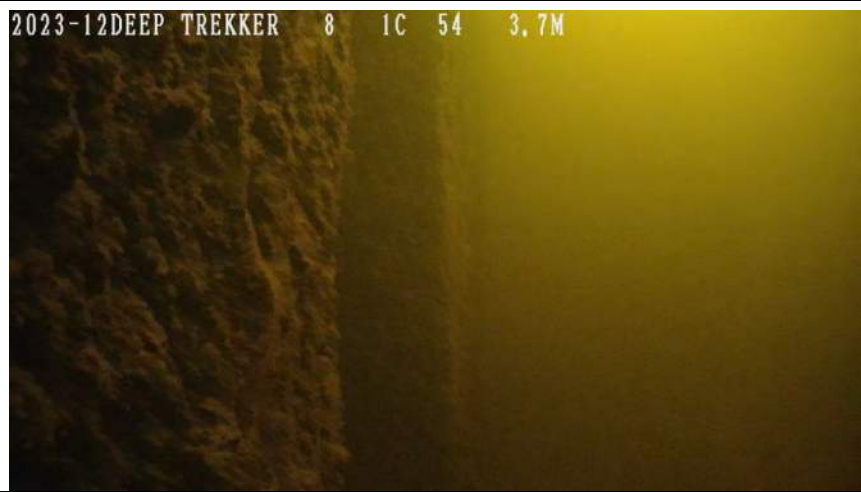
PHOTO # 116

Typical steel sheet pile condition at -0+051

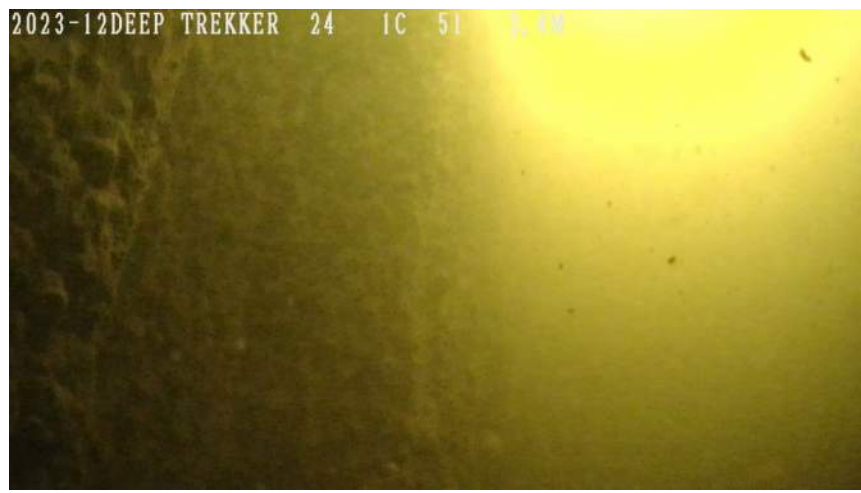
PHOTO # 117

Typical steel sheet pile condition at -0+055

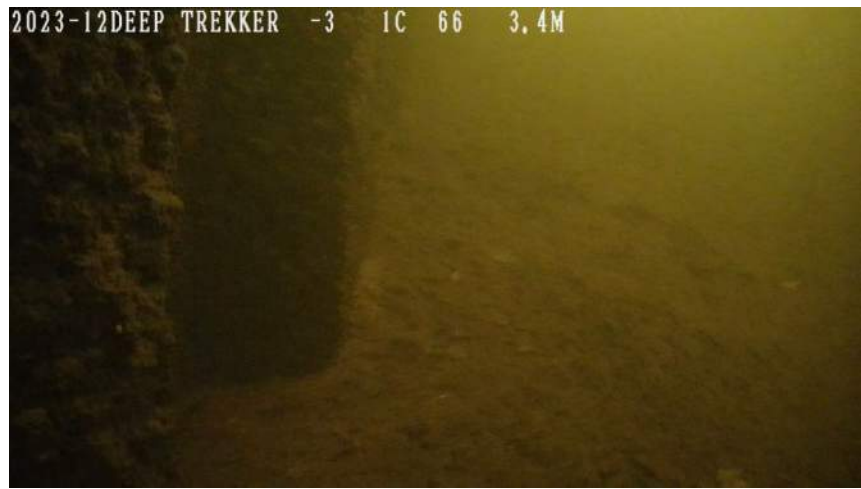
PHOTO # 118

Typical steel sheet pile condition at -0+060

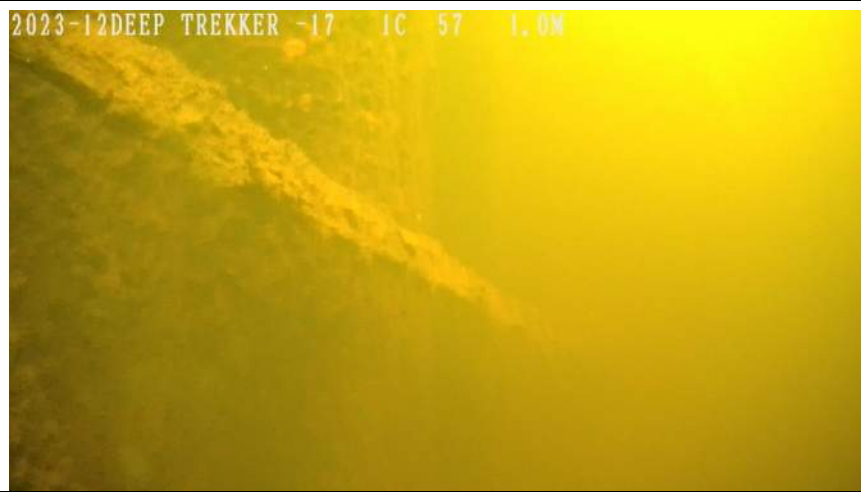
PHOTO # 119

Typical steel sheet pile condition at -0+064
