Parry Sound Harbour, Ontario

Bay St. Wharf (#401)
Condition Assessment Report

Small Craft Harbours, Fisheries and Oceans Canada

March 2024

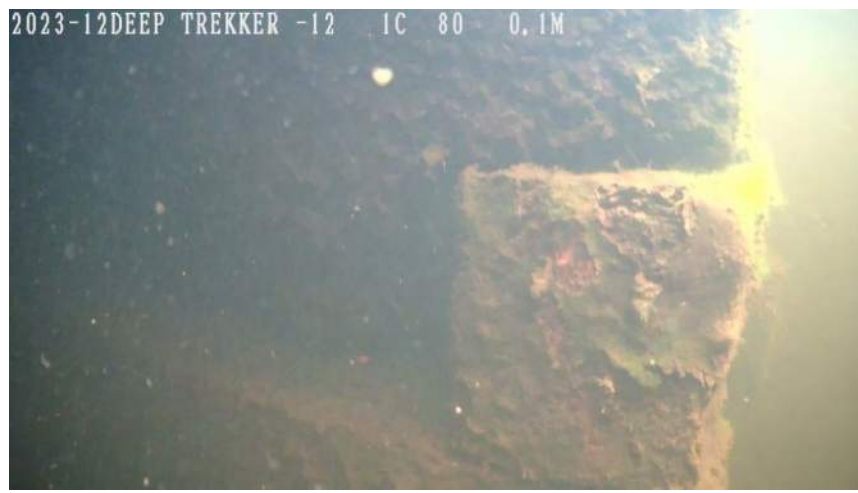
PHOTO # 120

Typical steel sheet pile condition at -0+070

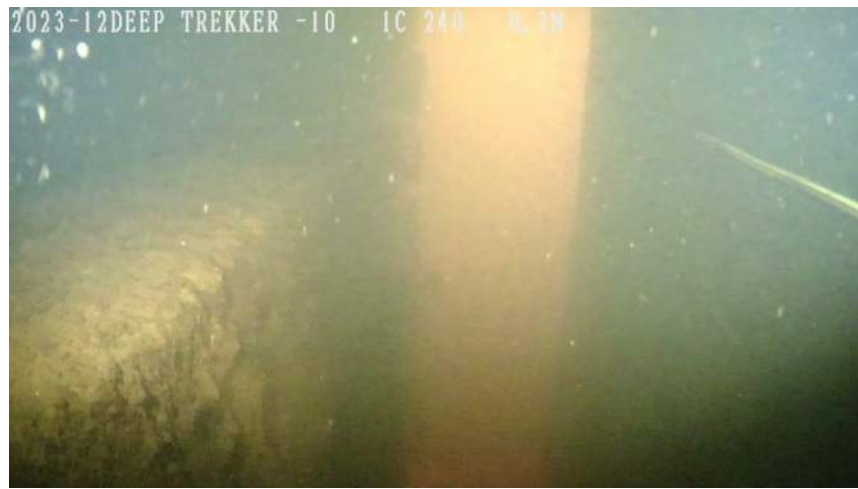
PHOTO # 121

Where sheet pile ends and timber cribbing starts at -0+076

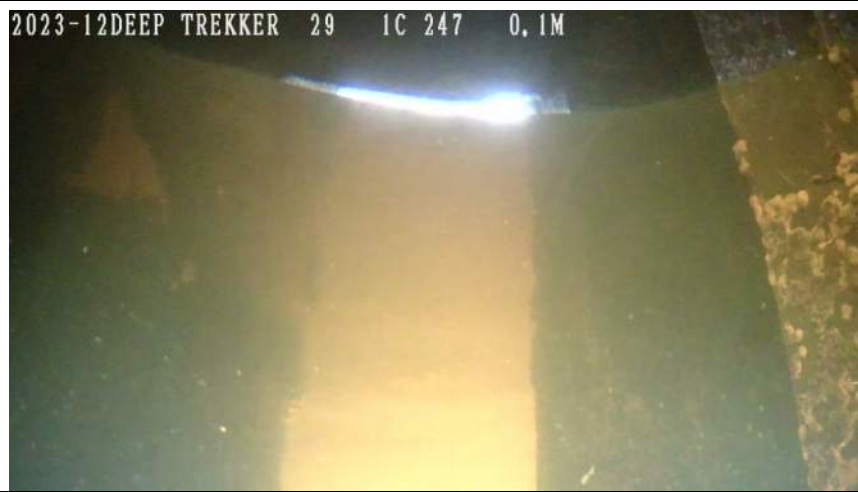
PHOTO # 122

Transition between sheet pile and timber cribbing at 0+076

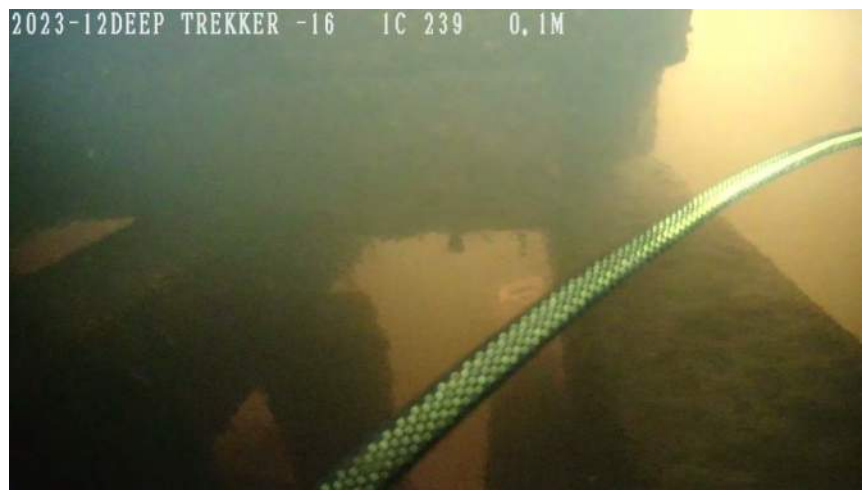
PHOTO # 123

Transition between sheet pile and timber cribbing at 0+076

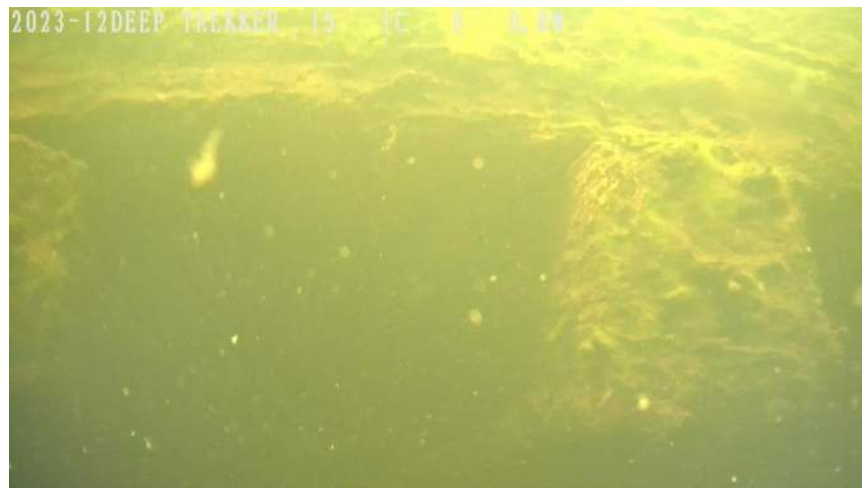
PHOTO # 124

Transition between sheet pile and timber cribbing at 0+076

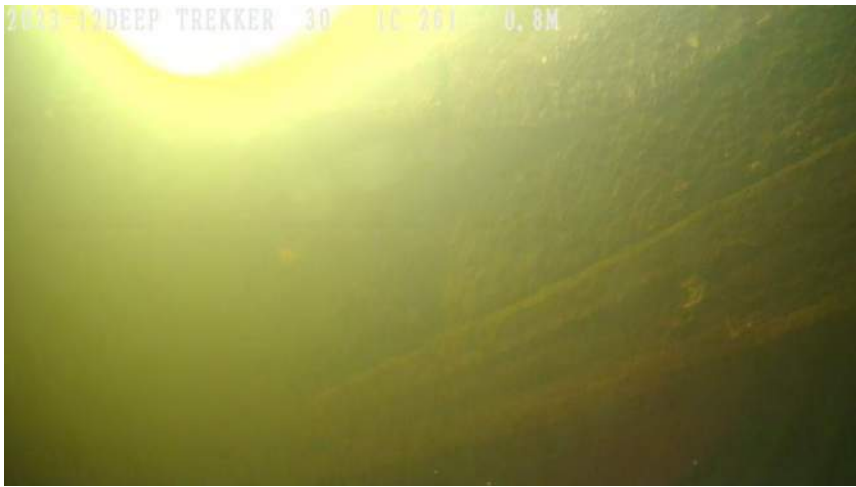
PHOTO # 127

General condition of
timber cribbing at -0+079

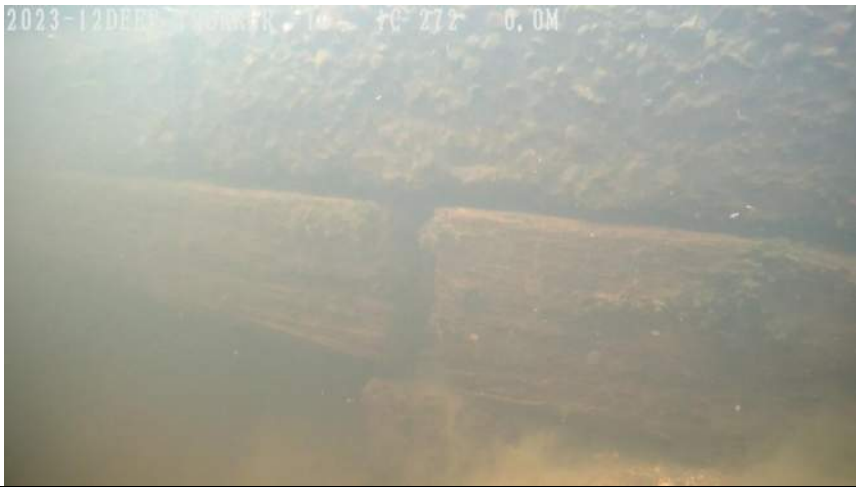
PHOTO # 128

General condition of
timber cribbing at -0+080

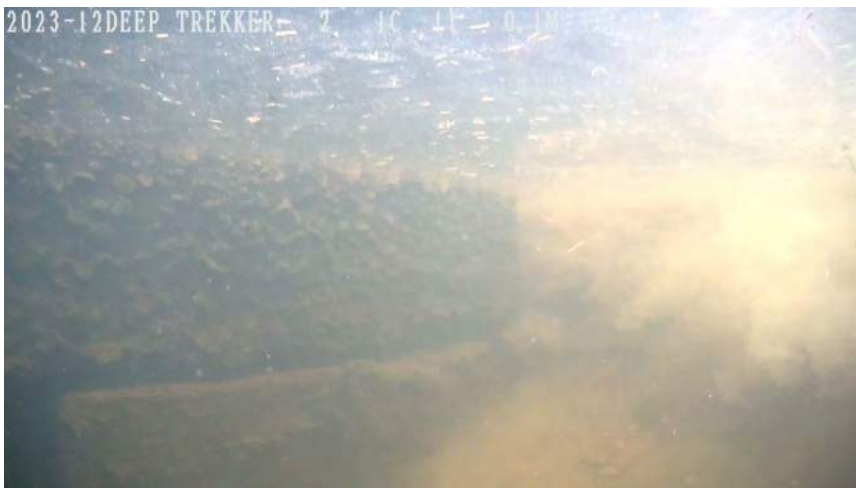
PHOTO # 129

General condition of
timber cribbing at -0+081

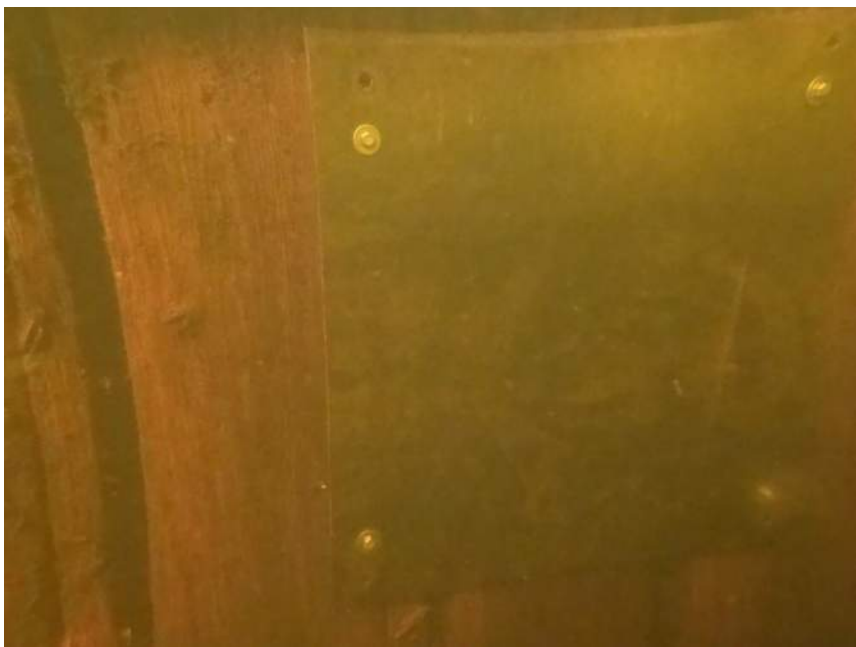
PHOTO # 131

General photo showing the hole patch in the timber
